## **Seaman Corporation**

# Improved Polyurethane Storage Tank Performance

Contract No. SP0600-04-D-5442, Delivery Order 1029

## **FY2009 Final Technical Report**

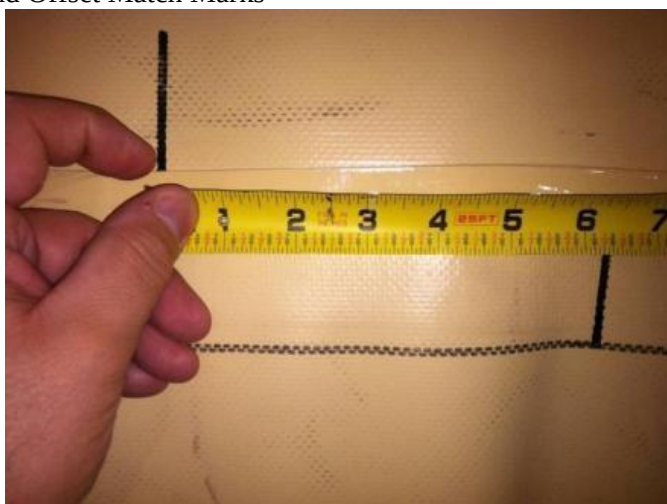
Figure 4.5.6 – Belly Band Offset Match Marks

If the feed rates vary between the belly band weld to the top versus the bottom blanket, a counter twist between tank top and bottom could be introduced which may potentially cause the tank to be unstable when filled with fluid. The fabricator who welded this tank has experience with a similar design of their own and cannot see it being done practically in any size larger than 3,000 gallons. The twist is much more predominant if the top and bottom are started in opposite directions. When the tank is flipped over and set-up for the easiest feed through the welder it aligns the material in the opposite direction from the initial weld. The picture below illustrates that even though the initial match marks were aligned, by the time the band came to a close the match marks were off by > 6 inches (Figure 4.5.6). It appears that this difference increases when the fill direction on the belly band panel opposes the warp direction on the top and / or bottom blankets.

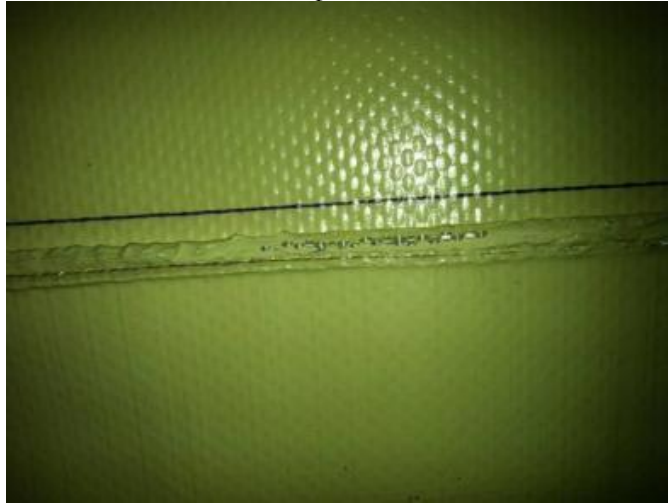
Figure 4.5.18 – Exposed Fiber Bundle Due to Compound Overflow

A few additional issues were captured during the RF welding process. If welding multiple plies does not appear to create an integral weld at the appropriate power setting, increasing the platen pressure or weld power should be the first options tried. In some instances, a closing seam weld was hit multiple times to get an integral weld. However, too much compound flow may occur leaving either a damaged fiber bundle at the seam or exposed scrim (Figure 4.5.18).

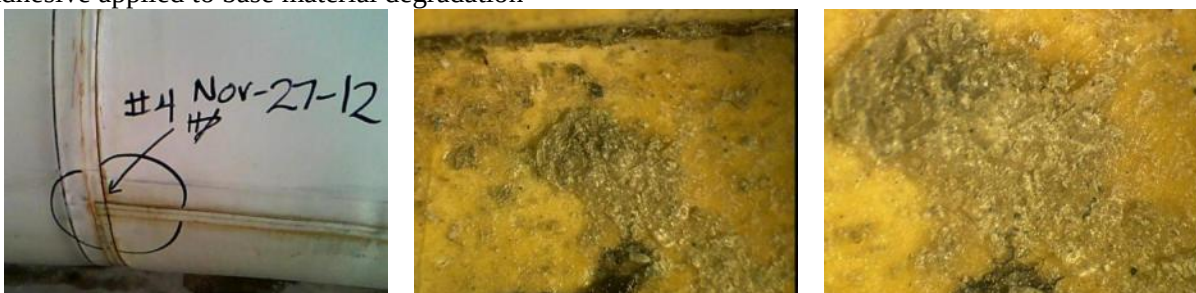
Figure 5.4.81 – Class II – T24-4 – T-Seam Closing – 27 NOV 12  
Adhesive applied to base material degradation

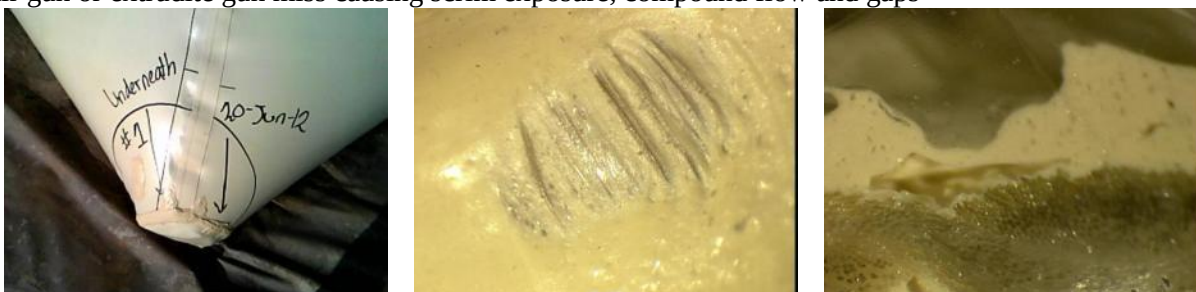
Figure 5.4.82 – Class II – T28-1 – Corner – 20 JUN 12  
Air gun or extrudite gun miss causing scrim exposure, compound flow and gaps

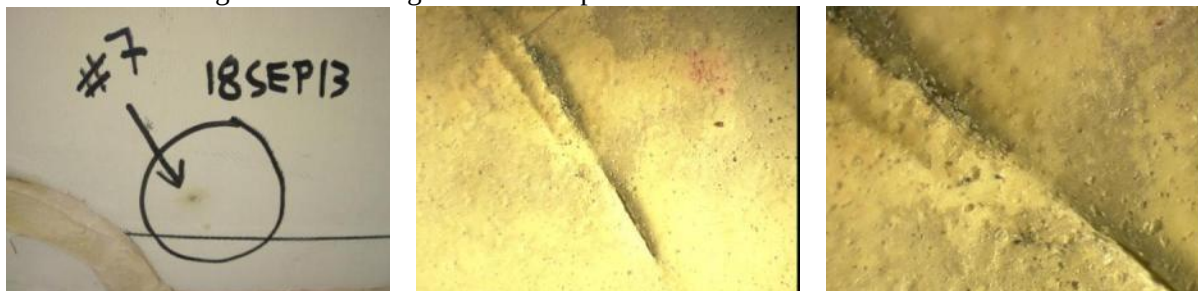
Figure 5.4.84 – Class I – T10-7 – Panel – 18 SEP 13  
Hot air or extrudite gun miss forming crack in compound

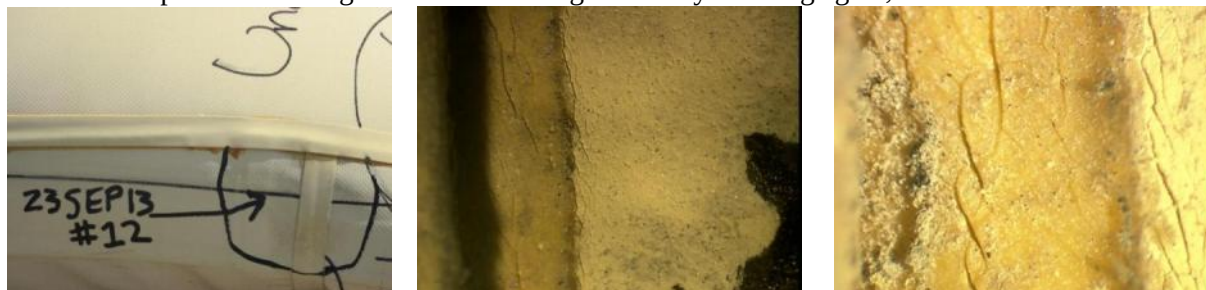
Figure 5.4.90 – Class I – T20-12 – T-Seam Closing – 23 SEP 13  
Localized compound stiffening and stress cracking caused by cleaning agent, adhesive or both

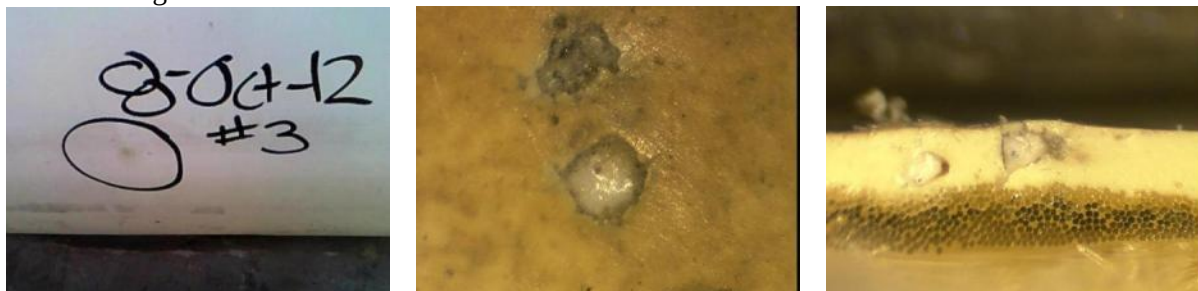
Figure 5.4.92 – Class I – T24-3 – Panel – 8 OCT 12  
Internal coating contamination

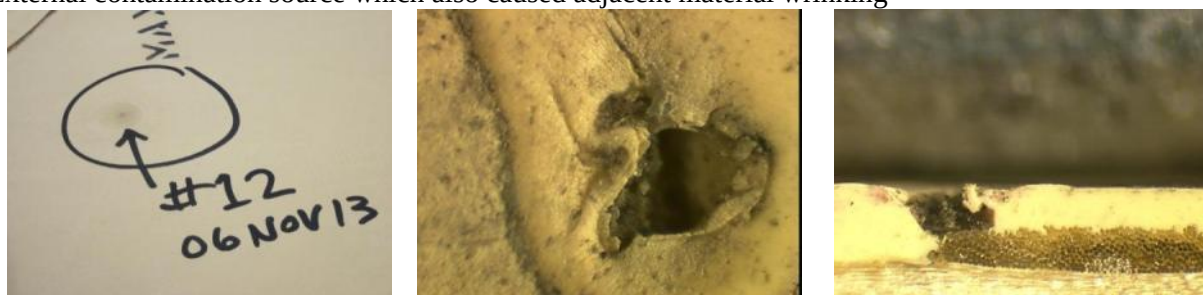
Figure 5.4.93 – Class I – T24-12 – Panel – 6 NOV 13  
External contamination source which also caused adjacent material wrinkling

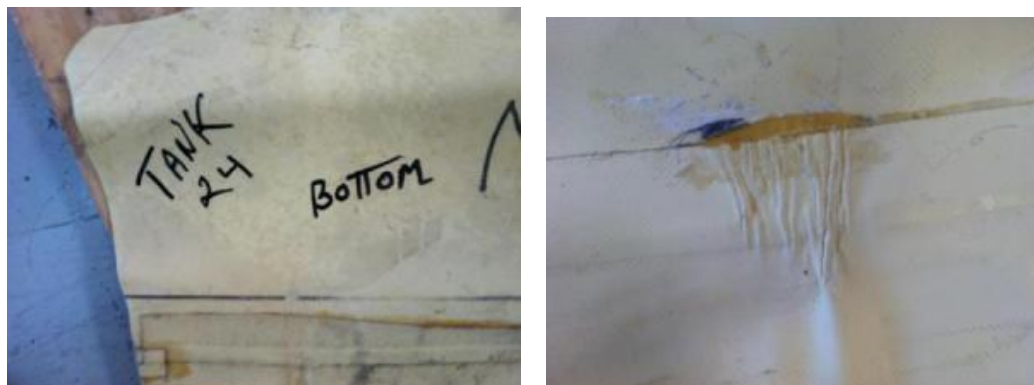
Figure 5.4.115 – No Leak Observed – T24 – Found during extraction  
Major wrinkle in bottom of Tank 24 closing cross seam – no leak noted, however, impossible to see in field
