AFRL-RQ-WP-TR-2014-0231

Douglas M. Yost, Adam C. Brandt, and Gregory A.T. Hansen
Southwest Research Institute (SwRI®)

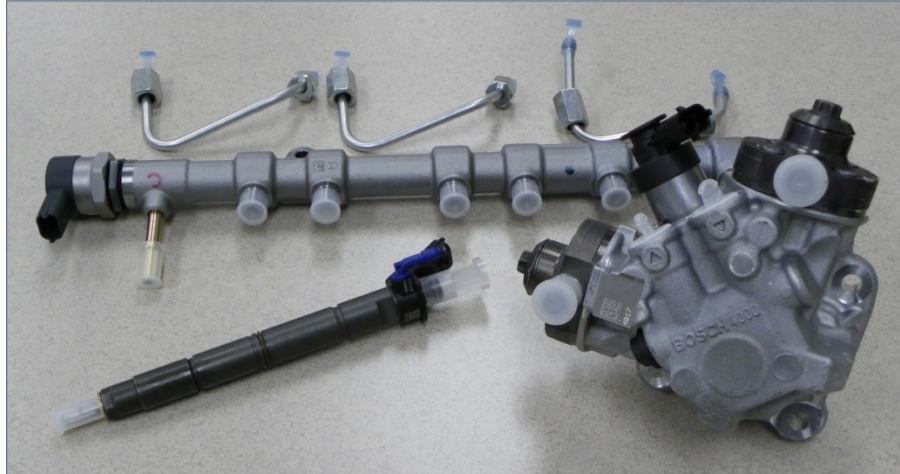
Figure A-2. For 6.7L Fuel Injection Pump, Rail, and Injector

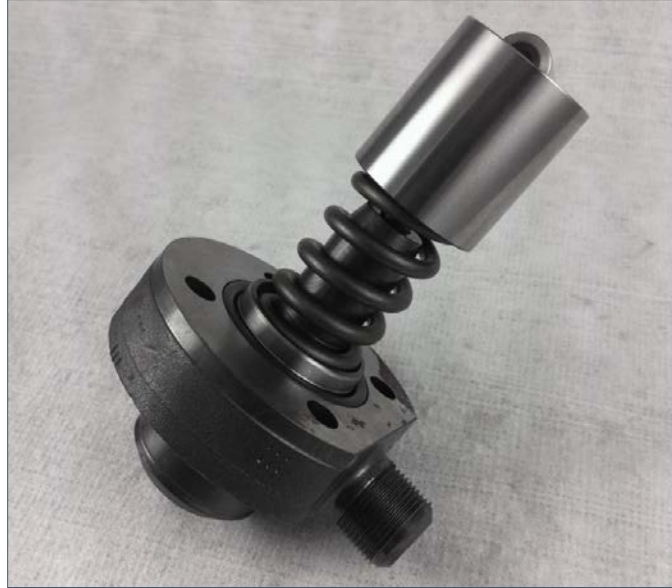
Figure A-3. Camshaft Follower and High Pressure Plunger and Barrel Assembly

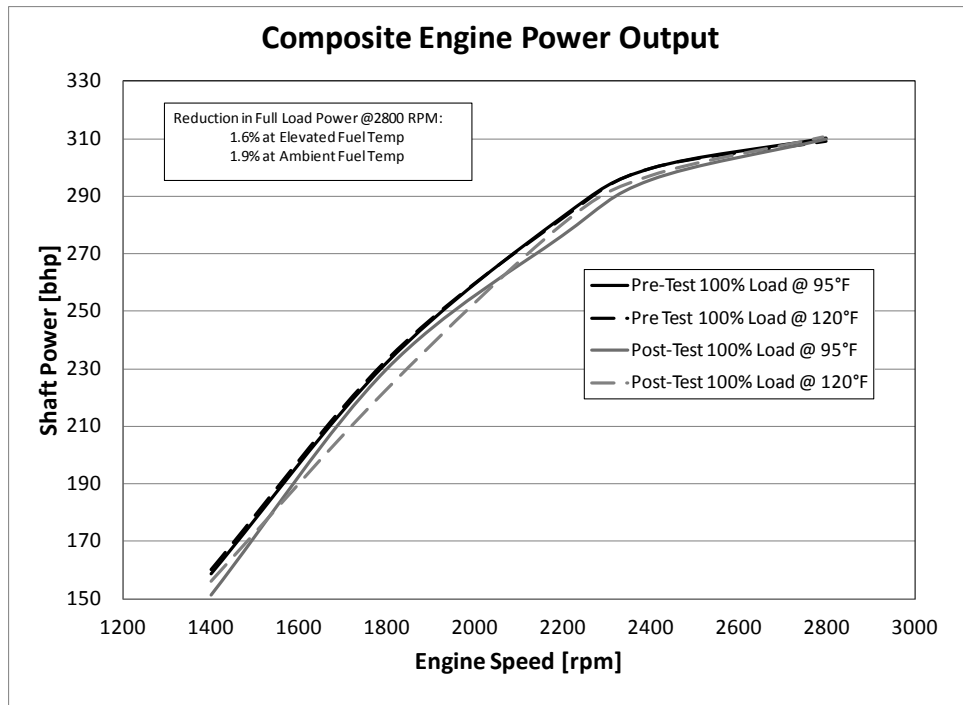
Figure A-7. Composite Engine Power Output

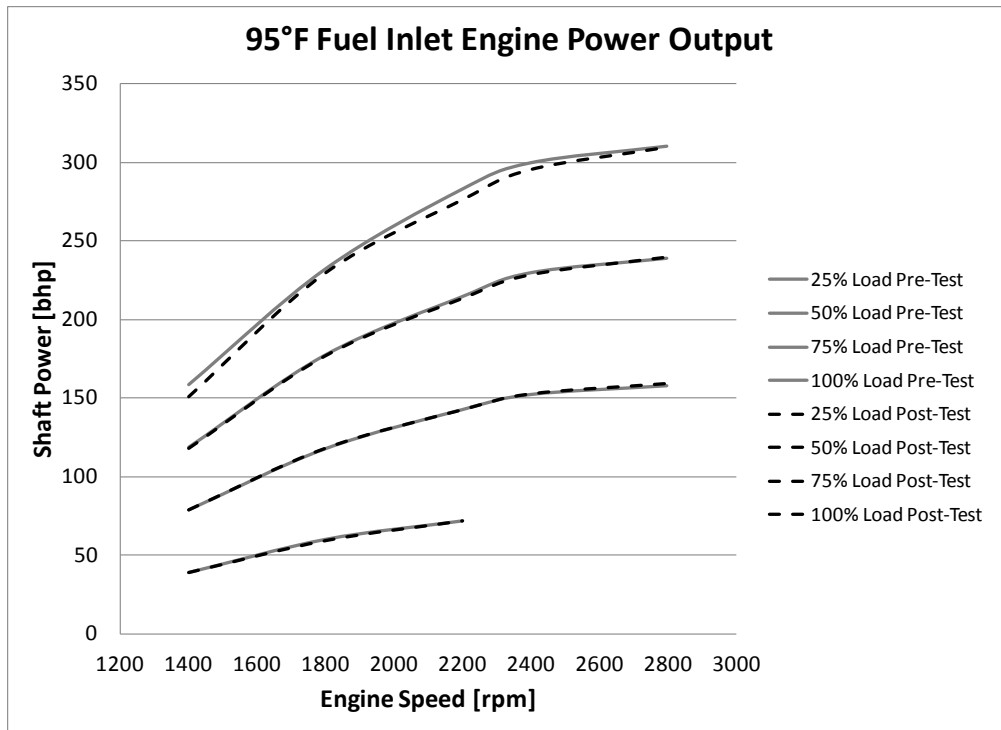
Figure A-8. Pre & Post Test Engine Power Output as 95 °F Fuel Inlet Temperature

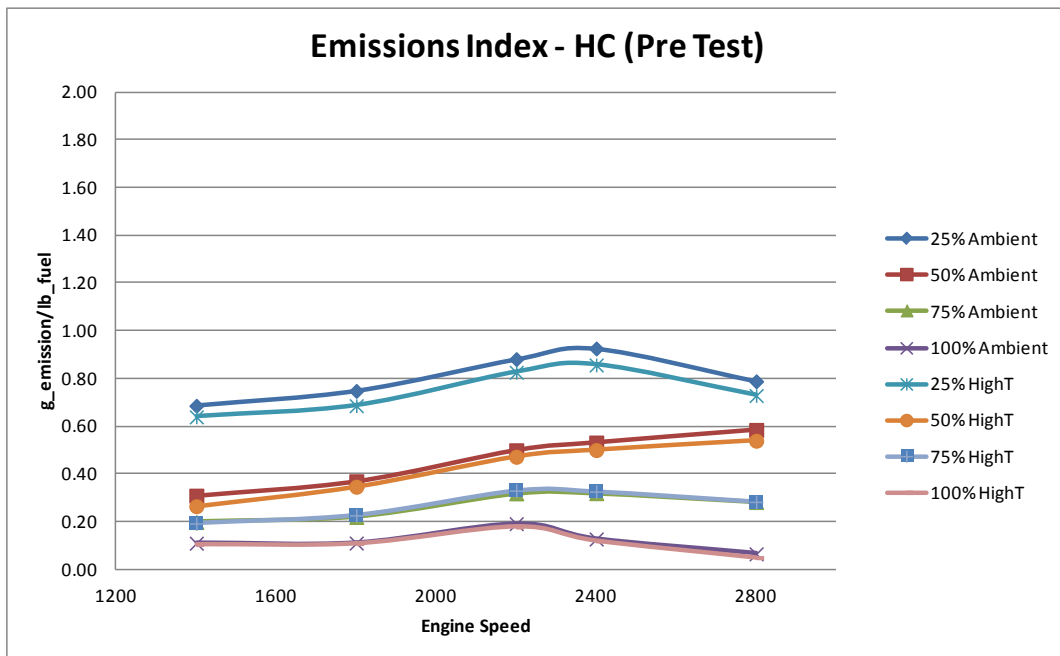
Figure A-12. AF8646 ATJ/JP-8 Blend, Pre Test HC Emission

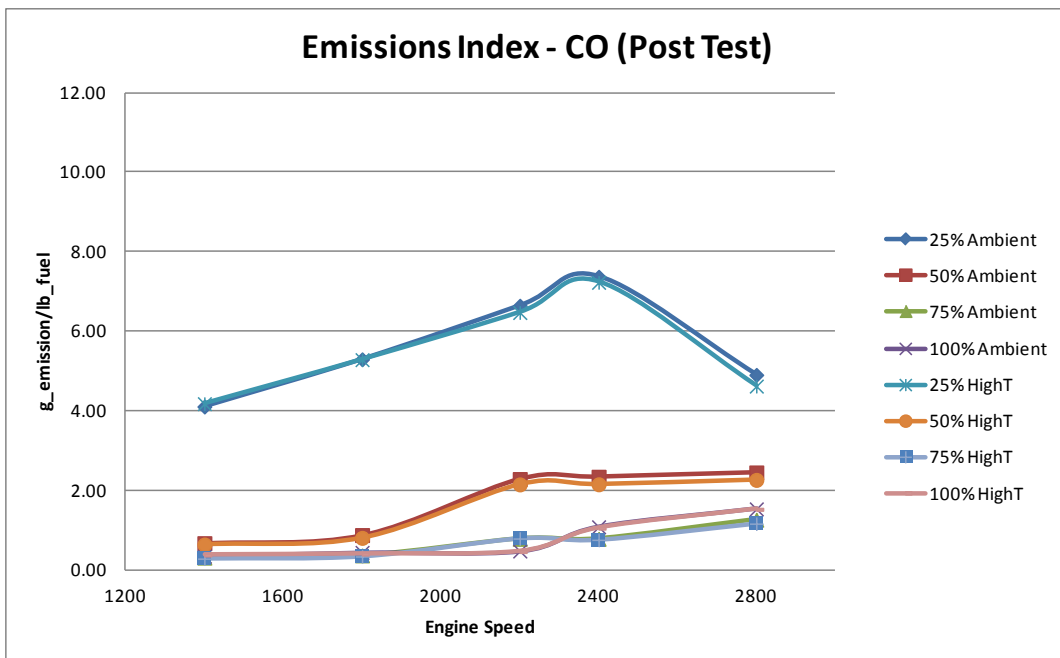
Figure A-15. AF8646 ATJ/JP-8 Blend, Post Test CO Emissions

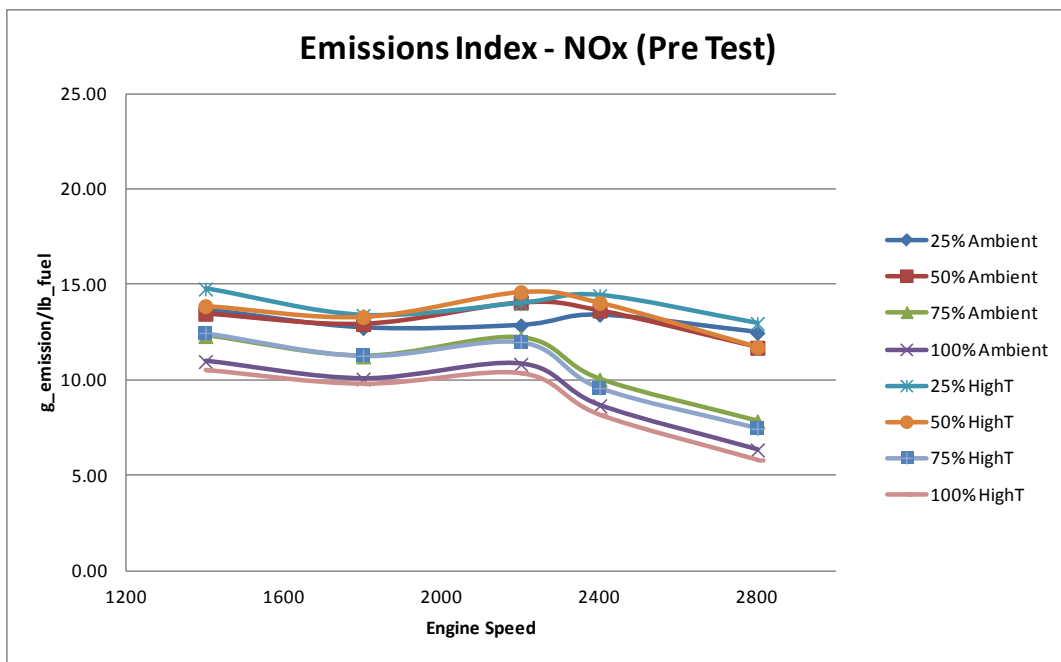
Figure A-16. AF8646 ATJ/JP-8 Blend, Pre Test NO_x Emissions

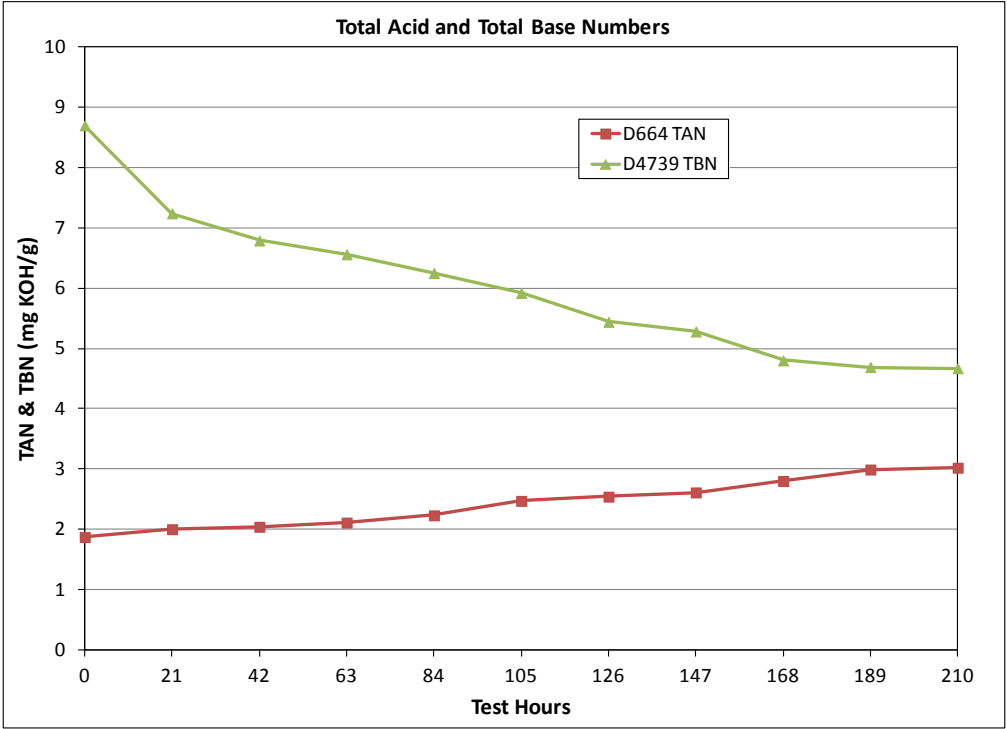
Figure A-20. Lubricant Acid and Base Number Change

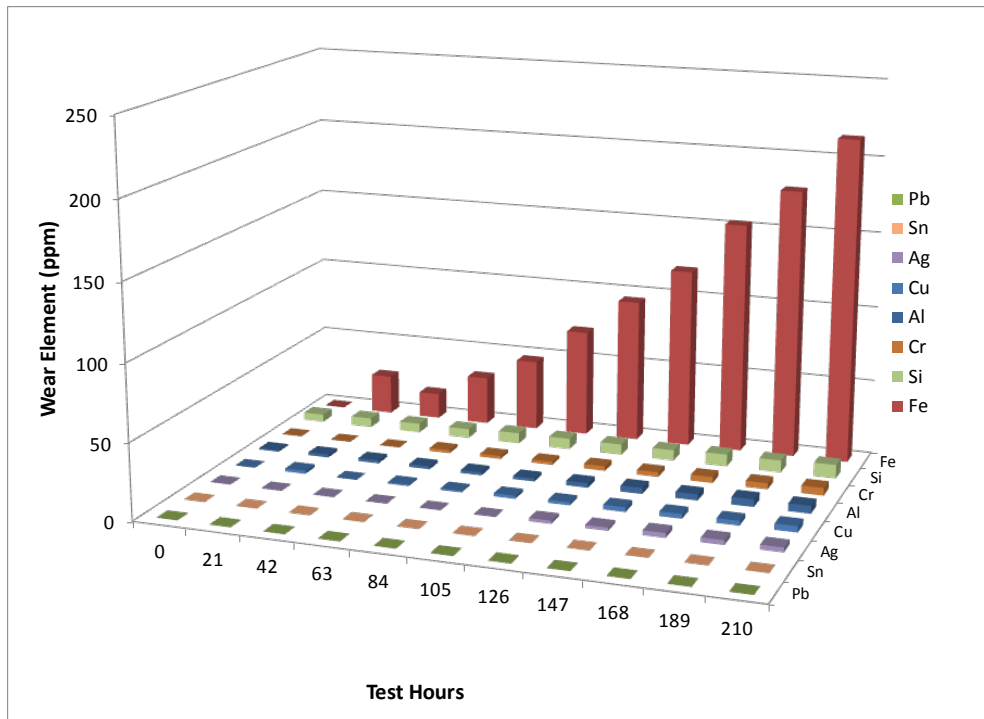
Figure A-22. Wear Metals from Used Lubricant Elemental Analysis

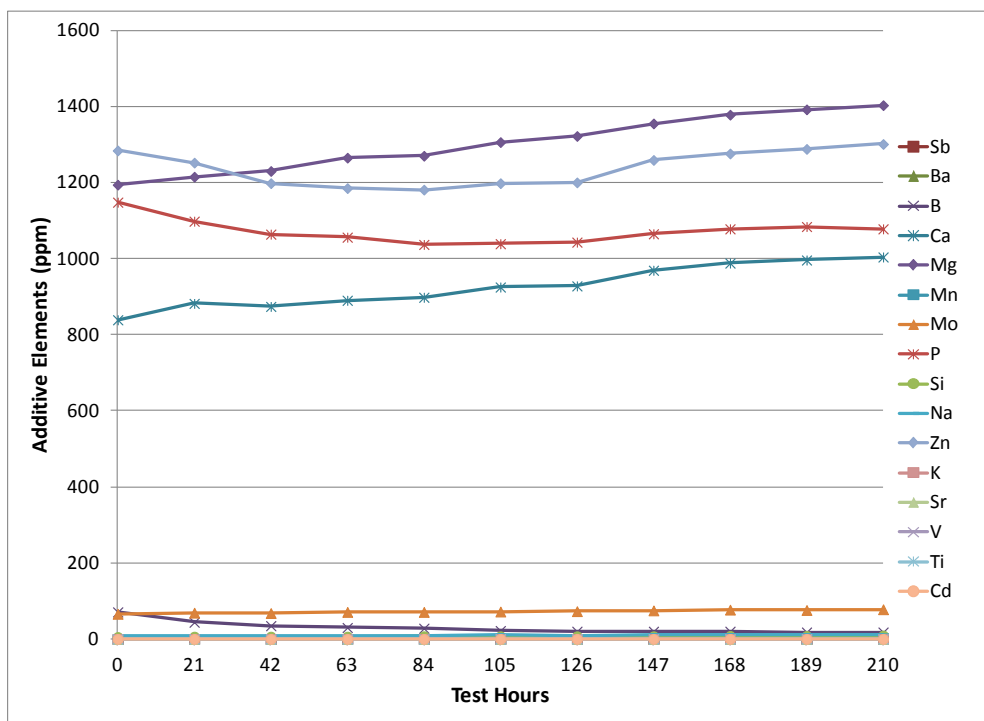
Figure A-23. Additive Metals from Used Lubricant Elemental Analysis

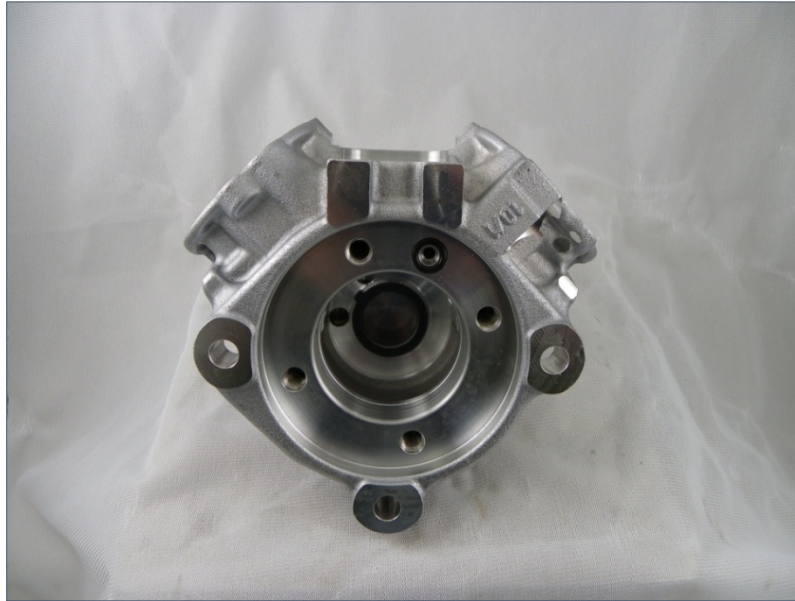
Figure A-24. HPCR Pump Body, Front (Representative Photo)

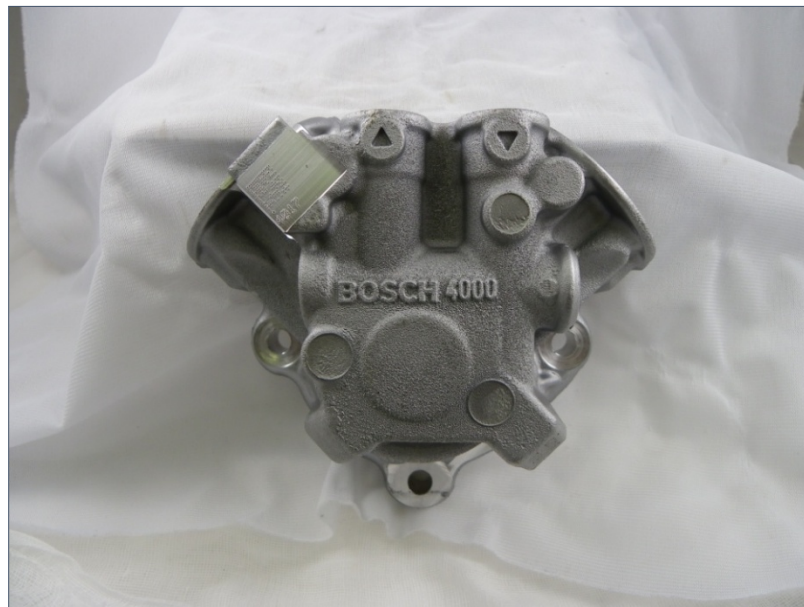
Figure A-25. HPCR Pump Body, Rear (Representative Photo)

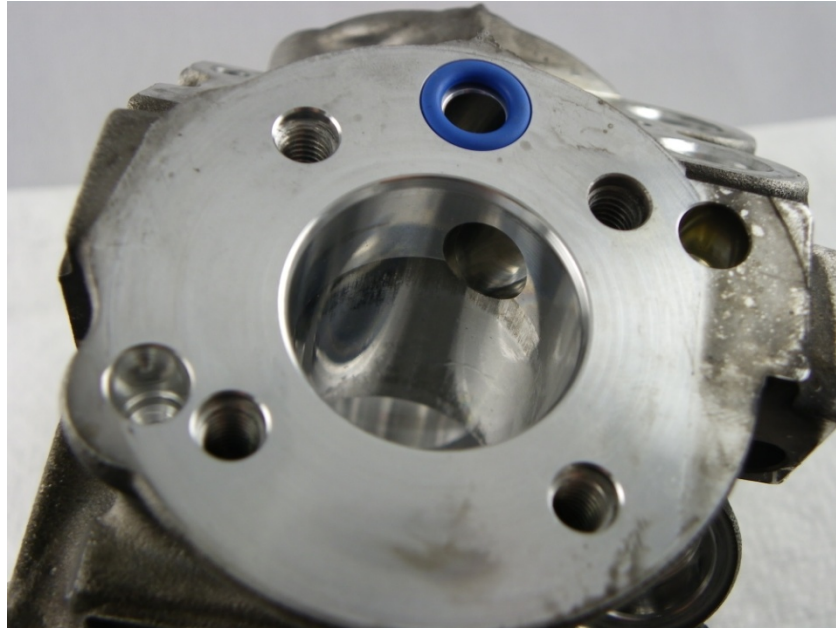
Figure A-26. AF8646 ATJ/JP-8 Blend, Post Test, Left Pump Bore

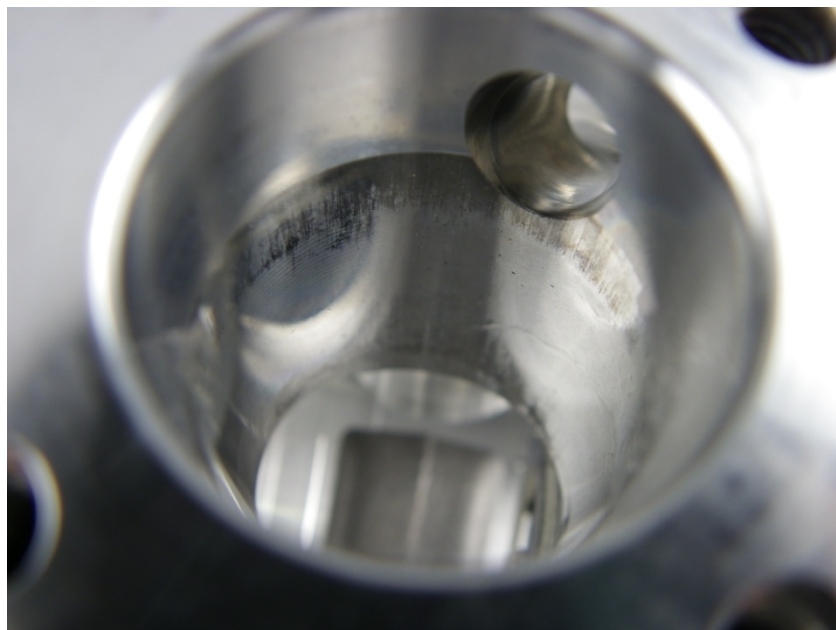
Figure A-27. AF8646 ATJ/JP-8 Blend Post Test, Left Pump Bore Close

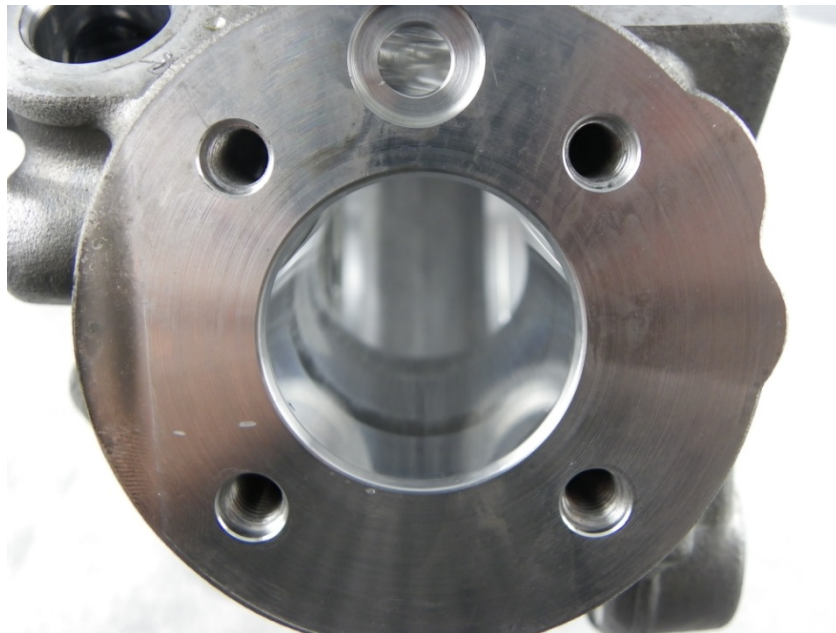
Figure A-28. AF8646 ATJ/JP-8 Blend, Post Test, Right Pump Bore

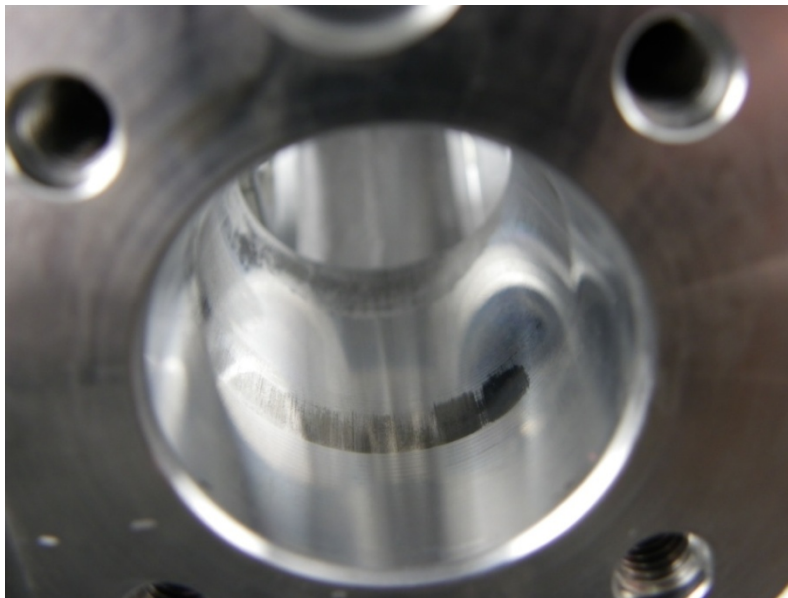
Figure A-29. AF8646 ATJ/JP-8 Blend, Post Test, Right Pump Bore Close

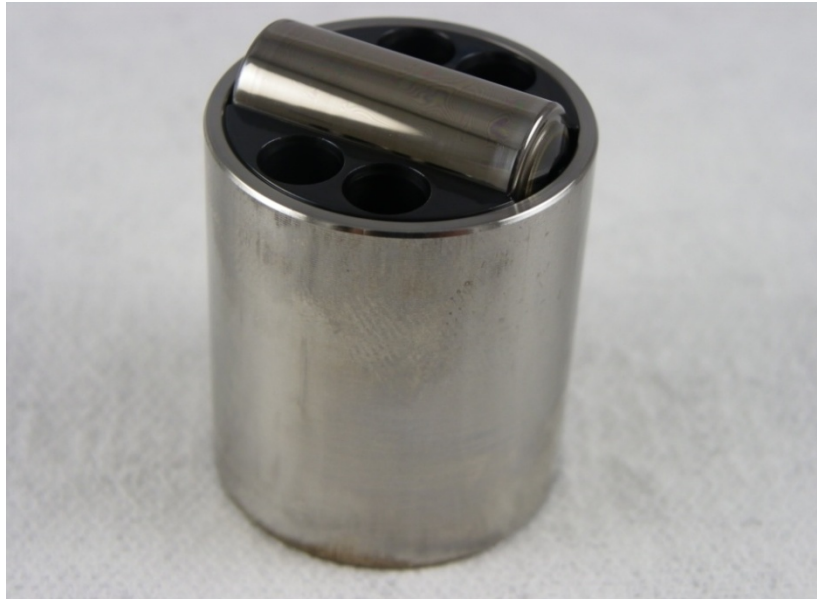
Figure A-30. AF8646 ATJ/JP-8 Blend, Left Cam Follower

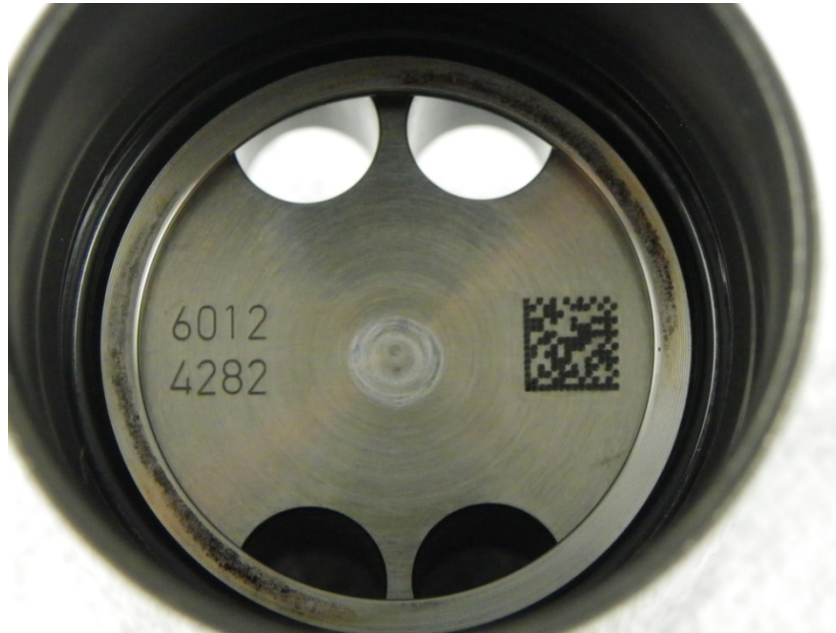
Figure A-32. AF8646 ATJ/JP-8 Blend, Left Cam Follower Under Crown

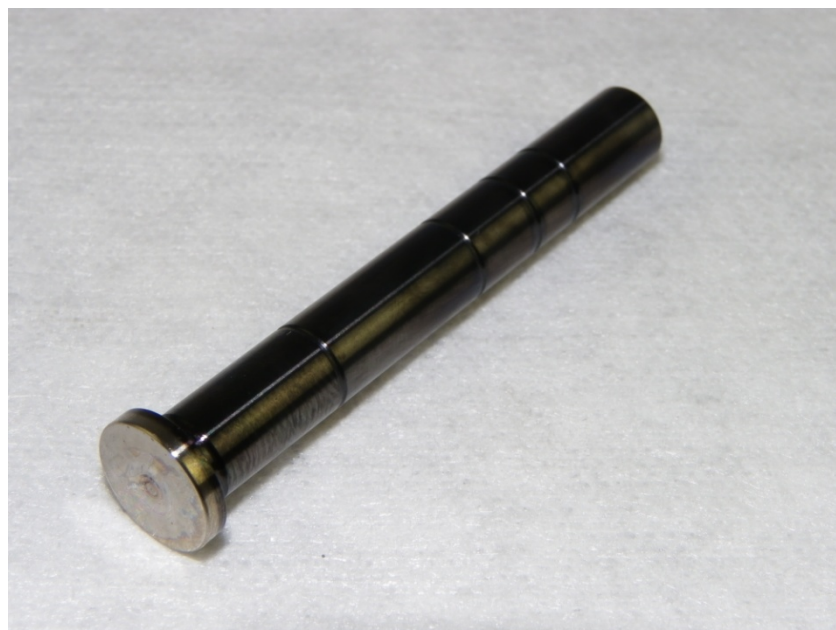
Figure A-33. AF8646 ATJ/JP-8 Blend, Left High Pressure Plunger

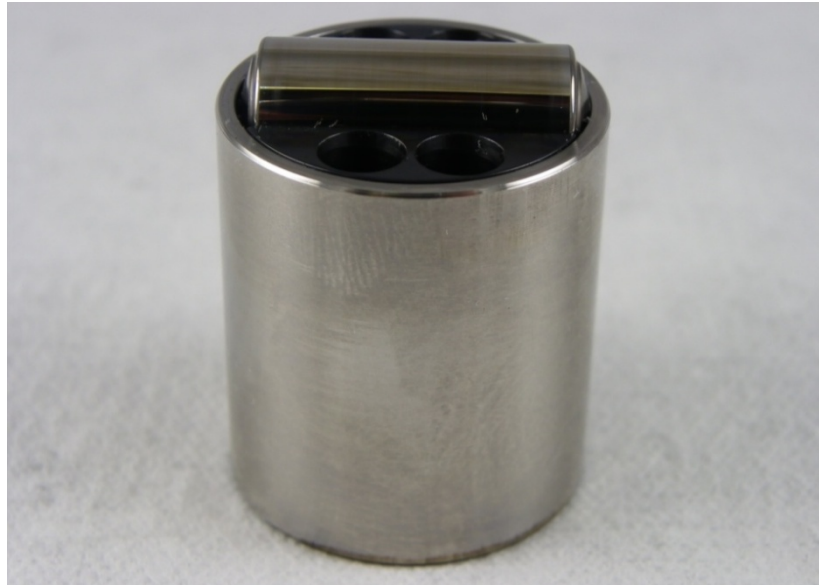
Figure A-34. AF8646 ATJ/JP-8 Blend, Right Cam Follower

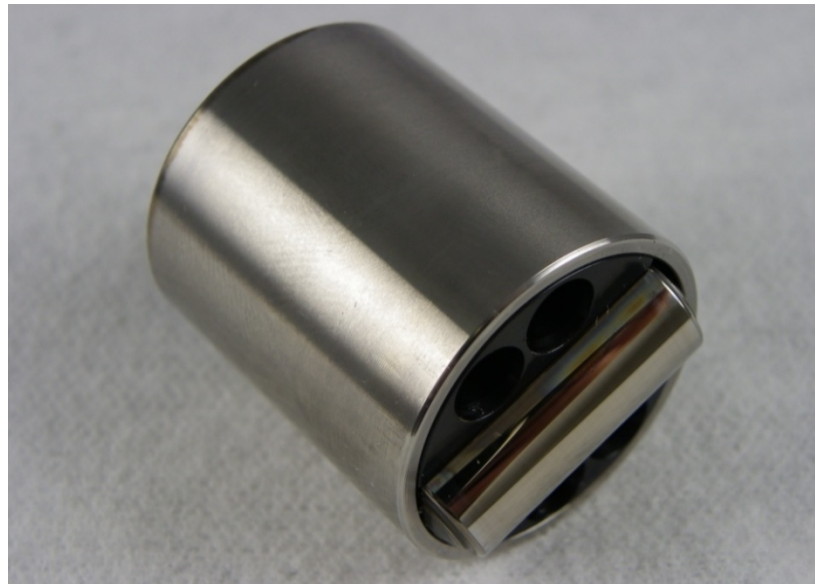
Figure A-35. AF8646 ATJ/JP-8 Blend, Right Cam Follower Roller

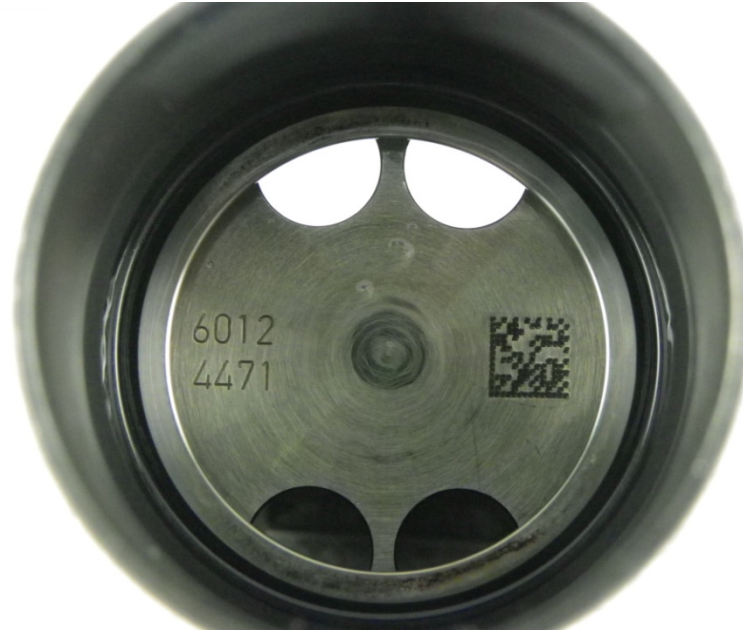
Figure A-36. AF8646 ATJ/JP-8 Blend, Right Cam Follower Under Crown

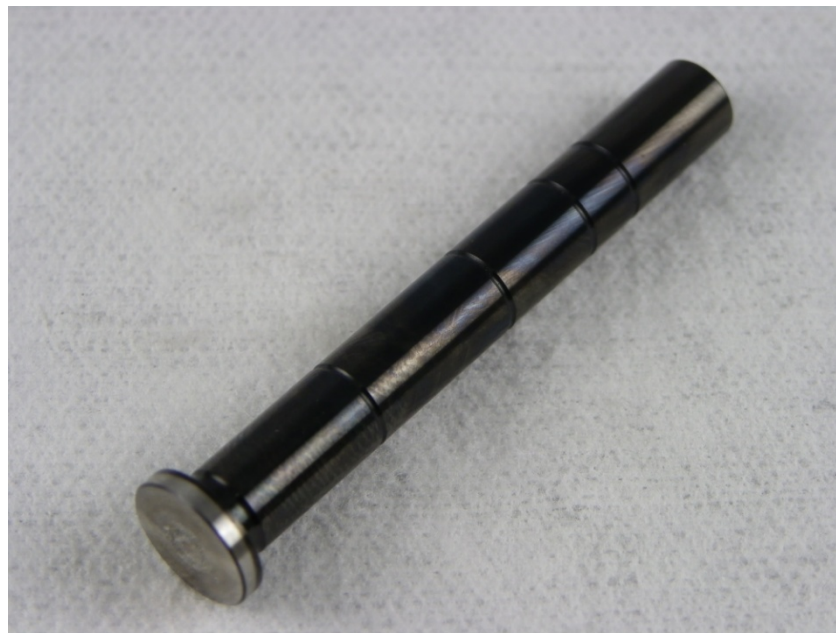
Figure A-37. AF8646 ATJ/JP-8 Blend, Right High Pressure Plunger

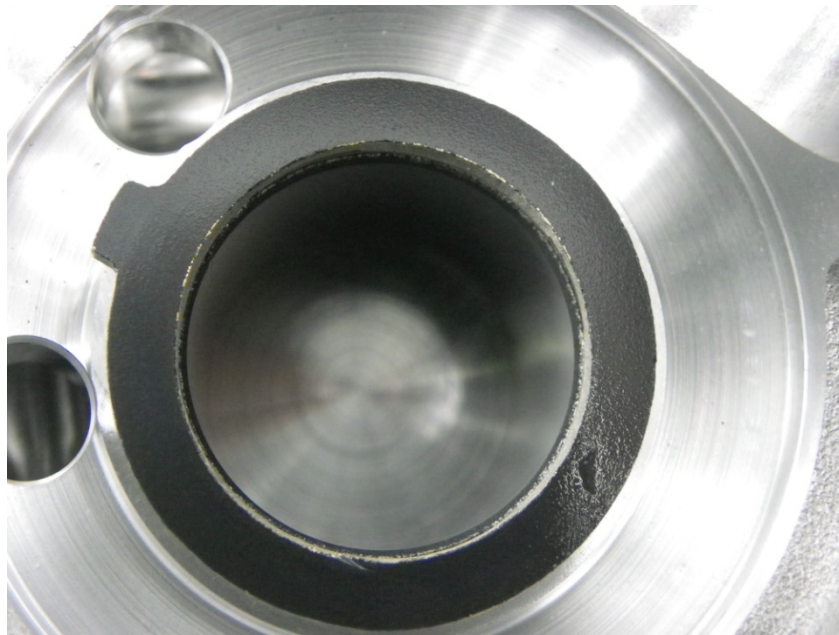
Figure A-38. AF8646 ATJ/JP-8 Blend, Rear Pump Body Camshaft Bushing

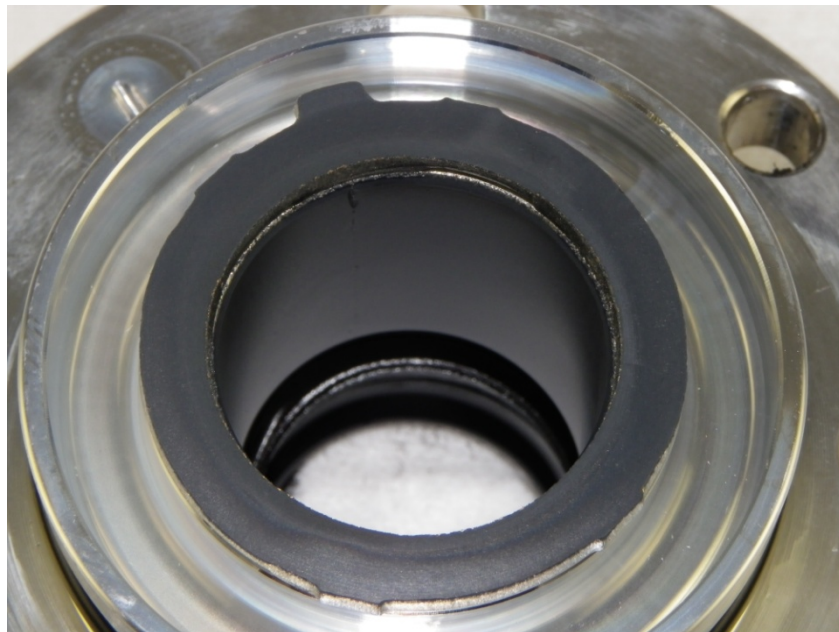
Figure A-39. AF8646 ATJ/JP-8 Blend, Front Pump Body Camshaft Bushing

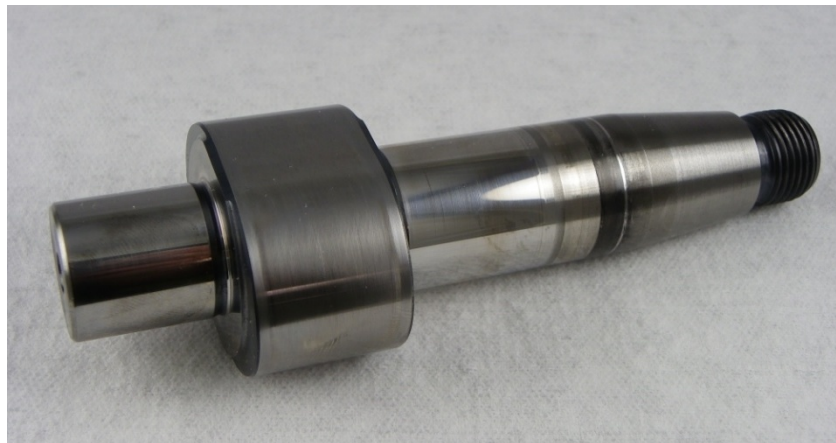
Figure A-40. AF8646 ATJ/JP-8 Blend, HPCR Pump Camshaft

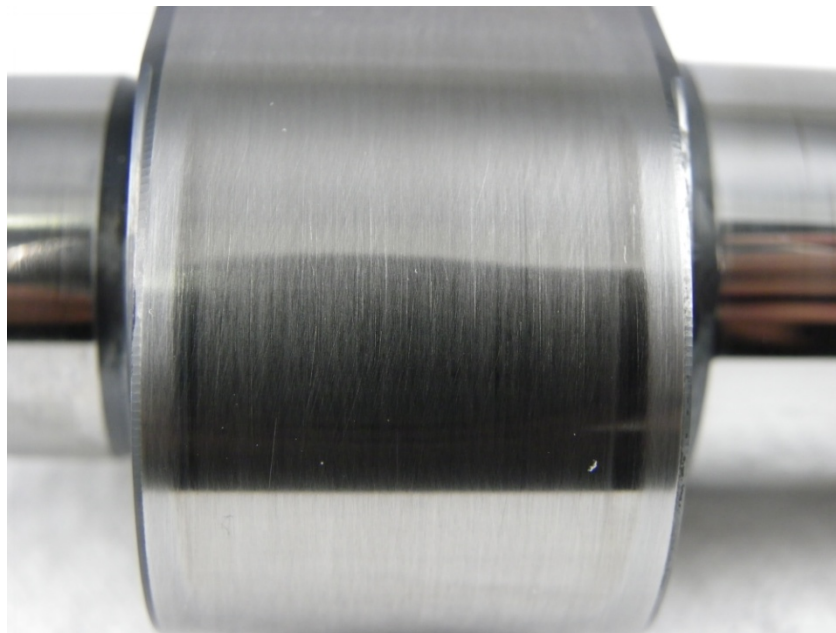
Figure A-41. AF8646 ATJ/JP-8 Blend, HPCR Pump Camshaft, Lobe Surface Close-Up

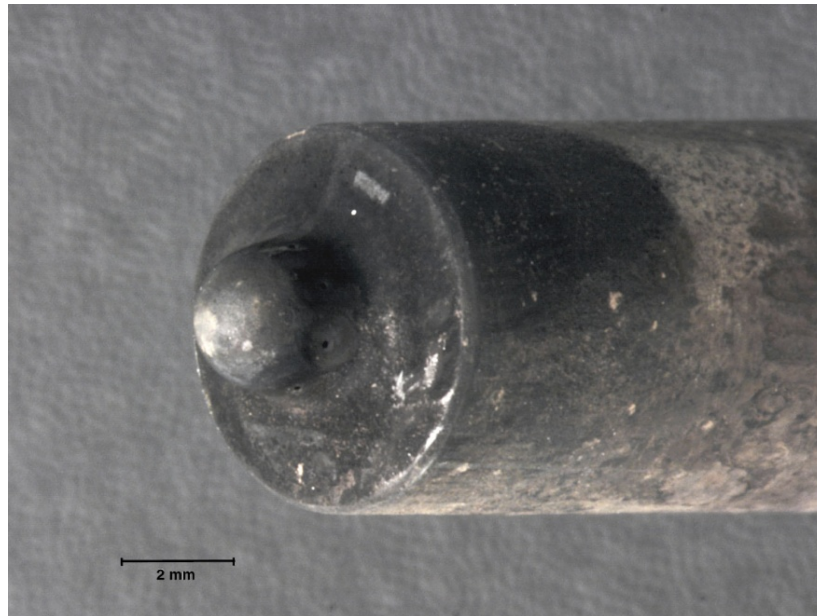
Figure A-42. AF8646 ATJ/JP-8 Blend, Injector Nozzle

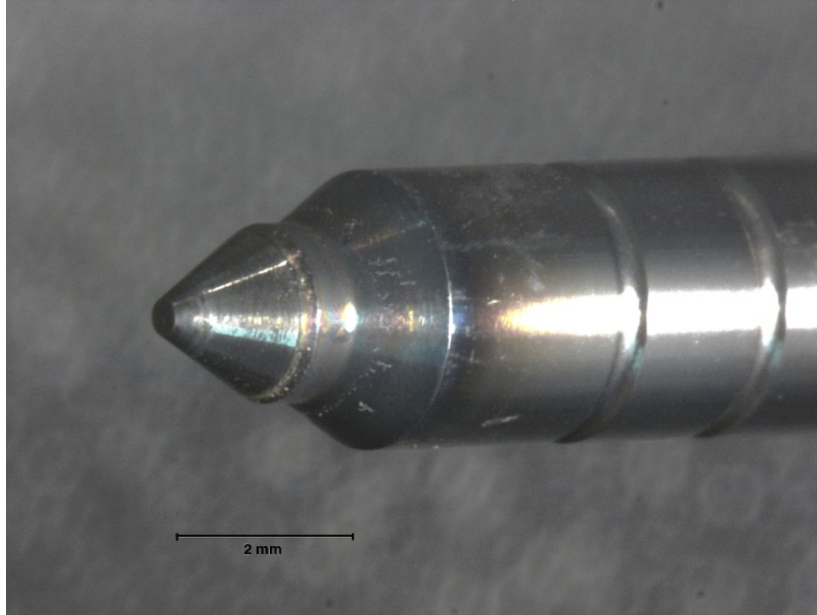
Figure A-43. AF8646 ATJ/JP-8 Blend, Injector Needle

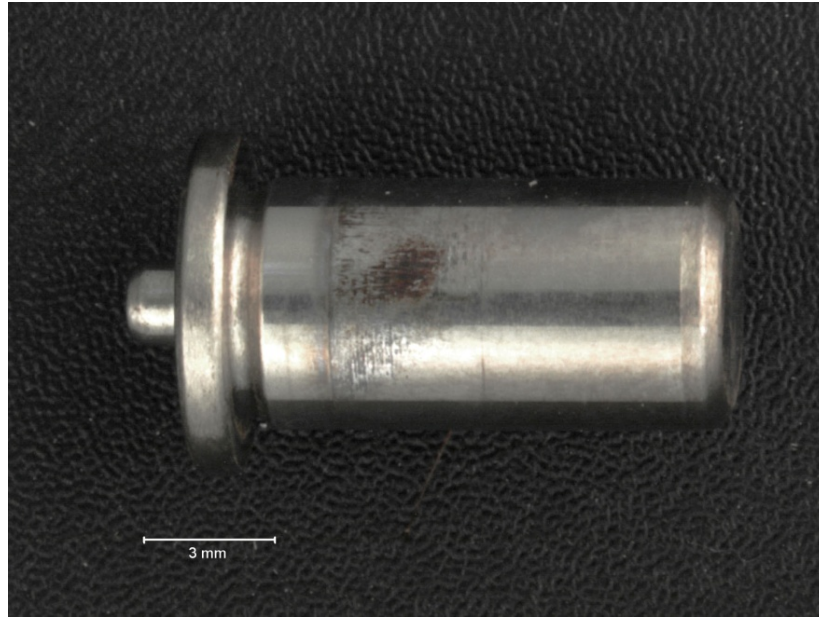
Figure A-44. AF8646 ATJ/JP-8 Blend, Upper Hydraulic Coupler Piston, Profile

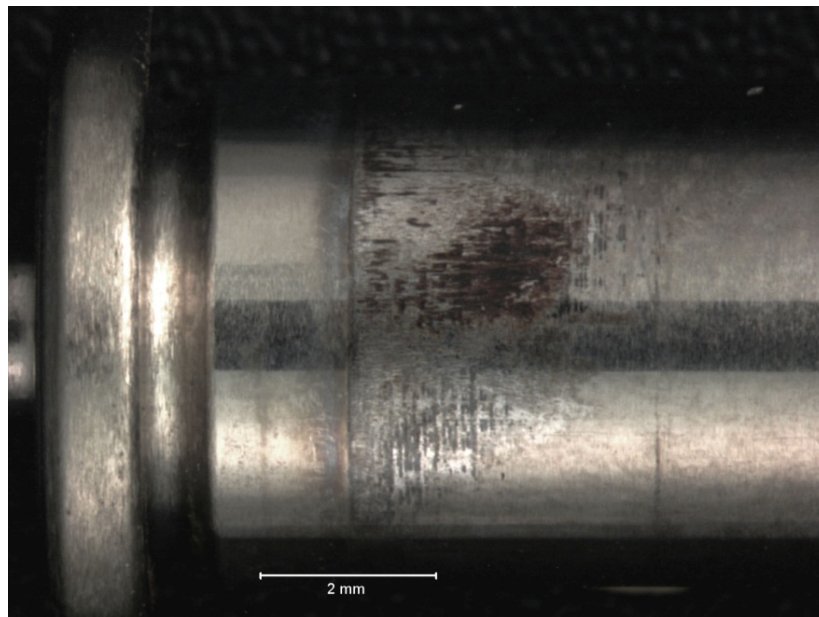
Figure A-45. AF8646 ATJ/JP-8 Blend, Lower Hydraulic Coupler Piston, Wear Scar Close Up

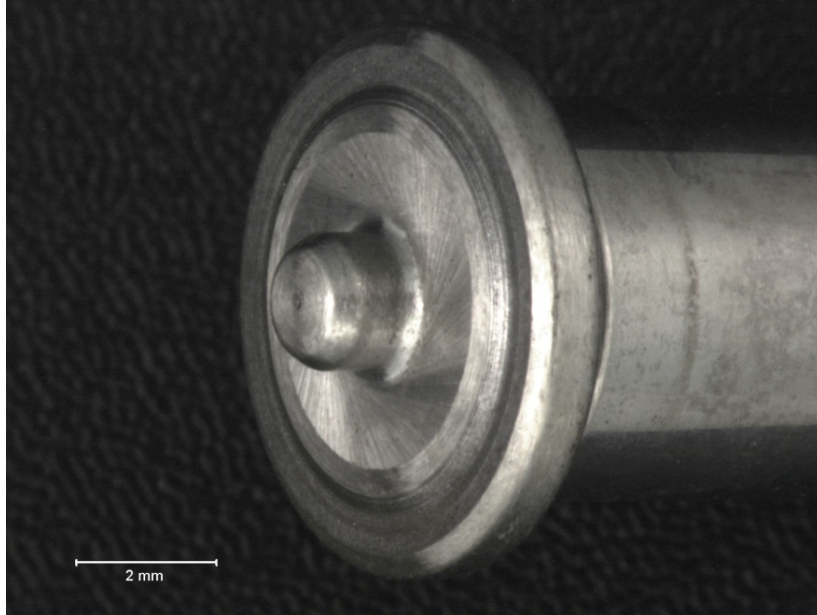
Figure A-46. AF8646 ATJ/JP-8 Blend, Upper Hydraulic Coupler Piston

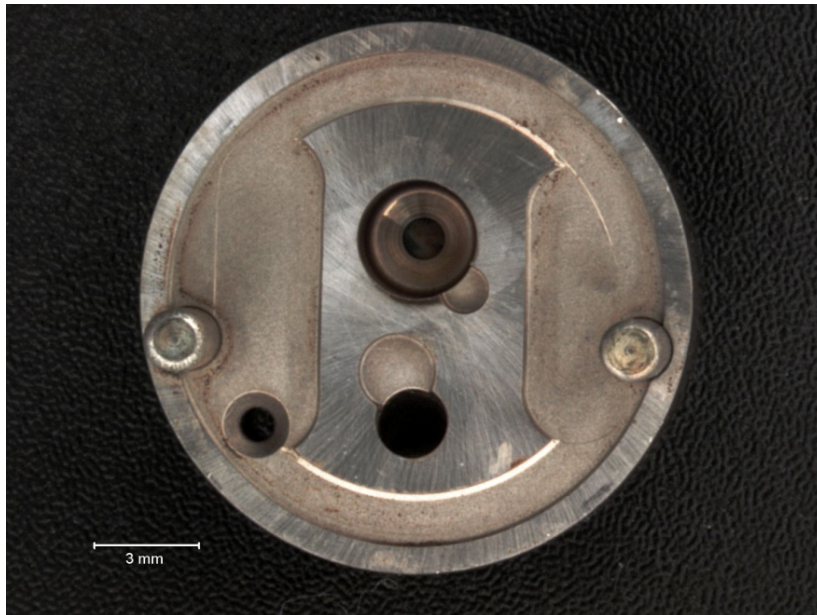
Figure A-51. AF8646 ATJ/JP-8 Blend, Control Valve Plate (Bottom)

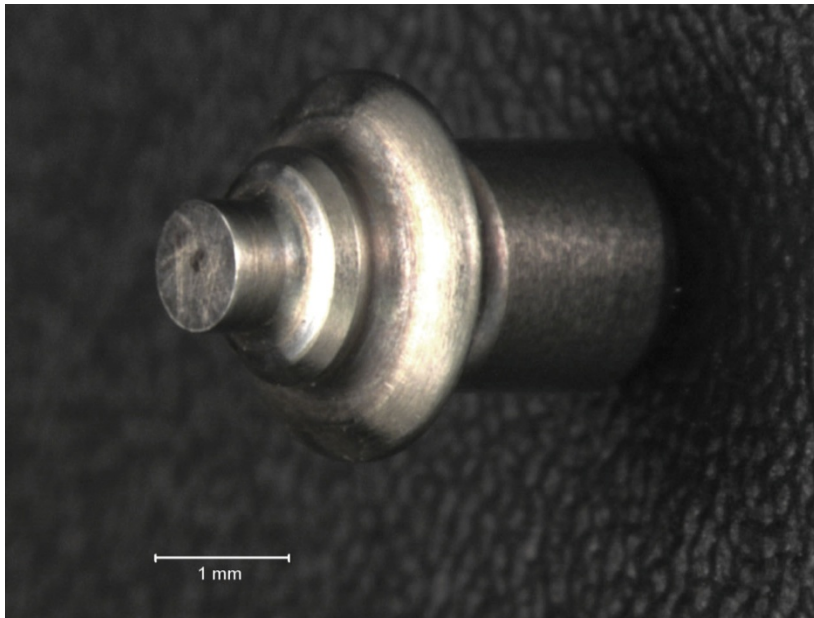
Figure A-52. AF8646 ATJ/JP-8 Blend, Fuel Injector Control Valve

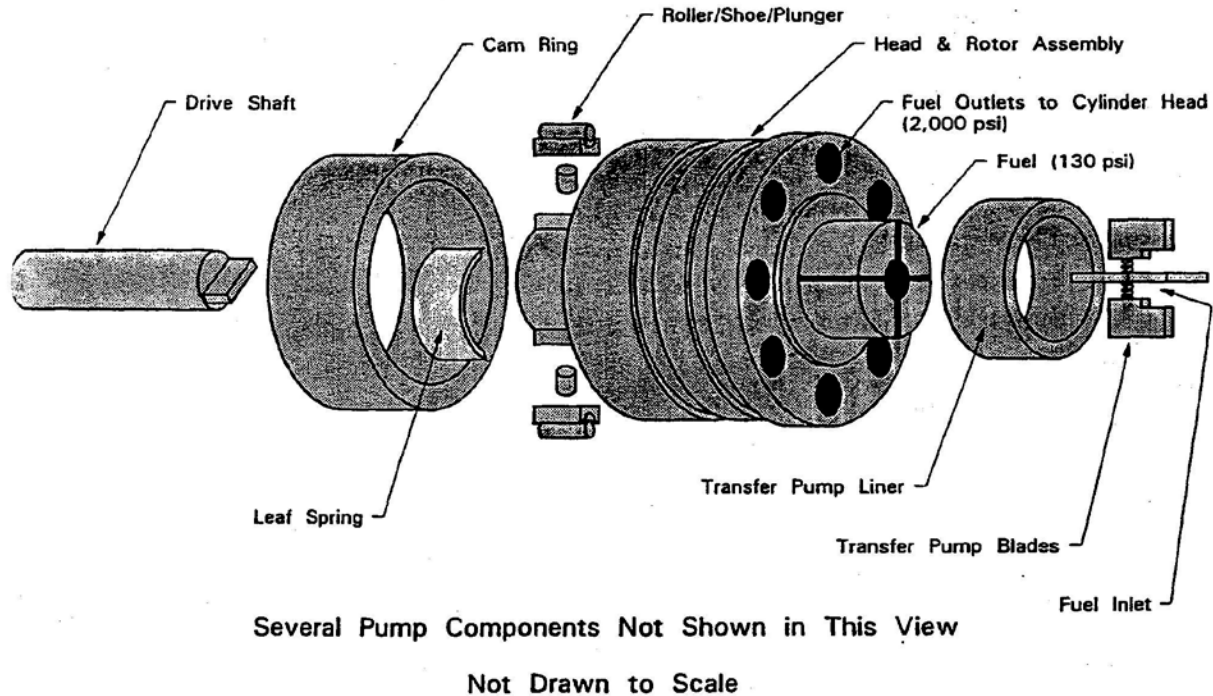
Figure B-2. Schematic Diagram of Principal Pump Components

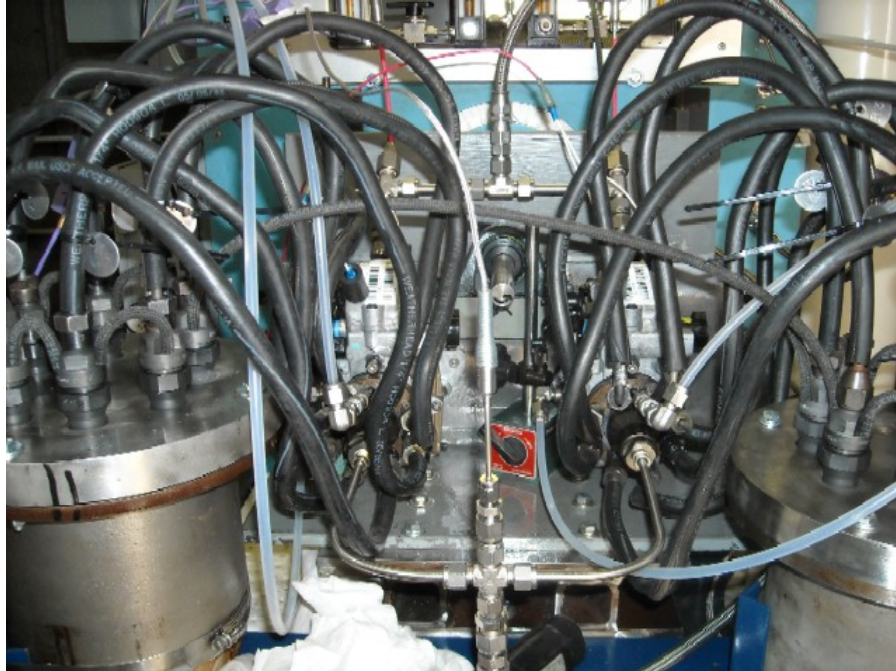
Figure B-3. Dual Stanadyne Rotary Fuel Injection Pumps Mounted on Stand with Fuel Injectors

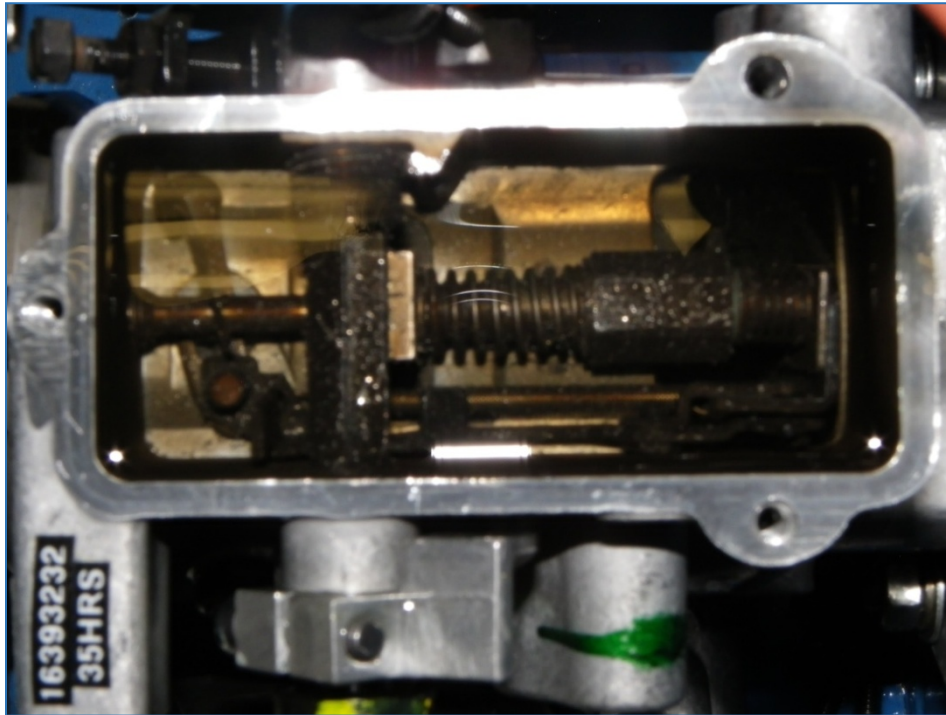
Figure B-4. Pump SN: 16393232 Showing Wear Debris at 35-hours with JP-8 Fuel at 77°C Inlet Temperature

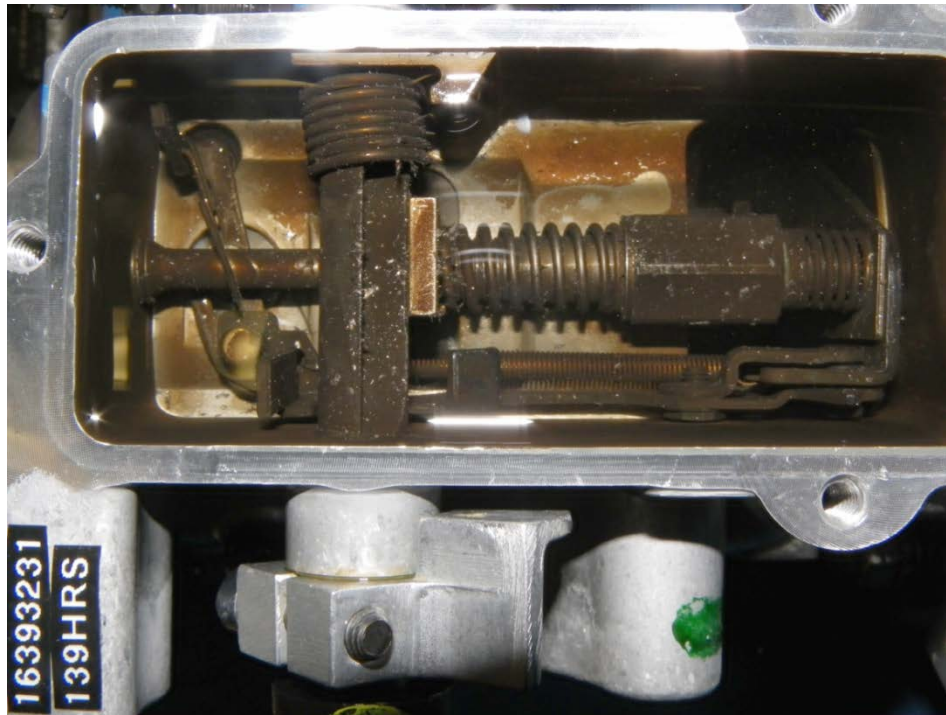
Figure B-5. Pump SN: 16393231 Showing Wear Debris at 139-hours with JP-8 Fuel at 77°C Inlet Temperature

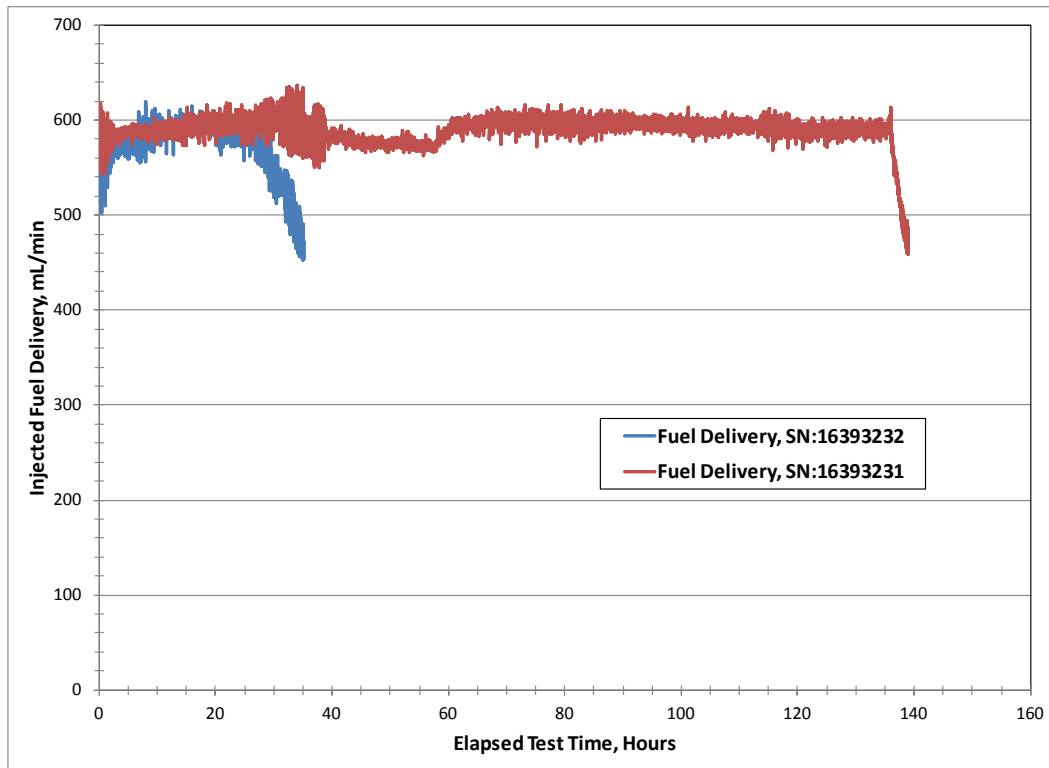
Figure B-6. Fuel Flow Rate Histories for JP-8 Fuel at Elevated Temperature
