AFRL-RQ-WP-TR-2014-0231

Douglas M. Yost, Adam C. Brandt, and Gregory A.T. Hansen
Southwest Research Institute (SwRI®)

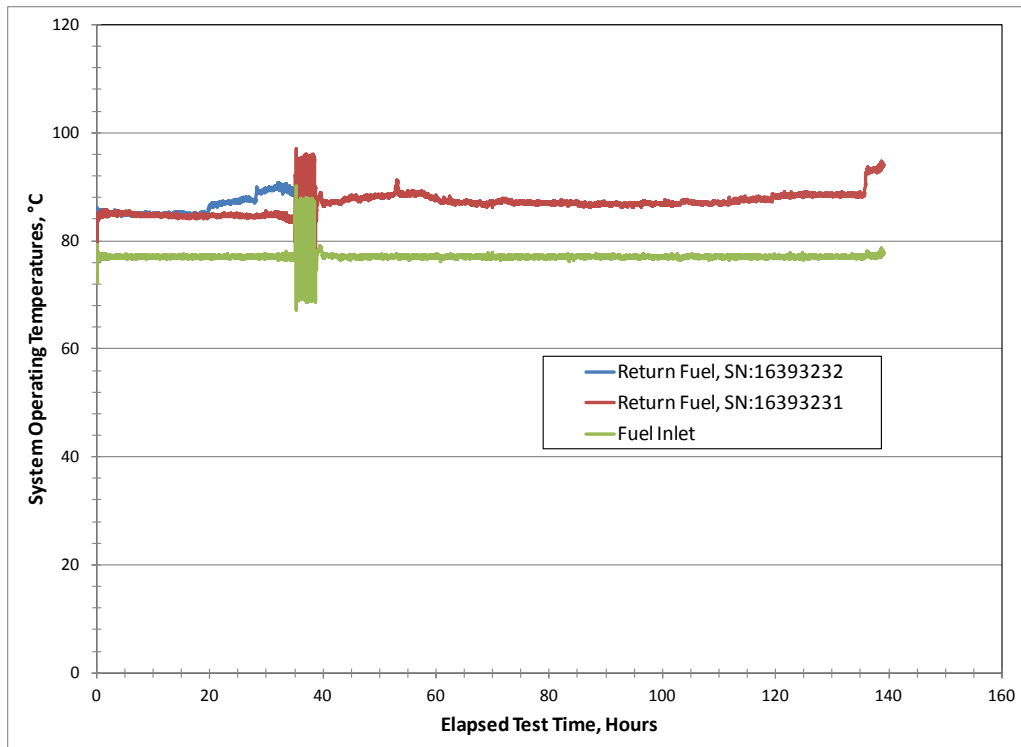
Figure B-7. Fuel Inlet and Fuel Return Temperatures for JP-8 Fuel at Elevated Temperature

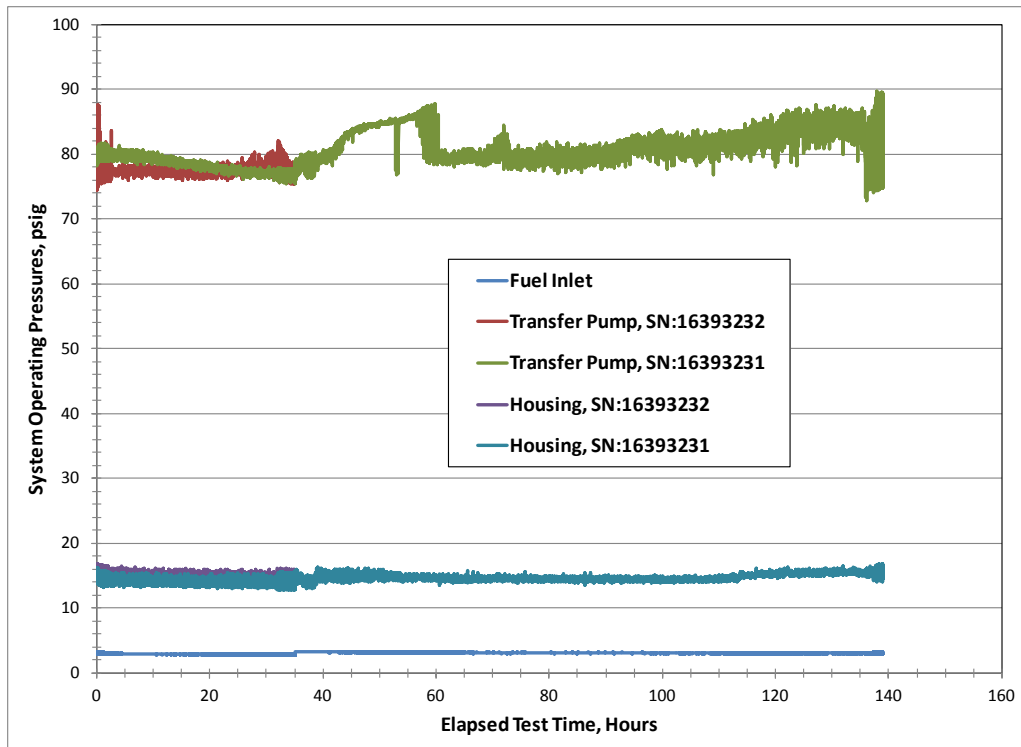
Figure B-8. Fuel Inlet, Fuel Transfer Pump, and Housing Pressure Histories for JP-8 Fuel at Elevated Temperature

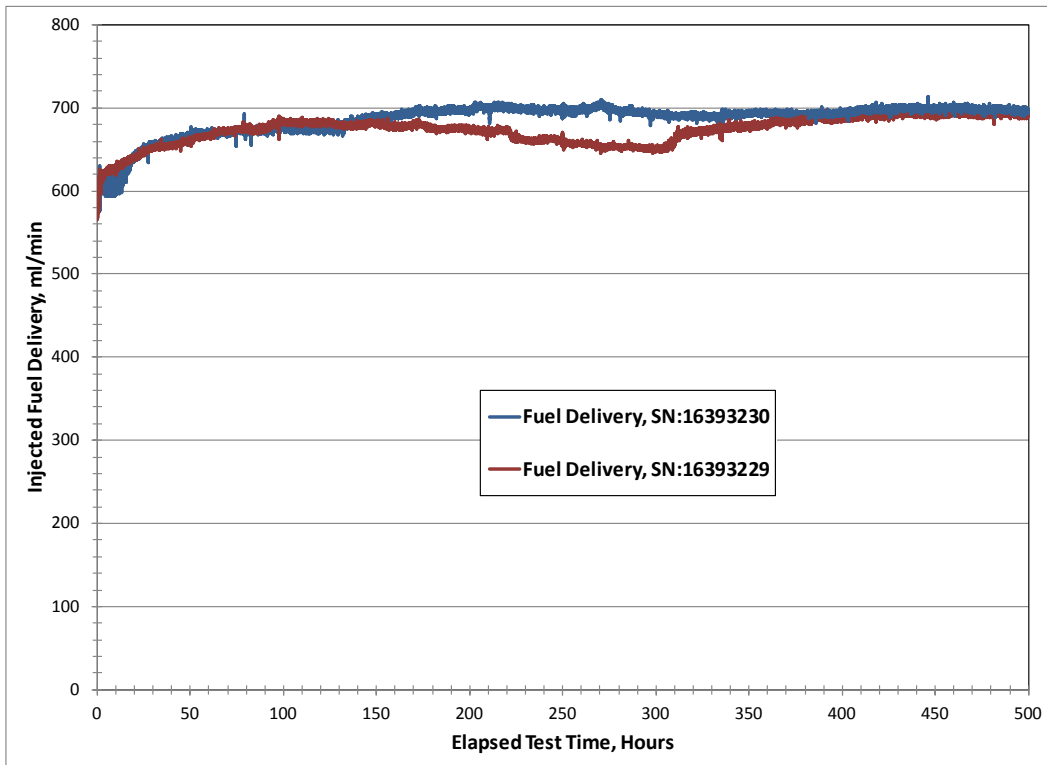
Figure B-9. Injection Pump Delivery Histories for ATJ/JP-8 Evaluation

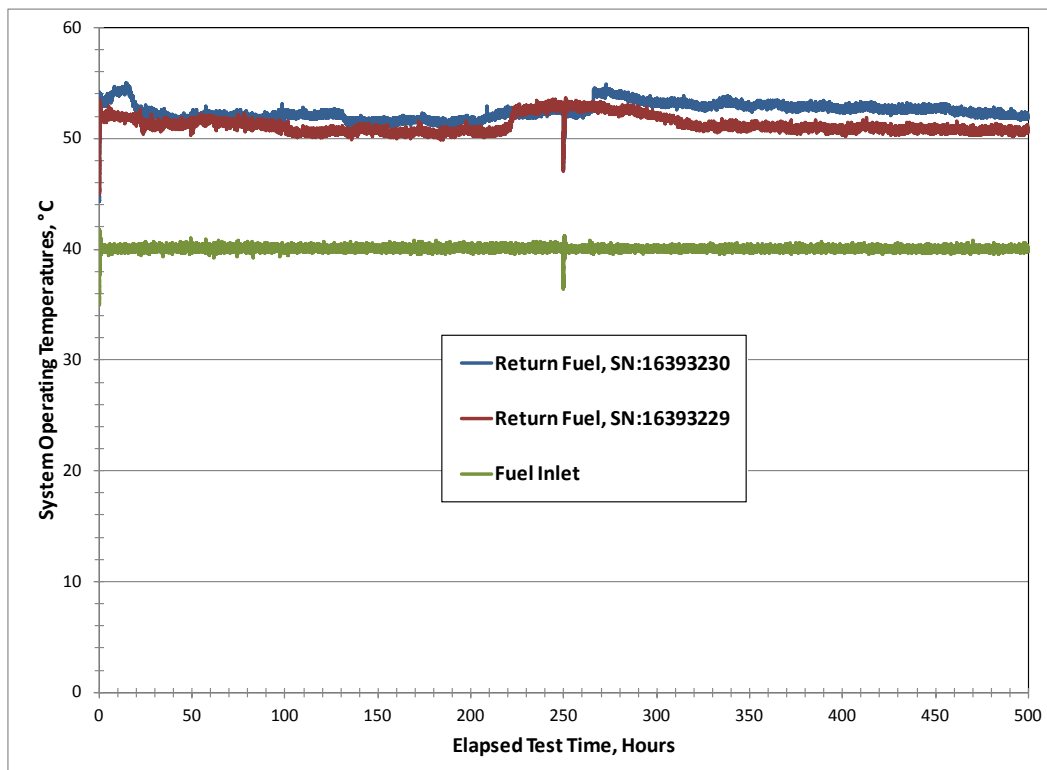
Figure B-10. Injection Pump Temperature Histories for ATJ/JP-8 Evaluation

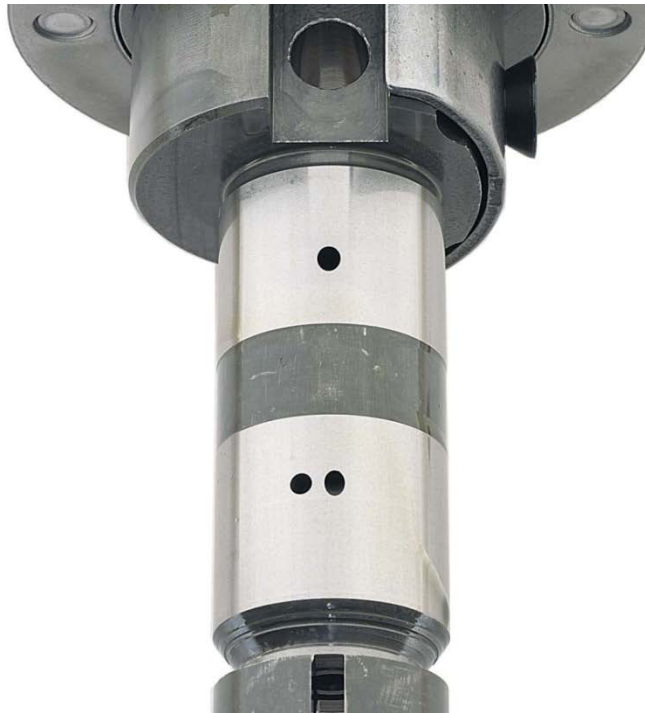
Figure B-14. Pump SN: 16393231 Distributor Rotor before Testing with JP-8 Fuel

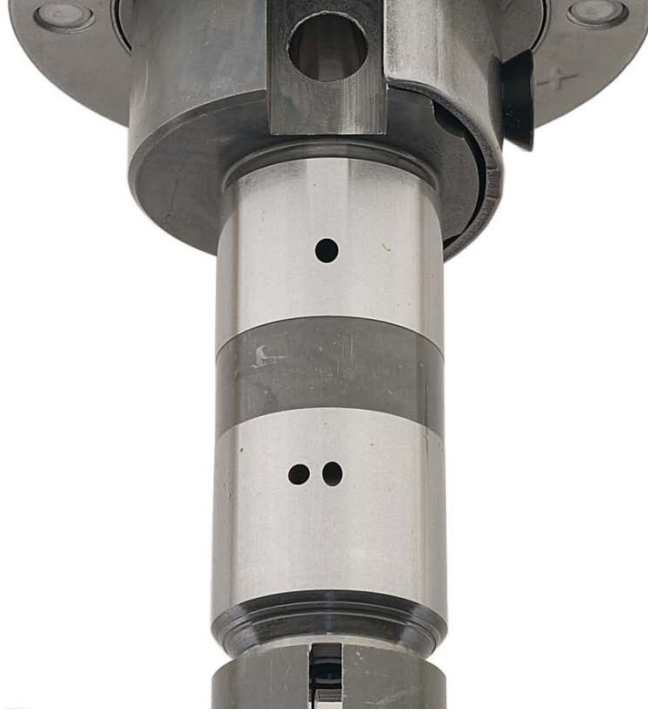
Figure B-32. Pump SN: 16393232 Distributor Rotor Before Testing with JP-8 Fuel

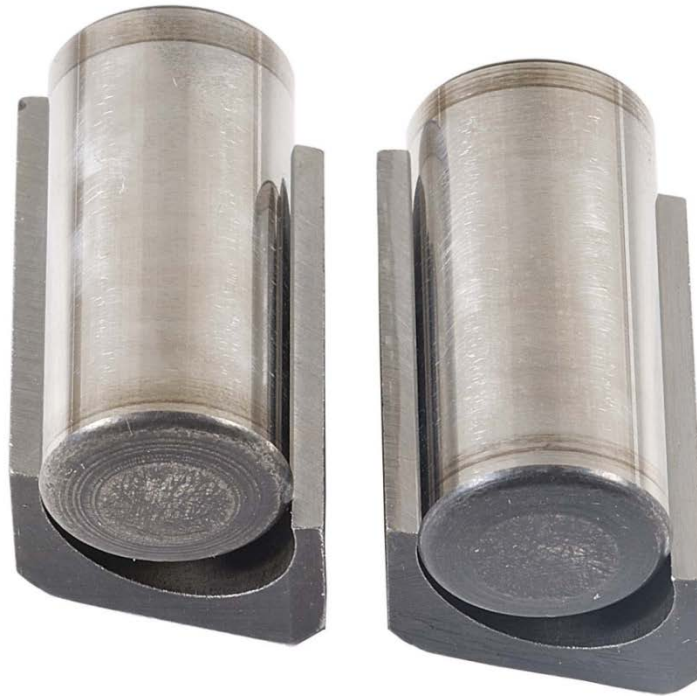
Figure B-34. Pump SN: 16393232 Rollers and Shoe Condition Before Testing with JP-8 Fuel

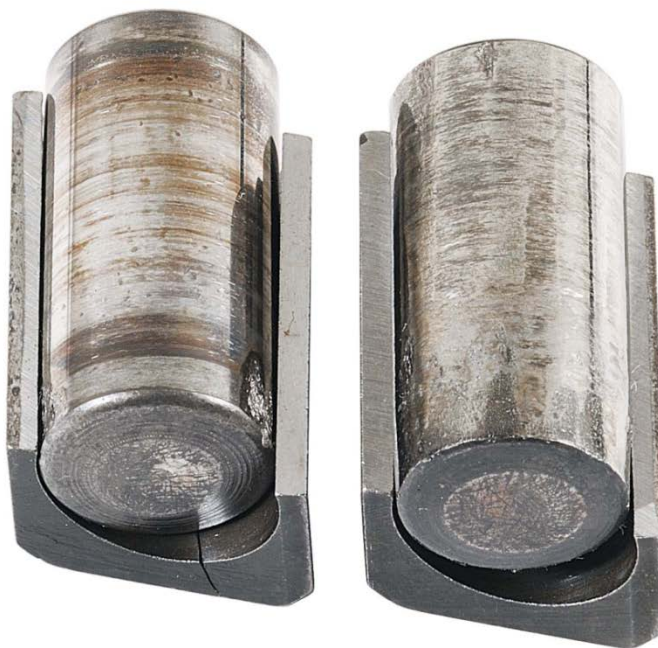
Figure B-35. Pump SN: 16393232 Rollers and Shoe with 35-Hours Testing with JP-8 Fuel

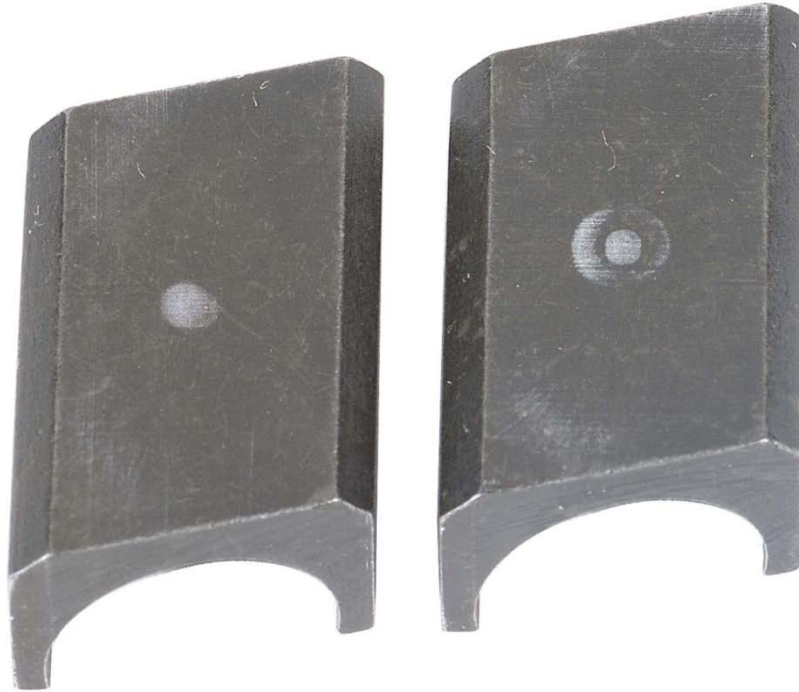
Figure B-36. Pump SN: 16393232 Roller Shoe Condition Before Testing with JP-8 Fuel

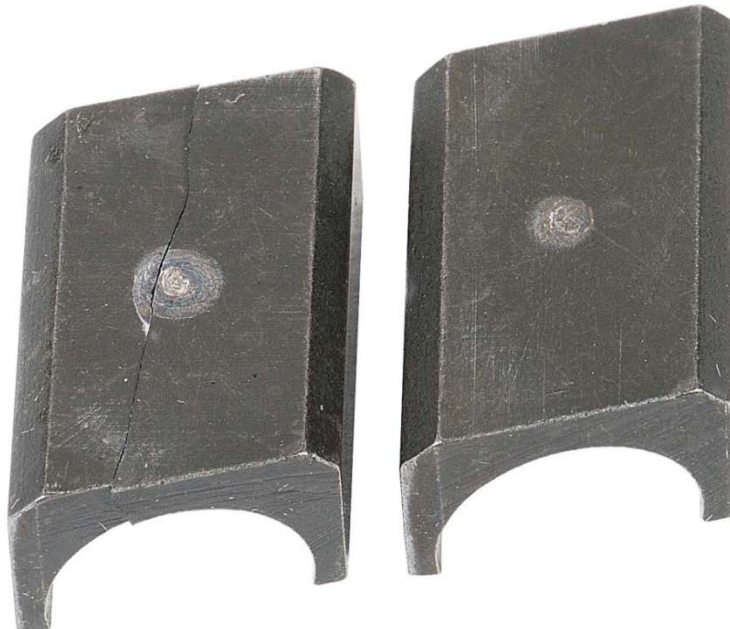
Figure B-37. Pump SN: 16393232 Roller Shoe with 35-Hours Testing with JP-8 Fuel

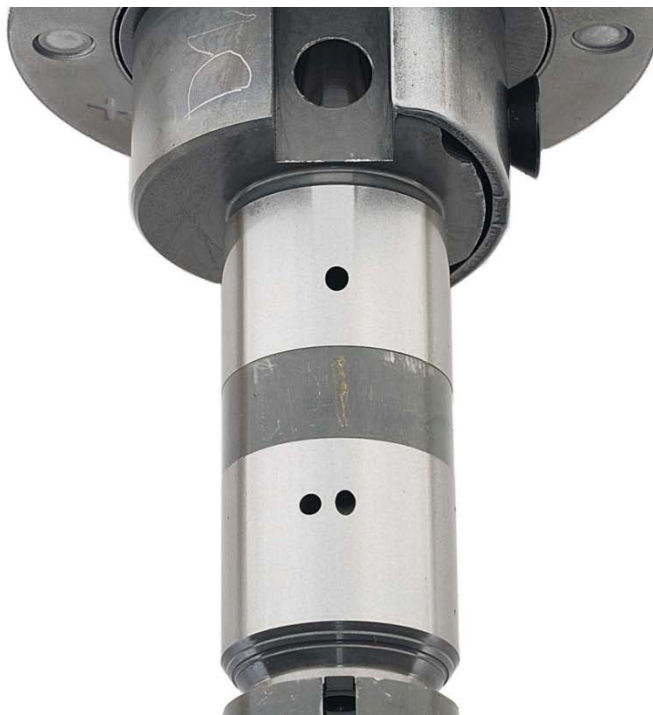
Figure B-50. Pump SN: 16393229 Distributor Rotor Before Testing with ATJ/JP-8 Fuel

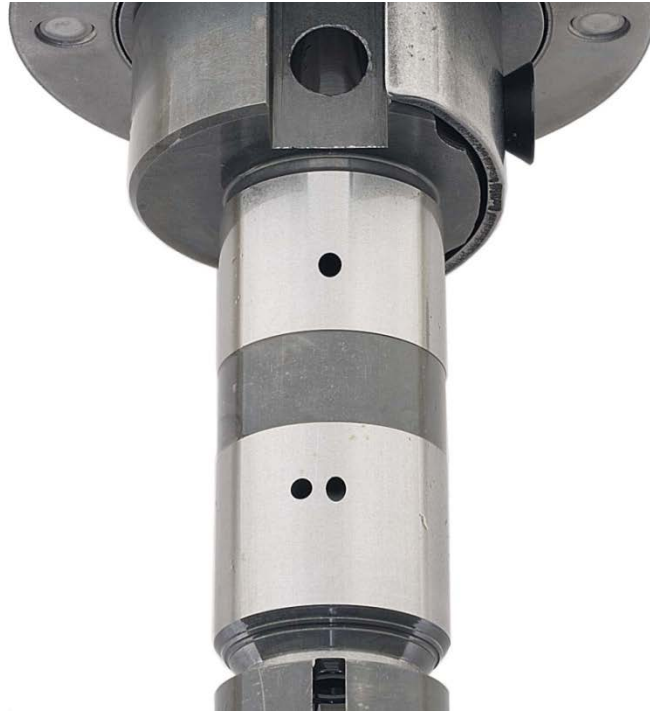
Figure B-68. Pump SN: 16393230 Distributor Rotor Before Testing with ATJ/JP-8 Fuel

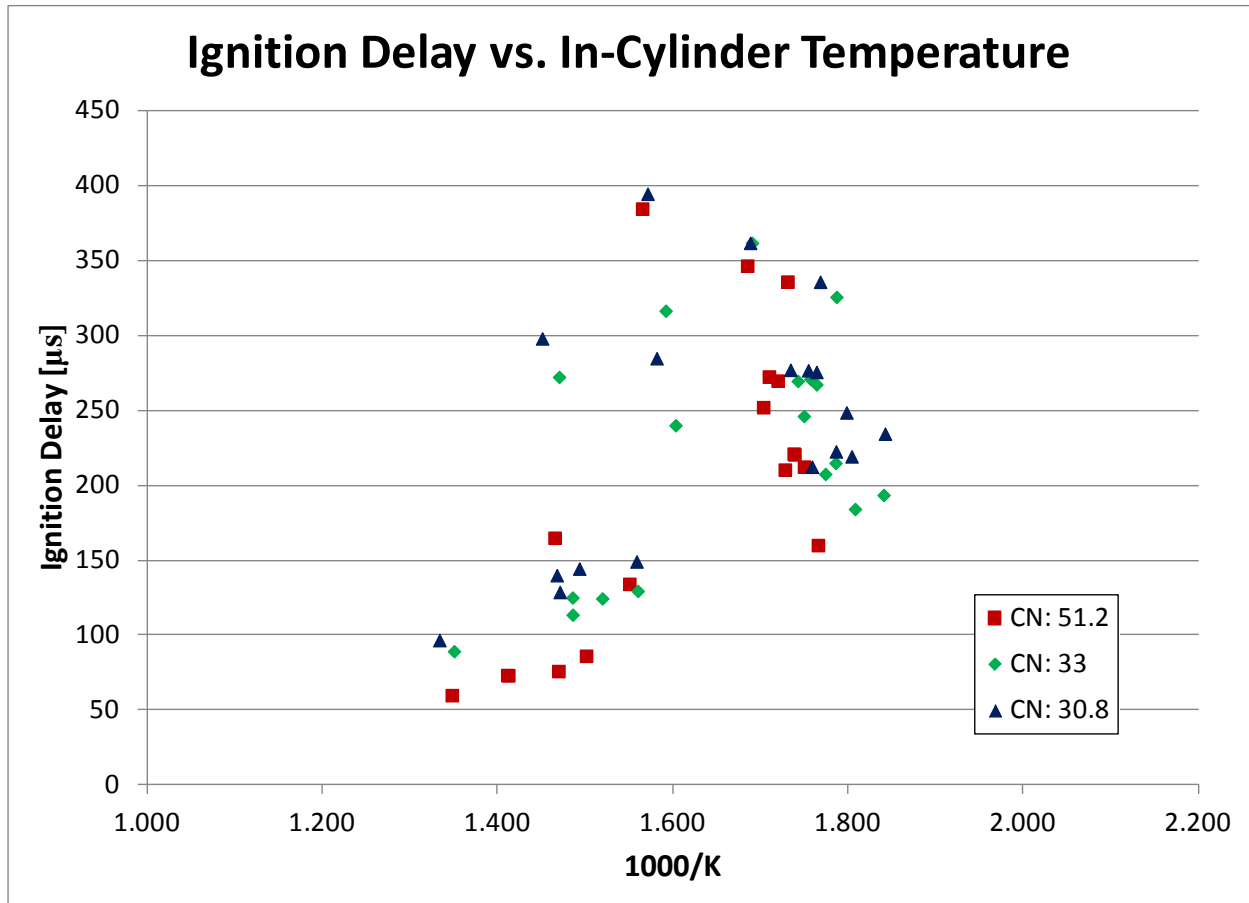
Figure C-7. Ignition Delay versus In-Cylinder Temperature at the Time of Injection

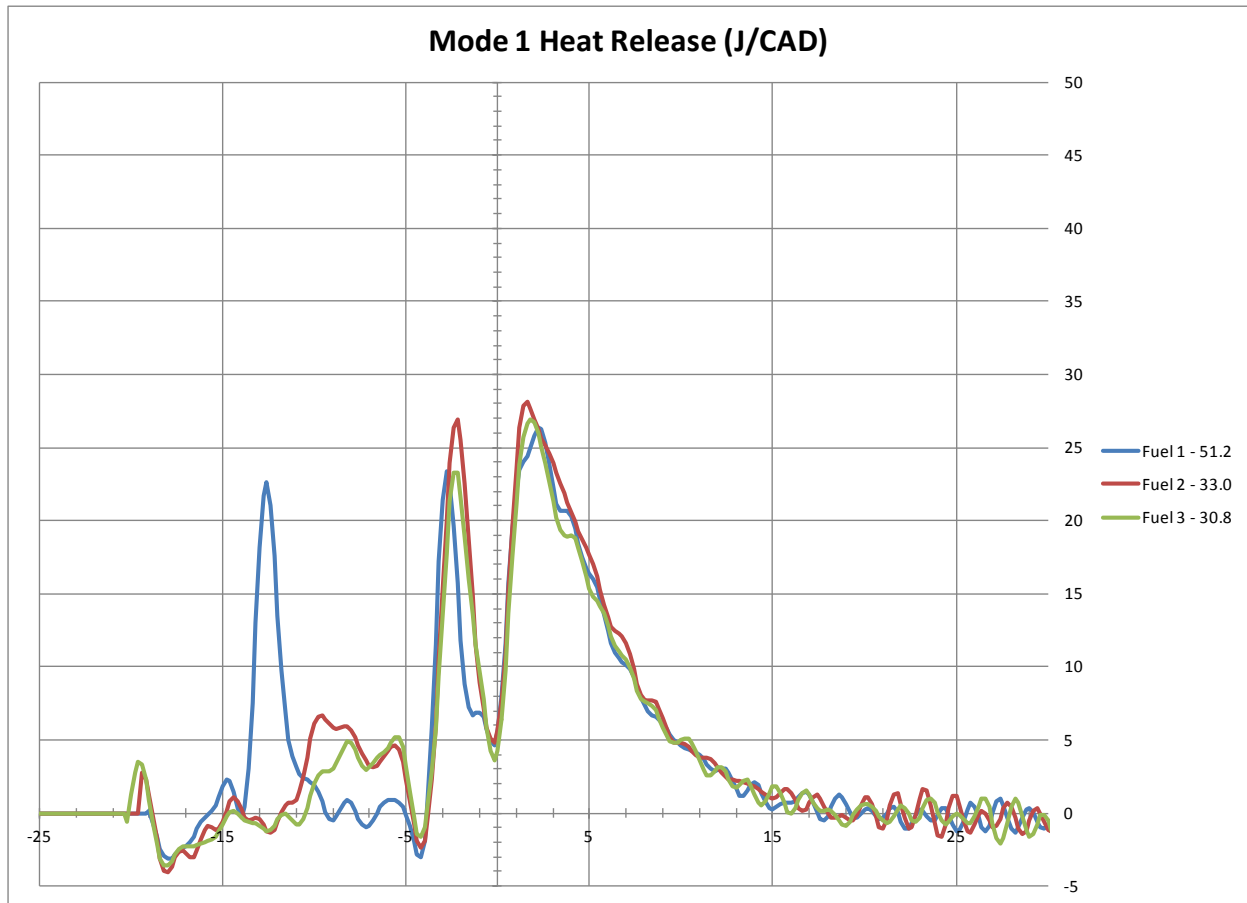
Figure C-8. Mode 1 Heat Release

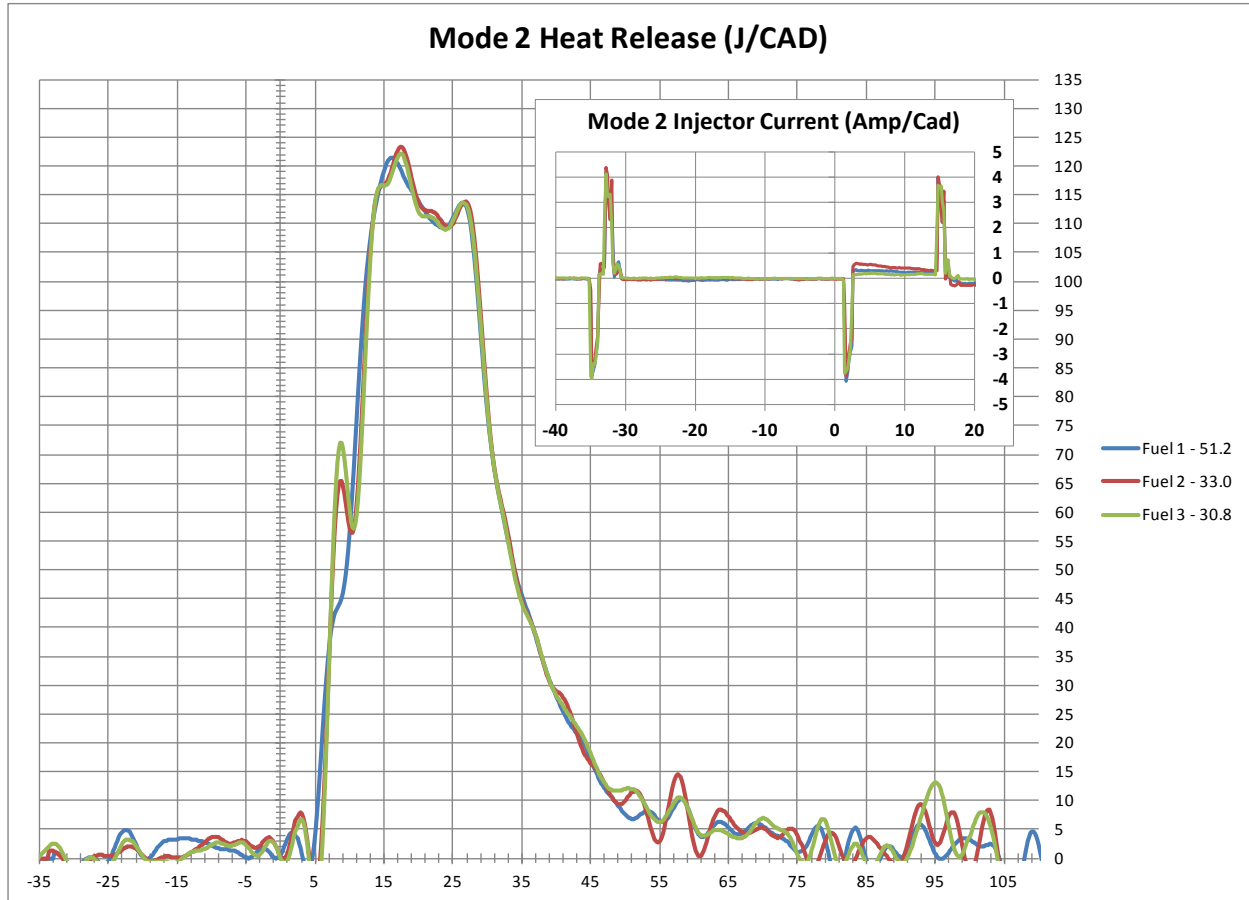
Figure C-9. Mode 2 Heat Release with Injector Current (Inset)

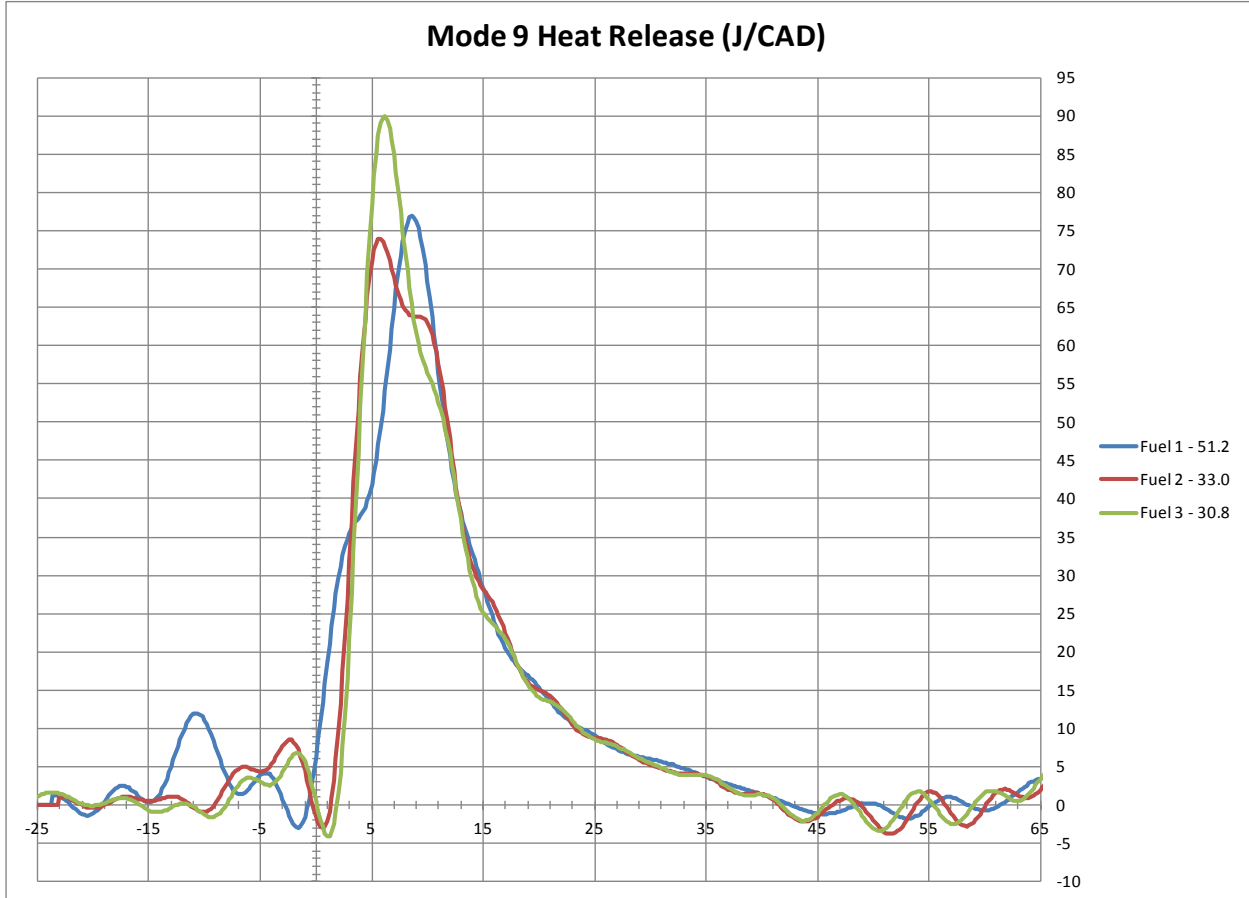
Figure C-10. Mode 9 Heat Release

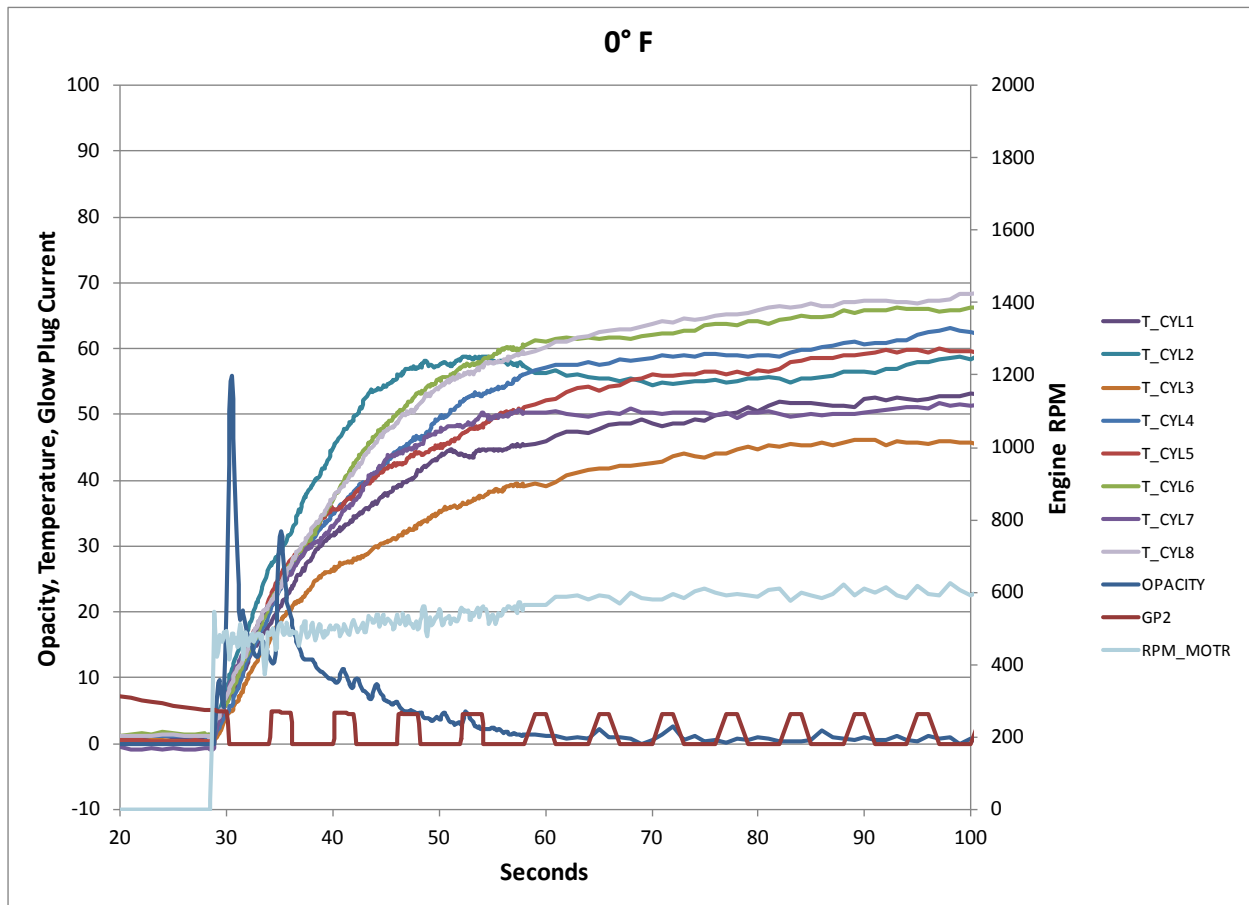
Figure C-14. High Cetane Cold Start at 0 °F

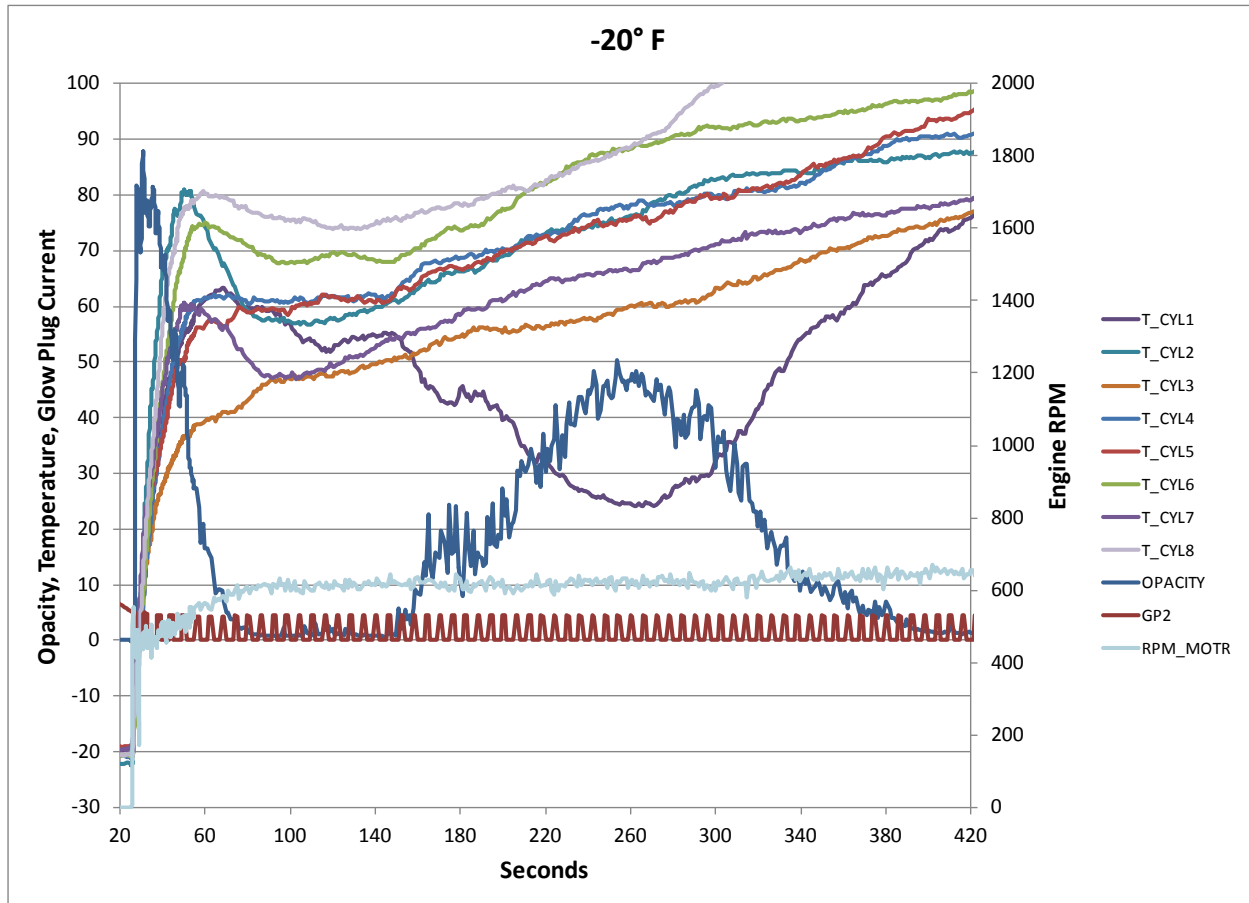
Figure C-15. High Cetane Cold Start at -20 °F
