Improved Concrete Cutting and Excavation Capabilities for Crater Repair

Phase 2

May 2015

Report 2 of a series

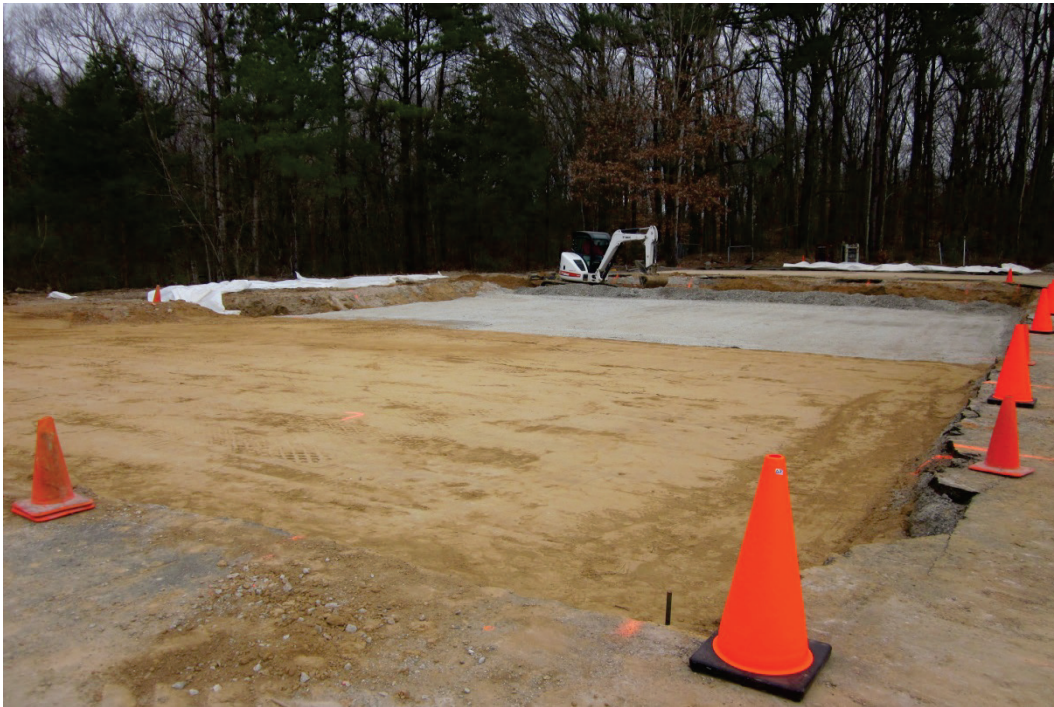
Figure 2. Test site construction preparation.

The existing subgrade was graded prior to construction with a 0.7 percent grade in the profile (east to west) and 0.3 percent grade south to north to allow for drainage (Figure 2). A drainage ditch was also constructed off the side of the center of the section (depicted in the far left of Figure 2). Silt was placed and compacted to a 12-in. depth over the western half (37.5 ft by 45 ft) of the test section as the base. For the eastern half (37.5 ft by 45 ft) of the test section, 6 in. of silt was used for the subbase, and 6 in. of crushed limestone was used as the base course. For the 24-in.-thick PCC section, 6 in. of limestone was used as the base course. Each layer was compacted to a target of 95 percent modified Proctor density or to the point that the in-place density did not increase with additional compactive effort. A Caterpillar CS433E vibratory smooth-drum roller and a Wacker WP 1550W plate compactor were used for compaction.

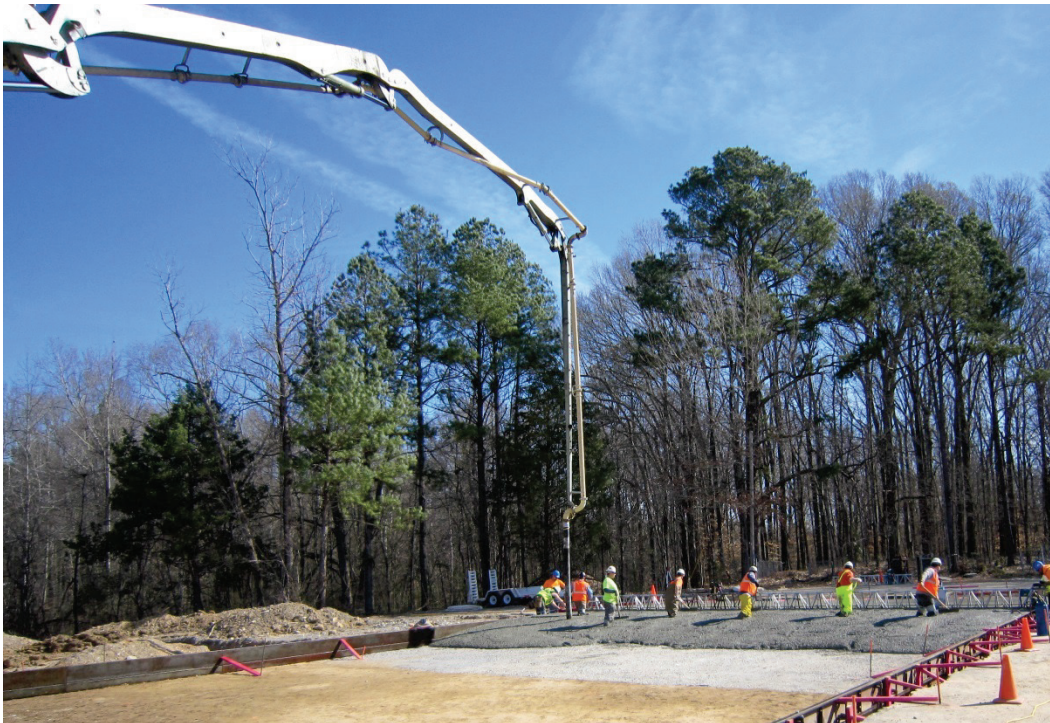
The PCC was placed by a pump truck (Figure 3), consolidated with 2-in. spud vibrators, and screeded with a self-powered, vibratory truss screed. A maximum slump of 7 ± 1 in. was specified. The PCC section was completed with a light broom finish, coated with a curing compound, and then saw cut to provide transverse and longitudinal joints. The joints were saw cut approximately 24 hr after the concrete placement. The 18-in.-thick section was saw cut to a depth of 5 in., and the 24-in.-thick section was saw cut to a depth of 6.5 in. Saw cut depths met the PCC specifications described in UFC 3-260-02. A white-pigmented curing compound meeting the ASTM C309-11 (2011b) specifications was used.

Figure 3. PCC placement using pump truck.

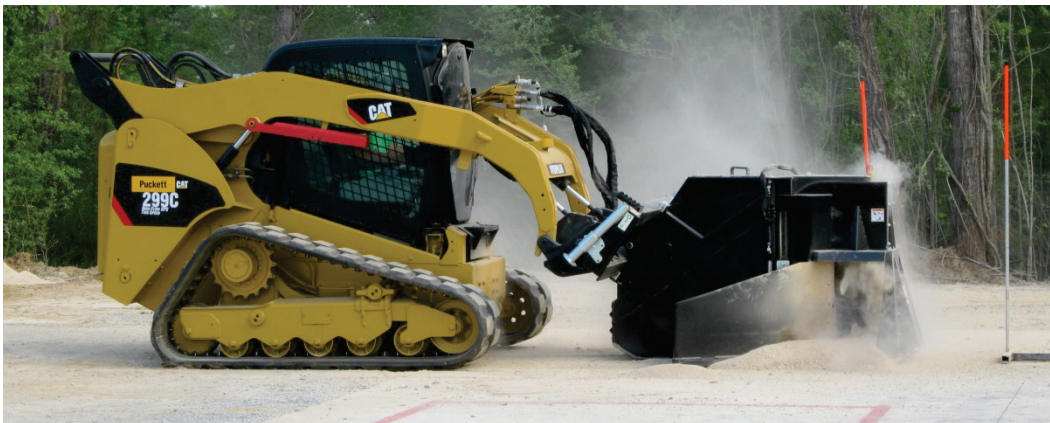
Figure 4. Caterpillar 299C CTL, operating the SW45 wheel saw attachment.

Caterpillar 279C compact track loaders (CTL), or skid steers, are high-flow, rubber-tracked machines with quick disconnect fittings that are used extensively in the current ADR TTPs. The quick disconnect allows attachments to be switched out rapidly without the use of tools. The Caterpillar 299C CTLs (Figure 4) are similar to the 279C CTLs except the 299C model has slightly more power and a higher operating capacity. The multi-purpose machines are employed for many of the ADR processes, including rapidly cutting around the upheaval area adjacent to craters in bomb-damaged pavement with wheel saw attachments, breaking pavement with the hammer attachment, removing debris with bucket attachments, screeding asphalt caps with the asphalt screed attachment, or cleaning up with the broom attachment. Specifications for the machines are listed in Table 3.

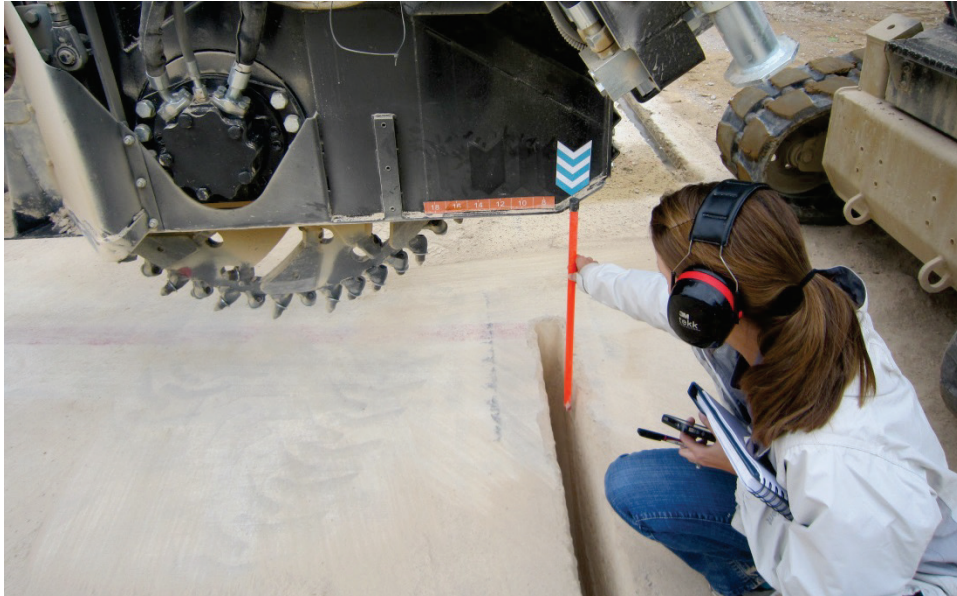
The magnetic arrow was placed at the desired location and used by the spotter to determine where to position the saw prior to cutting. The arrow on the wheel saw was aligned with the edge of the crater repair when the wheel saw was parallel to the ground. The spotter often used the rookie stick from the end target to assist in lining up the saw (Figure 10). The end saw target was placed at the desired distance from the edge of the crater repair. The locations of the arrow and the end target depended on the desired overcut lengths, as discussed later in this report. The CTL operator used the rookie pole alignment guide on the wheel saw to line up with the end target placed by the wheel saw spotter. Once the wheel saw attachment bumped the end target, the cut was complete.

Figure 10. Using the rookie stick to line up to the edge of the crater.

When the Caterpillar SW45 and SW360B wheel saws begin cutting, the saws move backwards as they plunge through the PCC, so lining up the saws can be deceiving for the spotter. More scatter was seen in the starting overcut data, likely due to the variability in the length as the saw moves backwards. To ensure consistency when measuring the starting overcuts, a rookie stick was used to line up the arrow and the marked corner (Figure 10).

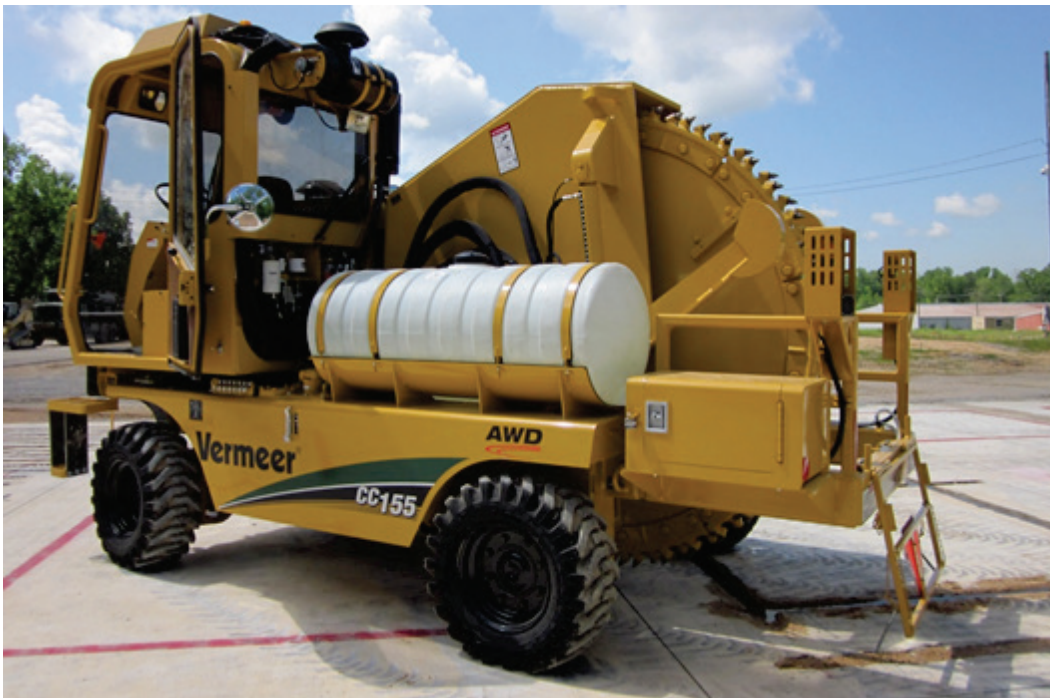
The Vermeer CC155 machine was equipped with the CC1531 concrete cutter wheel (Figure 11). The wheeled machine has a cab for the operator and has the ability to perform wet or dry cuts. Two water tanks are mounted on the machine with a total capacity of approximately 200 gal. The water is optional and can be used to suppress dust and to keep the cutting teeth from getting too hot. The CC1531 concrete cutter wheel is mounted near the center of the machine as opposed to being an attached arm. The CC1531 concrete cutter wheel makes a 5.5-in.-wide cut.

Figure 11. Vermeer CC155 concrete cutter with CC1531 wheel.

Parameter Specifications	Vermeer CC155/CC1531 combination
Gross power	155 hp
Overall width	96 in.
Overall height	120 in.
Length	165 in.
Weight (water tanks empty)	22,800 lb
Weight (water tanks full)	24,600 lb
Wheel diameter	84 in.
Wheel width (without teeth)	2 in.
Turning radius	18 ft
Max transport speed	10 mph or 900 ft/min
Number of teeth	90 per wheel
Maximum depth of cut	31 in.
Cutter tip speed (high gear)	1,844 ft/min
Cutter tip speed (low gear)	922 ft/min

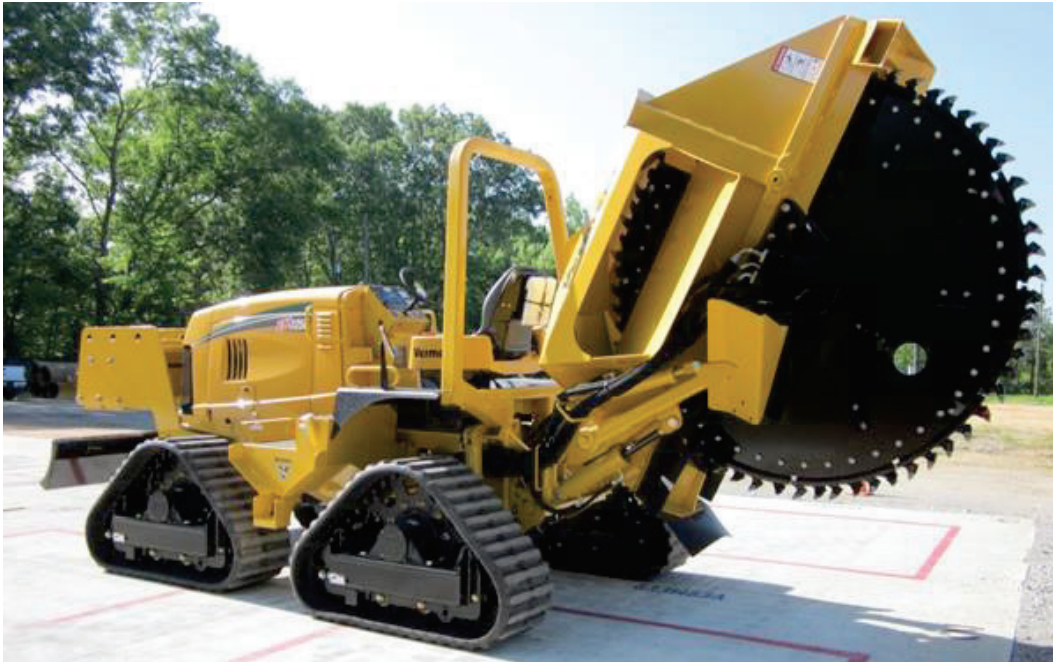
The Vermeer RTX1250 tractor (Figure 12) can switch between rubber tires and a rubber quad-track system. The rubber tracks were used for this evaluation. Although this evaluation included the tractor with no cab, there is an optional cab for the machine to protect the operator from concrete dust. The RTX1250 comes with many optional attachments: a reel carrier, a plow, a wheel saw, a trencher, a backhoe, and a backfill blade. Table 6 lists some key specifications of the tractor.

The RW1236W rockwheel attachment (Figure 12) is used on the Vermeer RTX1250 tractor for trenching or sawing through concrete. The center-mounted wheel is pulled behind the operator. The RW1236W makes a 5-in.-wide cut. Specifications for the RW1236W are shown in Table 7.

Figure 12. RTX1250 tractor with RW1236W rockwheel attachment.

Parameter Specifications	Vermeer RTX1250
Gross power	120 hp
Height	109 in.
Width	93 in.
Length	161 in.
Weight	13,620 lb
Max torque	350 ft-lb
Max transport speed	9 mph
Turning radius	20 ft

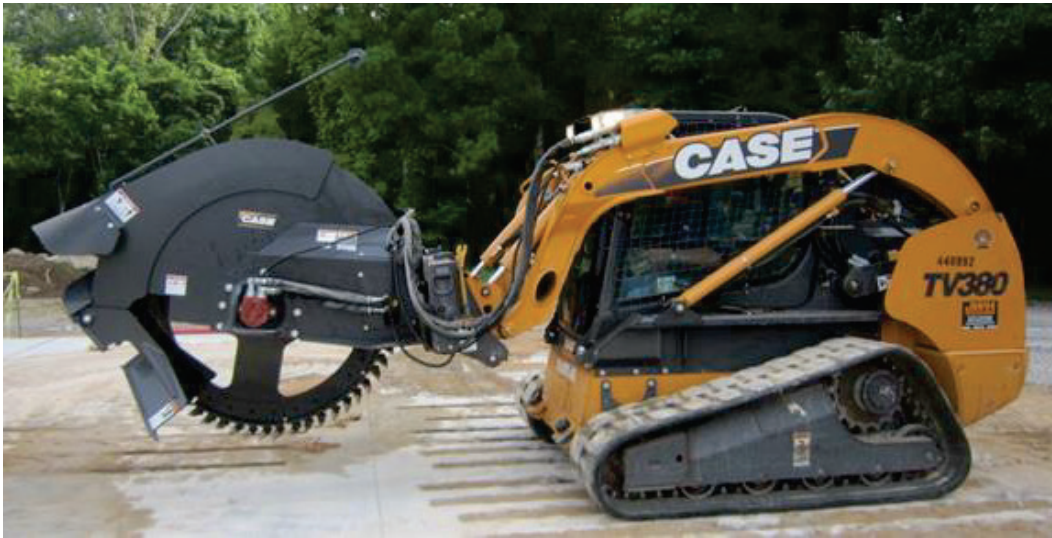
The CASE TV380 CTL (Figure 13) is similar to the Caterpillar 279C CTL. The tracked machine has a rigid track frame, which results in fewer moving parts than suspension track systems. Many optional attachments such as augers, rakes, backhoes, brooms, buckets, cold planers, couplers, dozer blades, hammers, forks, and wheel saws can be used with the CASE TV380 CTL. Table 8 presents the basic specifications for the machine.

Figure 13. CASE TV380 with Bradco RS24 rock saw attachment.

The Bradco RS24 rock saw (Figure 13) is similar to the Caterpillar SW360B wheel saw; however, the Bradco RS24 is equipped with 10 fewer cutting tools and produces 4-in.-wide cuts. The Bradco RS24 may be

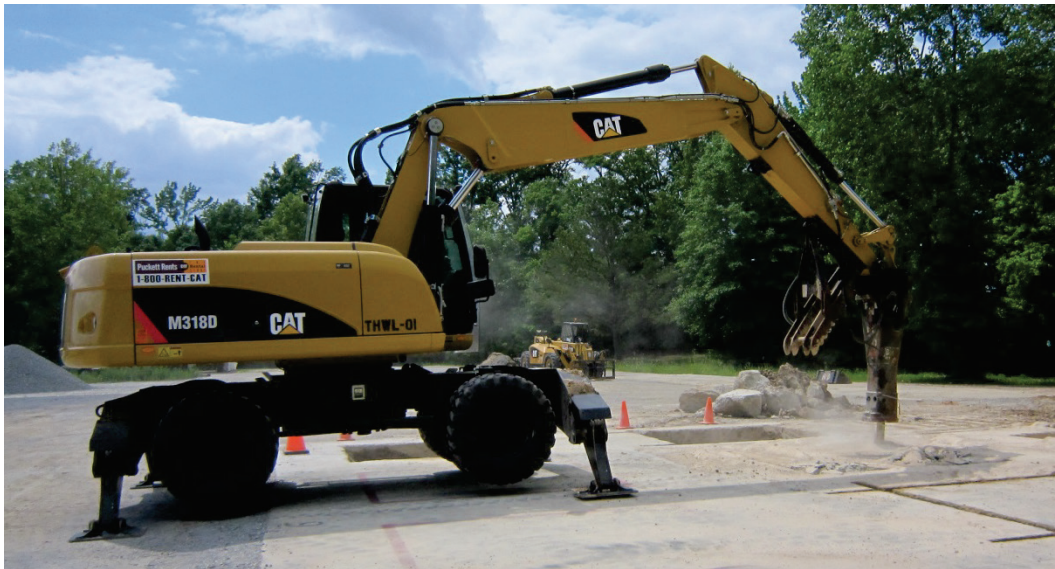
Figure 14. Caterpillar M318D excavator with H120E hammer.

A Caterpillar M318D wheeled excavator (Figure 14) or its equivalent is used in the ADR TTPs to break the PCC and excavate the broken PCC and underlying material. Wheeled excavators are preferred to tracked excavators for crater repair purposes because they minimize damage to the existing pavement around the repairs. The excavator is equipped with quick-disconnect fittings for the hammer and bucket work tool attachments. Table 10 presents the basic specifications of the Caterpillar M318D wheeled excavator.

The 18-in. and 24-in.-thick concrete was broken with amoil point Caterpillar H120E hammer (Figure 14). A 36-in.-wide bucket with a stationary thumb (Figure 15) was used for removing disturbed material. The teeth on the 36-in.-wide bucket were 8 in. long. Specifications for the Caterpillar H120E hammer are listed in Table 11.

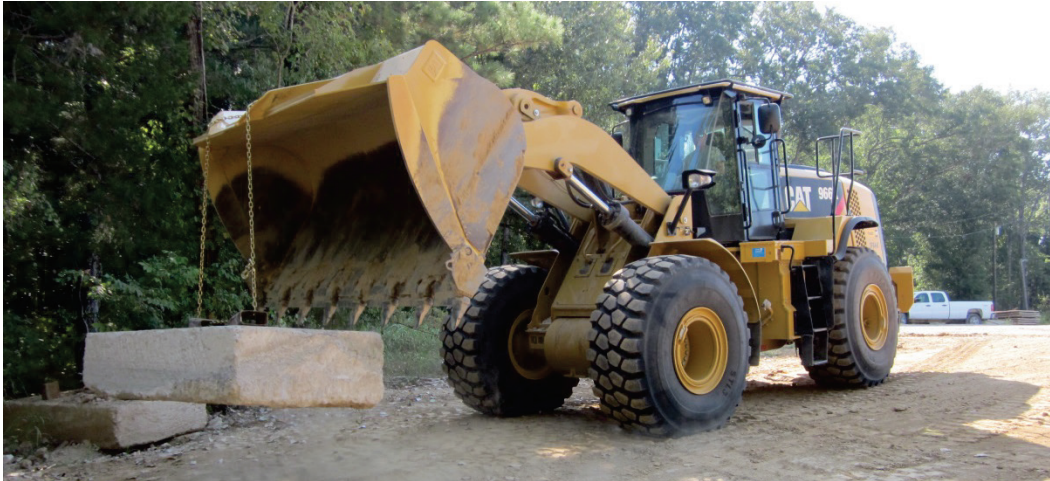
Figure 16. Caterpillar 966K front-end loader.

A front-end loader is a part of the ADR kit and is readily available. A Caterpillar 966K front-end loader with a 4-yd³ bucket (Figure 16) was employed for lifting sawed pavement sections by using anchoring systems and for general cleanup around the test site. The basic specifications for the Caterpillar 966K can be found in Table 12.

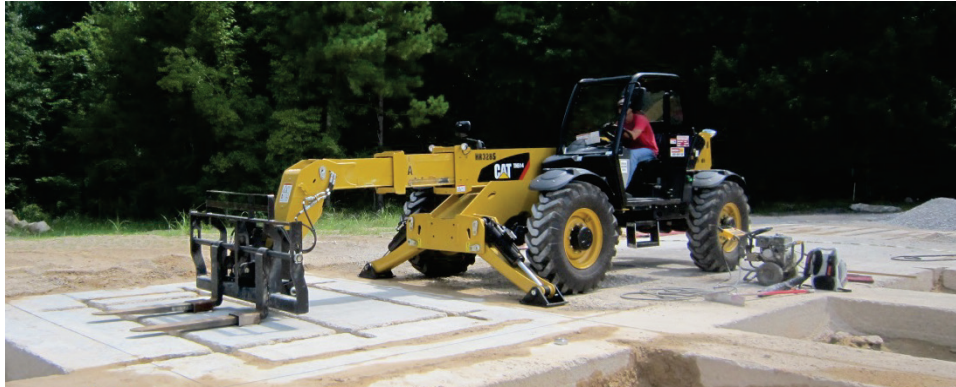
An extendable boom forklift is versatile and can be used for various ADR tasks. The Caterpillar TH514 telehandler (Figure 17) was used for this evaluation. Since the telehandler is readily available, it was tested for its ability to lift sawed pavement using an epoxy-anchoring system. The specifications for the Caterpillar TH514 telehandler are provided in Table 13.

Figure 17. Caterpillar TH514 telehandler.

Parameter Specifications	Caterpillar TH514
Rated load capacity	11,000 lb
Maximum lift height, stabilizers up or down	45 ft
Gross power	101 hp
Maximum torque	1400 rpm
Operating weight with carriage and forks	23,722 lb
Load at max height, stabilizers up	4,000 lb
Load at max height, stabilizers down	7,000 lb
Load at max reach, stabilizers up	1,000 lb
Load at max reach, stabilizers down	3,000 lb

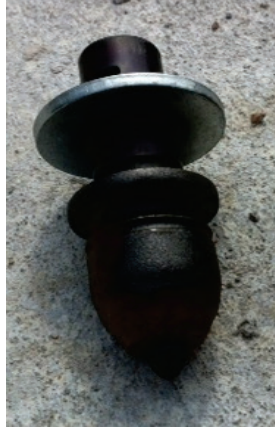
Figure 21. Wheel saw teeth, CAT model 227-7340.

The Caterpillar model 227-7340 concrete cutting tools (Figure 21) are the standard teeth sold with SW45 and SW360B wheel saw attachments. Previous testing (Bell et al. 2014) showed that these teeth produced

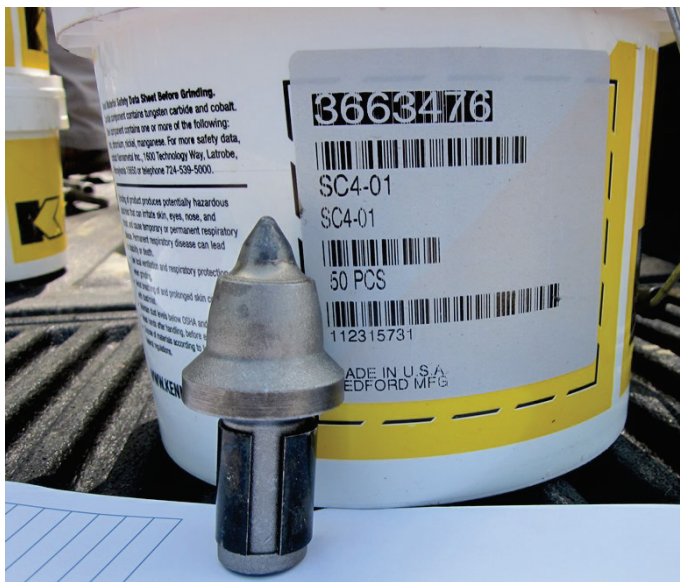
Figure 22. Wheel saw teeth, Kennametal model SM08.

The Kennametal model SM08 is a trenching tooth made of forged steel with a tungsten carbide insert with a 0.86-in.-diam shank. The 0.86-in.-diam shank fits in most Vermeer wheel saw attachments. The teeth are designed for use on soft, medium, hard, abrasive, or laminated rock. Figure 22 presents a diagram (Kennametal 2010) and picture of the teeth.

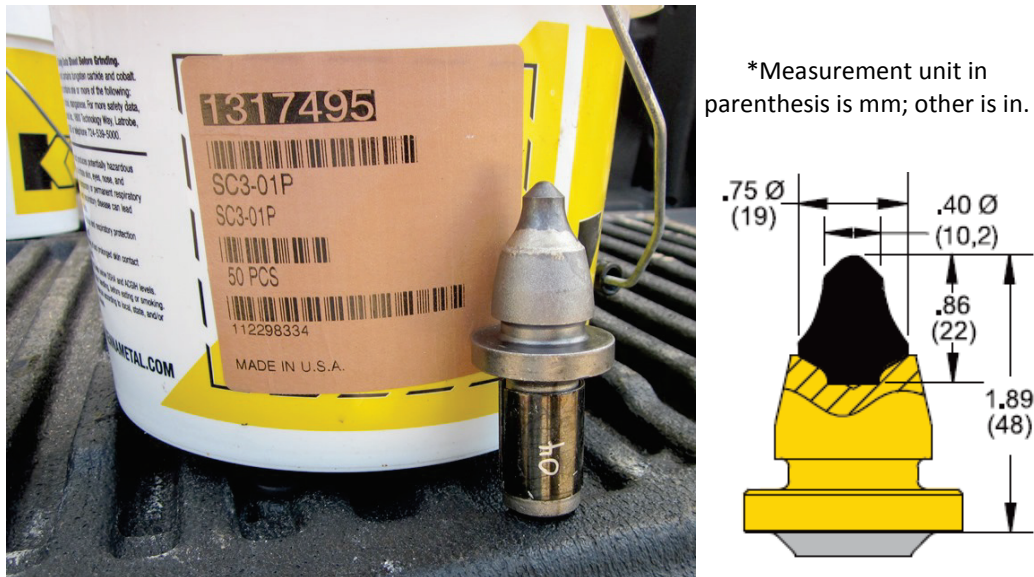
Figure 23. Wheel saw teeth, Kennametal model SM04.

The Kennametal model SM04 cutting tools are made of forged steel with a tungsten carbide tip and have a 0.86-in.-diam shank. The teeth fit most Vermeer saw equipment. The teeth are made for cutting through hard asphalt, concrete, or semi-rocky conditions (soft, medium, or abrasive rock). Figure 23 shows a diagram (Kennametal 2010) and picture of the SM04 teeth.

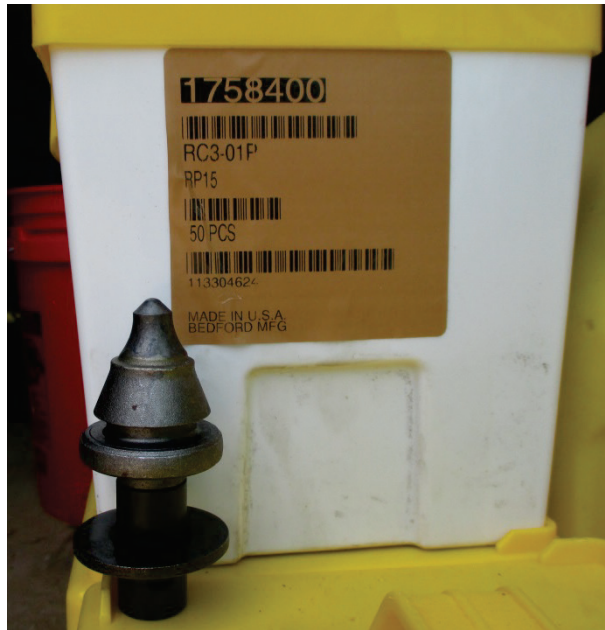
The Kennametal model RP15 teeth have a 0.76-in.-diam shank, which fits Caterpillar wheel saws. The cutting tools are made of forged steel with tungsten carbide tips. They are equivalent to the Kennametal model SM04 teeth except that the RP15 teeth have a smaller shank diameter. Common applications for these cutting tools on medium to high horsepower machines include hard to medium asphalt and concrete conditions. Figure 24 shows a diagram (Kennametal 2007) and picture of the RP15 teeth.

Figure 24. Wheel saw teeth, Kennametal model RP15.

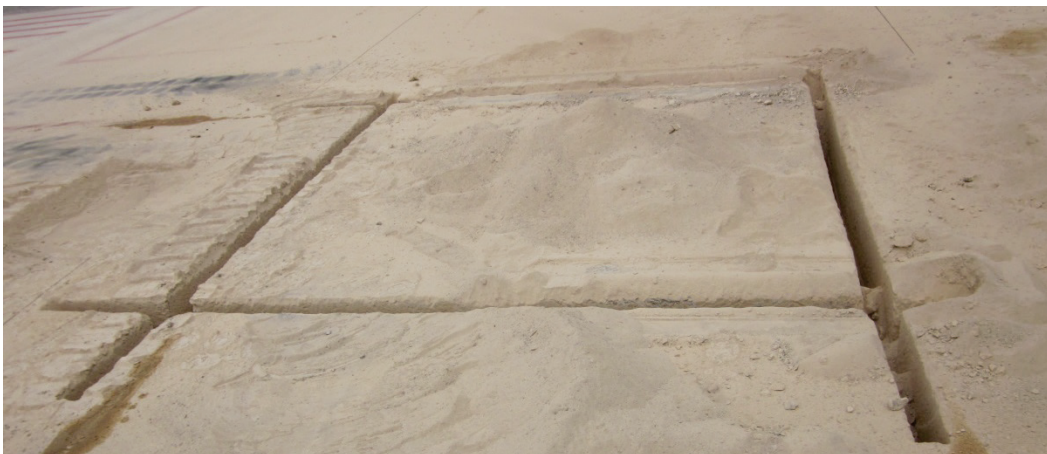
Figure 25. Long overcut lengths, as seen on Crater 8.

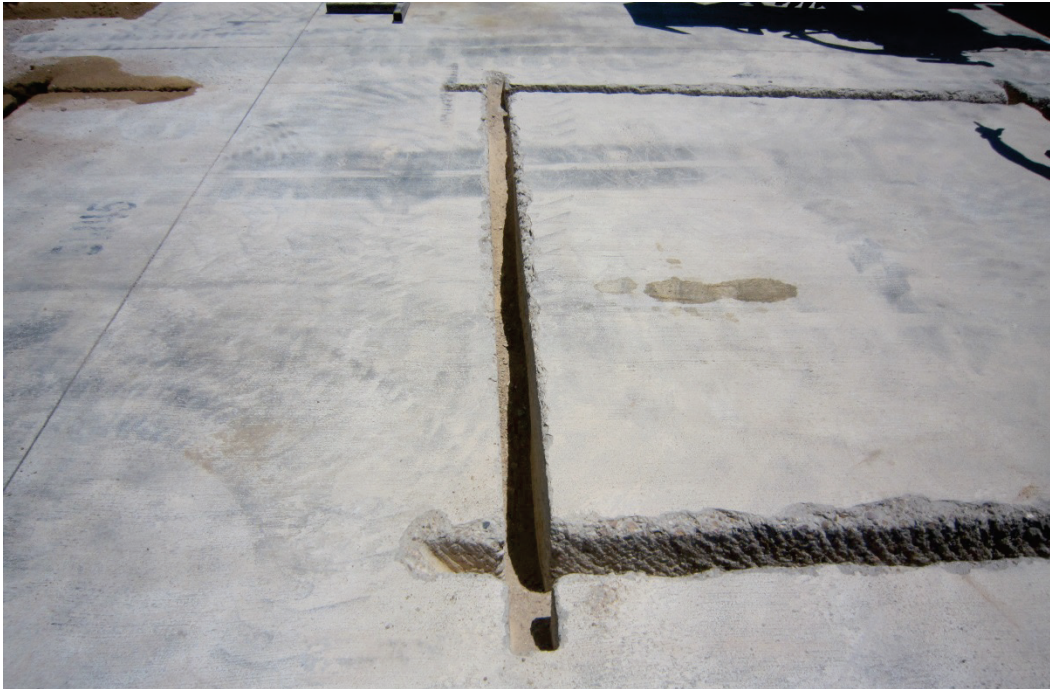
Figure 26. Short overcut lengths, as seen on Crater 9.

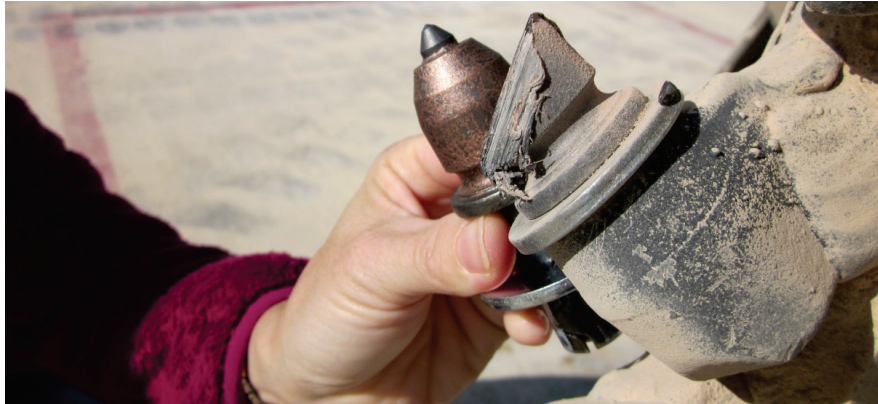
Figure 27. Worn concrete teeth after cutting, CAT model 227-7340.

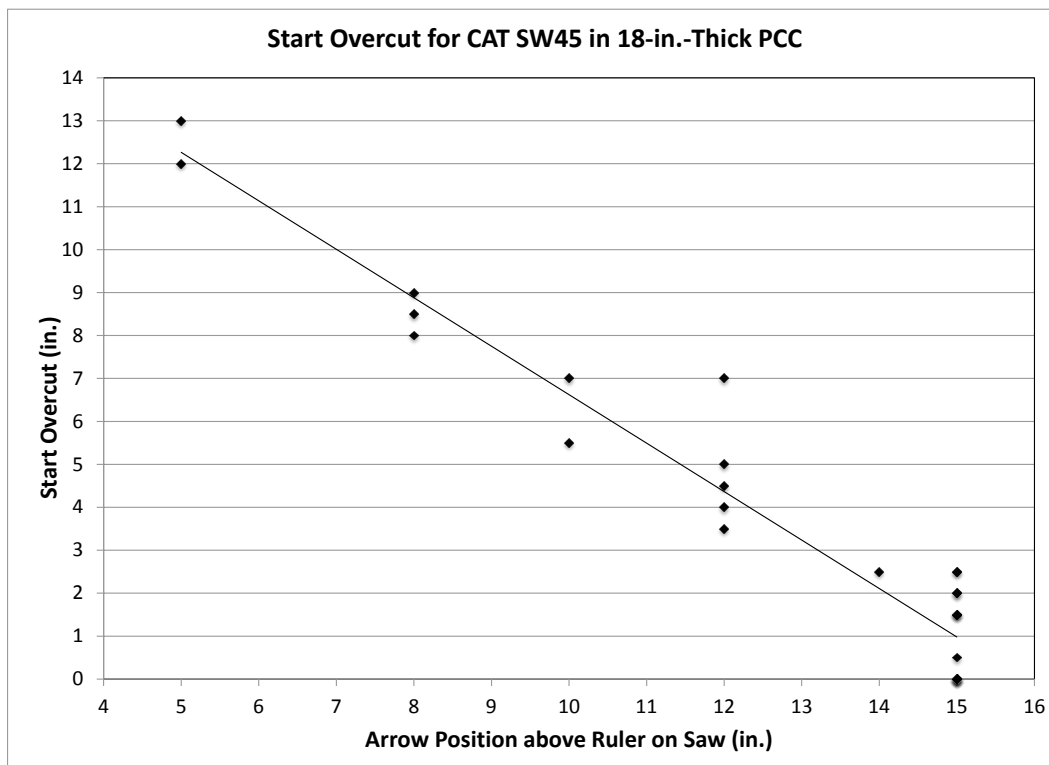
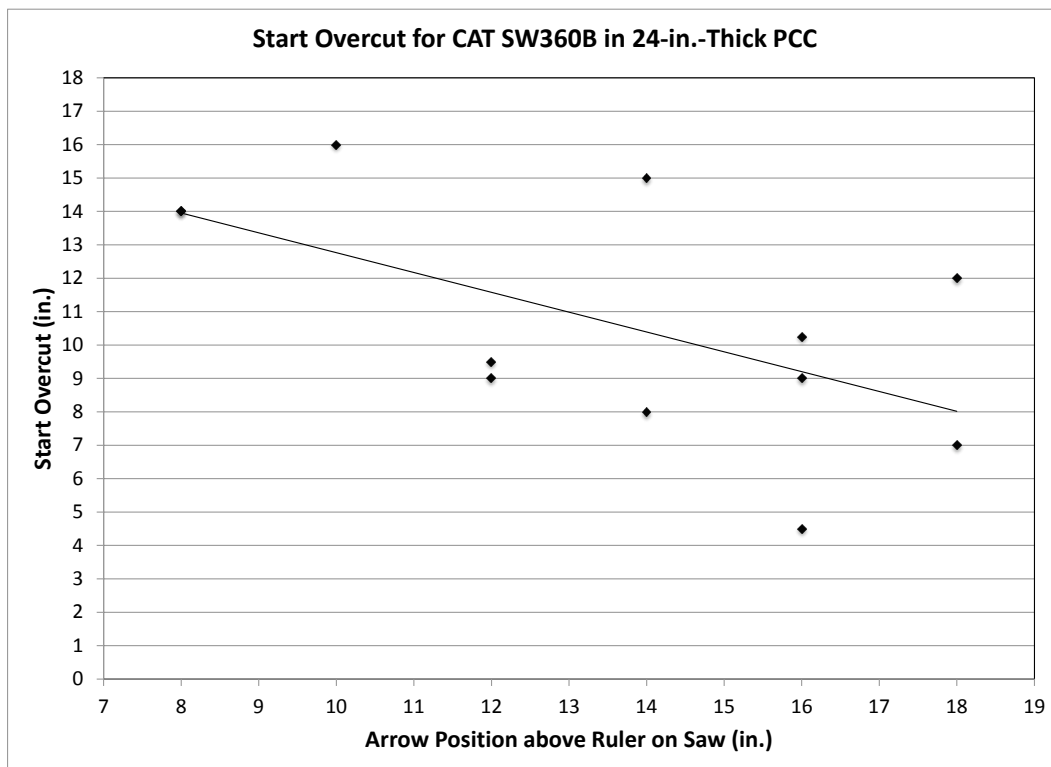
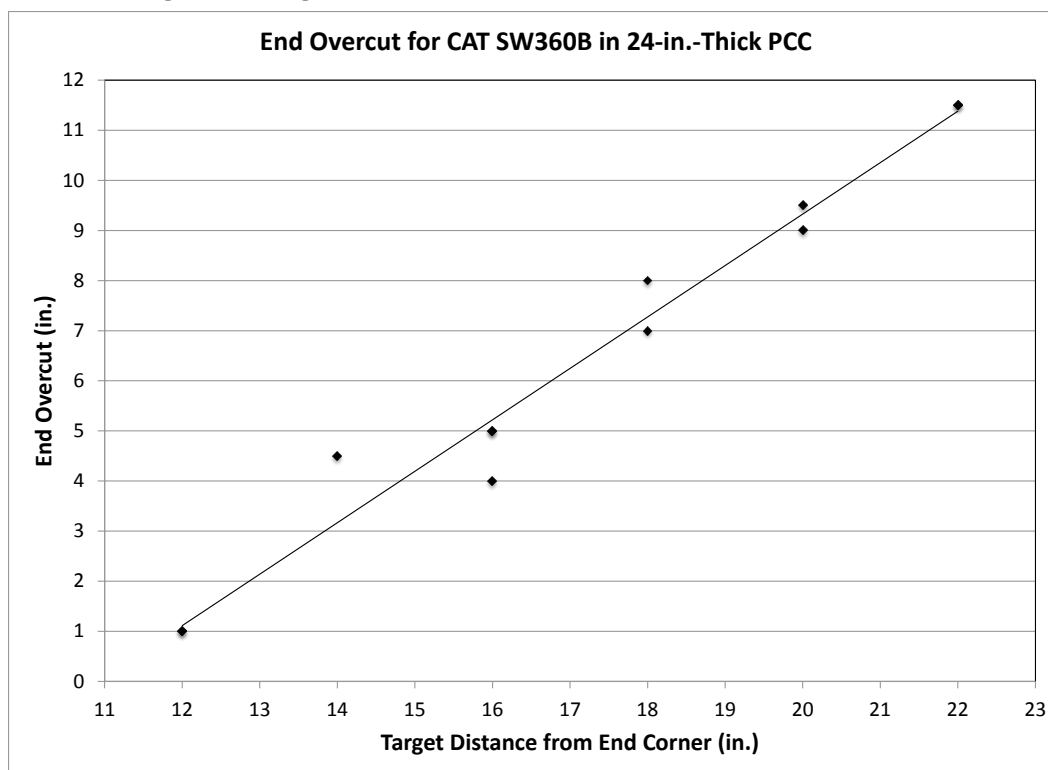
Figure 28. Saw placement data for CAT SW45 in 18-in.-thick PCC.

Figure 29. Target placement data for CAT SW45 in 18-in.-thick PCC.

Figure 30. Saw placement data for CAT SW360B in 18-in.-thick PCC.

Figure 31. Target placement data for CAT SW360B in 18-in.-thick PCC.

Figure 32. Saw placement data for CAT SW360B in 24-in.-thick PCC.

Figure 33. Target placement data for CAT SW360B in 24-in.-thick PCC.

The end overcuts were determined by placing the target at various distances away from the corner located at the end of the cut. The saw operator stopped the saw as soon as the machine bumped the target. Once all data were obtained, linear regressions were used to show approximately where the saws should be lined up to achieve the desired undercut.

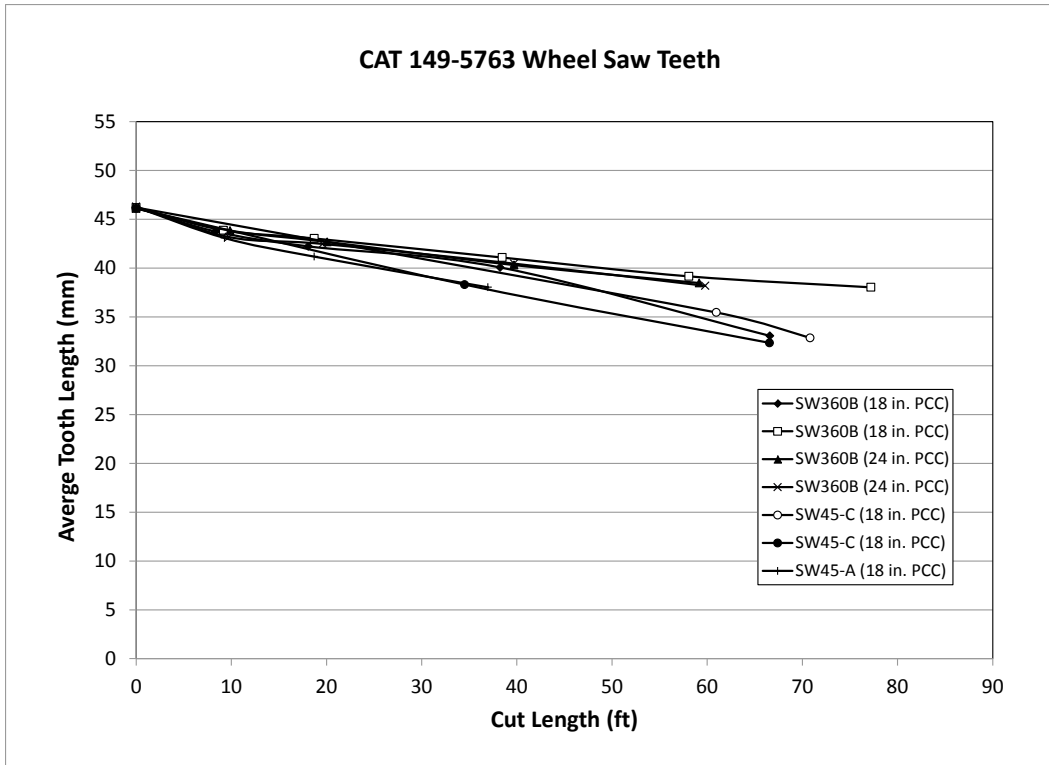
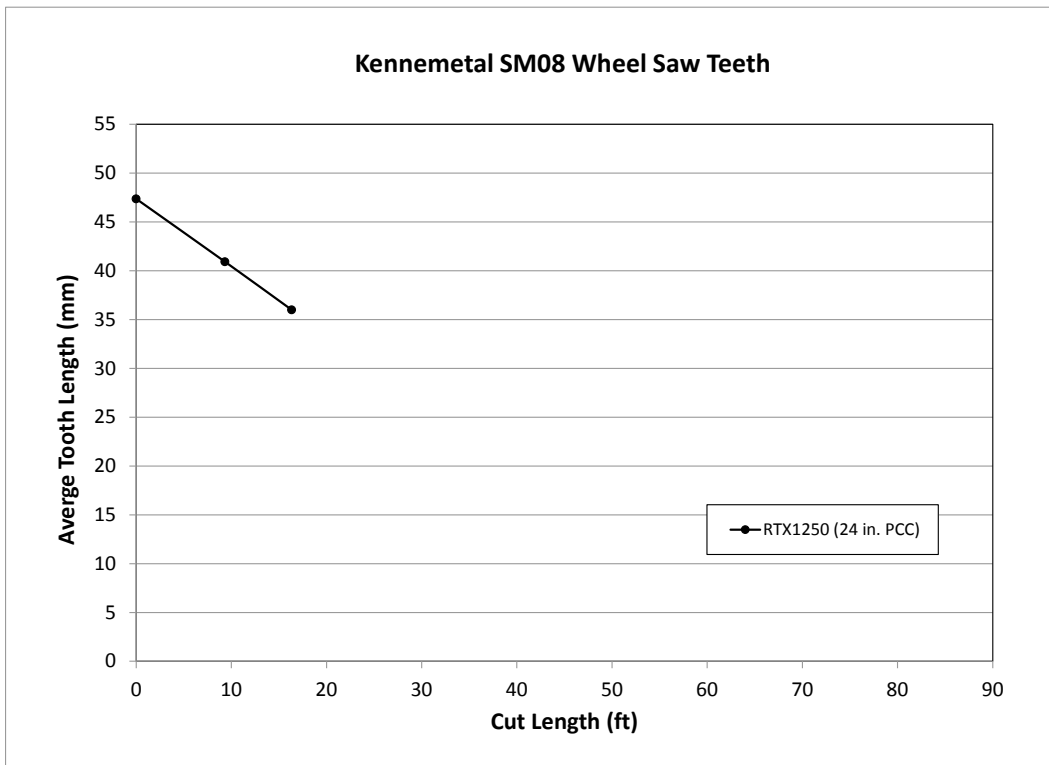
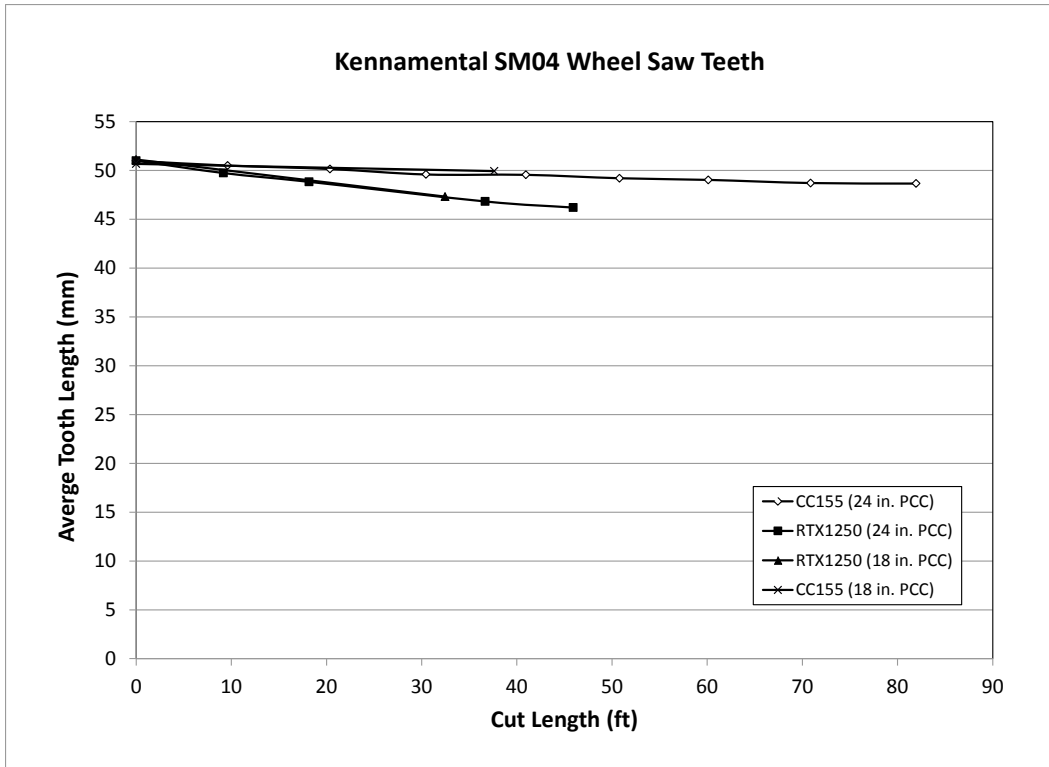
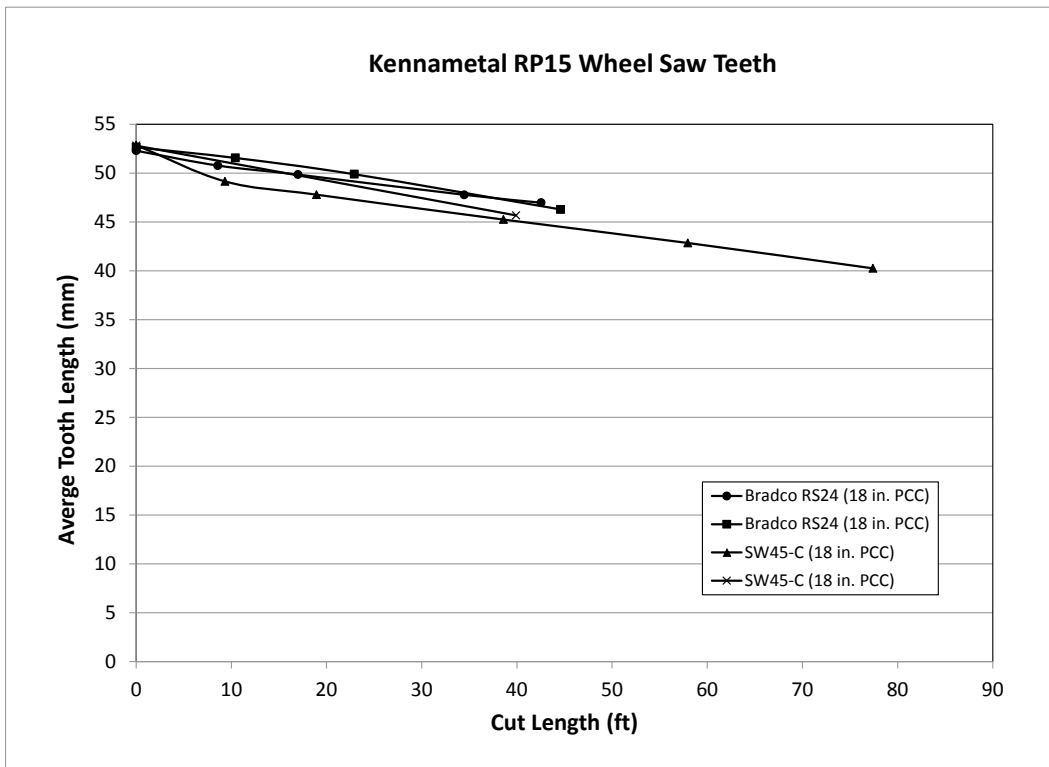
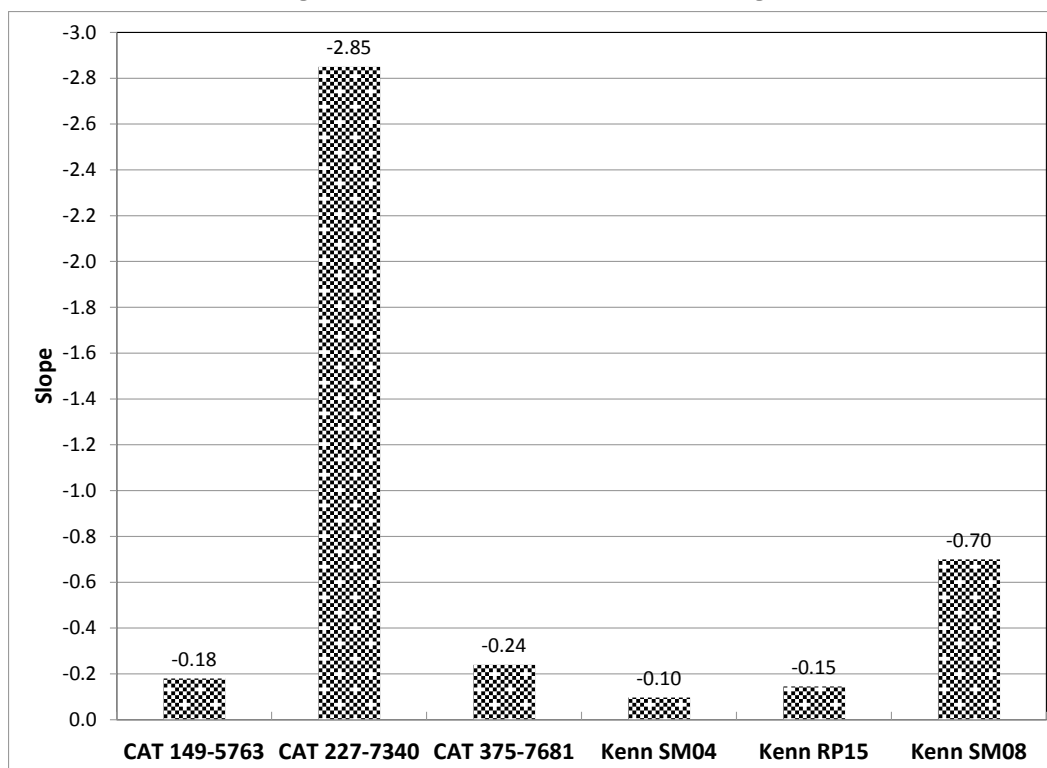
Figure 34. CAT model 149-5763 tooth length versus cut length.

Figure 35. CAT model 375-7681 tooth length versus cut length.

Figure 36. CAT model 227-7340 tooth length versus cut length.

Figure 37. Kennametal model SM08 tooth length versus cut length.

Figure 38. Kennametal model SM04 tooth length versus cut length.

Figure 39. Kennametal model RP15 tooth length versus cut length.

Figure 40. Slope of teeth wear with cut length.

The Kennametal SMO8 wheel saw teeth used on the Vermeer RTX1250 machine and CAT model 227-7340 wheel saw teeth tested on the Caterpillar machines were not durable enough for sawing through 18-in.-thick and 24-in.-thick PCC. Also, the preexisting CAT model 149-5763 wheel saw teeth (slope of -0.18) were slightly more durable than the newer CAT model 375-7681 teeth (slope of -0.24). These data are considered conservative due to the chert aggregate used in the PCC mix.

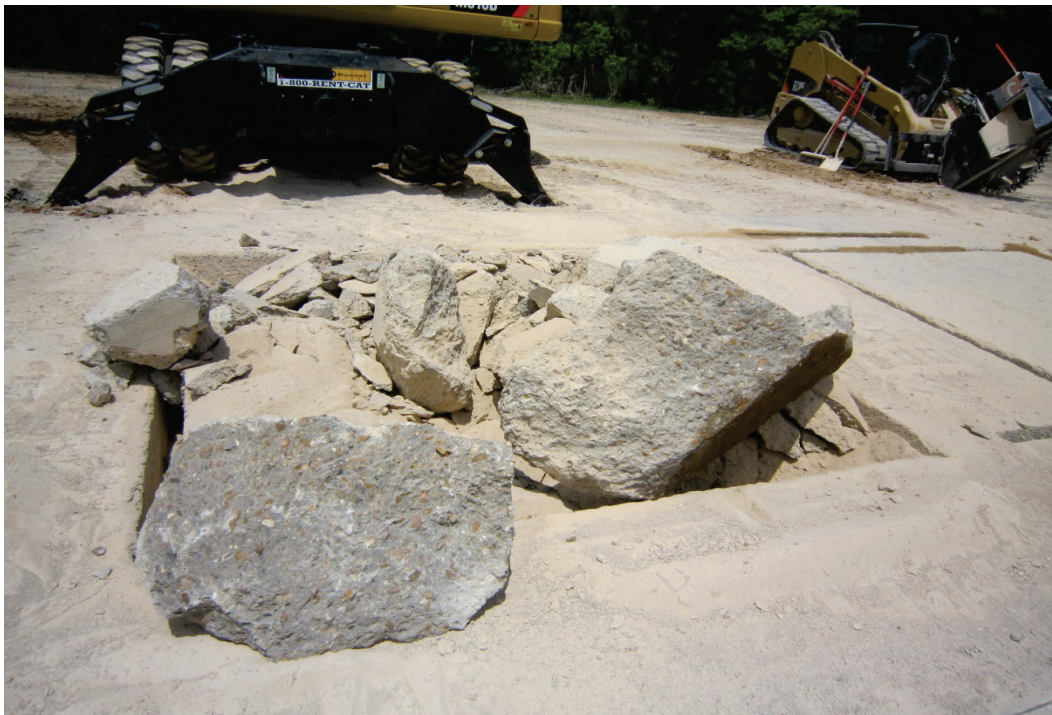
The PCC was cut to a depth of 15.5 in. for Craters 4 and 10. This was purposely done to see what effect the 2.5-in. less-than-full-depth cut had on the breaking and removal times. The breaking time required for Crater 4 was 8.25 min, which was the second longest break time. The less-than-full-depth cut and the little-to-no overcuts (less than 2 in.) caused an increase for the breaking time of Crater 4 because of the need for more breaks with the excavator hammer. The breaking of this crater also cracked the four corners of the parent slabs. Two of the corner breaks spread to the adjacent slabs and cracked to their existing cut lines. As a result, the excavator operator began breaking in the center of the sawed area for the remaining craters. The removal time was longer than most others due to the amount of small PCC debris.

Figure 43. Crater 10, with no overcuts and less-than-full-depth cuts.

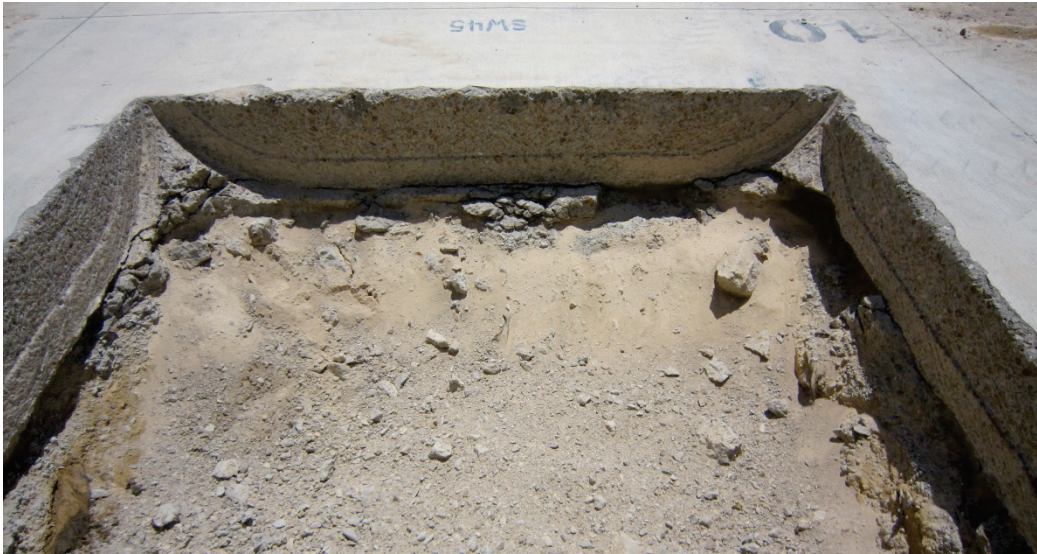
The 0-in.-long to 3- in.-long overcuts for Craters 4, 5, 10, and 11 left attached PCC remnants which began at the corners and broadened to the base of the repair. Figure 44 shows the attached PCC in the corners of a removed PCC section. This attached PCC also contributed to the longer breaking and removal times. It was difficult to get the 36-in.-wide bucket in the hole and remove the debris with PCC still attached in the corners.

Figure 44. Crater 10, with attached PCC at the corners.

The combination of the less-than-full-depth cut and small overcuts (0-3 in.) did not prevent the successful removal of PCC and underlying debris but more than doubled the breaking time (adding at least 7 min), increased the removal time by adding at least 3 min, and increased the operator's uncertainty in terms of knowing when to stop breaking. The short overcuts alone (0-3 in.), as seen in Craters 5 and 11, increased the breaking and excavation time (Figure 45 and 46, respectively). With the exception of Crater 10, where the operator was uncertain about the breaks, the breaking and excavation times of the craters with short overcuts (0-3 in.) and less-than-full-depth cuts differed by at most 1 min. Short overcuts often led to cracking of the corners of the parent slabs.

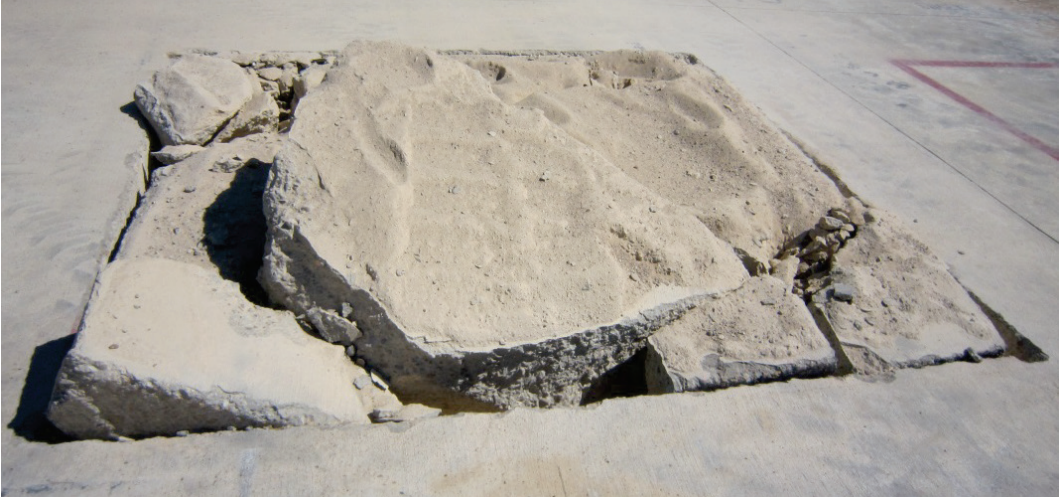
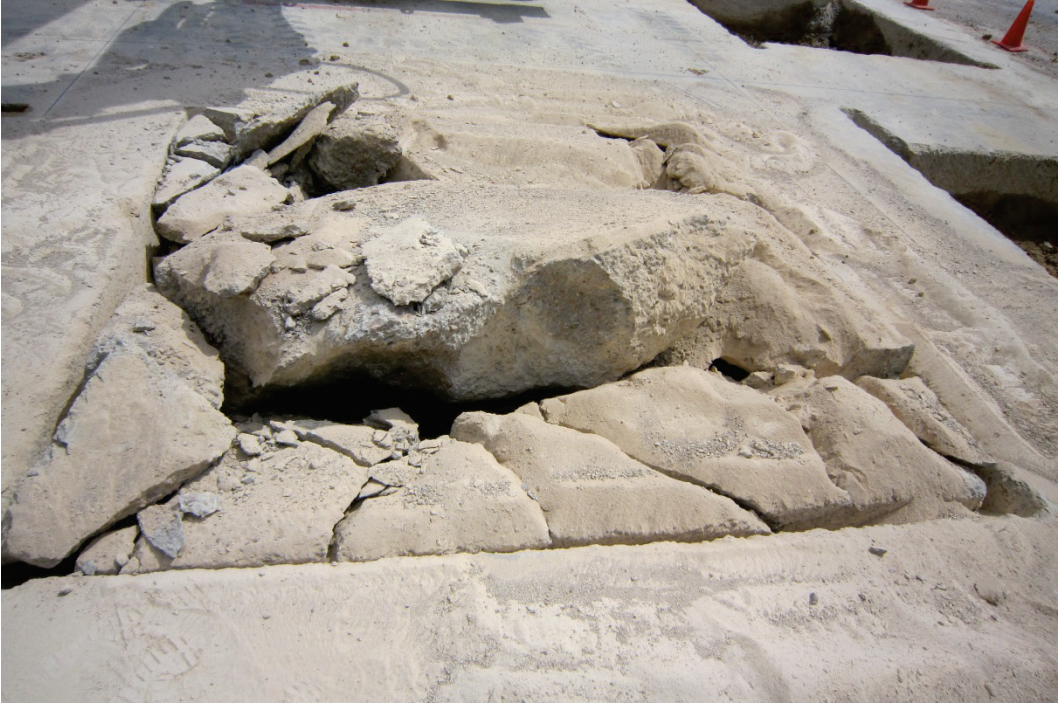
Figure 45. Crater 5, with short overcuts.

Figure 46. Crater 11, with short overcuts.
