Improved Concrete Cutting and Excavation Capabilities for Crater Repair

Phase 2

May 2015

Report 2 of a series

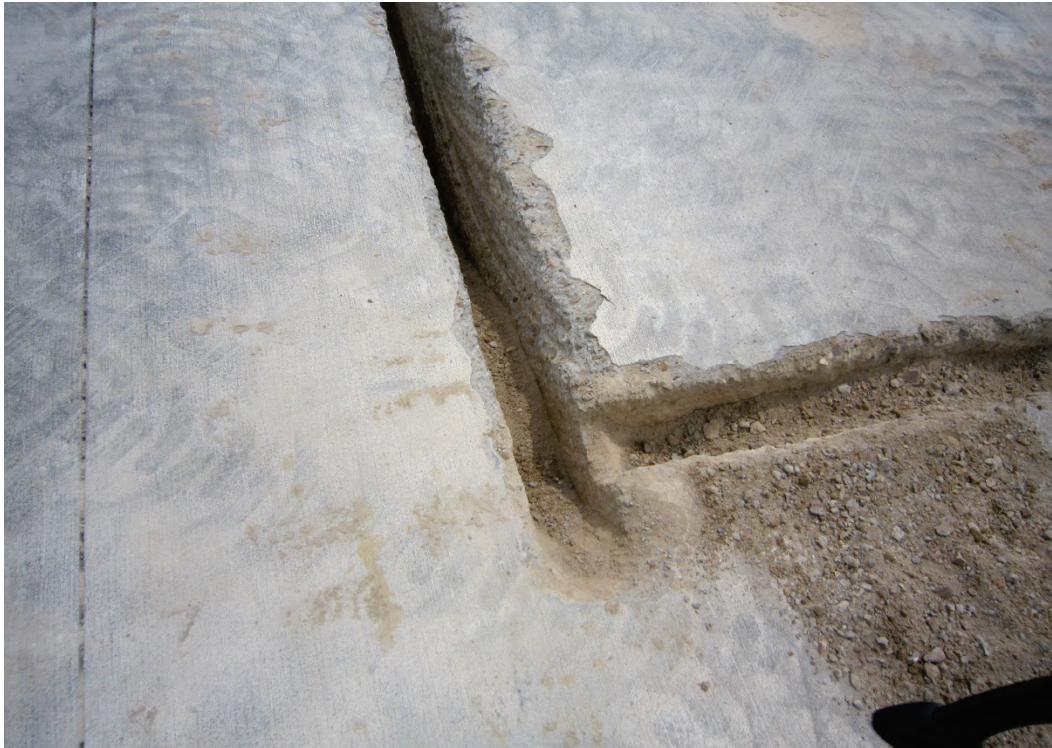
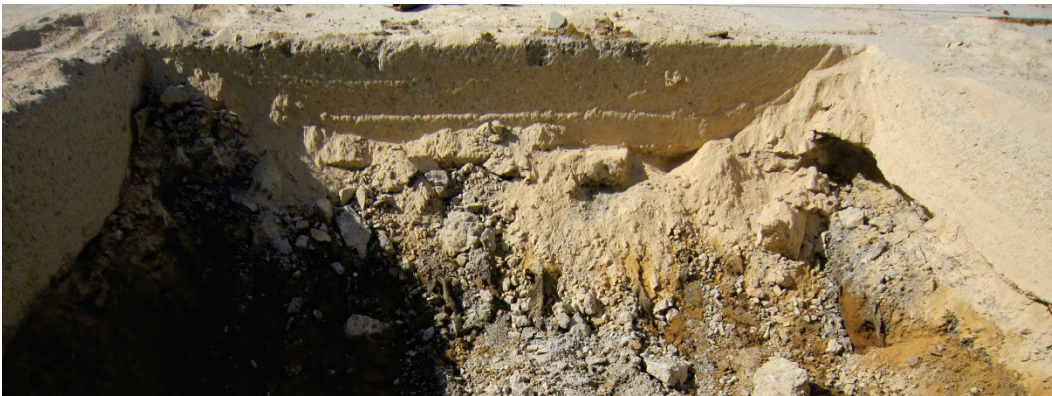
Figure 47. Crater 2, not fully sawed at corners.

Figure 48. Crater 2, corners broken with bucket.

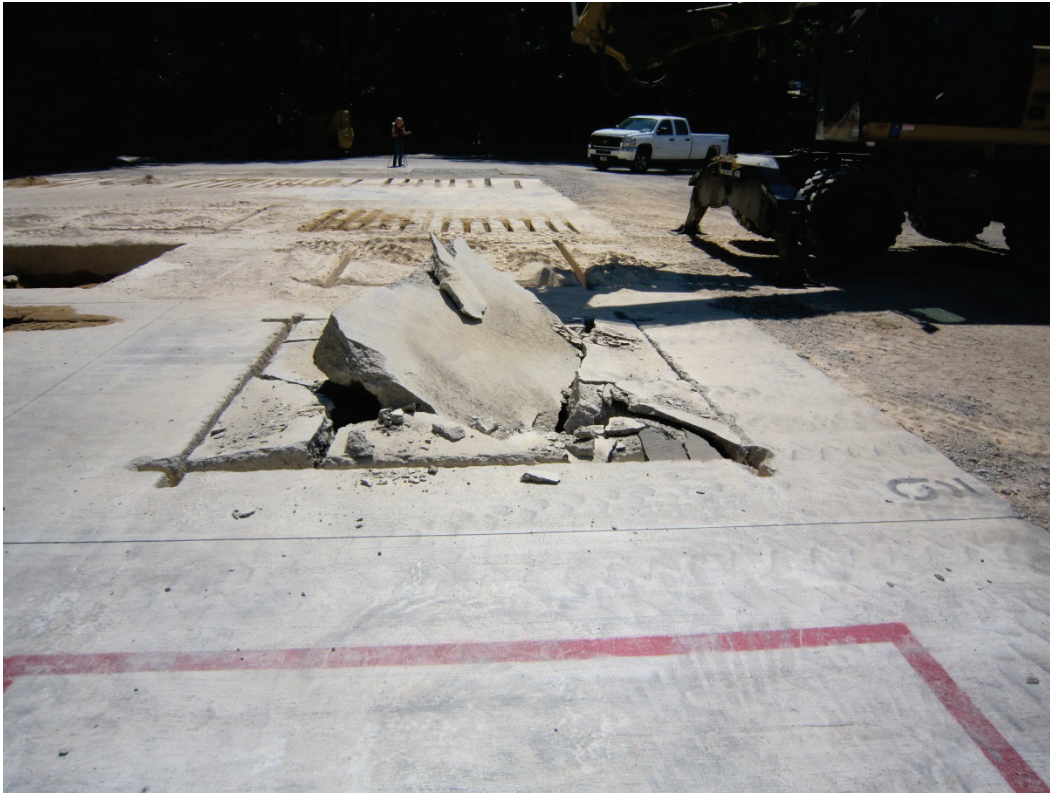
Crater 9 had 3-in.-long to 8-in.-long overcuts, which left some PCC still attached to the corners (Figure 49). These were small corners, and the PCC pieces attached were easy to break off and remove. Crater 9 had one of the fastest breaking times and the fastest removal time.

Figure 49. Crater 9 with 3-in. to 8-in. overcuts and PCC attached at corners.

The breaking and removal evaluation proved that longer overcuts decrease the breaking and removal times. The most efficient overcuts were determined to be 4 in. to 8 in. long. This range helped alleviate the risk of cracking the parent slab while decreasing the breaking and removal times. As mentioned in the undercut section, to obtain the 4-in.-long to 8-in.-long undercut range on the Caterpillar SW45, it is recommended that the target be set to 12 in. on the saw and 18 in. on the pavement at the end of the cut. For the Caterpillar SW360B, it is recommended that the target be set to 18 in. on the saw and 16 in. on the pavement at the end of the cut. The actual undercut length will vary because spotters' perceptions vary and also because the wheel saw moves back during the initial part of cutting.

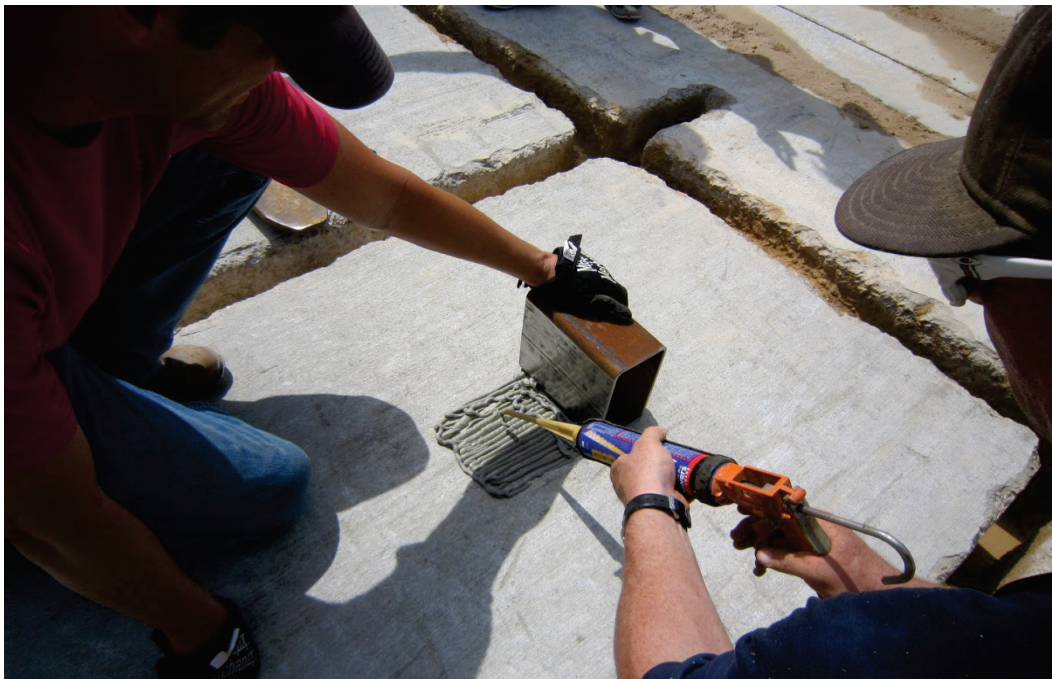
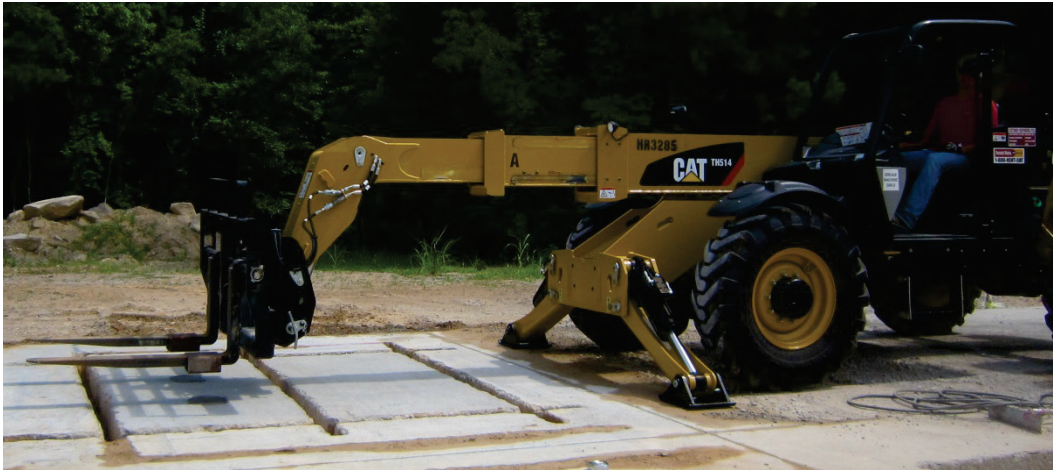
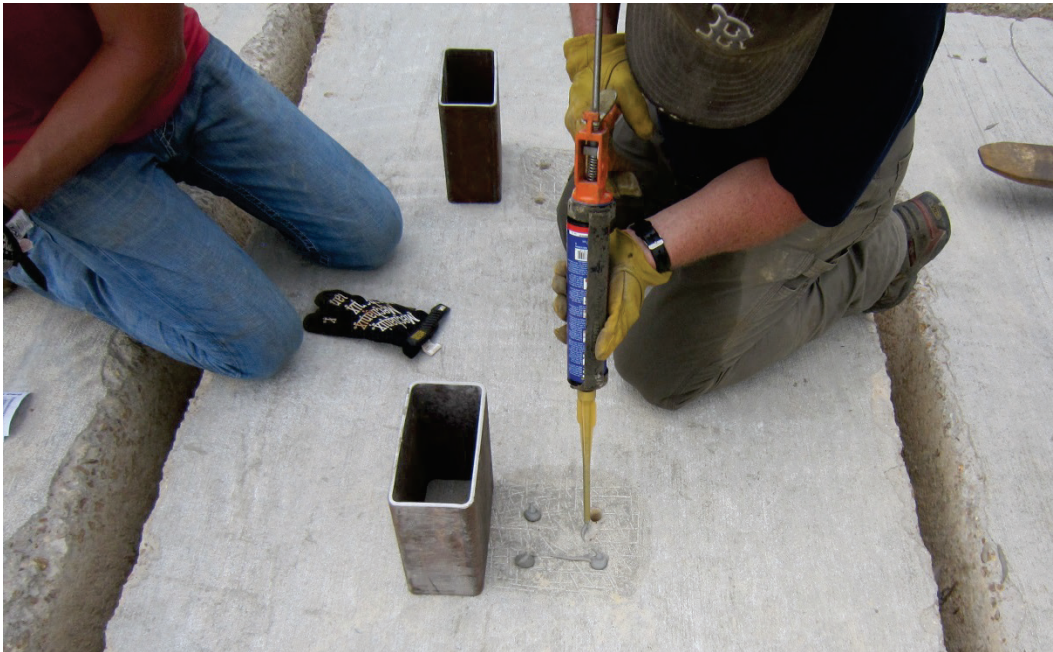
Figure 50. Application of epoxy below steel box beam.

Figure 51. Epoxy on pavement failed to hold.

Figure 52. Four drilled holes filled with epoxy.

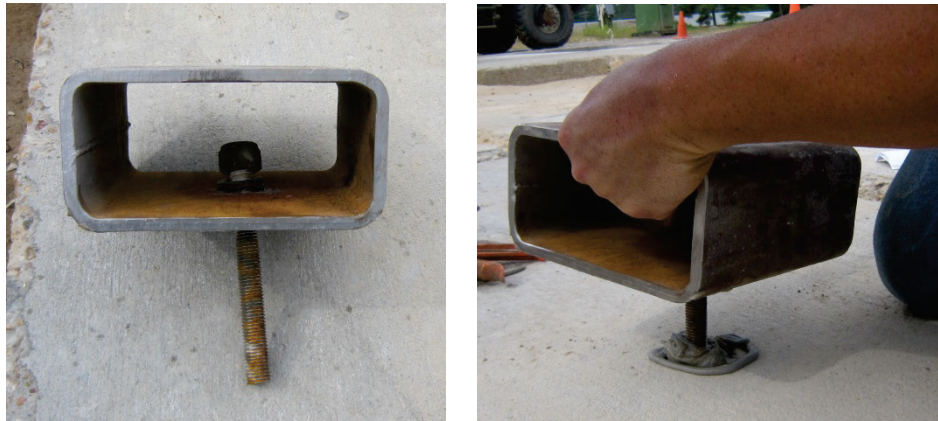
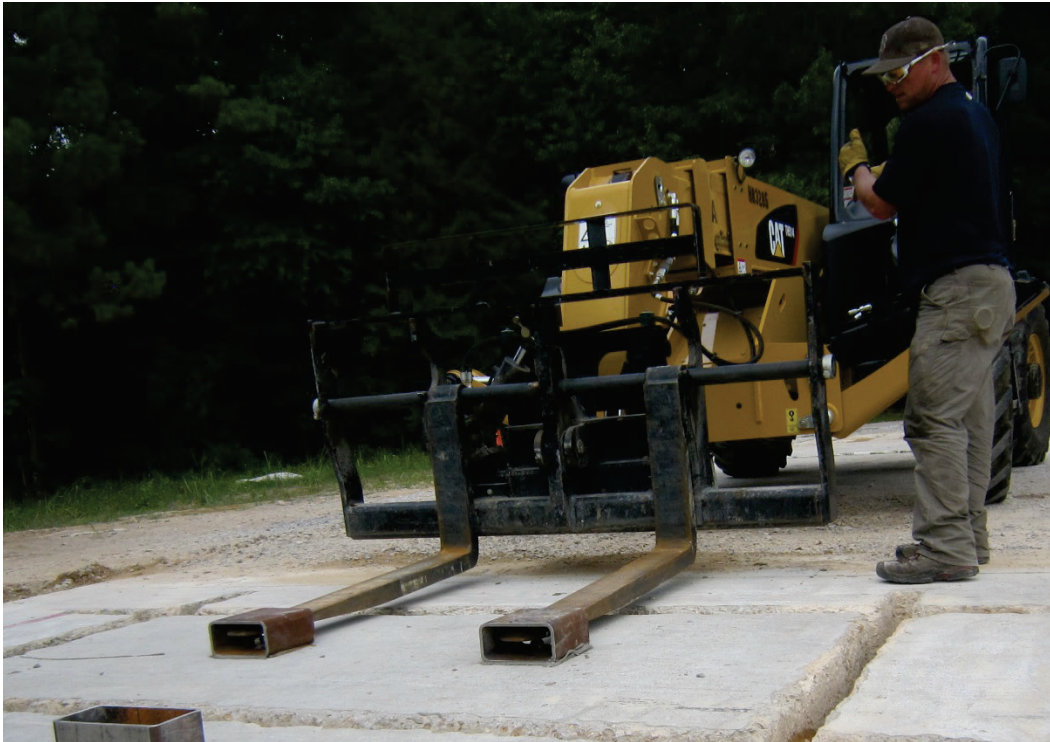
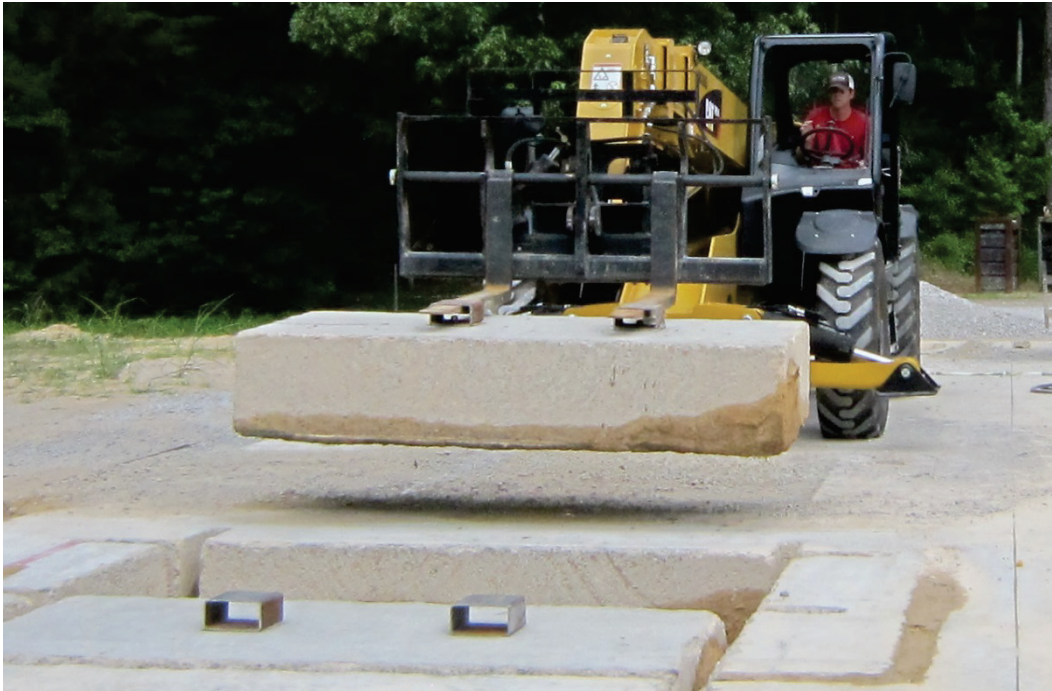
The fourth anchoring test consisted of using an all thread rod (0.75-in.-diam, 9-in. length) placed in a drilled hole with epoxy for each box beam. A 1-in.-diam opening was drilled on the bottom of both box beams for the all thread rod. A nut (0.75-in.-diam, 1-in. width across the flats, 0.5-in. height) and washer were fitted to the top of each all thread rod and tightened to ensure that the rod remained attached to the box beams (Figure 53). A Bosch hammer drill was used to drill two 1-in.-diam holes 6.5 in. deep within the PCC slab and 3 ft apart. The total drill time for each hole was approximately 2.5 min. One and a half tubes of epoxy (total ~15 oz) was used to fill the two holes to the top of the existing PCC. The box beam was

Figure 53. All thread rod with nut, inserted through opening on the bottom of the box beam and placed into drilled hole in PCC.

Figure 54. Placing the telehandler forks into the box beams attached with all thread rods with bolts and nuts.

Figure 55. Successful removal of PCC using the box beam with all thread rod.

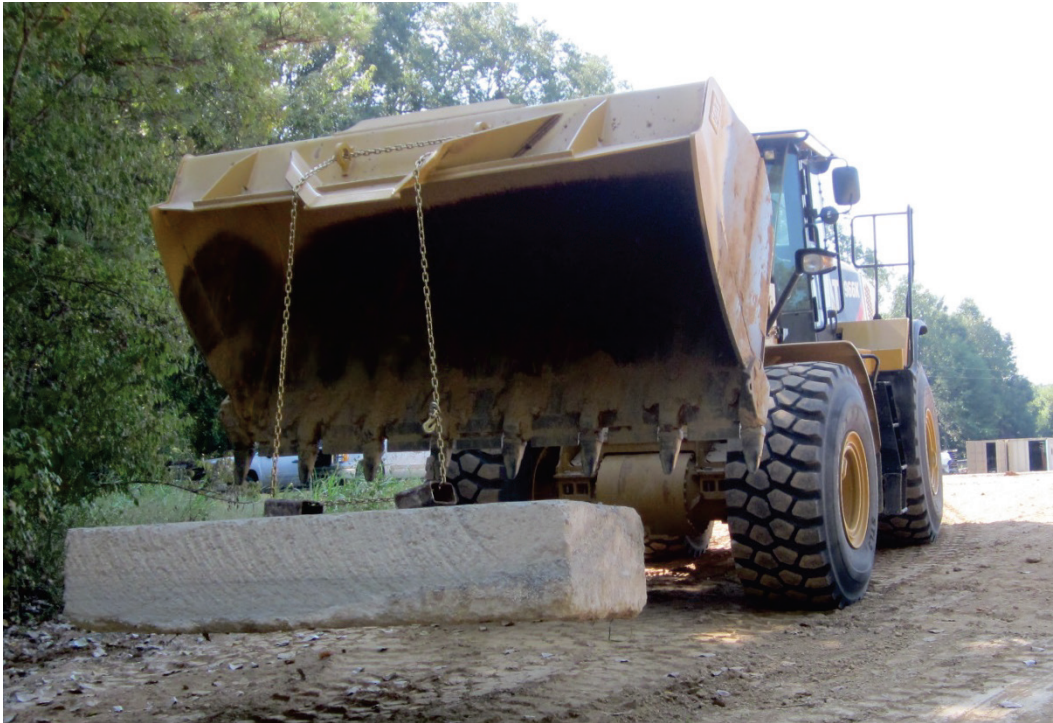
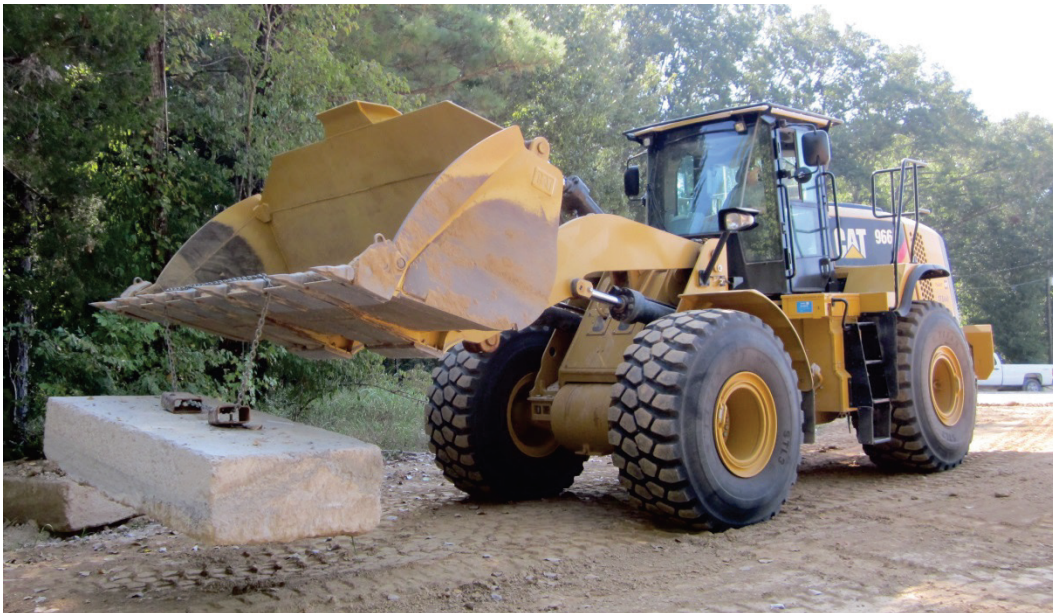
The fifth anchoring test was completed to determine whether the Caterpillar 966K front-end loader with a 4-yd³ bucket could be used to lift the slab. Since the PCC crater repair section of Crater 7 had already been lifted out of the parent slab, this test was conducted simply by lifting the PCC section off the ground. A 14-ft-long tow chain was used to thread through the box beam already attached from the fourth anchoring test. The chain was attached to the front-end loader bucket using the eye holes on the bucket of the front-end loader, as shown in Figure 56. The chain was also tested wrapped around the teeth of the front-end loader, as shown in Figure 57. Both of these attachment techniques were successful in lifting the 4.25-ft by 8.5-ft section of PCC.

Figure 56. Successful lifting of PCC using eye holes on the front-end loader.

Figure 57. Successful lifting of PCC using the teeth on the front-end loader.
