Evaluation of Precast Portland Cement Concrete Panels for Airfield Pavement Repairs

Lucy P. Priddy

May 2015

Final report

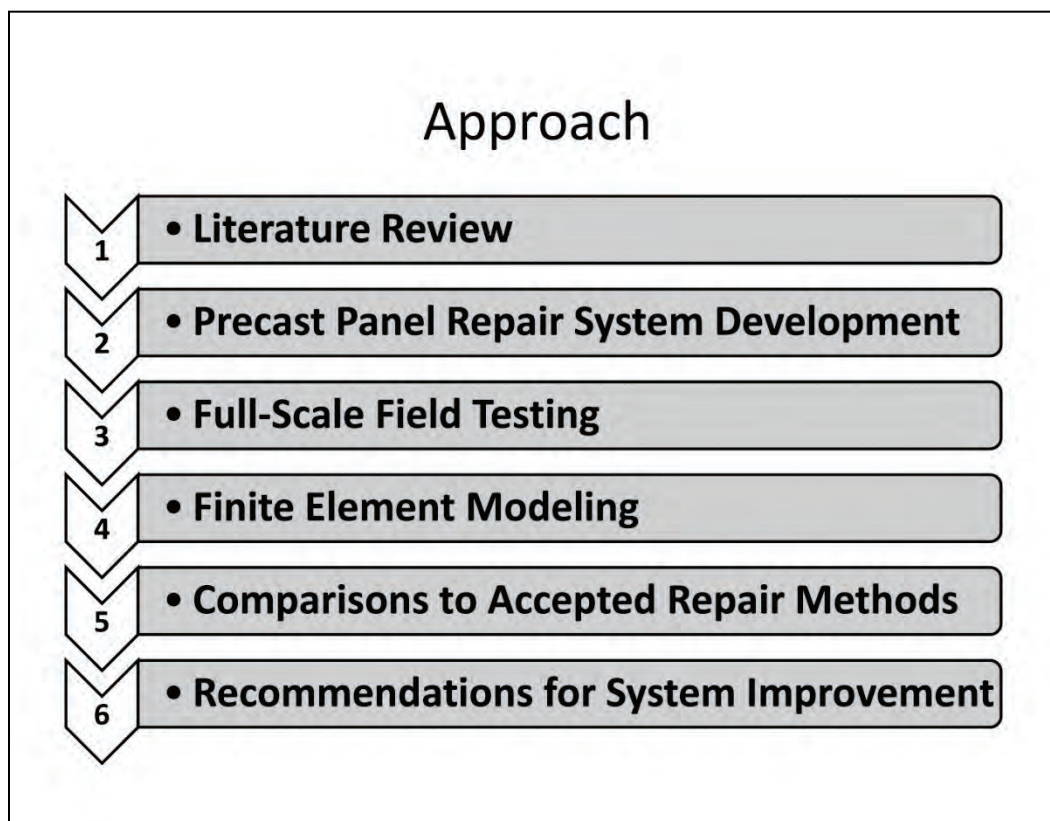
Figure 1.1. Research approach schematic.

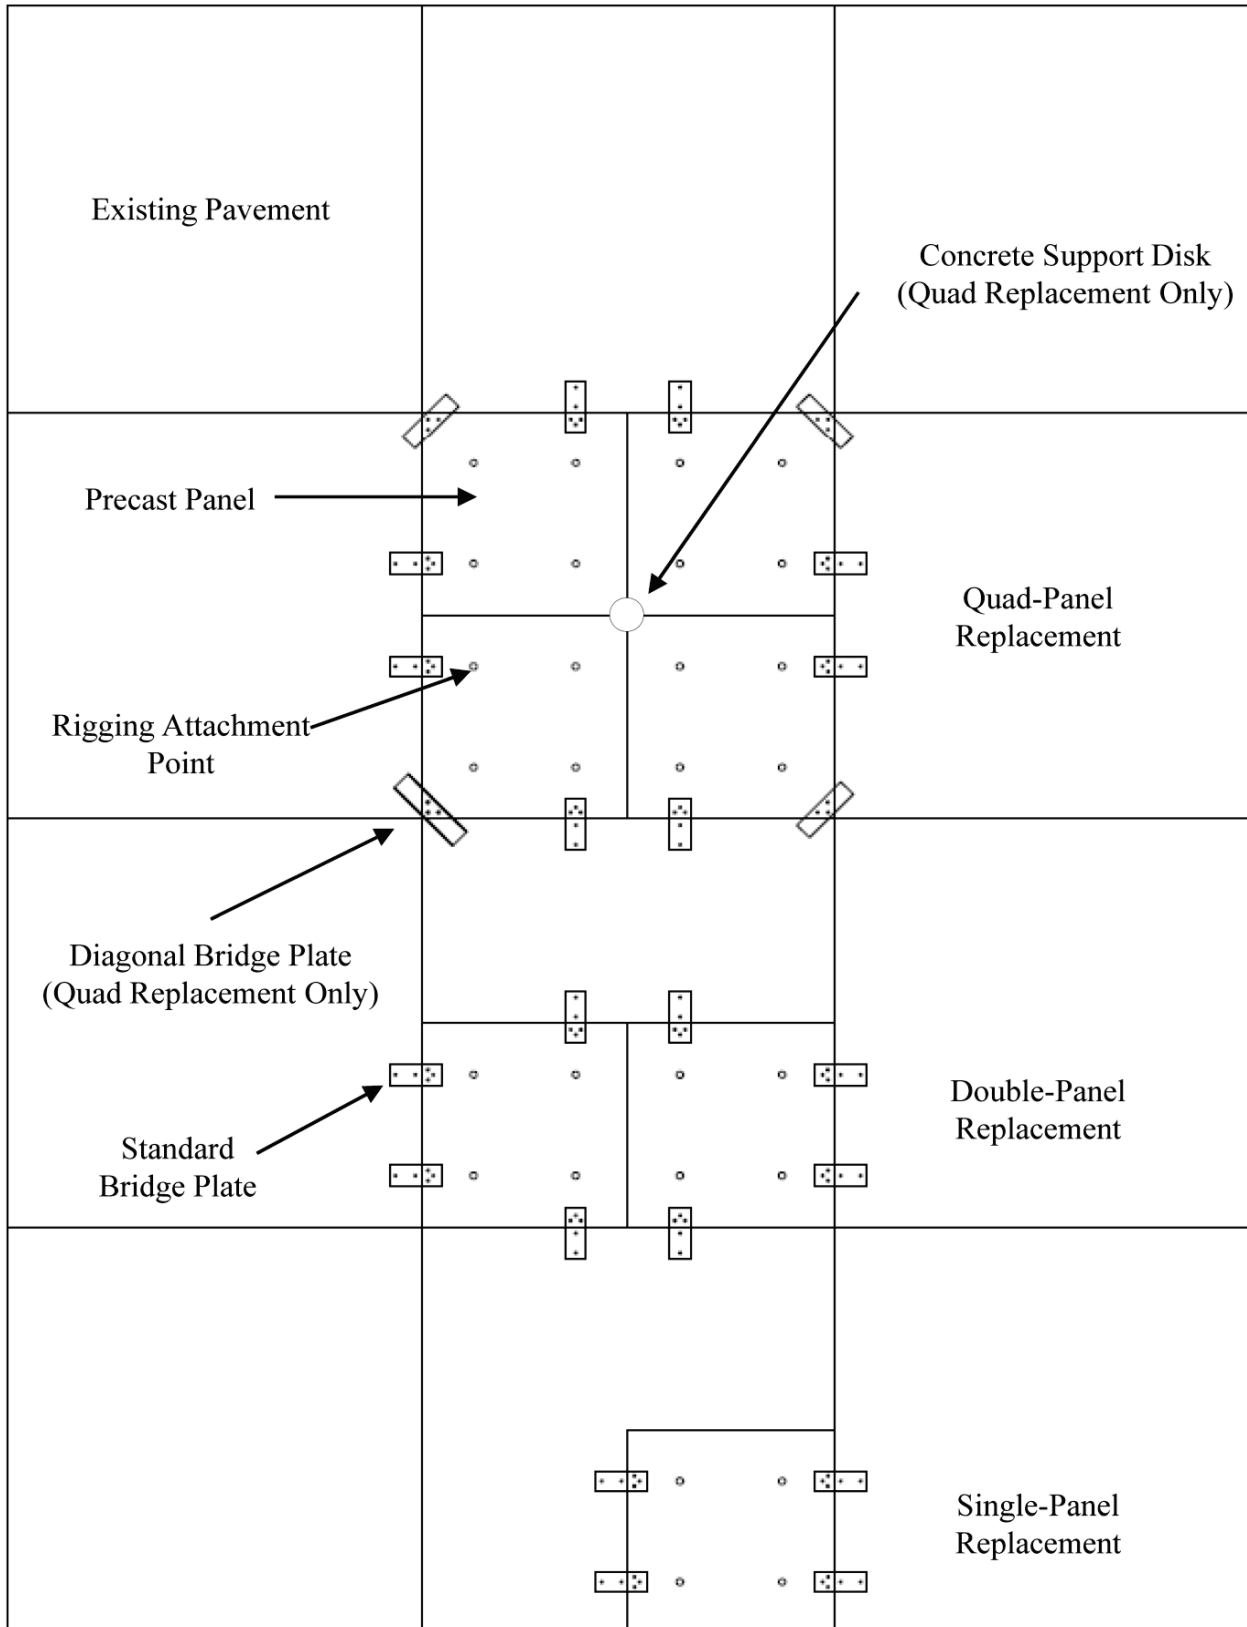
Figure 3.4. Bridge plate layout and lifting eye locations.

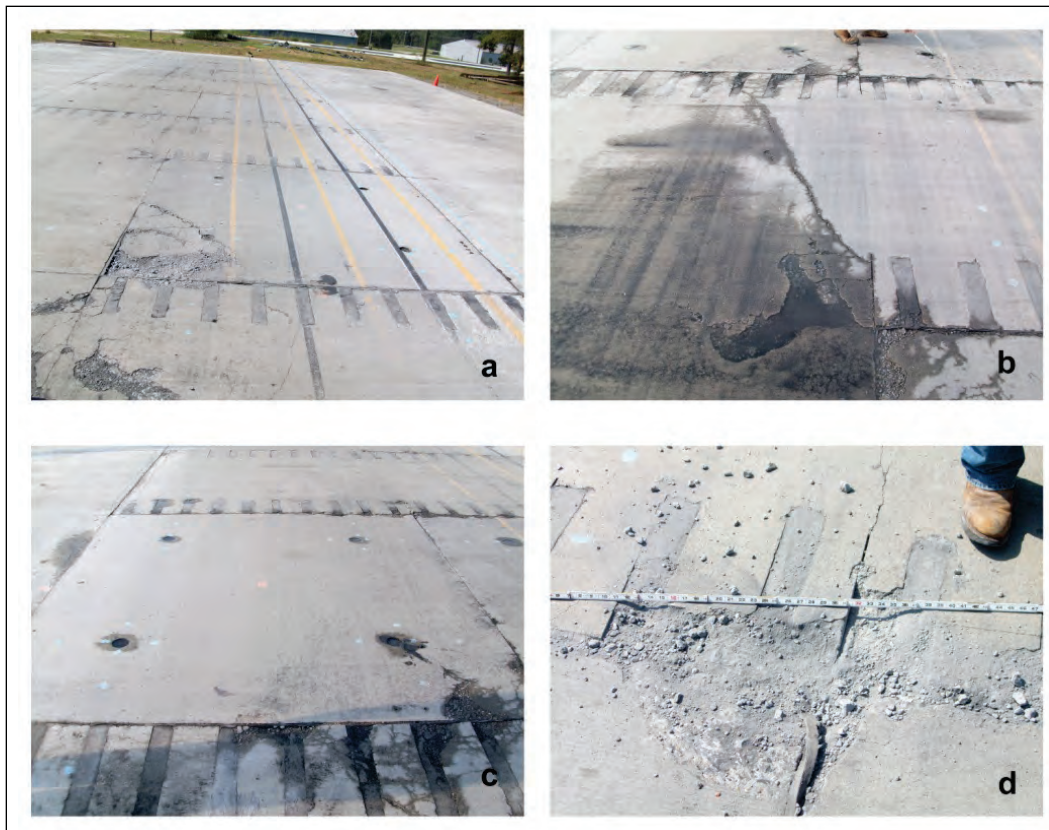
Figure 3.5. Repair failure details: (a) Repair 1, Panel 1: high-severity corner break/spall and shattered parent slab; (b) Repair 2: diagonal cracking in parent slab between Repairs 1 and 2 and cracking and spalling of Panel 2 due to the parent slab deterioration; (c) close-up of the cracking and deterioration in the parent slab and dowel slots and corner of Panel 2; (d) Repair 3, Panels 6 and 7: high-severity spalling in corner of Panels 6, 7, and the parent slabs south of the repair.

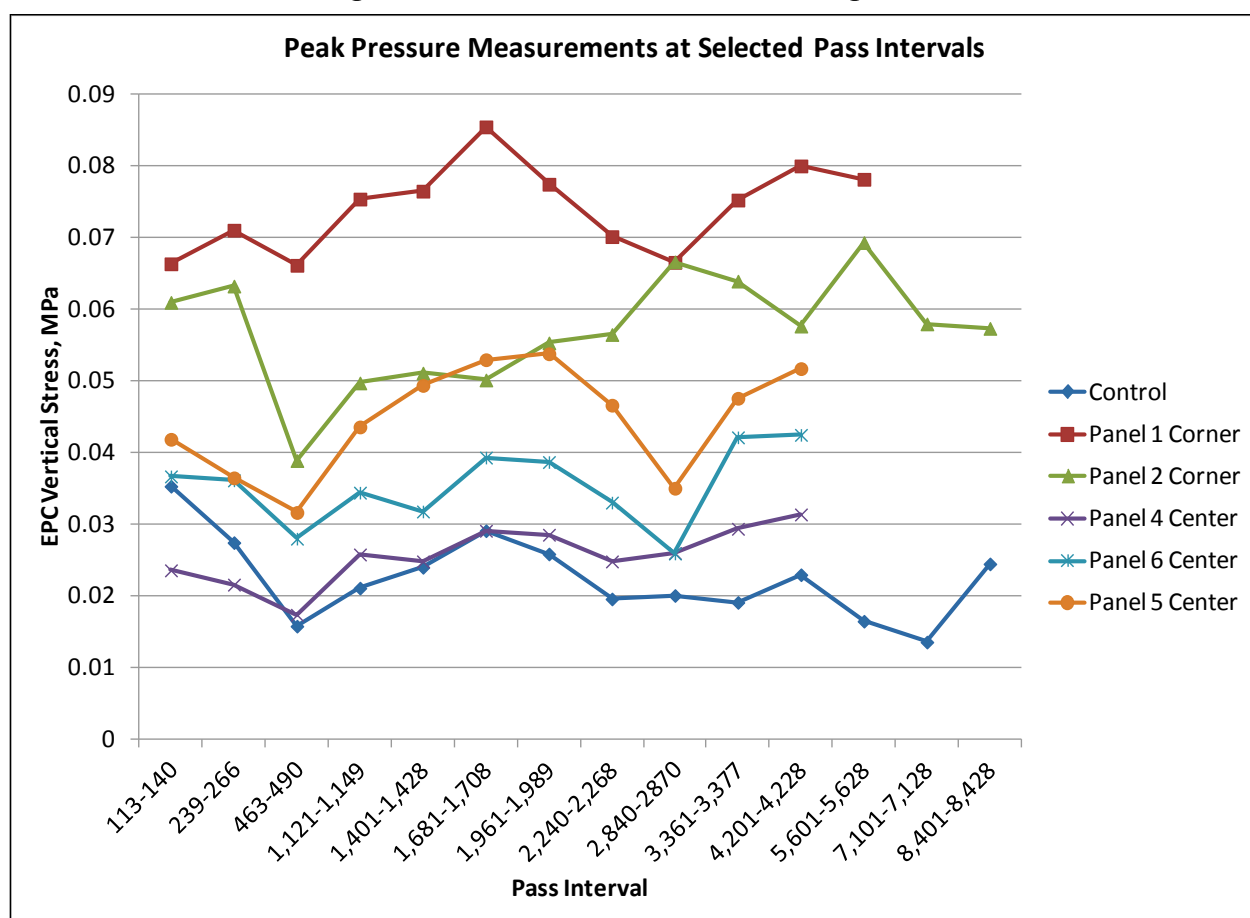
Figure 3.8. Vertical stress measurements using EPCs.

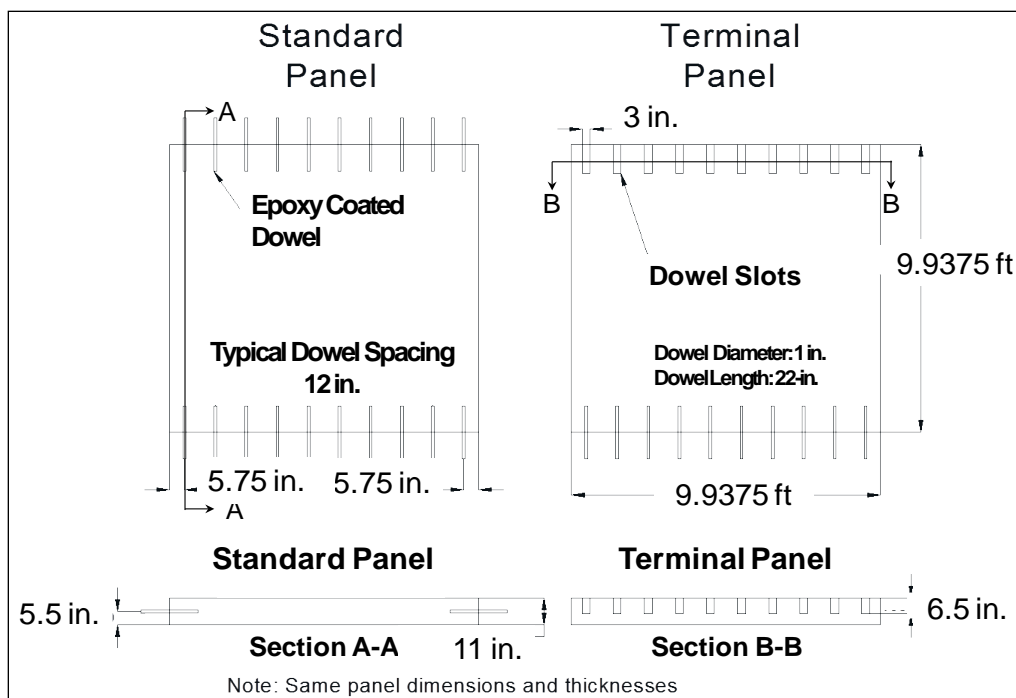
Figure 4.1. Precast panel schematics.

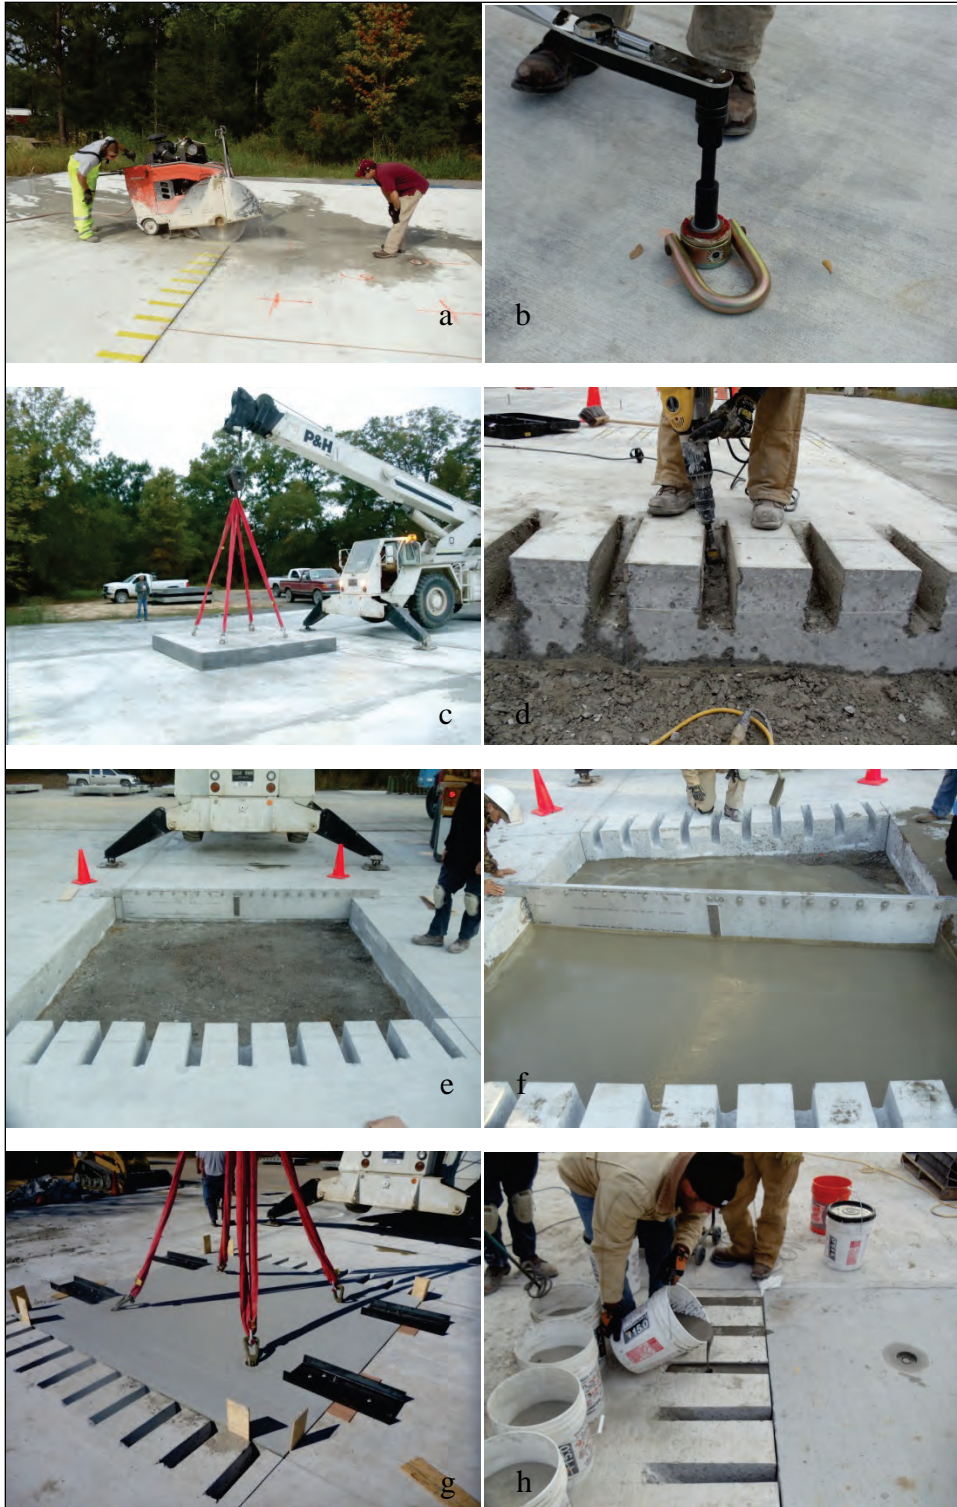
Figure 4.2. Repair procedure: (a) saw cutting the repair area and dowel slots, (b) installing lifting eyes to concrete expansion anchors, (c) removing parent PCC, (d) preparing dowel slots, (e) prepared repair area, (f) screeding flowable fill bedding material, (g) lowering panel into repair area, and (h) sealing dowel slots with rapid-setting grout.

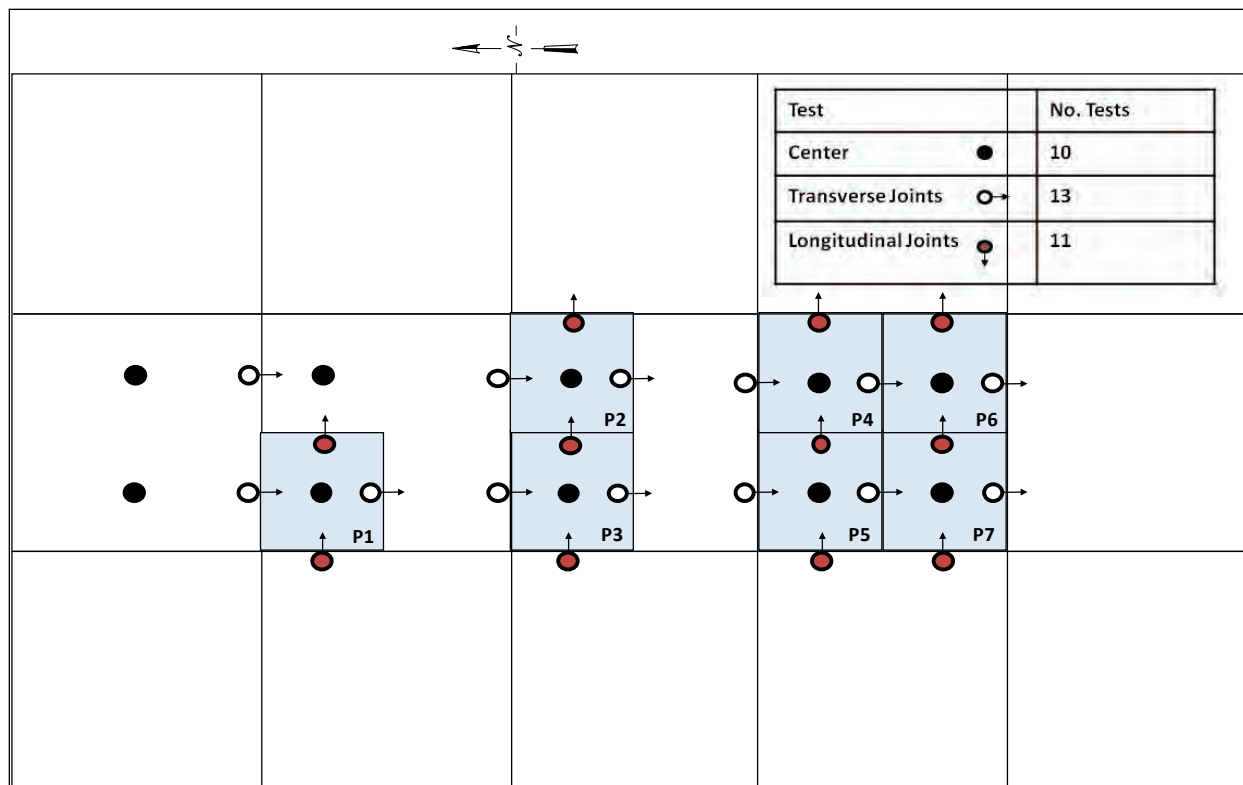
Figure 4.5. Location of HWD tests.

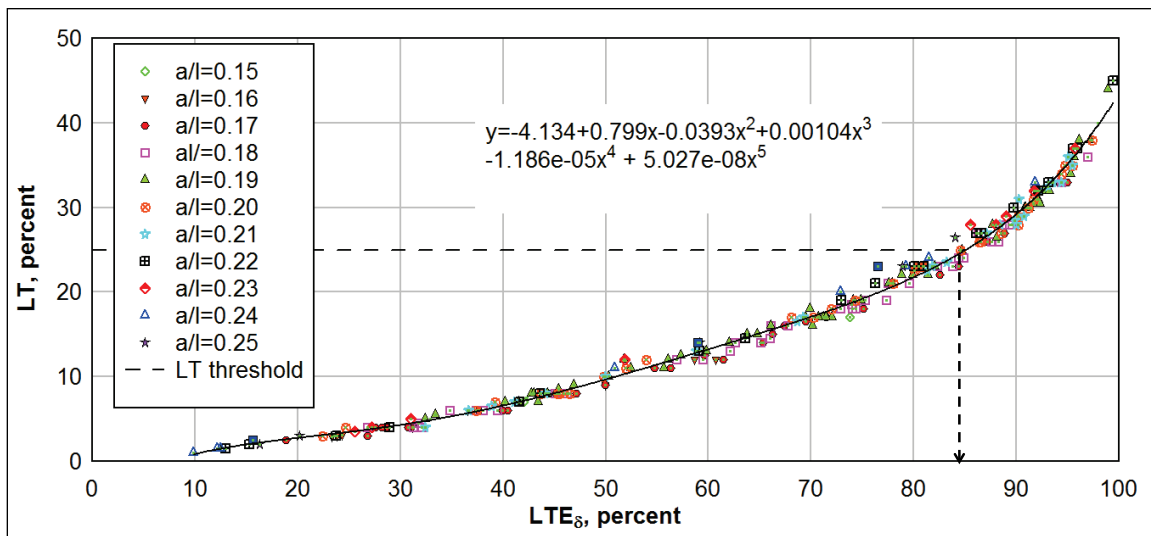
Figure 4.7. Relationship between LT and LTE_δ for the precast panel repairs.

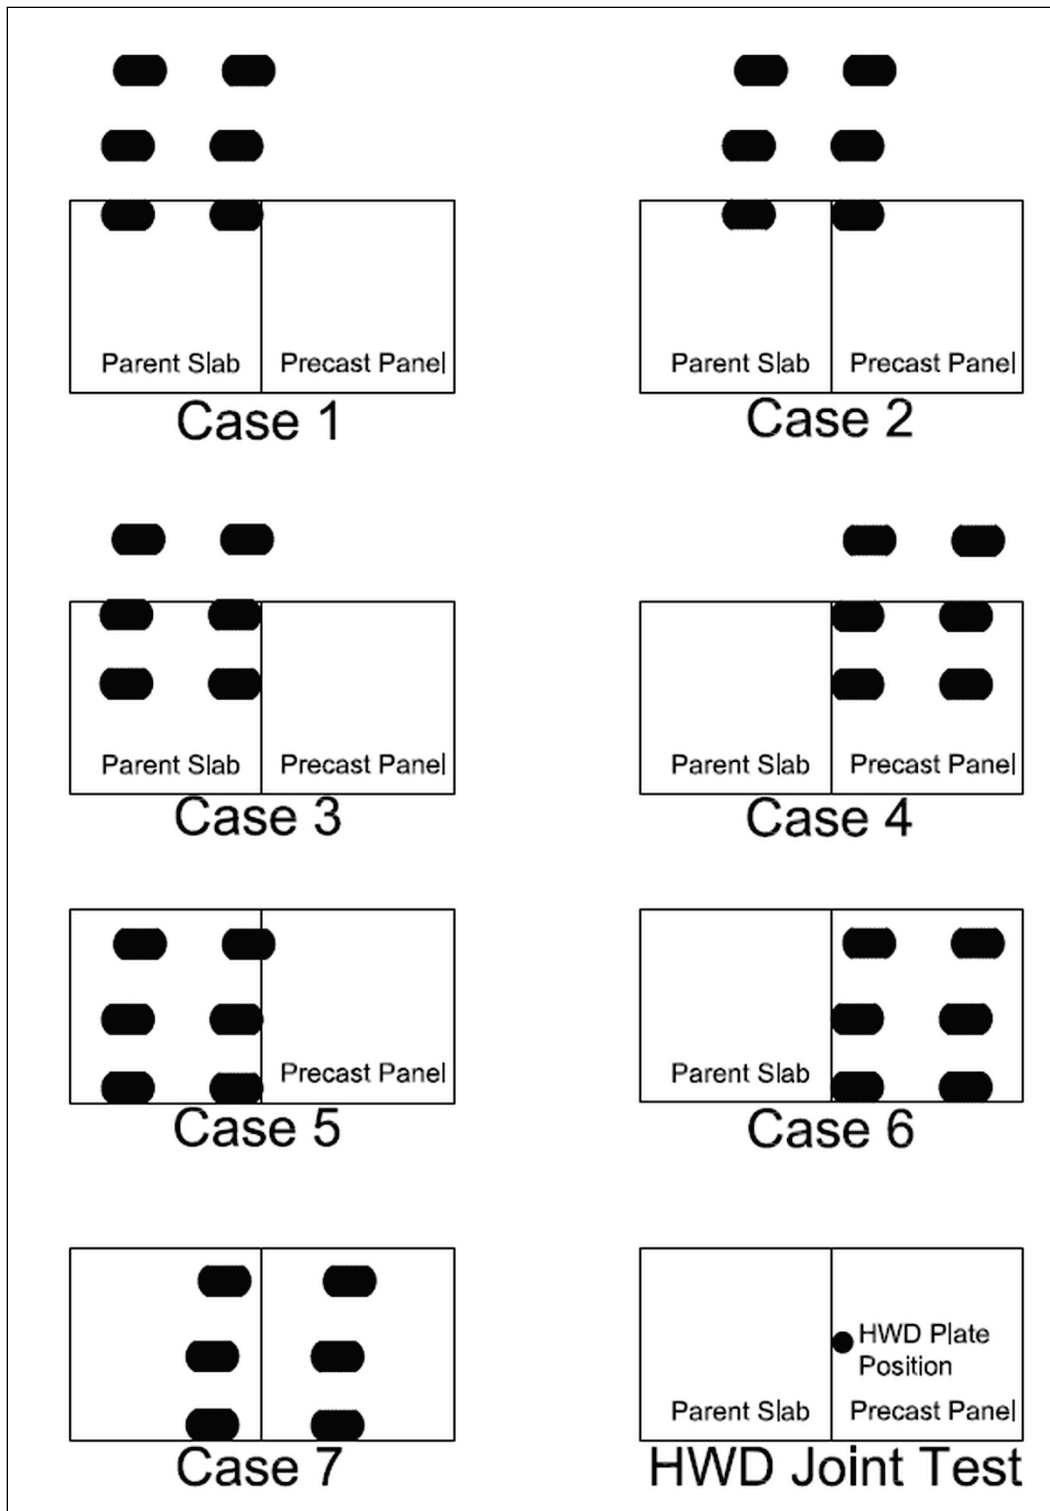
Figure 5.3. Load cases.

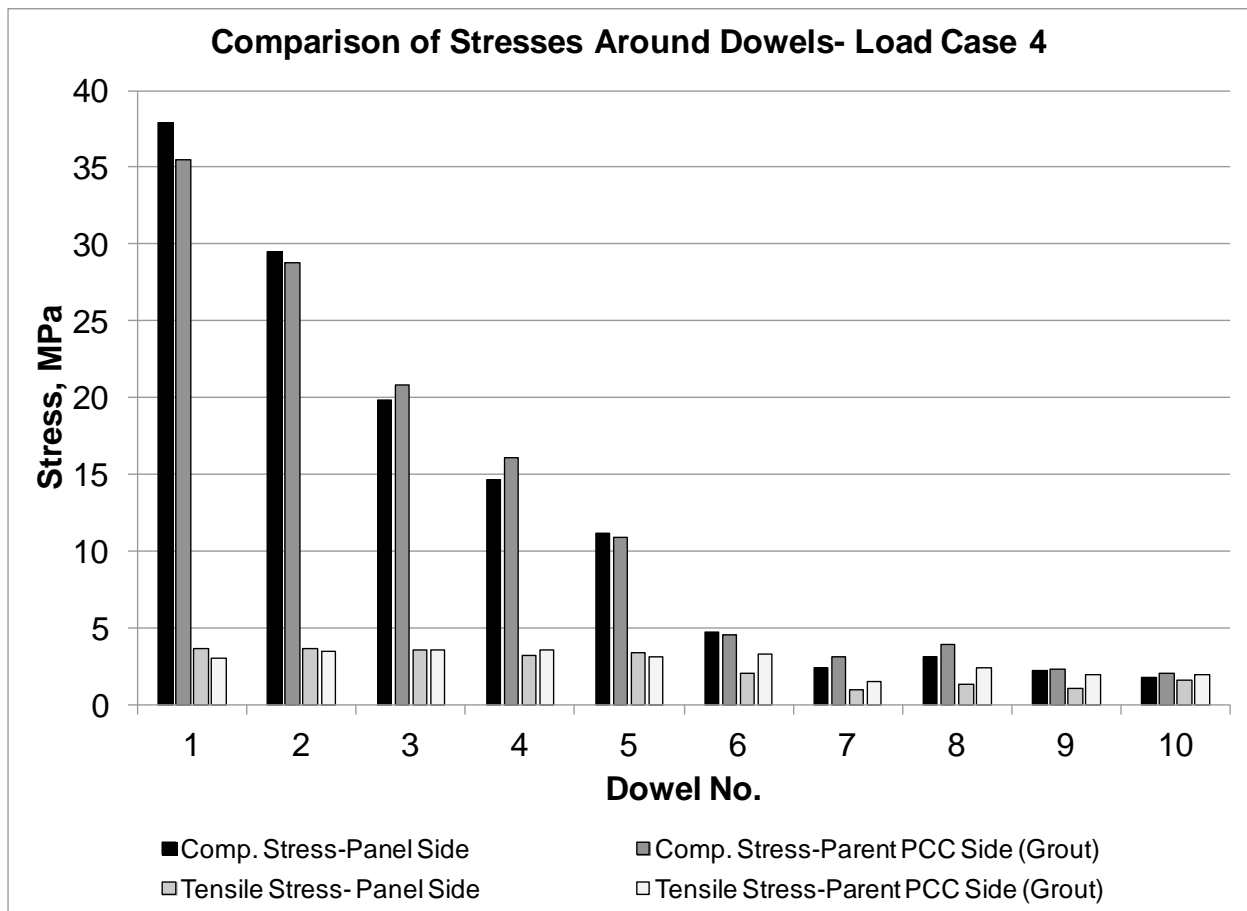
Figure 5.6. Comparison of stresses for all dowels (Load Case 4).

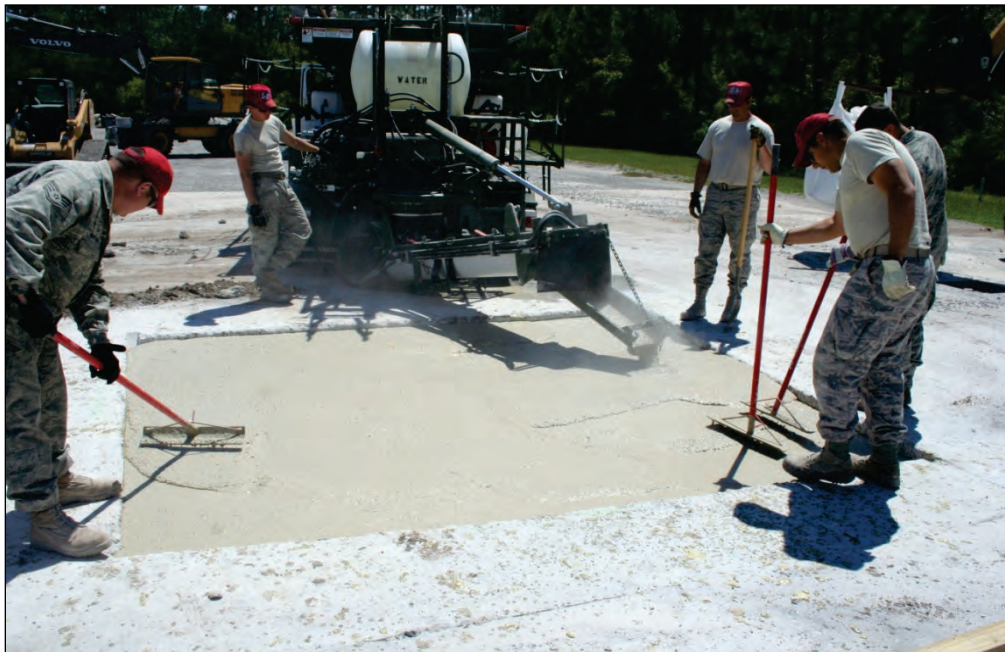
Figure 6.1. Placing rapid-setting cap.

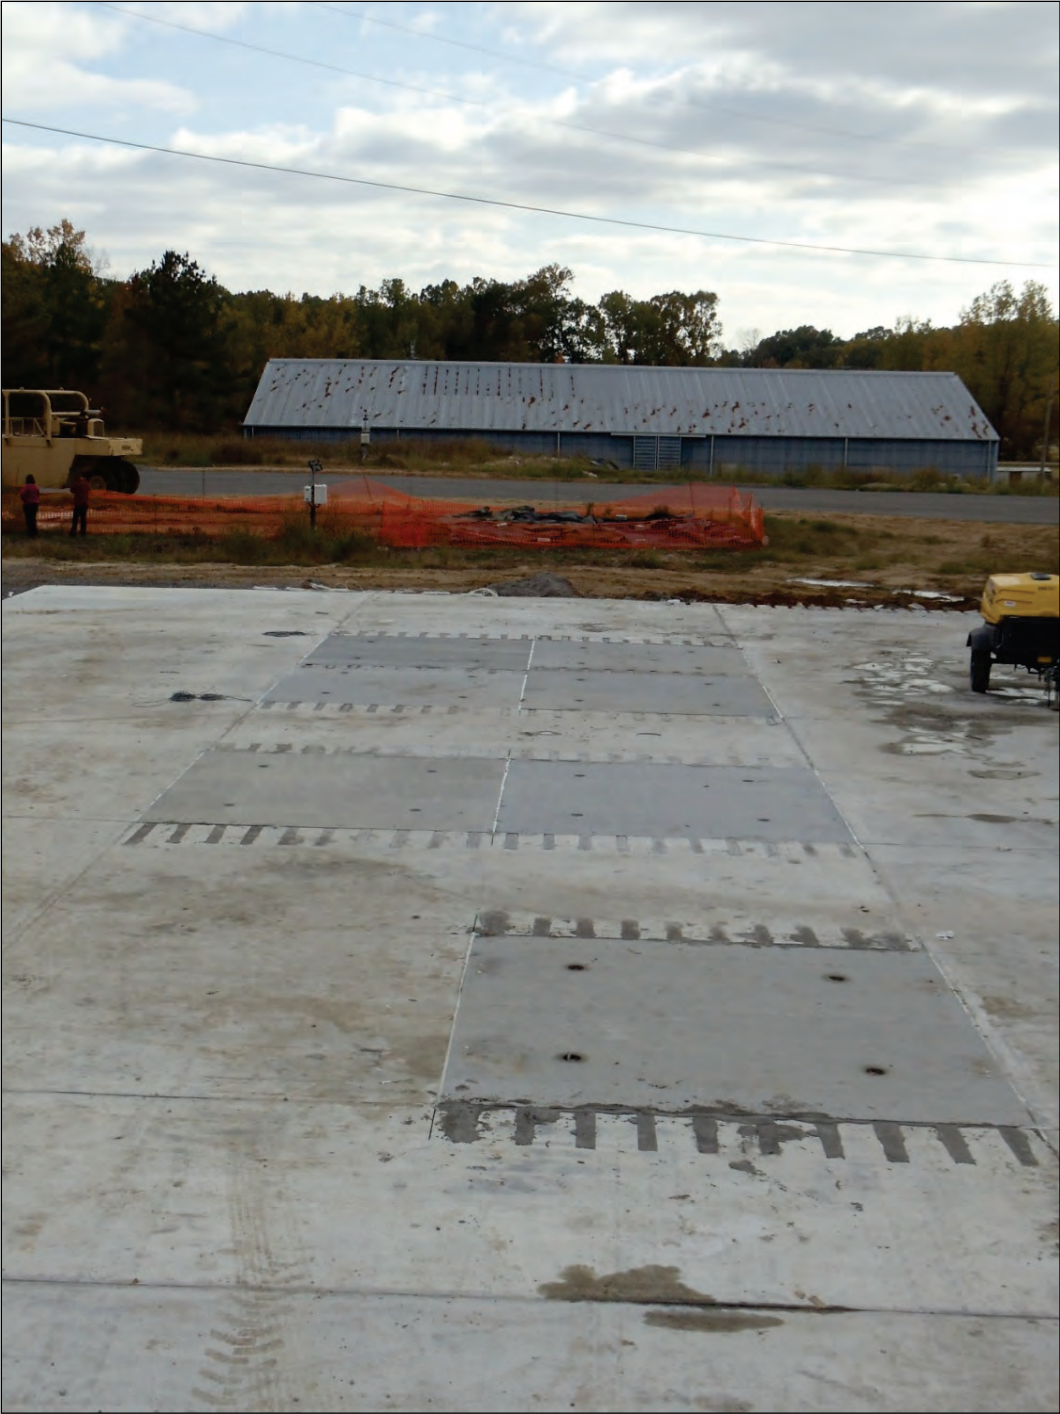
Figure 6.2. Precast PCC panel repairs.

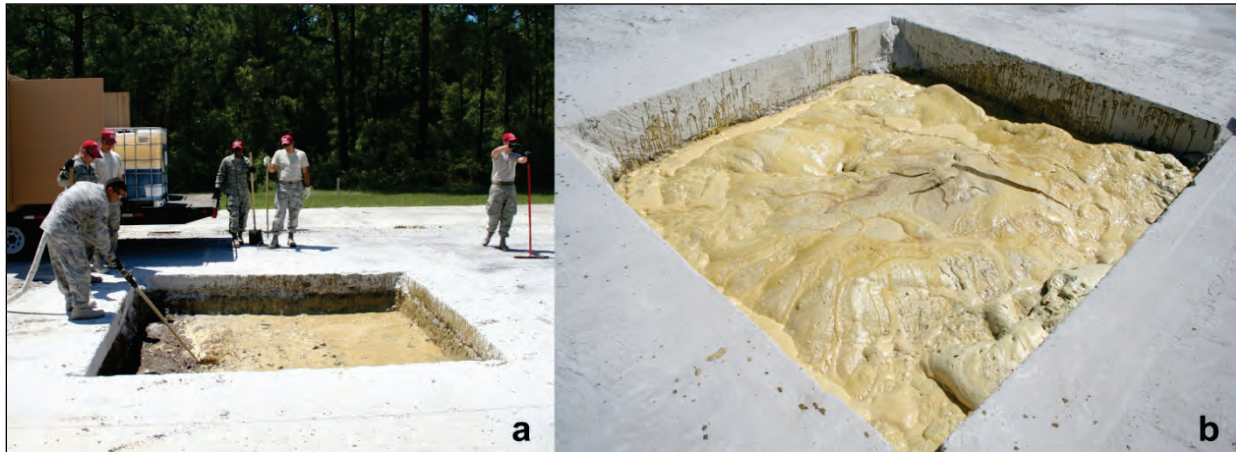
Figure 6.4. (a) Placing foam backfill and (b) hardened foam backfill after 15 min.

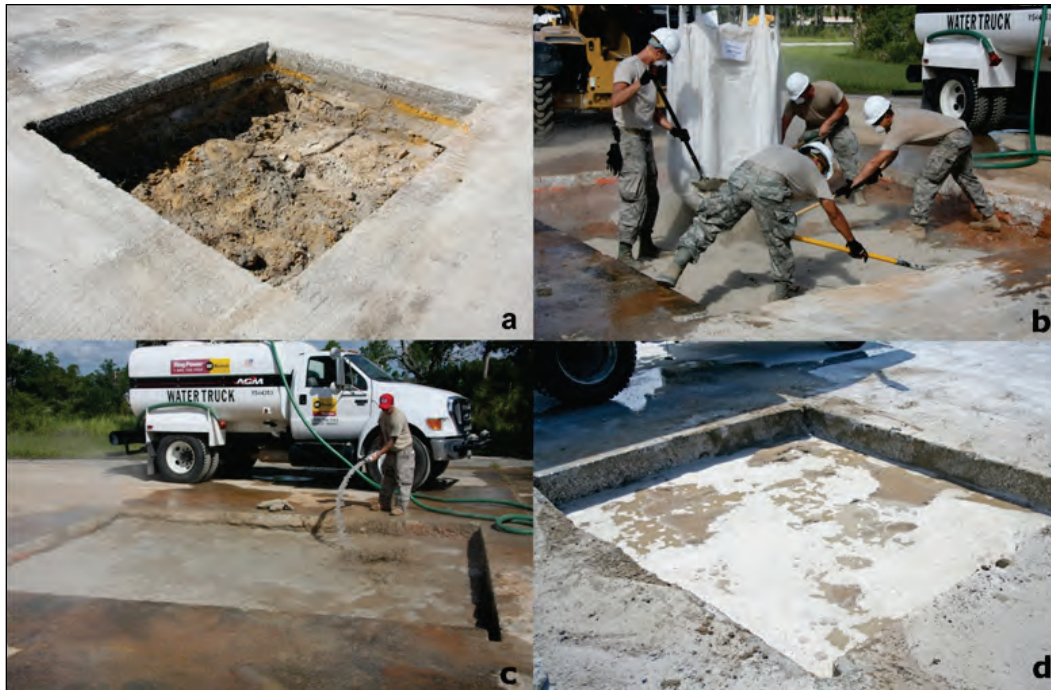
Figure 6.5. (a) Prepared repair, (b) backfilling with flowable fill, (c) adding water, (d) cured backfill surface after 15 min.

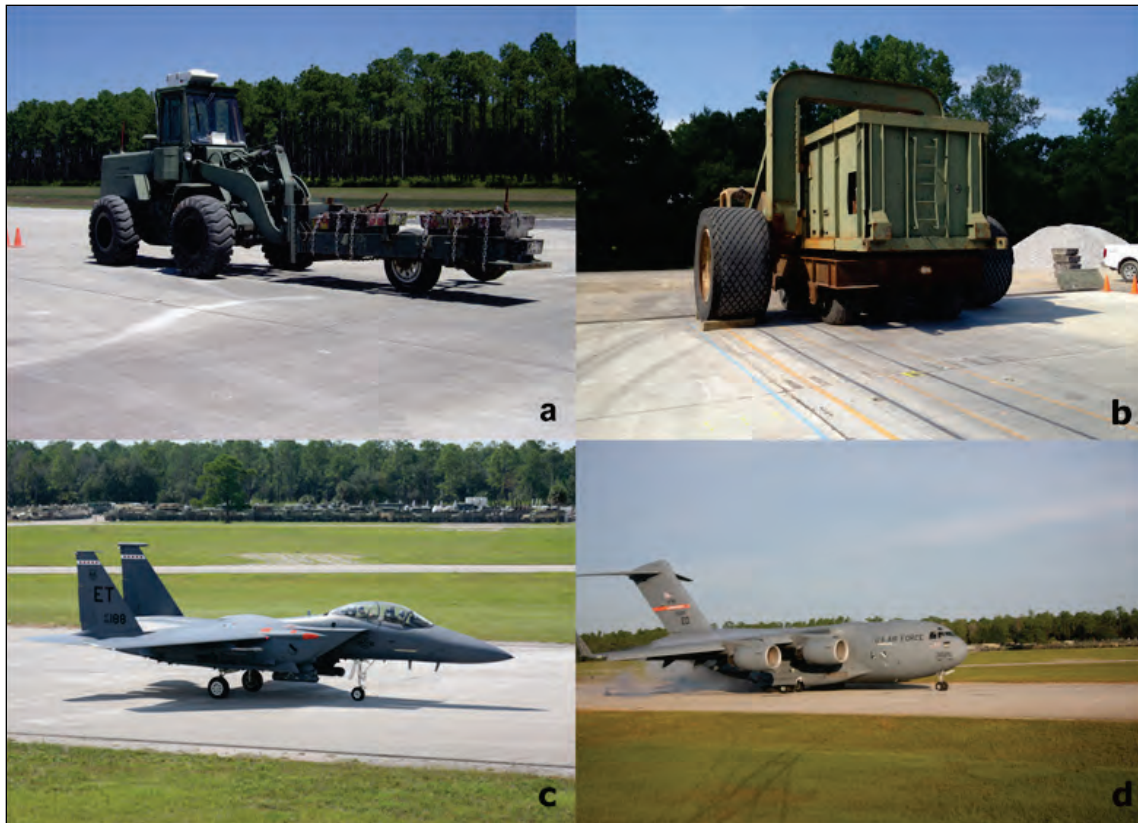
Figure 6.6. (a) F-15 load cart, (b) C-17 load cart, (c) F-15 aircraft, and (d) C-17 aircraft.

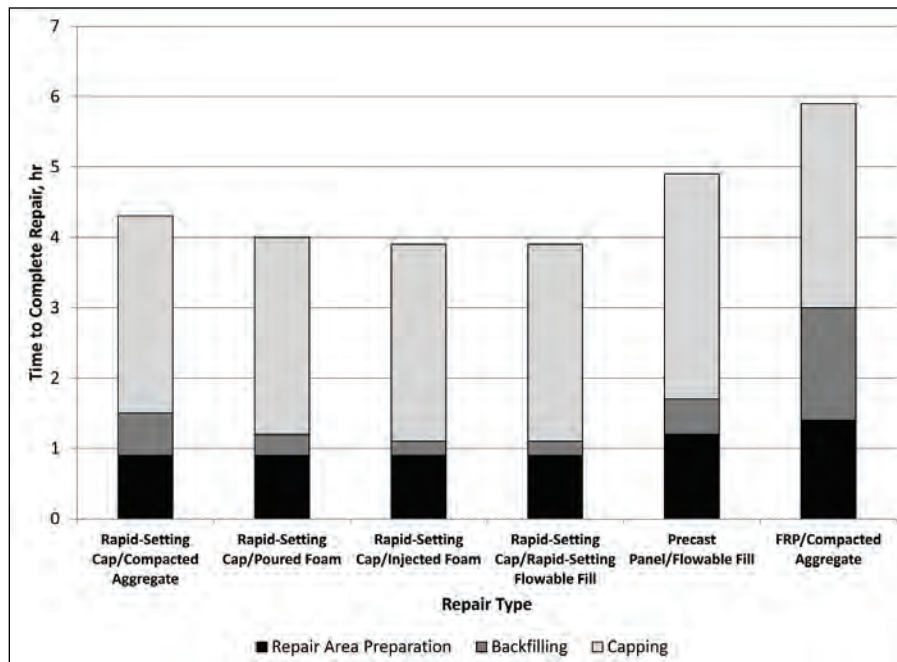
Figure 6.8. Comparison of time to complete steps to conduct a 3-m by 3-m by 0.6-m repair.

Area prep time was longer for the precast panels compared to the rapid-setting capped repairs due to the need to saw cut dowel receptacles in the parent PCC pavement. The FRP prep time was the largest due to need for careful excavation of the repair area. In contrast, the flowable fill and foam backfills required less careful excavation, as they did not rely on compacted aggregate for support. The need to place and cure rapid-setting repair material in the precast panel dowel receptacles accounted for the longer capping time for this repair compared to the rapid-setting capped repairs. The repair requiring the longest backfilling time was the FRP repair, which is not surprising because the FRP repair required backfilling a larger volume with careful compaction of the aggregate backfill for the structural support of the repair. Based on this analysis, all of the repair methods applied to small repairs could return the airfield to service within the 4- to 6-hr time window, indicating that they were all suitable for any of the operational repair scenarios.

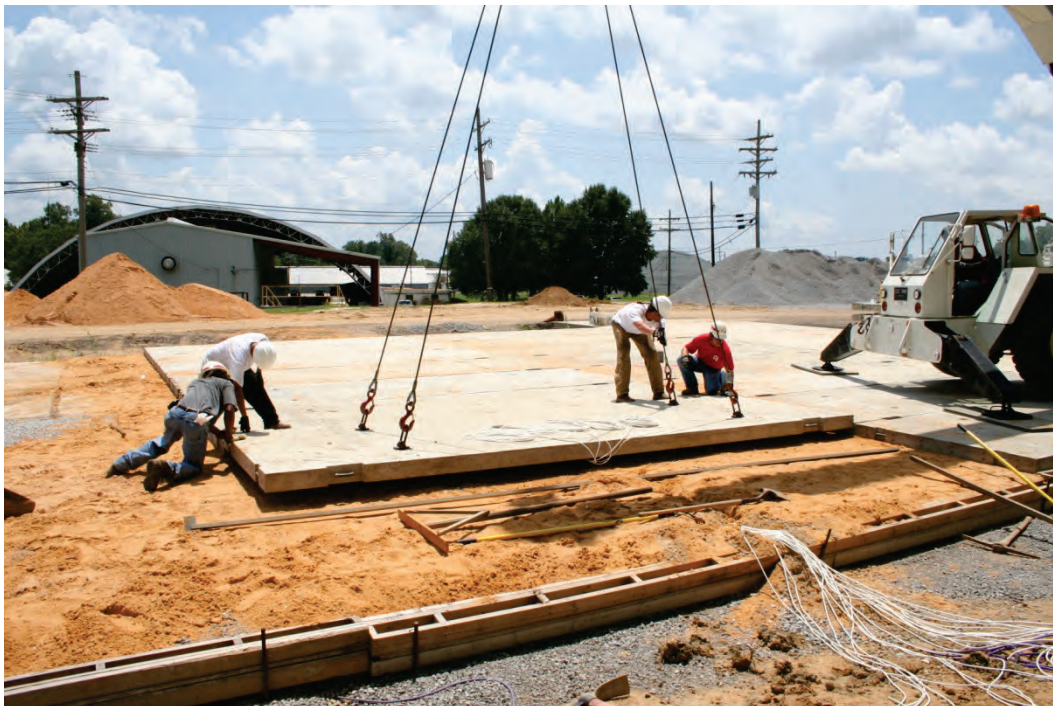
Figure A.3. Placement of a precast panel.

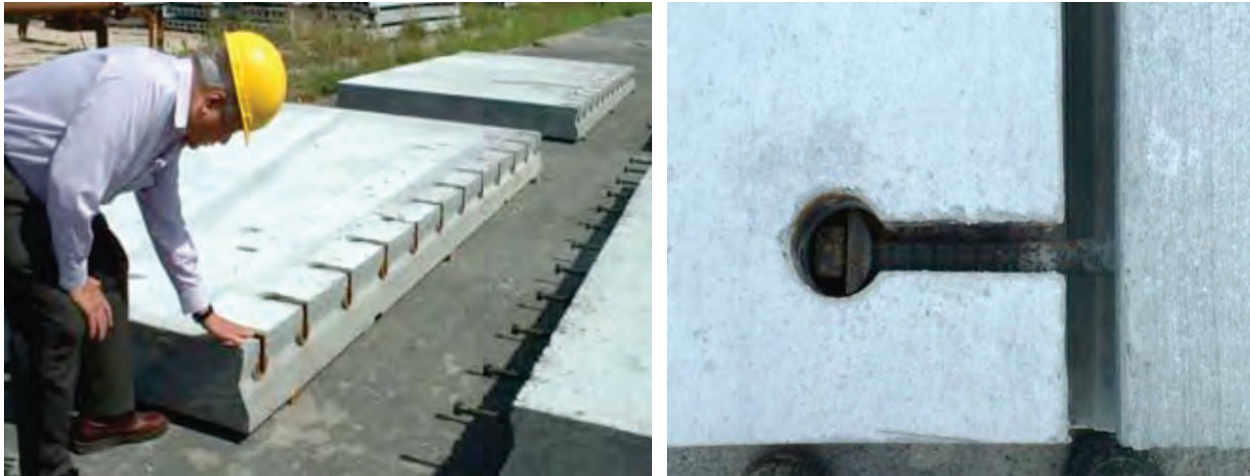
Figure A.8. (left) precast panel and (right) Kwik Joint connection (Kwik Slab 2011).

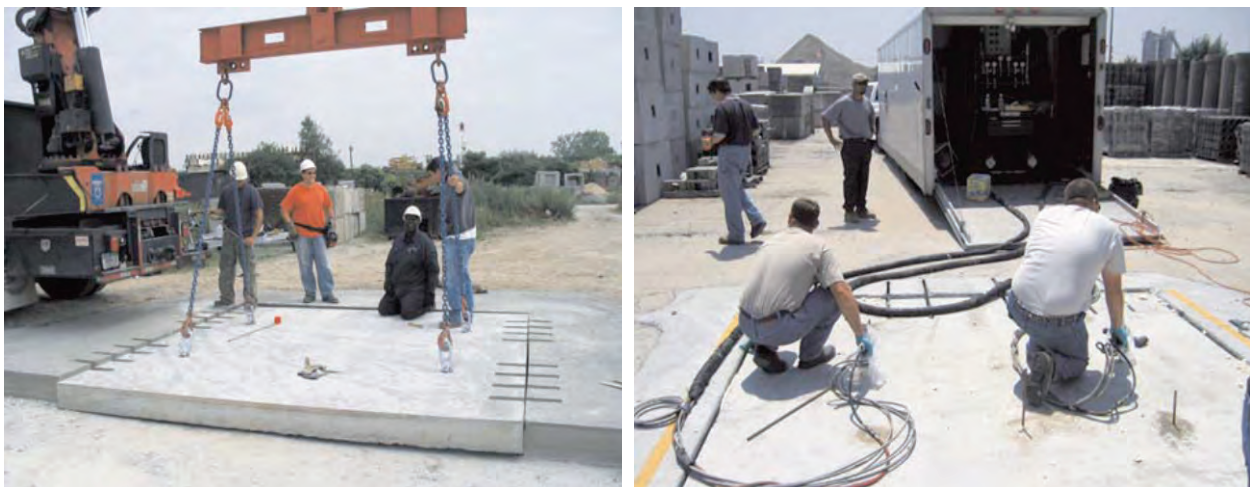
Figure A.9. (Left) installing Roman Road slab; (right) injecting polyurethane foam (Roman Stone Construction 2012).

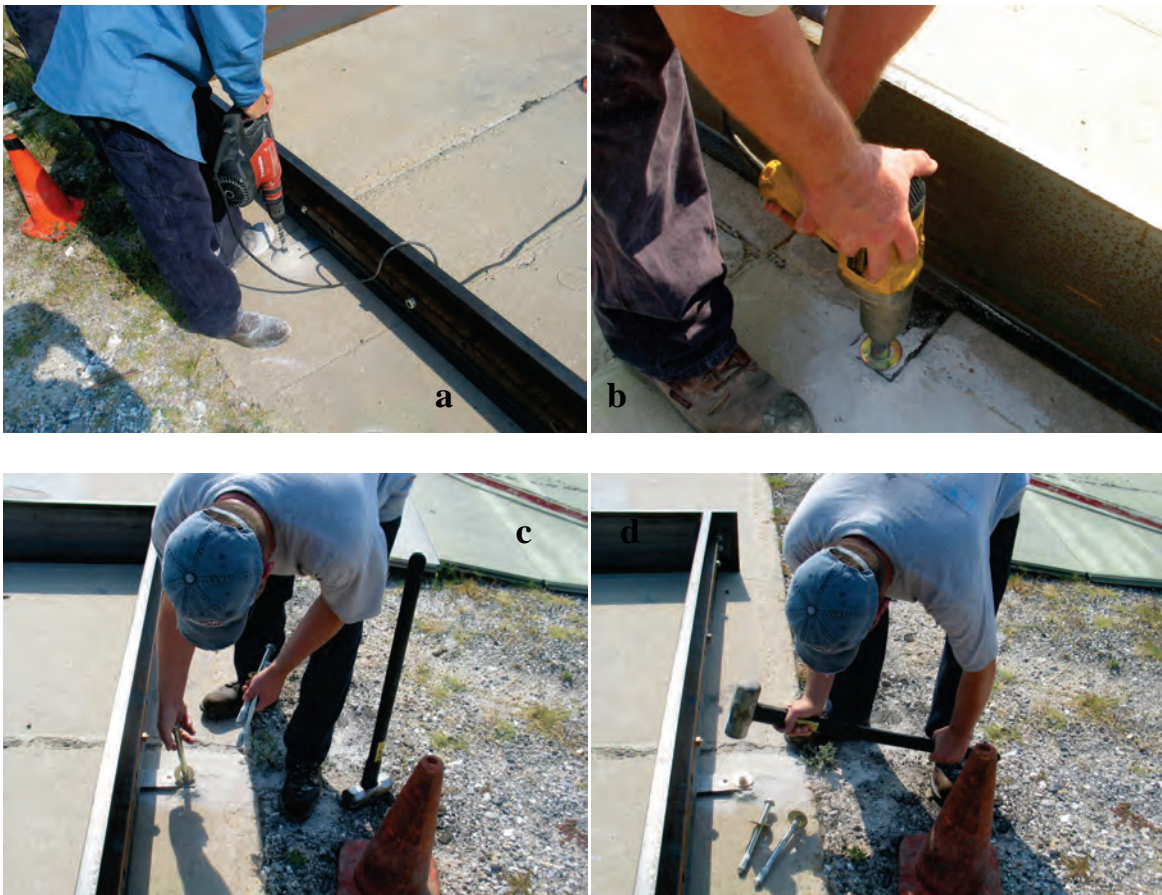
Figure B.6. Securing formwork to solid surface: (a) drilling anchor hole, (b-d) installing and activating the anchor.

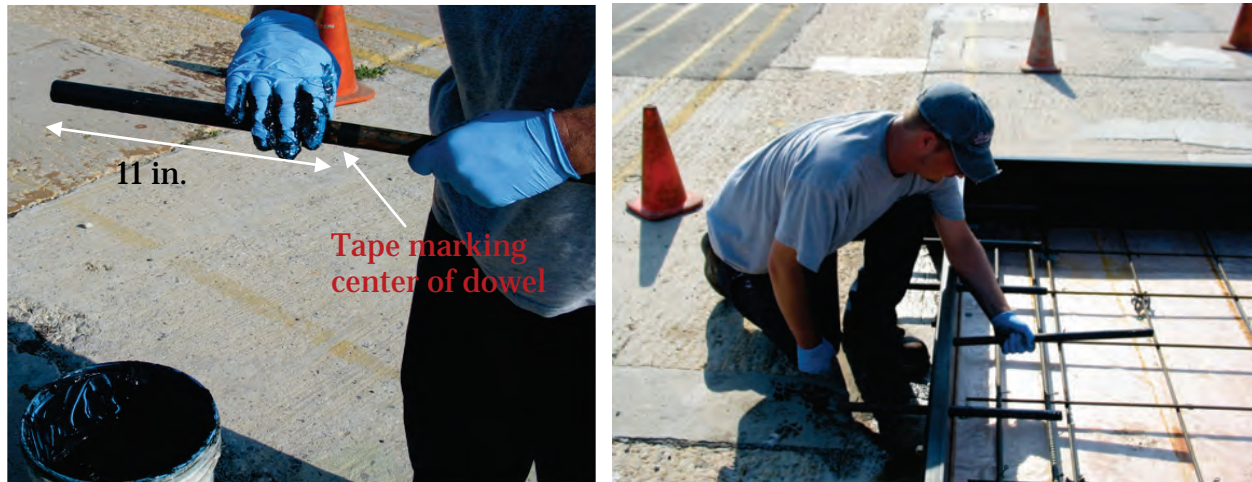
Figure B.10. Installation of the dowel bars.

Ensuring and maintaining proper alignment of each dowel was imperative. Misaligned dowels have the potential to prevent form removal, may possibly result in damage to the precast panel and/or the rigid form, and could negatively impact load transfer and/or cause premature pavement failure. The following paragraph describes the dowel installation process in greater detail.

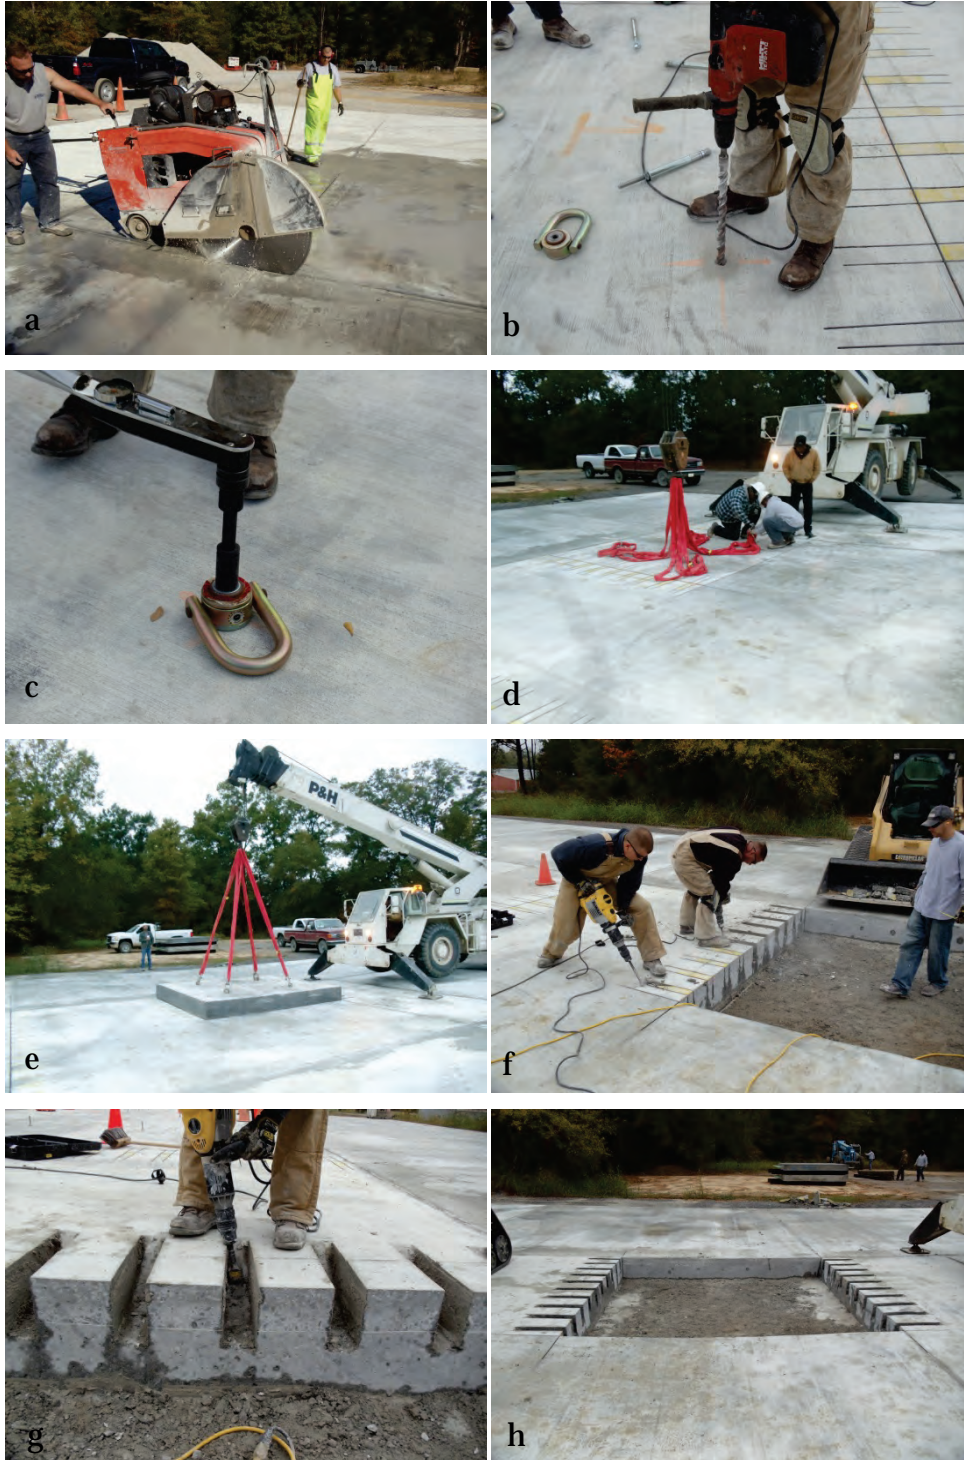
Figure C.4. Preparation and removal of parent PCC: (a) saw cutting dowel receptacles and repair area, (b) drilling to install concrete lifting anchors, (c) installing lifting eyes, (d) connecting lifting eyes to crane rigging, (e) lifting “damaged” pavement, (f) preparing dowel receptacles using jackhammers, (g) close-up of dowel receptacles, and (h) prepared repair area.
