Evaluation of Precast Portland Cement Concrete Panels for Airfield Pavement Repairs

Lucy P. Priddy

May 2015

Final report

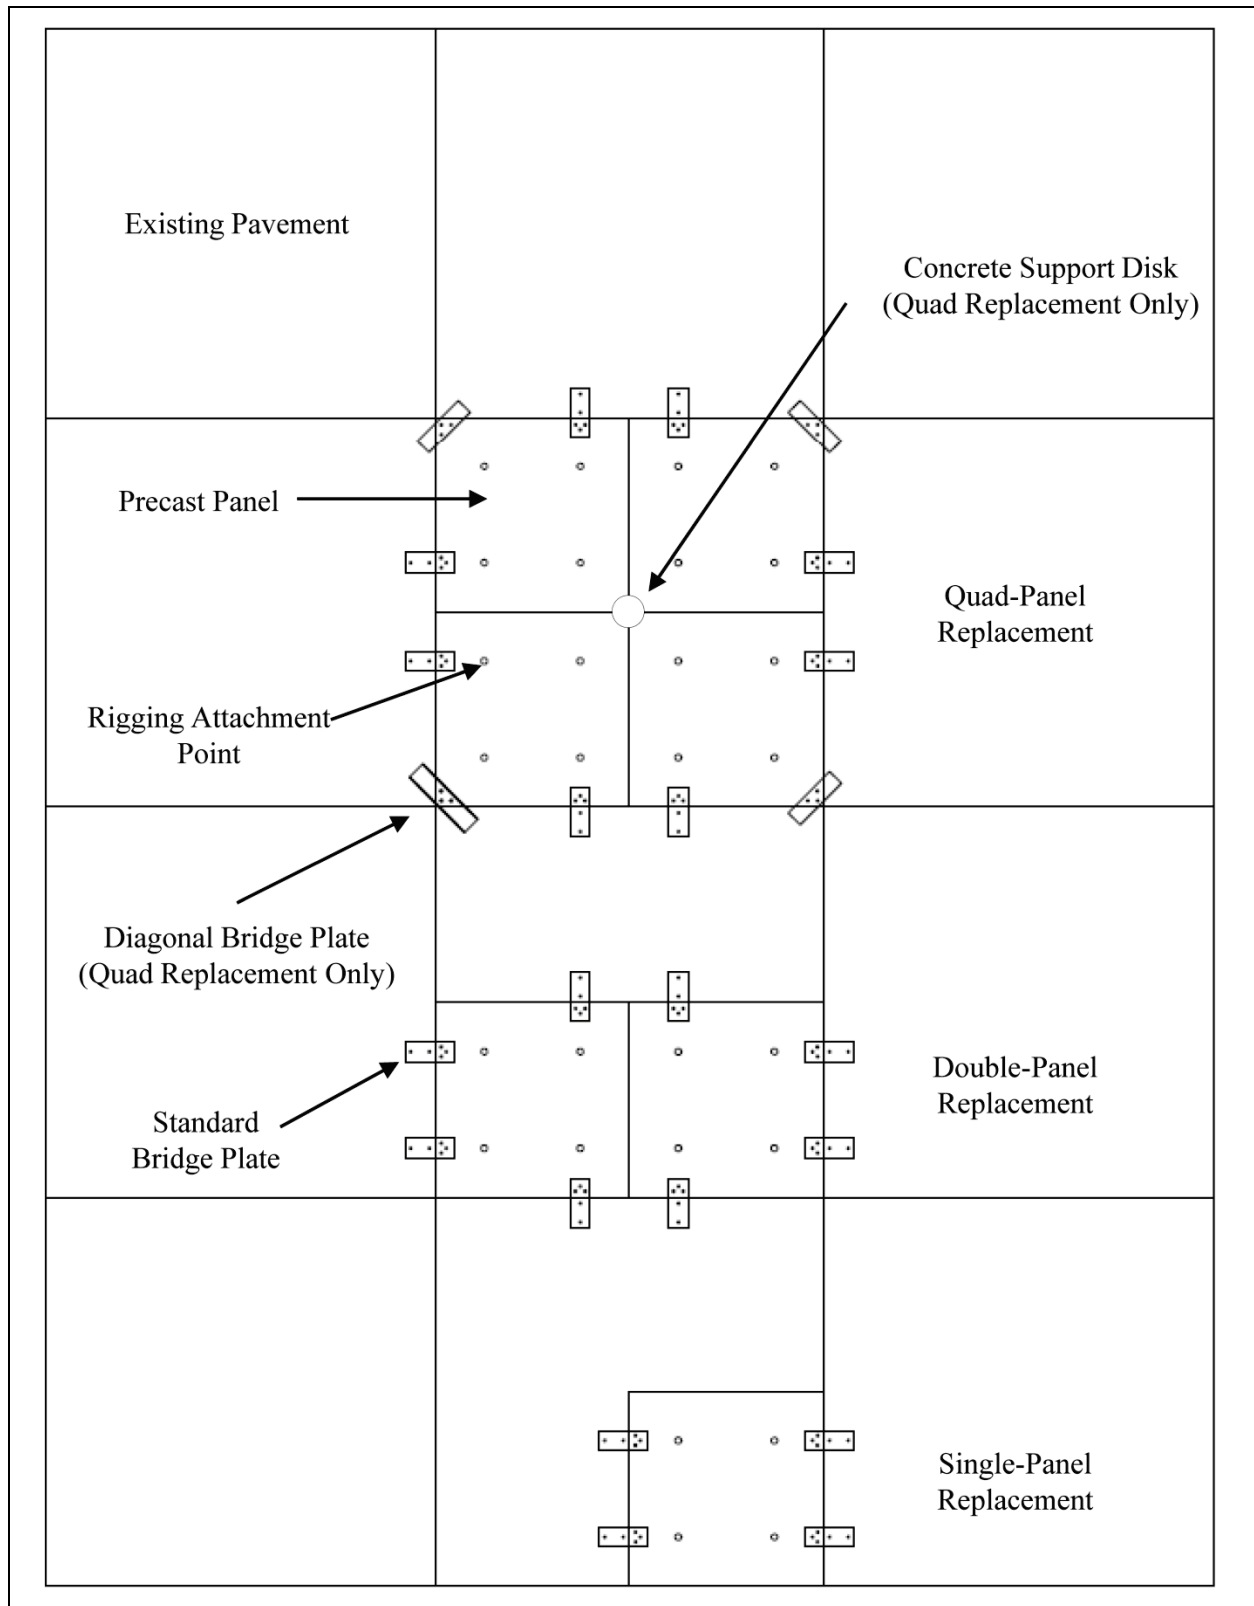
Figure C.5. Bridge plate configurations for the repairs.

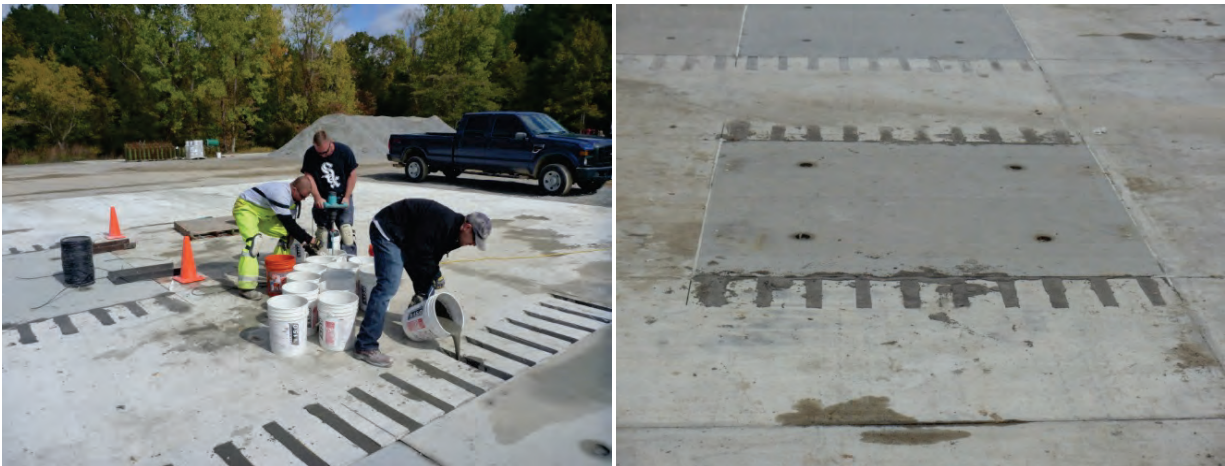
Figure C.8. Left: placement of rapid-setting grout in dowel receptacles, and right: grouted and sealed panel.

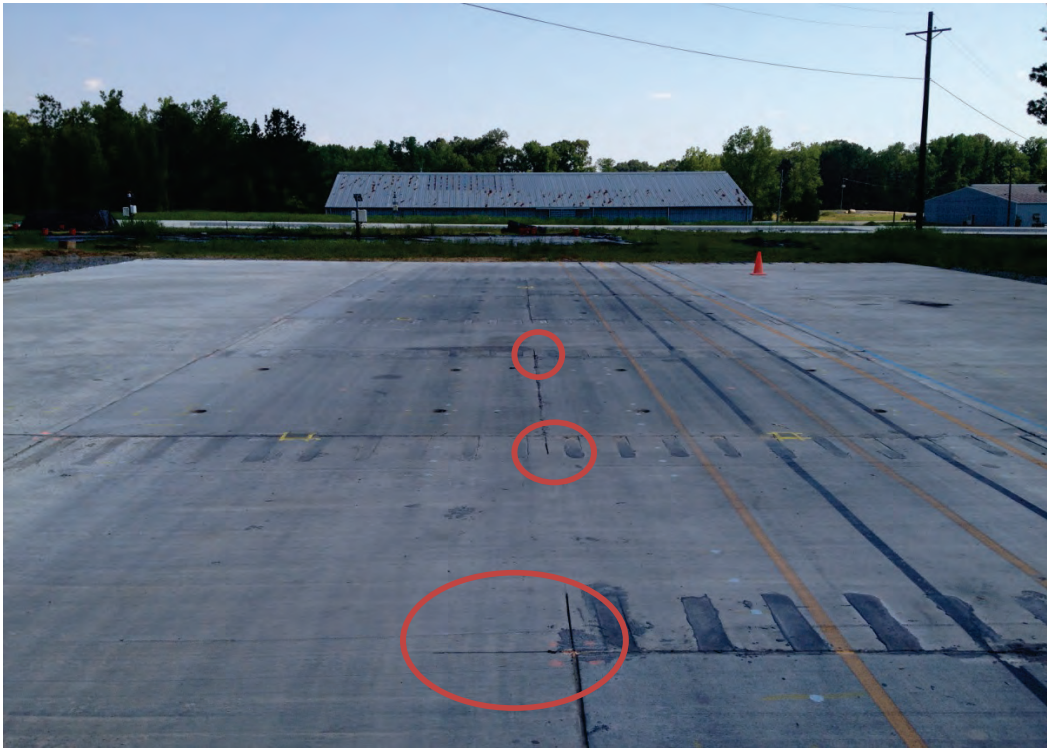
Figure D.5. Saw cuts at corners of panels.
