*Airfield Damage Repair Modernization Program*

## **AM2 Opposite Lay Evaluation**

June 2015

Final report

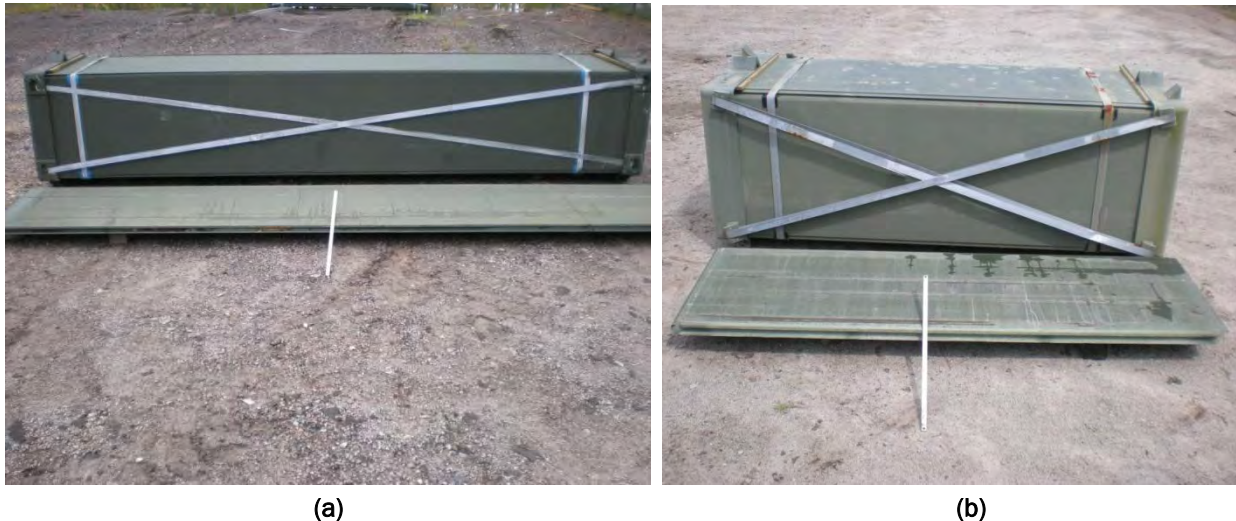
Figure 1. (a) F71 and (b) F72 mat packages.

AM2 airfield mat was developed in the 1960s under a program sponsored by the Naval Air Engineering Center, Philadelphia, PA. Various versions of AM2 were tested under simulated aircraft loads at the U.S. Army Engineer Waterways Experiment Station in Vicksburg, MS, from 1961 through 1971, with major procurements beginning in 1965. The original AM2 mat has been modified through the years to address limiting structural concerns. The current production version of AM2, modification version 5, was obtained from NAVAIR, Lakehurst, NJ. Photographs of the AM2 F71 and F72 packages similar to those used in this test are shown in Figure 1.

Pertinent properties of the AM2 mat used in this evaluation are shown in Table 3. Each full panel was 24 in. by 144 in. by 1.5 in. and fabricated from a single 6061-T6 aluminum alloy extrusion with end connectors welded to the 24-in. ends to form a complete panel. The core of the extruded panels was comprised of vertical stiffeners spaced 1.75 in. apart in the 12-ft direc-

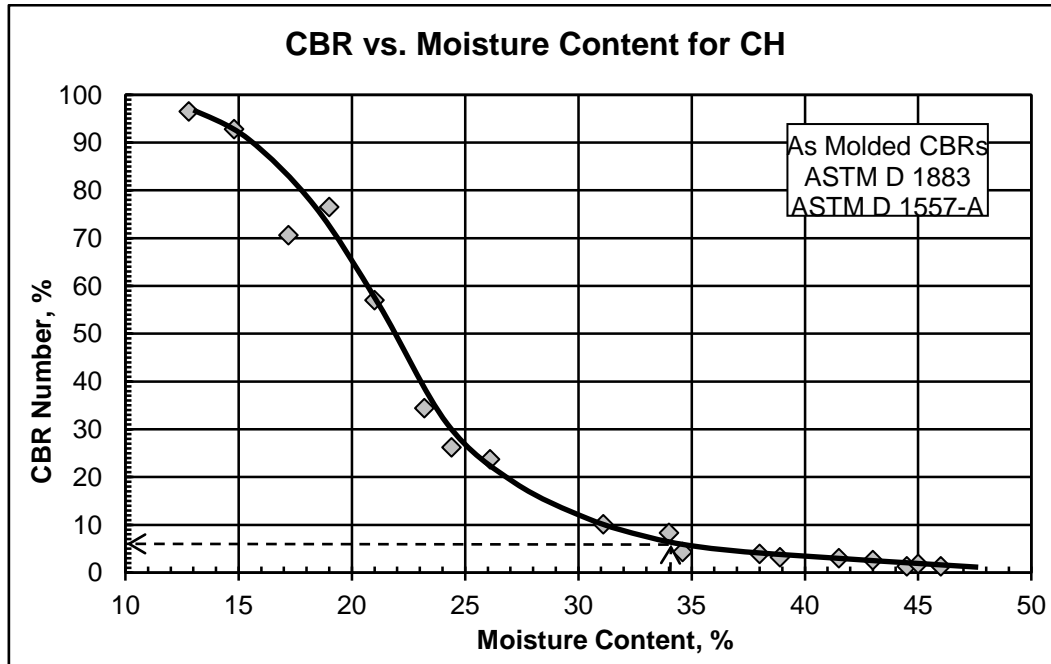
Figure 4. CBR vs. moisture content for CH subgrade material.

The pretest moisture content and density measurements presented in Table 4 generally follow the trends found from laboratory measurements presented in Figures 3 and 4. However, previous experience has shown that the field moisture content required to construct a CBR of 6 typically ranges from 30% to 32% instead of 34% as suggested in Figure 4. This occurs because of the higher compaction energy used in the field compared to laboratory compaction effort.

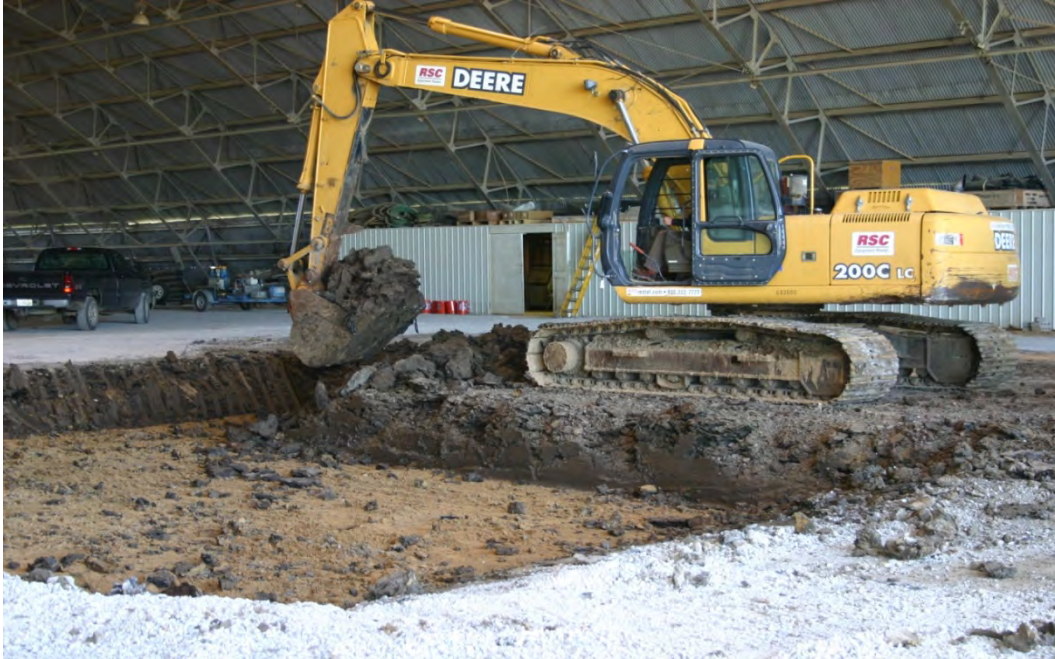
Figure 7. Test section excavation.

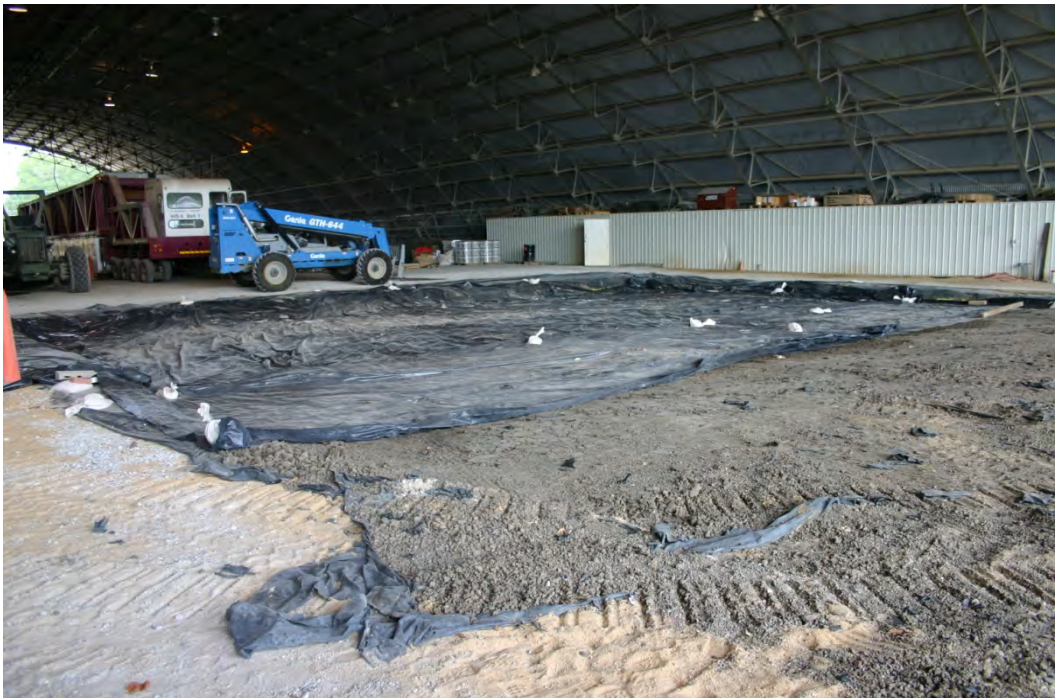
Figure 8. Test pit lined with impervious sheeting.

vibratory steel-wheel compactor to ensure that the remainder of the test section was constructed over a stable foundation. The bottom and sides of the test pit were lined with impervious 6-mil polyethylene sheeting to minimize moisture migration from the 36 in. of new CH soil serving as the test section subgrade, as shown in Figure 8.

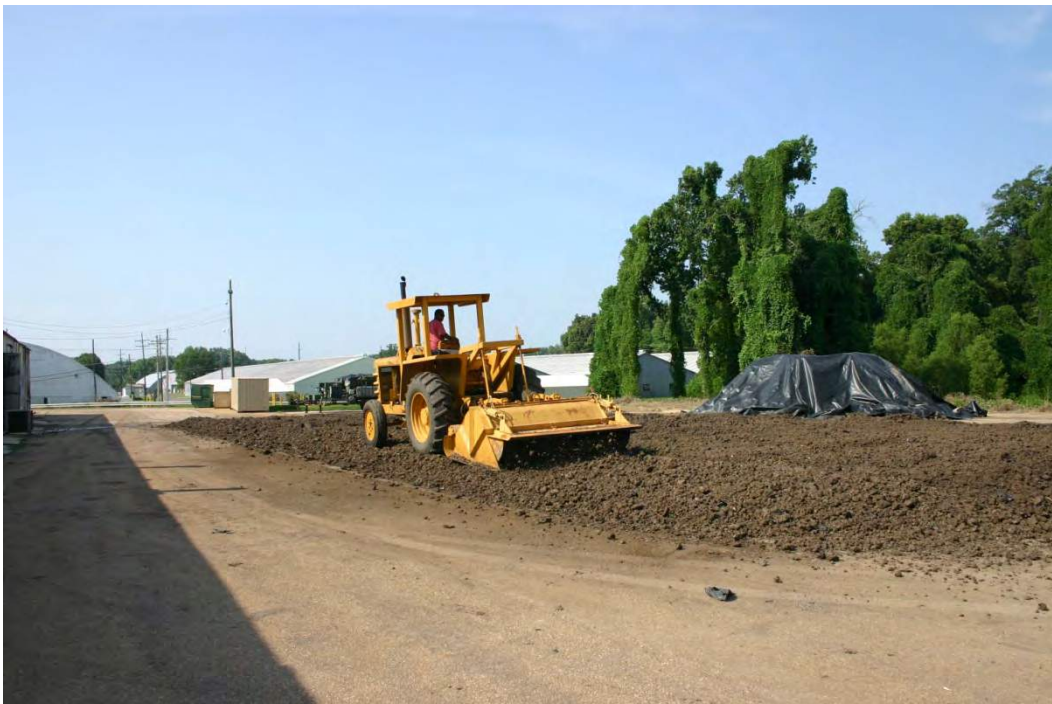
Figure 9. Pulverizing CH.

The CH was processed at a nearby preparatory site by spreading the material to a uniform 12-in. depth, pulverizing the material with a rotary mixer, adjusting the moisture content, and pulverizing the material again, as shown in Figures 9 and 10. This was an iterative process necessary to achieve a uniform distribution of moisture throughout the material. Once the CH had been processed to the target moisture content, the material was placed in the test section, spread and leveled by a bulldozer in 8-in. lifts, and then compacted with a pneumatic roller to a compacted thickness of 6 in., as shown in Figures 11 and 12.

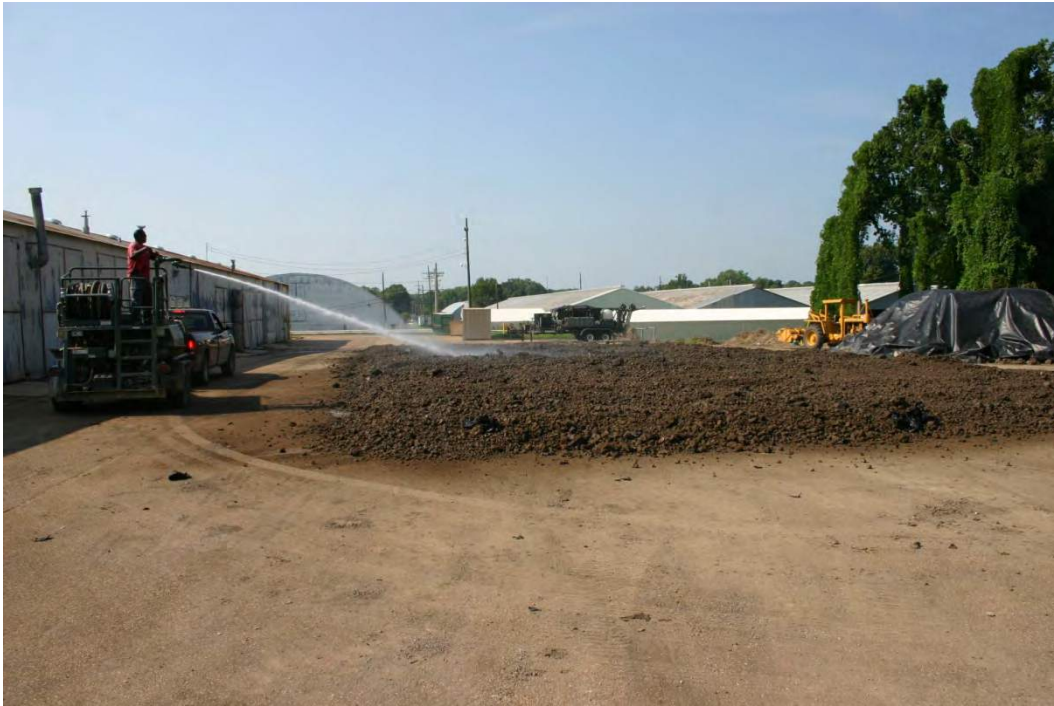
Figure 10. Addition of water to adjust moisture content.

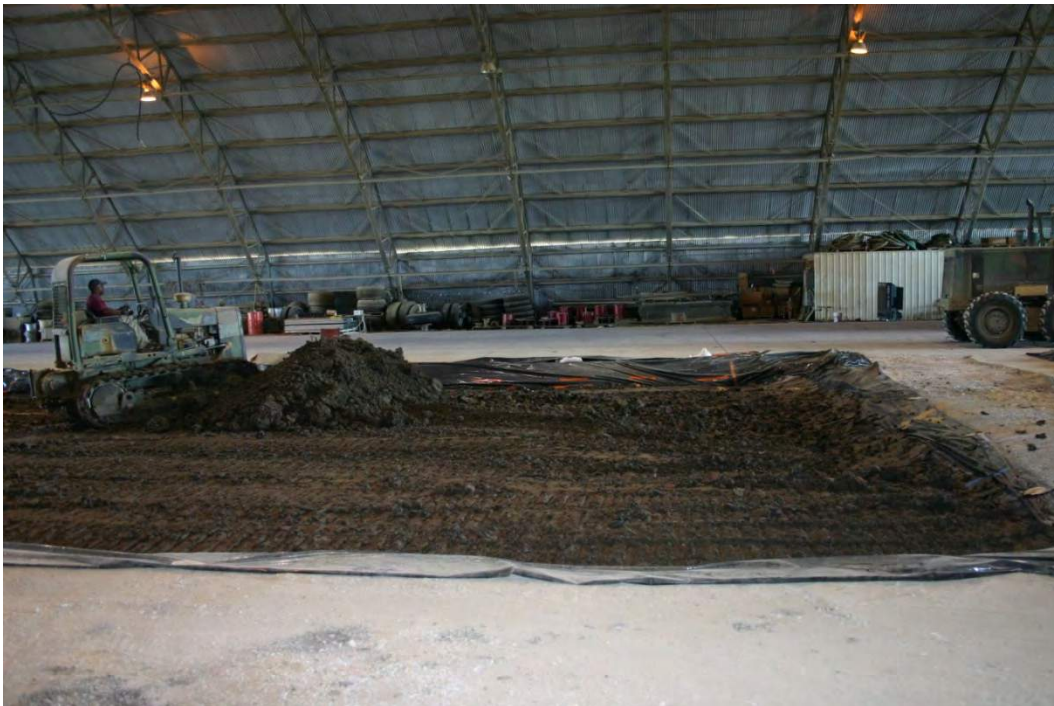
Figure 12. Compacting CH subgrade with pneumatic roller.

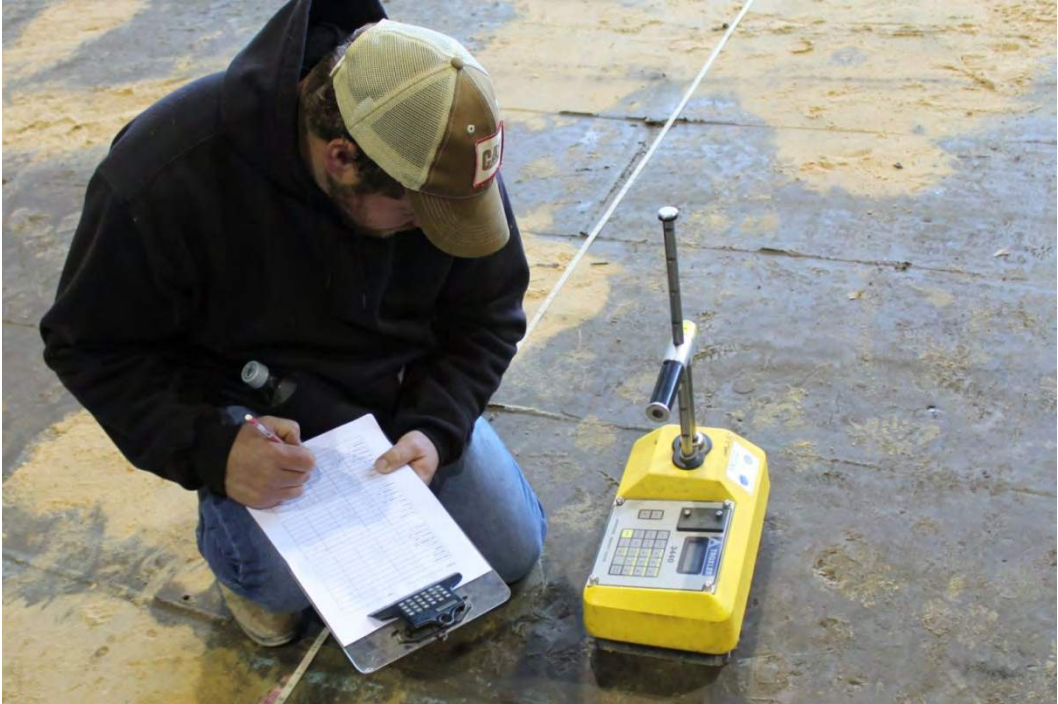
Figure 13. Nuclear moisture-density gauge test.

Each compacted lift was subjected to nuclear moisture/density tests (ASTM D 6938), as shown in Figure 13, in addition to convection oven moisture determination tests (ASTM D 4643) to verify that target values had been met. In situ CBR tests (CRD-C654-95), as shown in Figure 14, were conducted at four locations on every 6-in. compacted lift to verify that the target CBR of 6 had been reasonably achieved. If the average pretest CBR of a lift differed from the target value by more than +1.0 or -0.5 CBR, the lift was reconstituted. Each lift was surveyed to obtain an average thickness. After data collection, the surface was scarified with a rotary mixer to an average depth of 1 in. prior to placement of the following lift to facilitate bonding at the interface.

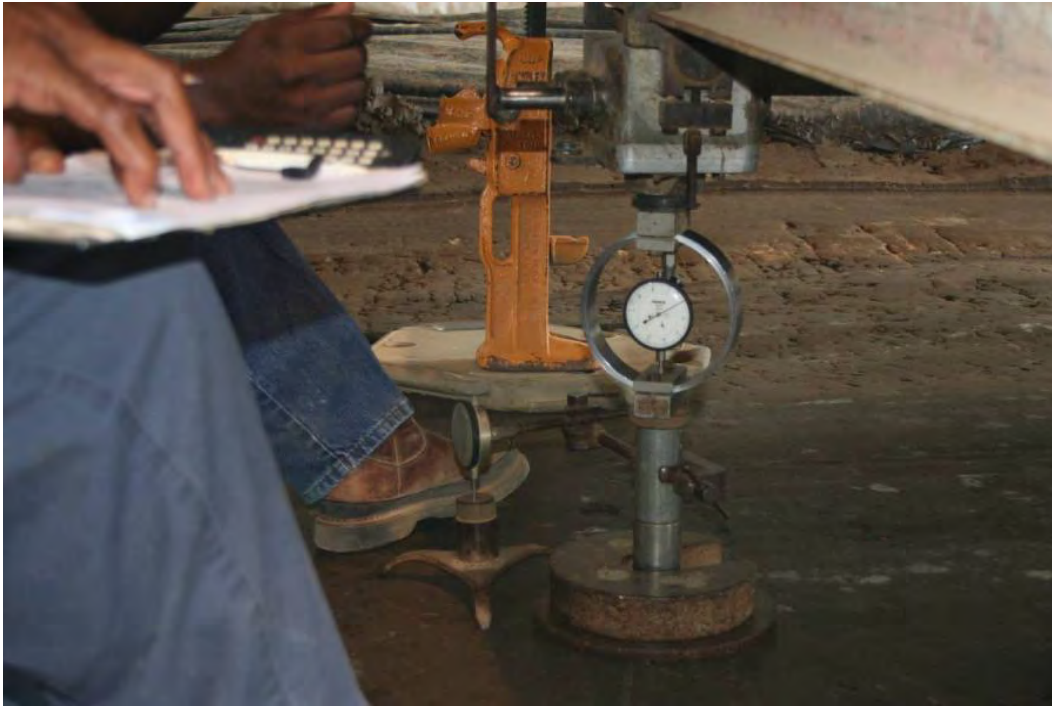
Figure 14. Field CBR test.

For the opposite lay test section, the upper 12 in. of the existing test bed were removed and reprocessed. Field CBR tests indicated that the existing material from 12 in. to 36 in. retained a CBR of approximately 6; therefore, reconstruction of the entire depth was unnecessary. The reprocessed material was replaced in two 6-in. lifts. Field CBR tests were performed on each lift at stations 10 and 30 along the centerline of each test item to ensure the target CBR of 6 was achieved.

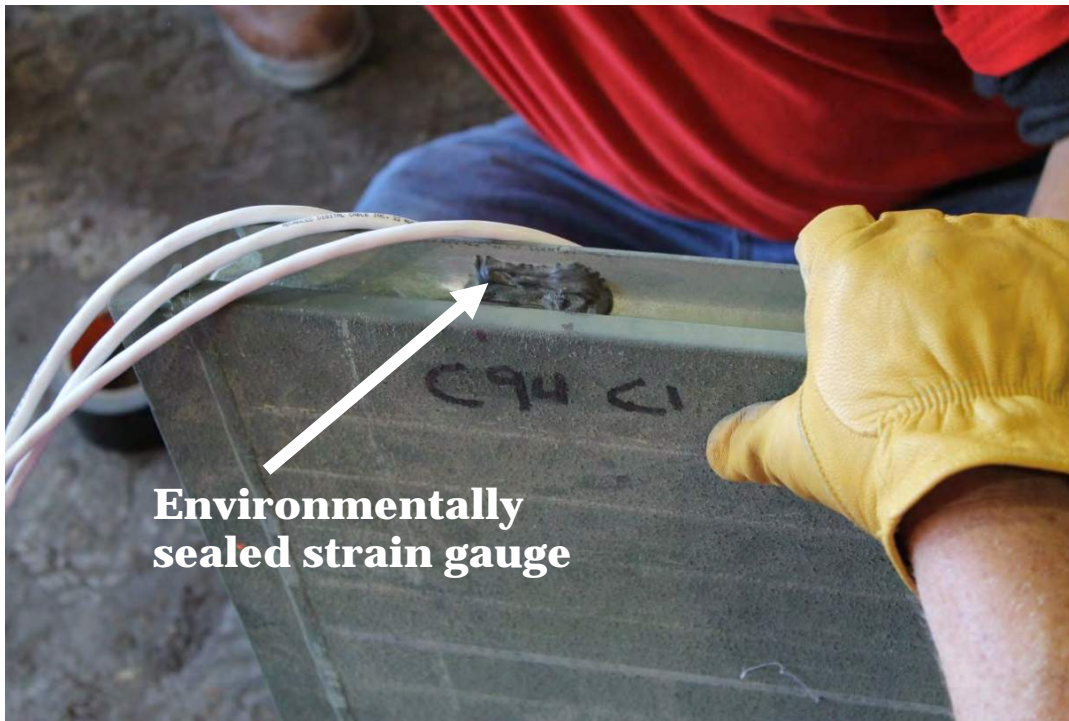
Figure 19. Modification to male hinge of AM2 panel.

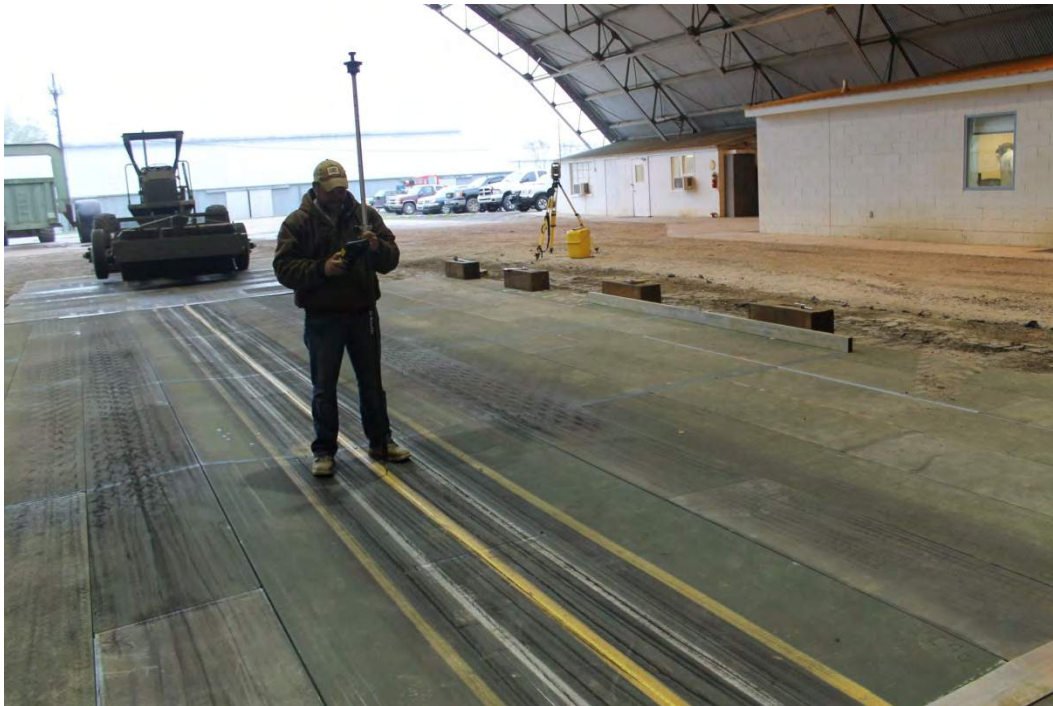
Figure 29. Surveying centerline profile.

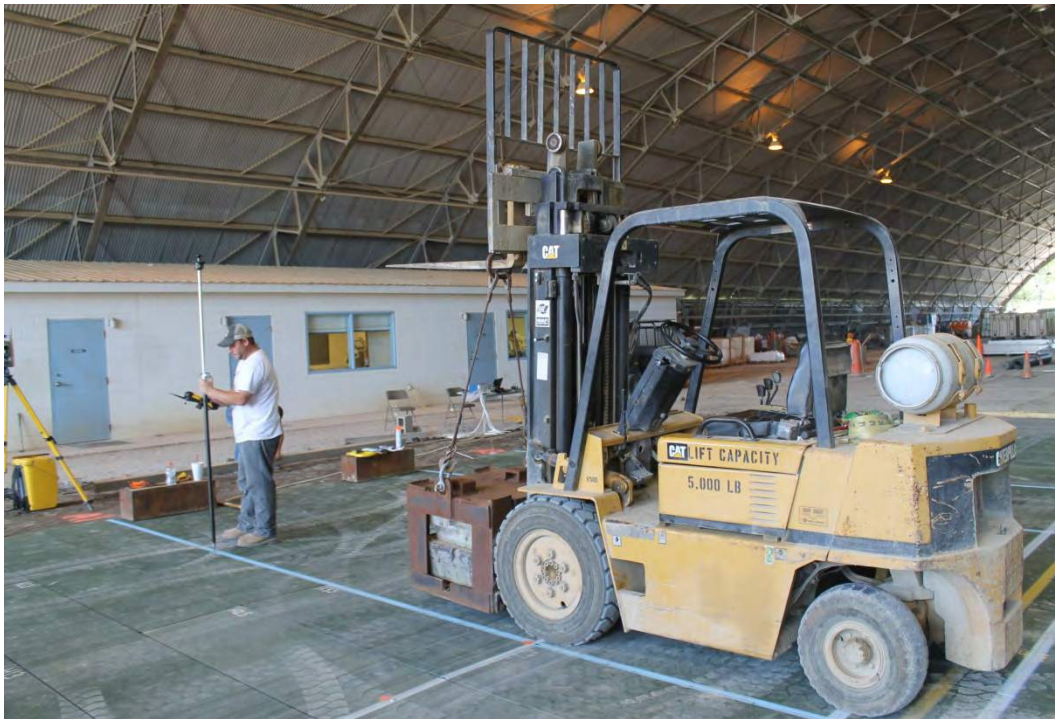
Figure 30. Typical survey of loaded cross section.

In an attempt to measure the permanent deformation of the subgrade underneath the mat surface, a forklift carrying two 2,000-lb lead weights was parked on the mat surface adjacent to each cross section, and elevation data were once again recorded at the same intervals (Figure 30). The wheel load applied was approximately 6,000 lb. These data are noted as “loaded cross sections” in this report. The goal of the load application was to deflect the mat enough to contact the subgrade but not so much as to induce elastic deflections in the subgrade.

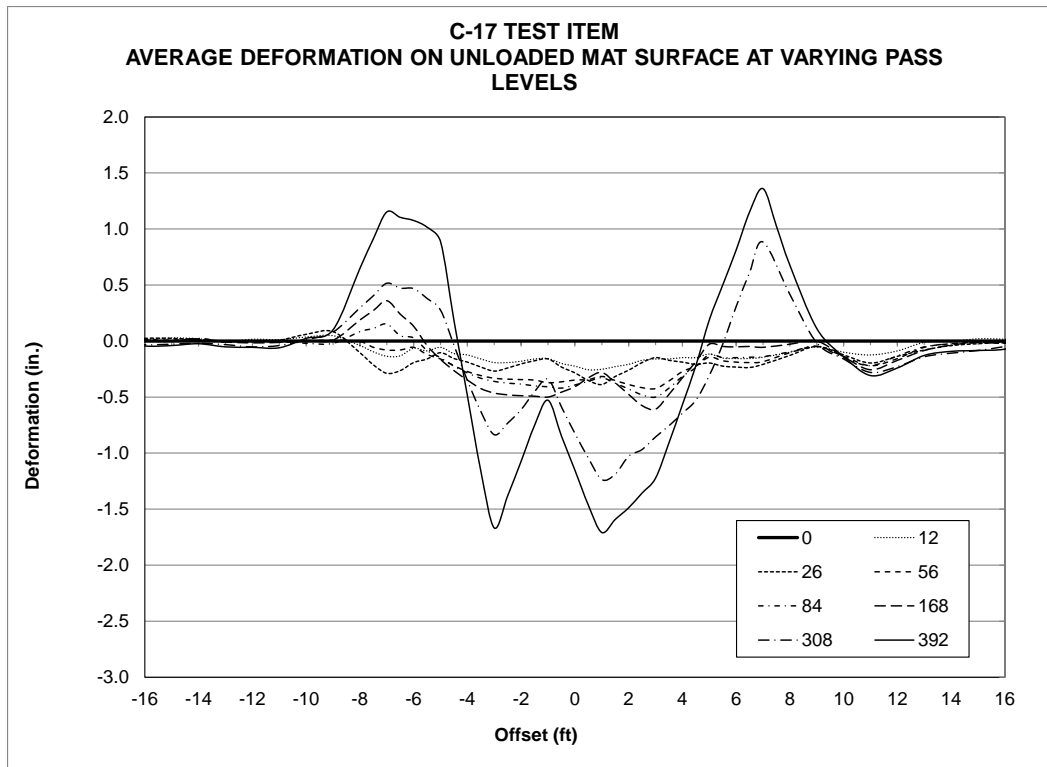
Figure 40. Average deformation on the unloaded mat surface in the C-17 item.

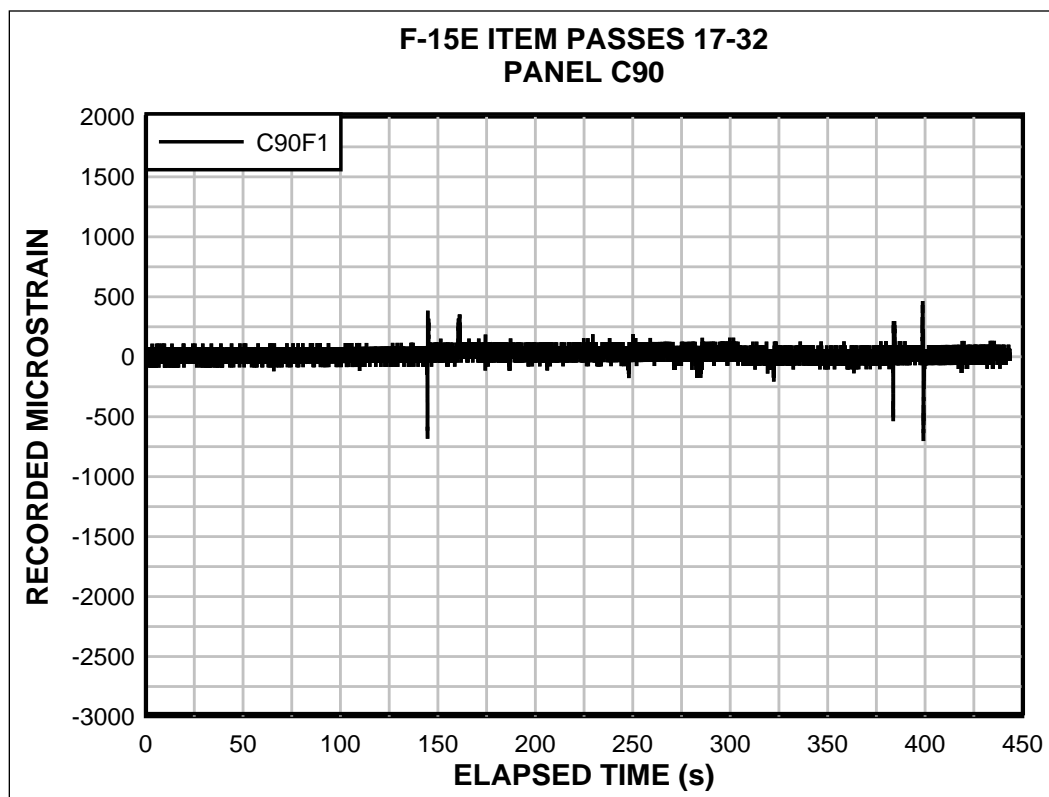
Figure 41. F-15E item, gauge C90F1, passes 17-32.

Example plots of the strain data recorded are shown in the following sections. The strain gauge data examples are presented in groups based on their comparable locations on the F-15E and C-17 test items. In each plot, the x-axis represents the elapsed time (during the recording period) in seconds, and the y-axis is the strain measurement in microstrain ( $10^{-6}$ ). Each of the positive peaks represents tensile strains, and the negative peaks represent compressive strains. The changing magnitude of the peaks was caused by the wander pattern used to simulate a normal distribution of traffic over the test section. The prominent peaks indicate that the load cart was located directly above, or adjacent to, the strain gauge.

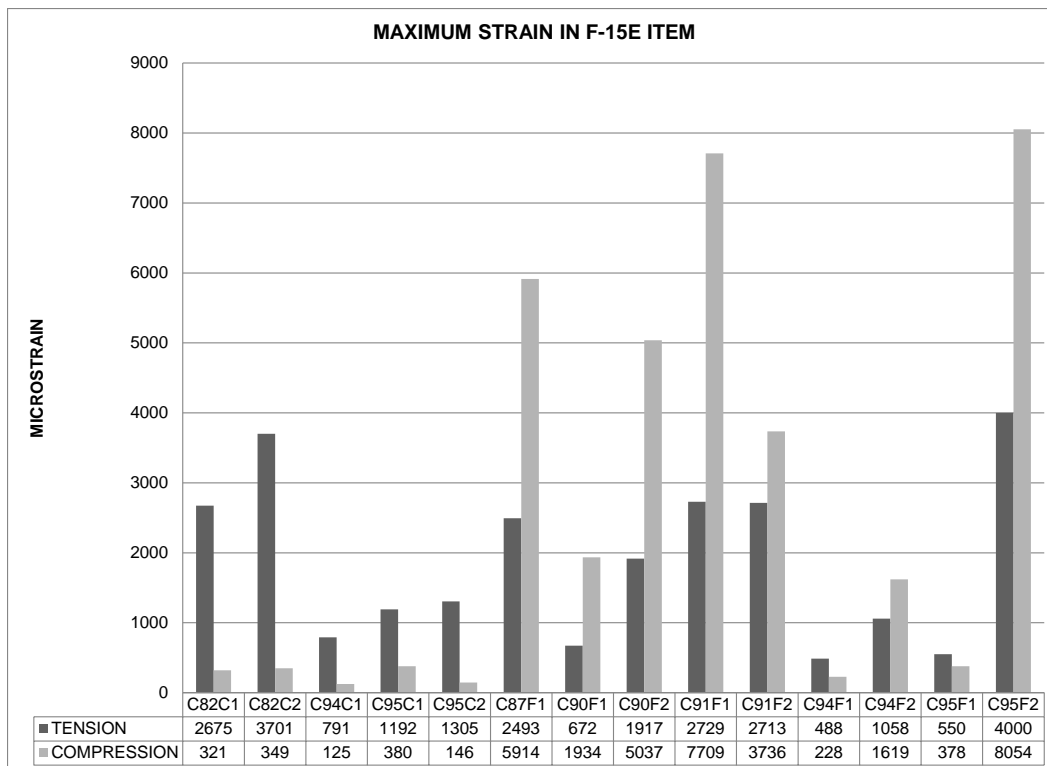
Mat breakage did not occur in the F-15E item; therefore, failure of a panel could not be linked to a measured strain at a particular location. Larger strains were measured at the F-joint than at the C-joint. This behavior is

understandable since the locking bar at the F-joint causes a greater resistance to cyclic movement, whereas the C-joint is free to rotate with the moving load without straining the female hinge. Compressive strains tended to accumulate throughout the test and were typically higher than tensile strains at the F-joint. The opposite was true at the C-joint; tensile strains were generally higher than compressive strains and tended to accumulate towards the end of the test. The single-wheel load applied on panels C94 and C95 likely triggered the panels to bow in a clockwise rotation, causing the female hinge of both panels to pull at the bottom flange. When the load was applied on panels C86 and C87, both panels bowed upward in a counterclockwise rotation. This rotation created tensile strains at the female hinge of panel C82. As deformation increased in the traffic area and the system became more unstable, panels C94, C95, C86, and C87 were able to bow upward in increasing amounts, causing higher tensile strains at the female hinges of C94, C95, and C82. A summary of the maximum strain measured by each working gauge in the F-15E item is plotted in Figure 69.

Figure 69. Maximum strains for F-15E Test Item.

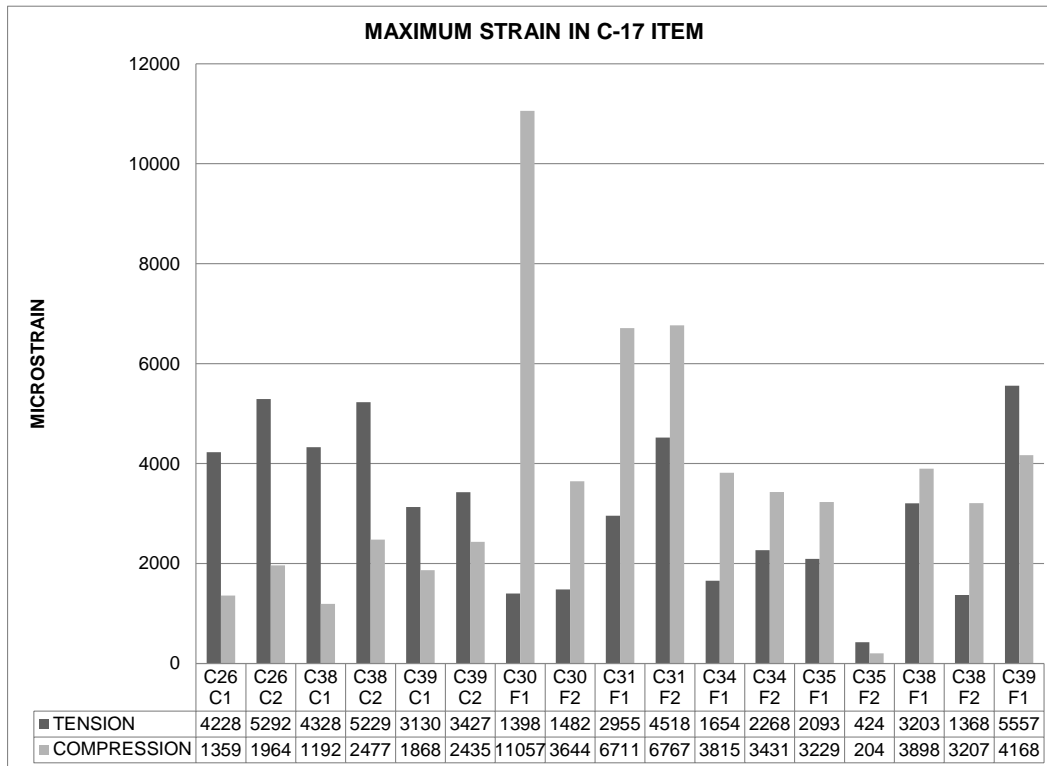
Unlike the F-15E item, the magnitudes of the tensile strains at the C-joint of panels in the C-17 item were generally higher than at the F-joint. It is possible that, since the multiple-wheel load cart distributes the load over a much wider area, a series of connected panels was allowed to bow, instead of just one panel attempting to rotate at the C-joint. Since both the male and female hinges of an instrumented C-joint were trying to rotate in opposite directions with the moving load, high tensile strains were measured at the female hinge. Compressive strains were generally larger than tensile strains at the F-joint. A clear pattern could not be established as to whether compressive strain was predominant at the lower overlap or the upper underlap rail. A summary of the maximum strain measured by each working gauge in the C-17 item is plotted in Figure 70.

Figure 70. Maximum strains for C-17 test item.

Compared to the F-15E item, tensile and compressive strains measured at the F-joints and C-joints were higher in the C-17 item. At the C-joint of panels in the C-17 item, tensile and compressive strains reached maximum values of more than 3,000 and 1,000 microstrain, respectively, at each gauge. At the C-joint of panels in the F-15E item, maximum tensile strains remained mostly under 3,000 microstrain, and maximum compressive strains were well below 1,000 microstrain for each gauge. At the F-joint of

panels in the C-17 item, maximum tensile strains were greater than 1,000 microstrain, with the exception of one gauge (C35F2). Maximum compressive strains were mostly greater than 3,000 microstrain. In the F-15E item, maximum tensile strains at the F-joints were under 3,000 microstrain, with the exception of gauge C95F2. Compressive strains were more comparable to those measured in the C-17 item, but were still generally less than 3,000 microstrain.
