## The Structural Insulated Panel “SIP Hut”

Preliminary Evaluation of Energy Efficiency and Indoor Air Quality

August 2015

### **Final Report**

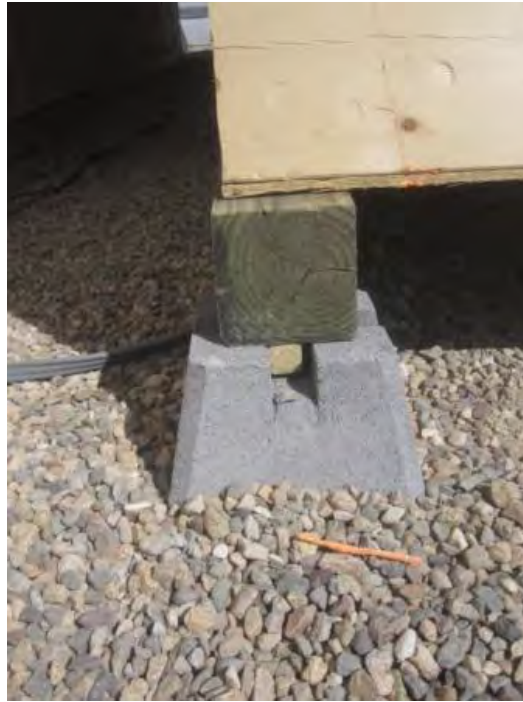
Figure 2-2. Site conditions at Camp Roberts.

The Camp Roberts site was a very level site with an existing crushed stone foundation (Figure 2-2). Minimal changes in gravel elevation were required to construct a level building foundation. The delivery truck parked adjacent to the construction site and a forklift was used to stage the SIP bundles for ease of construction.

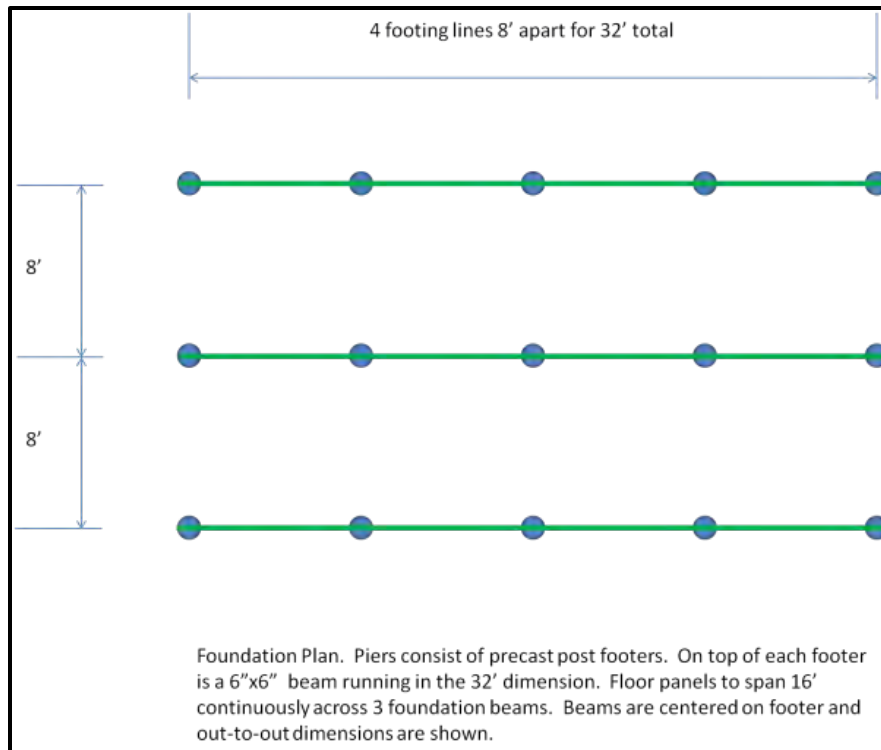
Figure 2-3. SIP hut 2.0 foundation plan.

Foundation plans were adjusted (Figure 2-3) to facilitate construction on an austere site and support the changes to the floor structure. Foundation blocks were placed directly on the ground, then three foundation beams were placed on the blocks. Floor panels were placed on these beams. Three Soldiers were able to build this foundation in 1 hour, 40 minutes, or 5 work-hours.

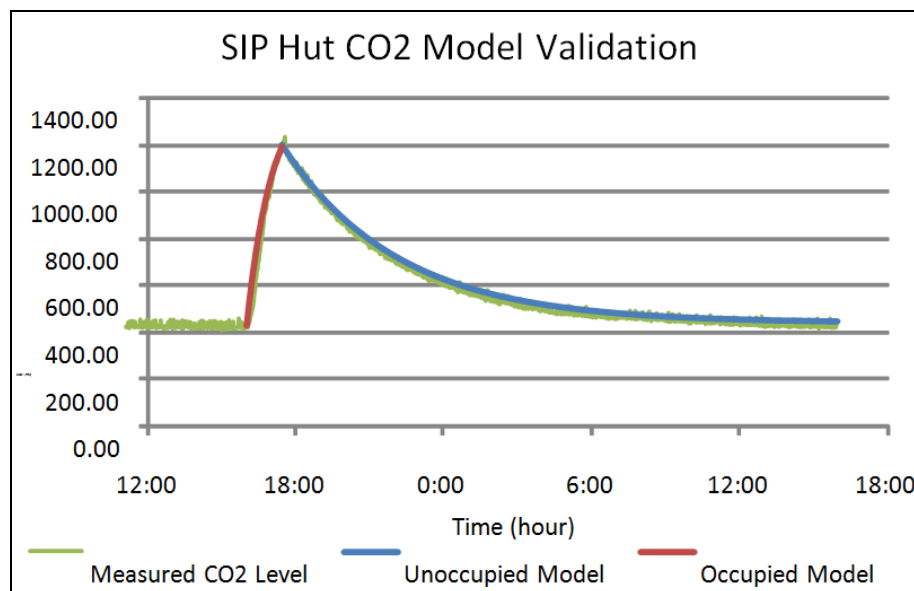
Figure 2-4. CO<sub>2</sub> test data and model validation.

- *CO<sub>2</sub> and Air Exchange.*  
CO<sub>2</sub> levels in the SIP hut were modeled and analyzed under occupied and unoccupied conditions. The results of this experiment and modeling effort can be used to properly design a system that provides fresh air and reduces CO<sub>2</sub> in the hut. CO<sub>2</sub> levels were collected on 10 February 2014. The tests included an hour of occupancy in the SIP hut at approximately 1500. This caused CO<sub>2</sub> levels to increase, and on vacancy to decrease due to the airflow by the ECU. Parameters from the SIP hut, ECU airflow, and estimated CO<sub>2</sub> from occupants were modeled, which resulted in a closely represented dataset (Figure 2-4). The CO<sub>2</sub> performance was slightly improved, but not sufficient for occupancy.

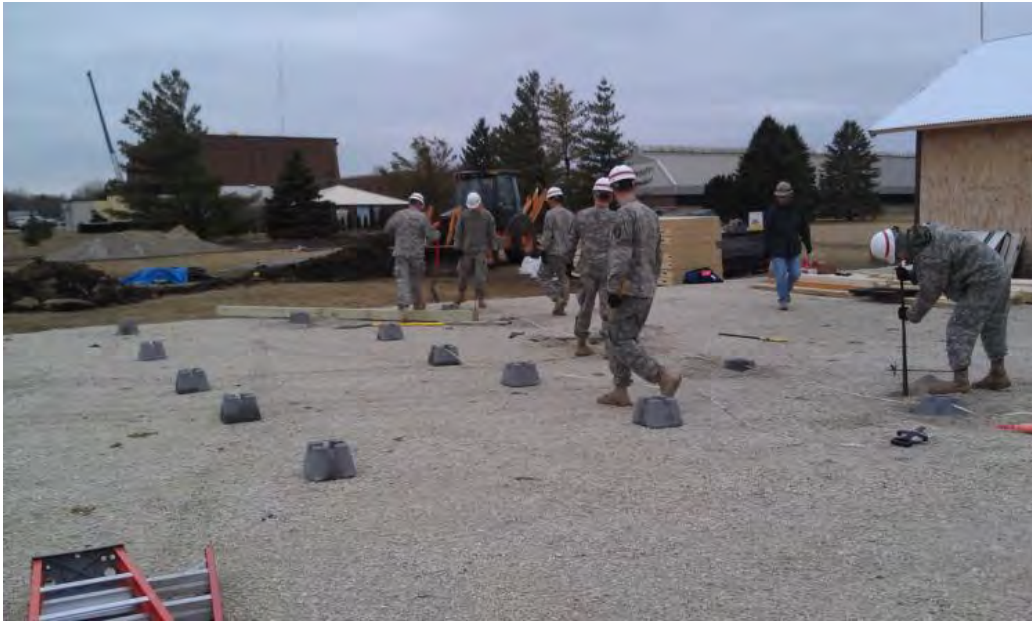
Figure 3-2. Setting up SIP hut foundation piers.

Six foundation beams were then placed on the blocks and connected at their ends with supporting boards. Cleats were screwed into each foundation beam to hold them in place on each foundation block. Tie-down cables were placed into grooves in the foundation beams and anchored with helical anchors on either end. Floor Panels were then placed directly on the foundation beams. Eight Soldiers were able to install the foundation in 4 hours. Figure 3-3 shows a detail view of the laminating board, foundation beam, foundation block, and Simpson Tie Connection. Figure 3-4 shows the placement of the foundation beam cleat in the foundation block, and Figure 3-5 shows the finishing of the foundation.

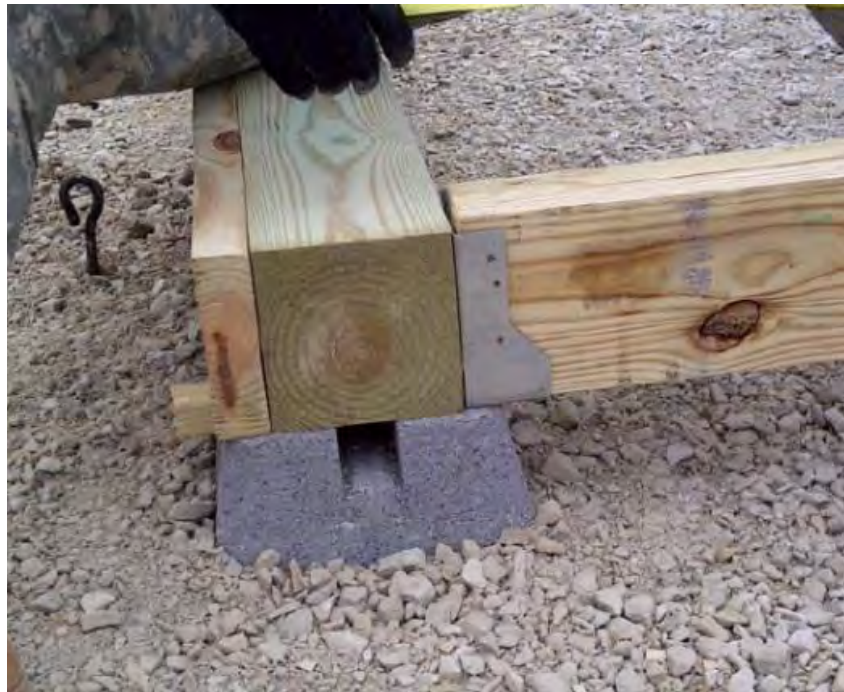
Figure 3-3. Foundation connection detail.

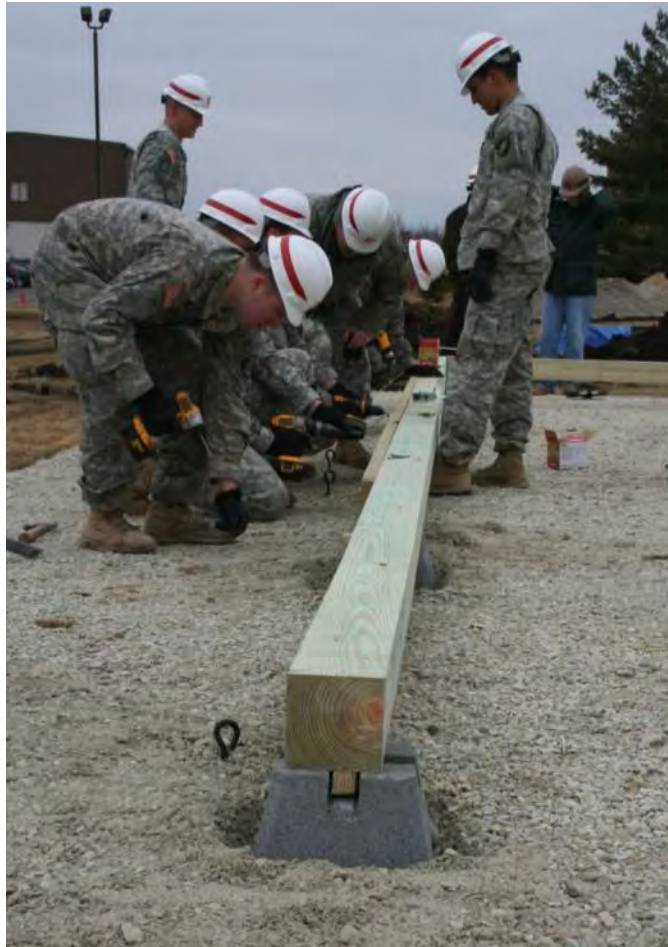
Figure 3-4. Foundation beam cleat.

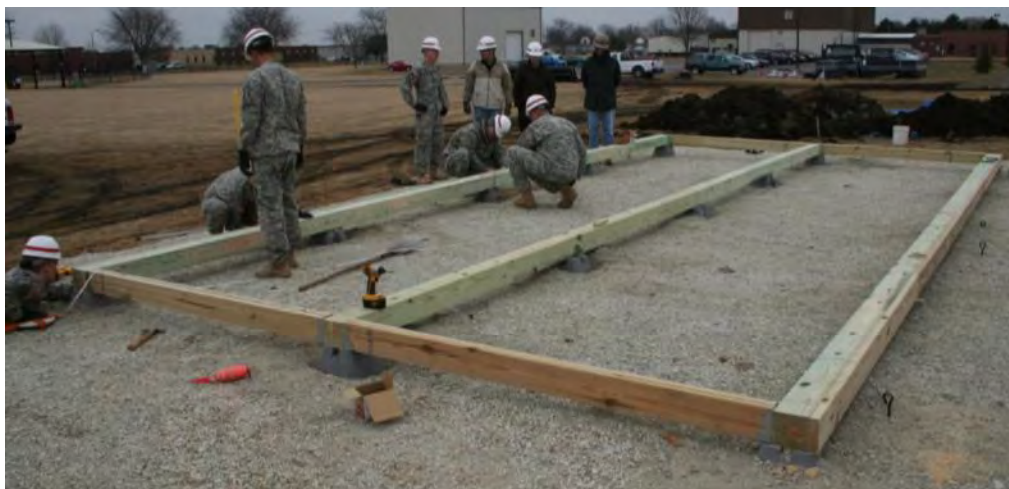
Figure 3-5. Finishing the foundation.

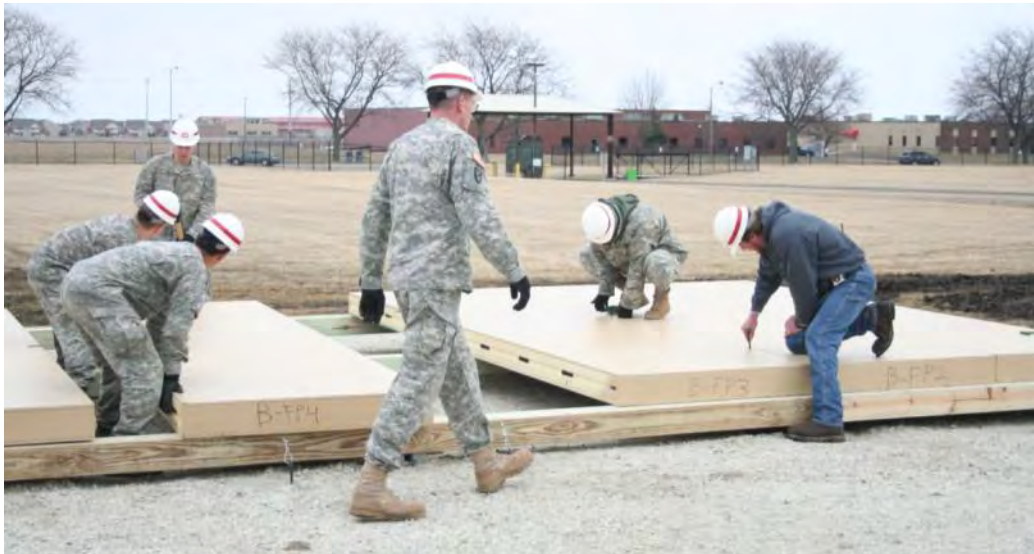
Figure 3-7. Placing floor panels and locking cam-lock.

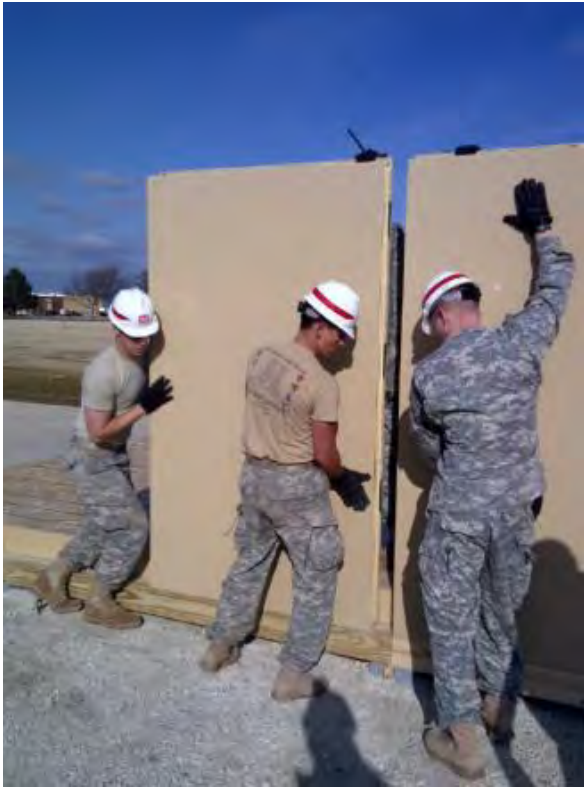
Figure 3-8. Wall panel placement.

This version of the SIP hut implemented a few upgrades. One of these was smaller dimensions. The wall heights were shortened to 6.5 ft. They were also shifted to sit directly on the foundation beam as opposed to the floor panels. This change allowed for quicker installation because screws were placed through the wall panels directly into the floor panels. The total time spent setting the floor panels was 4.5 work-hours and the wall panels took 9 work-hours. Figures 3-8, 3-9, and 3-10 show the wall panels being set. (Note that two of the floor panels had the LINE-X coating applied to the wrong side, which explains why bare OSB is visible on the floor in Figure 3-9.)

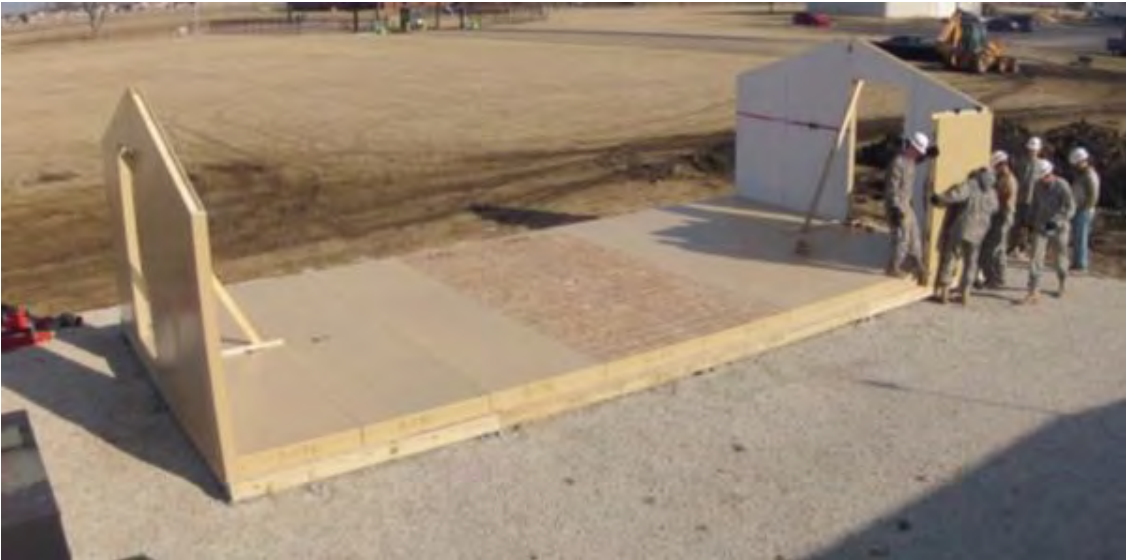
Figure 3-9. SIP hut wall construction.

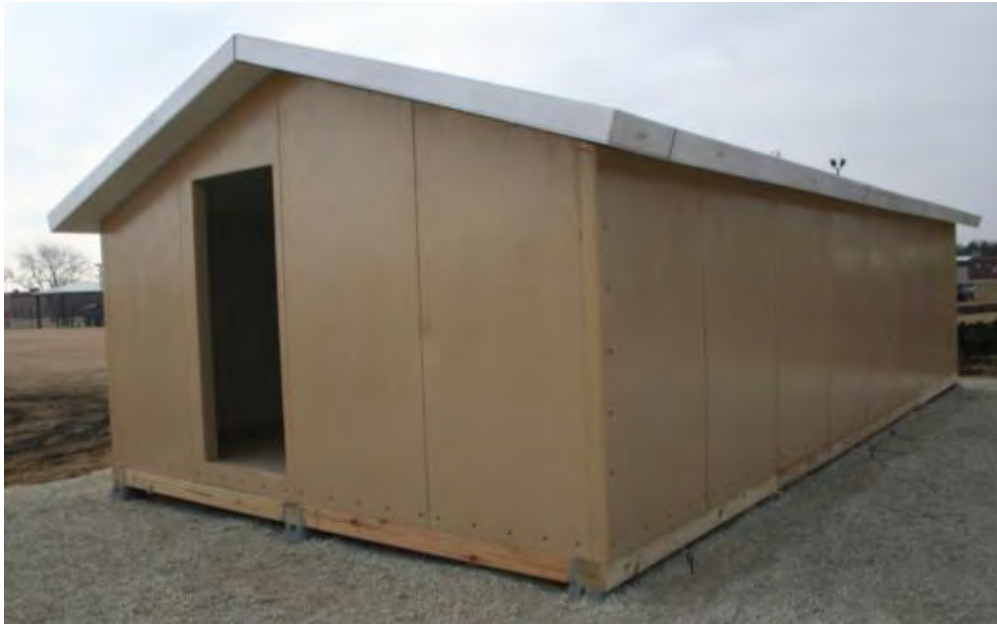
Figure 3-12. SIP hut before finishing.

Another change implemented during SIP hut 3.0 was that a roof jig was used to assist in the roof panel installation. The roof jig, similar to the prototype shown in Figure 3-11, was used to stabilize the roof panel and to protect the Soldiers doing the installation. The roof took 9 work-hours to install. Figure 3-11 shows the orientation of the roof jig. Figures 3-12 and 3-13 show the structure with the installed roof.

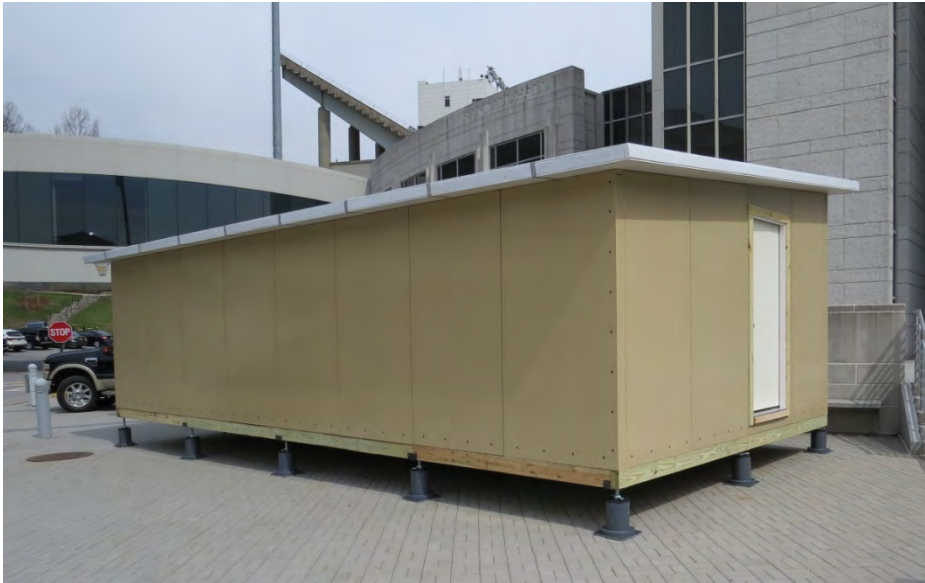
Figure 3-17. SIP hut 4.0.

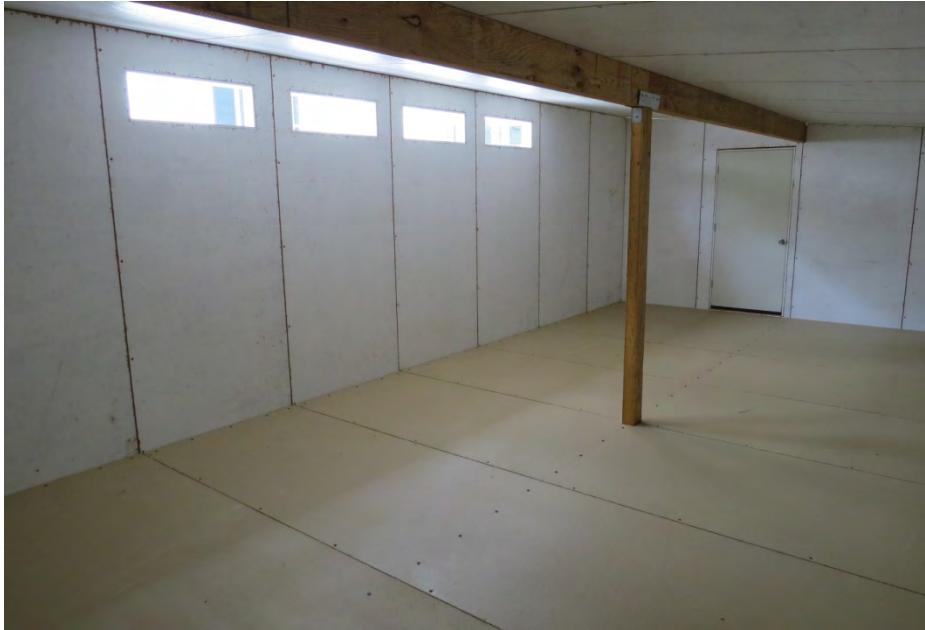
Figure 3-18. SIP hut 4.0 interior showing windows.

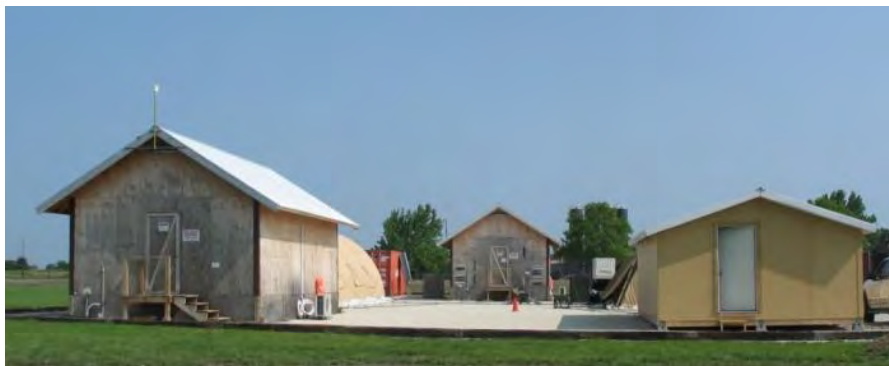
Figure 4-1. The improved B-hut (left), baseline B-hut (middle), and the SIP hut (right).

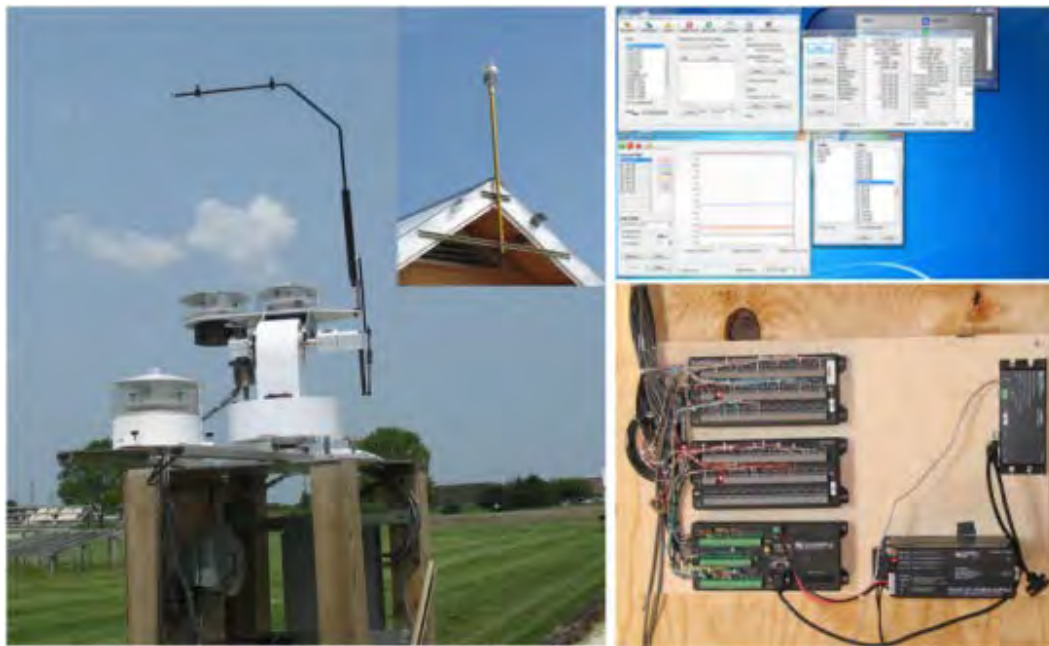
Figure 4-2. Weather station and data acquisition system with remote access capability.

An onsite station is collecting all weather parameters required to create an EnergyPlus weather file to run simulations and to validate models. Table 4-1 lists the performance monitoring instruments and Table 4-2 lists the weather station instruments. An instrument to measure the direct beam solar radiation is mounted on Eppley's automatic SMT solar tracker. A Shade Disk Kit (SDK) is mounted on the SMT tracker to measure diffuse solar radiation using a Black & White pyranometer. Each sensor reading is recorded at 5-minute intervals using a Campbell Scientific micrologger CR3000 (Campbell Scientific 2015) along with multiplexers. Two data files were maintained; one with 5-minute interval data and a second one with hourly data. Remote access of data for periodic monitoring and archival is performed through a telephone modem. Each heat flux transducer (HFT) was calibrated at ORNL using a LaserComp Fox-605 heat flux meter (LaserComp 2015). Figure 4-2 shows the data acquisition system (DAQ) and weather station.

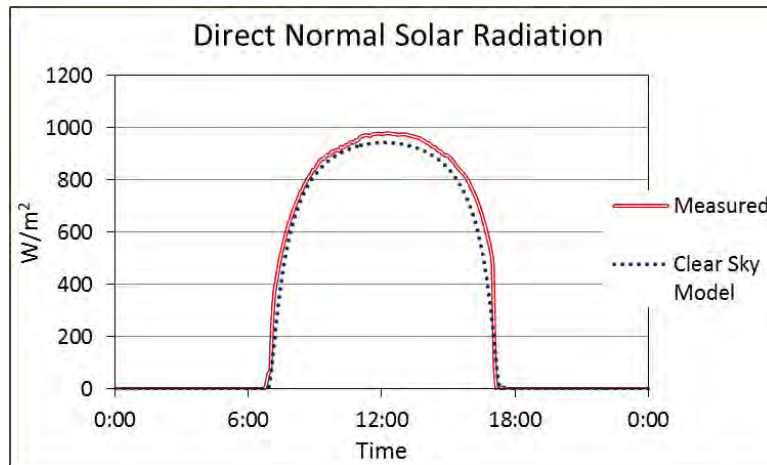
Figure 4-3. Direct normal solar radiation measured at weather station and estimated with the ASHRAE clear sky model.

To ensure that the measured solar data were accurate, the direct beam solar radiation measured by the pyrheliometer was compared against the American Society of Heating, Refrigerating, and Air-Conditioning Engineers (ASHRAE) clear sky model (ASHRAE 2013) that is used to predict direct beam solar radiation on a clear sky day. For comparison, Figure 4-3 shows the measured direct beam solar radiation against the predicted values from the ASHRAE clear sky model during a fairly clear sky day. EnergyPlus uses the direct beam and diffuse solar radiation from a weath-

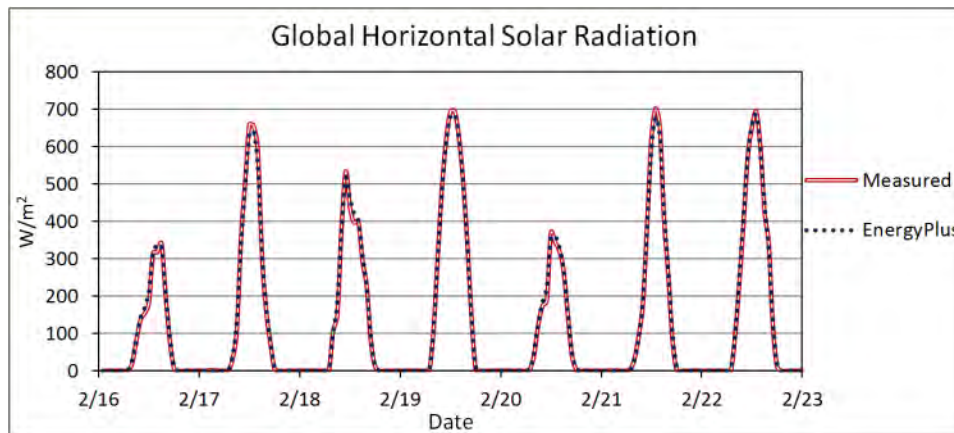
Figure 4-4. Measured global horizontal radiation and EnergyPlus calculated incident solar radiation on a horizontal surface.

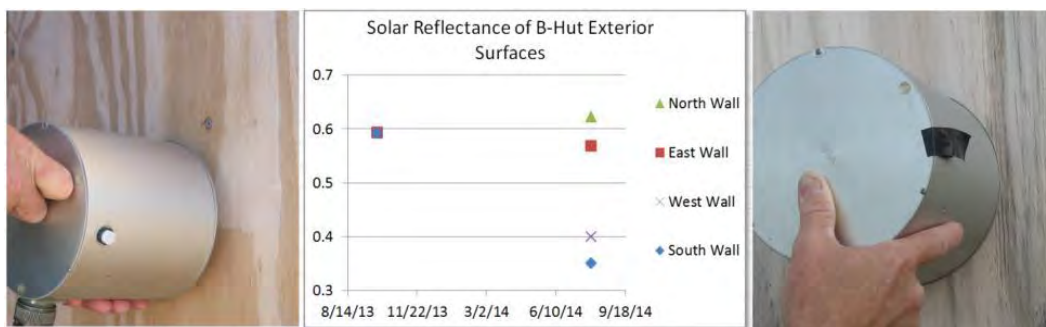
Figure 4-7. SR of B-hut exterior surfaces measured on 26 September 2013 and on 31 July 2014.

Maximum degradation in SR was observed on the south wall, followed by the west and east walls. The SR of the north wall increased slightly. This indicates that the change in SR is directly proportional to the amount of incident solar radiation on the surface. The same can be expected from the SIP hut, especially on its white-colored roof. Therefore, it is desirable to measure the SR of exterior surfaces periodically.

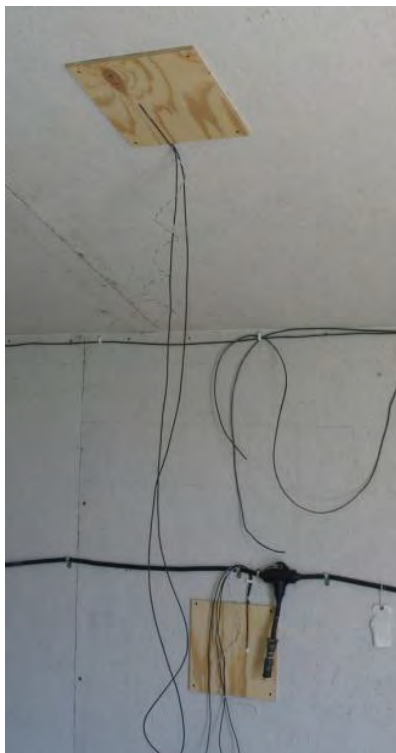
Figure 4-9. HFTs on wall and roof.

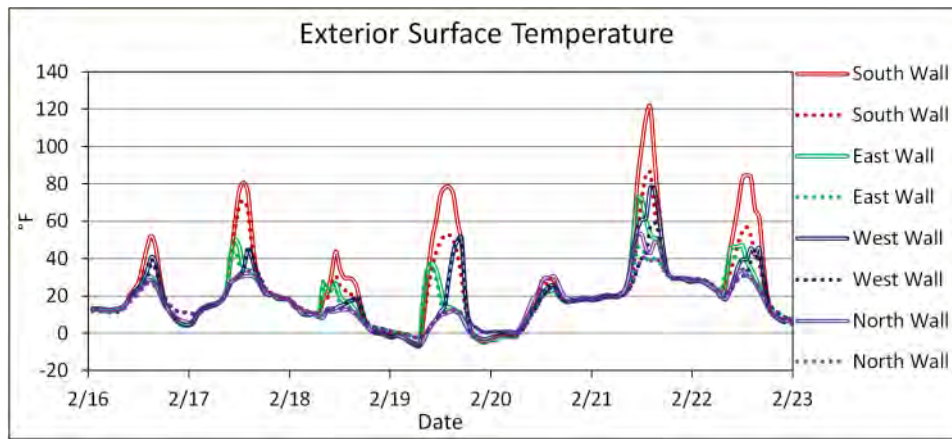
Figure 4-10. EnergyPlus calculated and measured exterior surface temperature before adjusting SR.

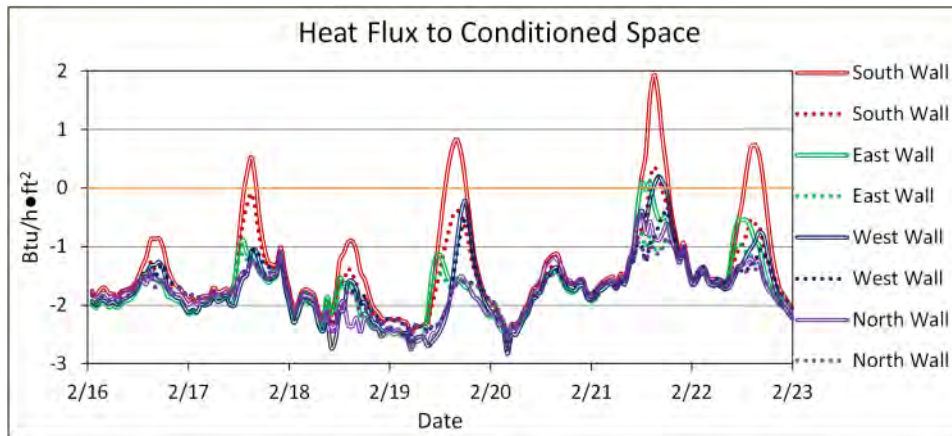
Figure 4-11. EnergyPlus calculated and measured heat flux before adjusting SR.

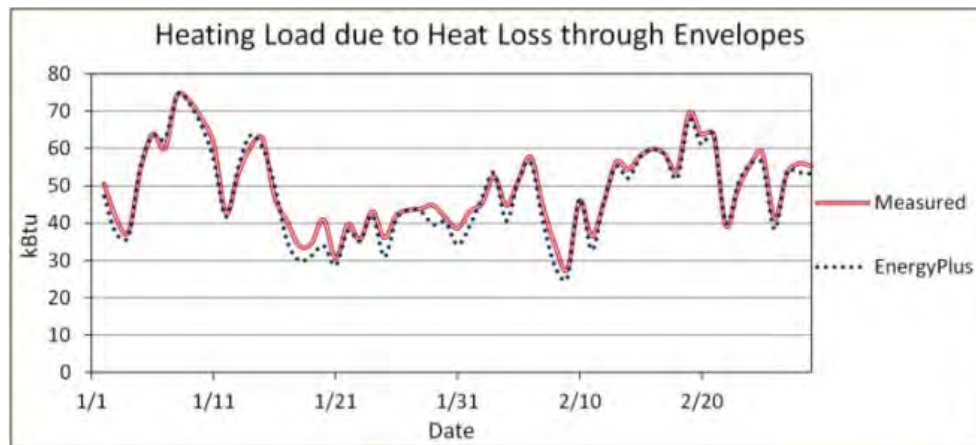
Figure 4-14. EnergyPlus calculated and measured daily heating load due to heat loss through the envelope.

Figure 4-14 shows EnergyPlus calculated and measured daily heating load due to heat loss through the envelope. Overall, EnergyPlus' predicted heating load match fairly well with measured data. For the period on January and February 2015, EnergyPlus underpredicted total heating load due to the heat loss through envelope by 3%. This difference is within the uncertainty of the measurements.

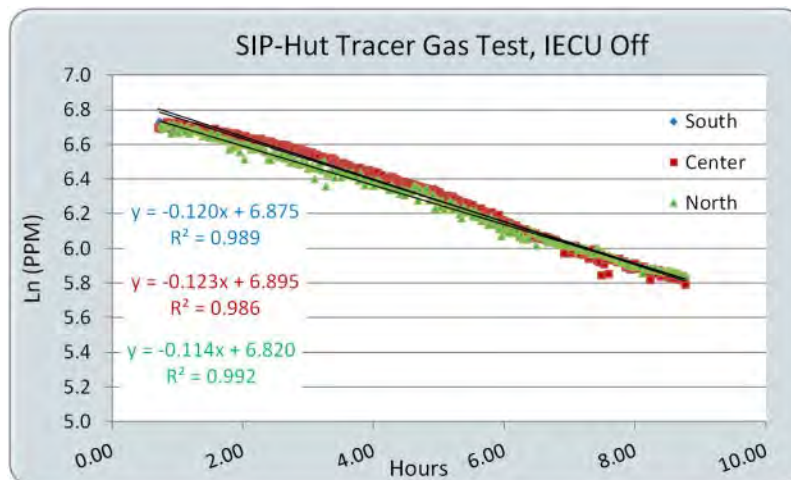
Figure 4-15. SIP hut tracer gas test result when IECU was turned off.

After releasing the tracer gas and achieving a well mixed condition, a LumaSense multipoint sampler was used to sample air from the north, center, and south sides of the hut. An Innova 1412 photoacoustic field gas monitor was used to measure the concentration of the tracer gas in the air. Figure 4-15 shows the results when the IECU was off and Figure 4-16 shows the result when the IECU was on. These plots use the natural log of tracer gas concentration in the Y-axis, and time elapsed in hours in the X-axis. The slope of the linear regression lines in these plots, multiplied by -1, gives the air changes per hour (ACH). As seen from these two figures, the air in the hut was well mixed given that concentrations from the three sampled locations were similar. When the IECU was off, the average air leakage rate was 0.119 ACH. When the unit was running, the average leakage rate increased significantly to 0.828 ACH.

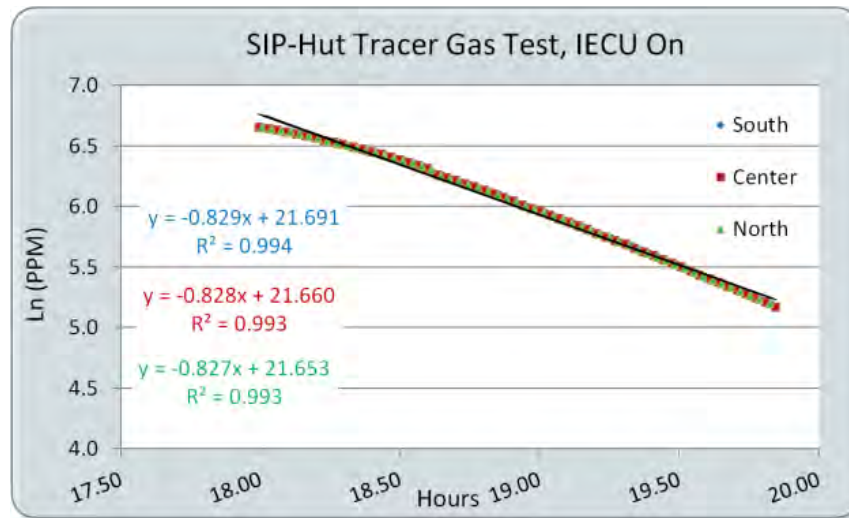
Figure 4-16. SIP hut tracer gas test result when IECU was turned on.

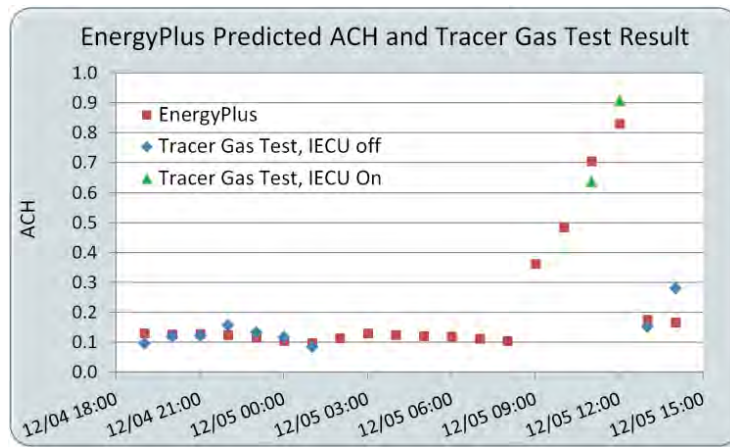
Figure 4-18. EnergyPlus-predicted ACH (after adjusting blower door test result) and tracer gas test result.

Figure 4-17 shows EnergyPlus-predicted ACH against the tracer gas test results with the IECU on and off. The blower door test results in Table 4-3 were used in EnergyPlus in these simulations. Results from simulation results match well with those from the tracer gas test when the IECU was off. However, when the IECU was on, ACH measured with tracer the gas test was 4.4 times higher than those obtained through EnergyPlus. The increase in ACH is potentially due to two main reasons: (1) the IECU changes the building pressure causing higher air change rate, and (2) a leaky flexible duct connecting the hut and the IECU. The slightly higher ACH from the tracer gas test during the last hour shown in Figure 4-17 was caused by the fact that the door was frequently opened during this period. The tracer gas test was interrupted at ~1:00 a.m. on 5 December due to a power supply loss and it resumed the next day at ~10:00 a.m. after restarting the generator.

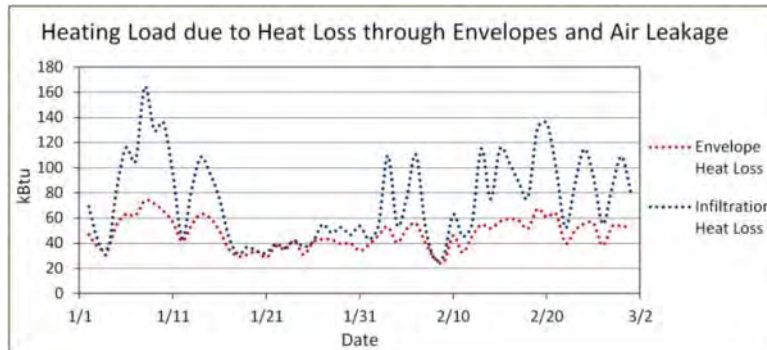
Figure 4-19. EnergyPlus-predicted daily heating load due to heat loss through envelope and due to air leakage.

Figure 4-19 shows the EnergyPlus-predicted daily heating load due to heat loss through envelope (also shown in Figure 4-14) and due to air leakage. For the SIP hut, the magnitude of the heat loss associated with heat flow through the envelope and air leakage, which are the two main contributors to heating loads, are comparable during calm conditions. Overall, heat loss due to infiltration was 35% greater than that from heat loss through envelope.

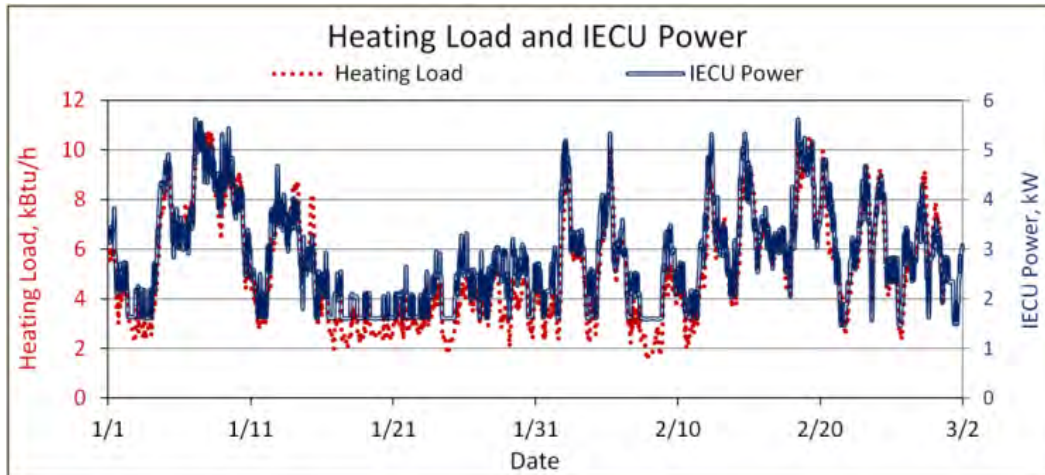
Figure 4-20. EnergyPlus-predicted heating load and IECU power for SIP hut.

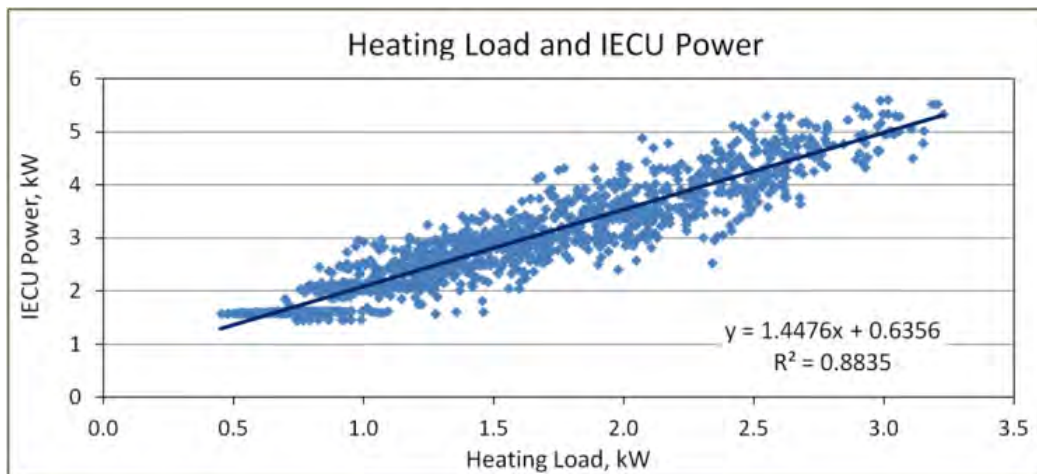
Figure 4-21. Correlation between EnergyPlus-predicted heating load and IECU power for SIP hut.

Figure 4-21 shows the correlation between the IECU energy use and the EnergyPlus calculated heating load. The linear regression equation allows the

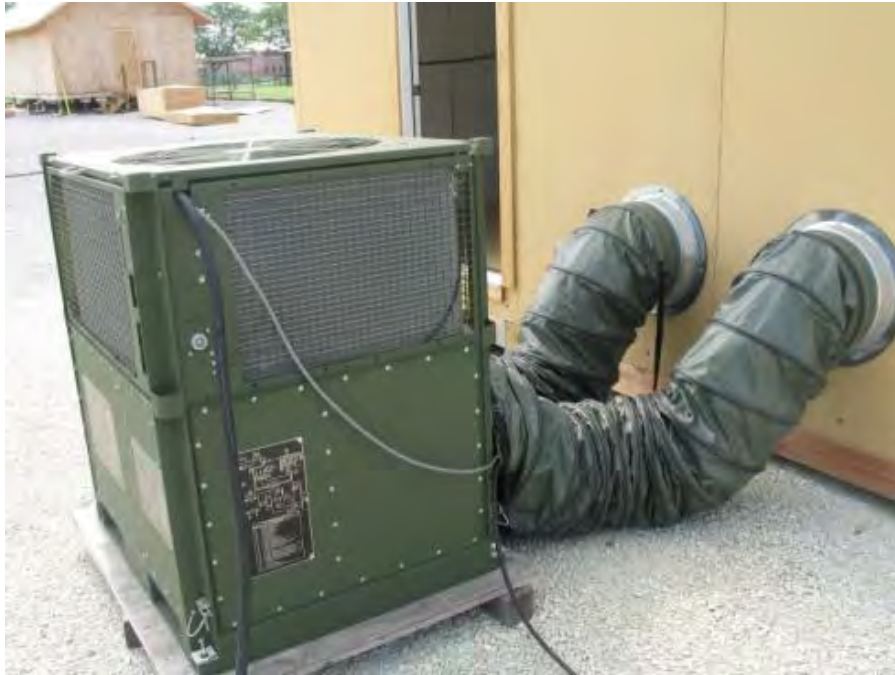
Figure 4-22. IECU serving the SIP hut and the flexible ducts used as supply and return ducts.

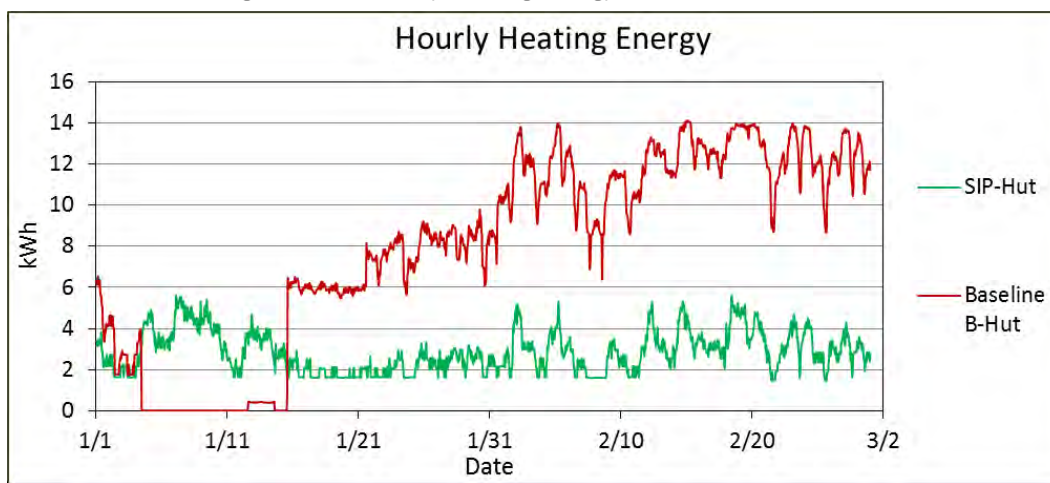
Figure 4-23. Hourly heating energy use in the test huts.

Figure 4-23 shows hourly heating energy use and Figure 4-24 shows indoor air temperature in the two huts. IECUs at the two EFOB-L B-huts were tripped during part of the first half of January 2015, which explains the missing data in these figures. Figure 4-25 shows the weekly average of the hourly heating energy for when the IECUs were operating in both huts. Indoor air temperature swing in the baseline B-hut was much more variable than that of the SIP hut during the monitoring period.

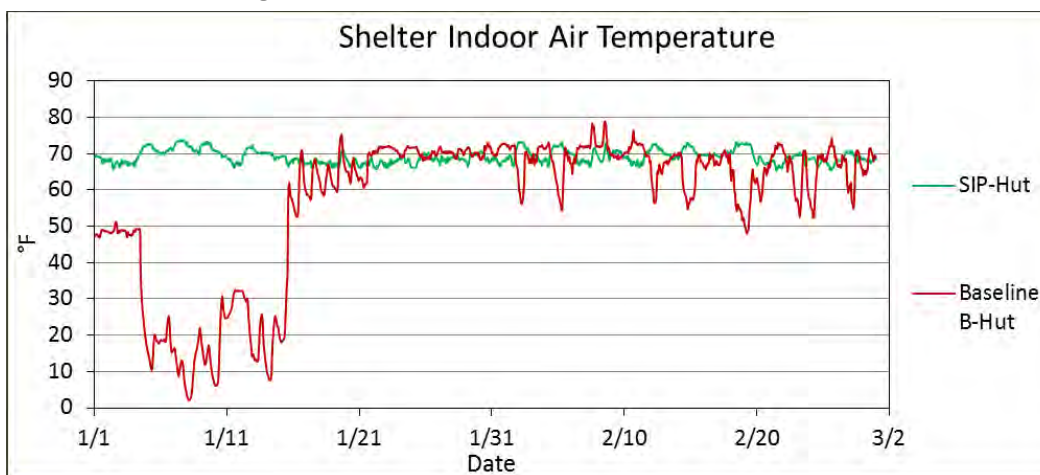
Figure 4-24. Indoor air temperature in the test huts.

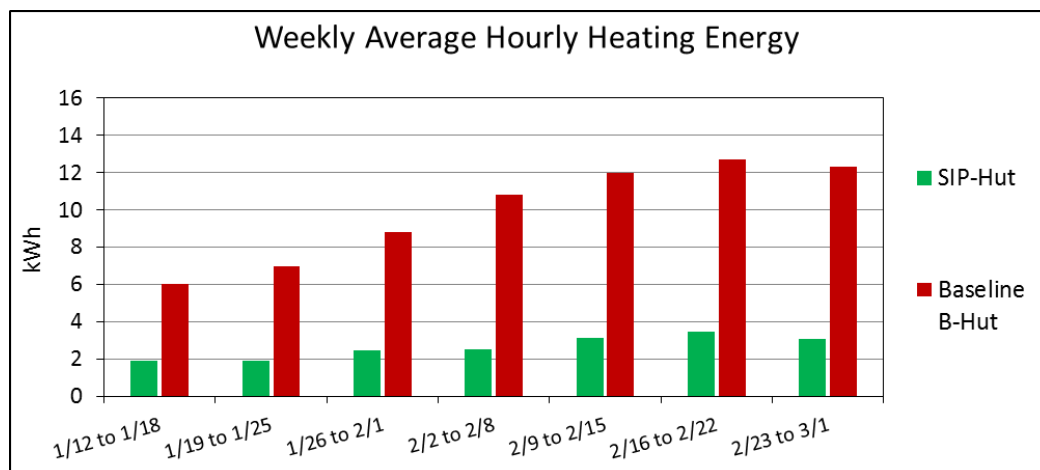
Figure 4-25. Weekly average of hourly heating energy, unadjusted for indoor air temperature.

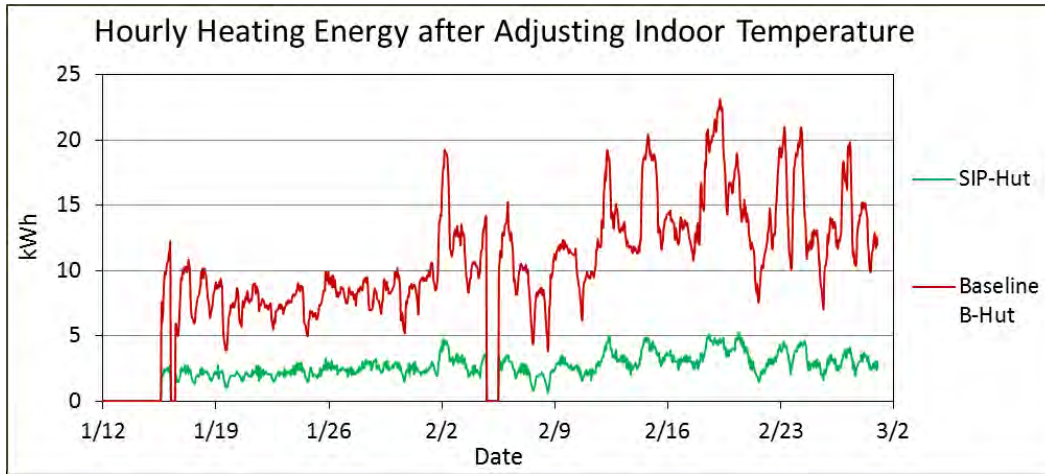
Figure 4-26. Hourly heating energy after adjusting indoor air temperature to 70 °F.

To estimate the heating energy use in each hut as if they were maintained at 70 °F, a fixed indoor air temperature of 70 °F was set in EnergyPlus and the simulations were rerun. Correction factors were calculated as ratios between EnergyPlus-predicted heating load when the indoor air temperature was set at 70 °F and when the measured indoor air temperature from each hut was used in EnergyPlus. Multiplying the measured IECU hourly energy use from each hut by these correction factors gives heating energy demand if the indoor air temperature was maintained at 70 °F. Figure 4-26 shows the hourly heating energy, Figure 4-27 shows the weekly average of the hourly heating energy, and Table 4-5 lists the average and maximum hourly heating energy after adjusting the indoor air temperature to 70°F for periods of time when the IECUs were on in both huts.

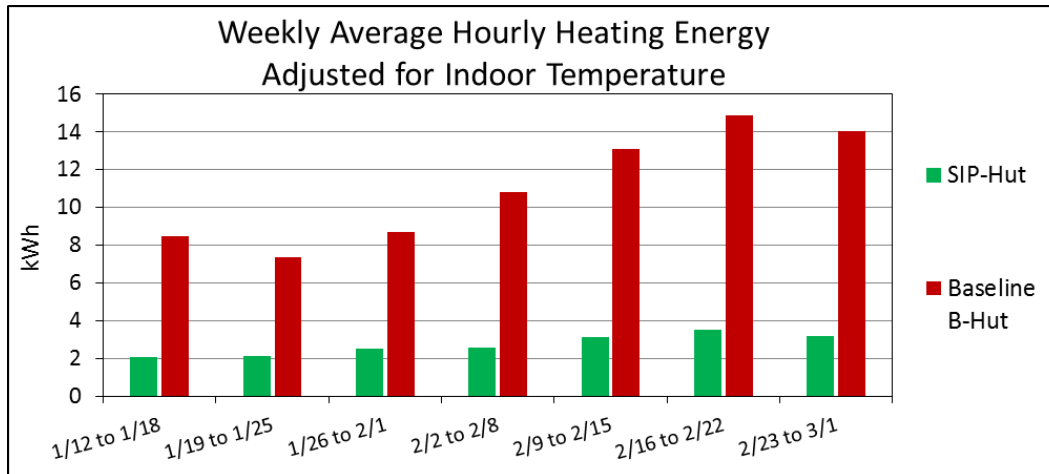
Figure 4-27. Weekly average of hourly heating energy, after adjusting indoor air temperature.

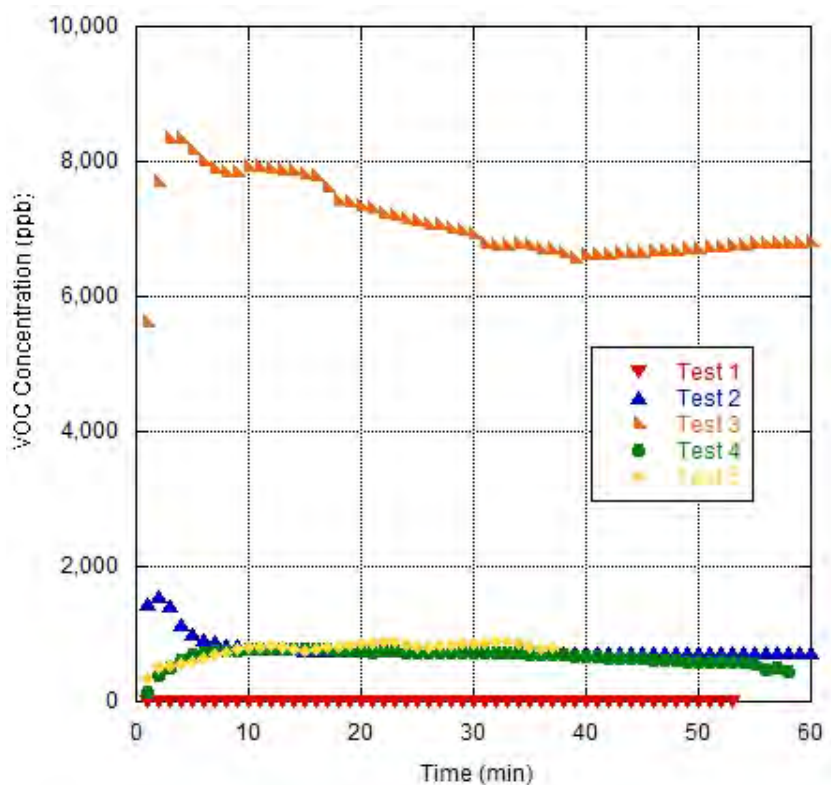
Figure 5-4. Total VOCs inside ERDC-CERL SIP hut during May 2014 IAQ study.

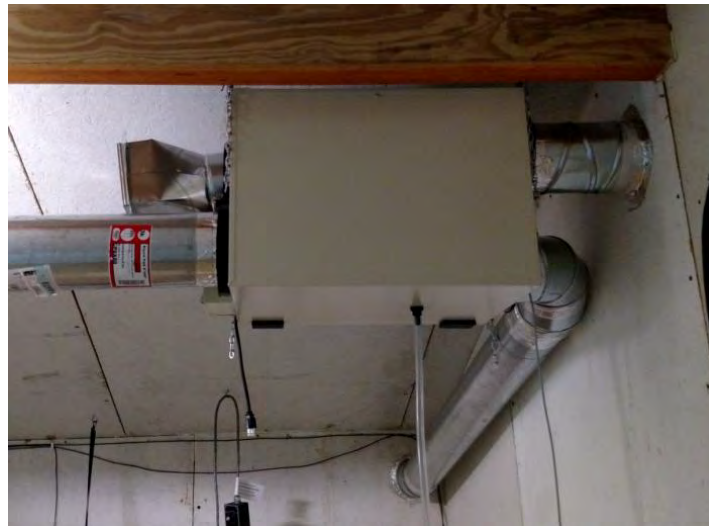
Figure 5-5. Fantech SHR 1504 heat recover ventilator installed in ERDC-CERL SIP hut.

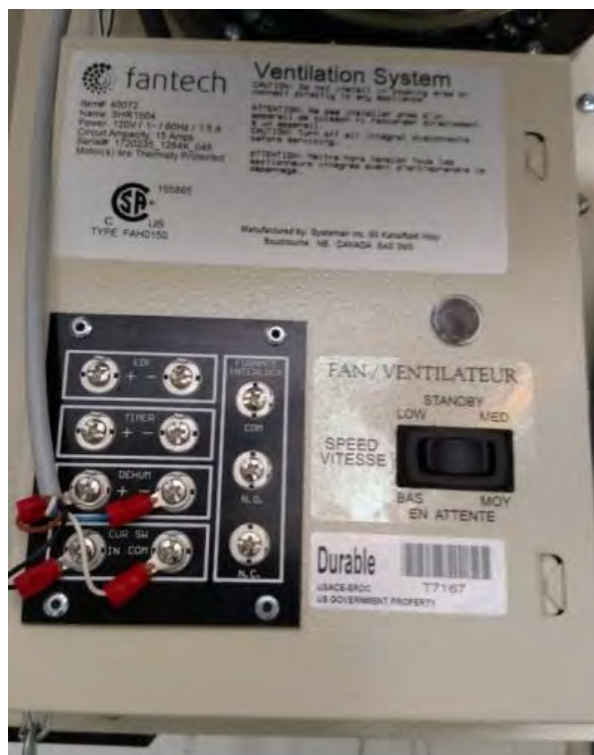
Figure 5-6. Fantech SHR 1504 HRV electrical panel.

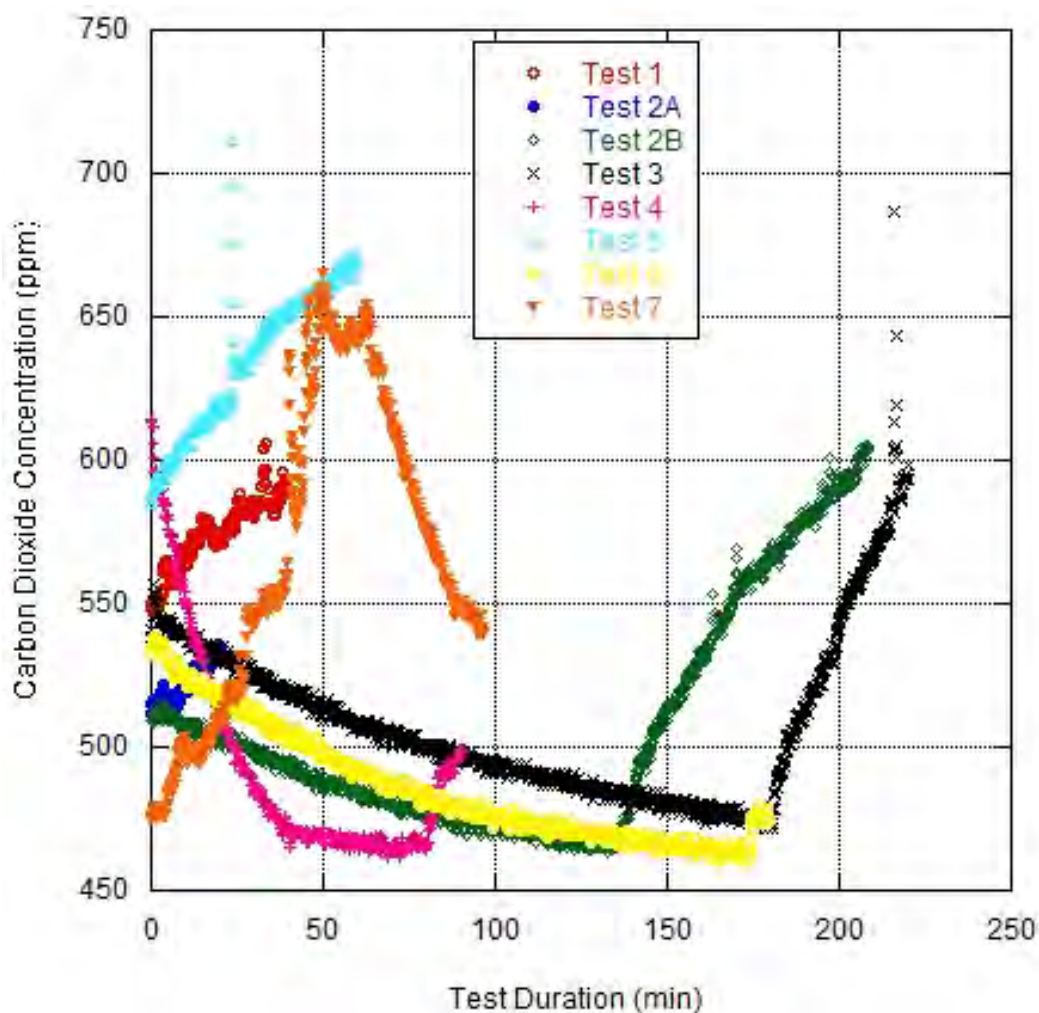
Figure 5-7. Carbon Dioxide Concentration inside ERDC-CERL SIP hut during March 2015 IAQ study.

The background CO<sub>2</sub> concentration (outside) was about 470 ppm as measured by the monitor. Most of the tests start at an elevated CO<sub>2</sub> level because the operator was in the hut performing test preparation before the start. The operator was positioned approximately 5 ft away from the sensor during the tests, with occasional movements to check on readings and equipment. According to the Illinois Department of Public Health, a CO<sub>2</sub> concentration above 1000 ppm is an indication of poor ventilation.\* Given the trends shown in Figure 5-7, it appears that that concentration could be reached in a number of hours, and most probably in a much shorter time
