## The Structural Insulated Panel “SIP Hut”

Preliminary Evaluation of Energy Efficiency and Indoor Air Quality

August 2015

### **Final Report**

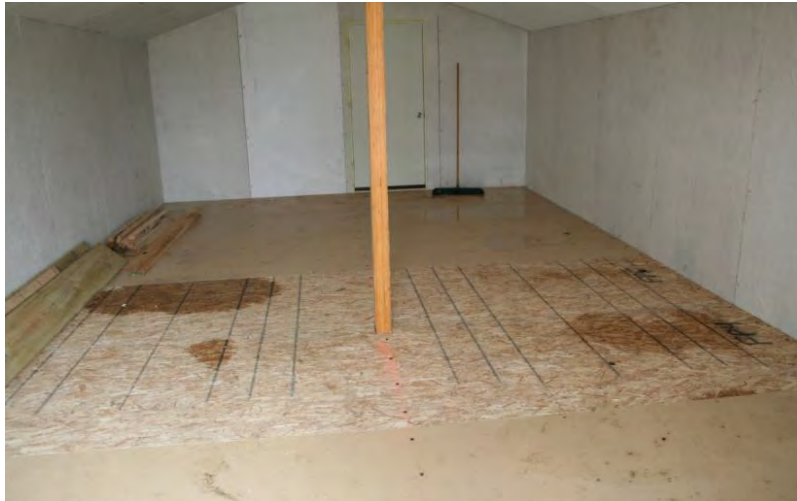
Figure 6-1. Standing water in SIP hut (14 March 2014).

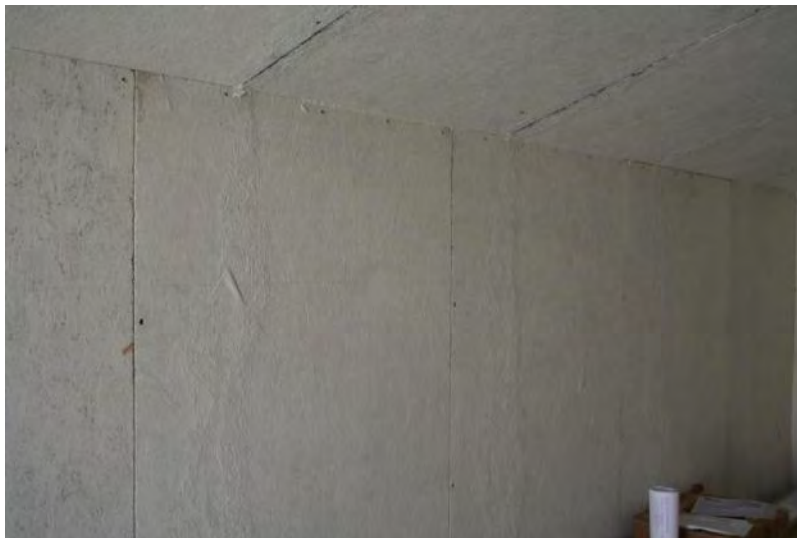
Figure 6-2. Water soaked into OSB panels from leakage (14 March 2014).

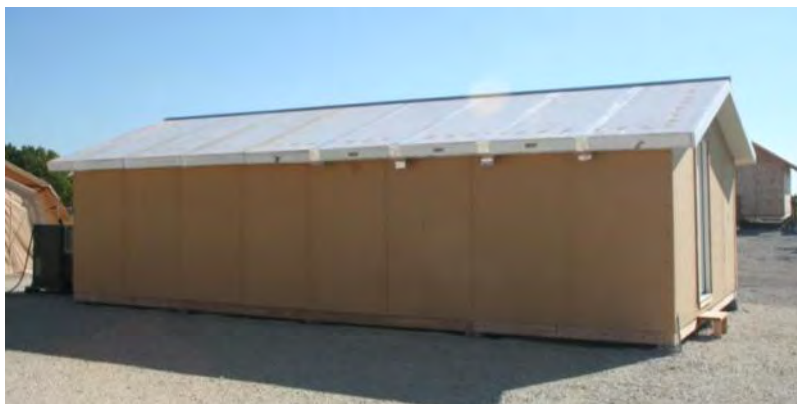
Figure 6-3. SIP hut with sealant (left half) and roofing tape (right half).

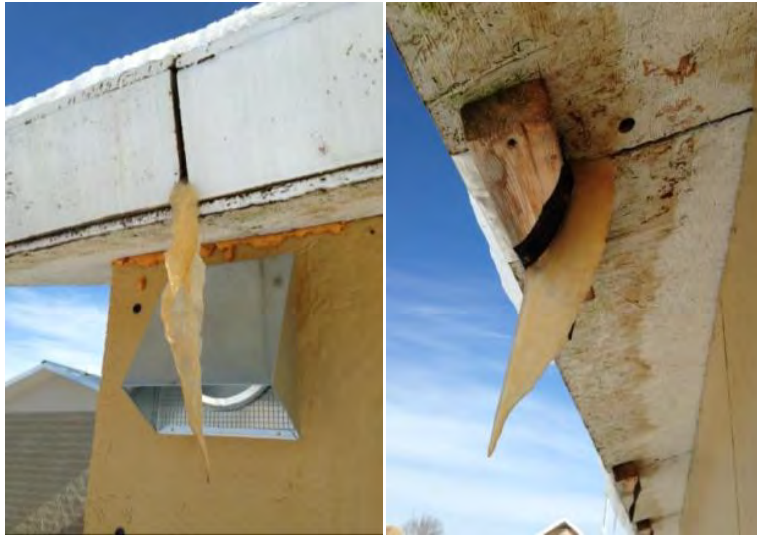
Figure 6-4. Icicles on seams with sealant (left) and tape (right).

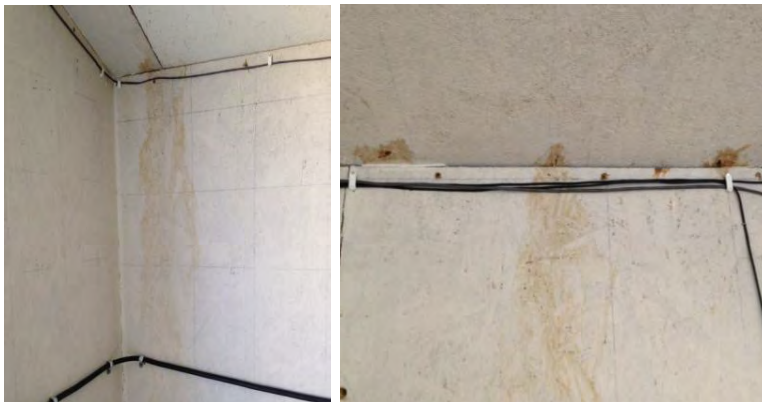
Figure 6-5. Staining on walls from water infiltration.

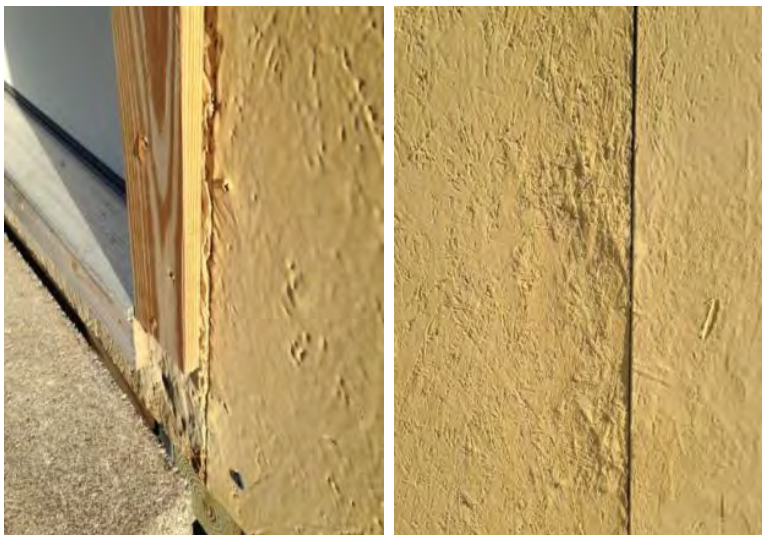
Figure 6-6. Separation of OSB strands in SIP hut panels.

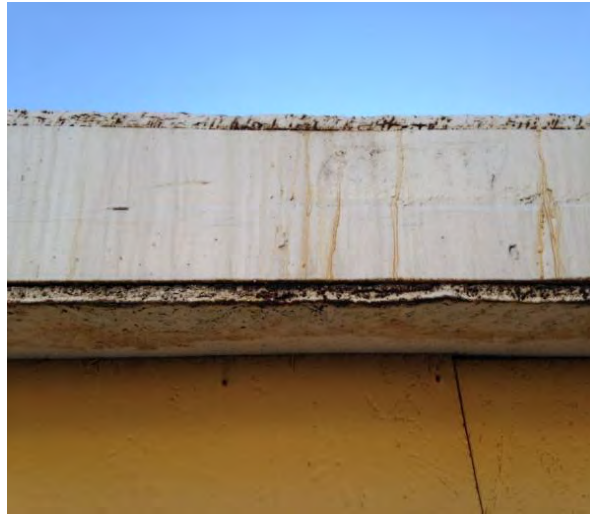
Figure 6-7 shows deterioration of the edges of the SIP's OSB panels on the fascia of the roof eave. Some separation of the exterior coating is also visible on the bottom side of the SIP's OSB panel. A temporary solution is to apply wide high-performance sealing tape (Figure 6-8) over the fascia surface to cover the edge seams of the SIPs to prevent water intrusion. This type of tape, while very durable and UV-resistant, cannot be exposed to the atmosphere indefinitely and should be covered by flashing when the metal roof is installed. Performing these added steps of roof protection will of course increase the SIP hut construction time, and require additional carpentry skills.

Figure 6-7. Deterioration of the edges of the SIP OSB panels on roof eave fascia.

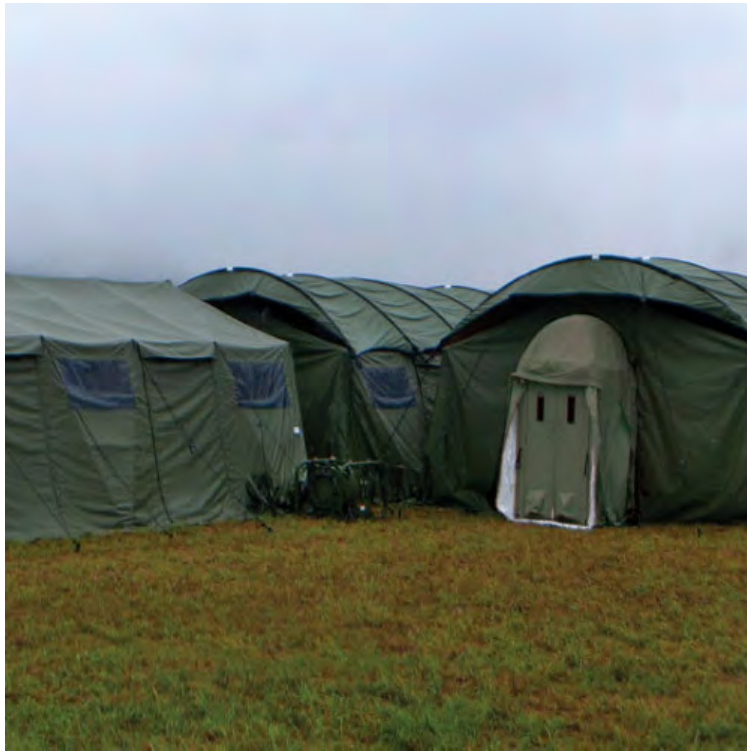
Figure 7-1. Currently available HDT Global Inc. COLPRO System (XCP100) using tactical soft wall shelters and airlocks (<http://www.hdtglobal.com/series/integrated-colpro-systems/>).

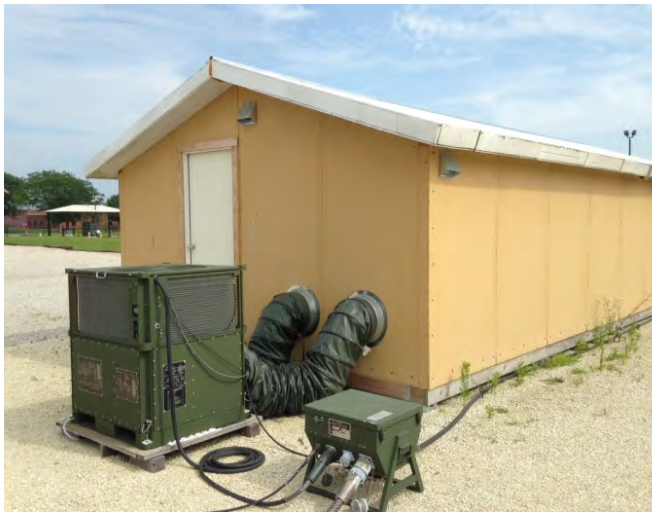
Figure 7-2. Integrated protection of SIP hut.
