*Environmental Security Technology Certification Program (ESTCP)*

## **Kinetic Super-Resolution Long-Wave Infrared (KSR LWIR) Thermography Diagnostic for Building Envelopes**

Scott AFB, IL

Final Report

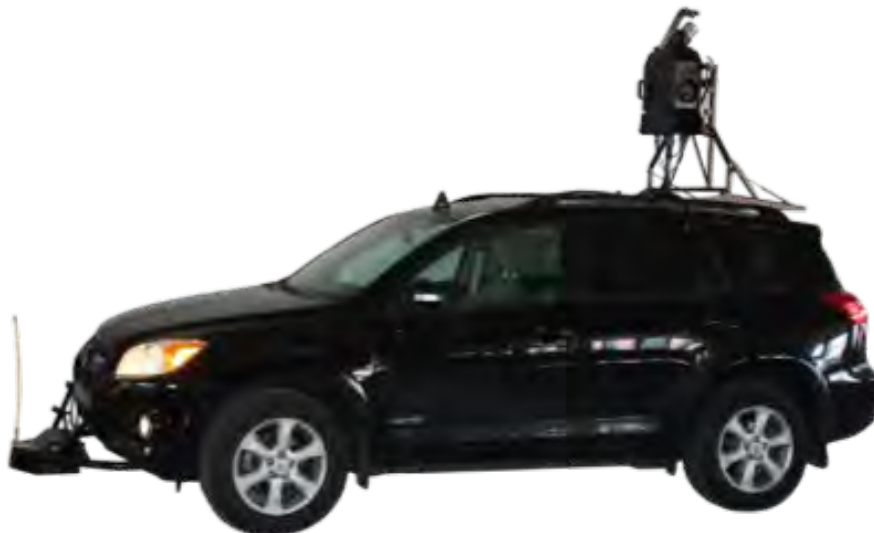
Figure 1. Specially equipped Essess scanning vehicle.

Combined, these hardware and software capabilities constitute a highly effective way to capture heat loss and building envelope data via drive-by thermal imaging (Figure 1). Each camera captures data in a video format, meaning that the drive-by system generates hundreds of thousands of images comprising over 2 terabytes of data each night. The LIDAR sensors (Figure 2) enable the system to generate a 3D map of the physical environment and map buildings to parcels in a highly accurate manner. The proprietary hardware and software configuration enables the system to capture vast amounts of data and subsequently process that data in a very efficient and automated manner.

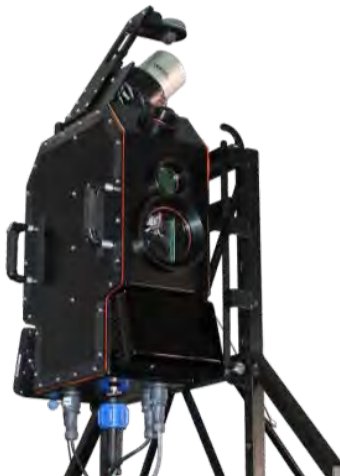
Figure 2. Contractor-developed scanning rig including GPS, long-wave infrared, near infrared and LIDAR instrumentation.

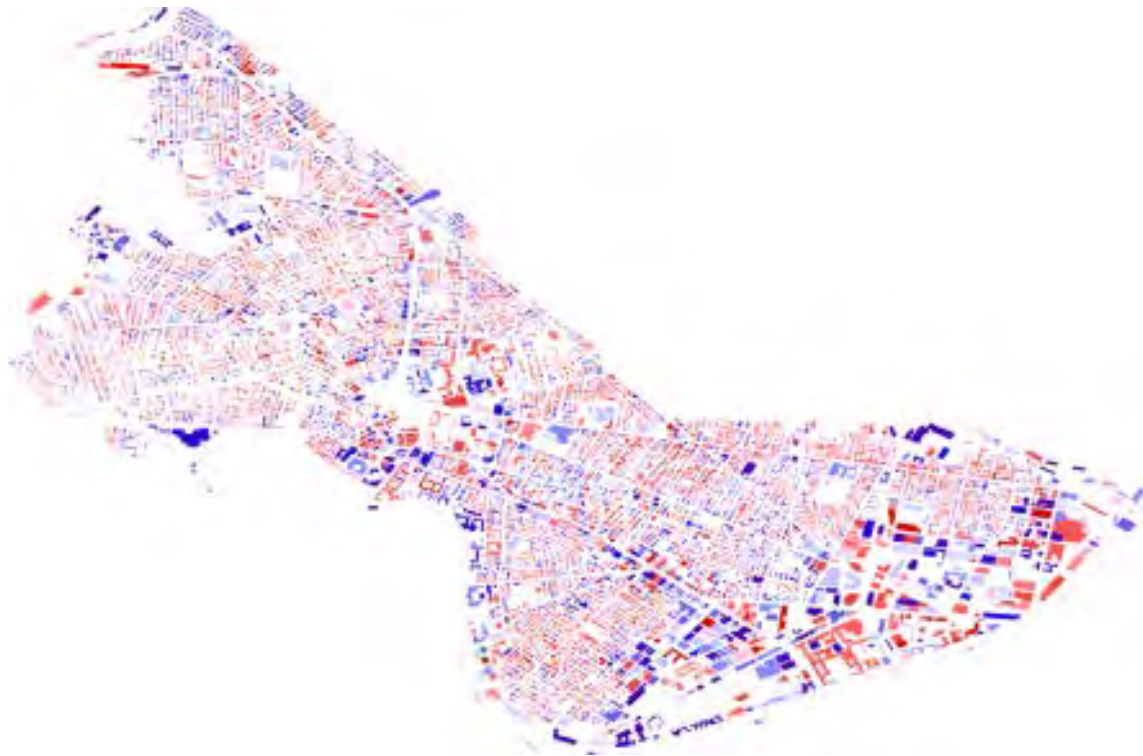
- *Anecdotal Observations.* The heat map of thermal imaging data collected from Cambridge, MA, (Figure 3) shows a distribution of blue (efficient building envelopes) and red (inefficient building envelopes) buildings. In certain cases buildings of similar vintage, square footage, location, and style have very different envelopes in terms of energy efficiency. This suggests that there are numerous instances where thermal imaging data may very well be the main differentiating factor in determining building envelope quality between two otherwise similar structures, even for cases where only one side of the building is visible from the street.

Figure 3. Building envelope efficiency map of over 17,000 buildings in Cambridge, MA.

The practical applications of high-throughput thermal imaging were researched and studied for multiple years before a prototype was built. The first imaging rig was tested in Cambridge, MA, and the data were analyzed to create a heat map overview of the city as shown in Figure 3. The rapid scanning methodology and processing of imaging data were also demonstrated at Fort Drum, NY in February 2011.

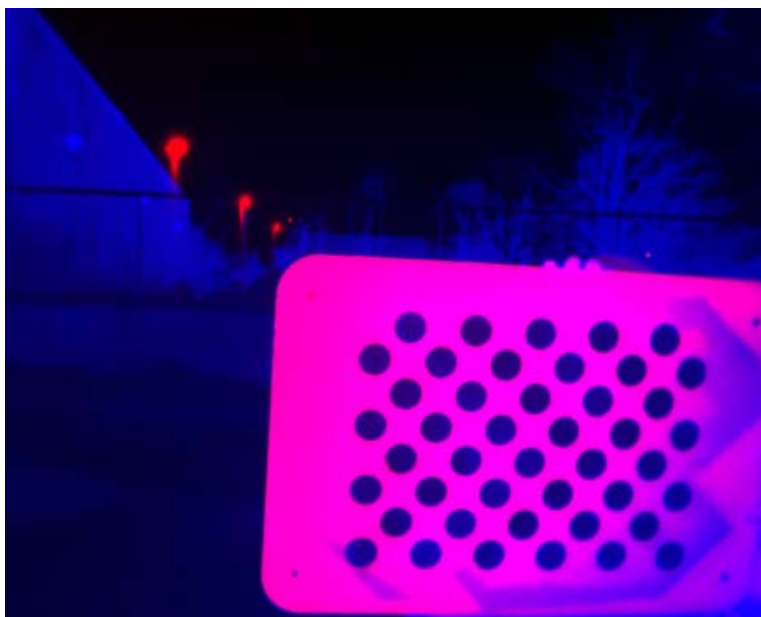
Figure 15. LWIR camera calibration device.

The field engineer used an asymmetric circle calibration grid to optically calibrate the long-wave infrared cameras according to industry best practices (Figure 15) The thermal calibration was conducted using a black body radiation source at Essess headquarters.

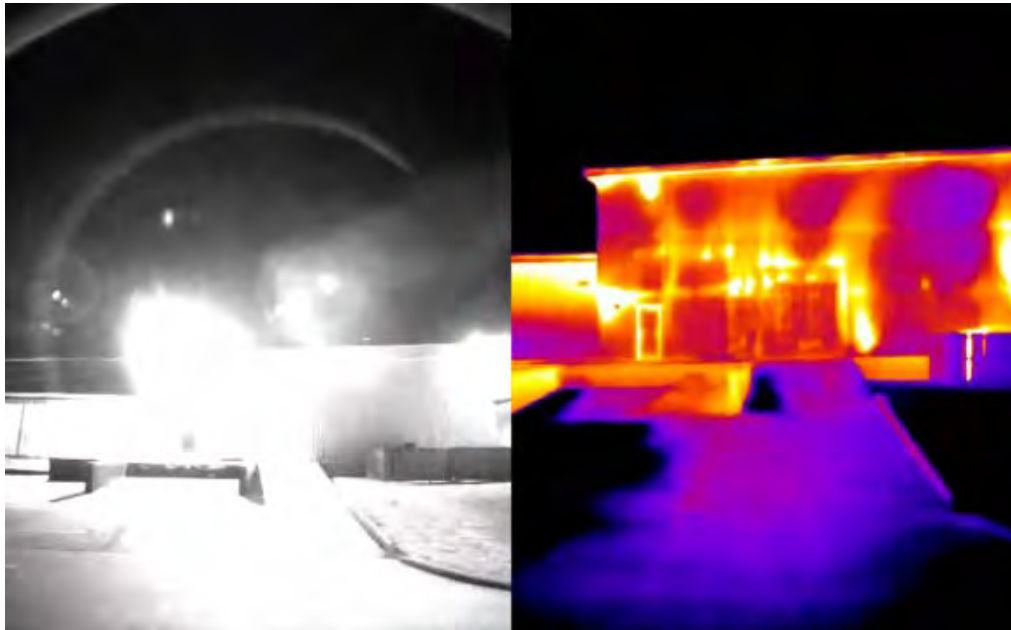
Figure 26. Rearview of Bldg 1961, Scott AFB.

The back of the building around timestamp 43:31 is particularly emissive, with large amounts of heat leaking out. The wall has apparent insulation issues (Figure 27).

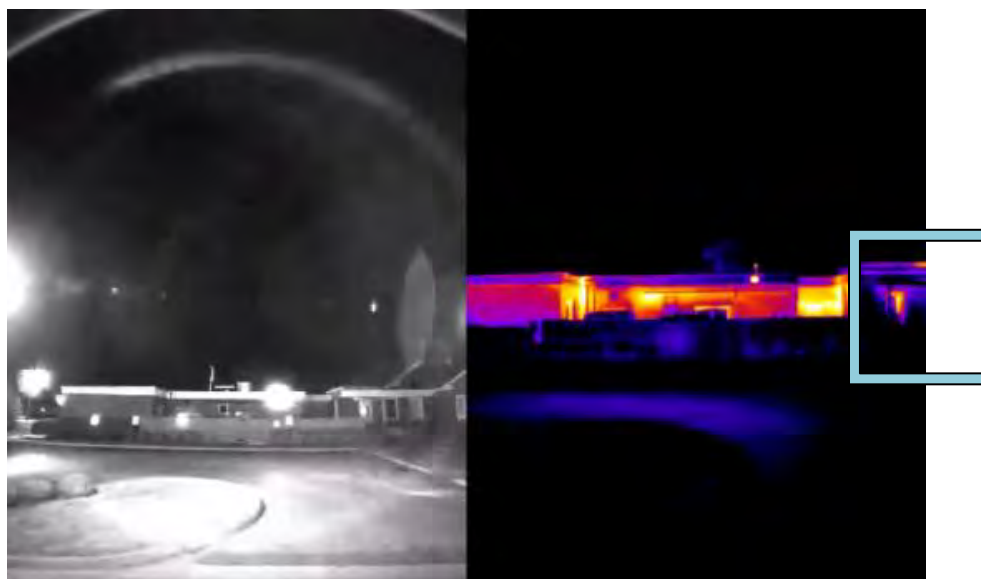
Figure D-3. NIR image (left) and thermal image (right) of Bldg 5, Scott AFB.

The section of wall at 63:02 in the Drive-by Application (Figure D-3, center of the right picture above as outlined by the blue rectangle) has a notable warm spot that does not correspond with any differentiable feature in the near IR. This may indicate a poorly insulated part of the brick wall, and may be worth investigating further.

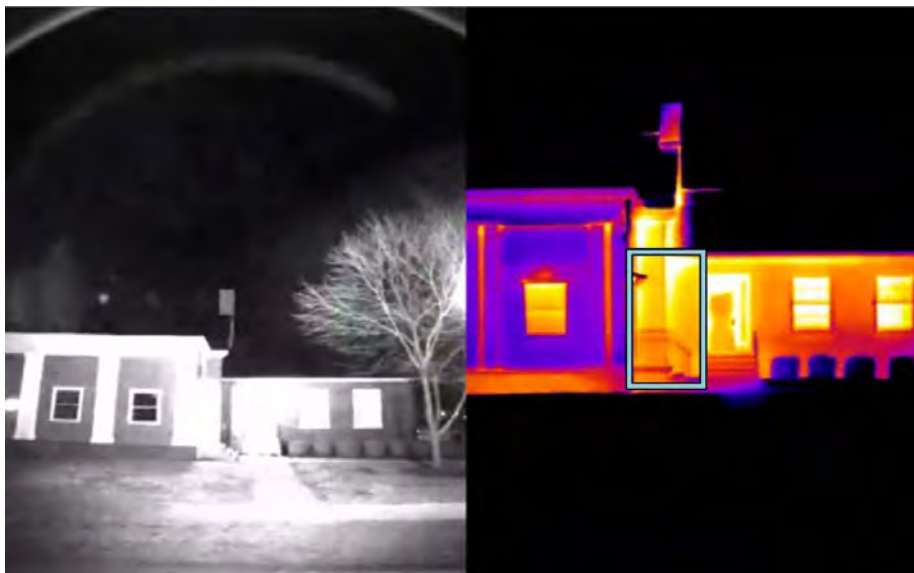
roof meets the wall) also appears abnormally warm. These areas should be investigated further and addressed immediately.

Figure D-4. NIR image (left) and thermal image (right) of Bldg 5, Scott AFB. Highly emissive door frame shown in polygon at the right.

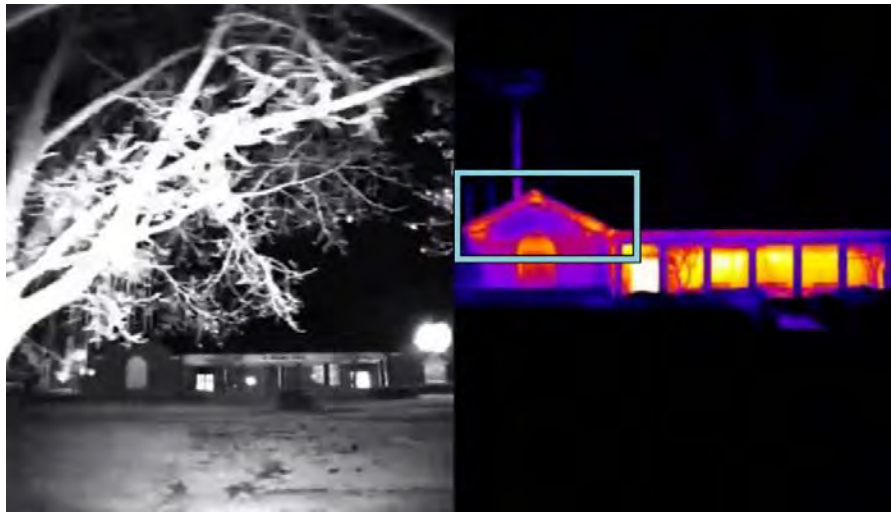
The soffit (where the wall meets the roof) at 198:33 in the Drive-by Application is notably emissive (Figure D-12). This should be further investigated.

Figure D-12. NIR image (left) and thermal image (right) of Bldg 8, Scott AFB.

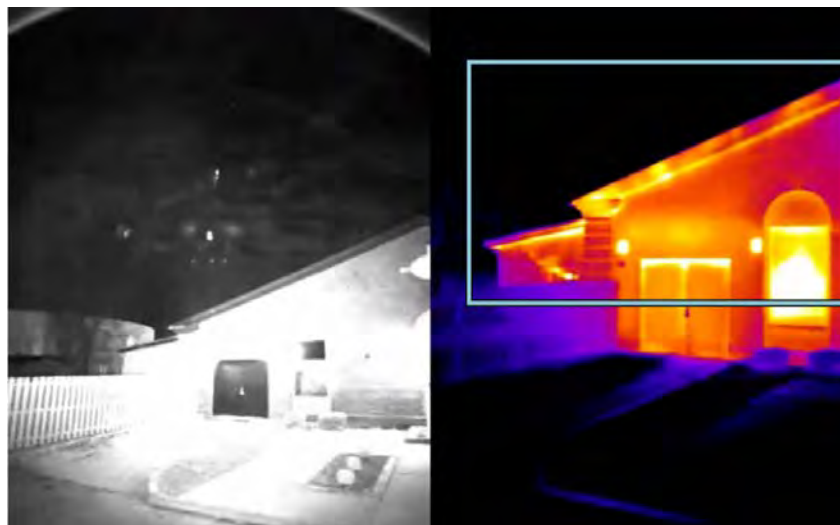
The soffit at 198:44 (Figure D-13) is abnormally emissive. There may be leakage occurring on the wall to the left as well. The area above the door also shows some heat loss, which is most likely caused by poor insulation.

Figure D-13. NIR image (left) and thermal image (right) of Bldg 8, Scott AFB. Note highly emissive area within the rectangle in the right hand image.

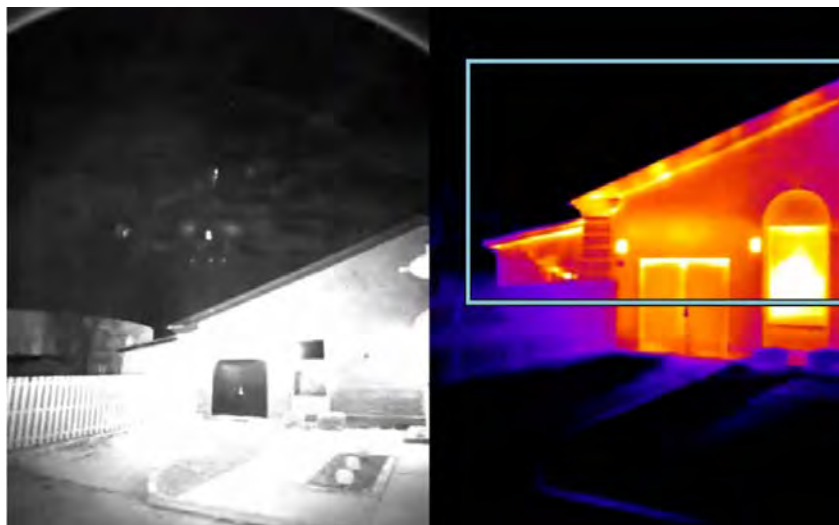
Around the back of the building at timestamp 198:53, there are some patches of poorly insulated wall in addition to the leaky soffit (Figure D-14). There may also be a thermal bridge through the insulation represented by the long horizontal line above the window. The immediate fix for this building involves addressing the soffit leaks.

Figure D-14. NIR image (left) and thermal image (right) of Bldg 8, Scott AFB. Areas of the wall and the soffit appear to exhibit high heat loss.

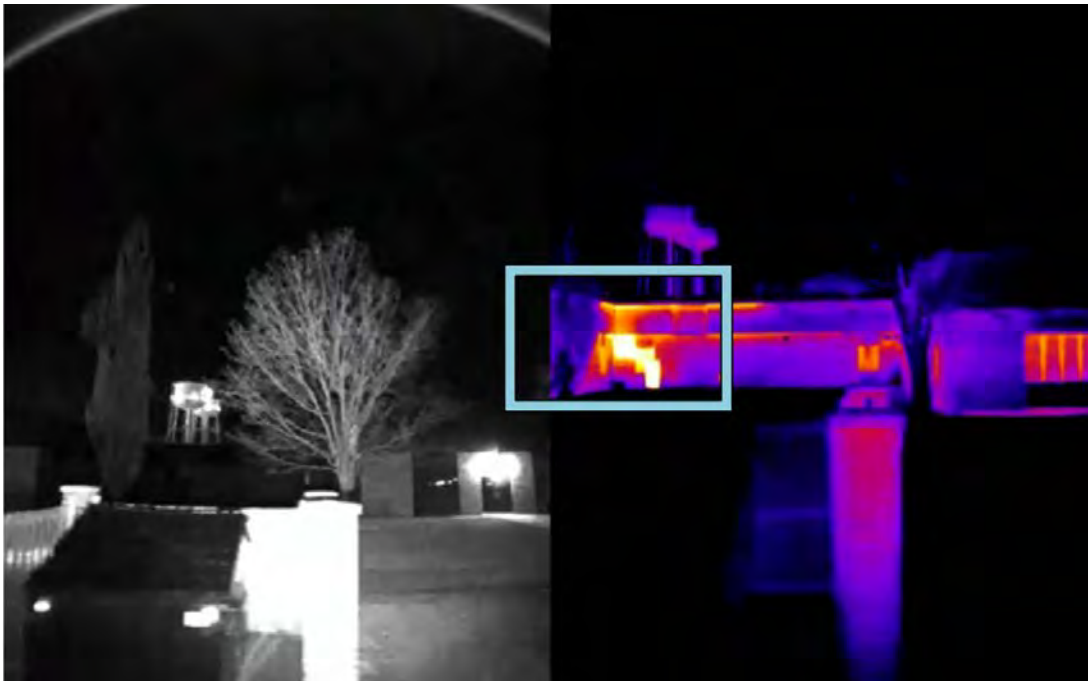
Figure D-19. NIR image (left) and thermal image (right) of Bldg 10, Scott AFB.

There is a particularly emissive patch of wall in the left corner at timestamp 69:25 of the Drive-by Application (Figure D-19). This heat loss captured by the camera system may be caused by poor insulation in the wall. However, this type of signature can also be caused by a piece of equipment generating heat. Given the consistent appearance of the remainder of the building, this area should be further investigated by the base energy manager.

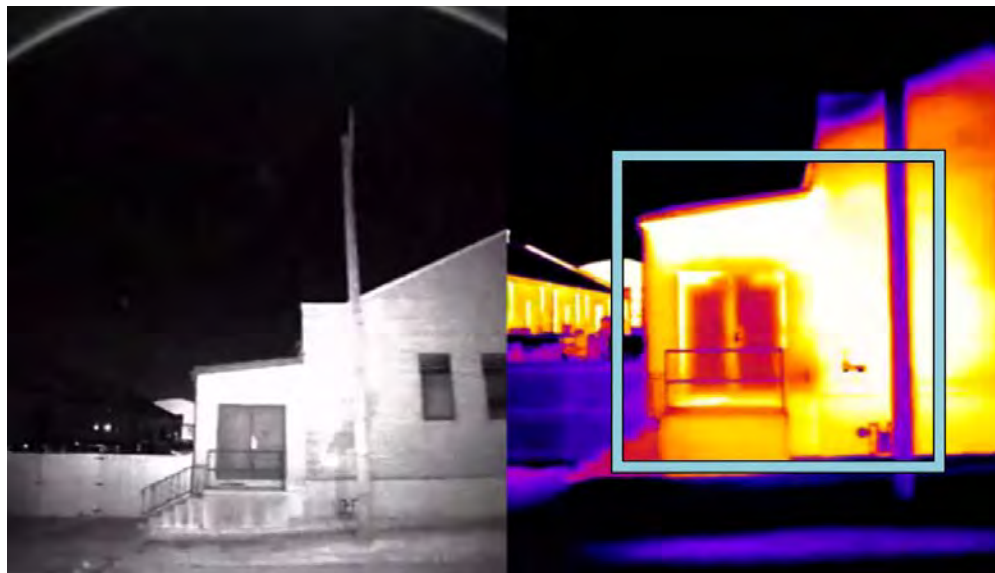
Figure D-27. NIR image (left) and thermal image (right) of Bldg 61, Scott AFB.

The wall surface and door frame around timestamp 71:22 (Figure D-27) are notably emissive. The area of the wall outlined by the rectangle is very poorly insulated.

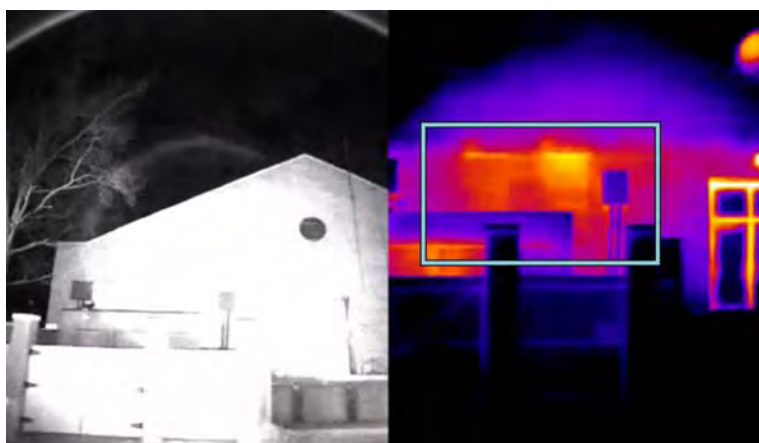
The wall of the attached structure at 71:26 (Figure D-28) is much more emissive than other brick surfaces of the building. In fact, this wall is more emissive than nearly all other emissive brick surfaces across the base. It is likely that the area is missing insulation. There is also a notable insulation hole in the wall at timestamp 71:41, to the left of the electrical box.

Figure D-28. NIR image (left) and thermal image (right) of Bldg 61, Scott AFB. A highly emissive area is shown within the rectangle in the right hand image.

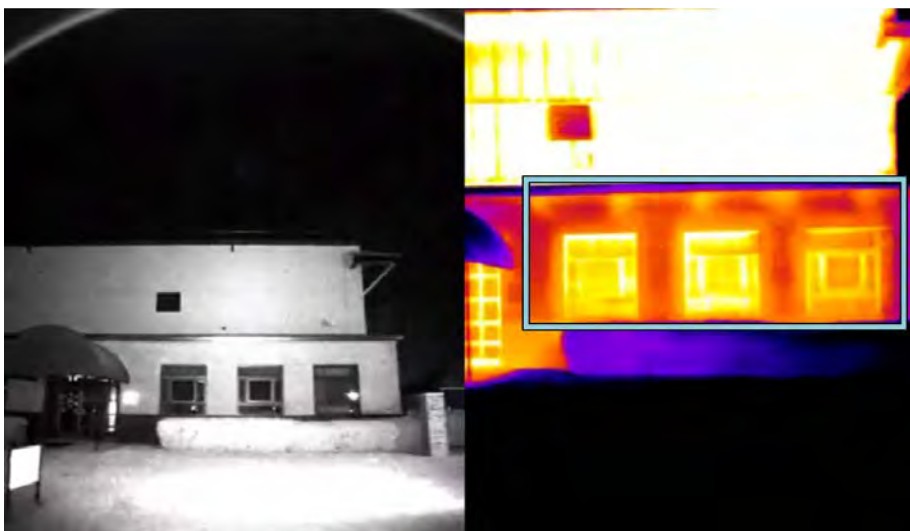
Figure D-33. NIR image (left) and thermal image (right) of Bldg 433, Scott AFB. The window frames appear to be highly emissive.

These insulation holes also appear around timestamp 70:25 (Figure D-33). Additionally, either the walls around the windows are poorly insulated, or abnormal leakage from the windows is heating the walls around them. This should be investigated as the window leakage issue could be solved with simple weather-stripping and caulking.

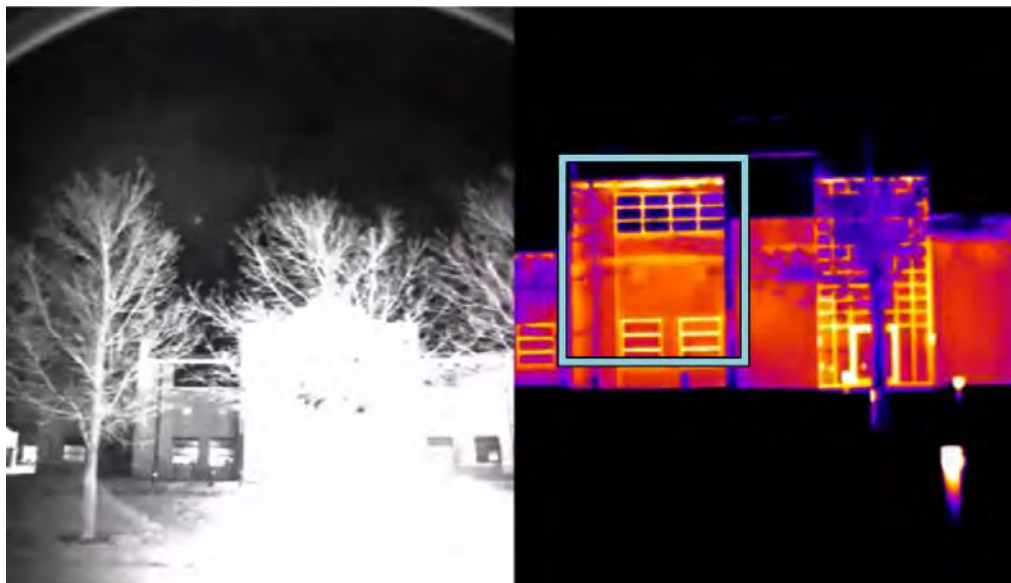
Figure D-37. NIR image (left) and thermal image (right) of Bldg 470, Scott AFB.

The soffit seen at timestamp 68:29 is fairly emissive (Figure D-37). There are also some spots on the walls that may represent insulation holes and there are soffit leaks across the top portion of the area outlined by the polygon.

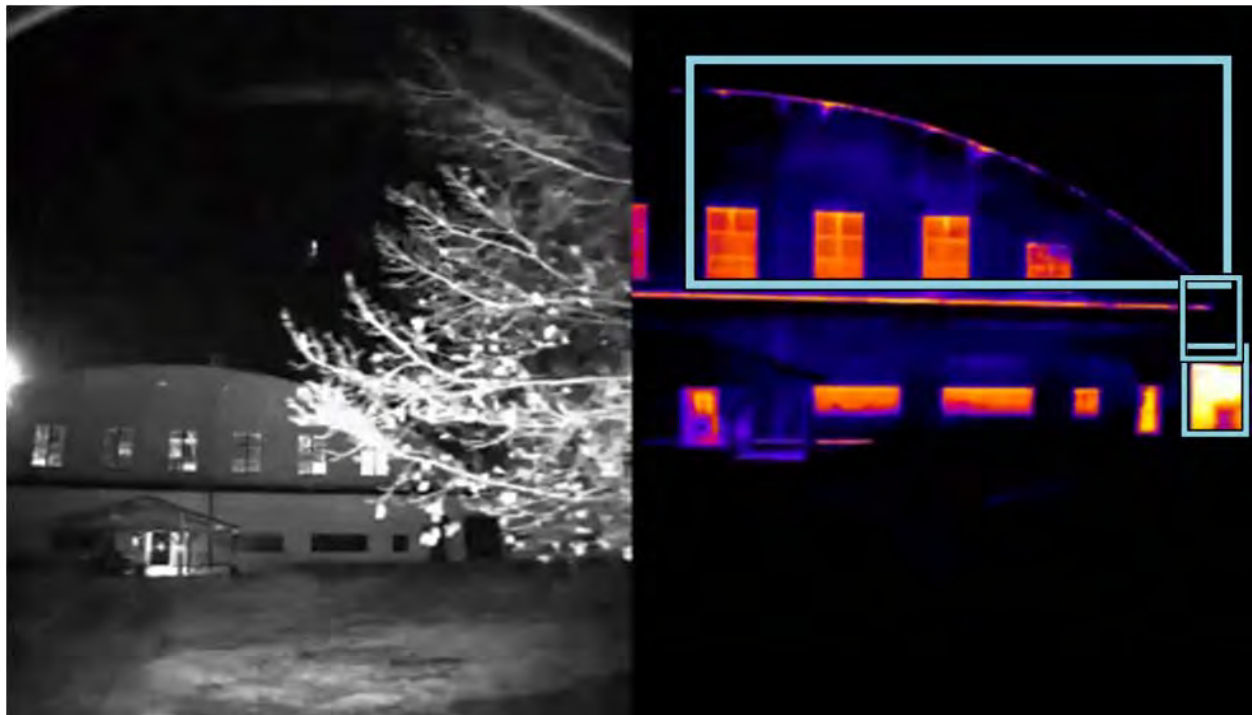
The roofline of Bldg 506 is notably warm, as is the door frame to the right of the image at timestamp 235:20 in the Drive-By Tool (Figure D-42).

Figure D-42. NIR image (left) and thermal image (right) of Bldg 506, Scott AFB. A particularly emissive area is shown in the rectangle to the right.

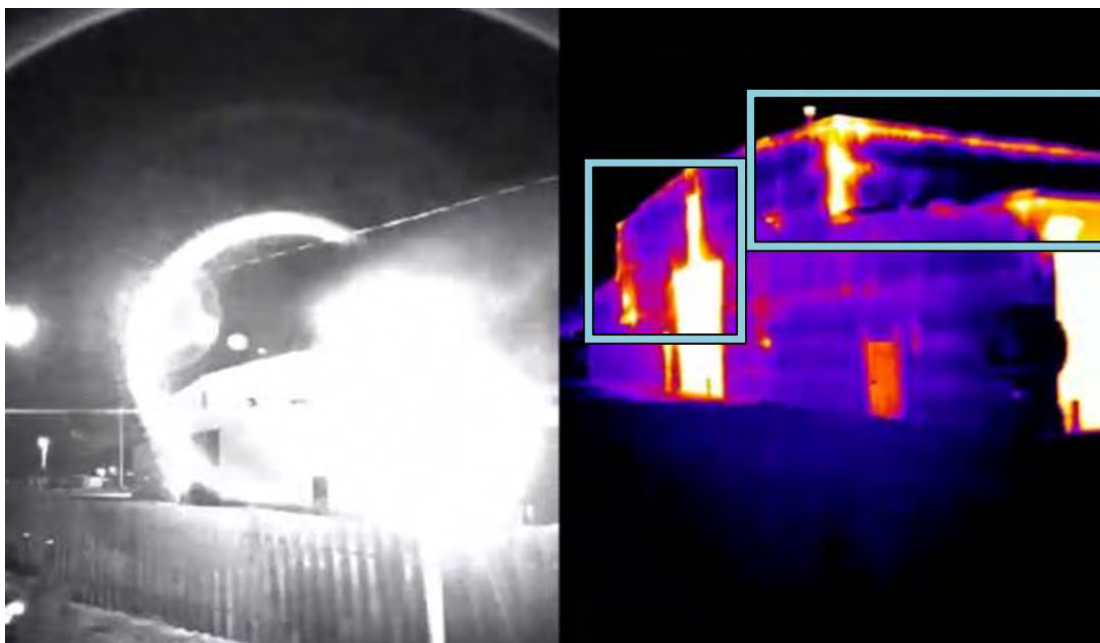
The wall surface at timestamp 75:36 (Figure D-46) has some large, highly emissive patches to the left of the large garage door. The corner of the wall shown in the middle of the image also seems to be poorly insulated.

Figure D-46. NIR image (left) and thermal image (right) of Bldg 548, Scott AFB. The large door, upper corner and soffit areas appear to be thermally inefficient.

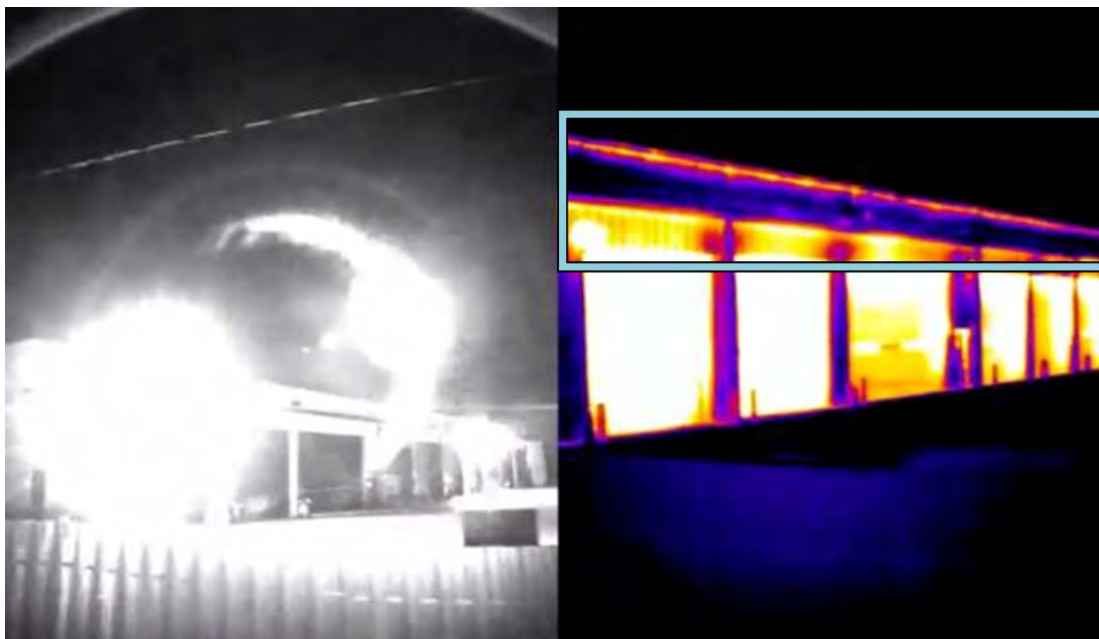
The soffit at the top of the wall at timestamp 75:37 (Figure D-47) is highly emissive. The garage doors themselves are emitting a lot of heat, though this may be difficult to effectively remediate.

Figure D-47. NIR image (left) and thermal image (right) of Bldg 548, Scott AFB. The garage doors and soffit areas appear to be thermally inefficient.

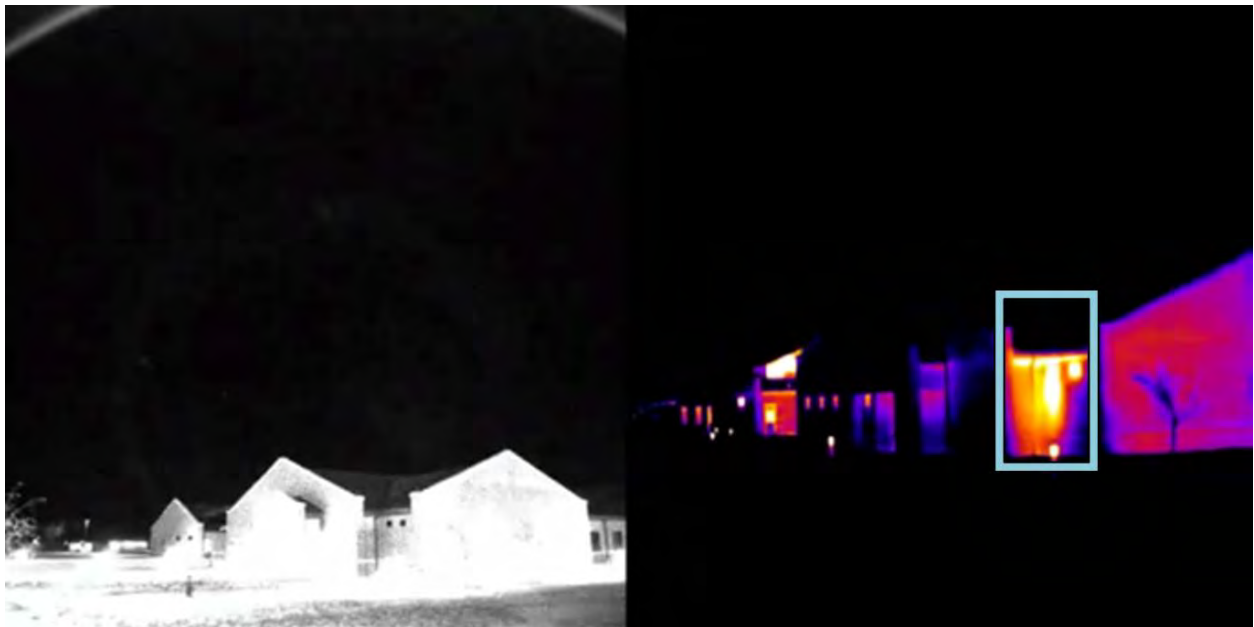
There is a suspicious hotspot in the corner of the wall around timestamp 89:07 that may indicate a poorly insulated location (Figure D-58).

Figure D-58. NIR image (left) and thermal image (right) of Bldg 755, Scott AFB. A particularly emissive area is in the rectangle at the right.

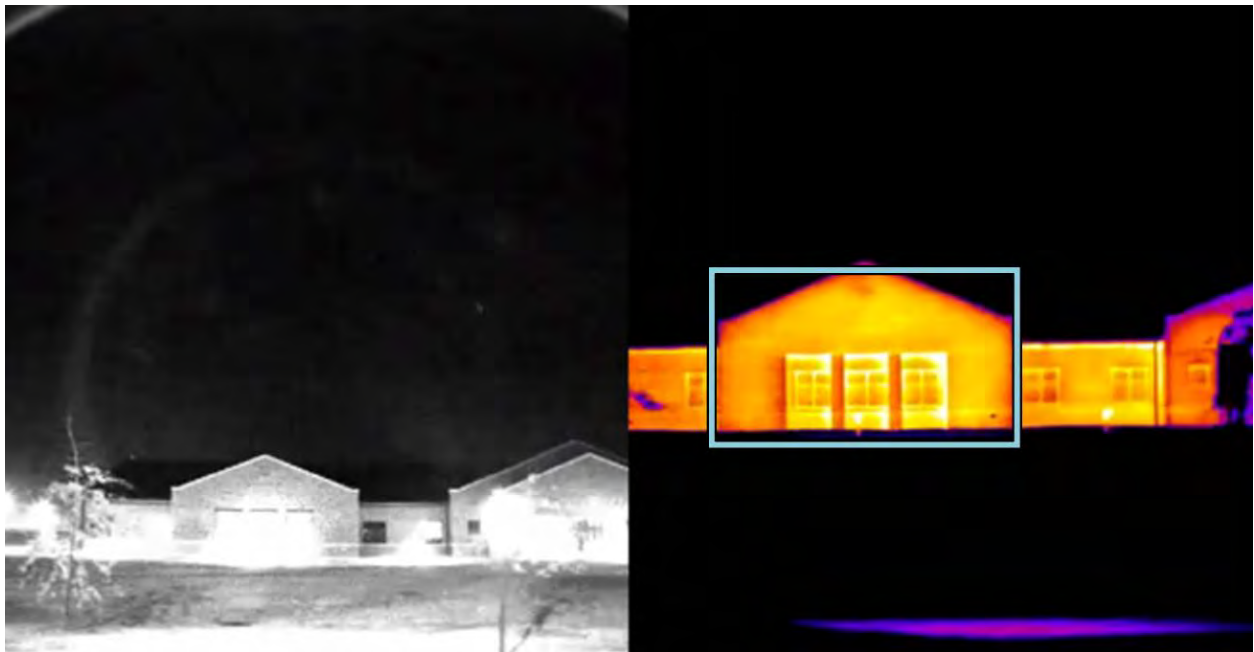
The wall around timestamp 89:34 is also highly emissive, with particular bright spots along window frames in the middle of the image (Figure D-60).

Figure D-60. NIR image (left) and thermal image (right) of Bldg 755, Scott AFB. The window frames appear to be particularly emissive.

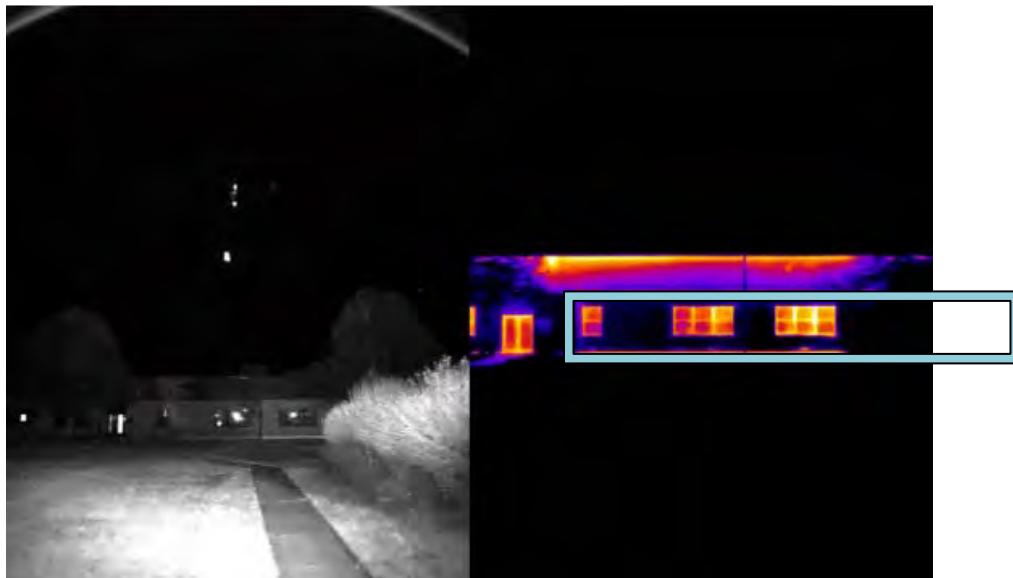
The roof at timestamp 223:10 is losing significant energy when compared to the rest of the building (Figure D-64).

Figure D-64. NIR image (left) and thermal image (right) of Bldg 861, Scott AFB. Significant heat loss appears to be shown at the roof line.

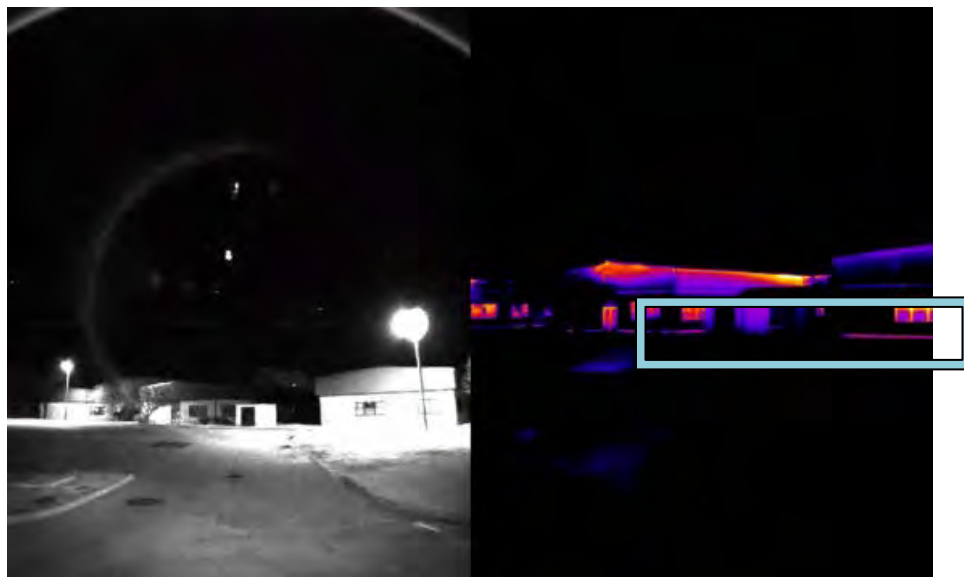
The roof at timestamp 223:25 is also notably emissive while the rest of the building is not particularly emissive (Figure D-65).

Figure D-65. NIR image (left) and thermal image (right) of Bldg 861, Scott AFB. Another view of apparent heat loss at the roof line.

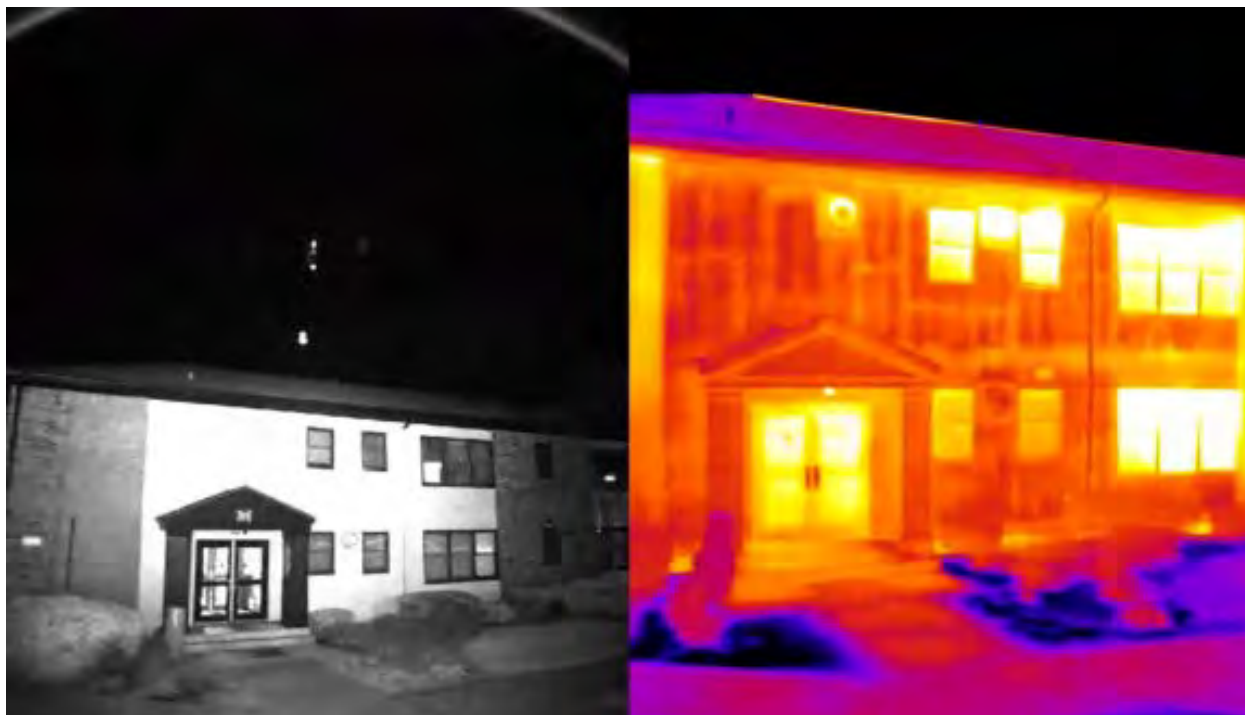
There are notable insulation gaps and thermal bridges along the surface of the wall at timestamp 134:08 (Figure D-69). The entire wall is poorly insulated. The area above the second floor windows also appears to be lacking insulation.

Figure D-69. NIR image (left) and thermal image (right) of Bldg 1512, Scott AFB. The doors and windows appear to be highly emissive.

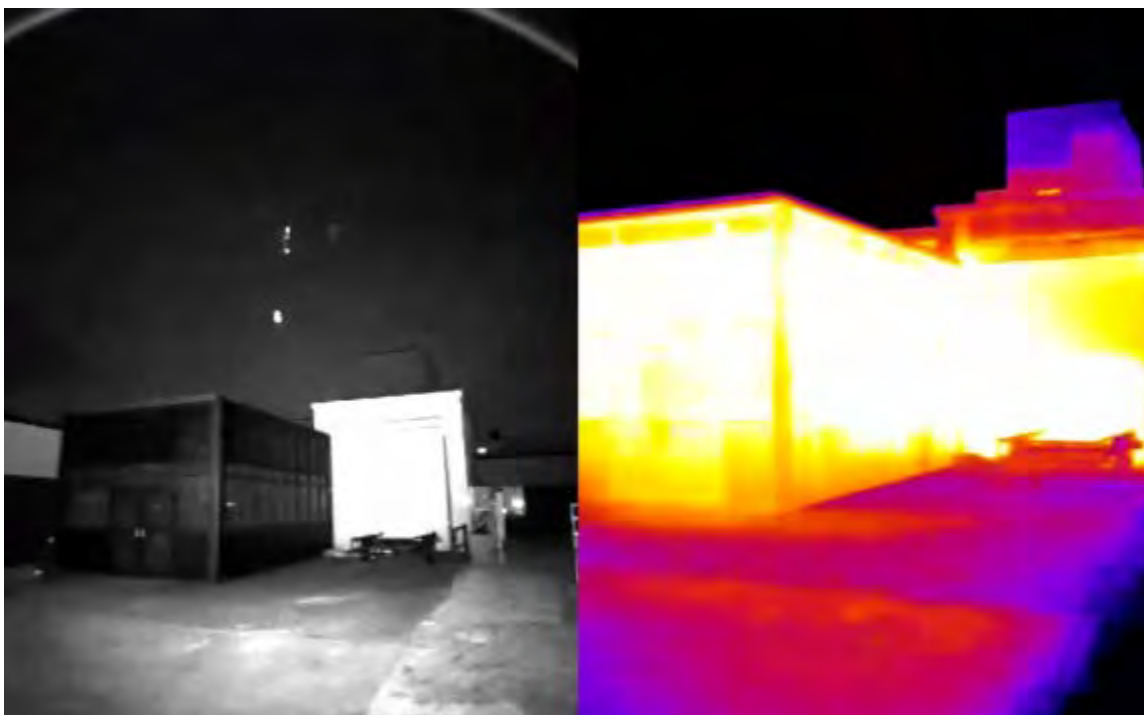
Figure D-78. NIR image (left) and thermal image (right) of Bldg 1529, Scott AFB.

At timestamp 145:53 in the Drive-by Application there is a very emissive loading bay door and entryway (Figure D-78). This is one of the most emissive buildings on the entire base. This building should be investigated for insulation problems and insulation should be added to the entire loading bay.

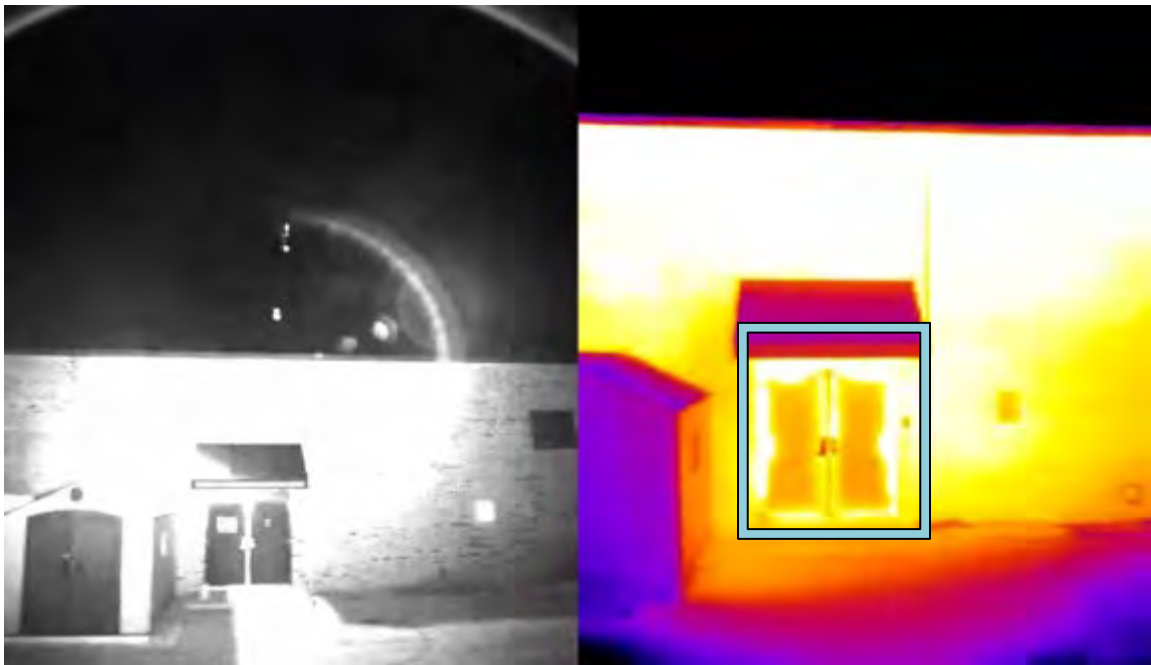
Figure D-91. NIR image (left) and thermal image (right) of Bldg 1650, Scott AFB. There appears to be significant energy loss around the door frame.

The door frame visible at timestamp 162:27 indicates convective leaks along the outer frame. The wall is also losing energy. This would also be a good candidate for adding insulation to the wall and weather-stripping to the door.

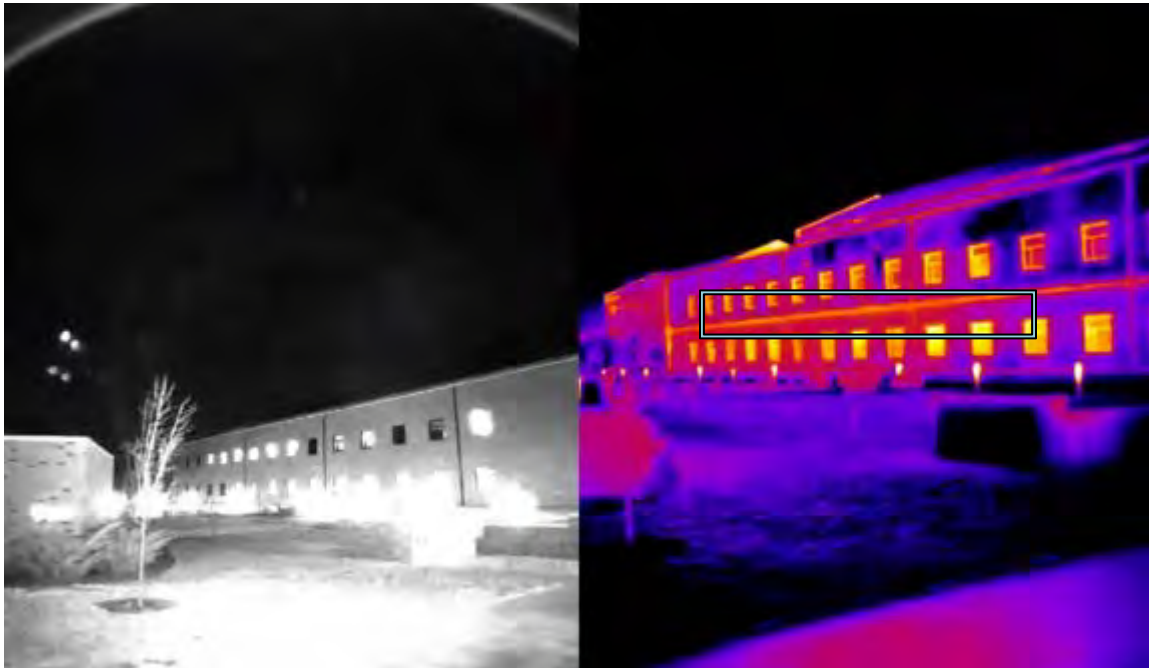
Figure D-95. NIR image (left) and thermal image (right) of Bldg 1900, Scott AFB.

There are some large thermal bridges stretching both across the wall and from ground to roof around timestamp 34:58 (Figure D-95).

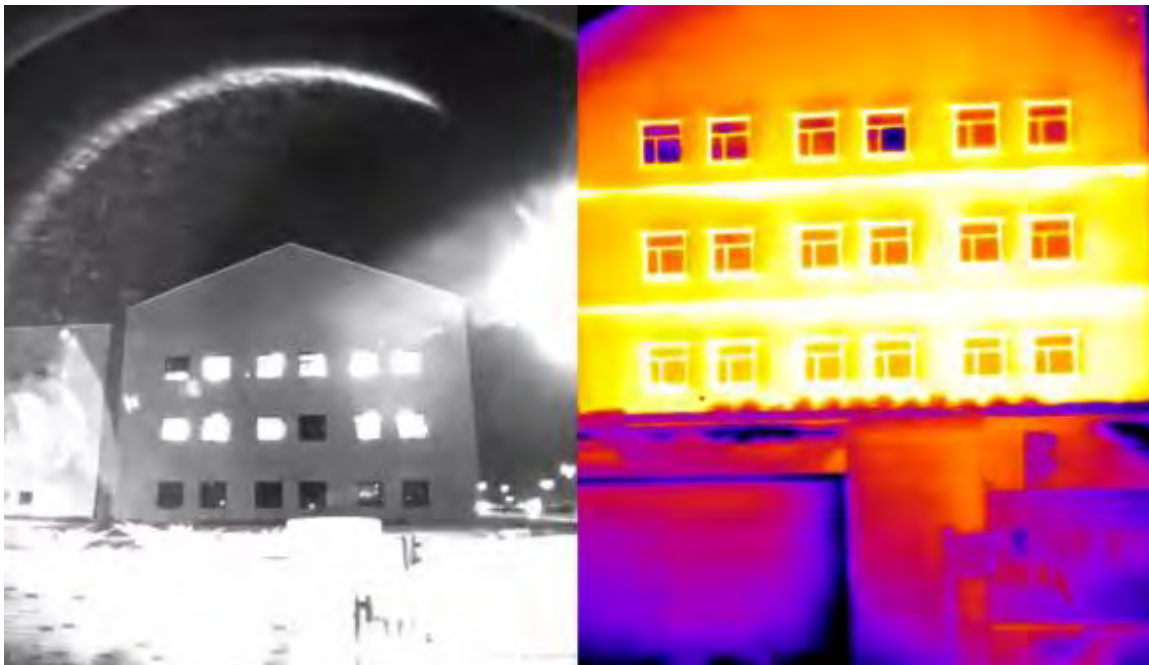
Thermal bridges are also visible around the other side of the building at timestamp 35:22 (Figure D-96). The window frames are also fairly emissive. Window frame leaks can be addressed by caulking and weatherstripping. There is also a thermal bridge between the first and second floors and the second and third floor.

Figure D-96. NIR image (left) and thermal image (right) of Bldg 1900, Scott AFB. Thermal bridges are apparent between the rows of windows.

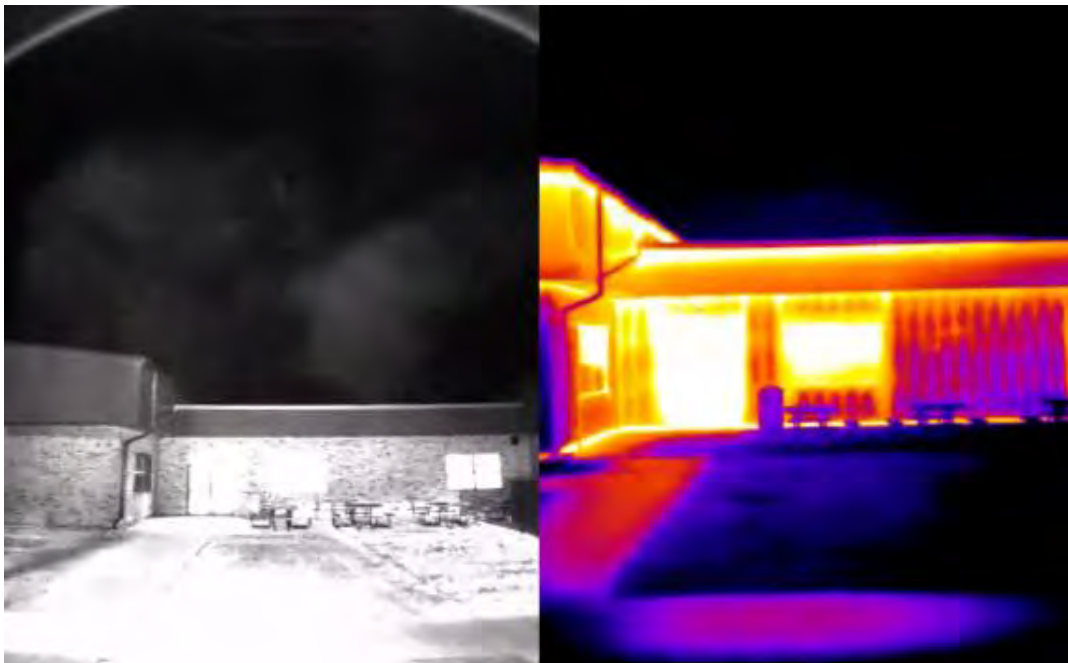
The soffit and door frames around timestamp 113:32 are notably leaky (Figure D-112). The area outlined by the polygon is showing poor insulation. Both doors are also very leaky.

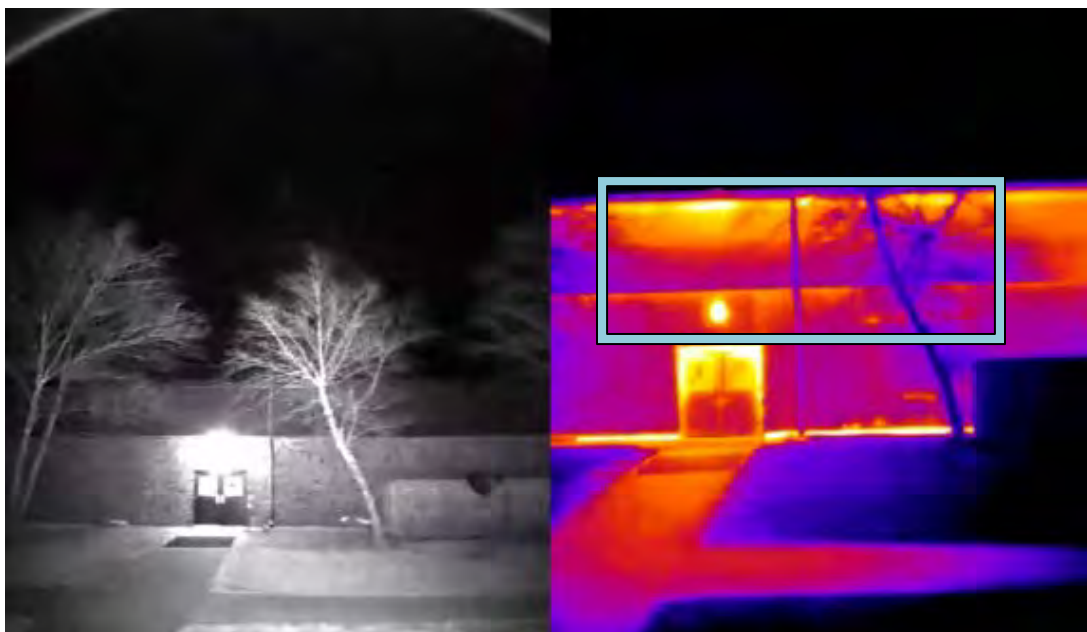
The soffit and roof line at timestamp 113:57 is fairly emissive, and the door frame may have a sizable convective leak (Figure D-114). It is recommend-

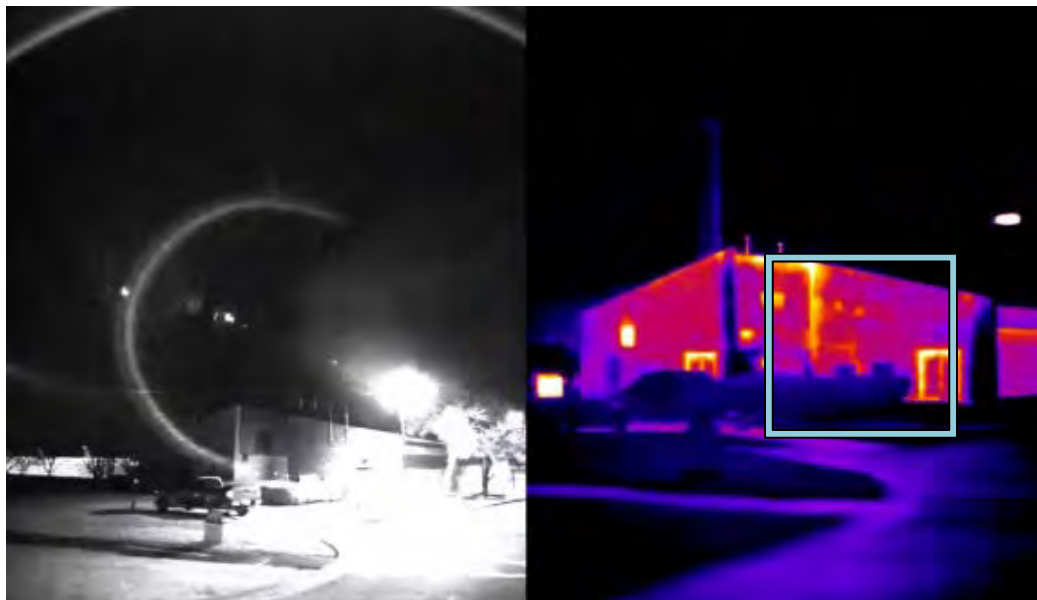
Figure D-118. NIR image (left) and thermal image (right) of Bldg 3689, Scott AFB.

The wall of Bldg 3689 at timestamp 122:48 has a number of emissive patches, which indicate holes (Figure D-118)). There is also a large hot stripe at the juncture in the middle of the image that may be worth investigating further. The double doors on the right of the image are also leaking energy. Weather-stripping is recommended to fix energy leaking around the door frame.

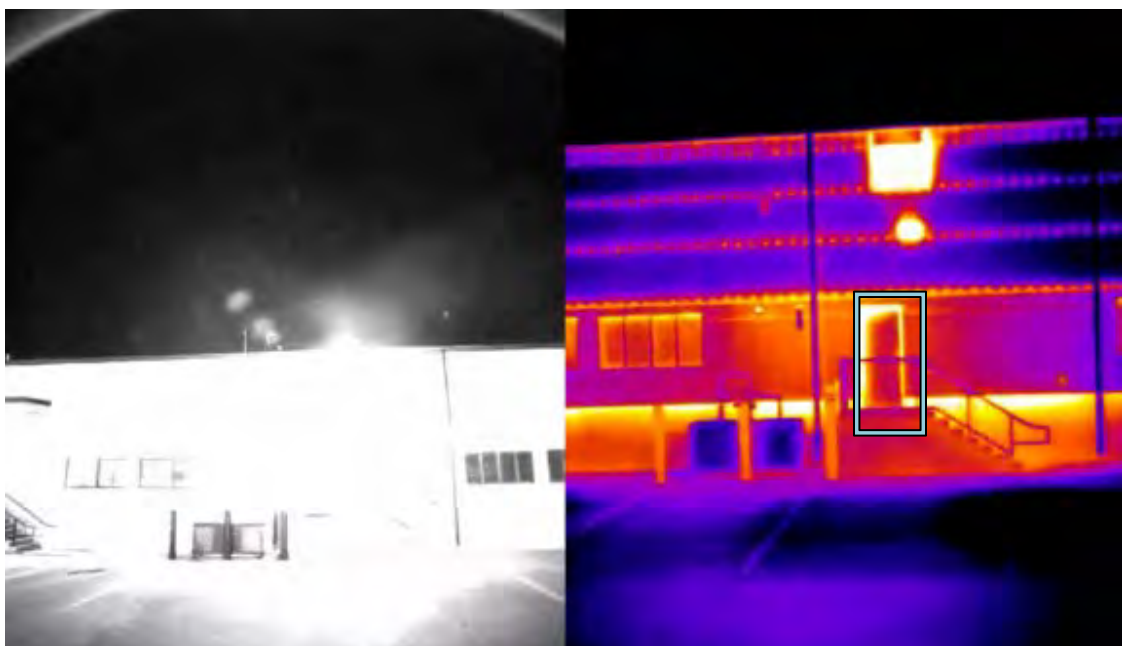
The door around timestamp 98:32 has a fairly emissive frame, which indicates air leaks (Figure D-129). The top of the building has a large hotspot that may be caused by a vent.

Figure D-129. NIR image (left) and thermal image (right) of Bldg 4010, Scott AFB. Note the large hotspot near the top of the building.
