*Environmental Security Technology Certification Program (ESTCP)*

## **Kinetic Super-Resolution Long-Wave Infrared (KSR LWIR) Thermography Diagnostic for Building Envelopes**

Scott AFB, IL

Final Report

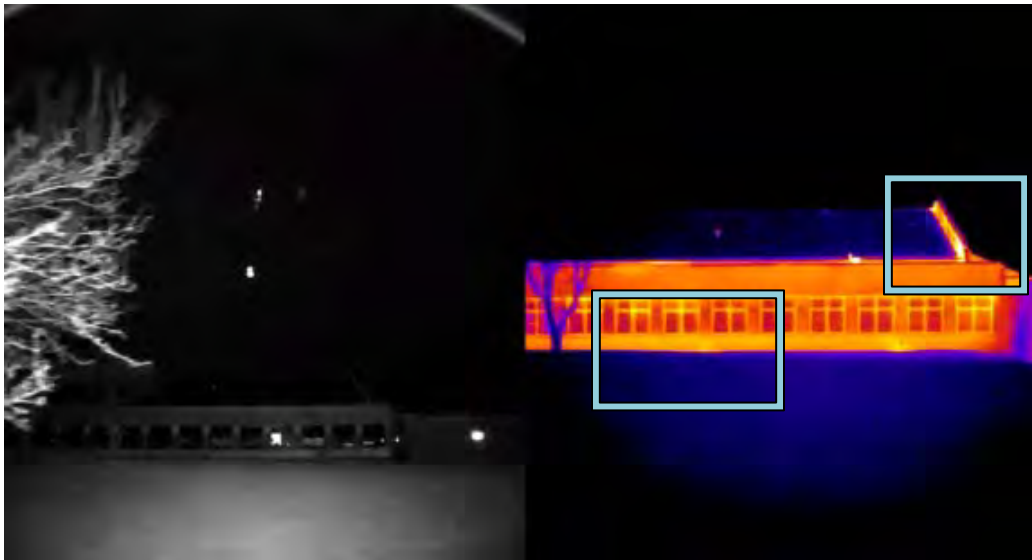
Figure D-138. NIR image (left) and thermal image (right) of Bldg 5008, Scott AFB.

In addition to a generally high-emission wall, there are a number of leaky window frames and a hotspot on the roofline visible at timestamp 255:29 (Figure D-138).
