**ENVIRONMENTAL DEGRADATION OF NICKEL-BASED SUPERALLOYS  
DUE TO GYPSIFEROUS DESERT DUSTS**

DISSERTATION

AFIT-ENY-DS-15-S-066

**AIR FORCE INSTITUTE OF TECHNOLOGY**

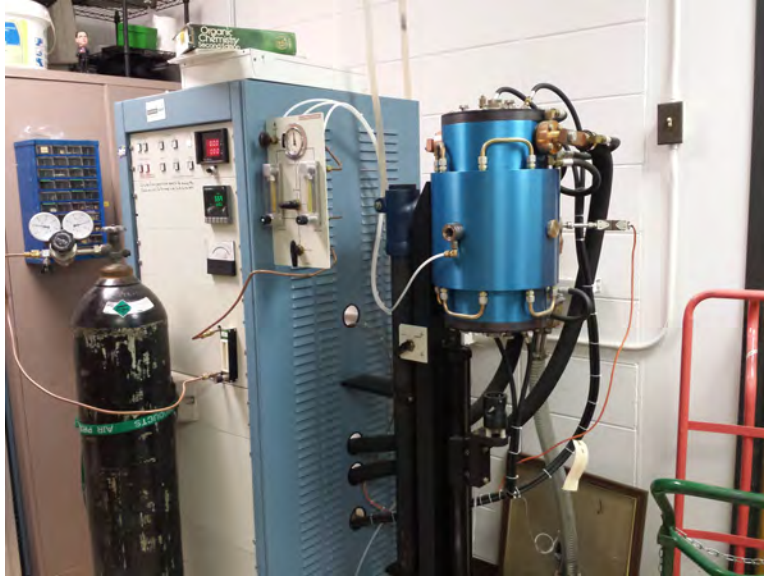
Figure 3.1: UDRI furnace used in all crucible and SR testing. The furnace was controlled manually using an optical pyrometer as a guide. All testing was completed in a  $N_2$  atmosphere.

Figure 3.1 shows the Thermal Technologies LLC Laboratory Furnace used in this research. The model used has a 4" diameter, 6" tall graphite heating zone. The heating chamber is encased in a water-cooled thick-walled 6061-T6 extruded aluminum shell. This furnace model has a maximum operating temperature of 2500°C. All testing was performed under a N<sub>2</sub>-blanketed reducing atmosphere to protect the graphite liner from oxidation at high temperature. This furnace, as currently configured, is only capable of static/batch heating cycles.

Past experience with this furnace has shown the built-in s-type thermocouple to consistently read low compared to the optical pyrometer described in Section 3.2.3. The low readings are due to the designed placement of the thermocouple in the heating zone. The thermocouple is only used as a guide for initial manual control of the furnace until the pyrometer can be used above  $\sim 750^\circ\text{C}$ . Actual test measurements are taken using the micro-optical disappearing filament pyrometer described in Section 3.2.3 aimed at a half-inch viewing port on the static furnace in conjunction with the built-in thermocouple to monitor chamber temperature during each run. Figure 3.2 shows thermocouple reading versus pyrometer for all static reducing (SR) test runs. Since the pyrometer can only read temperatures above  $750^\circ\text{C}$ , a second conversion curve (dashed line) was constructed based on a simple two-point line fit between the thermocouple reading at room temperature and the thermocouple reading when the pyrometer read  $770^\circ\text{C}$  (the lowest pyrometer reading recorded during testing with the UDRI static furnace).

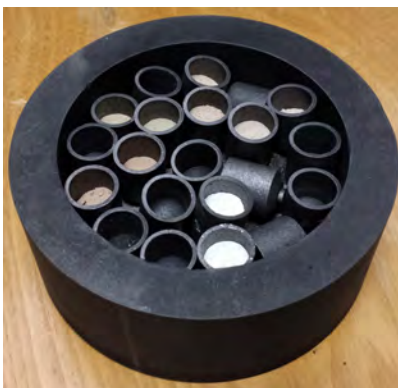
Figure 4.1: Loaded crucibles in graphite cup. Two replicates of each dusts were loaded for each test run. Empty crucibles were used to fill gaps between test samples to ensure samples remained upright during testing.

Media identified in Tables 3.1 and 3.2 were subjected to five minute soaks at peak temperatures ranging from 800-1300°C in the UDRI static furnace. Approximately 0.5 g of each media was measured into 12.5 mm diameter by 16 mm tall LECO® model 767 graphite crucibles. The mass of each sample was taken before and after each temperature run to determine mass loss due to off-gassing. Fresh dust charges were used for each temperature soak. Crucibles were loaded into the large graphite cup, as seen in Figure 4.1, for loading into the furnace. Empty graphite crucibles were added to fill the cup and ensure loaded crucibles did not fall during loading and testing.

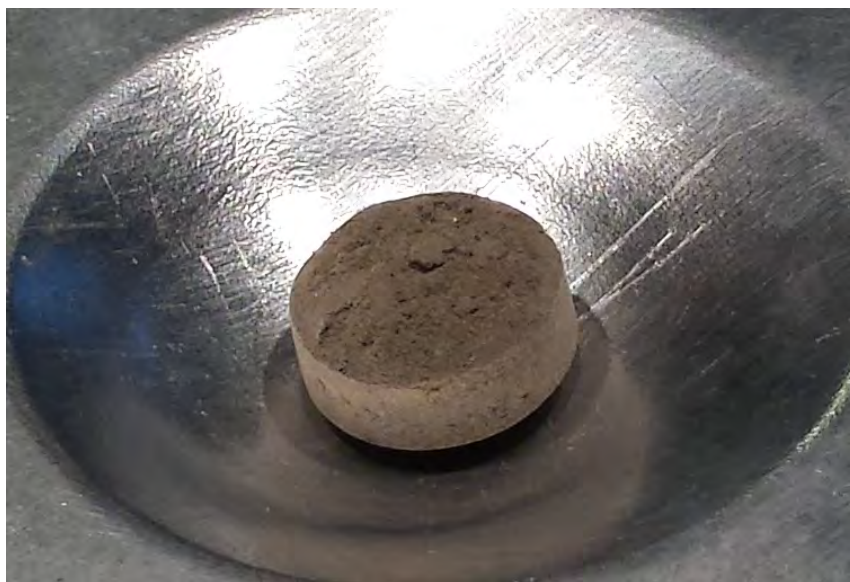
Figure 4.3: Example of the physical appearance of a crucible charge at its onset of sticking (GB1 at 850°C). The onset of sticking represented the lowest temperature, in this study, at which a dust sample remained as a monolithic pellet upon removal from the crucible. This also indicates the lowest temperature at which a sand may begin to form a deposit within a GTE.

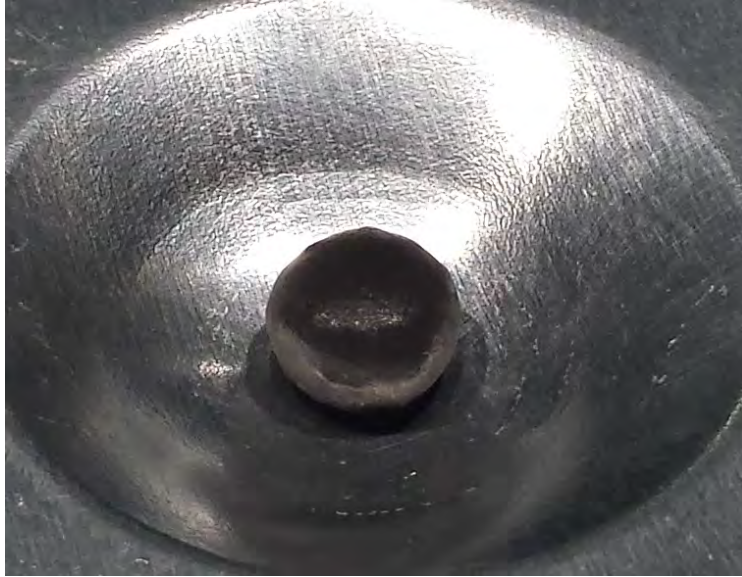
Figure 4.4: Example of the physical appearance of a crucible charge at its onset of fusion (GB1 at 1150°C). The onset of fusion represents the lowest temperature, in this study, at which a dust sample became molten during temperature soak. This also indicates the lowest temperature at which a sand may begin to infiltrate porous GTE structures.

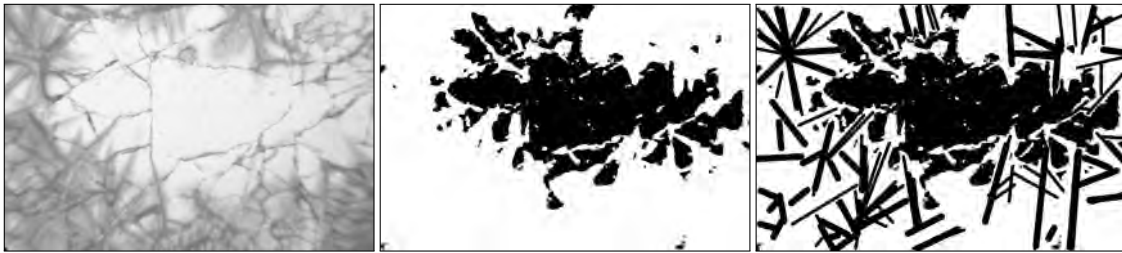
Figure 4.9: Measurement of glass fraction alone (middle image) proved to be insufficient to quantify melting behavior. Therefore, recrystallized phases were considered also. The image on the right includes mullite crystals to account for melt fraction. Images are of .5CMAS soaked at 1320°C (non-polarized image on left).

Mullite has a crystalline structure so it will not block transmitted light under polarization. As a result the use of glass fraction caused the measure of melting progression to be low. Therefore it was necessary to reanalyze thin-sections showing the presence of mullite. Secondary mullite crystal formations were identified individually in thin-section images and manually painted black in GIMP. Secondary mullite is easy to identify in samples because its high aspect ratio (long, skinny

crystals) stands out from other crystal structures found in the samples. Primary mullite crystals could not be accounted for as their low aspect ratio (platelet crystals) was not distinguishable from other structures in the thin-sections. Figure 4.9 shows an example of an edited thin-section image before and after accounting for mullite formations. Based upon the inclusion of mullite formations, the melt fraction of each sample is shown in Table 4.4. The updated values in Table 4.4 track better with the melting behavior suggested by DSC runs. However, the updated values are still low because they do not account for primary mullite.
