AMMRC TR 85-28

# ENVIRONMENTAL ASSISTED CRACKING IN HIGH HARDNESS ARMOR STEEL

WILLIAM A. HERMAN and GLENN M. CAMPBELL  
PROCESS RESEARCH DIVISION

September 1985

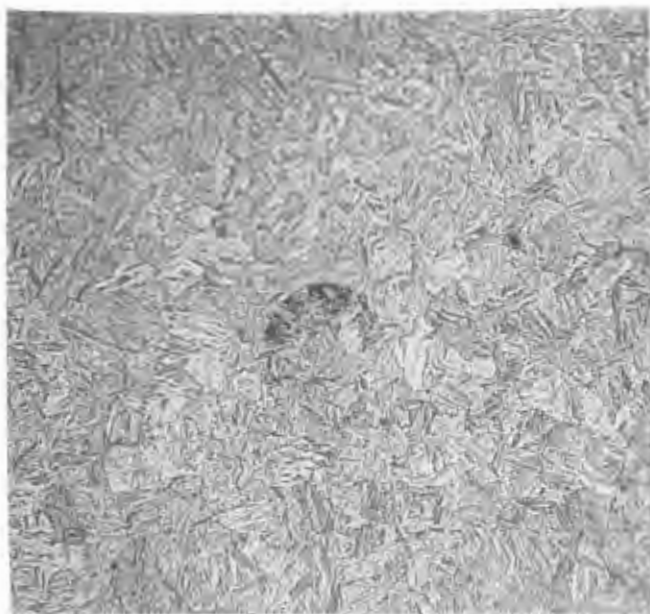
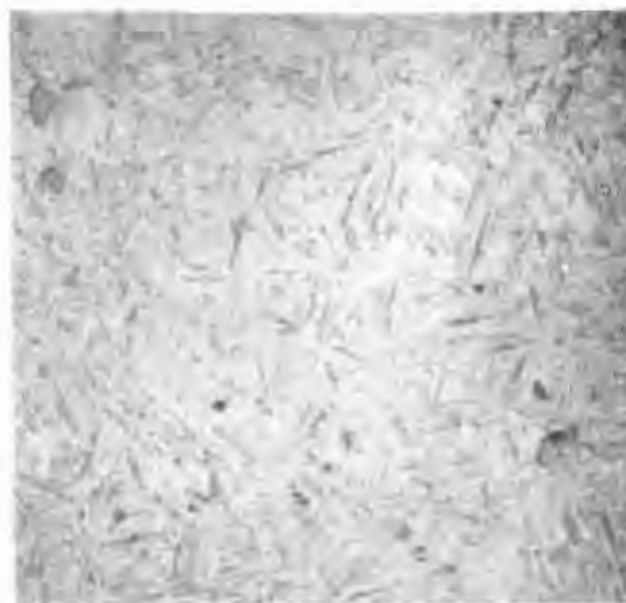
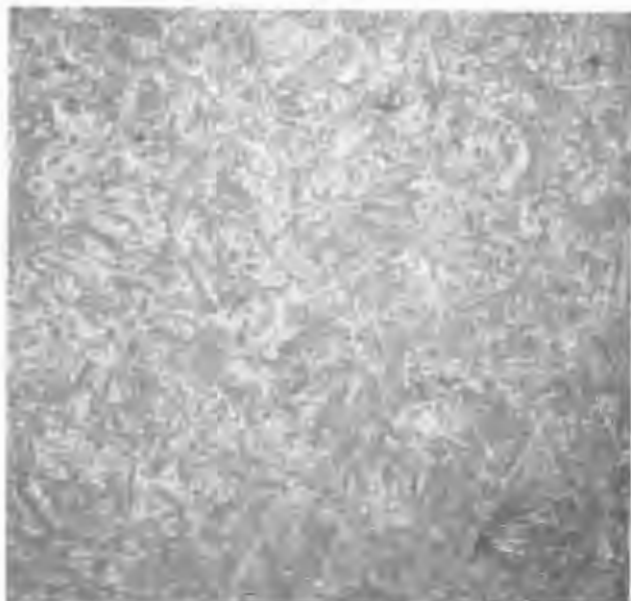
Figure 3. Comparison of Microstructures.

Cracked Plate, Mn-Mo-B

Uncracked Plate, Mn-Mo-B

Raw Stock, Ni-Cr

1. Tempered martensite microstructure seen in all samples.
2. Inclusions are spheroidized.
3. No inherent material deficiency (i.e., banding) can be linked to the cracking phenomenon.

For comparison, a nickel-chromium grade of high hardness armor was examined and similar results, both microstructurally and mechanically, to the Mn-Mo-B grade were obtained (Table 5 and Figure 3). Since the Ni-Cr grade of high hard is a richer alloy (Table 3), it is typically tempered at higher temperatures. This reduces the relative tendency for EAC to occur. However, it is felt that if Ni-Cr and Mn-Mo-B high-hard steels are processed in exactly the same manner, both will possess similar susceptibilities to EAC.
