FTIR Analyses of Hypervelocity Impact Deposits: DebrisSat Tests

1. REPORT DATE 27 MAR 2015	2. REPORT TYPE Final	3. DATES COVERED -			
4. TITLE AND SUBTITLE FTIR Analyses of Hypervelocity Impact Deposits: DebrisSat Tests		5a. CONTRACT NUMBER FA8802-14-C-0001			
		5b. GRANT NUMBER			
		5c. PROGRAM ELEMENT NUMBER

Aerospace Technical Operating Report No.
TOR-2015-00941

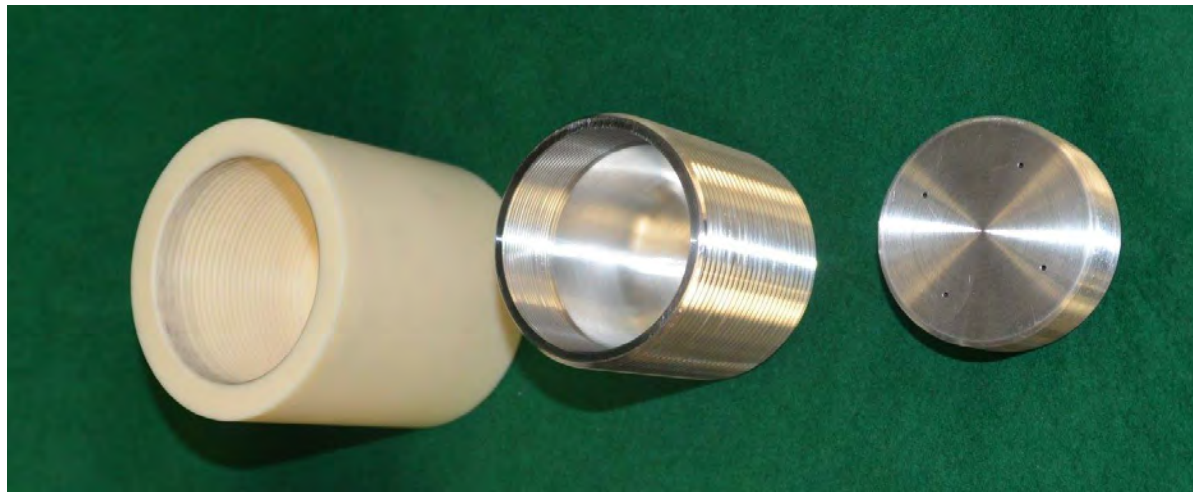
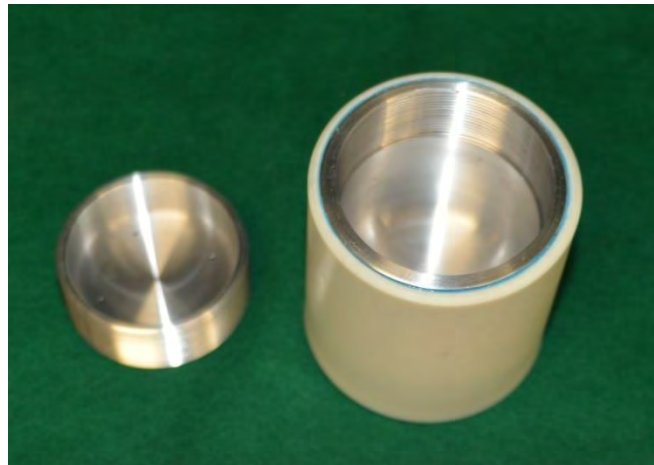
Projectile

Hollow aluminum and Nylon cylinders. Constructed from three pieces:
Outer Nylon shell (sabot) with aluminum inserts.
~600 grams, 8.6 cm diameter X 10.3 cm long – size of a “coke can”

Same type of projectile was used for all three tests.

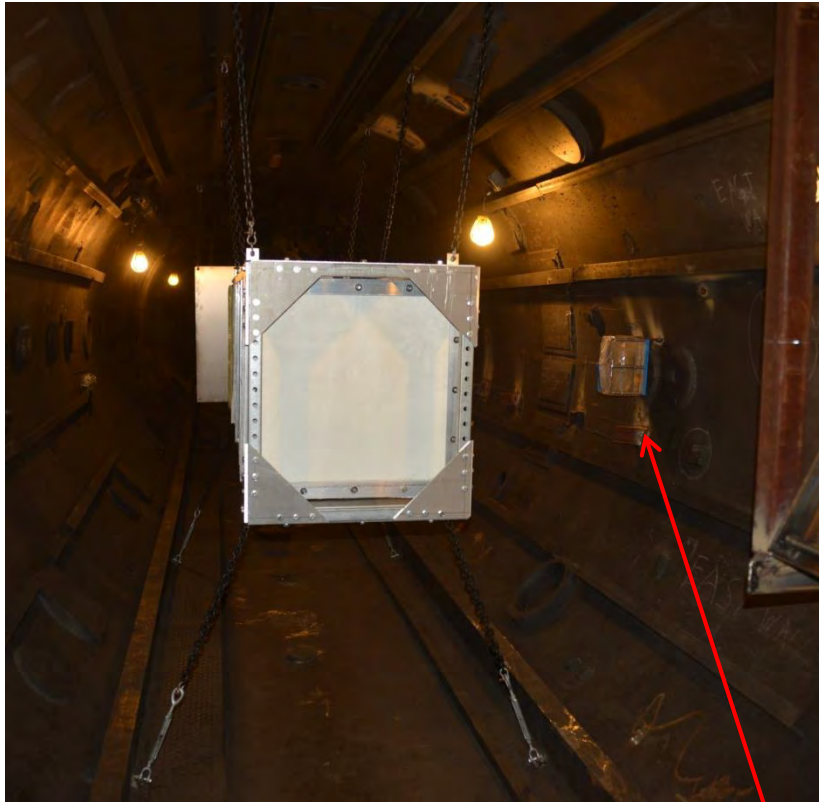
Target and Witness Plate in Chamber

Note no soft catch panels present in chamber

Looking Down Range

Fiberglass panel in front.

Looking Up Range

Kevlar panel in back.

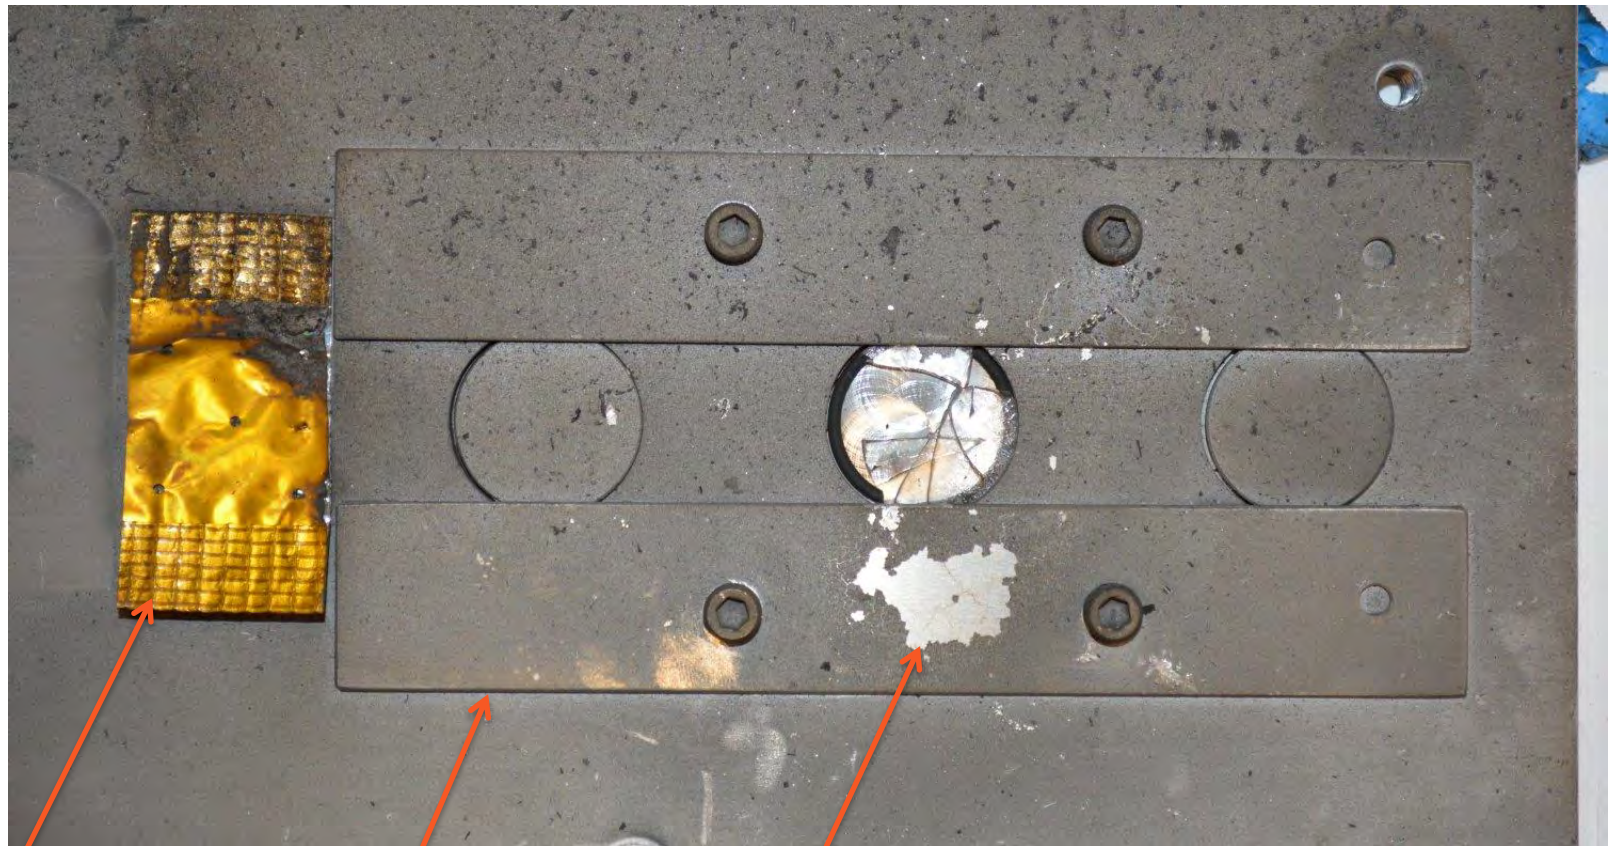
Witness Plates: Post Test (unprotected)

Note blistered coating flaked off and
fractured quartz window

Exposed surfaces are covered with a matte gray coating and fine debris

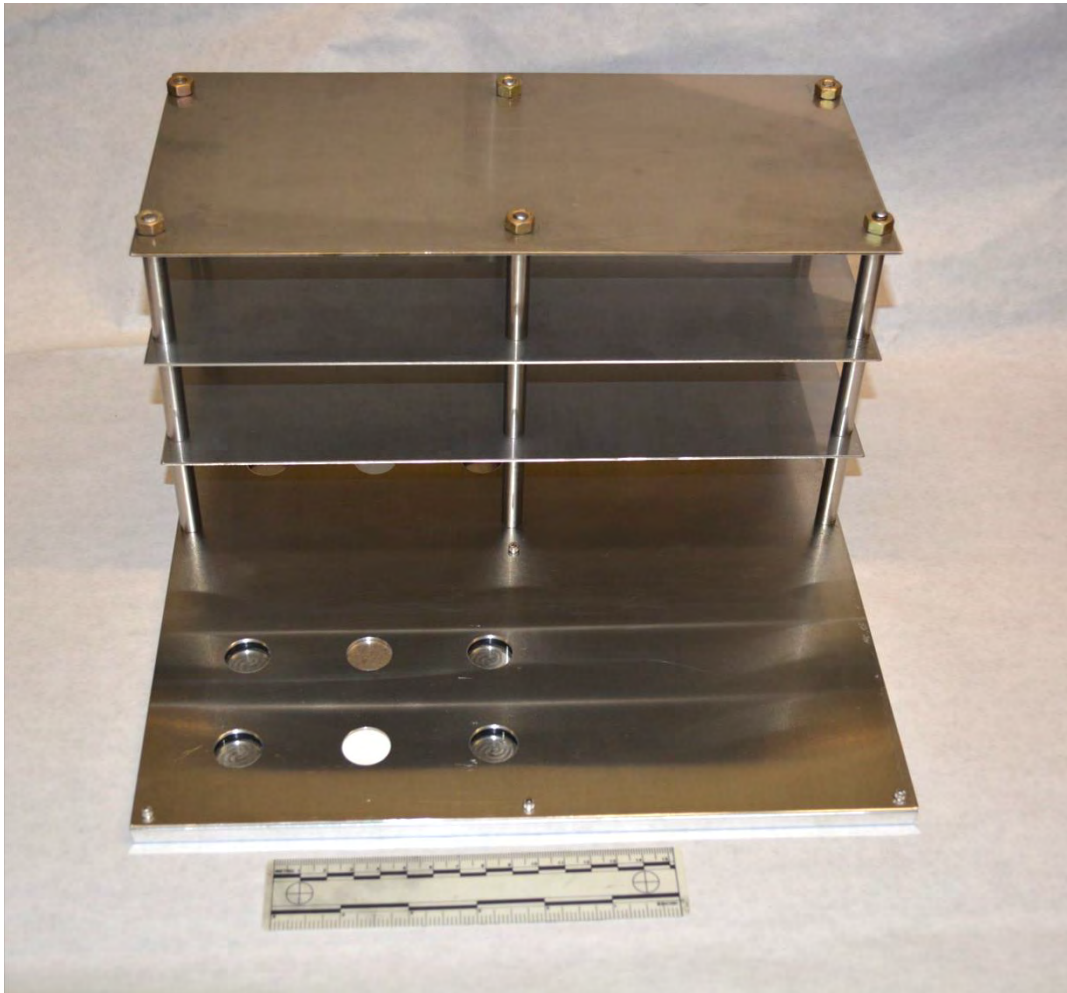
Witness Plate Assembly: Pre Test

Witness Plate Samples:

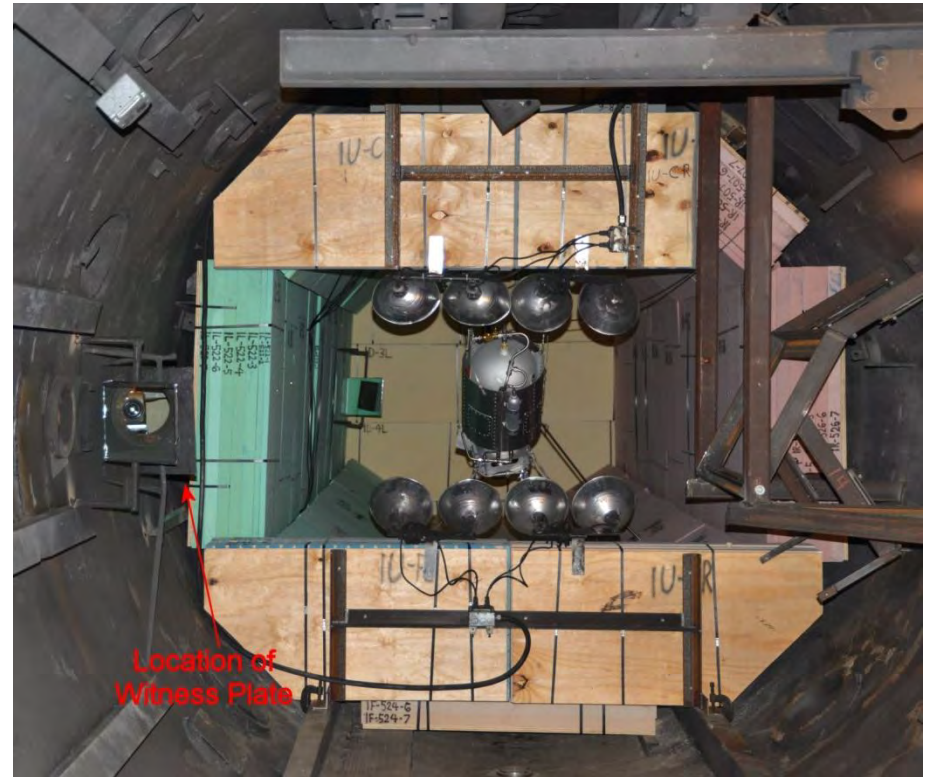
Witness plates installed in chamber

Witness plate assembly installed about 2-3 meters up range of Debris-LV

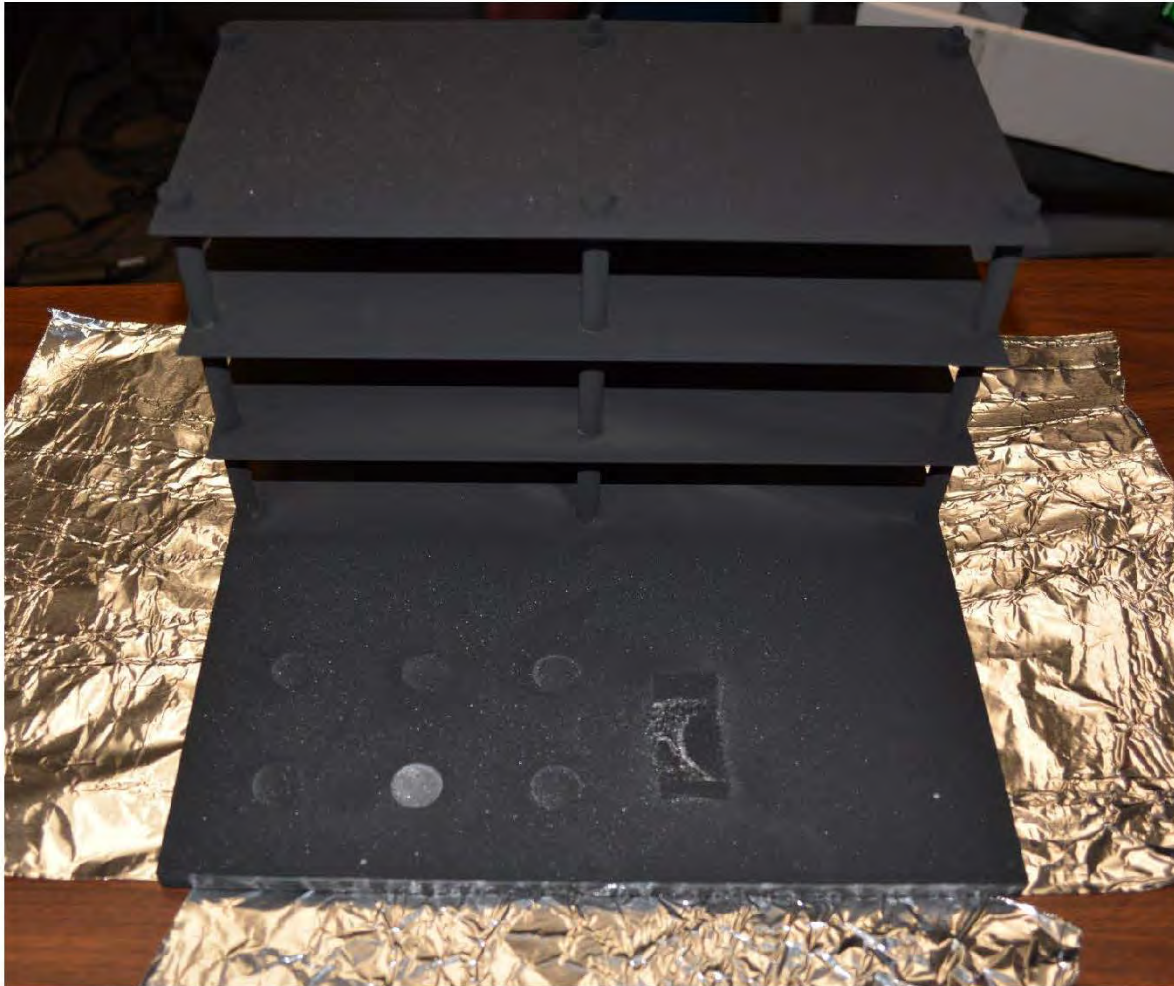
Witness Plate Assembly: Post Test

Assembly is covered with a black sooty substance, even under the Whipple plates. There is significant darkening

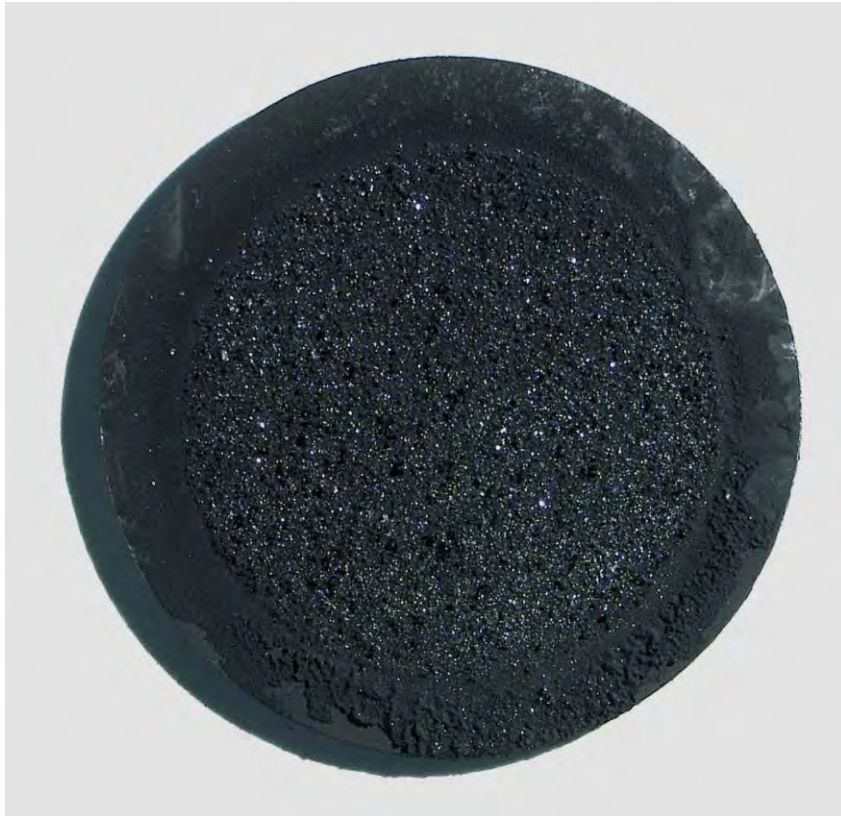
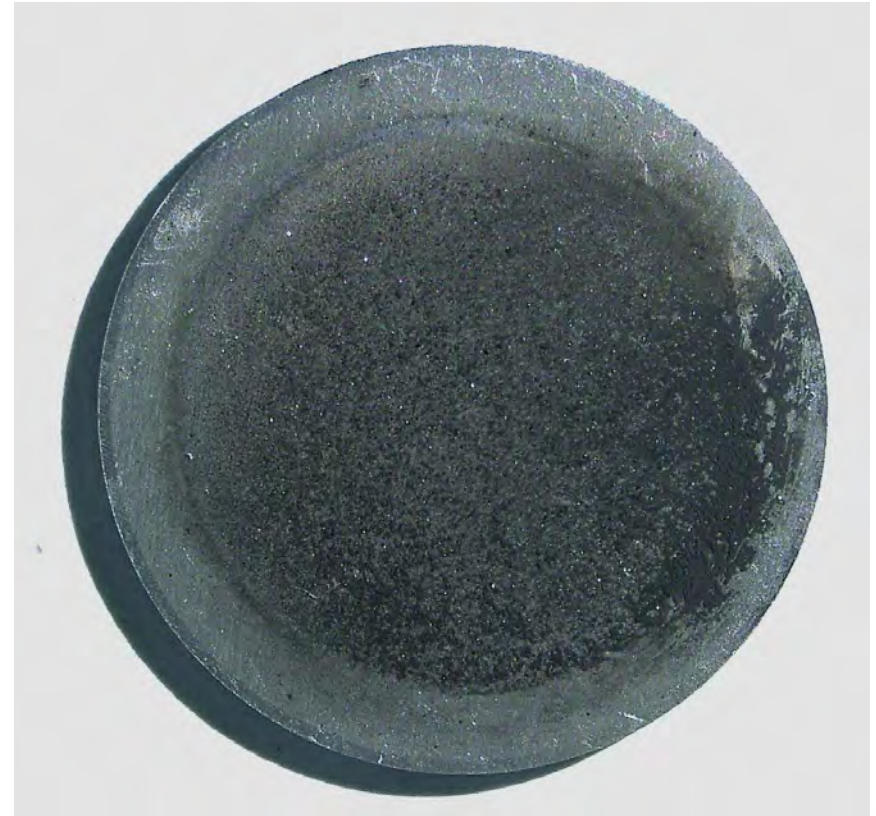
Aluminum Disks (1" dia)

Directly exposed (B2)

Protected under Whipple plates (D2)

Directly exposed samples covered in coarse soft catch debris.
Less material under Whipple plates

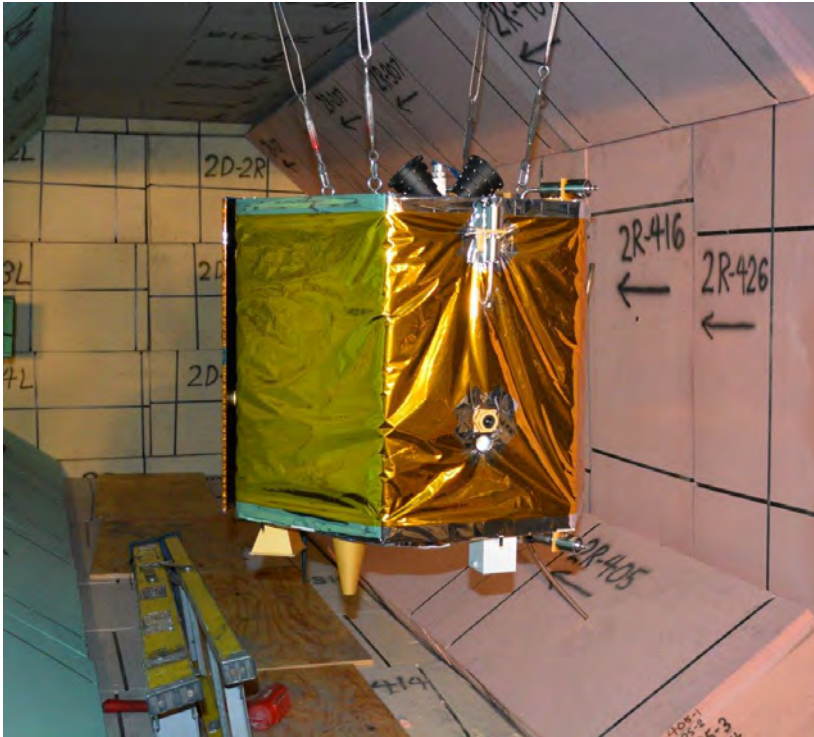
Installed in Chamber: Pre test

Looking down range.
Outer surface covered with
multi layer insulation.

Looking up range.
Solar panels - undeployed

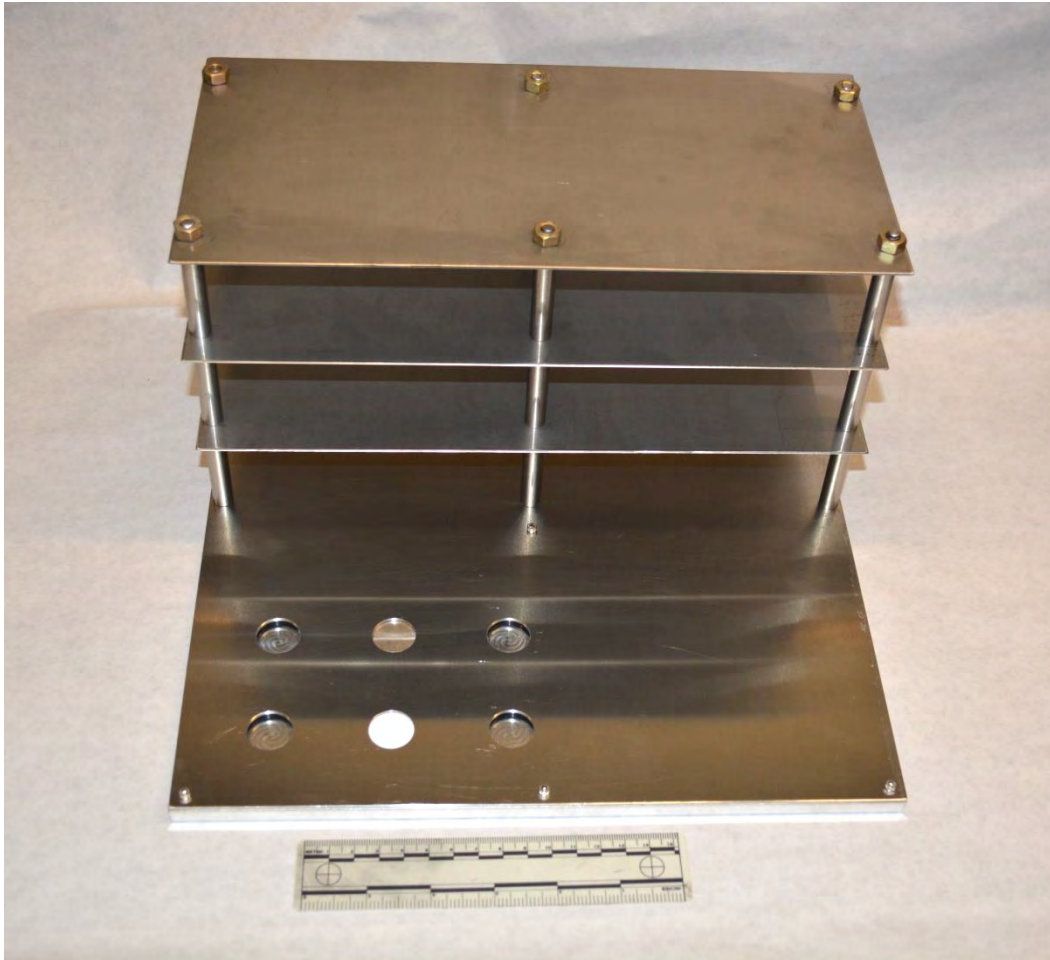
Witness Plate: Pre Test

Witness plates located in same position in chamber as Debris-LV.
~2-3 meters up range of DebrisSat.

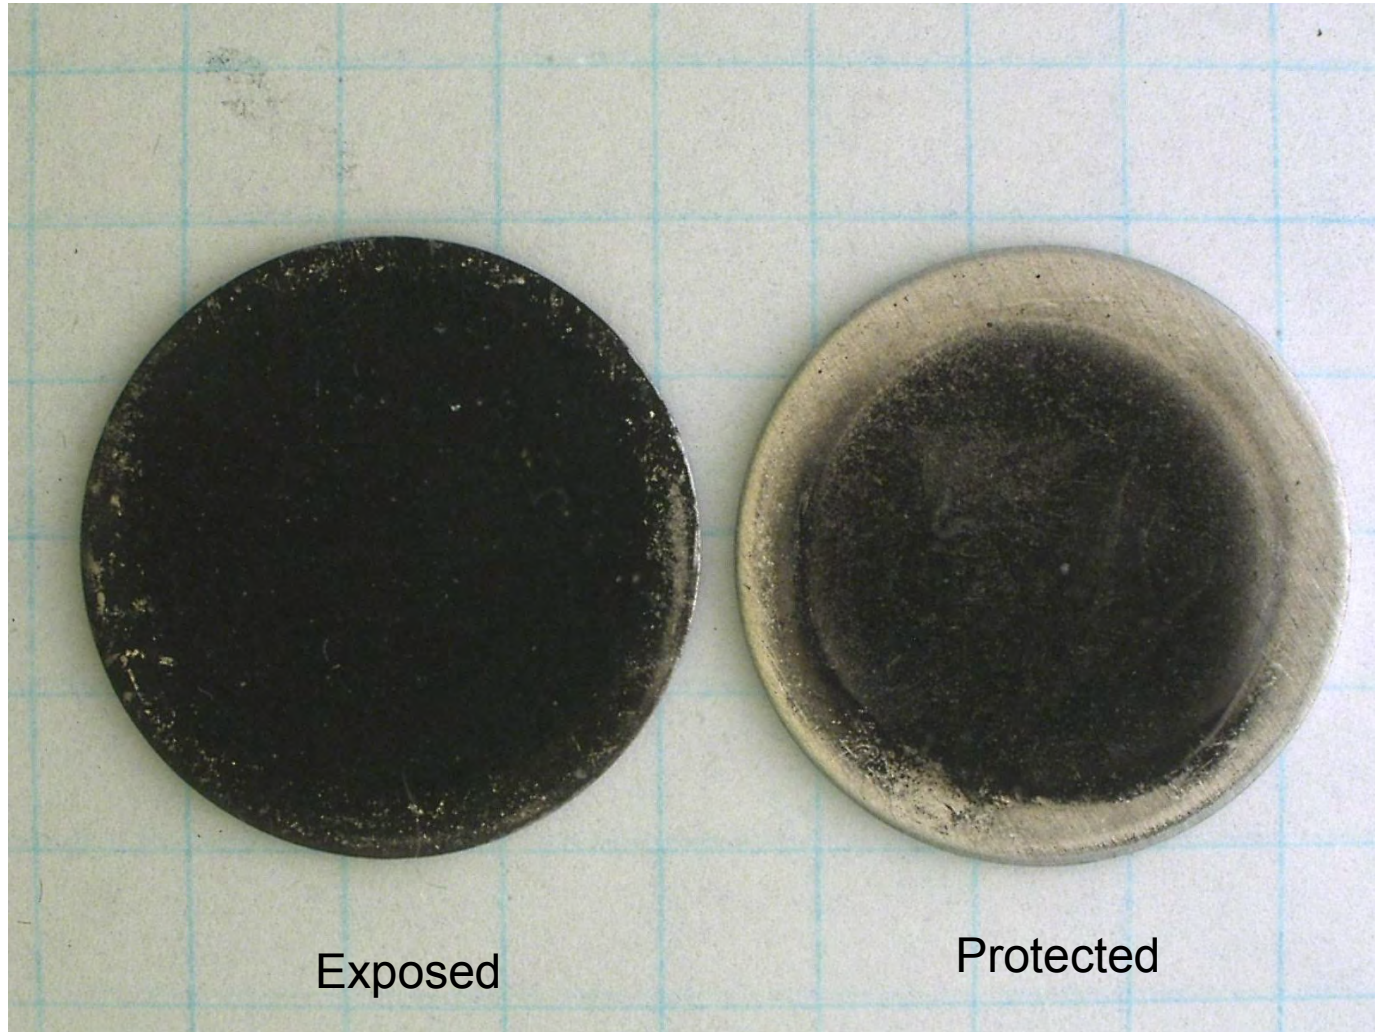
Post Test: Aluminum Disks

Significant accumulation of debris, especially soft catch fragments on exposed disk

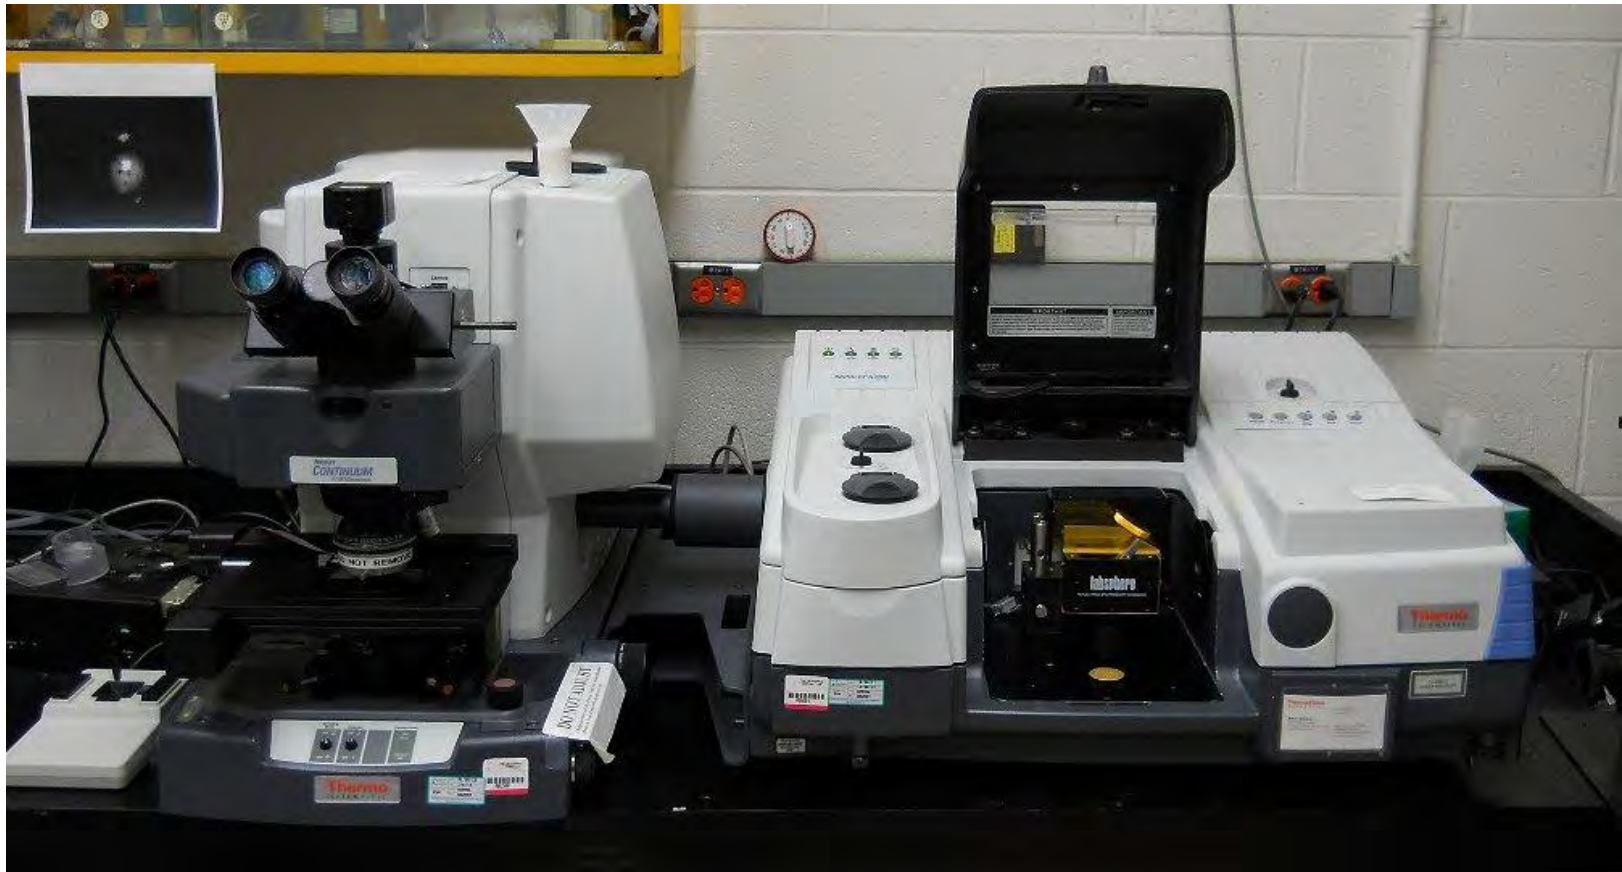
Fourier Transform Infrared (FTIR) Spectrometer

Thermo-Nicolet 6700 FTIR and Continuum Microscope
Labsphere integrating sphere in sample compartment at right

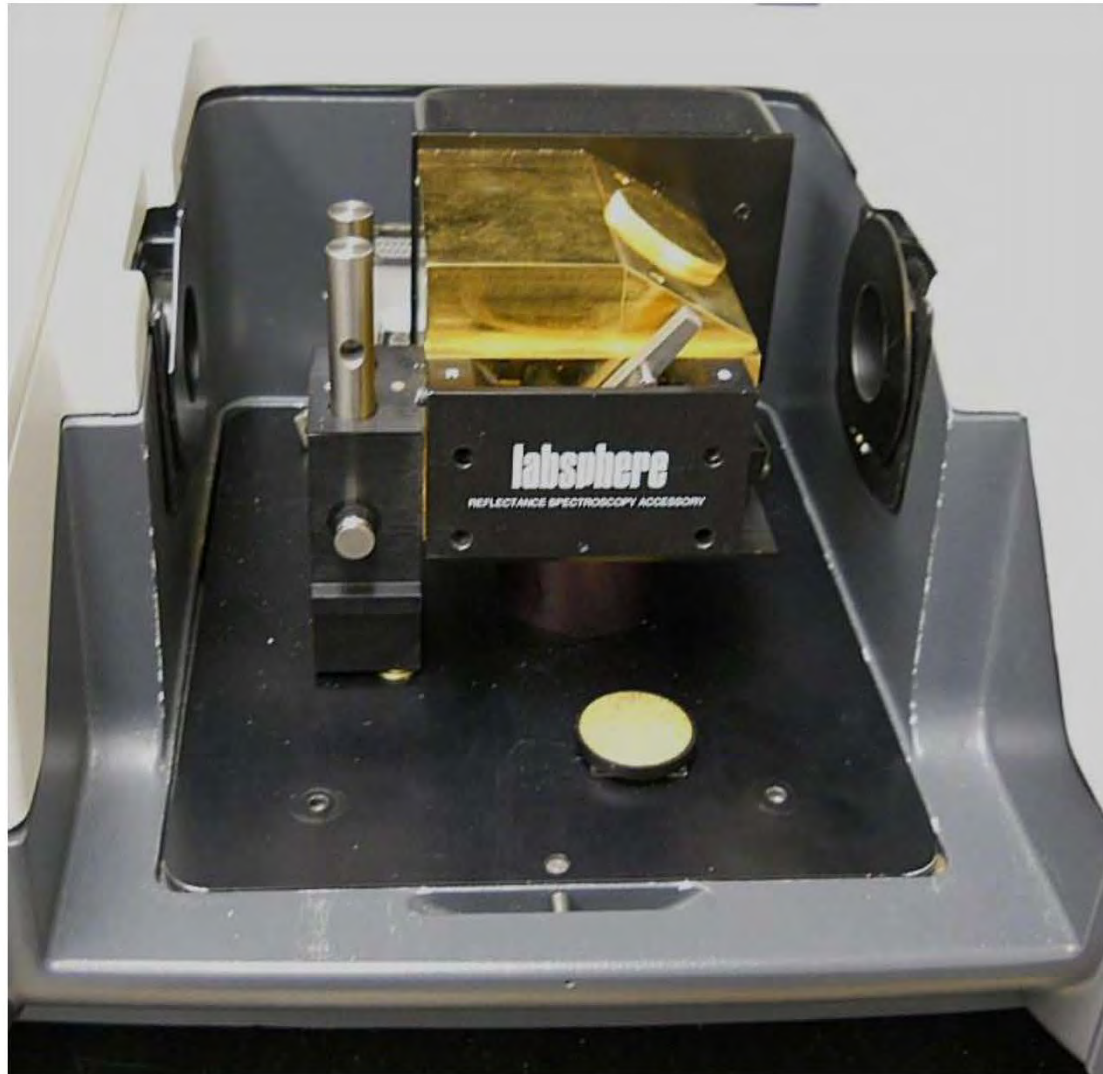
Hemispherical Reflectance

Labsphere Integrating Sphere
