DebriSat Pre Preshot Laboratory Analyses

March 27, 2015

Aerospace Technical Operating Report No.
TOR-2014-03083

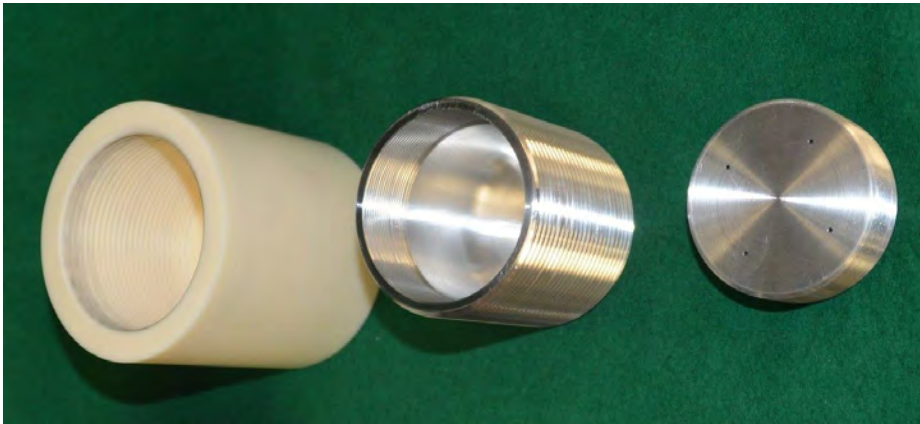
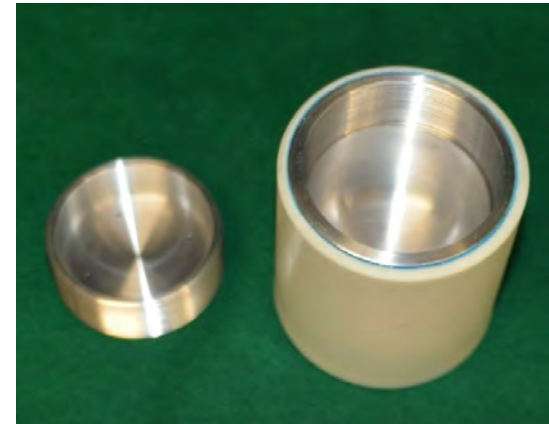
Projectile

Flash X-ray of projectile in flight

- Constructed from three pieces:
- Outer Nylon shell (sabot) with 2 part hollow aluminum insert.
- ~600 grams, 8.6 cm diameter X 10.3 cm long – size of a soup can.
- Velocity ~ 6.8-6.9 km/s.
- During flight Nylon base separated from Nylon-aluminum body.
 - In all three tests.

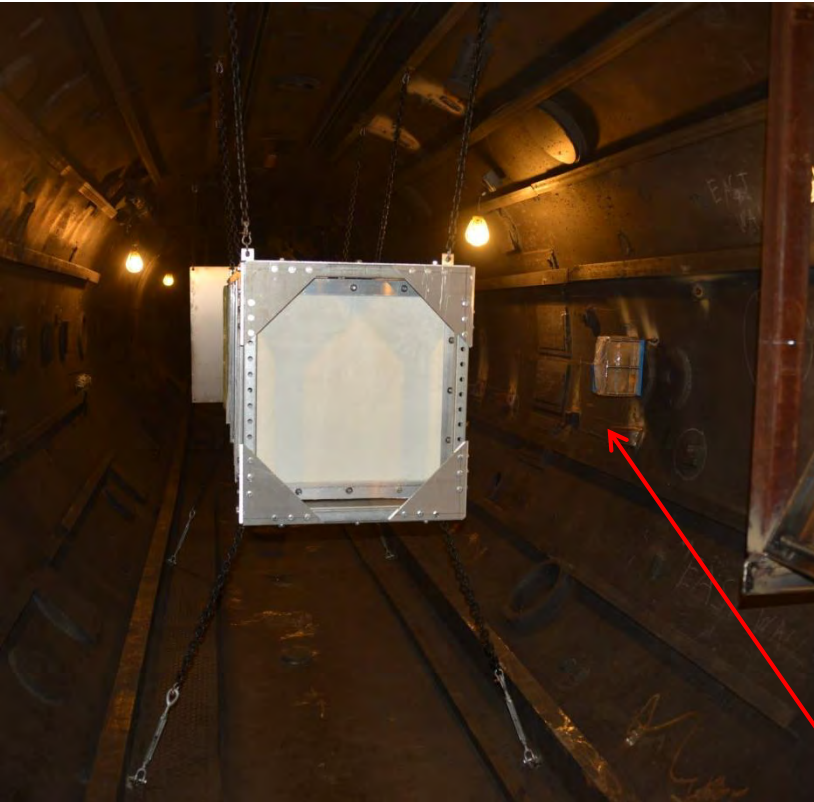
Target and Witness Plate Mounted in Chamber

Looking Down Range

Fiberglass panel (Bumper #1) in front.

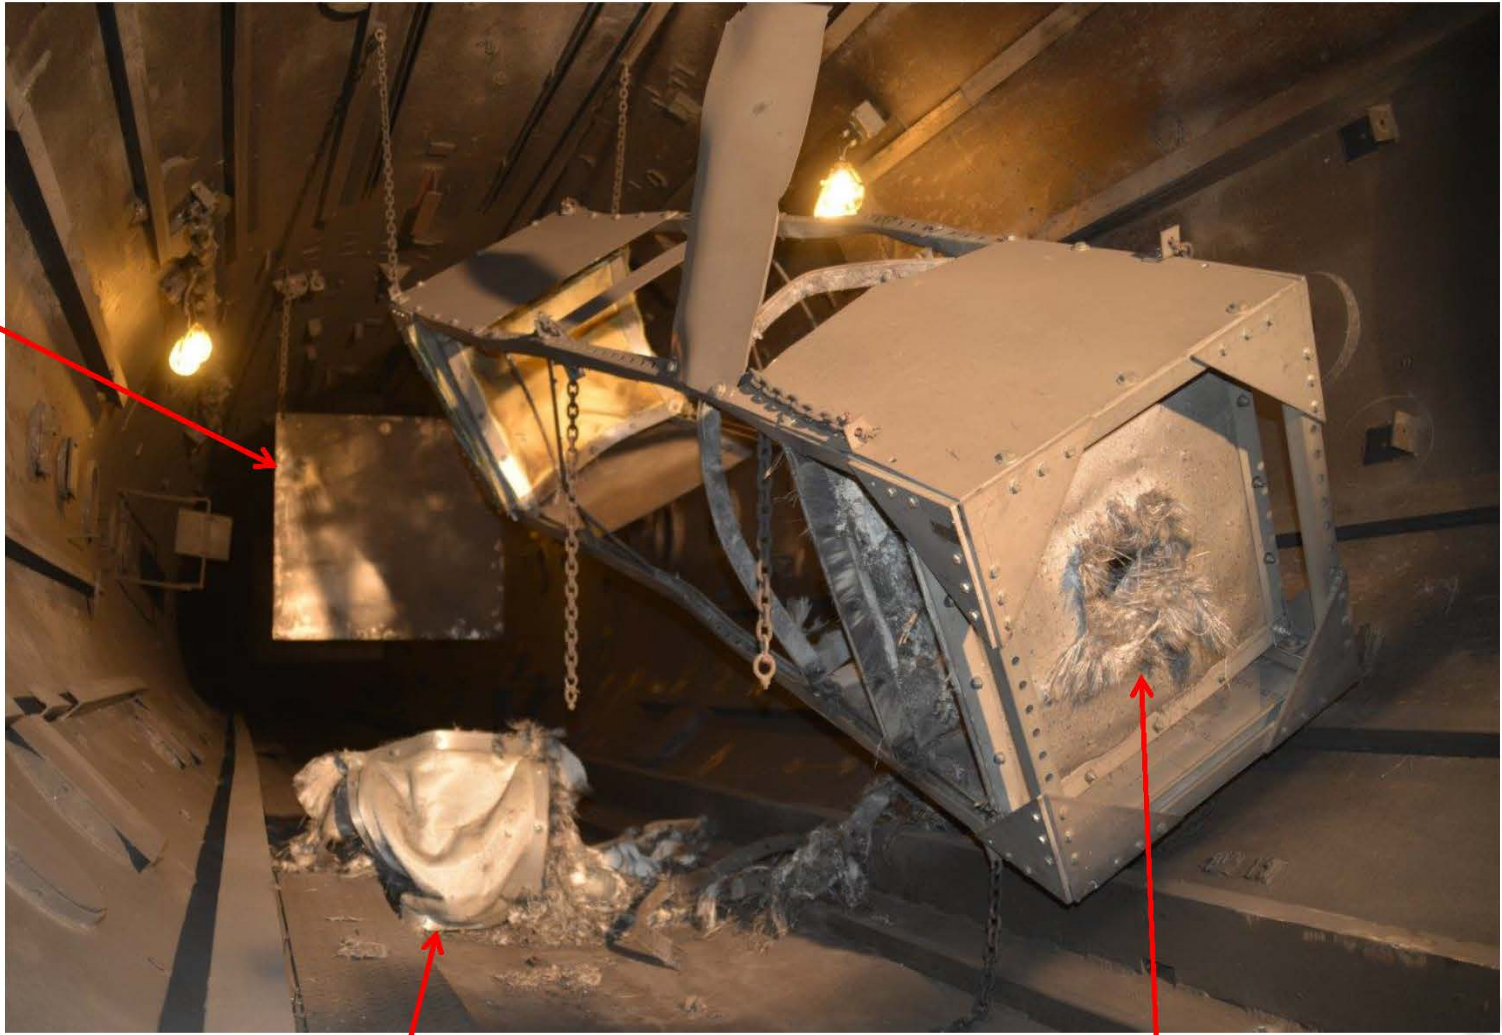
SBU Marking Target - Post Test

4th and 5th bumpers were dislocated from the frame. 4th bumper was penetrated, 5th was not.

First 3 bumpers were penetrated

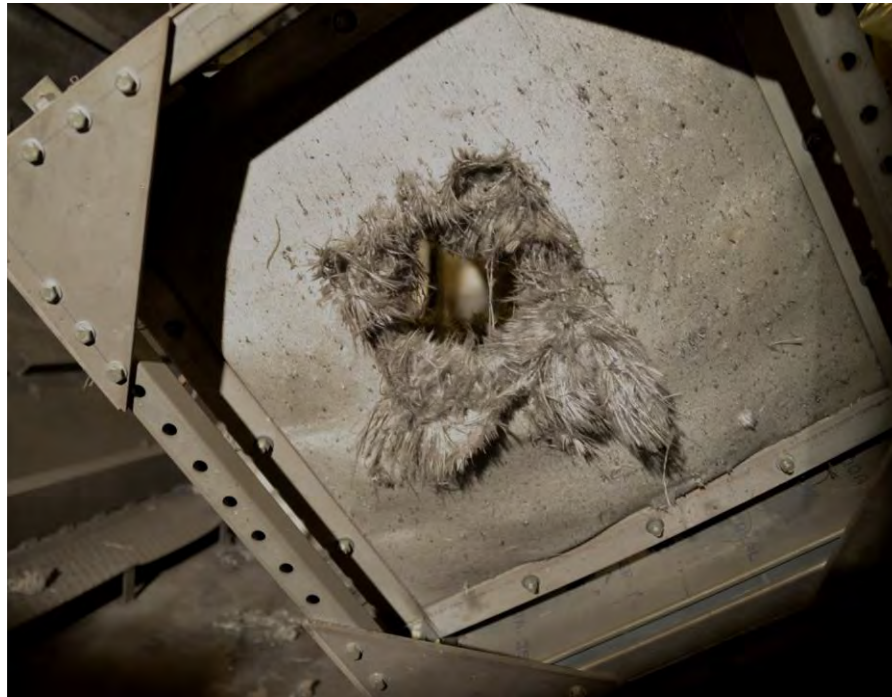
Front side of 1st bumper.
Note that some fiberglass has ejected up range.

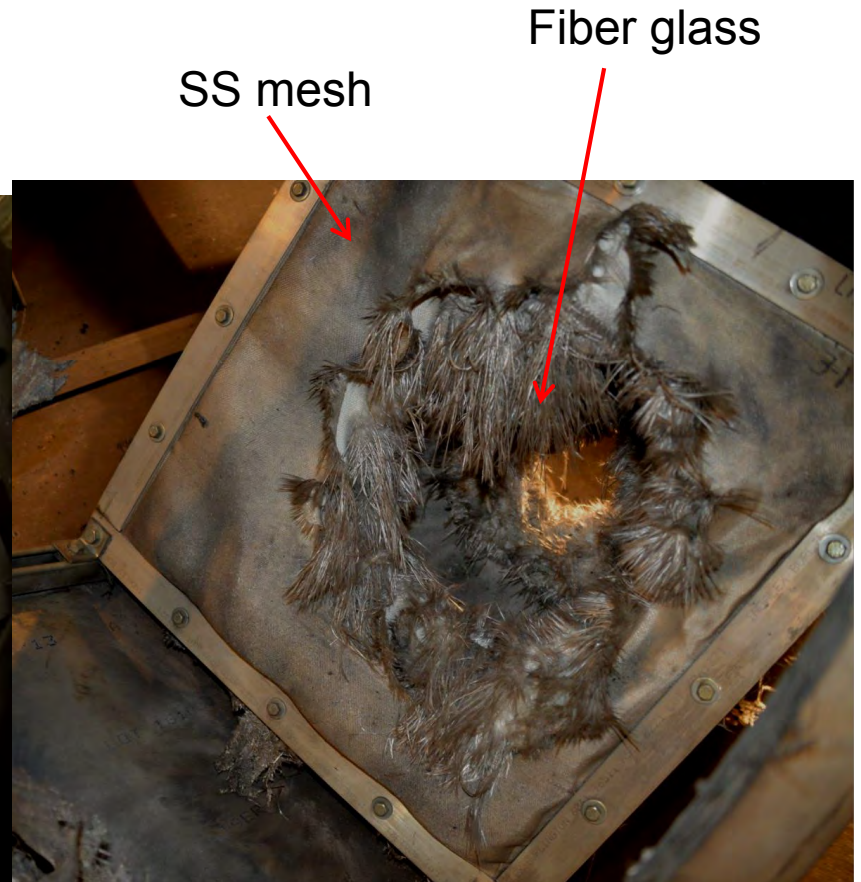
Back side of 3rd bumper.
Note that fiberglass protrudes through SS.

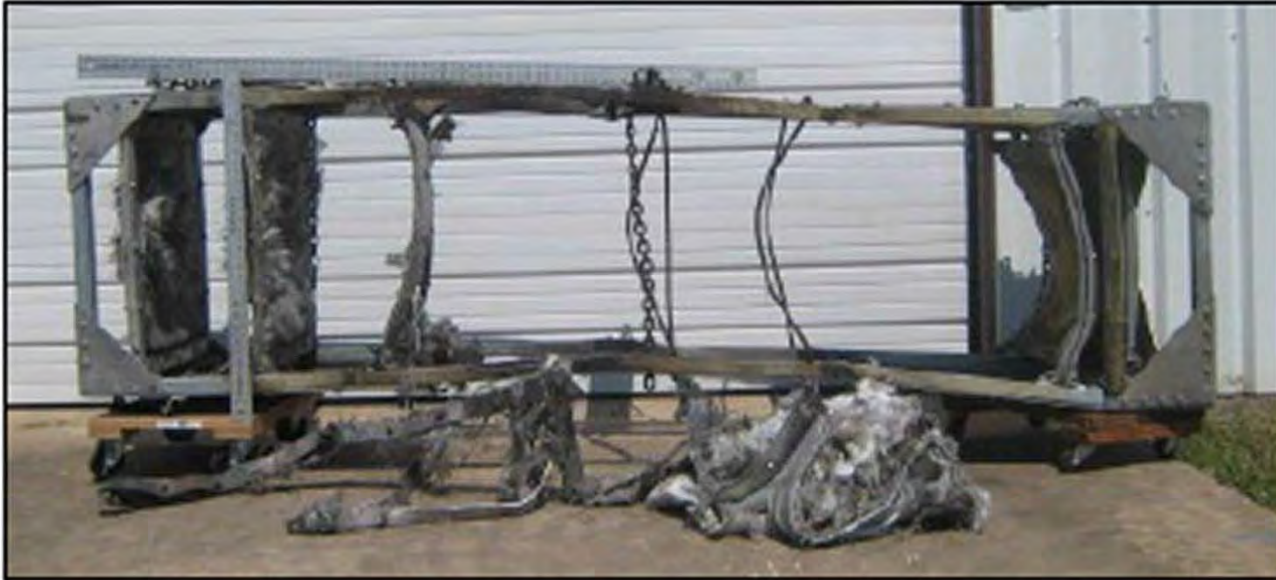
Bumper 1: Fiberglass	Bumper 2: Fiberglass	Bumper 3: steel mesh	Bumper 4: Fiberglass	Bumper 5: Fiberglass	Rear wall 1: Kevlar	Rear wall 2: Kevlar
130 mm diameter perforation	300 mm diameter perforation	600 mm diameter perforation	300 mm diameter perforation (TBD), bumper frame dislocated from shield structure	No complete penetration, bumper frame dislocated from shield structure	Tear on outer fabric layer, no complete penetration	No damage

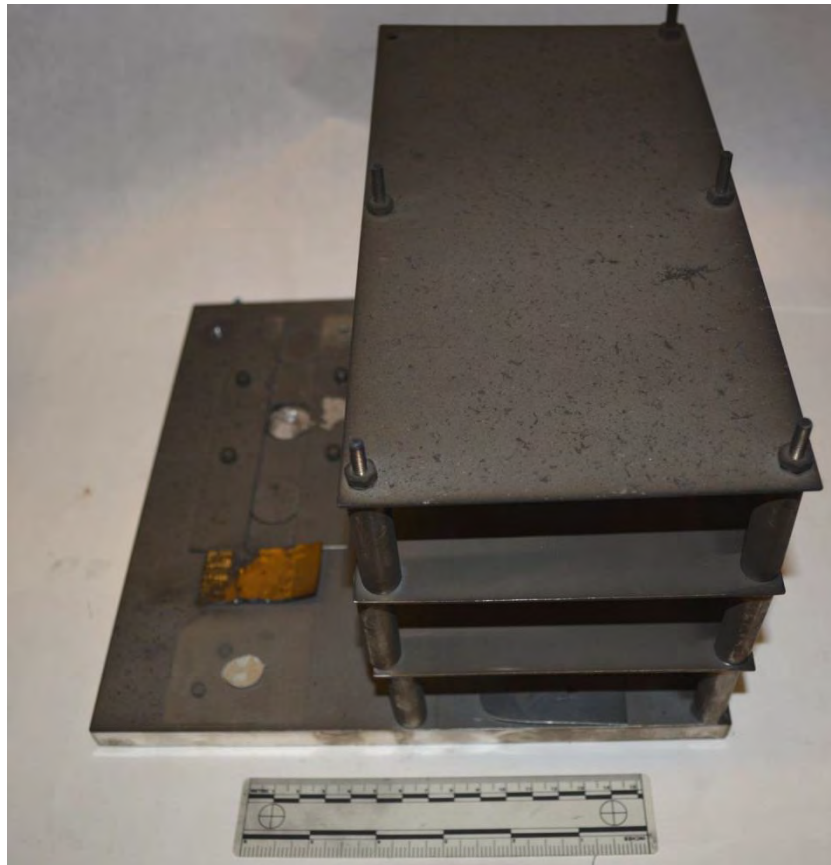
Witness Plates: Post Test

With Whipple plate shields

Whipple plates removed

Exposed surfaces are covered with a matte gray coating and fine debris.
Note thin darker band on base plate on up range side.

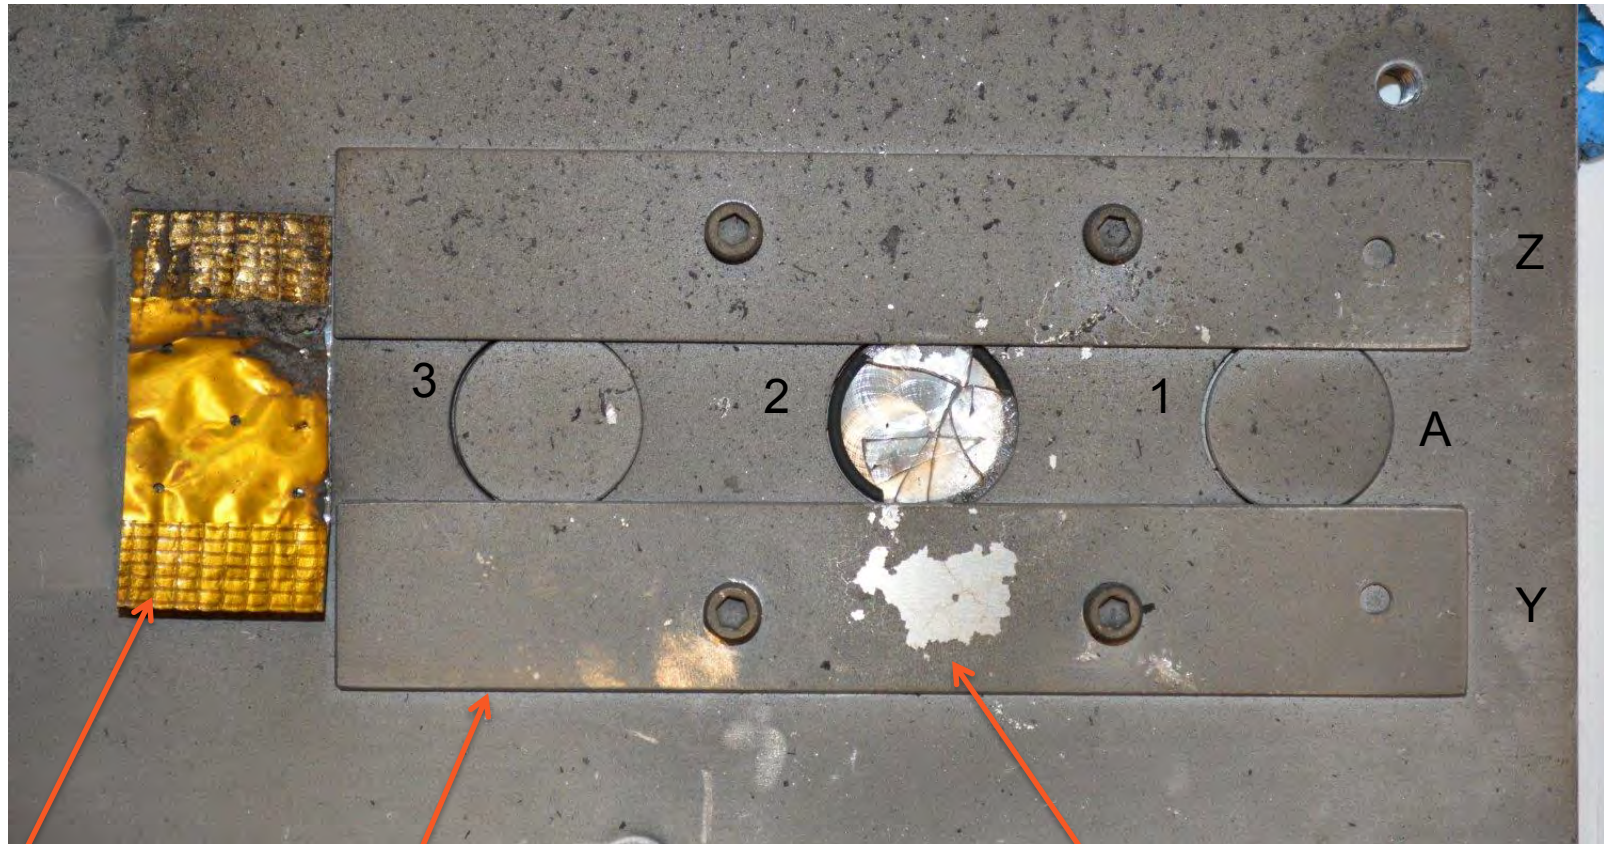
Witness Plates: Post Test (unprotected)

Note blistered and peeled coating and fractured quartz window

Exposed surfaces are covered with a matte gray coating and fine debris.
Note larger deposits are concentrated toward the down range side of the plate.

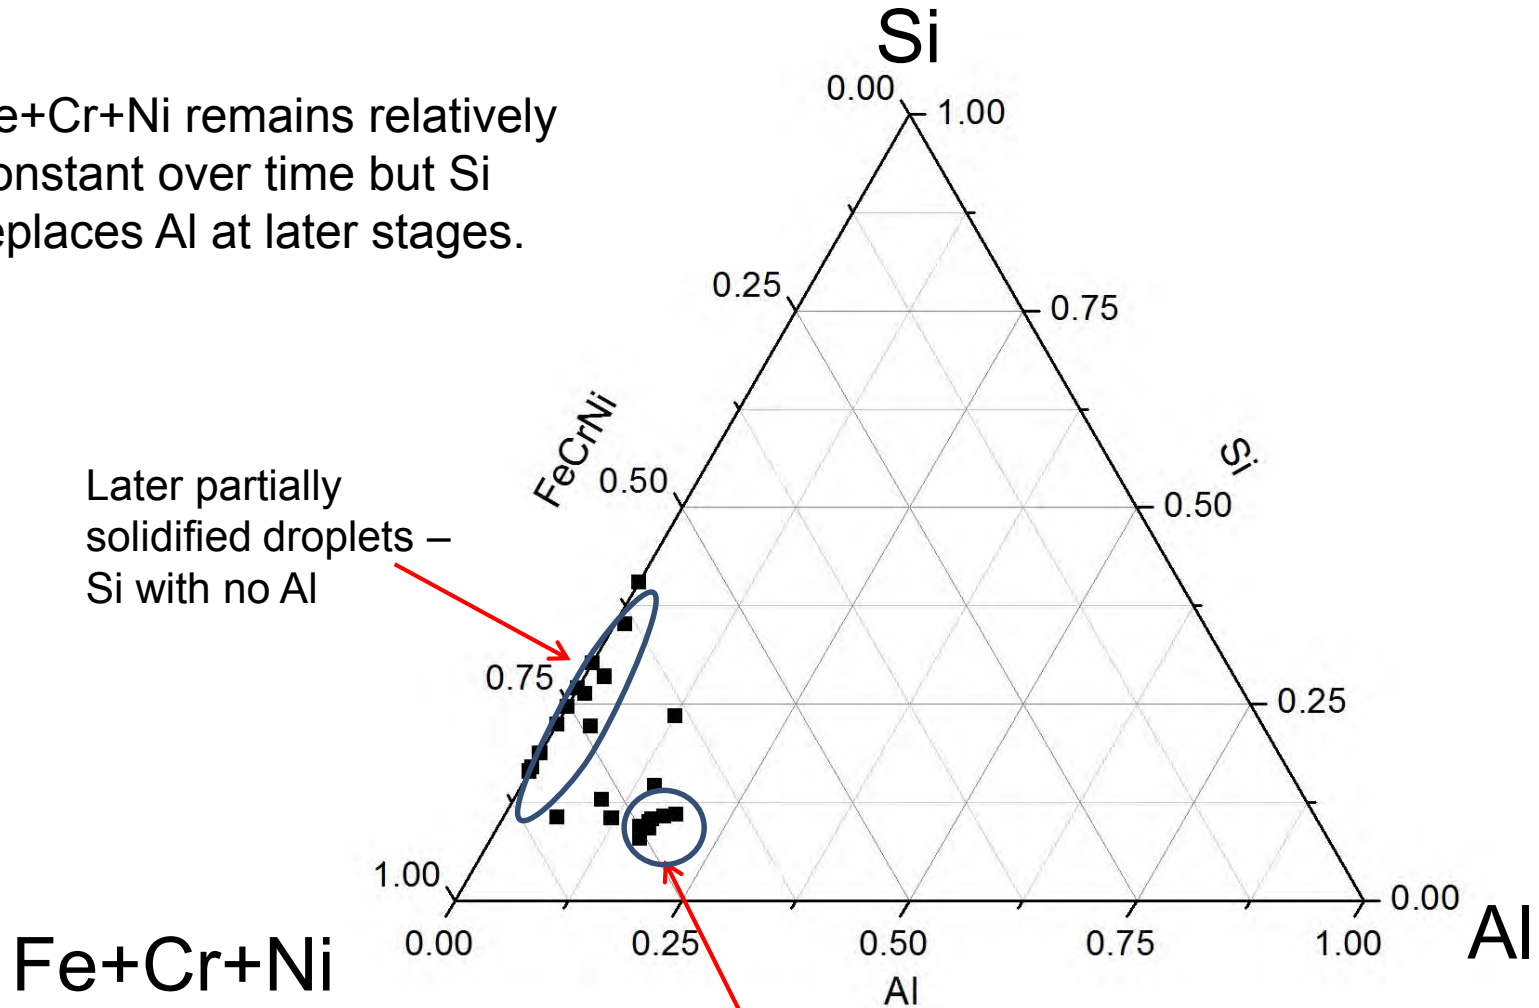
Composition of Fe-Cr-Ni Phase

Fe+Cr+Ni remains relatively constant over time but Si replaces Al at later stages.

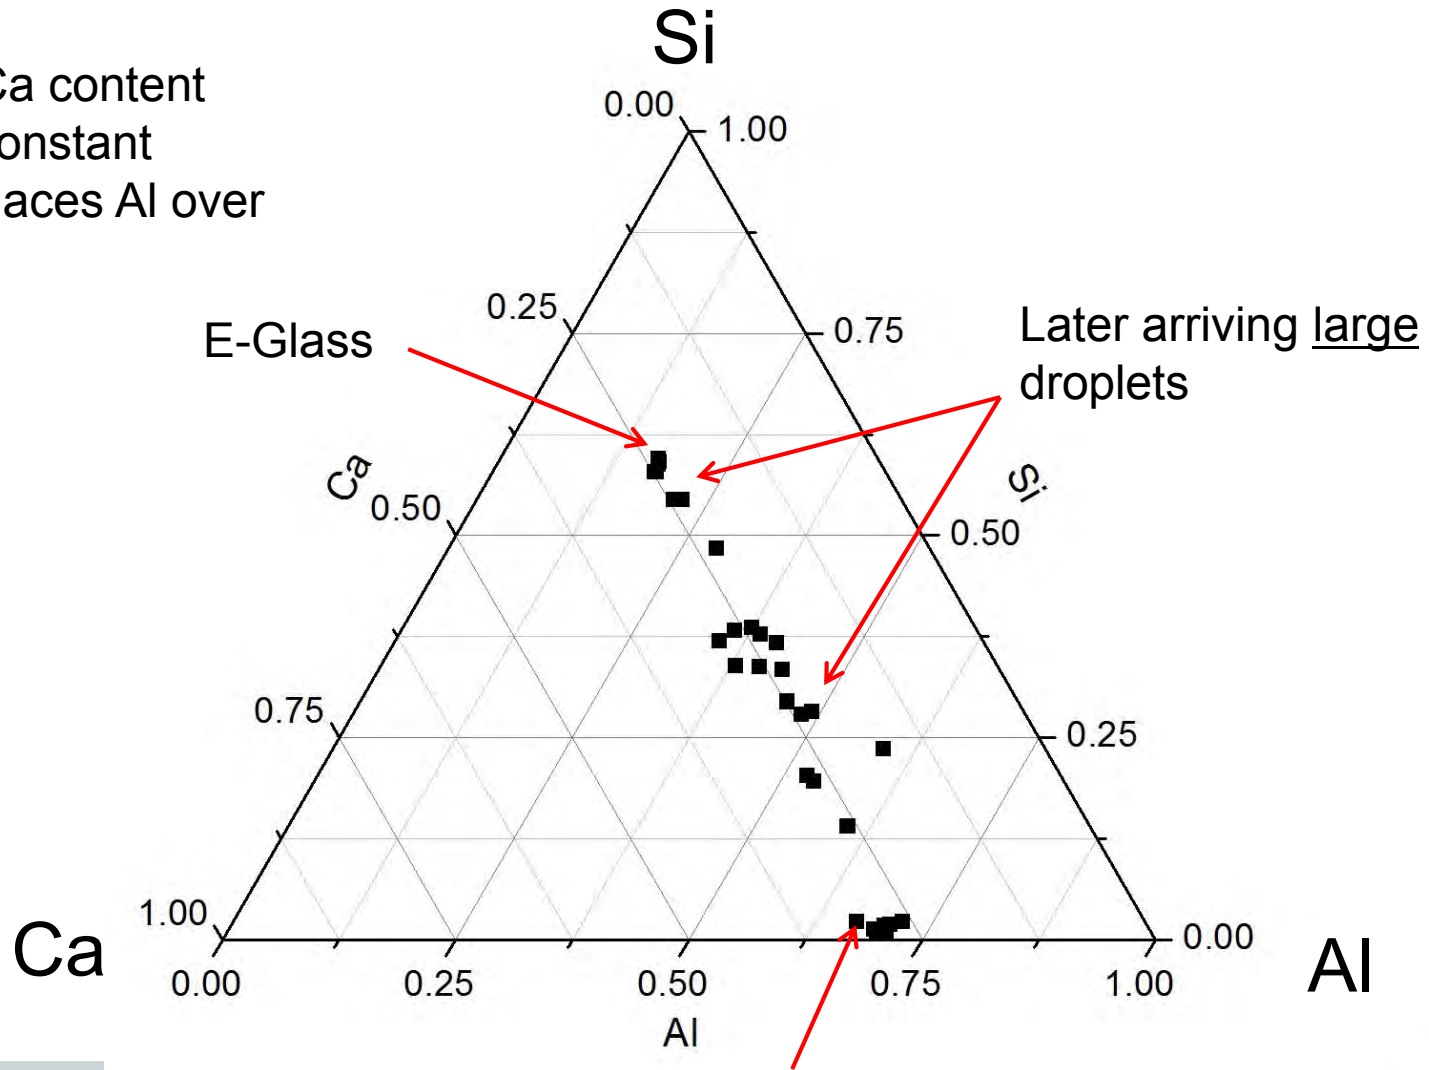
Composition of the Oxide-Silicate Phase

Relative Ca content remains constant but Si replaces Al over time.

Early oxide in complex flow patterns with Fe-Cr-Ni phase has high Al from the projectile?

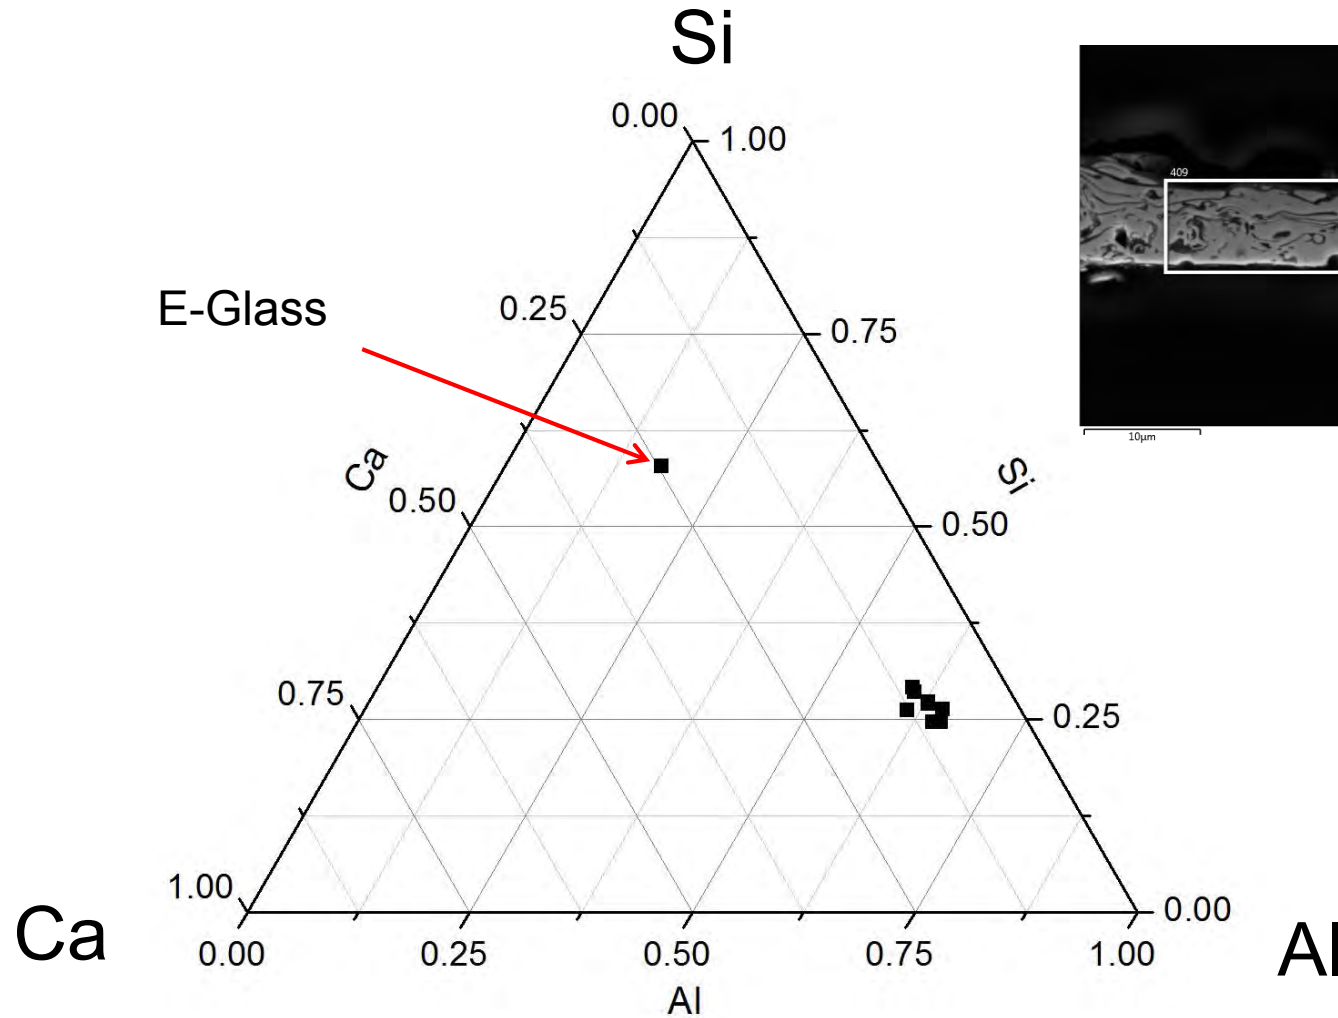
Integrated Ca-Al-Si Content of Fe-Cr-Ni and Ca-Al-Si Phases in Early Complex Flow Structure

In the early deposits there is considerably more aluminum than could have come from just E-glass – must have come from the projectile.

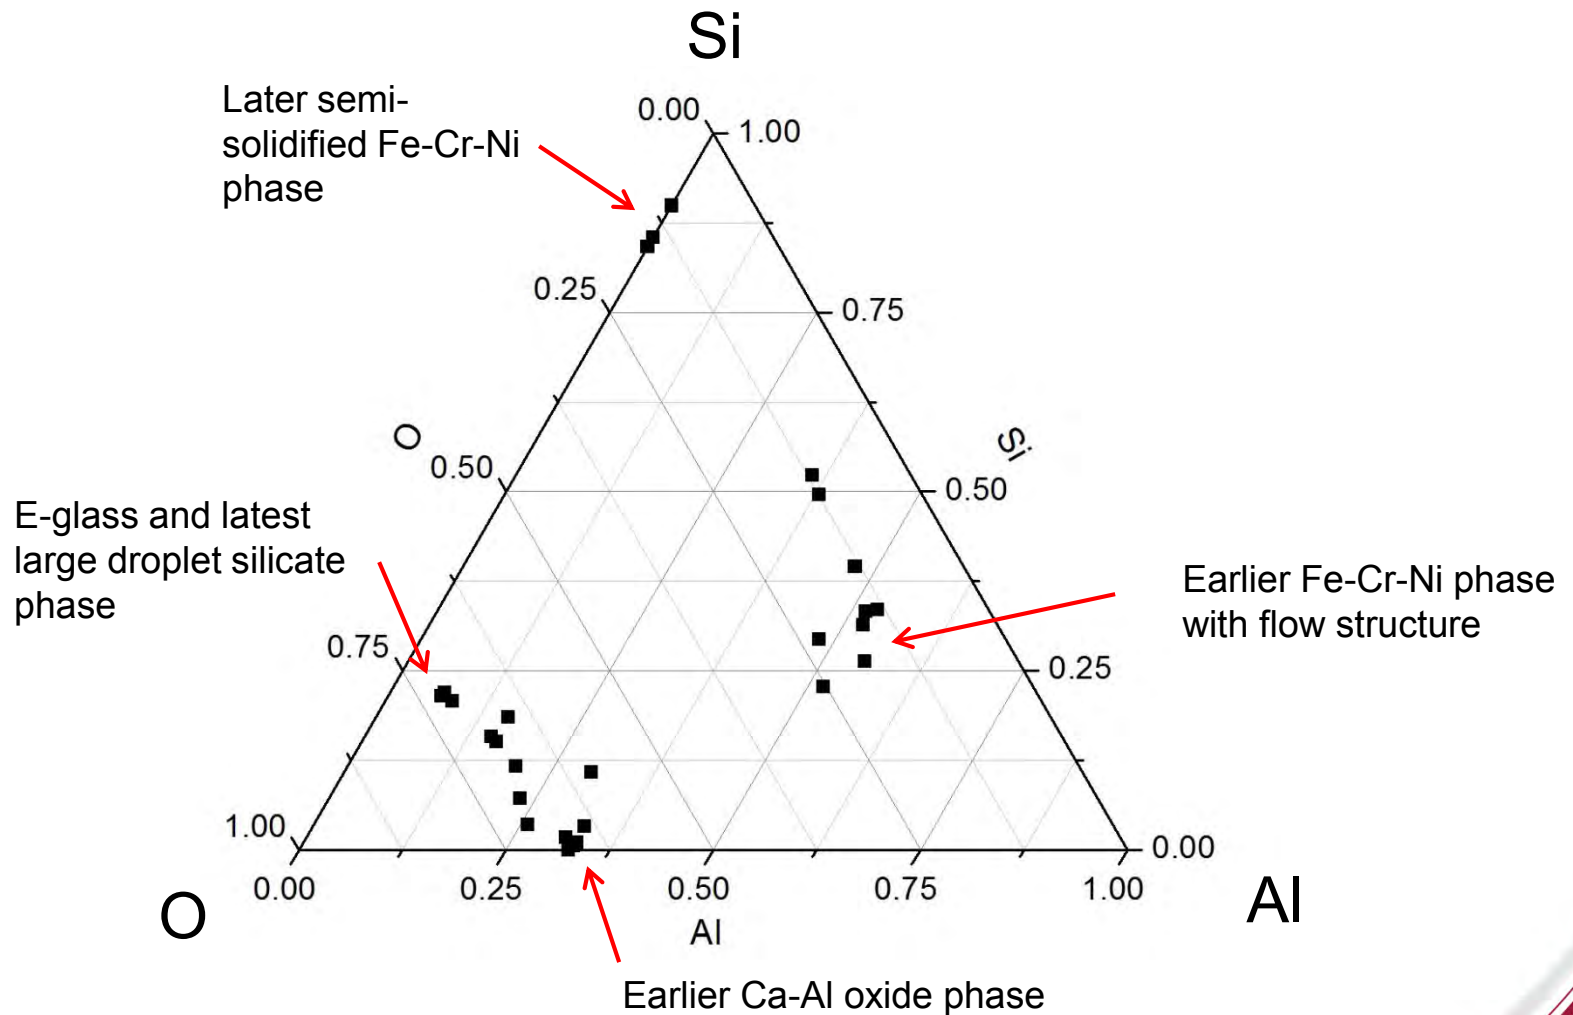
Relative Al-Si-O Contents of Fe-Cr-Ni and oxide/silicate phases

Aluminum content decreases over time – less contribution from the projectile.
Relative oxygen content remains nearly constant. Two episodes of deposition: early with flow structure and later semi-solidified large droplets.

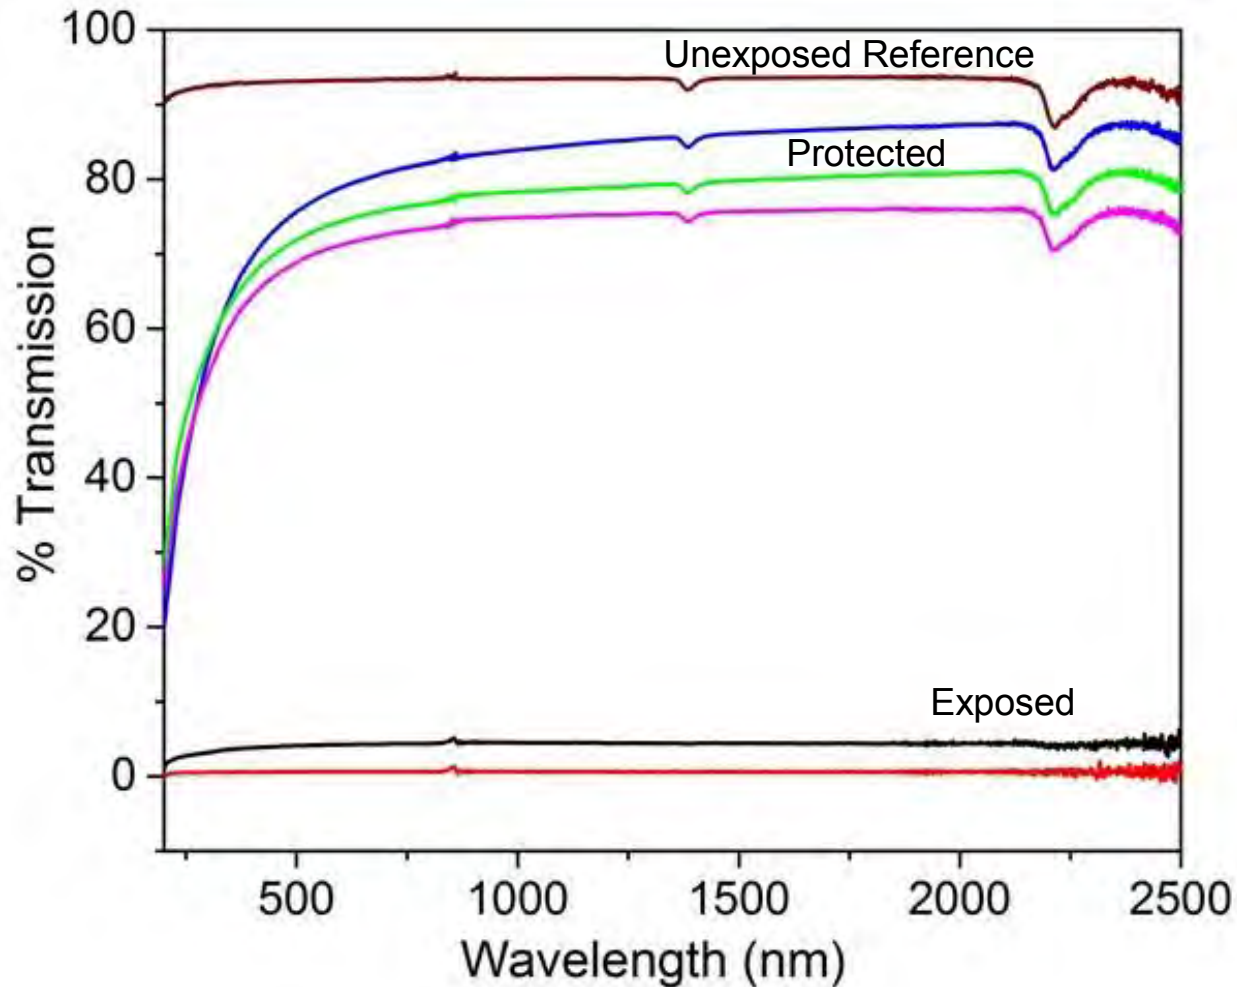
UV-VIS-NIR Spectroscopy (transmission) – SiO₂ Witness Plates

Protected samples show a 10-20% drop in transmission while exposed samples are nearly opaque.

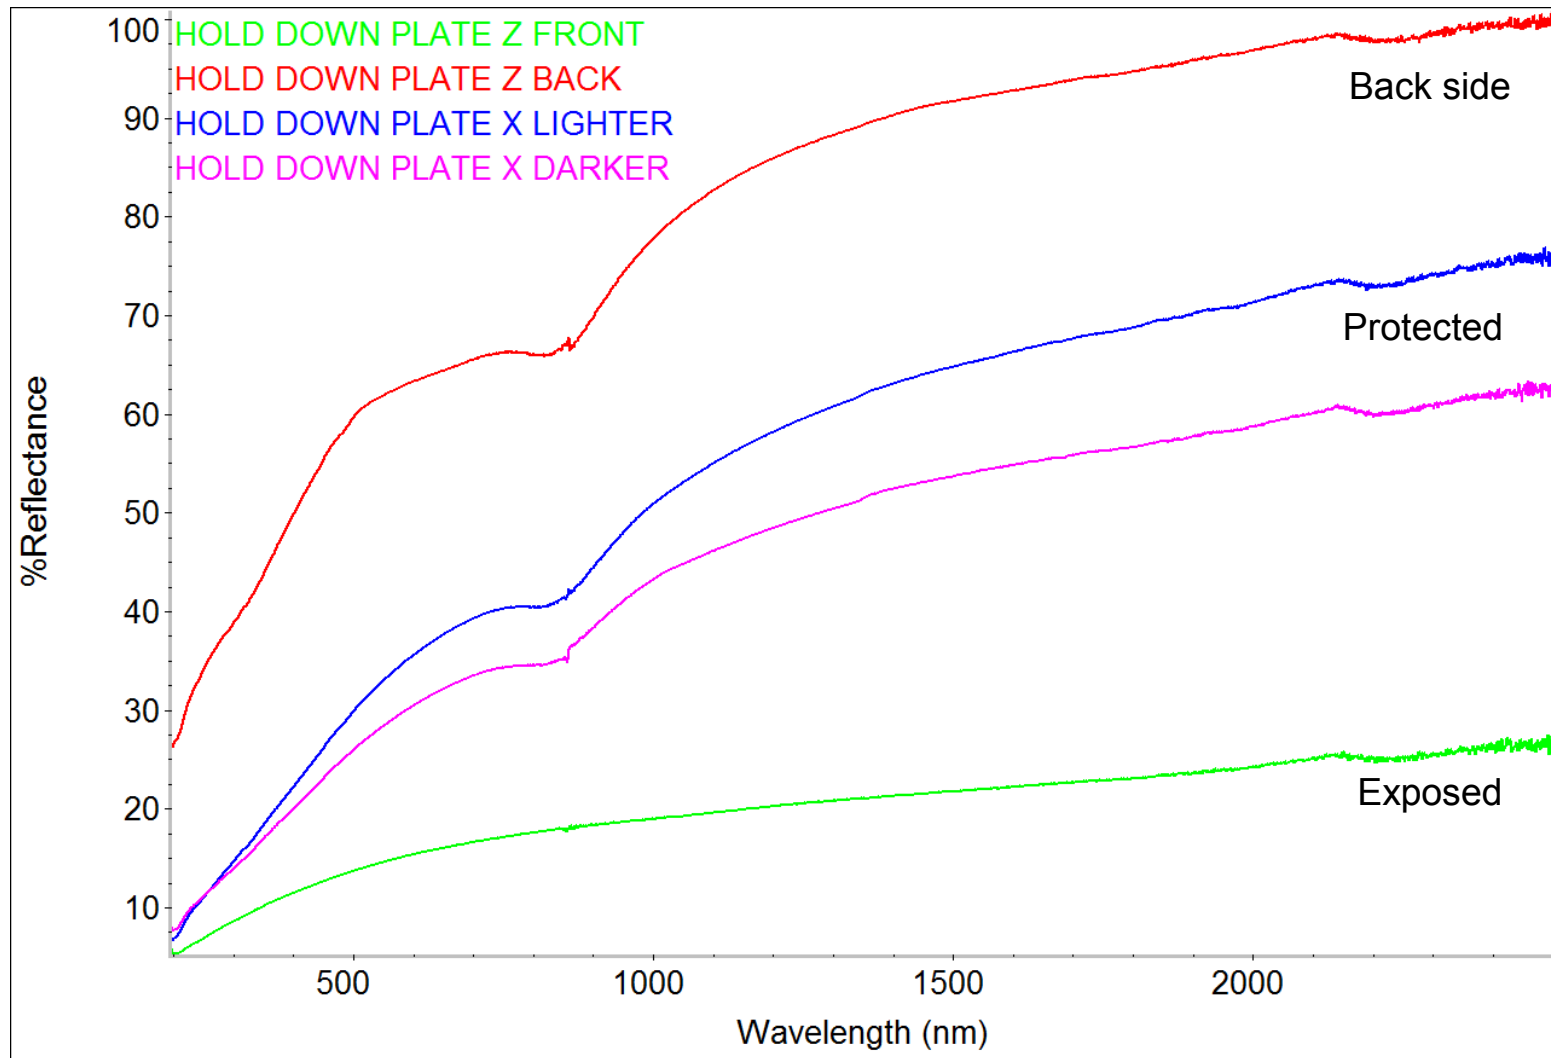
UV-VIS-NIR Spectroscopy (reflectance) – Hold Down Plates

Significant decrease in reflectance on exposed surfaces.
Less so on protected surfaces.

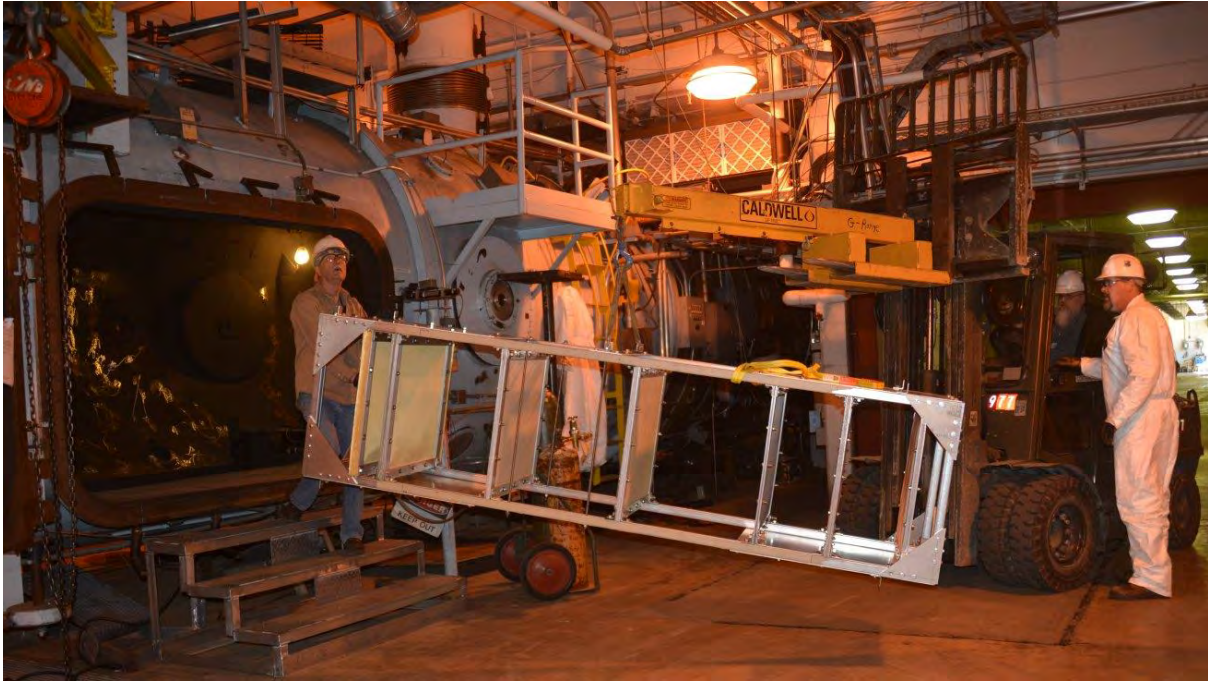
Target being loaded into chamber.
Target is 2.63 meters long and weighs about 700 lbs.

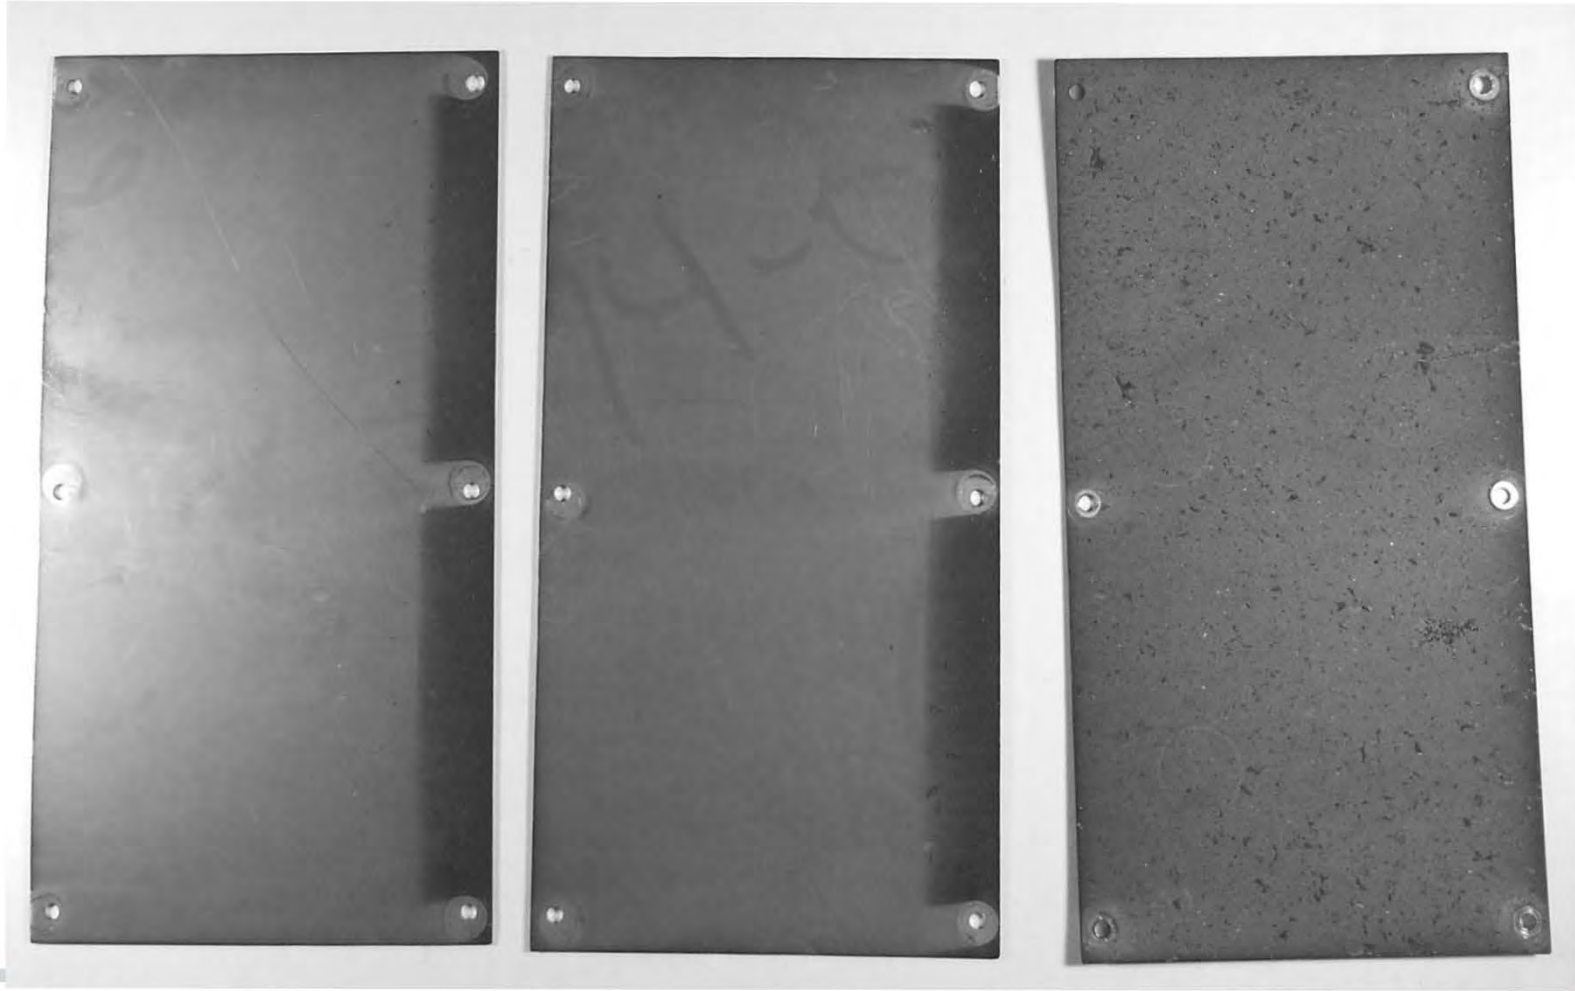
Up range is to the right – note sharp band of deposits on up range side (right) of middle and lower Whipple plates

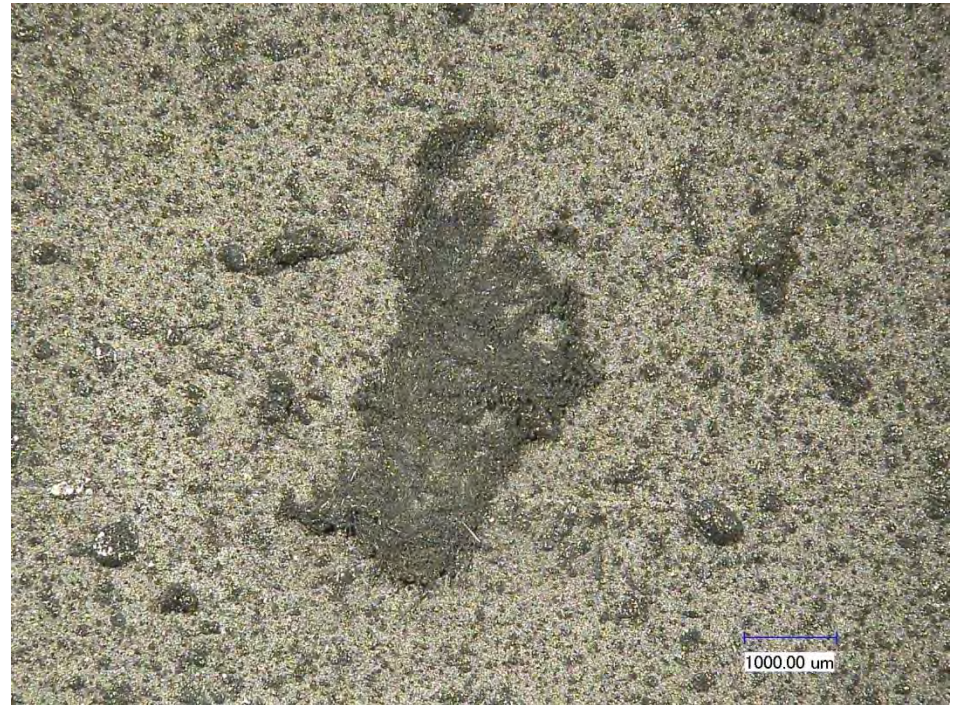
Close up of larger deposits on down range side plate.
