# **Final Environmental Assessment**

## **San Antonio Creek Restoration**

### **Vandenberg Air Force Base California**

**8 September 2008**

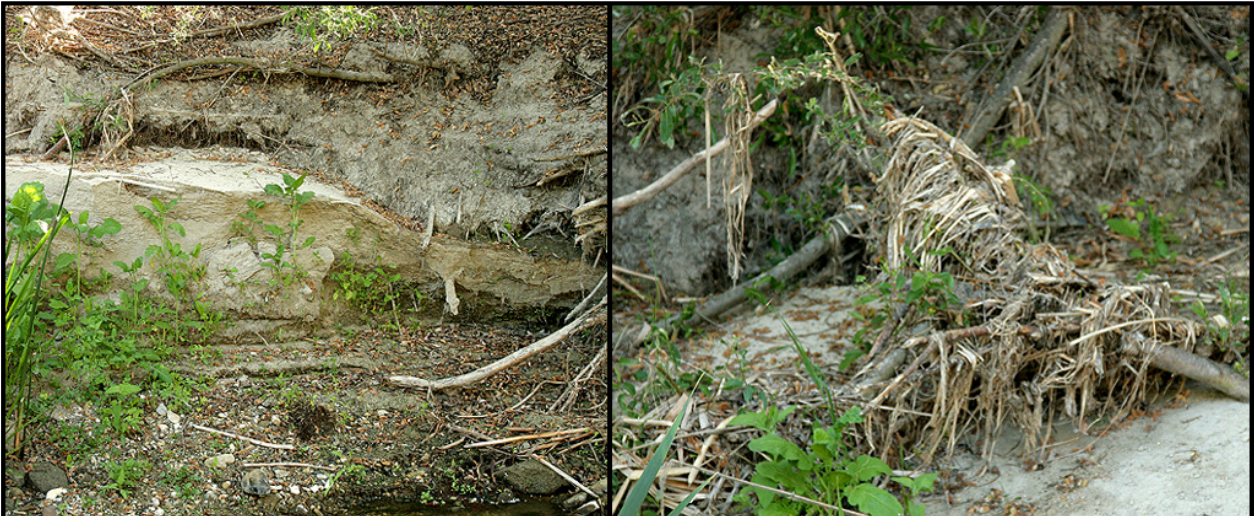
Figure 5. Shelving on the bank (left) and sediment deposits (right) were two features used to determine the OHWM.

The boundaries of Waters of the United States include areas encompassed by the OHWM of San Antonio Creek, wetlands adjacent to the San Antonio Creek channel, and areas bound by the San Antonio Creek channel. Near average rainfall levels in the 2007-2008 rainy season indicate that the OHWM established during that rainy season is likely reflective of normal circumstances. A total of 4.75 acres within the project area constitute Waters of the United States. Map 7 illustrates the extent of the Waters of the United States within the project area.
