## **THESIS**

### **GLASS FIBER RESIN COMPOSITES AND COMPONENTS AT ARCTIC TEMPERATURES**

June 2015

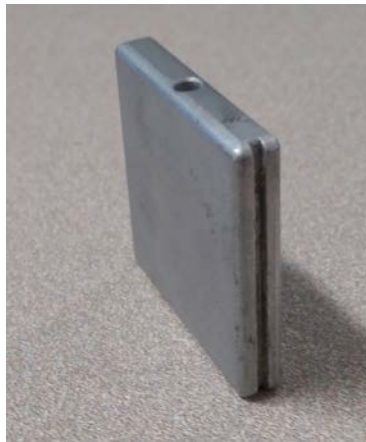
The first attempt at a holder consisted of a 50.8 mm by 50.8 mm by 6.35 mm aluminum block (see Figure 2). A 3.18 mm hole was drilled through the center of one of the 6.35 mm sides and a groove cut into one of the sides parallel to the hole. In addition, all of the corners were rounded off. The fiber would go through the hole, wrap around the block in the side groove, through the hole again, and be pinched between the block and grip. In theory, this design would distribute the load over a long contact patch and prevent shearing of the fiber. In reality, either the machining marks in the hole or the radius of around the edge of the whole sheared the fiber at less than one newton of force.

Figure 2.    First fiber holder.

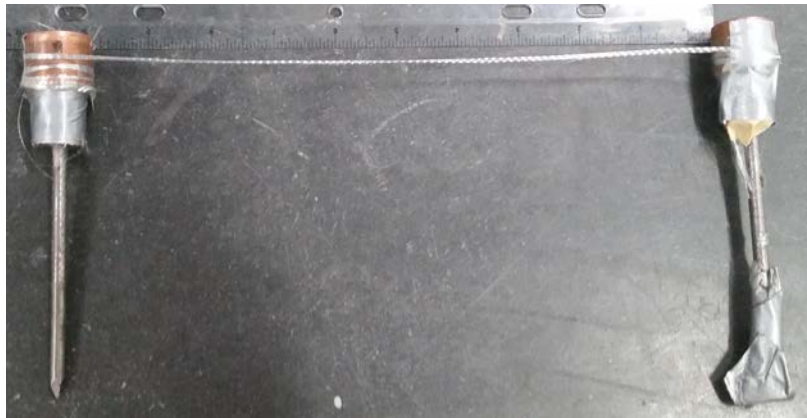
Any holder produced had to fit within the 6.35 mm wide grip of the MTS, so this eliminated wrapping the fiber around a pipe. A coupling nut that had an inner diameter slightly larger than the gutter nail and a 25.4 mm to 19.1 mm copper pipe reducer were purchased. Two layers of duct tape were wrapped around the gutter nail, and the coupling nut was threaded onto the duct tape. The reducer, which had a small side inner diameter slightly smaller than the widest part of coupling nut, was then hammered on the coupling nut. To put all the pieces together, Gorilla glue was applied to the small end of the reducer to attach it directly to the nail (see Figure 3).

Figure 3. Fiber setup with successful holder.

While the final holder design worked on 7500 Hexcel 6 ounce plain weave E-Glass fabric, it broke in attempts to test other fabric used in previous experiments. The torque caused by the fiber rotating around the pipe reducer was too great for the duct tape and Gorilla glue. Both would fail, allowing the pipe reducer to freely move and the fiber to unwind off the reducer. Additionally, the nail had started to flex under the load. Had time permitted, a holder with a similar design with a corresponding clamp would have been machined from two blocks of steel. This would have prevented the end from spinning and reduced the likelihood of fiber slip.

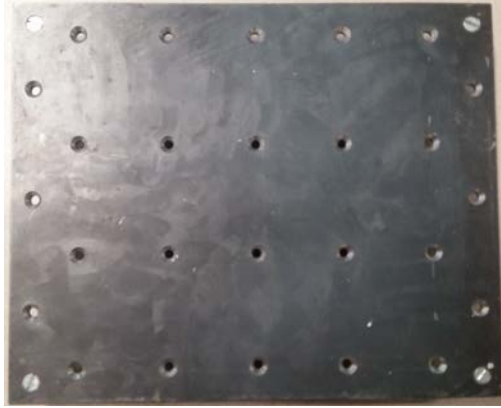
The bottom plate was a 6.35 mm in thickness. It had 27 through holes for attaching it to the middle plate, and four 10–24 threaded holes in the corners of the plate to be used for guide screws (see Figure 4). All holes were countersunk in the back to allow the plate to lie flat.

Figure 4. Underside view of bottom plate.

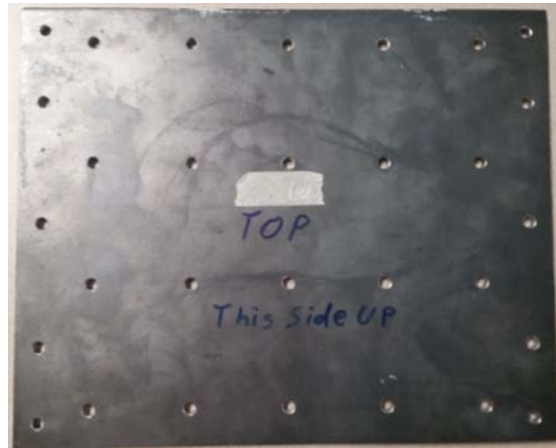
The top plate consisted of 10–24 clearance holes that matched the pattern of the screw pattern of the middle plate (see Figure 6). The top plate was originally intended to ensure a smooth top specimen surface, but early tests showed that the surface was naturally smooth without the top plate. It was needed to prevent the screws from puncturing the plastic vacuum sheet.

Figure 6. Top plate.

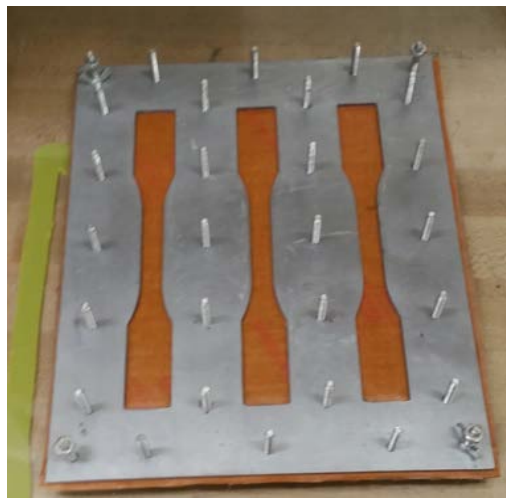
The mold assembly was fastened using 10–24 machine screws (see Figure 7). The four corner guide screws were inserted into the bottom plate first. The cardboard and wax

paper gasket was then placed on top of the bottom plate using the four corner screws as a guide. The middle plate was then placed onto of the gasket in the same manner. Wingnuts were then gently threaded on to the corner screws to keep the two plated together as the remaining screws were installed. The screws were tightened enough to create a seal, but not enough to crush the cardboard. If the screws were over tightened, the cardboard would protrude into the specimen holes causing an uneven specimen surface. Nuts were then threaded on to the four corner screws about 6.35 mm from the top. The nuts were used to support the top plate during curing.

Figure 7. Assembled mold.

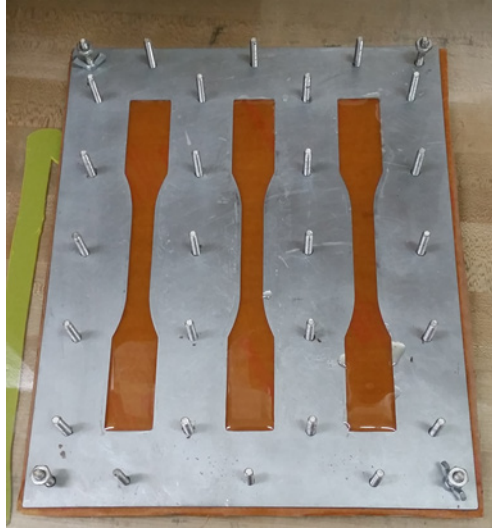
To insert the resin into the mold, a 500 ml syringe was used to minimize resin spilling outside of specimen holes. When inserting the resin into the mold, great caution was used to prevent bubbles from forming in the specimen, but some bubbles would still form. Dragging the tip of the syringe across the bubbles would usually pop them if the mold was not completely full. Due to this, the narrow section of the specimen was filled first, so there would be no air pockets in the critical part of the specimen (see Figure 8). Dipping the syringe in the resin beaker will cause air bubbles to form, but dipping the syringe into the same spot each time and making extra resin minimized the amount of air in the syringe.

Figure 8. Resin-filled mold.

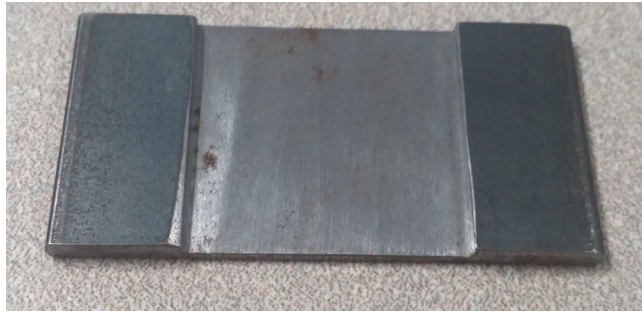
To prevent the resin specimen from being crushed by the MTS, protection is required. To protect the specimen, a 1.59 mm groove was cut into a 38.1 mm wide by 3.18 mm thick strip of steel (see Figure 11). This was then cut into 25.4 mm long pieces. The groove and specimen were then roughed up with sandpaper and washed. Two strips were then glued to the specimen using Gorilla glue with the groove contacting the specimen (see Figure 12).

Figure 11. Resin protection.

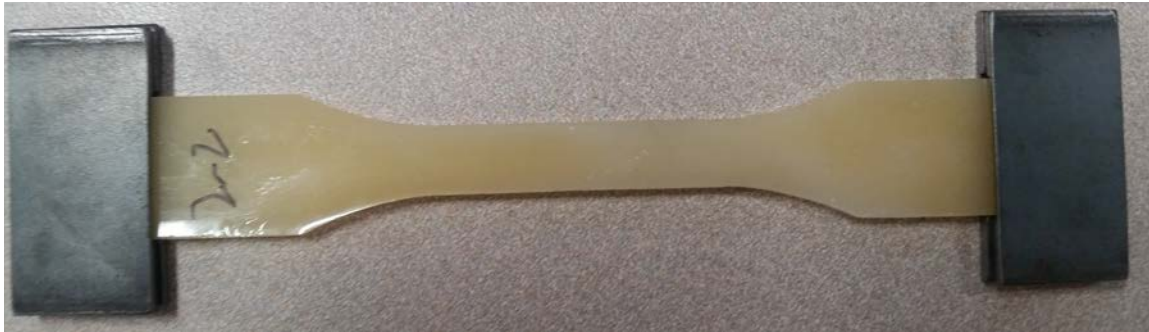
Figure 12. Complete resin specimen.

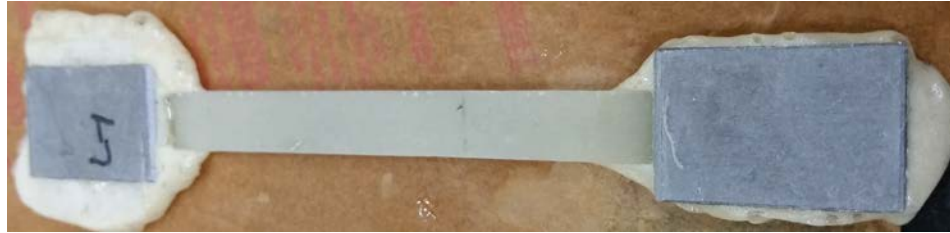
It was decided to attempt to use the same original tabs with the 12.7 mm samples, and attempting to stabilize them with extra glue, or scrap piece of composite (see Figure 15). This too failed, so it was decided to extend the length of the tabs to 63.5 mm and 12.7 mm wide, and switch to an epoxy.

Figure 15. Third composite specimen attempt.

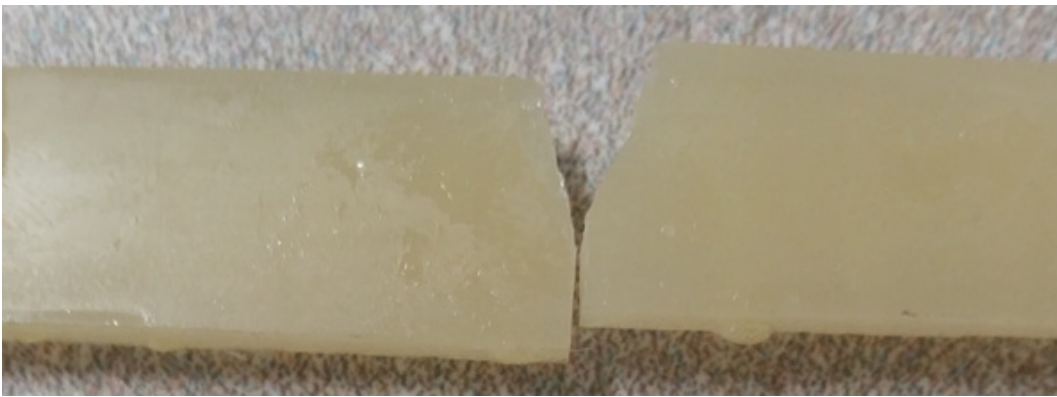
The resin samples exhibited signs of brittleness in how they broke. The breaks were not clean and consistently resulted in pieces missing from the center following failure. In one case, a piece was exhibited to fly approximately 3 m following failure. It appears that the missing piece was bigger on the cold samples (see Figure 20) than on the room temperature samples (see Figure 21).

Figure 20. Typical failure of a resin specimen at room temperature.

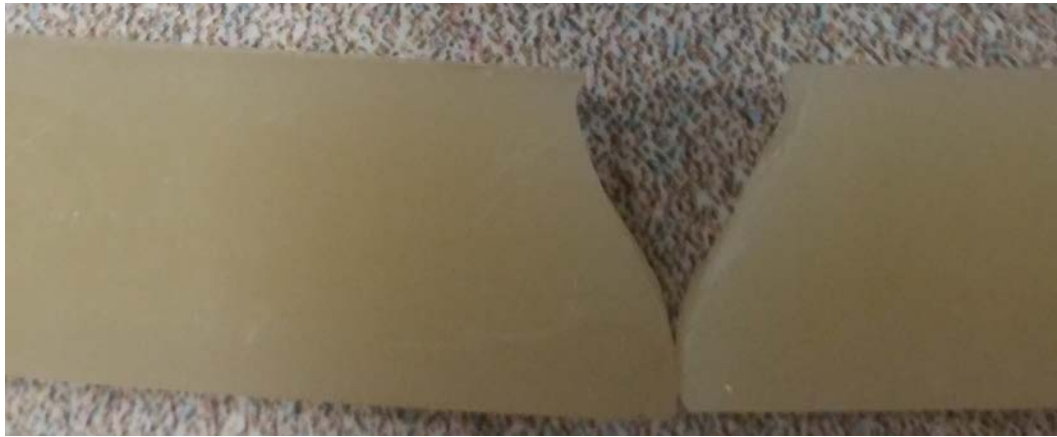
Figure 21. Typical failure of a resin specimen at cold temperatures.
