TECHNICAL REPORT REMR-CS-11

**IN SITU REPAIR OF DETERIORATED  
CONCRETE IN HYDRAULIC STRUCTURES  
LABORATORY STUDY**

**R. P. Webster, L. E. Kukacka**

Process Sciences Division  
Brookhaven National Laboratory  
Upton, New York 11973

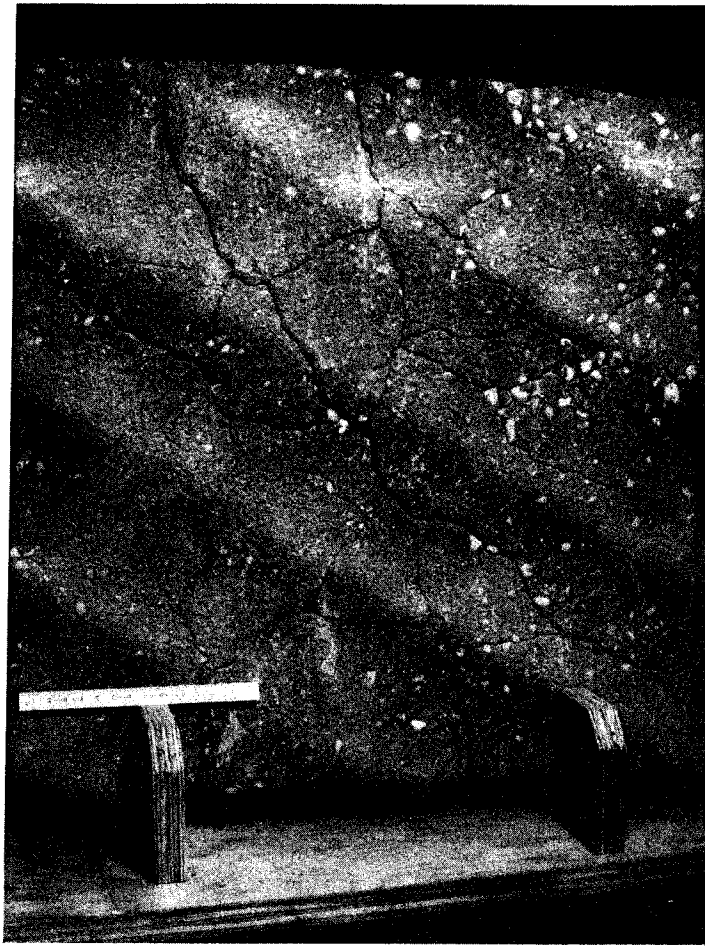
Figure 1. Typical "cracked" concrete slab.

10. The "cracked" slabs were fabricated by casting them individually into sheet metal forms. After the mixture had taken its initial set (3 to 4 hr after being fabricated), the corners of the forms were opened, and the slabs were flexed by hand until cracks began to open up in the surface. Cracks varying in width from hairline to 1/4 in. could be created this way (Figure 1). All slabs were sandblasted prior to being repaired.

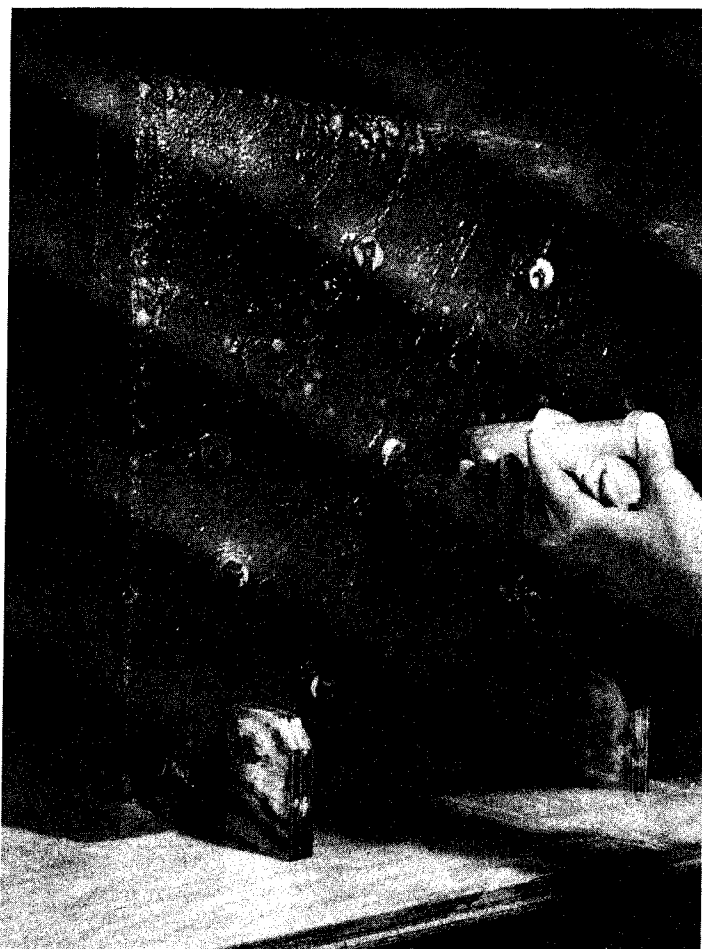
Figure 2. Repair of slab by injection using a plastic syringe.

25. The water-saturated slabs were soaked in water for a minimum of three days between steps 2 and 3. They were then patted dry to a SSD condition before the injection ports (1-in. diam wooden dowel into which a hole had been drilled) were glued to the surface. Because of the small quantities of materials used to repair the slabs, all the injection work was done by hand using plastic syringes (Figure 2).

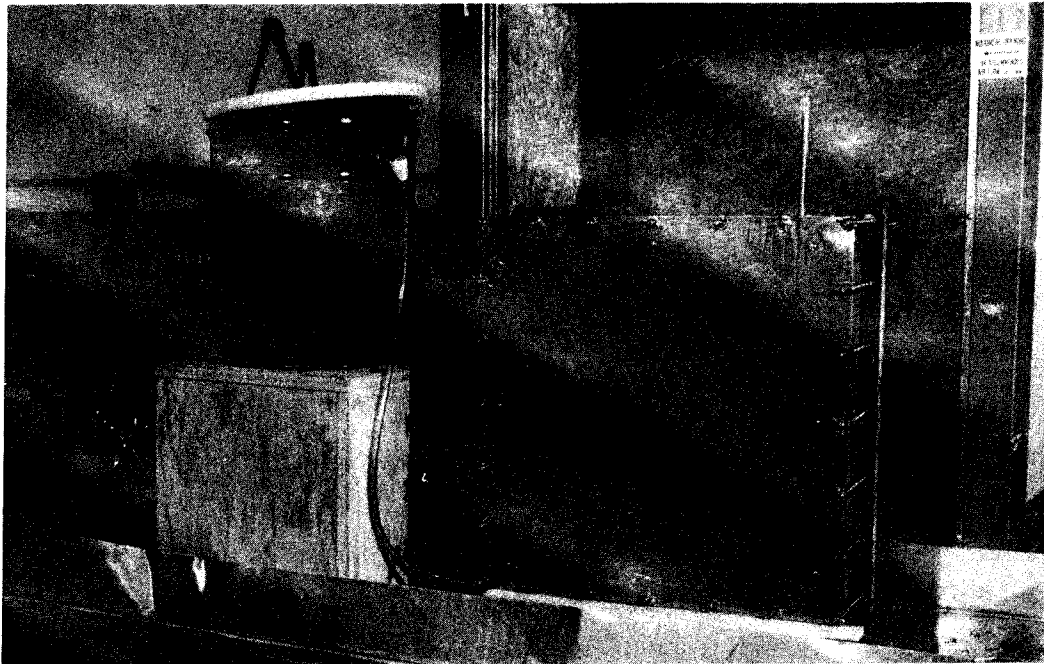
A. Laboratory set-up for vertical impregnation studies.

37. All vertical impregnations were done using a soaking jacket which was braced against the face of the slab (Figure 6). The soaking jacket was made of 0.05 in. thick stainless steel sheet with a 0.5 in. thick stainless steel spacer around the edge of the jacket. A closed-cell polyurethane was used as a gasket material to seal the soaking jacket to the face of the slab. The sides and back of all slabs were coated with a gel epoxy to prevent leakage of monomer during soaking.
