**AIRPLANE LANDING MAT INVESTIGATION**  
**TESTS ON STEEL, PIERCED TYPE, M7**

**TECHNICAL MEMORANDUM NO. 3-266**

**WATERWAYS EXPERIMENT STATION**

**DECEMBER 1948**

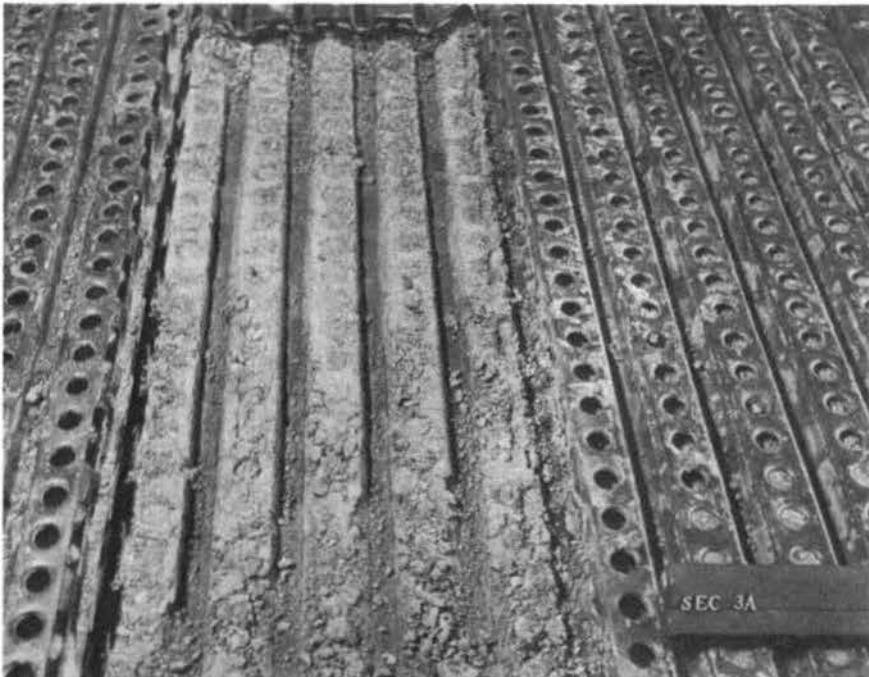
Fig. 2. Appearance of subgrade after removal of plank at 528 coverages

men replaced the plank in 20 minutes. The closing side joint was made by welding each bayonet of the plank being replaced to the adjacent planks. The end joint where all bayonets had been cut away was also welded. The welding time was 30 minutes. These welded joints held satisfactorily throughout the remainder of the test. Plate 9 shows the metal cut away in order to remove the plank and the appearance of the subgrade after the plank was removed. Plate 10 shows the welded joints.

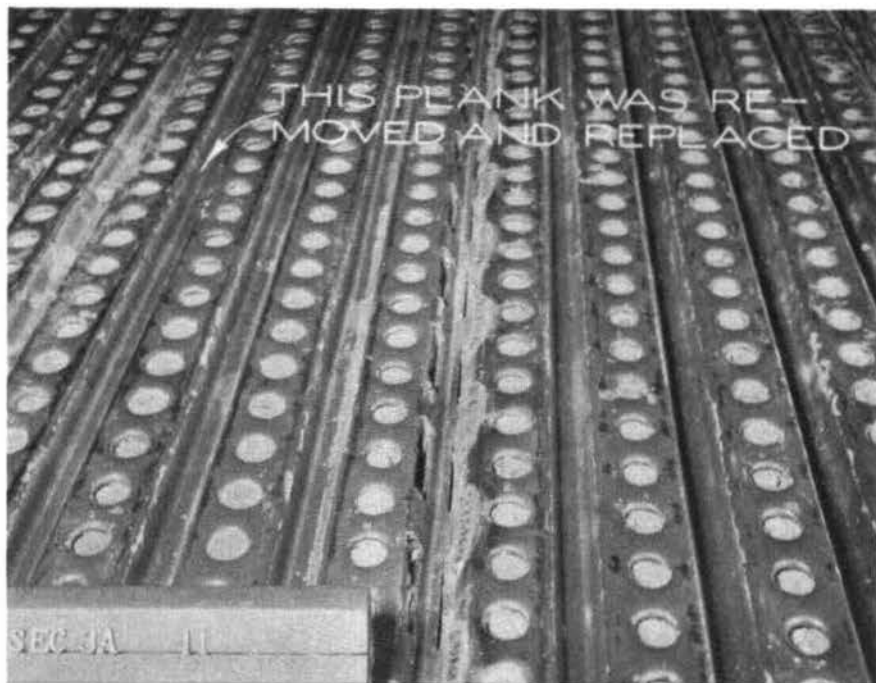
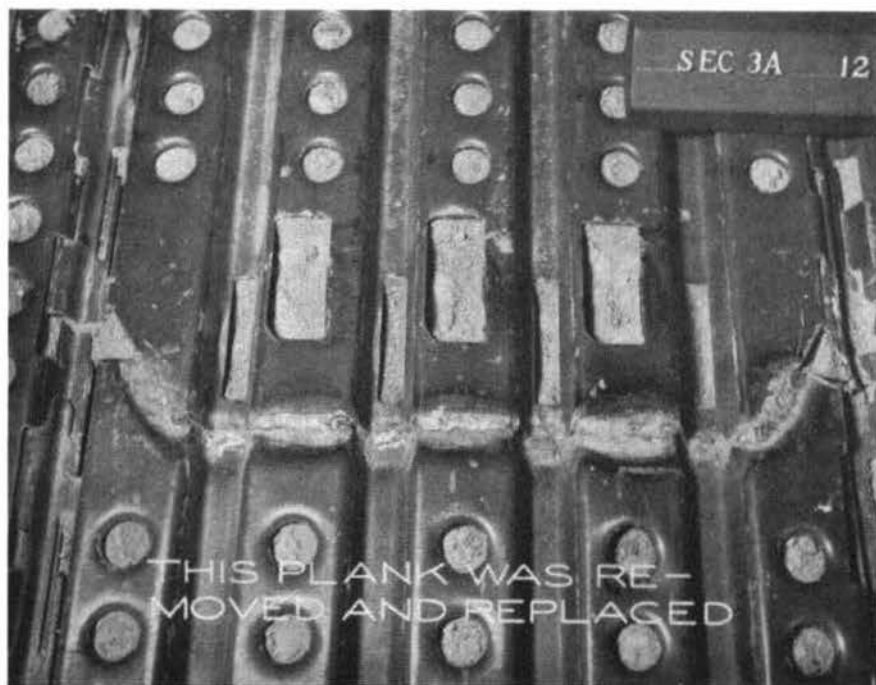
Side joint

End Joint

Welded joints where plank was replaced in area of M7 landing mat

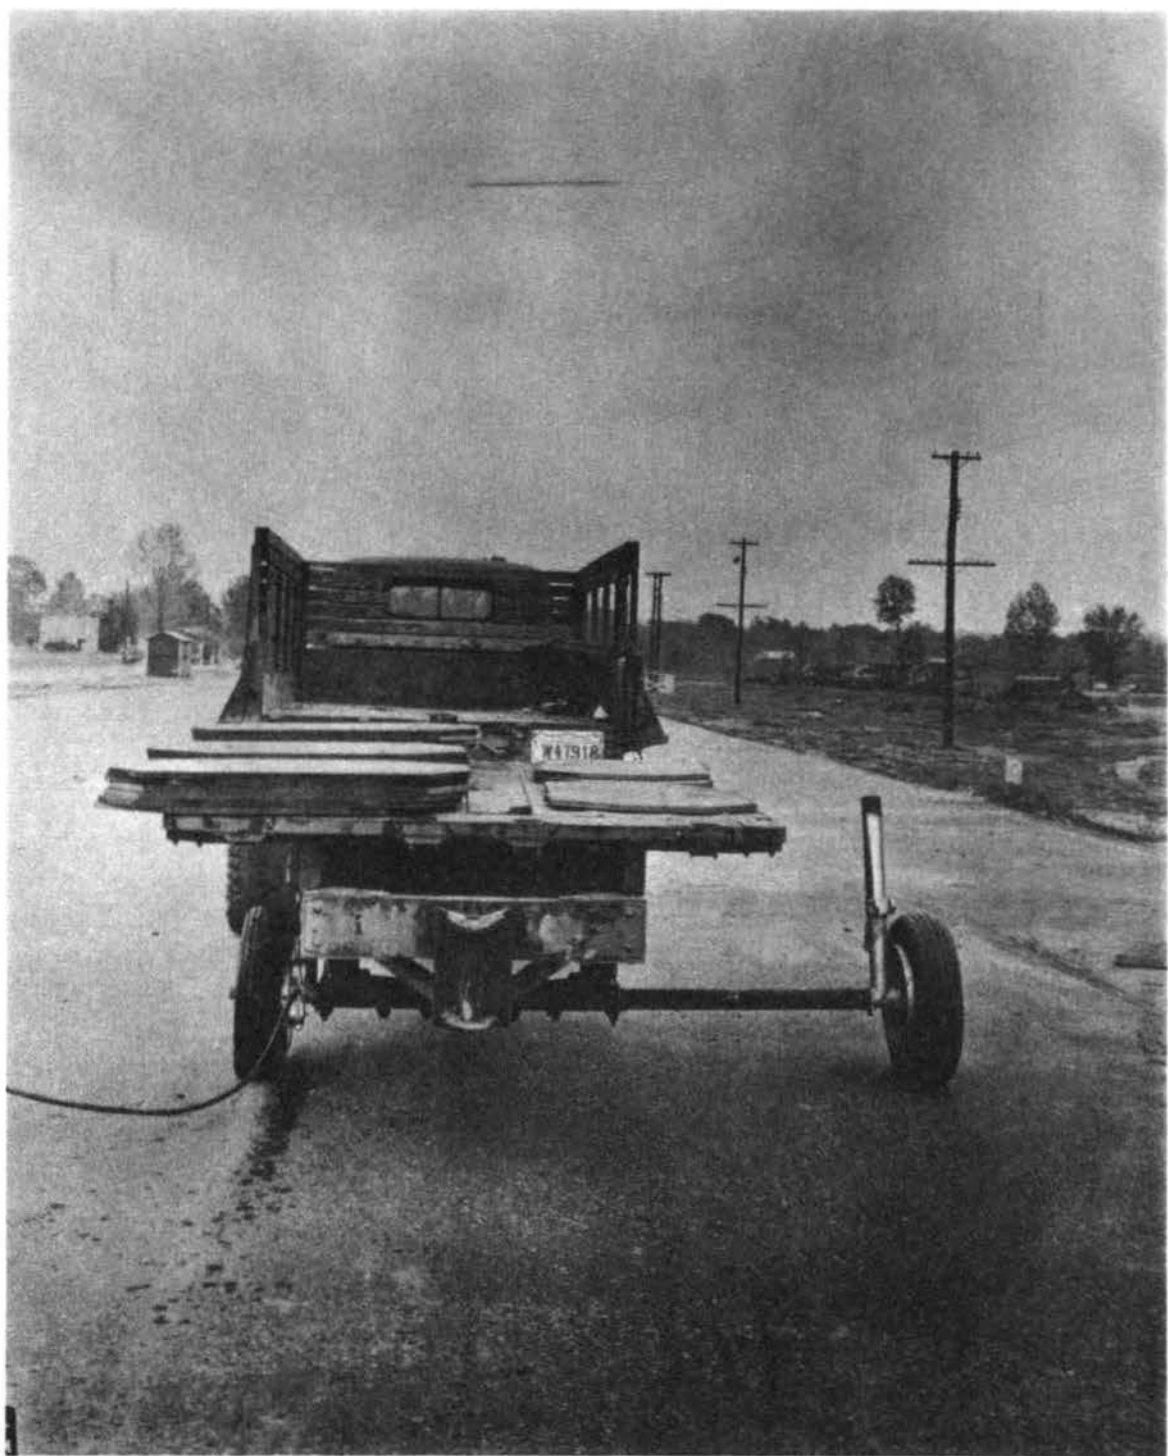
Load cart used in tire wear tests

16. A special load cart was improvised for use in these tests. It consisted of an Athey wagon with the tracks replaced by two 26- by 6.6-in. airplane tires, wheels and landing gear assemblies. One of these wheels was set partially under the Athey wagon body, and served as the

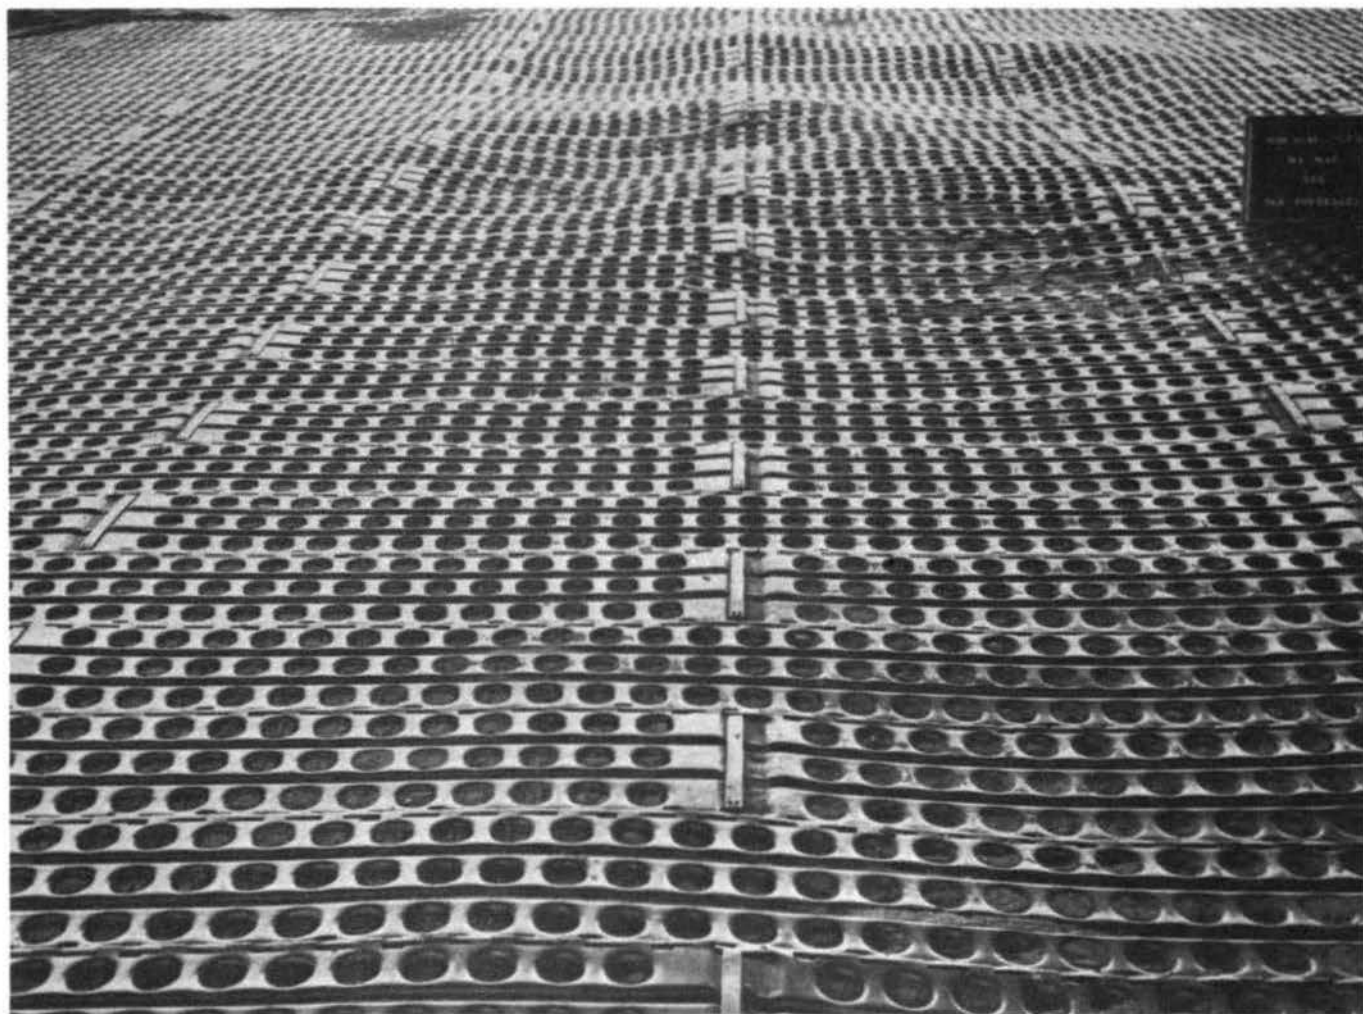
M6 mat in section 4 after 966 coverages

of the lane, but none had occurred back of station 0+90. At 450 coverages the roughness mentioned above had progressed back into the lane to station 0+75 and a few more breaks had occurred, bringing the total to 19. At this stage of the test the mat north of station 0+75 was bending under every pass of the wheel load, and the end connectors were being subjected to terrific punishment but none of them had broken or allowed the end joints to open up. The area between 0+50 and 0+75 was still in good condition with few, if any, mat breaks. From 450 coverages to the end of the test at 966 coverages the roughness of the entire section increased very slowly, but the decided roughness at the north end did not progress farther into the section; in fact, after about 500 coverages the subgrade seemed to consolidate and get somewhat harder. Mat breakage increased at a comparatively uniform rate from this stage to the end of the test. Despite the great amount of bending to which the mat was subjected, however, all end connectors held and all end joints were in good condition throughout the test. The total breakage in section 4 is listed below:

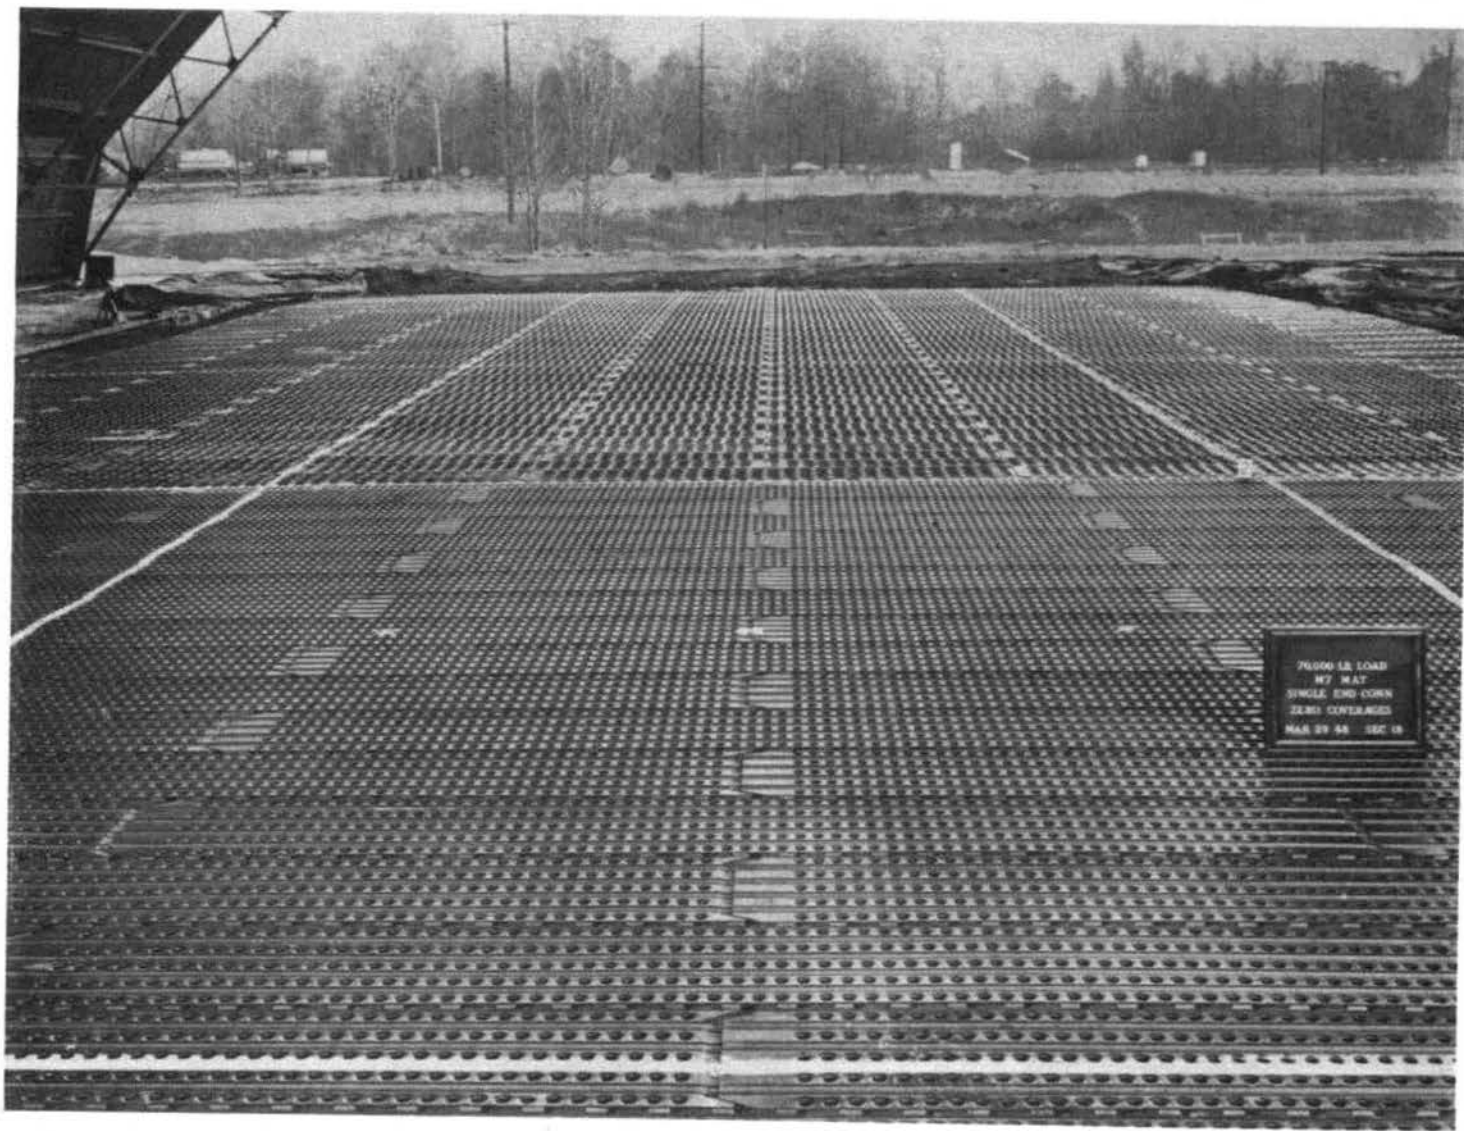
M7 and M6 mats in lane 1 before testing

32. M7 and M6 mats in lane 1. As a result of the very slow bedding rate observed in the test on lane 2 it was decided to leave a thin layer of lightly compacted material or bedding mulch at the surface in test lane 1. This was accomplished by leaving about an inch of loose material on the section. Both types of mat bedded into the subgrade much faster and more satisfactorily than they had in the subgrade of lane 2. The M6 mat was completely bedded down at 16 coverages, and except for the small area containing the PBS blanket referred to in paragraph 12, the M7 mat was fairly well bedded at 90 coverages. After the mat was completely embedded in the subgrade, there was little change in the appearance or condition of the lane throughout the tests. The general surface of the traffic lane had been depressed from 1 in. to 1-1/4 in. at 90 coverages, and this had increased by about 1/4 in. at 1000 coverages. No mat breakage occurred during the test. The subgrade consolidated to the extent that CBR values increased from about 16 to 48 at 2 in. below the surface, 16 to 30 at 9 in. below the surface, and 12 to 20 at 15 in. below the surface. There was no appreciable change below this depth. Plate 30 shows the mats before testing and plates 31 and 32 show the M7 and M6 mats, respectively, after testing. It was noticeable that the 70,000-lb dual wheel load did not impose as severe a test on the mats as the 50,000-lb load on a single wheel used on lane 2.

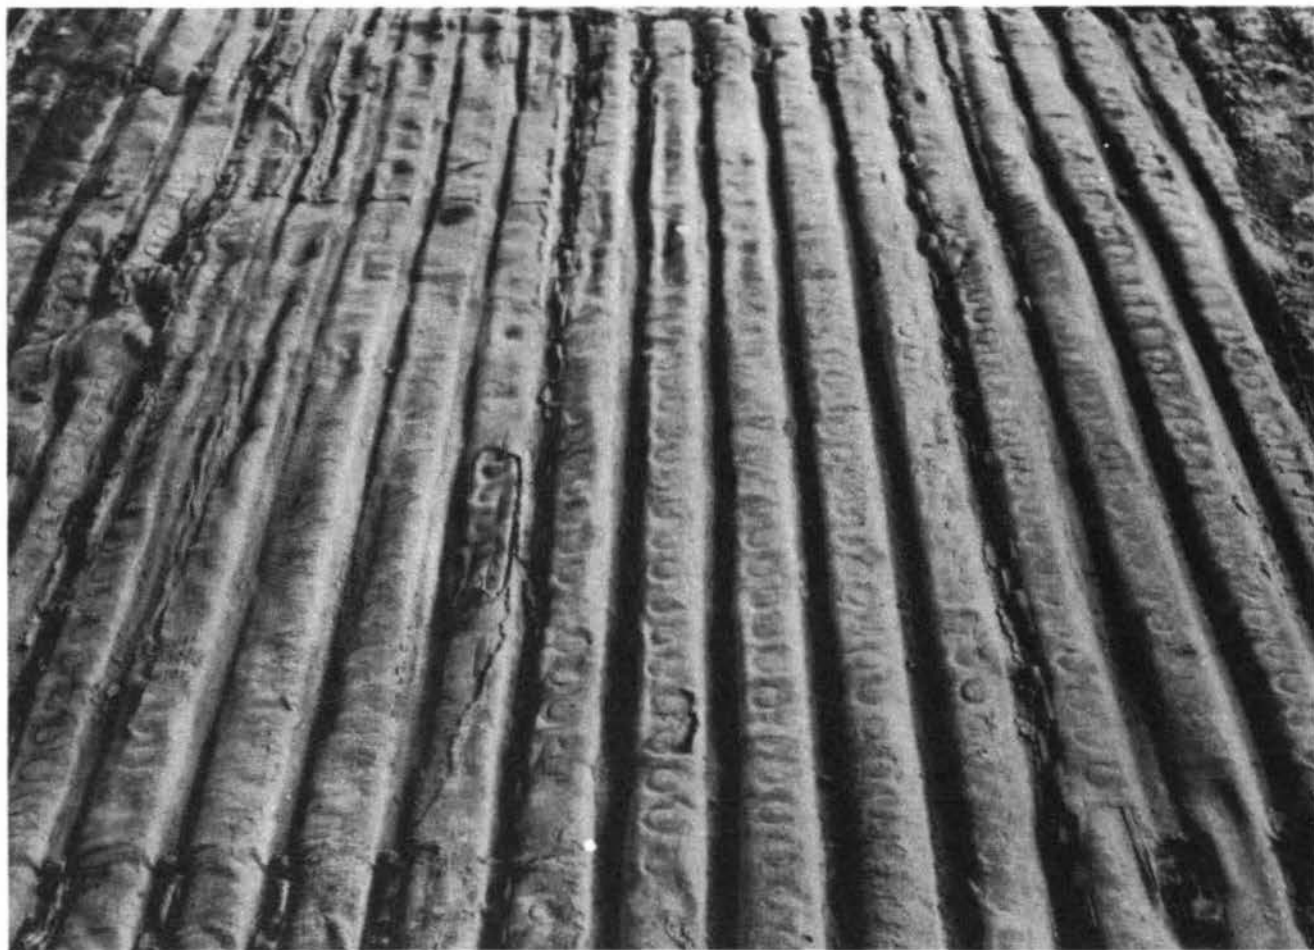
Appearance of PBS after removal of M7 mat at 1000 coverages

lane 1 and its behavior was observed during the traffic test. This blanket was made of used PBS and was not in very good condition. It was observed that the M7 mat bedded into the subgrade more slowly over the PBS than it did in the remainder of the section. As the ribs of the M7 mat were forced into the subgrade, the fabric of the PBS blanket was stretched so tightly that a few breaks occurred, but it is possible that these were at points weakened by previous use. It is also probable that the stretching would have been more severe if a large area of PBS had been placed under the mat. Very few actual cuts were found in the blanket, though a few holes did appear under end joints. Plate 33 shows a section of the blanket when the mat was removed after 1000 coverages. The PBS was cut and punctured much less than in previous tests where PBS was placed under M6 and other types of landing mats. It would not have allowed much dust to be picked up by the backwash from propellers, and might have reduced the quantity of moisture percolating into the subgrade. It is believed that the blanket would have been subjected to more severe punishment on a soft subgrade because of the greater amount of movement.

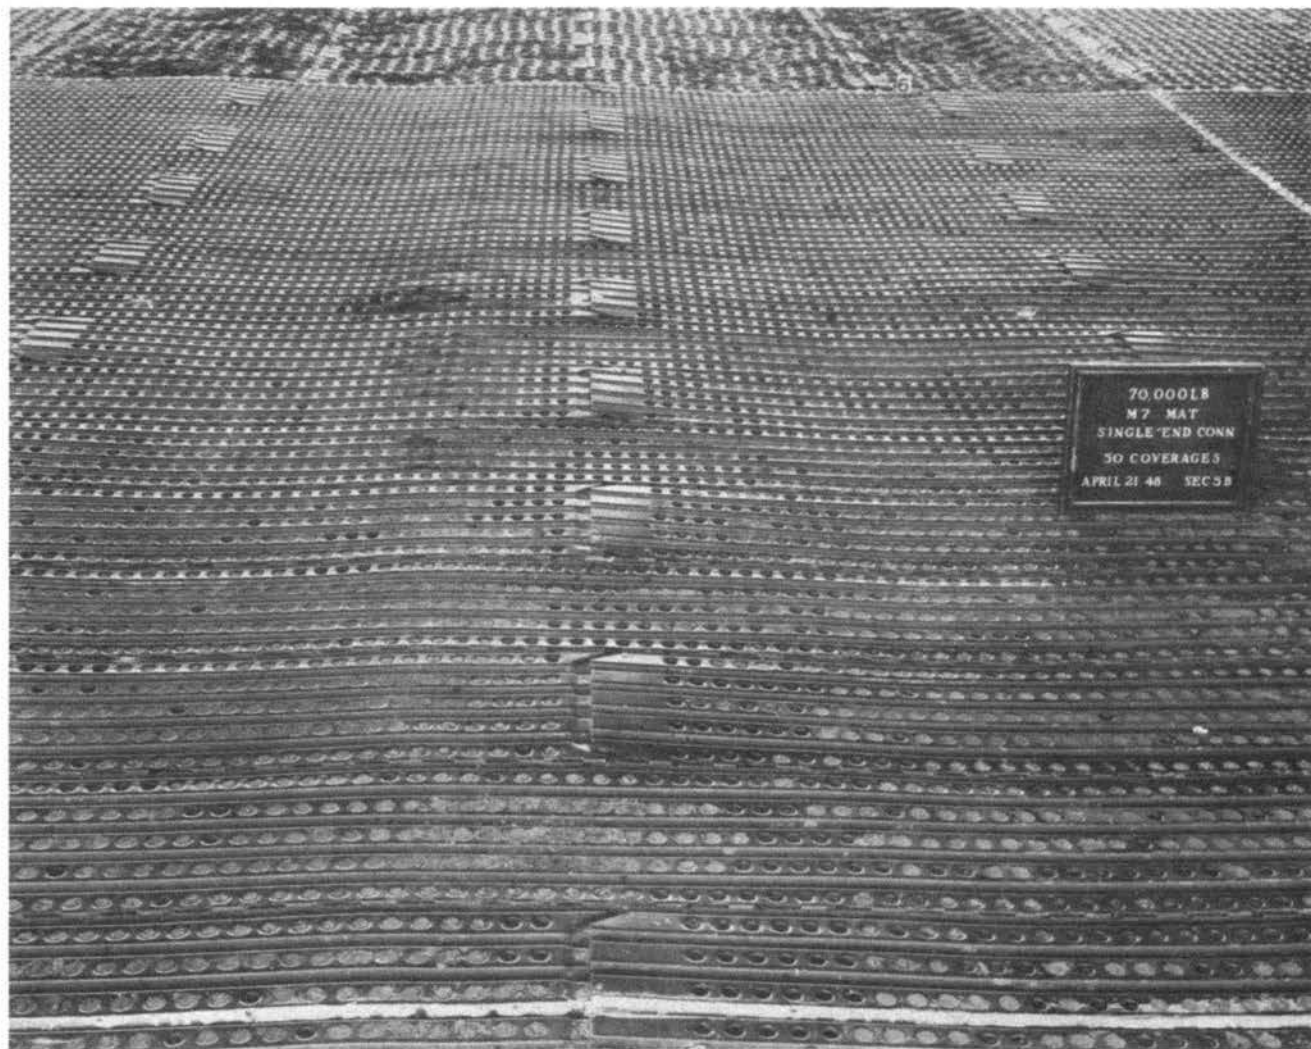
M7 mat in subsection 5b after 50 coverages

34. M7 mat in subsections 5a and 5b. Lane 3, which included subsections 5a, 5b, and section 6, was built with a weak subgrade calculated to induce early mat breakage for better comparisons of the relative merits of the two mats and the benefits derived from the two methods of engaging the locking lugs on the M7 mat. However, the number of locking lugs engaged had no effect on results obtained from these tests since few, if any, of them were actually stressed and none of them was broken under traffic. Hence, while all lugs were engaged in subsection 5b and

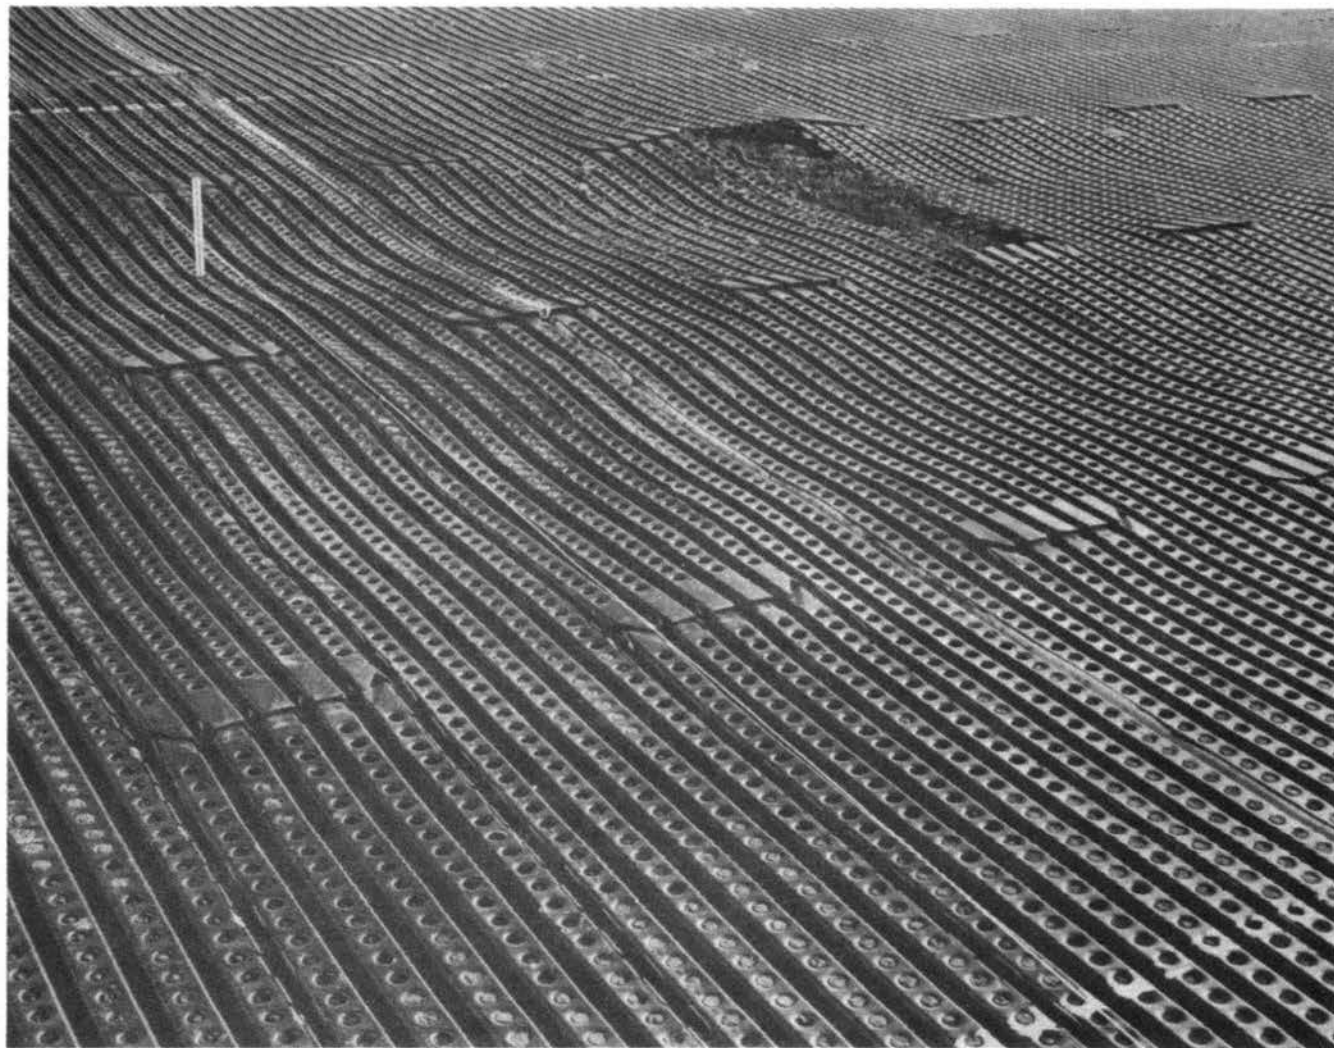
Appearance of M7 mat surface, subsection 5b after 182 coverages  
(the half plank was removed to permit soil sampling)

38. Surfaces included in tests. Three typical surfaces were used in the tire wear tests. These were: (a) M6 landing mat bedded into the subgrade by traffic; (b) M7 landing mat bedded into the subgrade by traffic; and (c) asphalt concrete pavement, well cured and scoured clean by traffic. The load cart was towed over the M6 mat against the overlapping edges of the planks and across the end joints at various angles. It was towed over the M7 mat both between end joints and across end joints at various angles. The two landing mat surfaces are shown in the traffic test plates, especially plates 31 and 32. The asphaltic concrete pavement was a previously-used test site. Plate 43 shows the typical texture of that portion of the lane used in these tests; the dark portion on the right is where the tire was skidded.

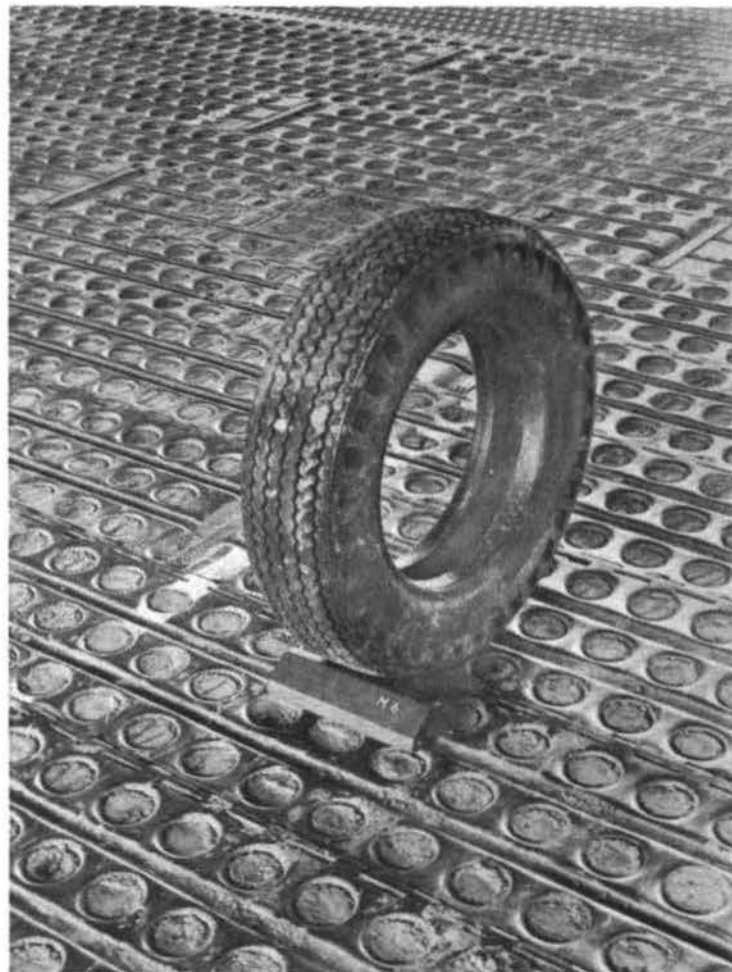
Fig. 1. Typical tire used in tire wear tests

Fig. 2. Appearance of tire after test on M6 mat

Plates 44 and 45 show the appearance of the tires before and after the test, together with small sections of the surfaces on which they were tested. It is noted that the amount of rubber lost was greatest for the asphaltic concrete, next for the M7 mat, and least for the M6 mat. The amount lost on the M7 mat was 91 per cent of that lost on the pavement,

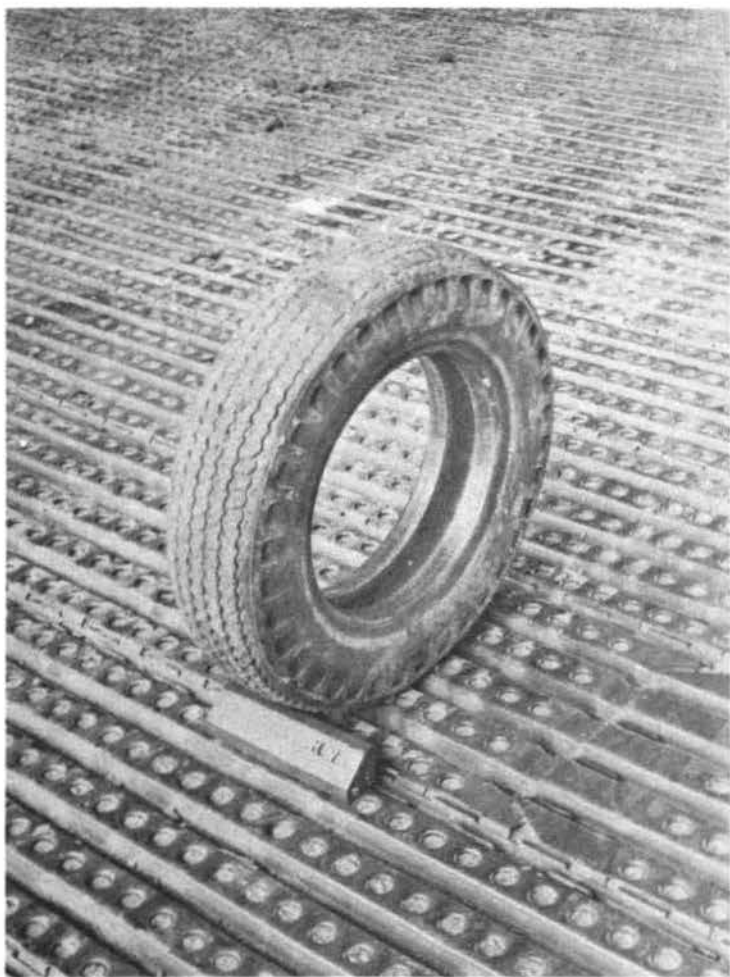
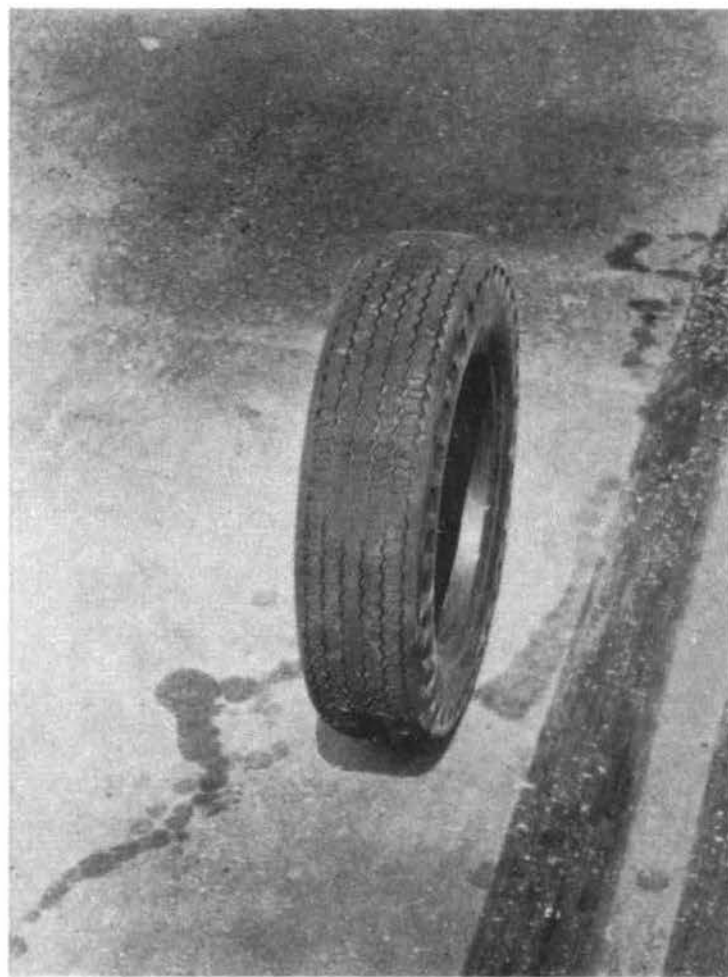
Fig. 1. Appearance of tire after test on M7 mat

Fig. 2. Appearance of tire after test on asphalt concrete pavement

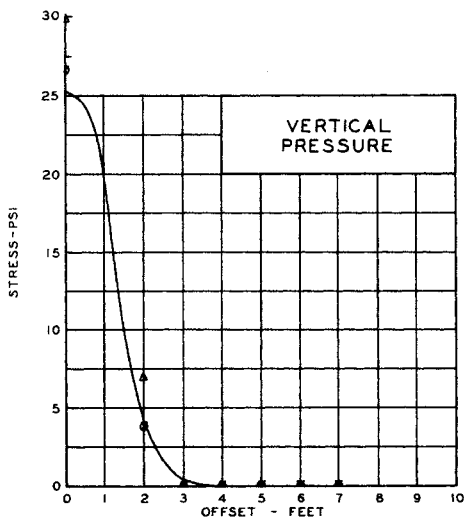
PRESSURE DISTRIBUTION UNDER LANDING MAT  
30,000-LB LOAD

43. An inspection of the plots gives an idea of the relative merits of the landing mats in distributing stress at the 12-in. depth. It can be seen that in practically all cases the stress at the 12-in. depth shows only a small difference for the condition of no mat, M6 mat, or M7 mat. For the lower loads, the trend is not very consistent, but for the higher loads the condition of no mat resulted in the higher stresses, M6 mat the next, and M7 mat the least. The deflection measurements, which are considered more reliable than the stress measurements since deflections are easier to measure than stresses, show this same trend. Under the center (at zero offset) of a 60,000-lb load (plate 50) the deflections were 0.110, 0.094, and 0.088 in. for no mat, M6 mat, and M7 mat, respectively. In general, the vertical pressure and the minor principal stresses reached a value of practically zero at an offset of about 3 ft, but the horizontal pressures, the major principal stresses, and the deflections showed measurable quantities out to about 5 to 6 ft.

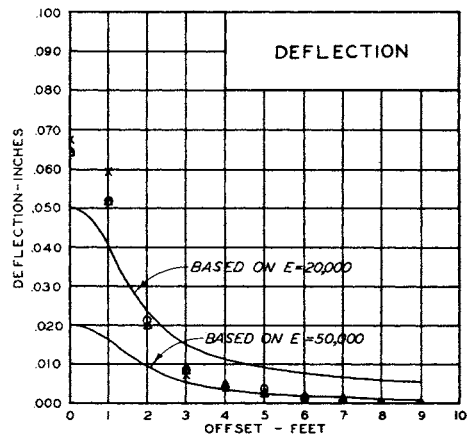
PRESSURE DISTRIBUTION UNDER LANDING MAT  
45,000-LB LOAD
