**INVESTIGATION OF SOLVENT RESISTANT TREATMENTS
FOR BITUMINOUS PAVEMENTS**

TECHNICAL MEMORANDUM NO. 3-246

WATERWAYS EXPERIMENT STATION
VICKSBURG, MISSISSIPPI

DECEMBER 1947

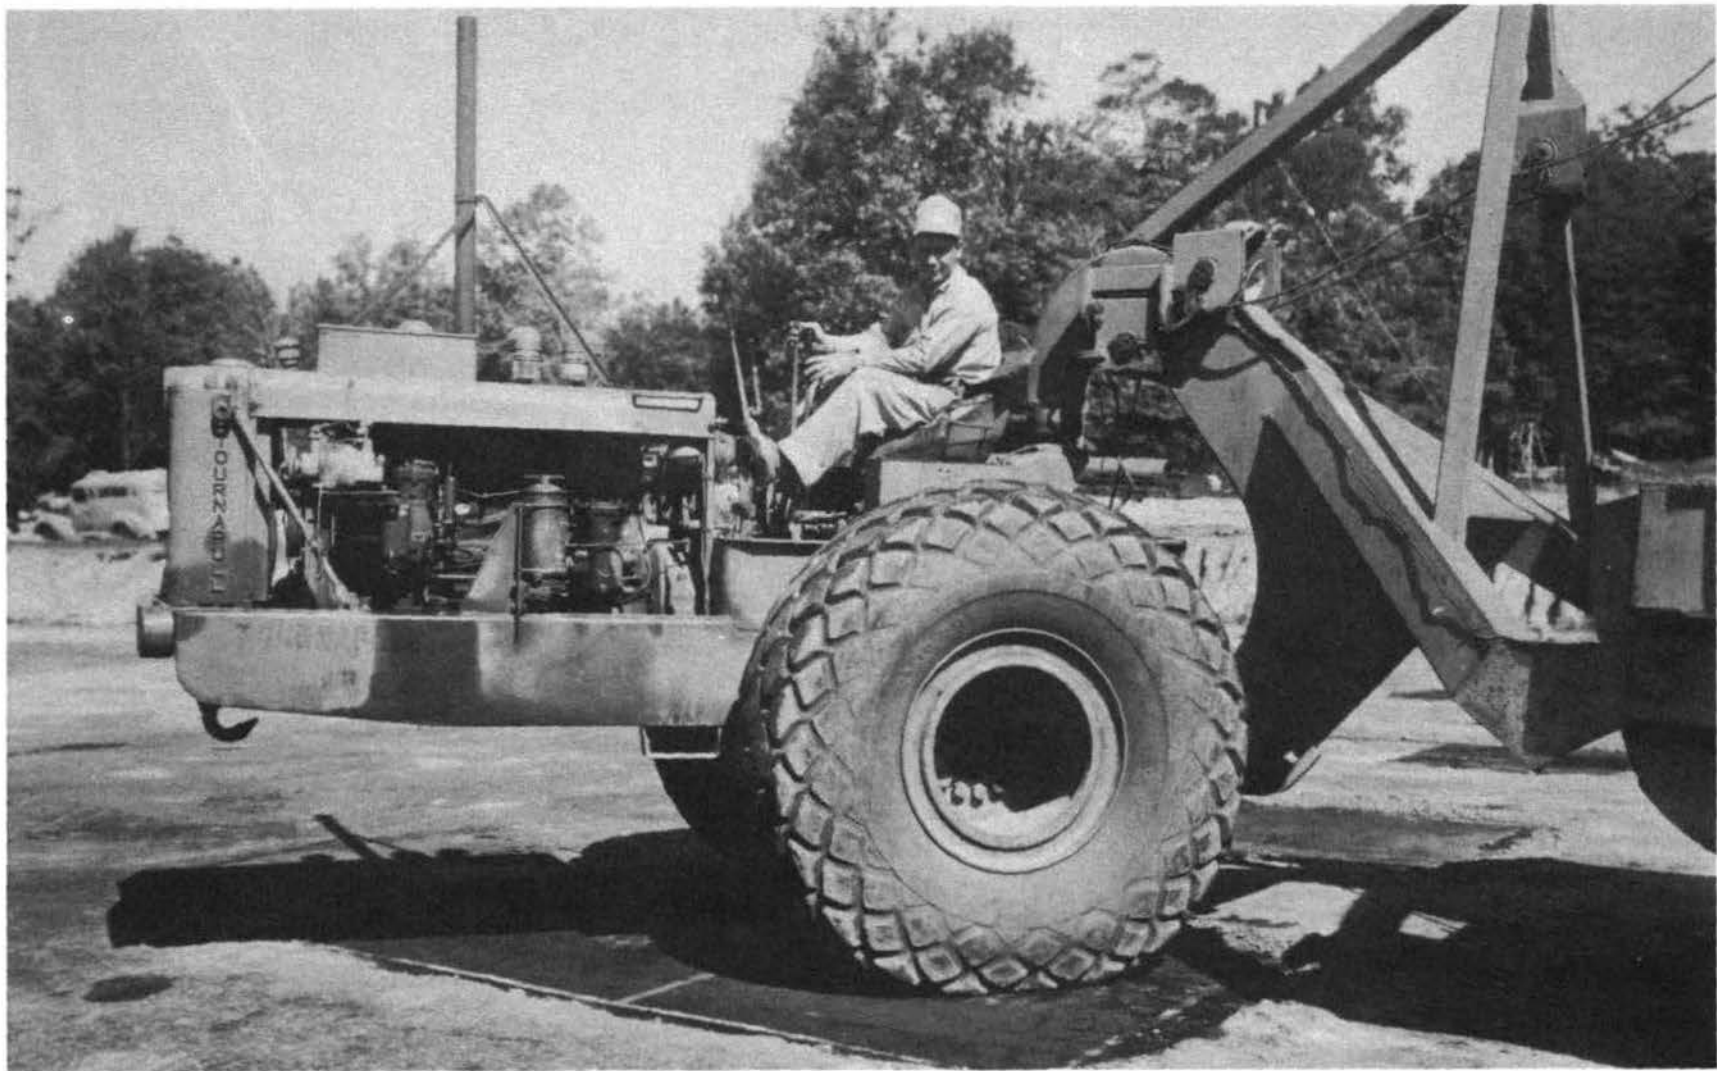
TOURNAPULL IN TESTING POSITION

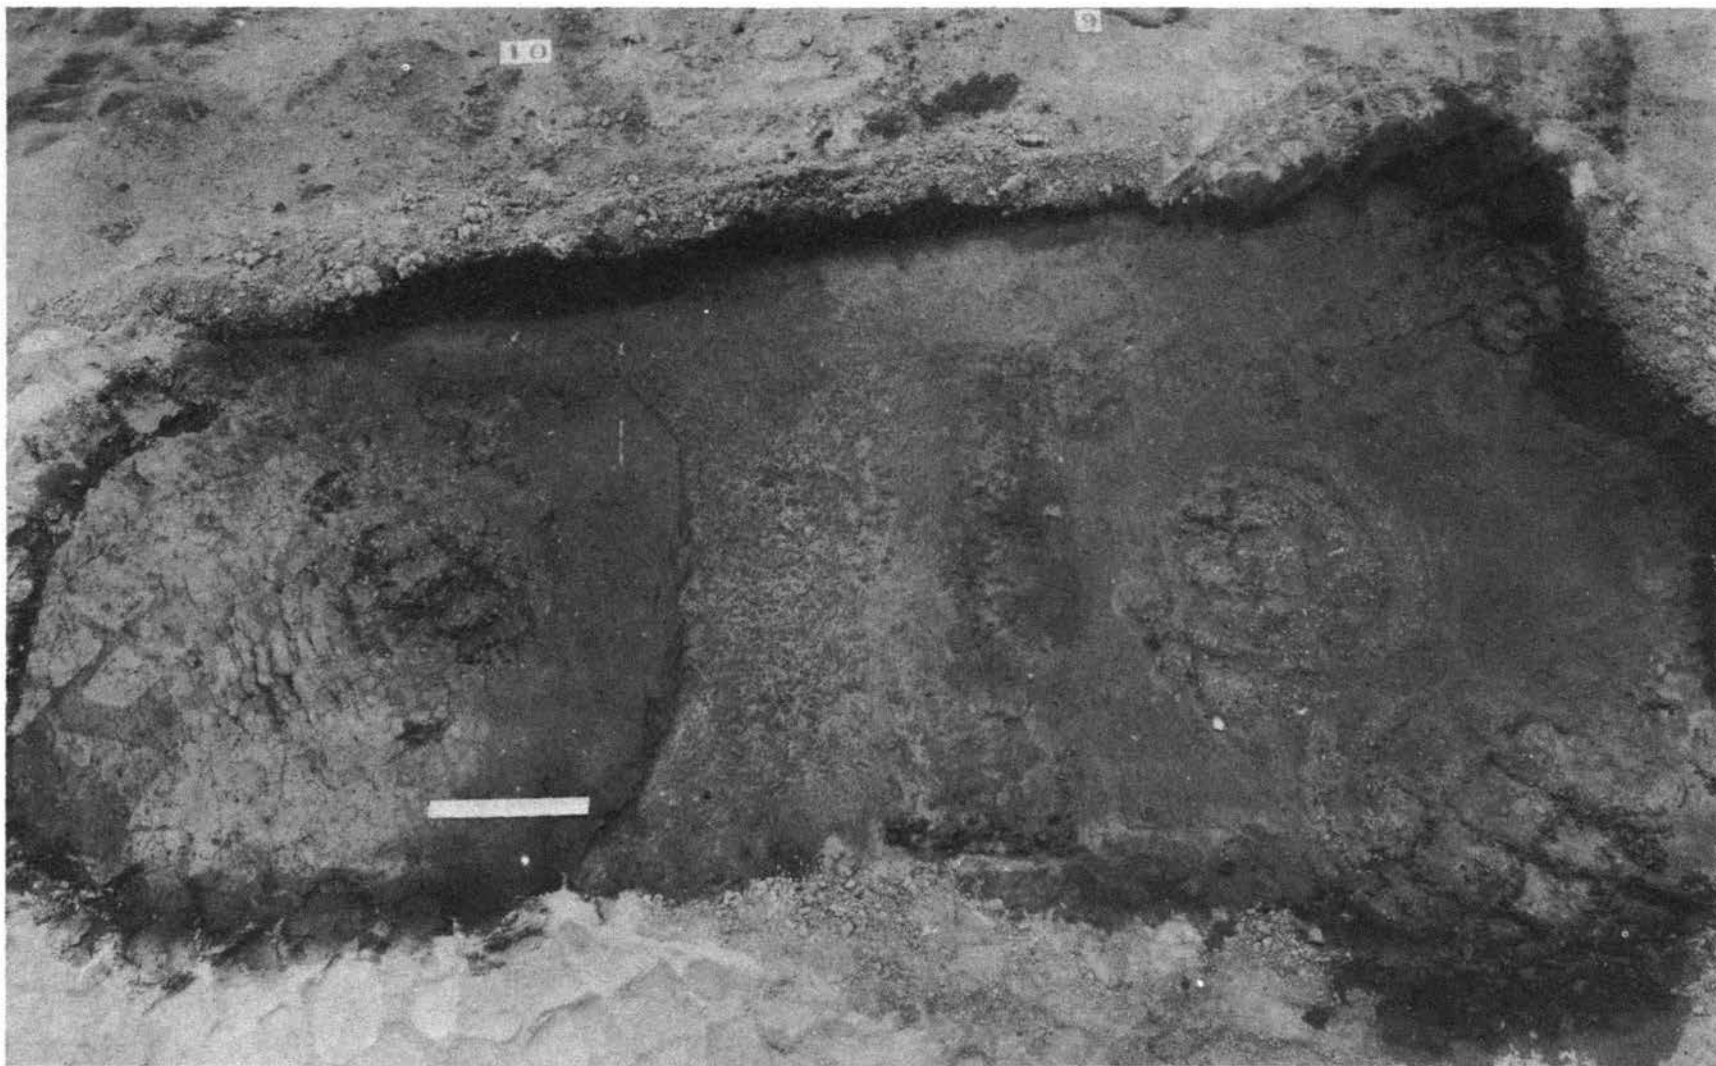
KEROSENE SATURATED TEST AREAS AFTER 10 CYCLES

The pavement was rigid enough after 10 cycles that the roller cracks could still be seen plainly (photograph 17) although a slight amount of shearing and tearing out of aggregate had started. The aggregate gradation for this mix was the same as shown on plate 2 and made a very low stability mix when tar was used as a binder. Reference to table 5 shows that the original in-place stability was only 102 lb and that no value could be obtained for pavement after testing. The pavement was too granular to be cored, yet it was the most satisfactory of any tested under these testing conditions. Results of laboratory tests on cores from bituminous test areas at MacDill Field, Florida, indicate that a high-stability tar concrete can be constructed. In view of this, the lack of stability in the tar concrete tested assumes minor importance since this may be compensated for by proper design.

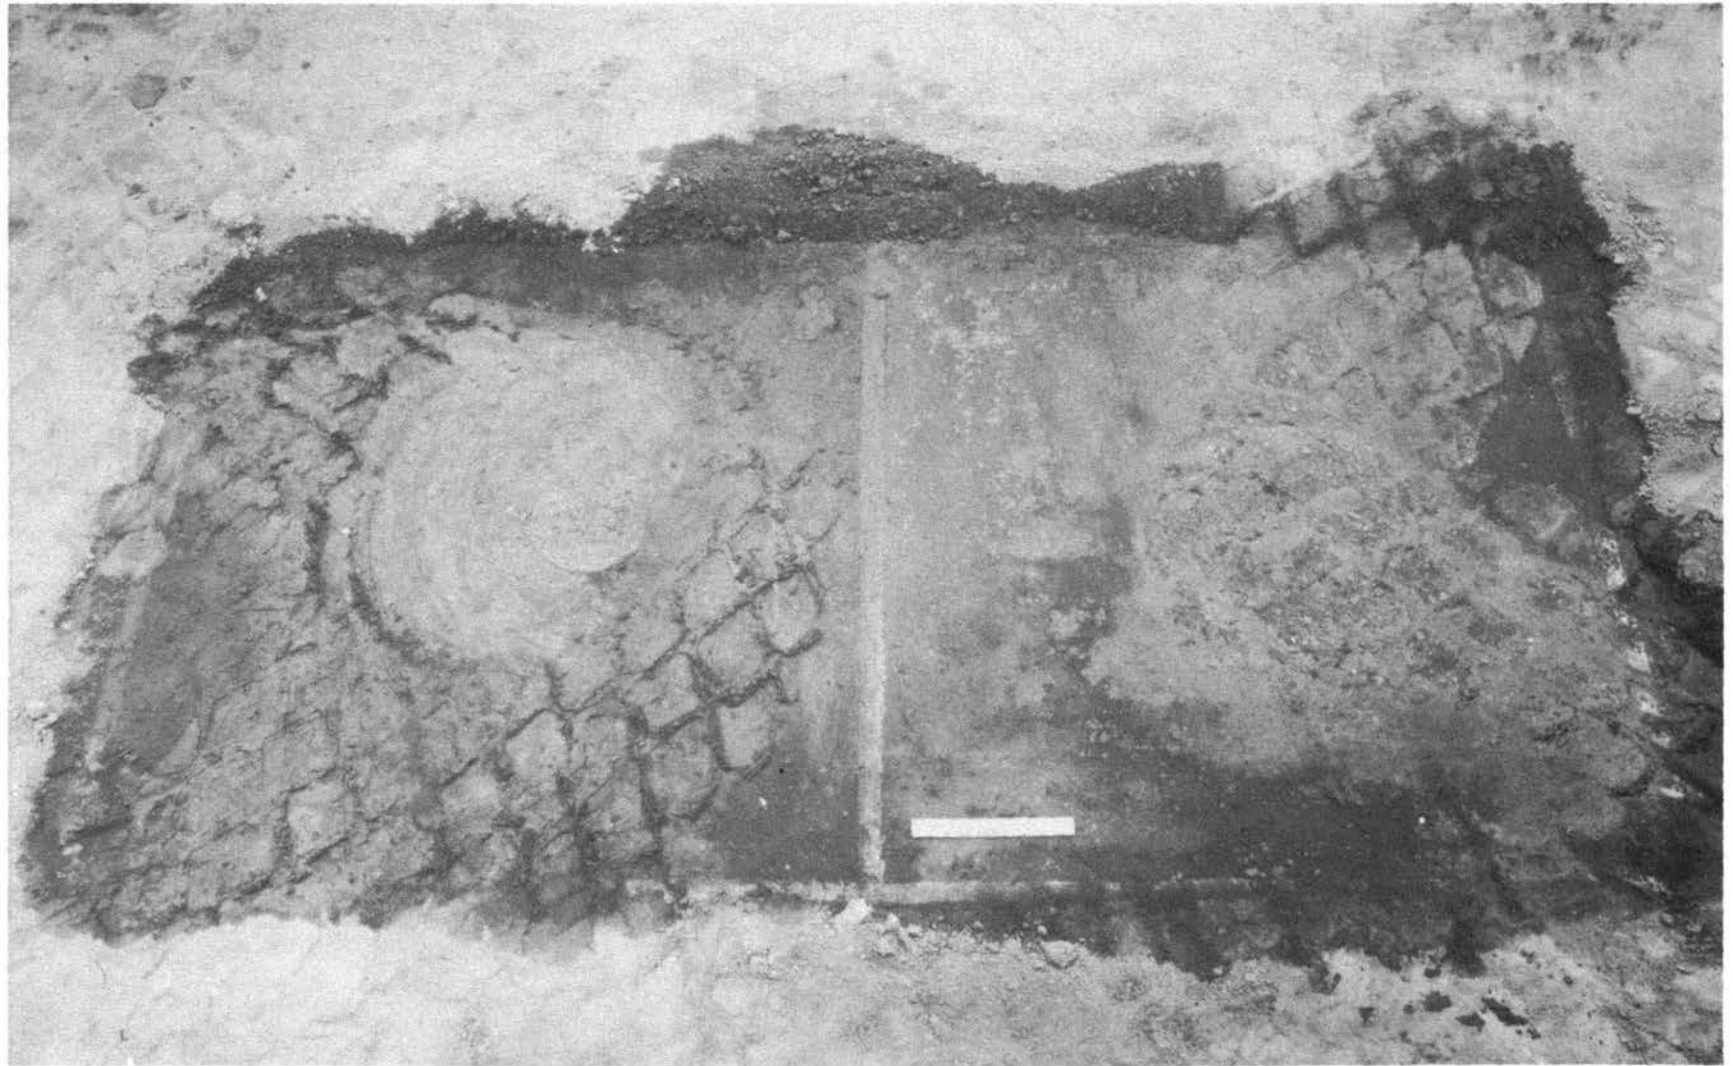
KEROSENE SATURATED TEST AREAS AFTER 10 CYCLES

the test area after 5 and 10 cycles. The tar seal protected the pavement until it was displaced, and only slight stripping of the pavement was noted at the end of the field test.

47. Cordo 3M-219#1. This vinylite solution was painted on the surface. A slight scum was formed during the third cycle. The solution was clear so that it was very difficult to determine when the aggregate was scrubbed clean. Scouring of the treatment and slight stripping of pavement aggregate was noted in the third cycle. Photograph 22 shows the test area at the end of the fifth cycle with very little scum and no loose aggregate. The solvent attacked the unprotected pavement where the Cordo was scrubbed away, but the attack seemed slow. No scour of the pavement took place. Photograph 23 shows the test area after 10 cycles.
