FLOOD PLAIN INFORMATION

ASHLAND, NEBRASKA
SALT CREEK
WAHOO CREEK

PREPARED FOR
CITY OF ASHLAND STATE OF NEBRASKA

DEPARTMENT OF THE ARMY, OMAHA DISTRICT, CORPS OF ENGINEERS, 68102

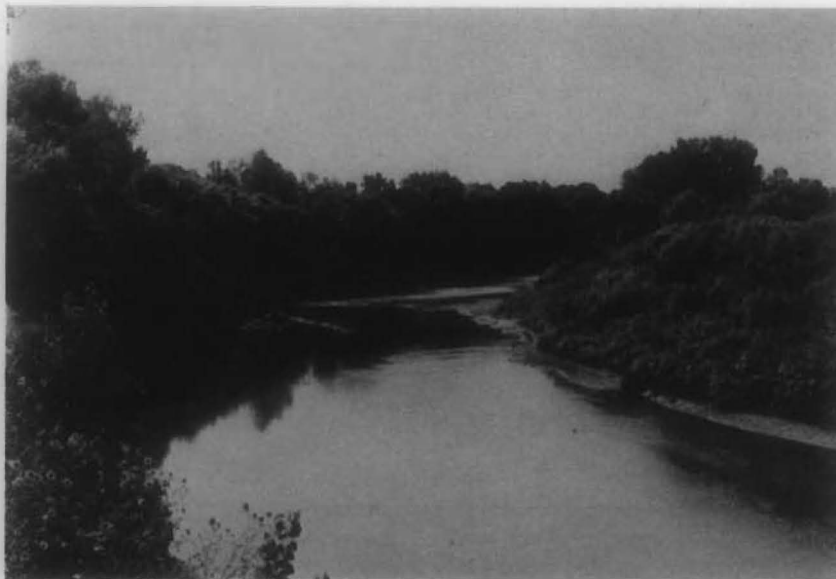
Figure 2. Salt Creek improved channel
looking downstream from west
line of Section 10, T12N, R9E

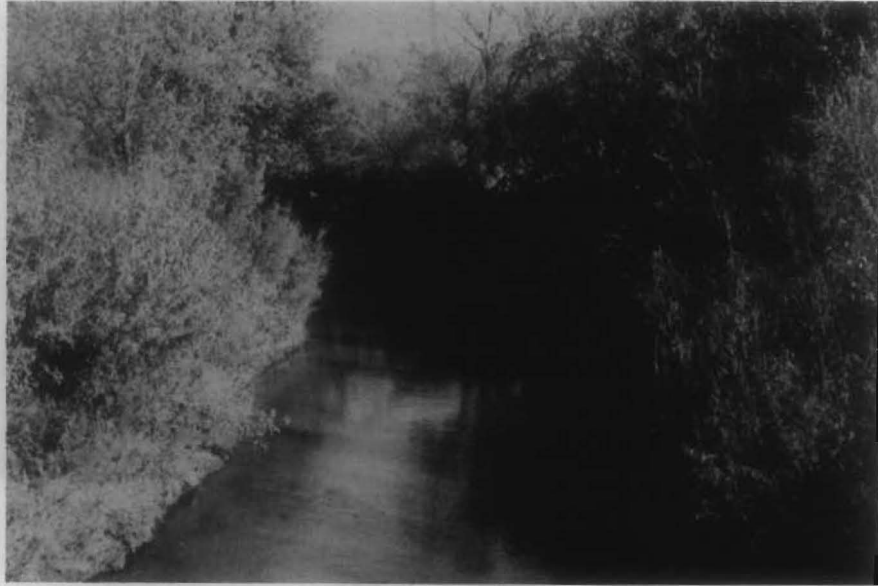
Figure 5. Wahoo Creek channel
looking east from
Nebraska State Highway 63

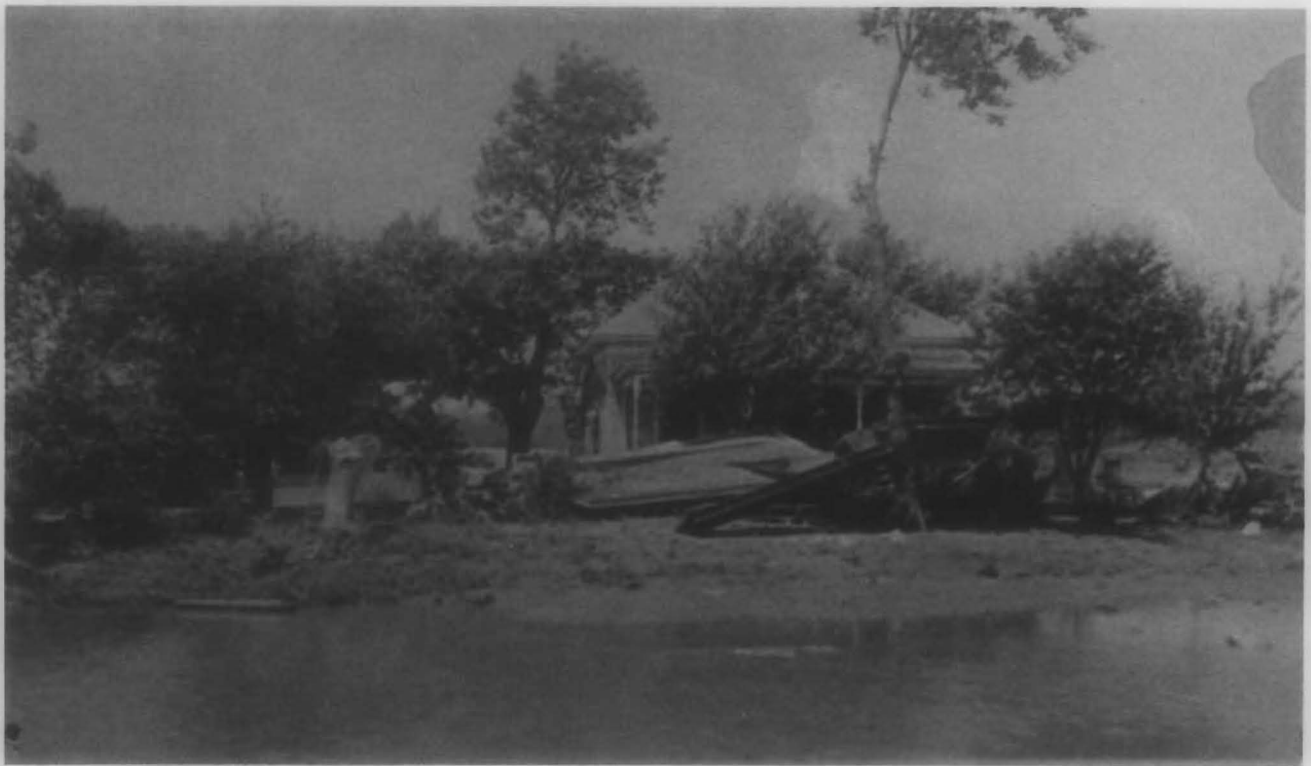
Figure 6. Flood damage on Silver Street
July 1908 (Courtesy City of Ashland)

7 July 1908 - Heavy, high intensity rains caused the worst flooding in the Ashland area residents memory. The 1908 flood not only caused great damage to houses and bridges in the Ashland vicinity, but also took a life, that of W. P. Snell. This flood also produced a hero, a youth named Guy Hooker, who saved many lives with his small boat and tireless efforts.

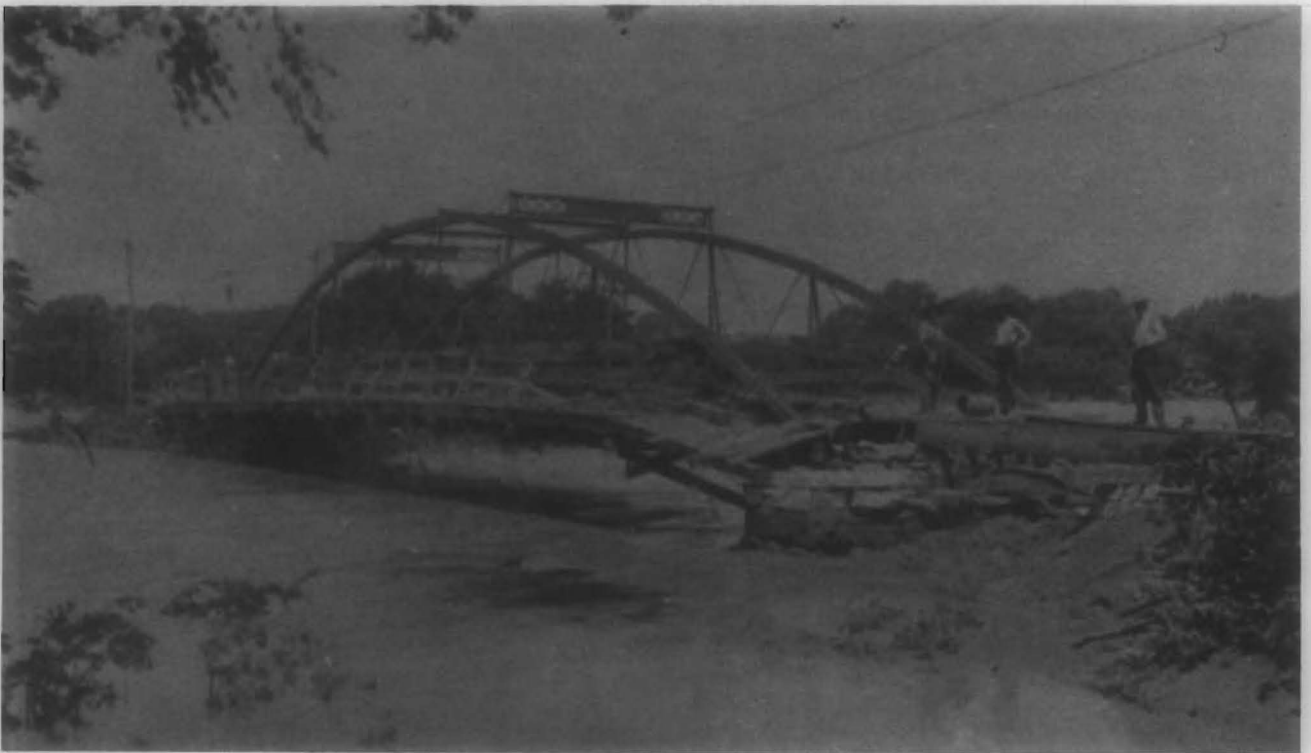
Figure 7. Bridge one block south of present Silver Street
bridge - July 1908 (Courtesy City of Ashland)

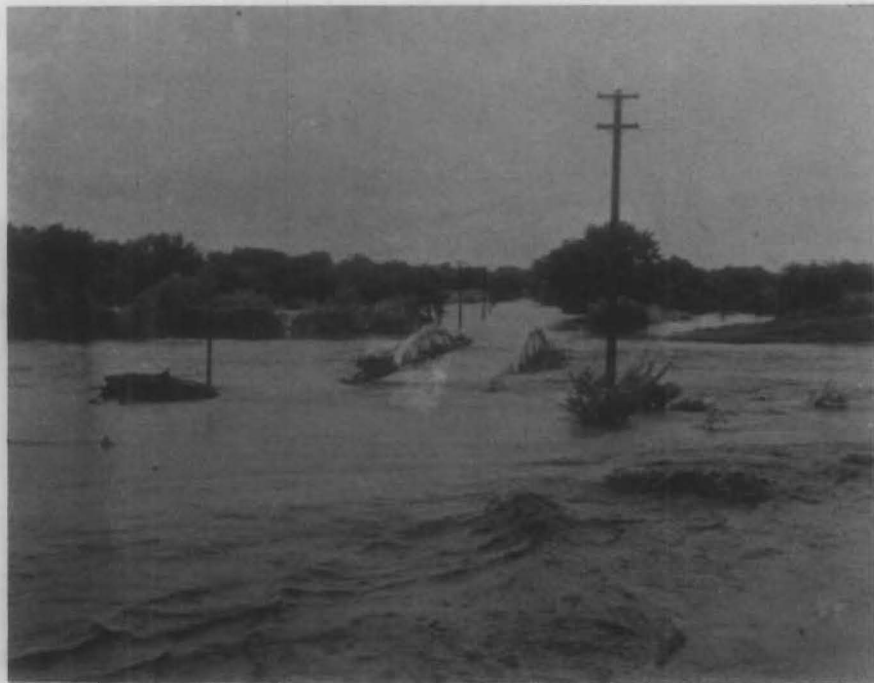
Figure 9. Cover picture 13th Street bridge
June 1951

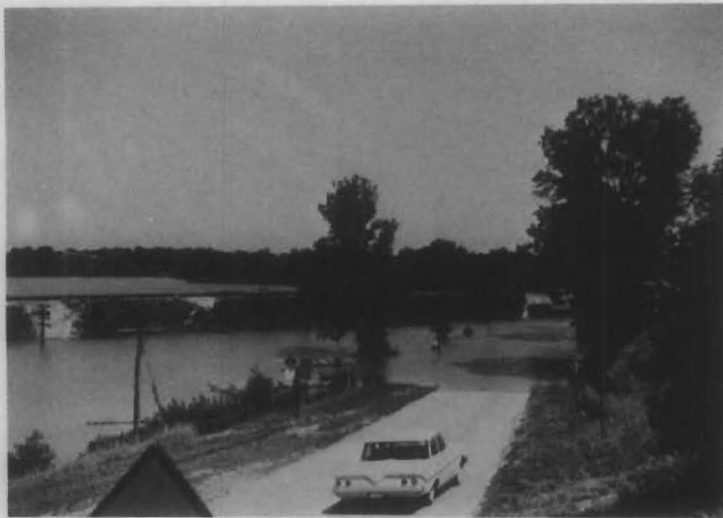
Figure 12. 1963 flood, 13th Street underpass

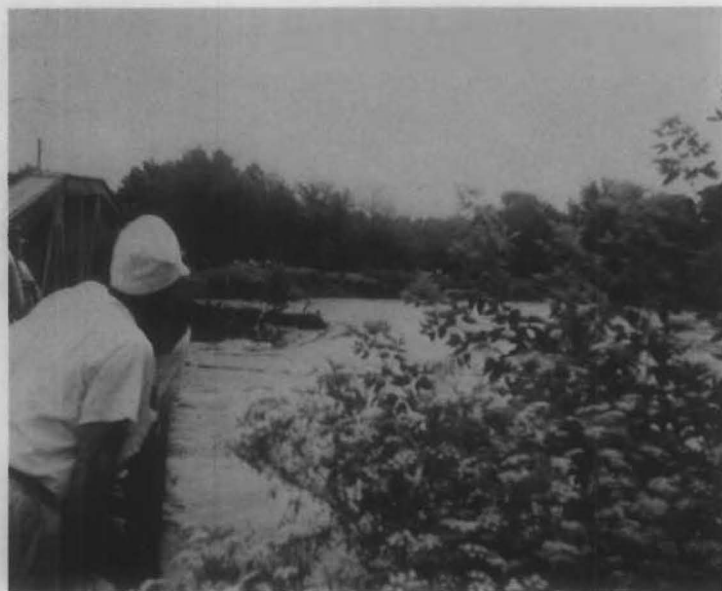
Figure 13. 1964 flood, debris at 13th Street bridge

Floating debris can collect at bridges raising upstream water levels. Prediction of the degree or location of the accumulated debris is impossible; therefore, for the purposes of this report, it was necessary to assume that there would be no accumulation of debris to clog any of the bridge openings. During floods, trees, brush and other

Obstructions - During floods, debris collecting on bridges could decrease their carrying capacity and cause greater water depths (backwater effect) upstream of these structures. Since the occurrence and amount of debris are indeterminate factors, only the physical characteristics of the structures were considered in preparing profiles of the Intermediate Regional and Standard Project Floods. Similarly, the maps of flooded areas show the backwater effect of obstructive bridges, but do not reflect increased water surface elevation that could be caused by debris collecting against the structures, or by deposition of silt in the stream channel under structures. The water surface profiles show the effect of the structures on flood flows. Raised roadways as well as buildings on the flood plain will also tend to obstruct flows.

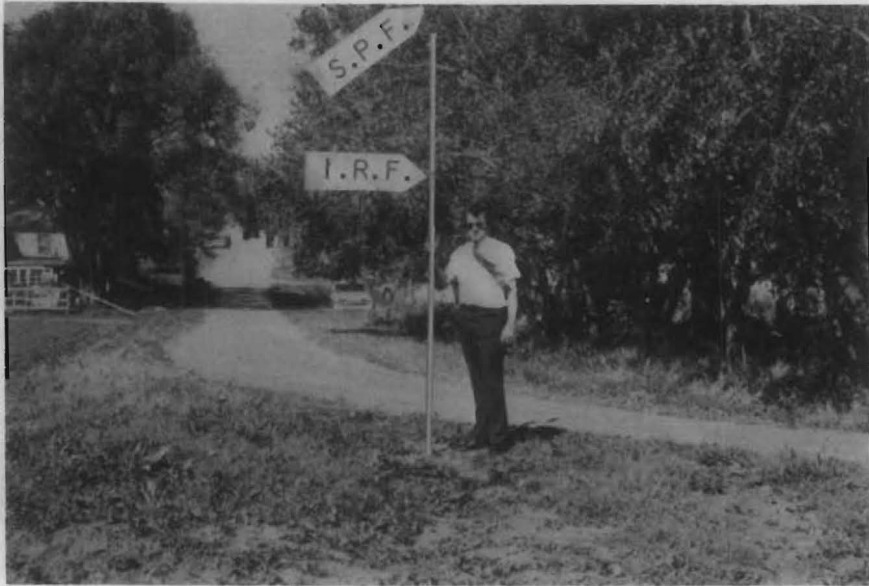
Figure 15. Depth of potential floods -
14th and Cedar Streets

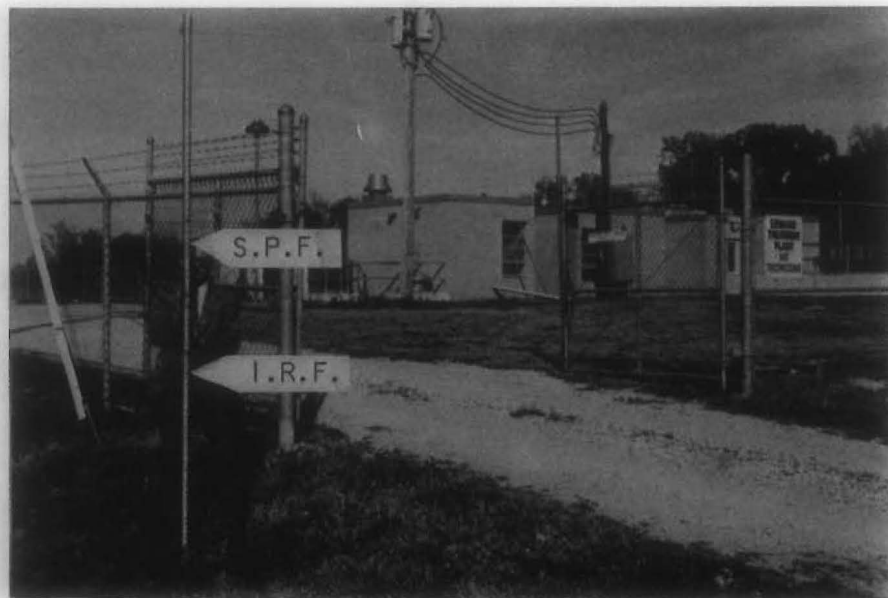
Figure 18. Depth of potential floods - Ashland Municipal Sewage Treatment Plant

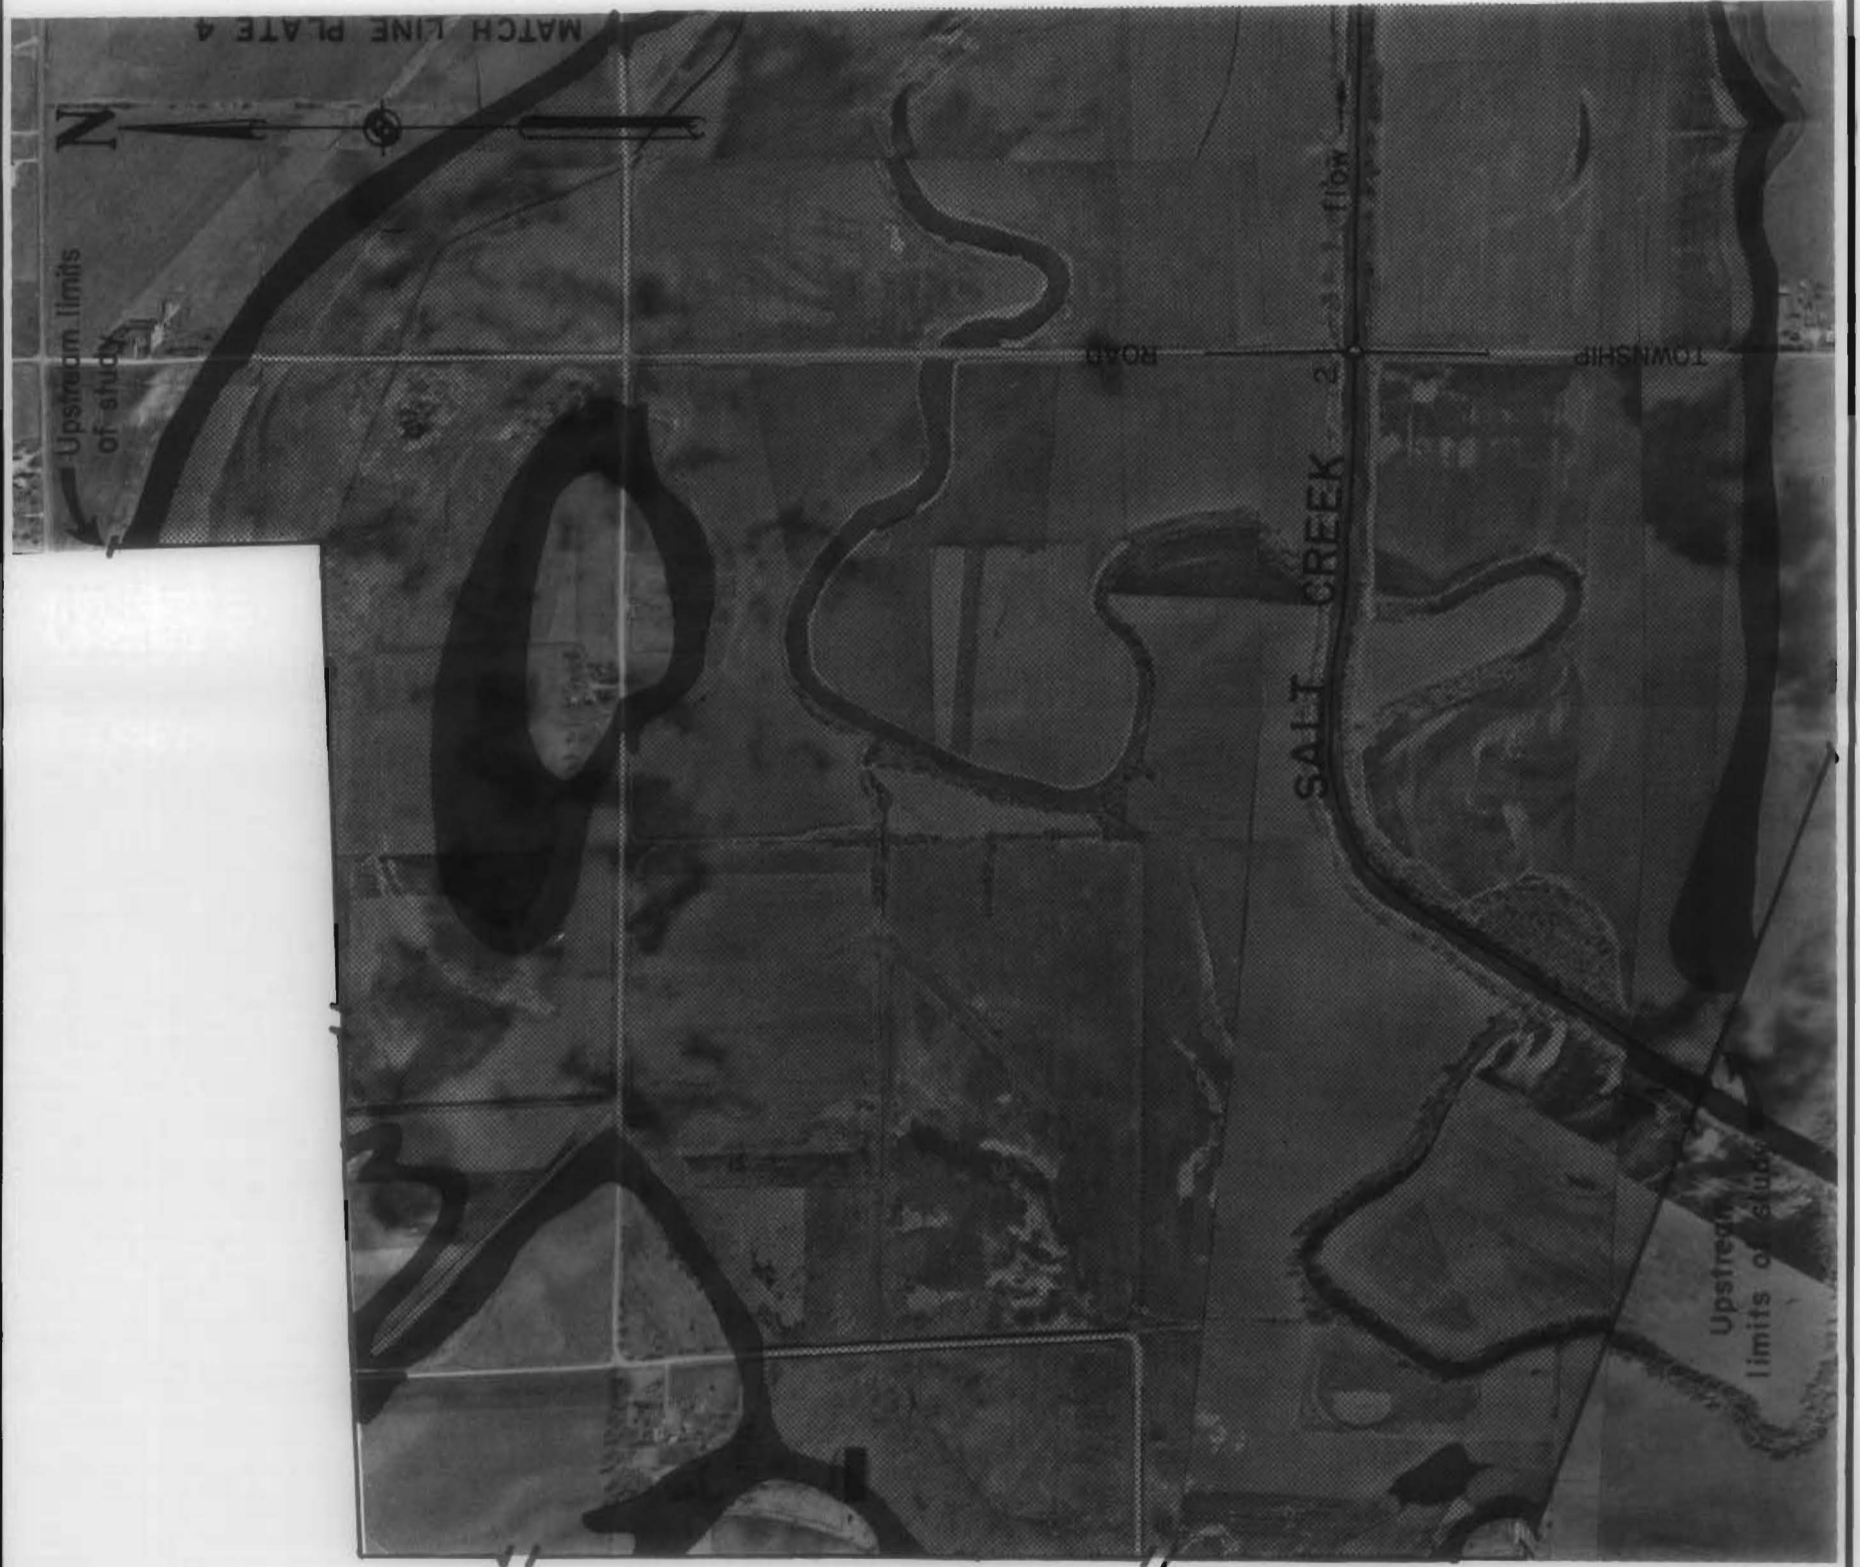
SALT CREEK BASIN
ASHLAND, NEBRASKA
SALT CREEK
FLOODED AREAS

Flooded areas and flood damages - The areas along the study reach that would be flooded by the Intermediate Regional Flood and the Standard Project Flood are shown on plates 3 through 6. Water surface profiles for these floods were determined using the backwater computer program HEC-2, "Water Surface Profiles" developed by the U. S. Army Corps of Engineers. The profiles on plates 7 and 8 show the elevations of the water surfaces and water depths relative to the streambed. Plates 9 and 10 show cross sections across the flood plain and show

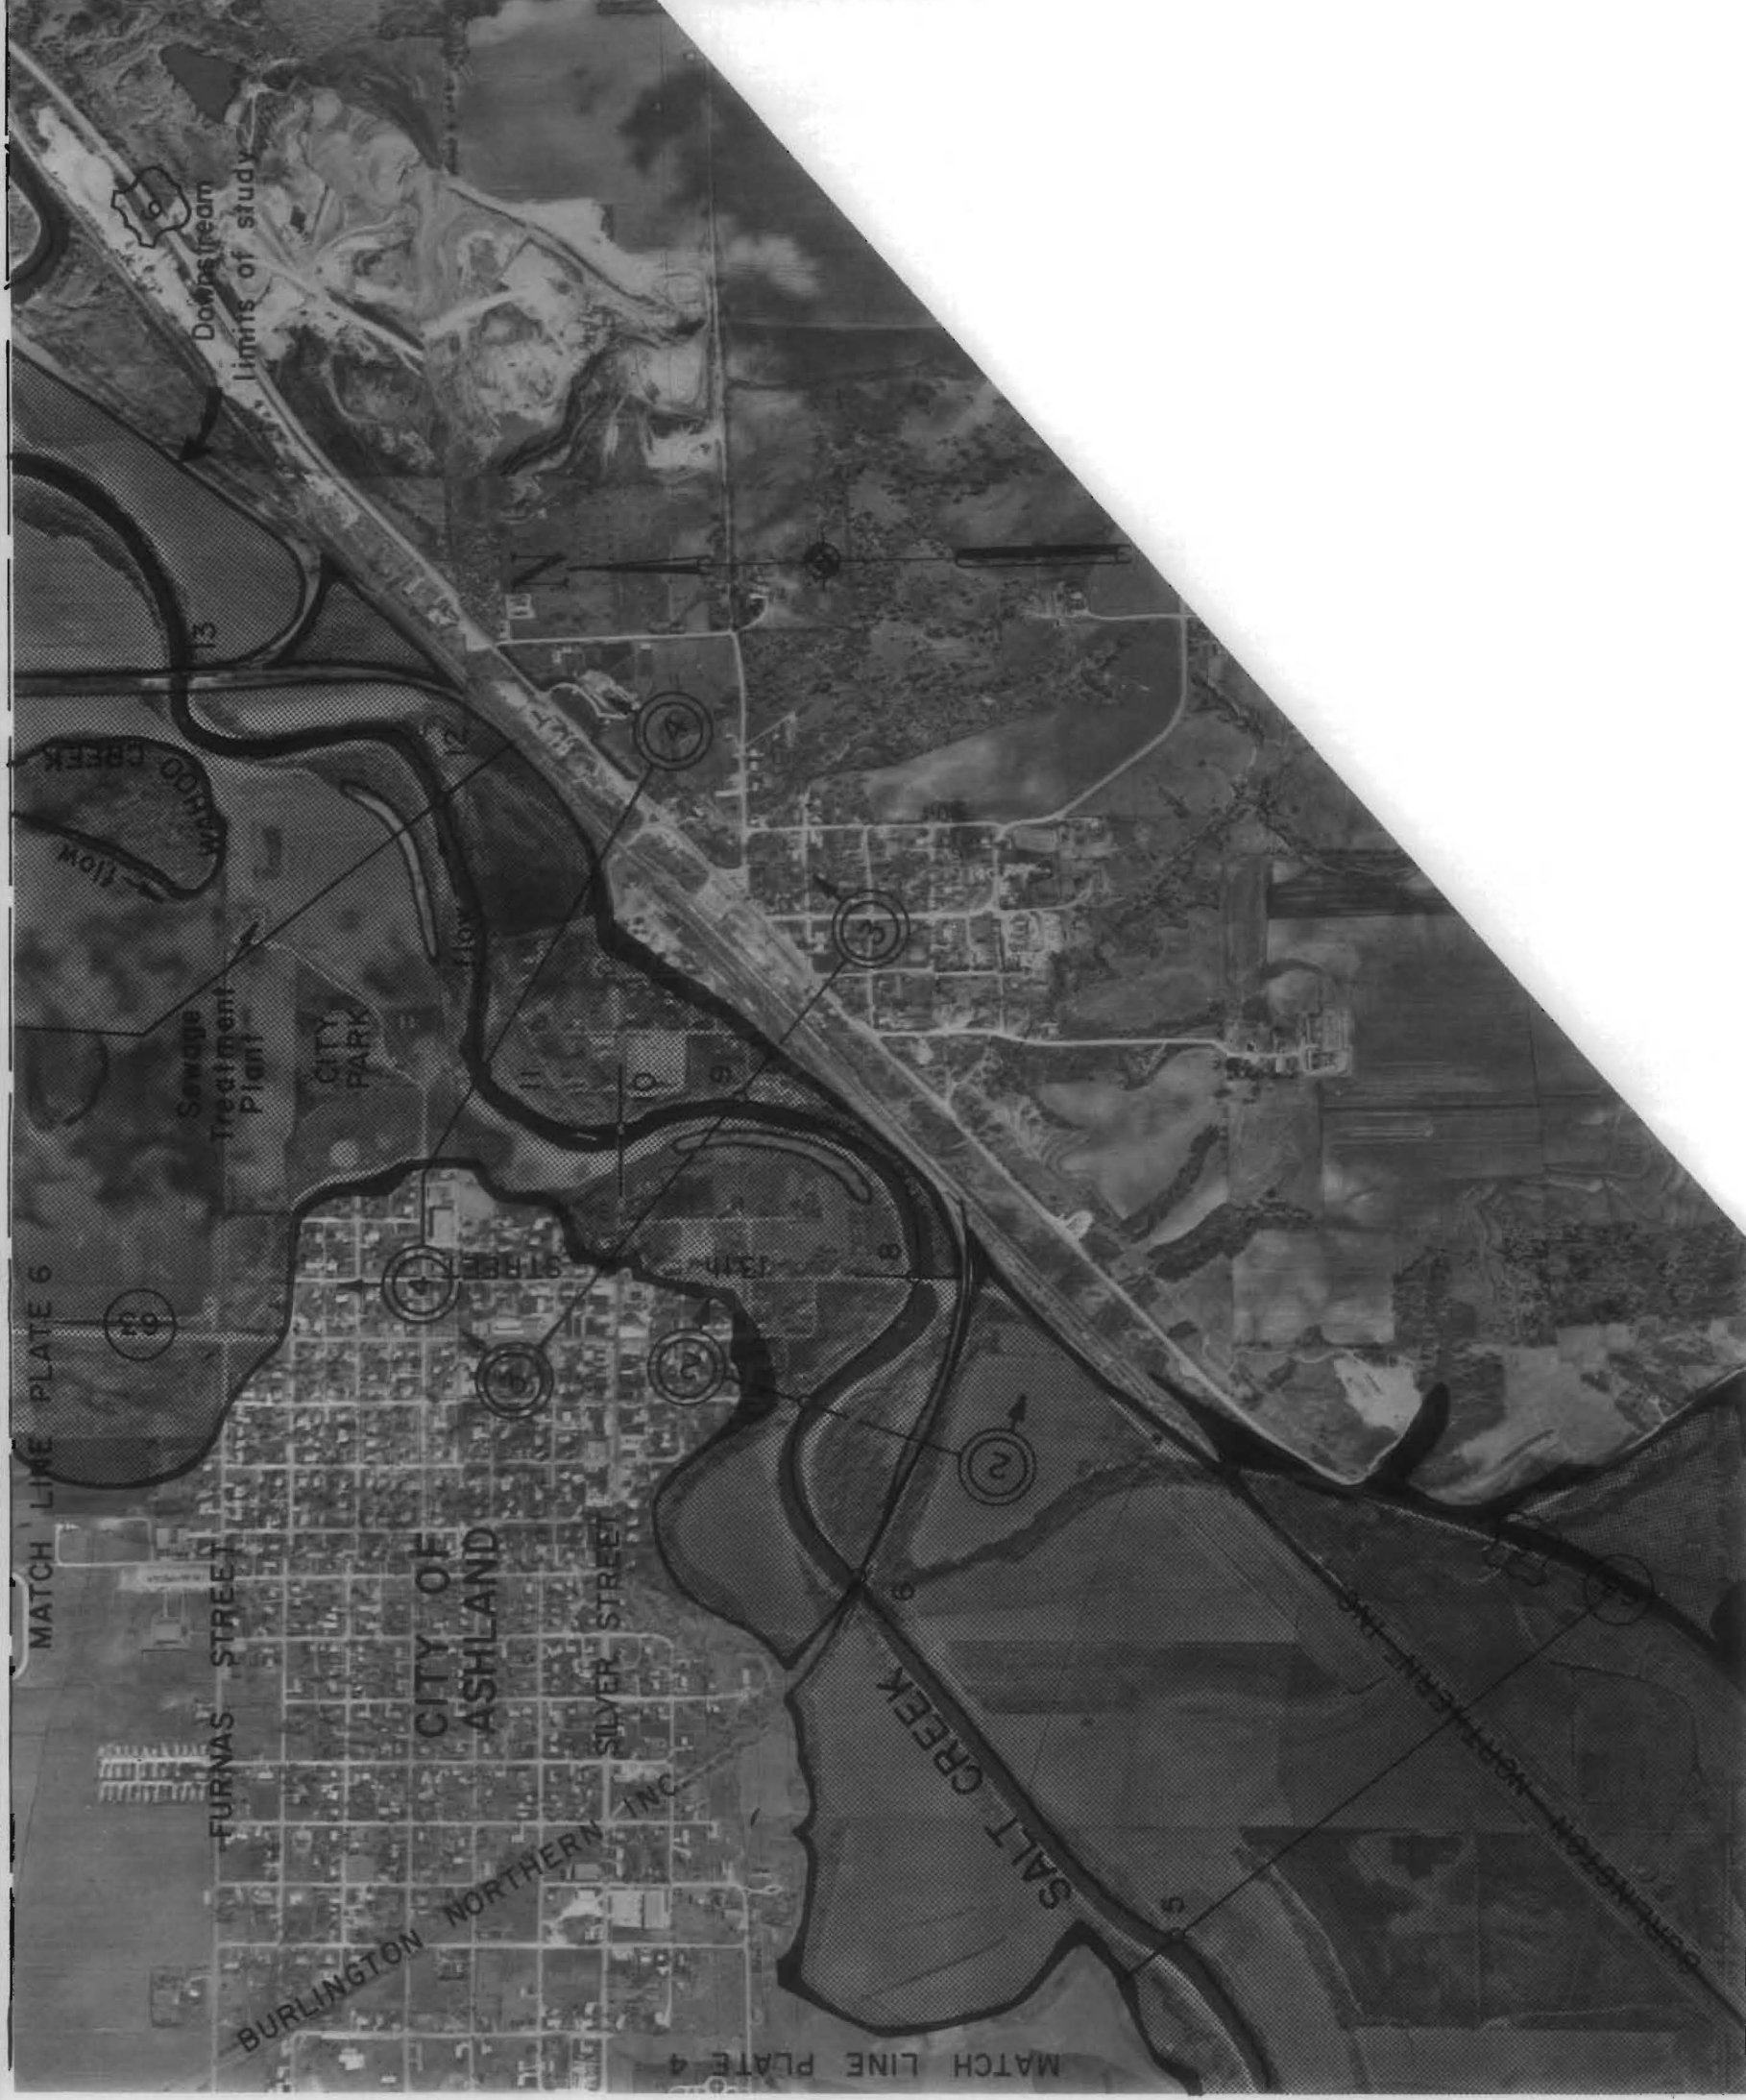
SALT CREEK BASIN
ASHLAND, NEBRASKA
**SALT CREEK
WAHOO CREEK
FLOODED AREAS**

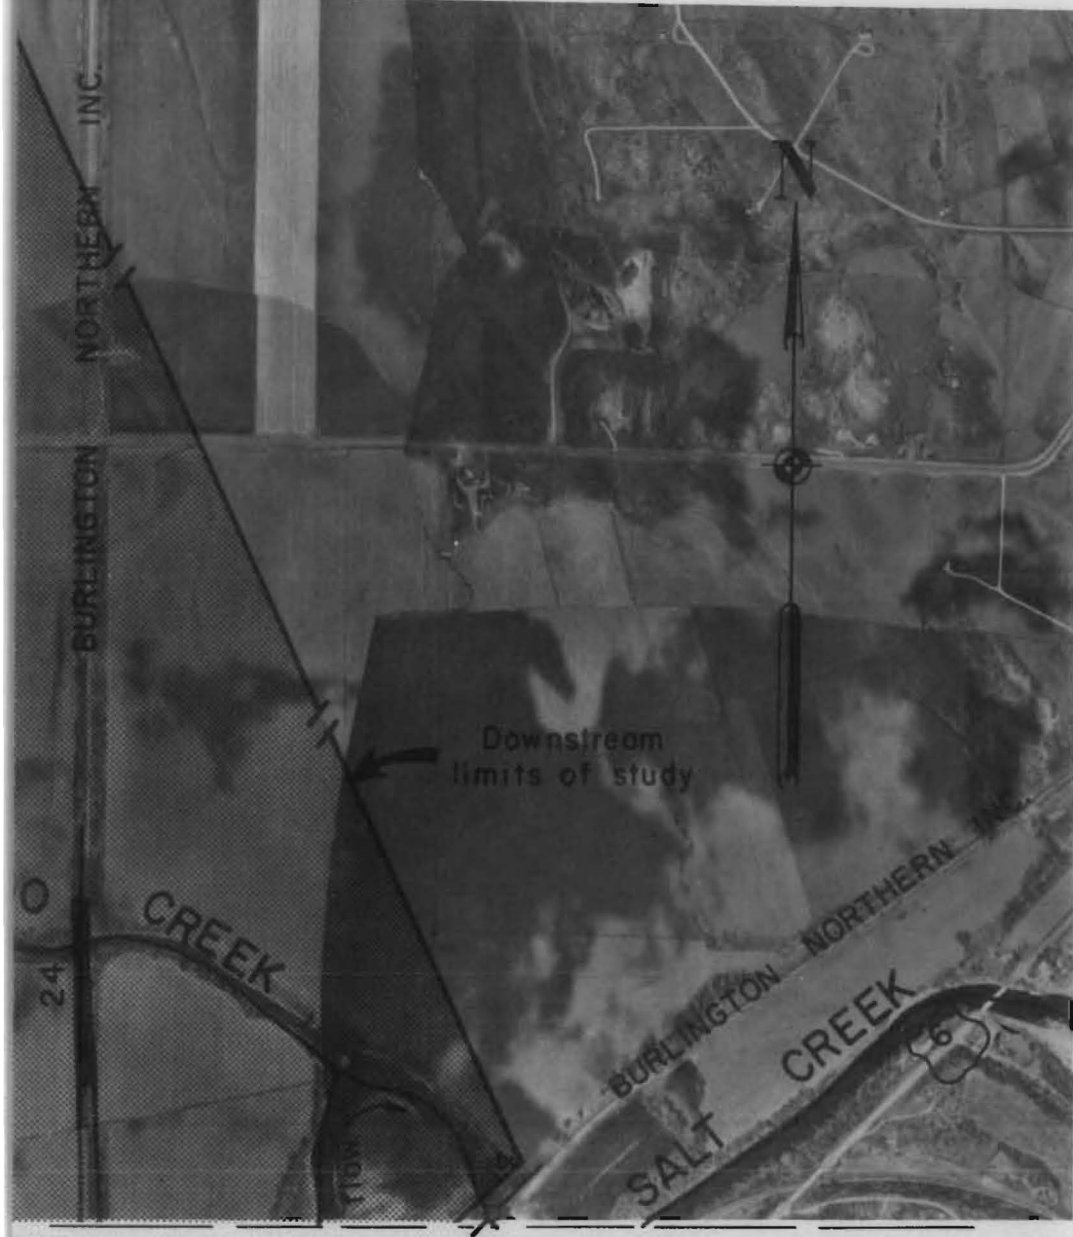
SALT CREEK BASIN
ASHLAND, NEBRASKA
SALT CREEK
PROFILE
 U. S. ARMY ENGINEER DISTRICT, OMAHA
 CORPS OF ENGINEERS OMAHA, NEBRASKA
 JULY 1976
