NATIONAL ADVISORY COMMITTEE FOR AERONAUTICS

September 1944 as  
Restricted Bulletin E4I07

A POSITIVE-REPLICA TECHNIQUE FOR EXAMINING FINISHED METAL  
SURFACES AND ITS APPLICATION TO AIRCRAFT-ENGINE CYLINDERS

By Thomas P. Clark

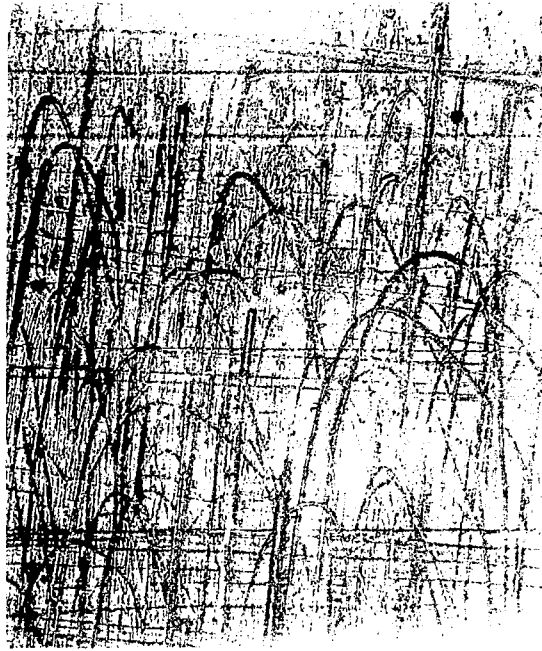
Figure 8. - A positive replica of the area at the top of ring travel in an Allison V-1710 cylinder barrel after 120 hours of test running. The top ring was free. X112.

Figure 8 shows the area within the top ring band in the cylinder in which the top ring did not stick. The looping scratches were presumably generated by the top compression ring as it rotated slightly at the top of the stroke. Figure 9 shows the area at the top of ring travel in the barrel run for 33 hours in which the top ring was stuck. The burnishing effect of the ring impact has removed the scratches in this barrel but has left the deeper cross-hatched grooves of the honing operation. Figure 10 shows a replica of the worn surface of the barrel run for 225 hours taken at approximately the same area shown in figure 9. The ring was stuck in this cylinder. This cylinder presents an excellent example of the surface found at the top of ring travel in a worn cylinder barrel. A characteristic burnished area with the fringe of smeared metal extending downward is clearly shown.
