# RESEARCH MEMORANDUM

GENERAL HANDLING-QUALITIES RESULTS OBTAINED DURING  
ACCEPTANCE FLIGHT TESTS OF THE BELL XS-1 AIRPLANE

Walter C. Williams, Charles M. Forsyth, and Beverly P. Brown

Langley Memorial Aeronautical Laboratory  
Langley Field, Va.

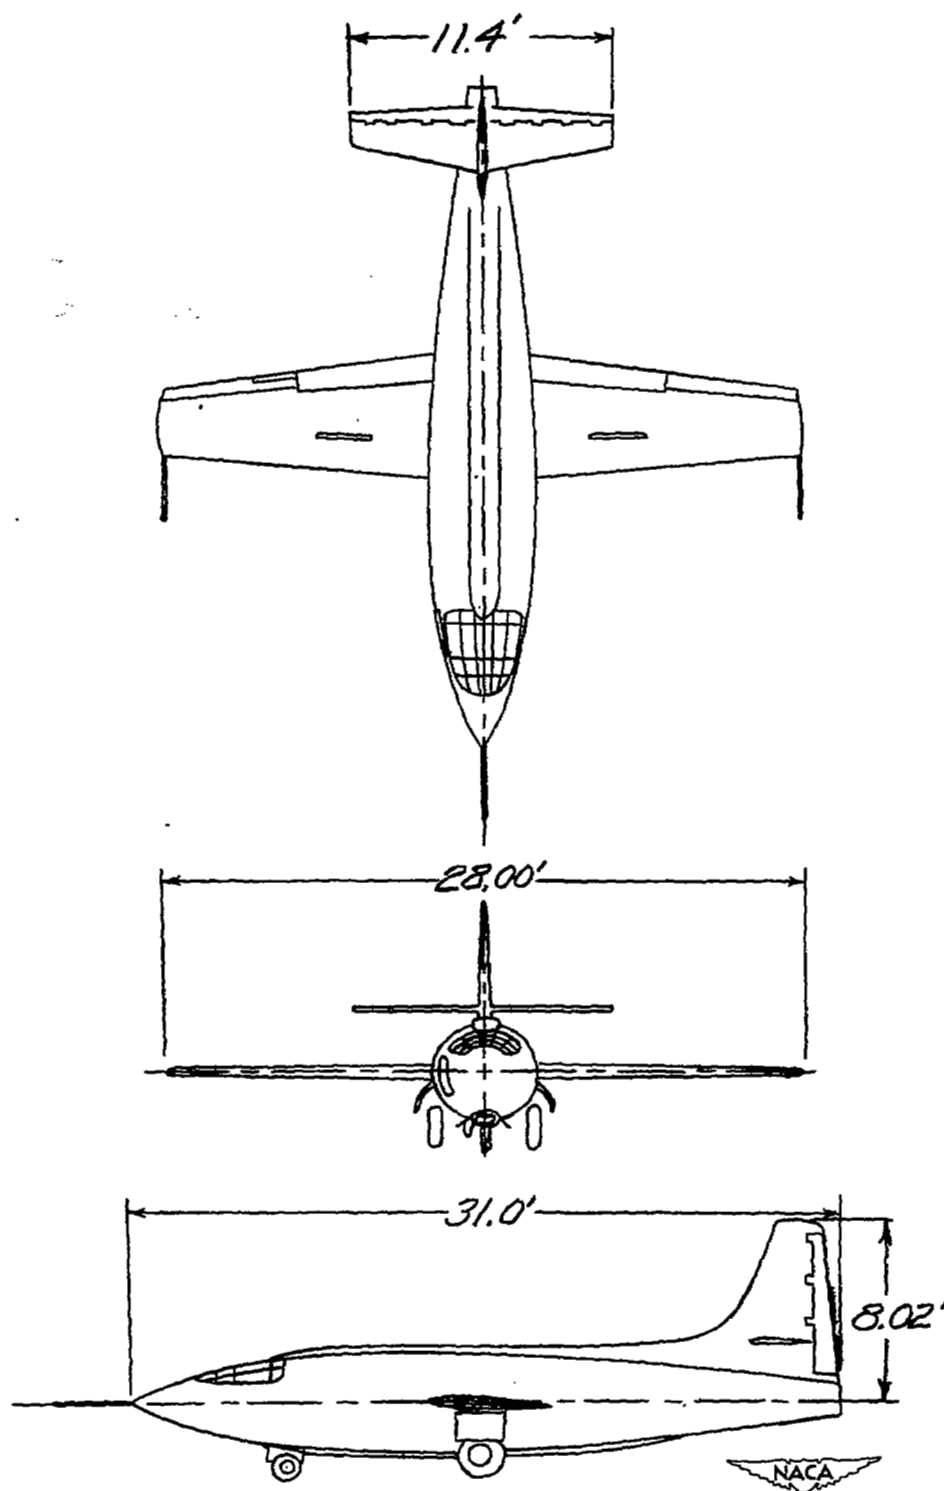
Figure 1.- Three-view drawing. X-1 airplane.

The Bell XS-1 airplane is a single-place, midwing monoplane powered by a four-cylinder, liquid-fuel rocket engine, built specifically for flight research in the transonic speed range. The physical characteristics of the airplane as tested are listed in table I. A three-view drawing of the airplane is presented in figure 1 and photographs of the airplane are presented as figure 2. The variation of control-surface position with wheel and pedal movement is presented in figure 3. Figure 4 presents no-load measurements of the control-system friction made by measuring the control position and control force as the control was slowly deflected. The large amounts of friction in the rudder and aileron control systems should be especially noted.

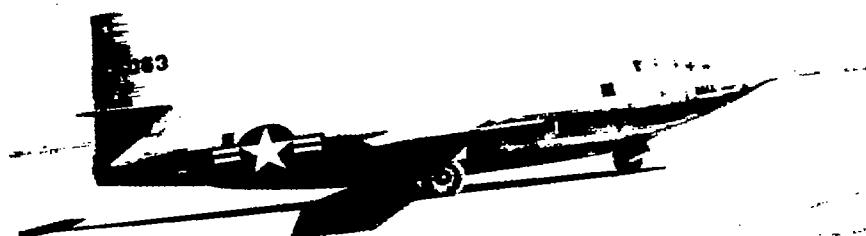
(a) Side view.

(b) Front view.

Figure 2.- XS-1 airplane.

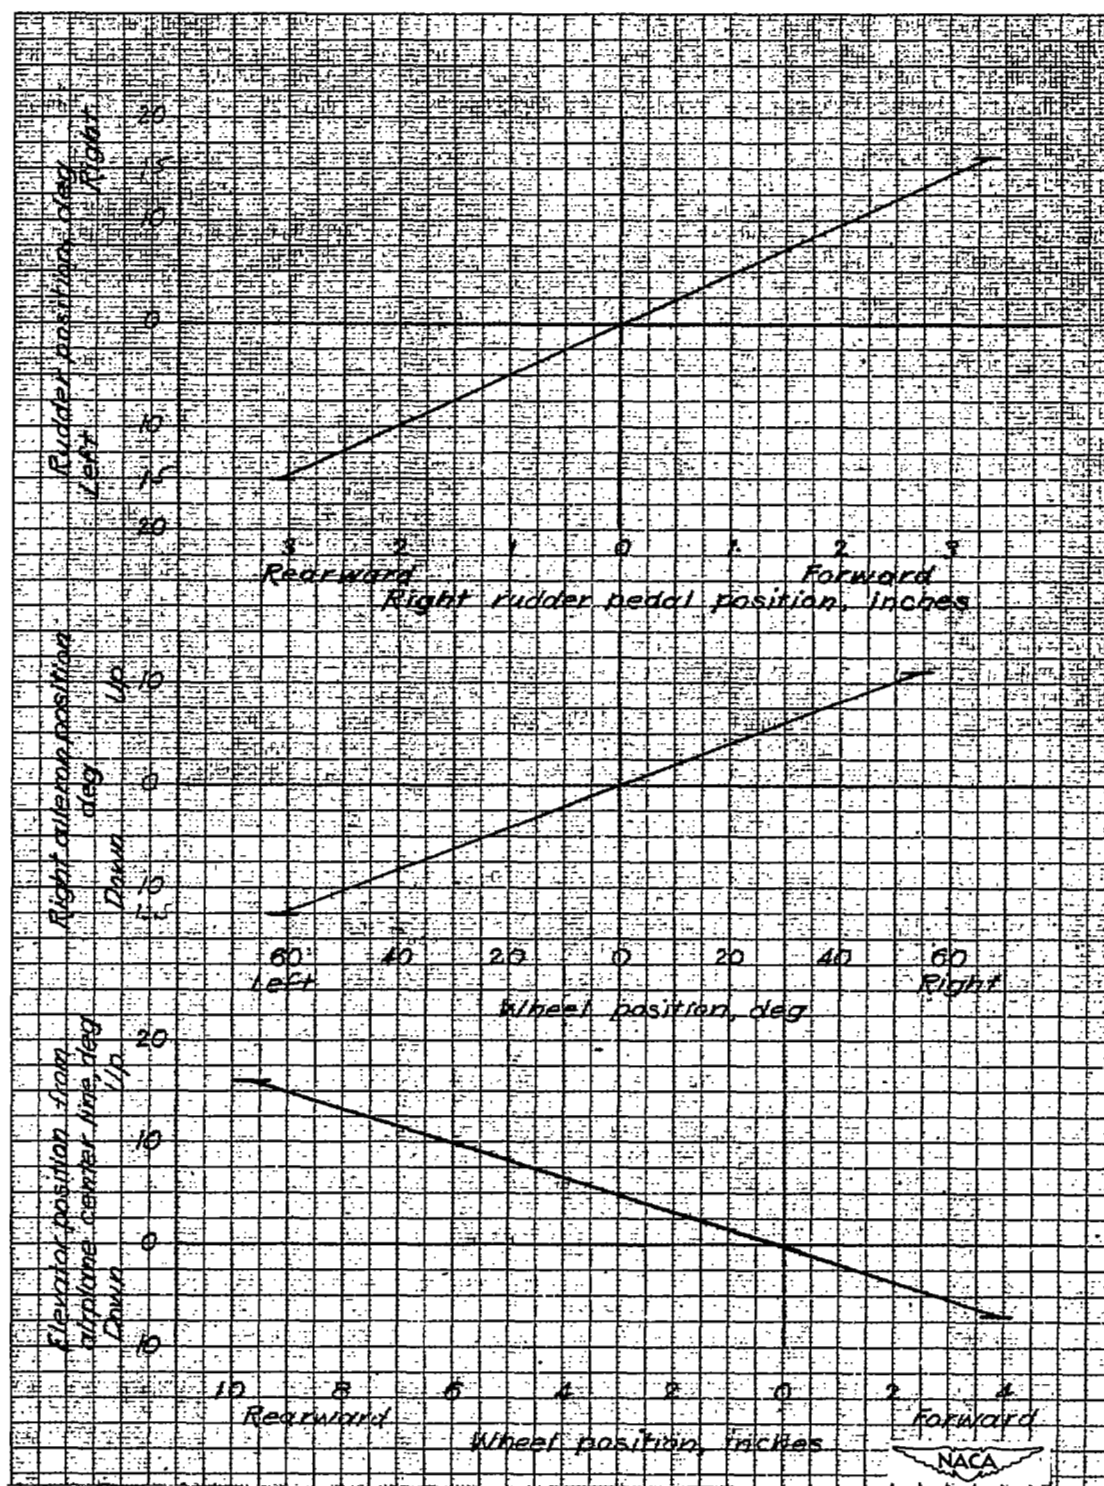
Figure 3.- Variation of control-surface deflection with pilot's control position. XS-1 airplane.

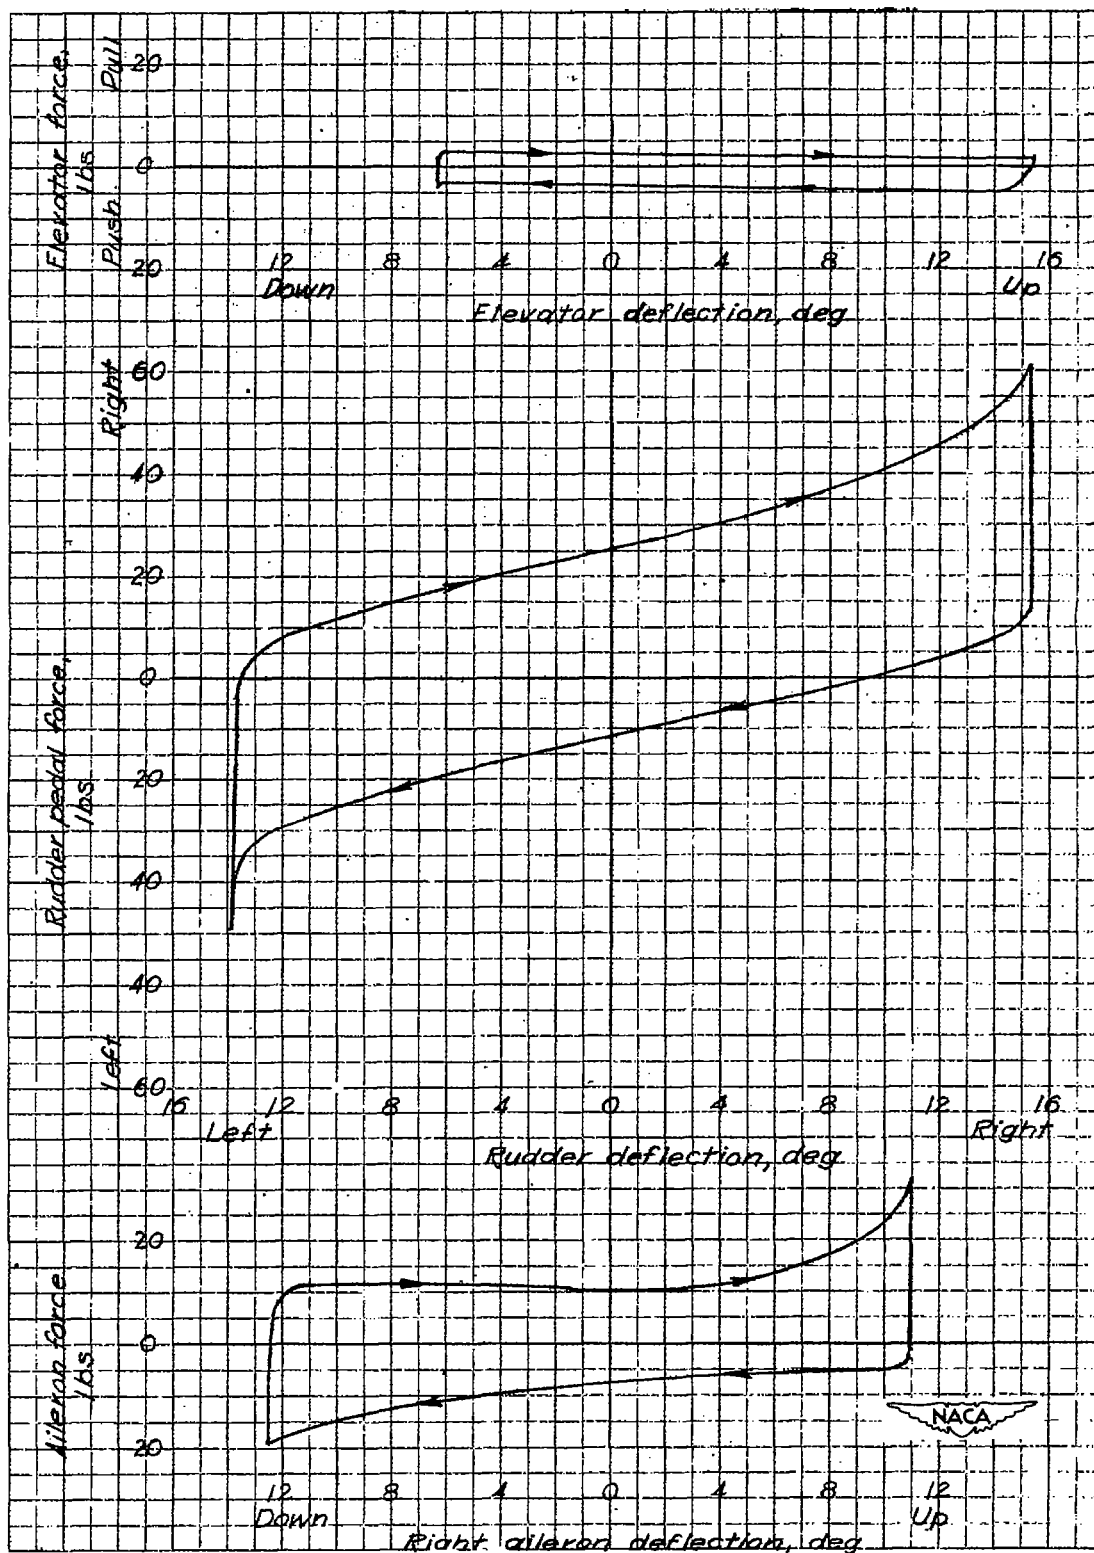
Figure 4.- Control forces required to deflect control surfaces under no load on the ground. XS-1 airplane.

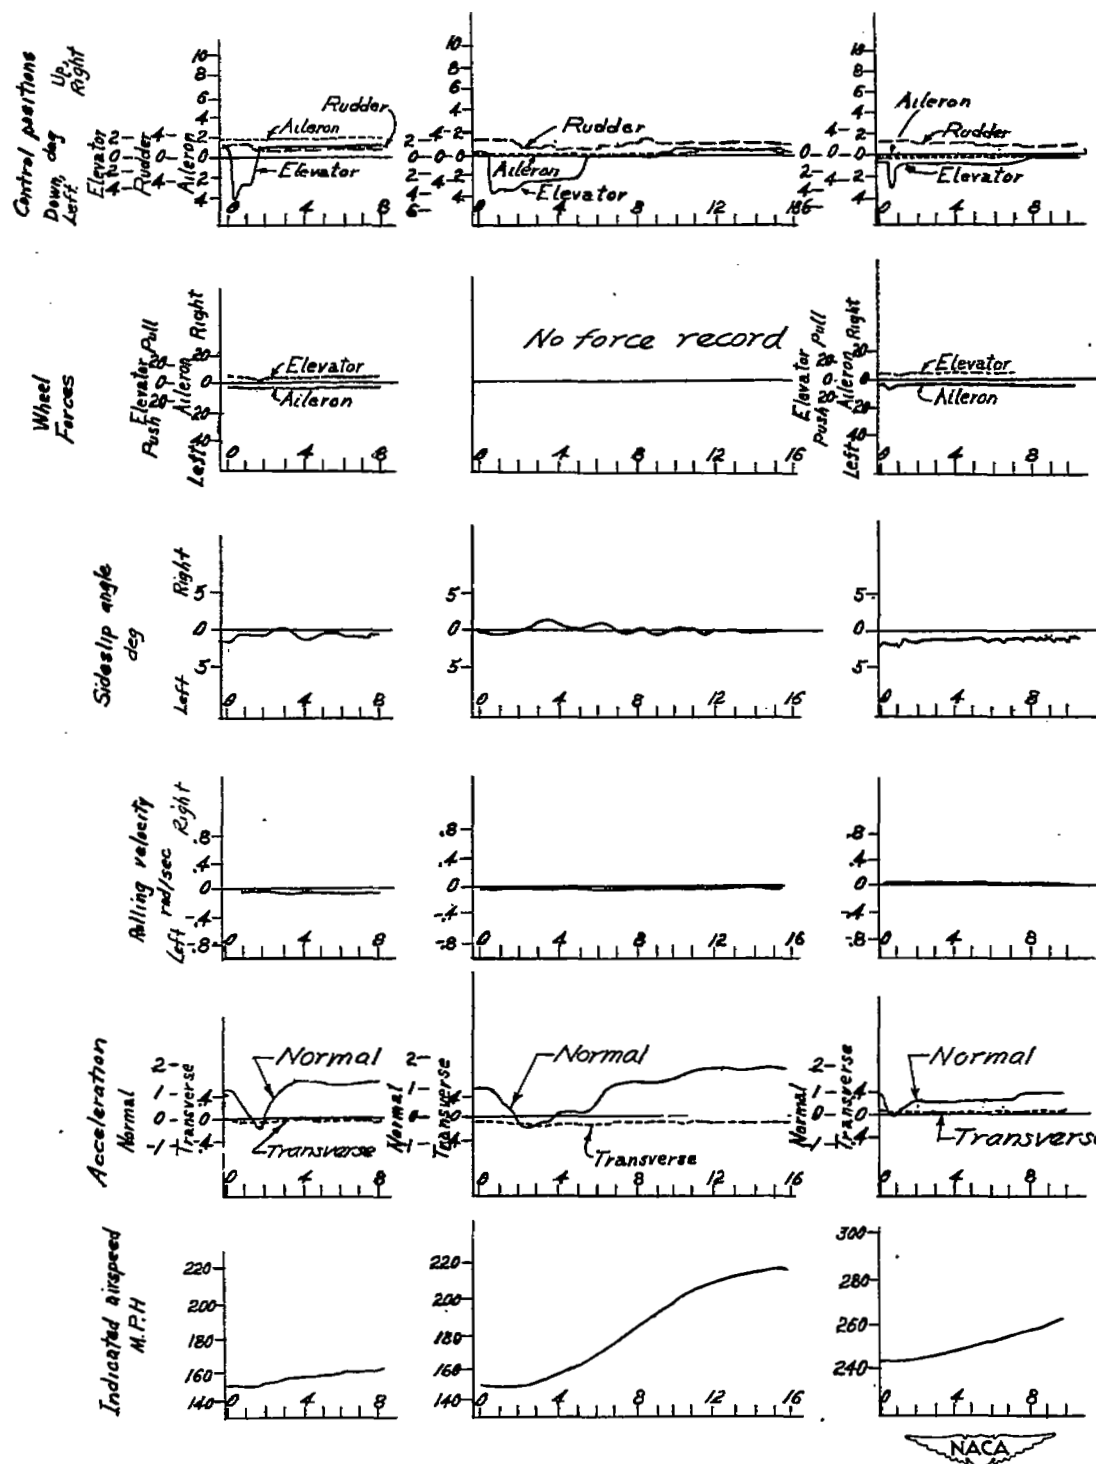
Figure 5.- Time histories of abrupt deflection and release of elevator control. XS-1 airplane.  $\frac{W}{S} = 32.5 \text{ lb/sq ft.}$

elevator control. Results of these tests are presented in figure 5. This figure shows that the short-period longitudinal oscillation is completely damped.

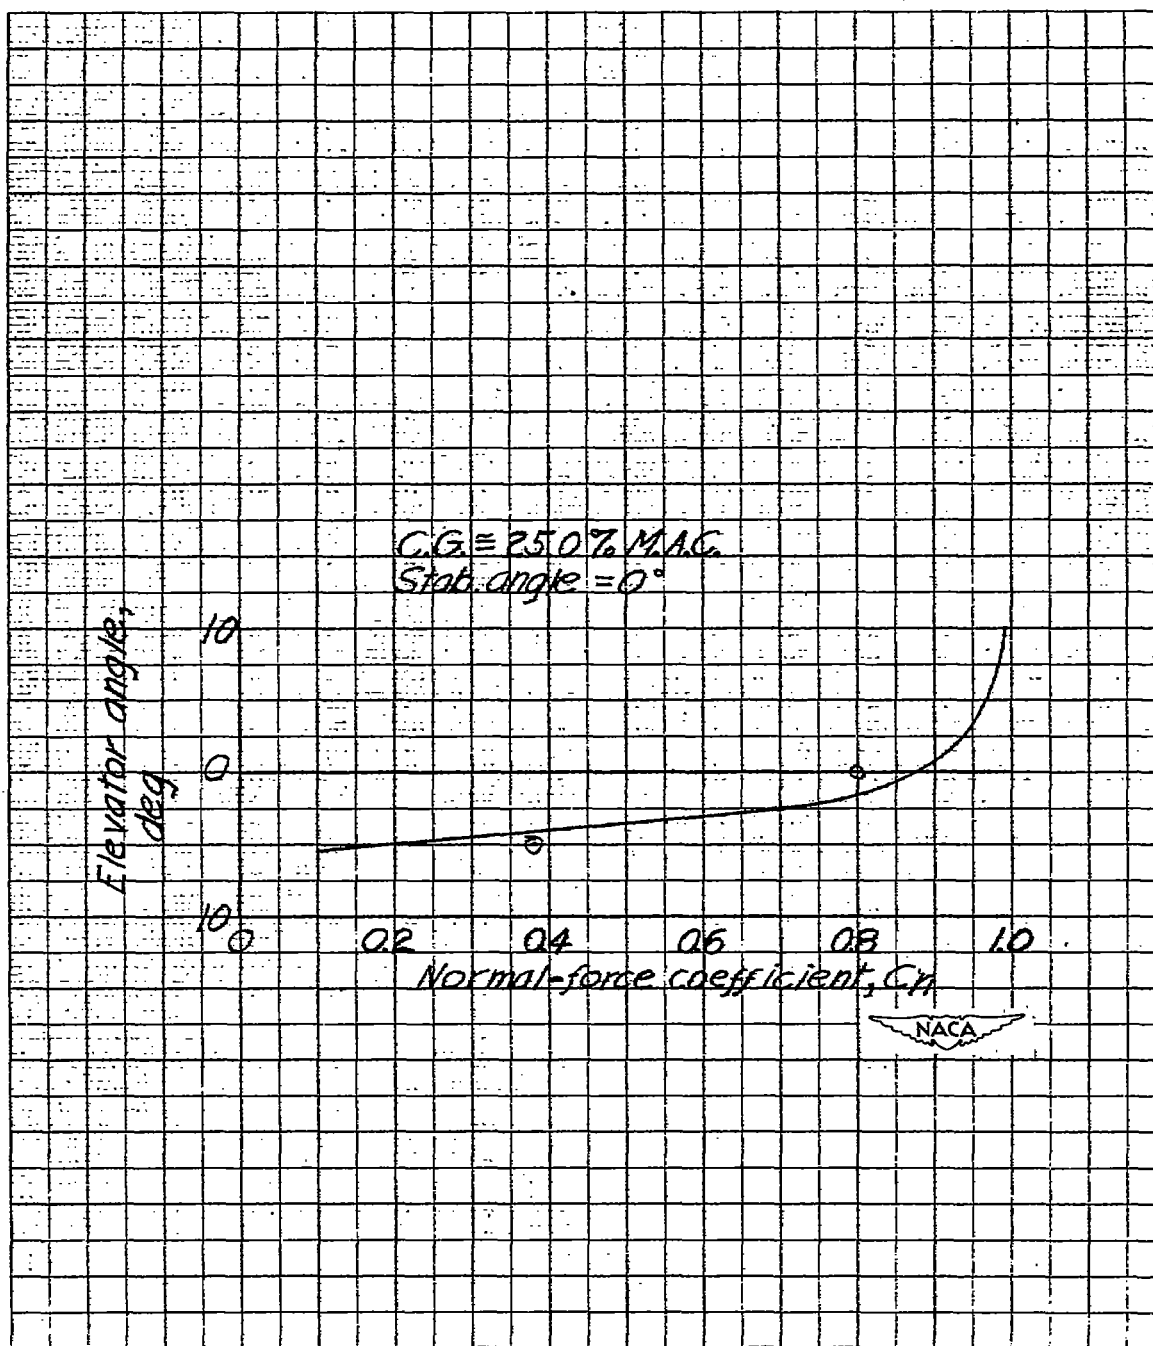
Figure 7.- Variation of elevator position, corrected to zero stabilizer position, required for trim with normal-force coefficient for steady gliding flight with flaps and gear up. Center-of-gravity location at approximately 25 percent M.A.C.; XS-1 airplane with 10-percent-thick wing.

The static longitudinal stability was obtained from measurements of the elevator positions and forces required to trim at various speeds. Figures 6 to 9 present the results of these measurements. In figure 6 the elevator position and force required for trim as a function of indicated airspeed is plotted for steady gliding flight at various wing loadings and stabilizer positions for the airplane with the 10-percent-thick wing. Examination of the data shows that both the stick-fixed and stick-free static longitudinal stability are positive but low. The relatively high friction in the elevator control ( $\pm 3$  lb) combined with the small size of the elevator and low stick-free stability has the effect of masking the measured control forces. The elevator-position variation with indicated airspeed of figure 6 is replotted in figure 7 as the variation of elevator position for trim with normal-force coefficient. The elevator positions have been corrected to zero stabilizer angle by using a value of  $r$ , the elevator effectiveness, of 0.42 obtained from flight data. A marked increase in the stick-fixed static stability is noticed as maximum lift is approached. These results are in general agreement with wind-tunnel results.

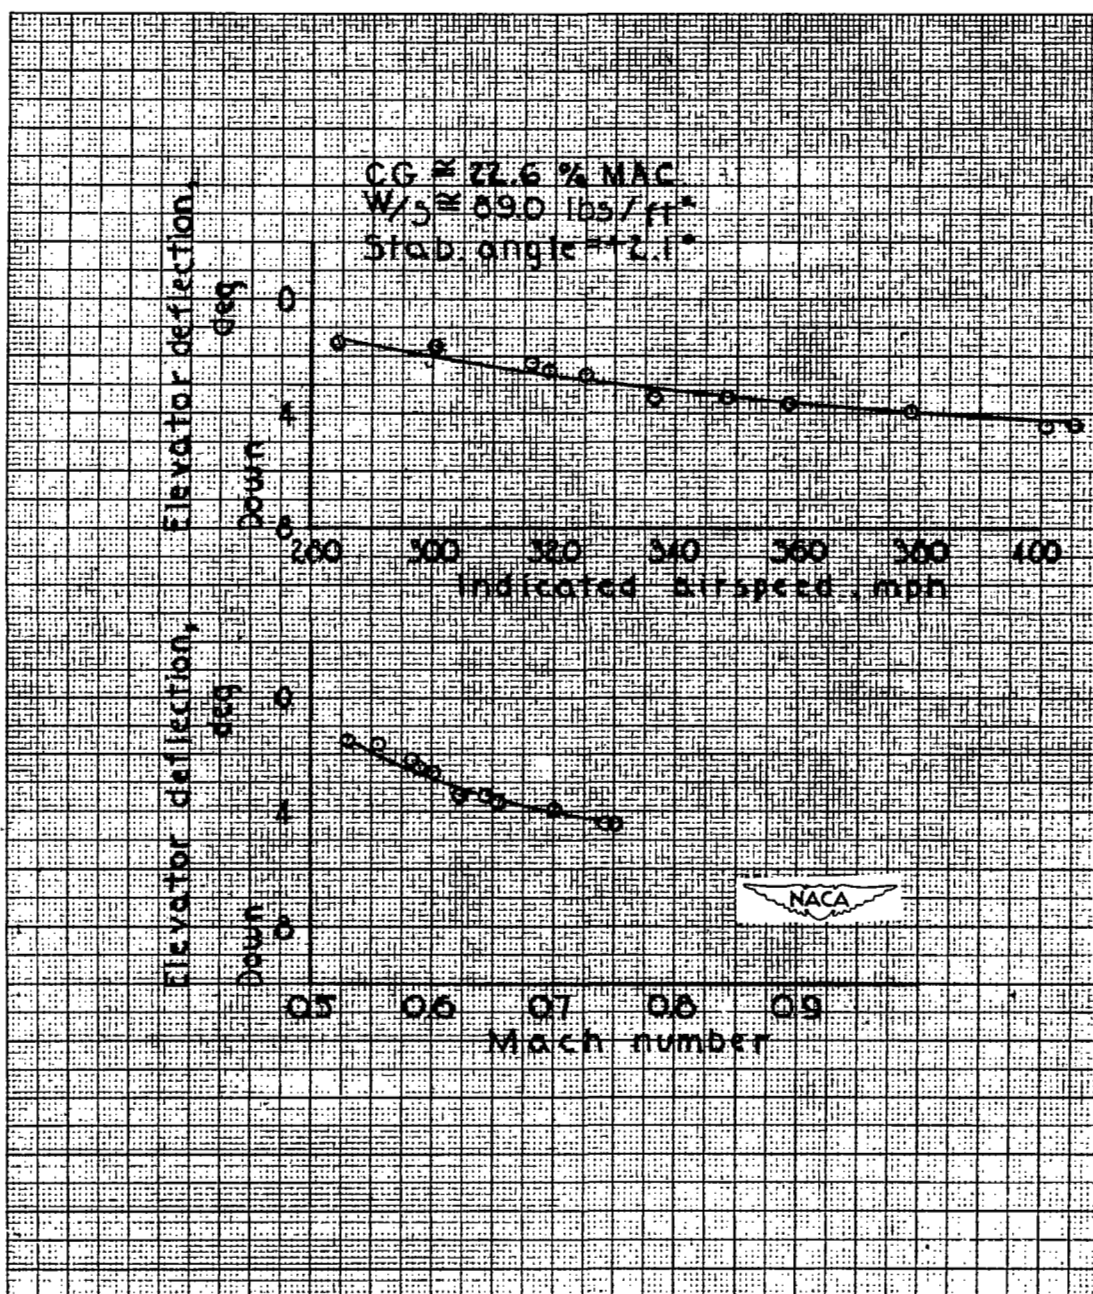
Figure 8.- Variation of elevator position with indicated airspeed and Mach number for trim in steady powered flight. XS-1 airplane with 10-percent-thick wing. Center of gravity approximately 22.6 percent M.A.C.;  $\frac{W}{S} = 89$  lb/sq ft. Stabilizer position 2.1°.

The variation of elevator position with indicated airspeed and Mach number for steady power-on flight is presented in figure 8. The center-of-gravity location for these results was at about 22.6 percent mean aerodynamic chord as compared with the center-of-gravity location of about 25 percent mean aerodynamic chord for the results of figures 6 and 7. The speed range covered was from an indicated airspeed of 284 miles per hour to 406 miles per hour and for a Mach number range from 0.53 to 0.75. The results as seen from this figure indicate that power has little effect on the longitudinal stability of the Bell XS-1 up to the highest speeds tested. Also, no undesirable longitudinal-trim changes are indicated.

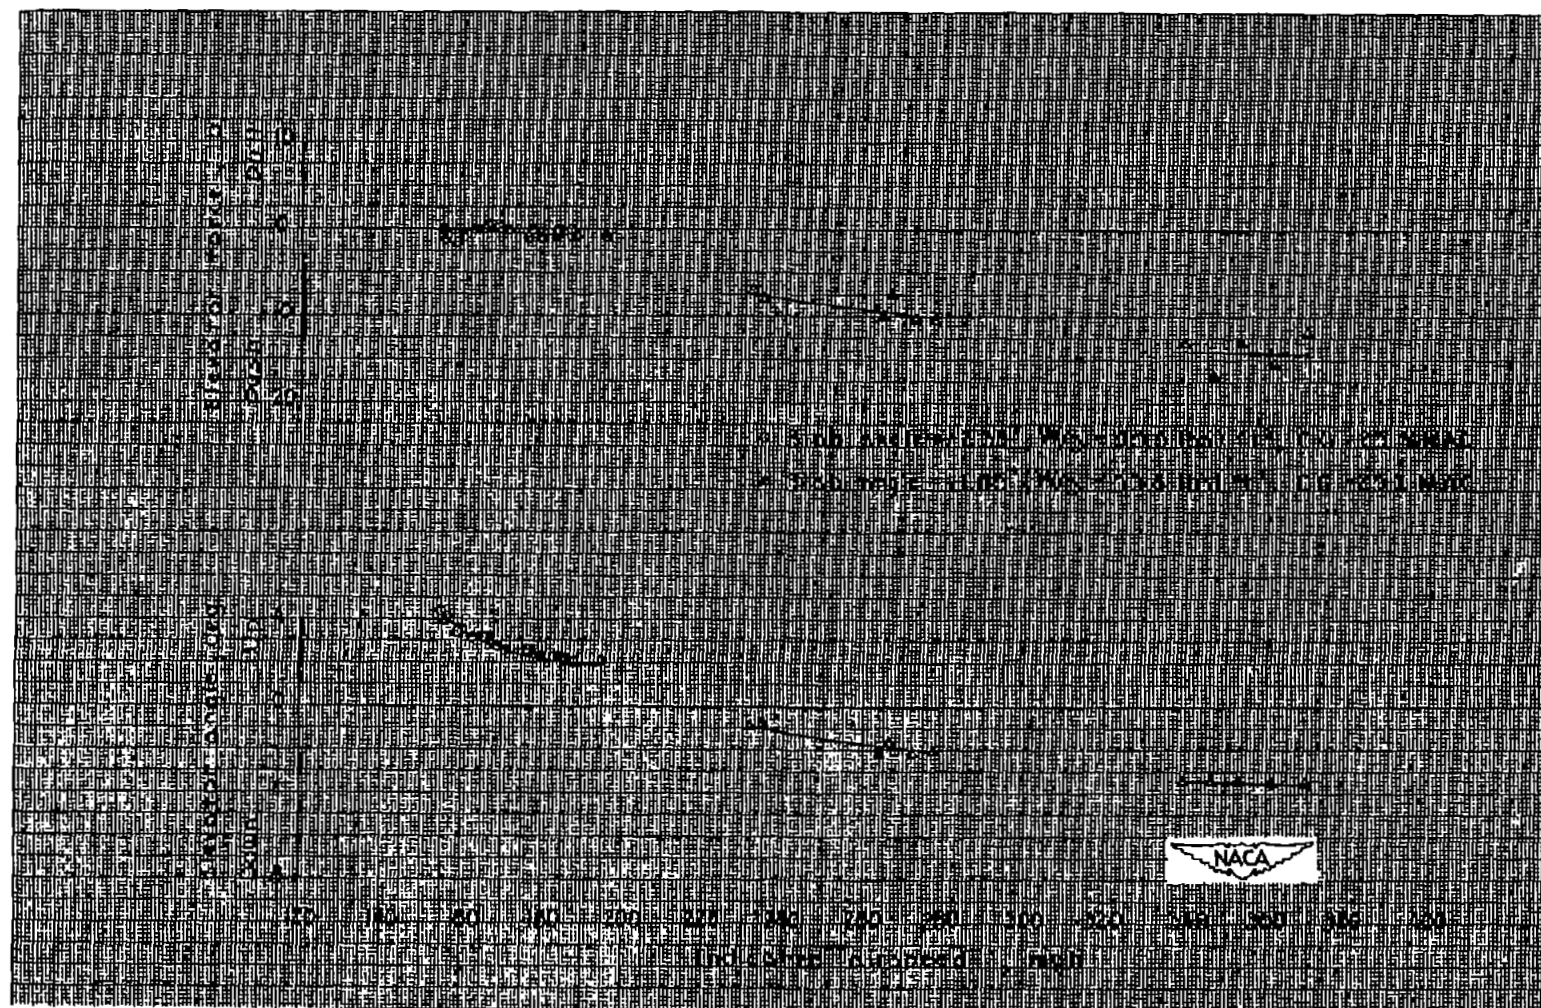
Figure 9.- Variation of elevator stick force and position with indicated airspeed for trim in steady gliding flight with several stabilizer settings. XS-1 airplane with 8-percent-thick wing.

Center of gravity 25 percent M.A.C.;  $\frac{W}{S} = 53.8$  lb/sq ft.

The results of tests with the 8-percent-thick wing (fig. 9) in steady gliding flight, although limited, bear out the positive but low static longitudinal stability evidenced by the results for the airplane incorporating the 10-percent-thick wing. No appreciable differences in the static longitudinal stability of the Bell XS-1 airplane with either the 10-percent-thick or the 8-percent-thick wing are evidenced from these results (figs. 6 and 9).

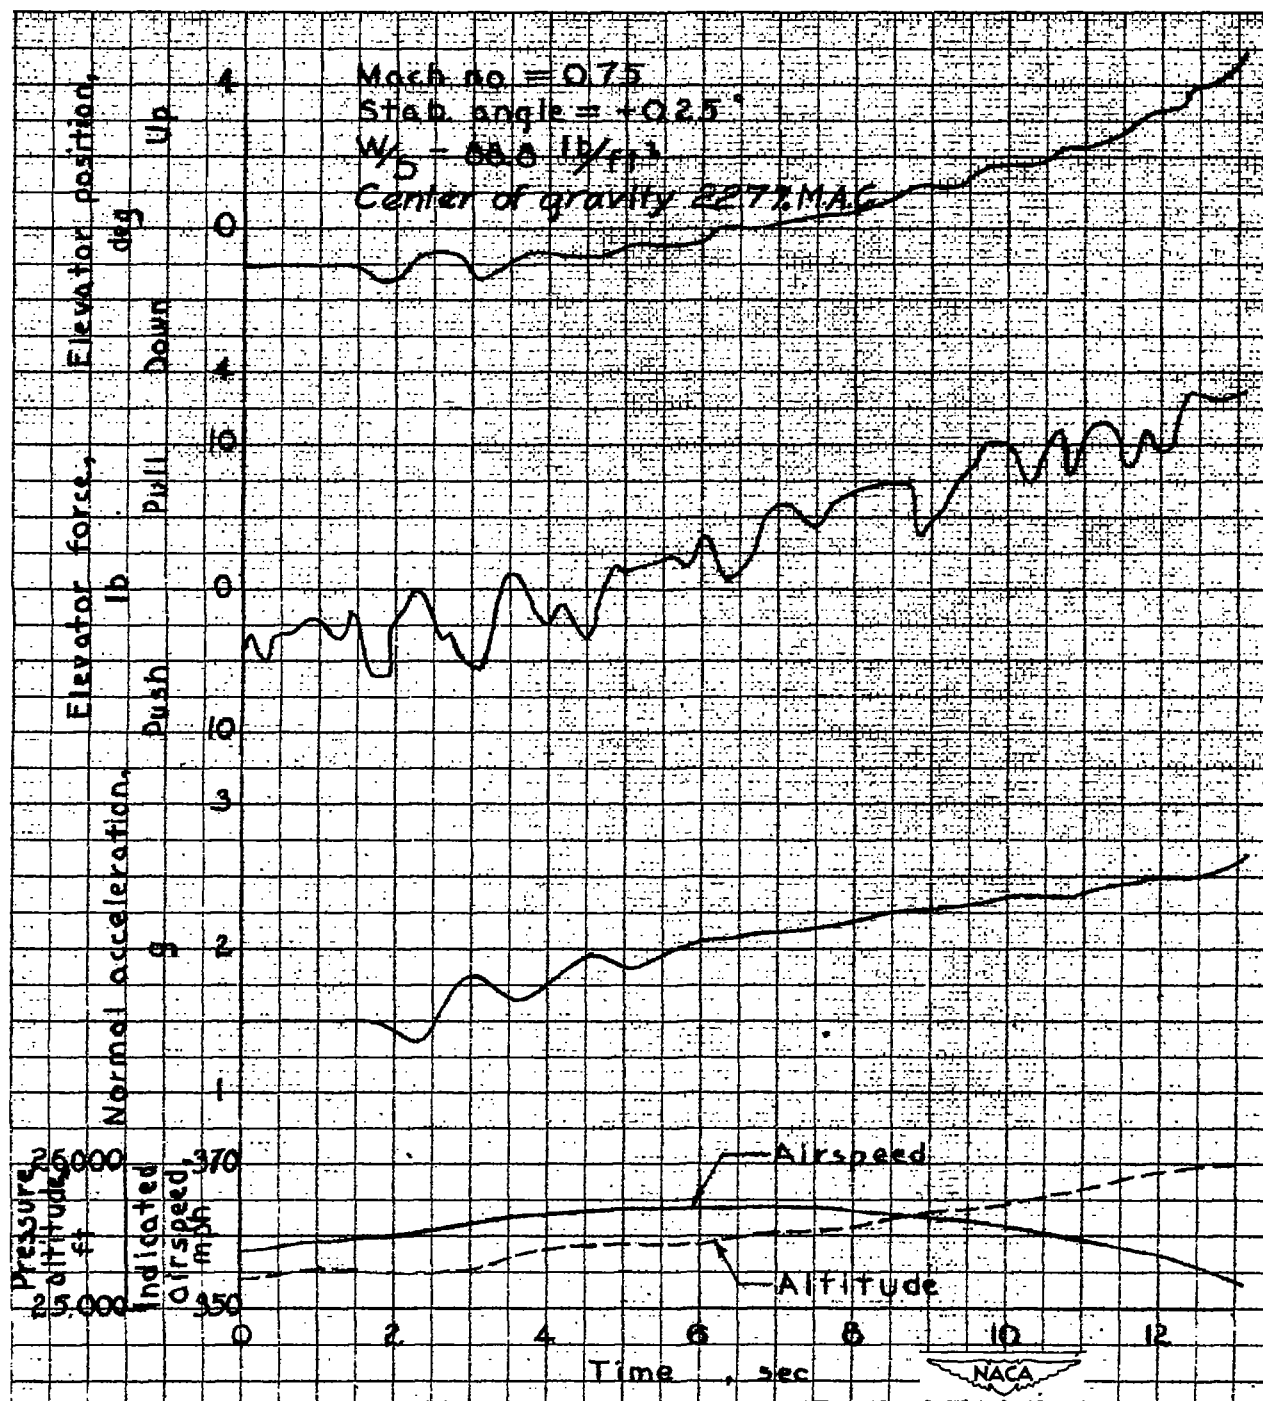
Figure 10.- Time history of a power-on turn with slowly increasing normal acceleration at a Mach number of about 0.75. XS-1 airplane with 10-percent-thick wing.

altitude so that complete data for a given Mach number would be obtained in one run. Time histories of two turns are presented in figures 10 and 11. In one turn (fig. 10) the record switch was turned on after the turn was started, but the turn was fairly steady considering the friction in the control system. In the other turn (fig. 11) the elevator was moved in an unsteady manner and the rate of increase of acceleration with time was too high at the beginning of the turn. Since several of the turns were made in this manner, the slopes of the curves of elevator deflection against normal-force coefficient and the elevator force per  $g$  should be compared only in a general way for large changes in acceleration or lift coefficient for turns at different Mach numbers. Figures 12 through 16 present the stick-fixed and stick-free accelerated-flight longitudinal-stability results obtained from the turns. The Mach number range covered is from 0.48 to 0.75. The elevator-position variation with normal acceleration and normal-force coefficient and the force per  $g$  gradients indicate a decrease in stability for turns (figs. 13 to 16) made at Mach numbers from 0.65 to 0.72. At the highest Mach number tested ( $M = 0.75$ ) an increase in longitudinal stability is indicated (figs. 14 and 16).

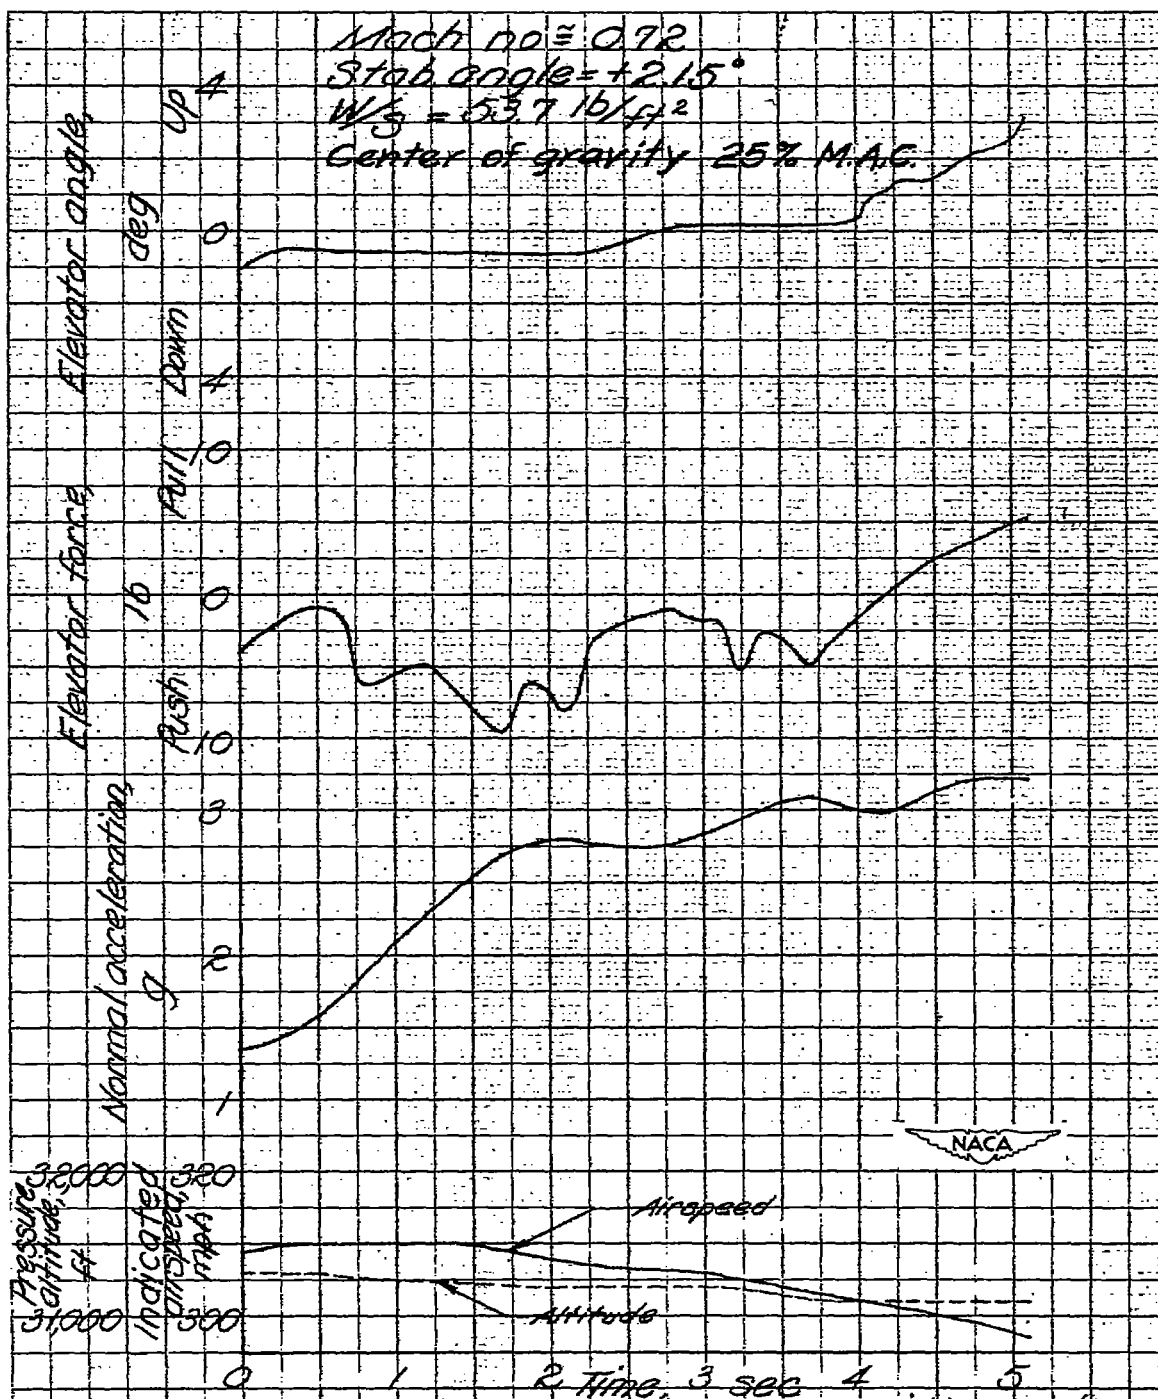
Figure 11.- Time history of a power-off turn with rapidly increasing normal acceleration at a Mach number of about 0.72. XS-1 airplane with 8-percent-thick wing.

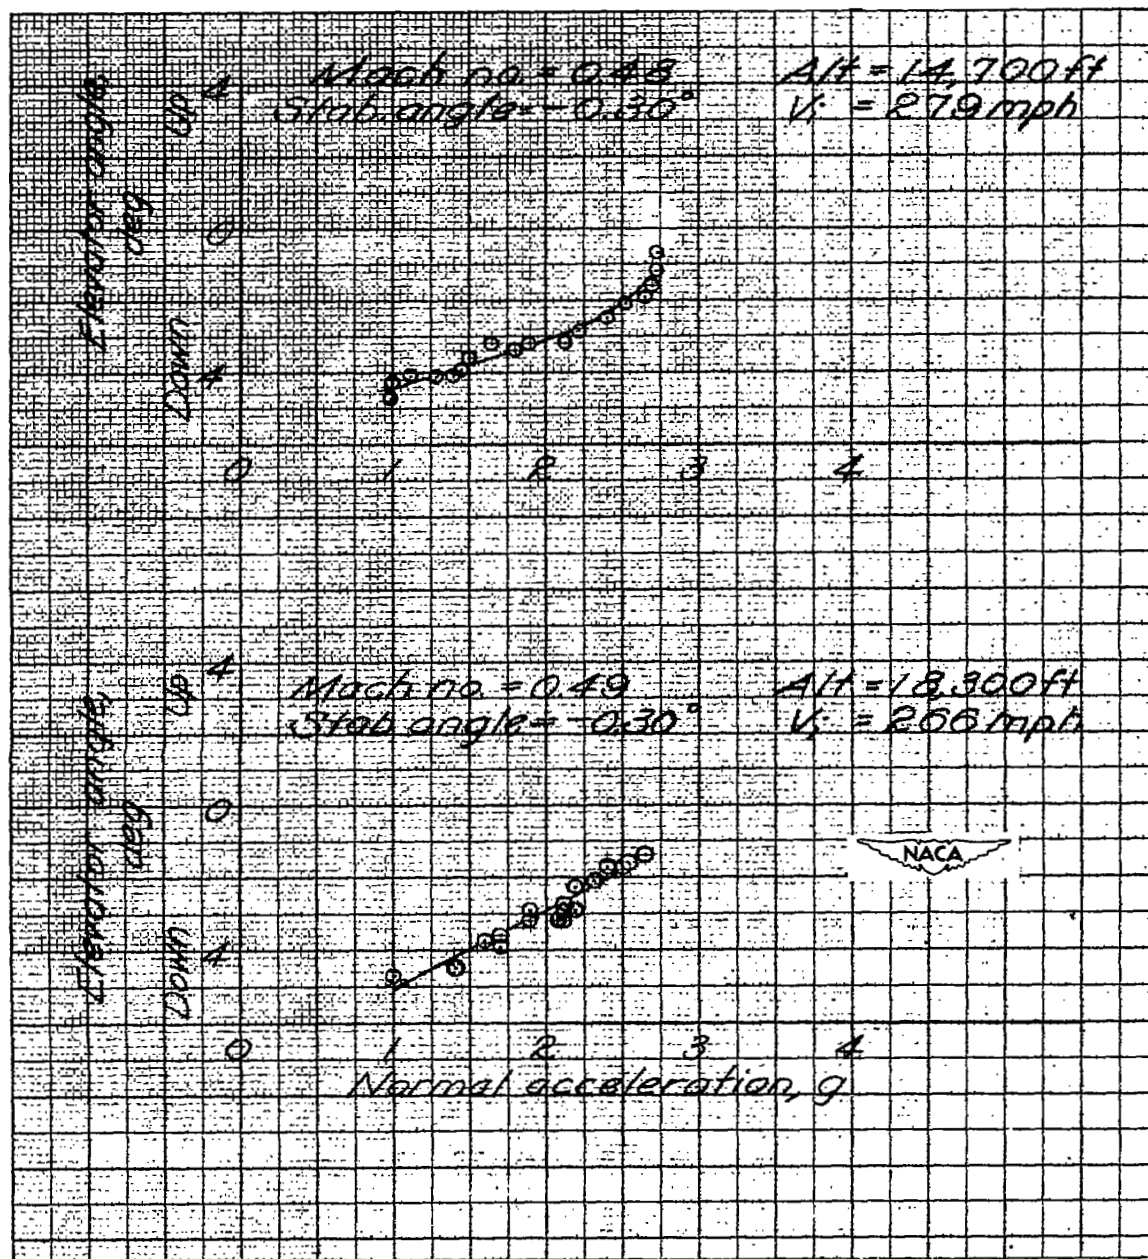
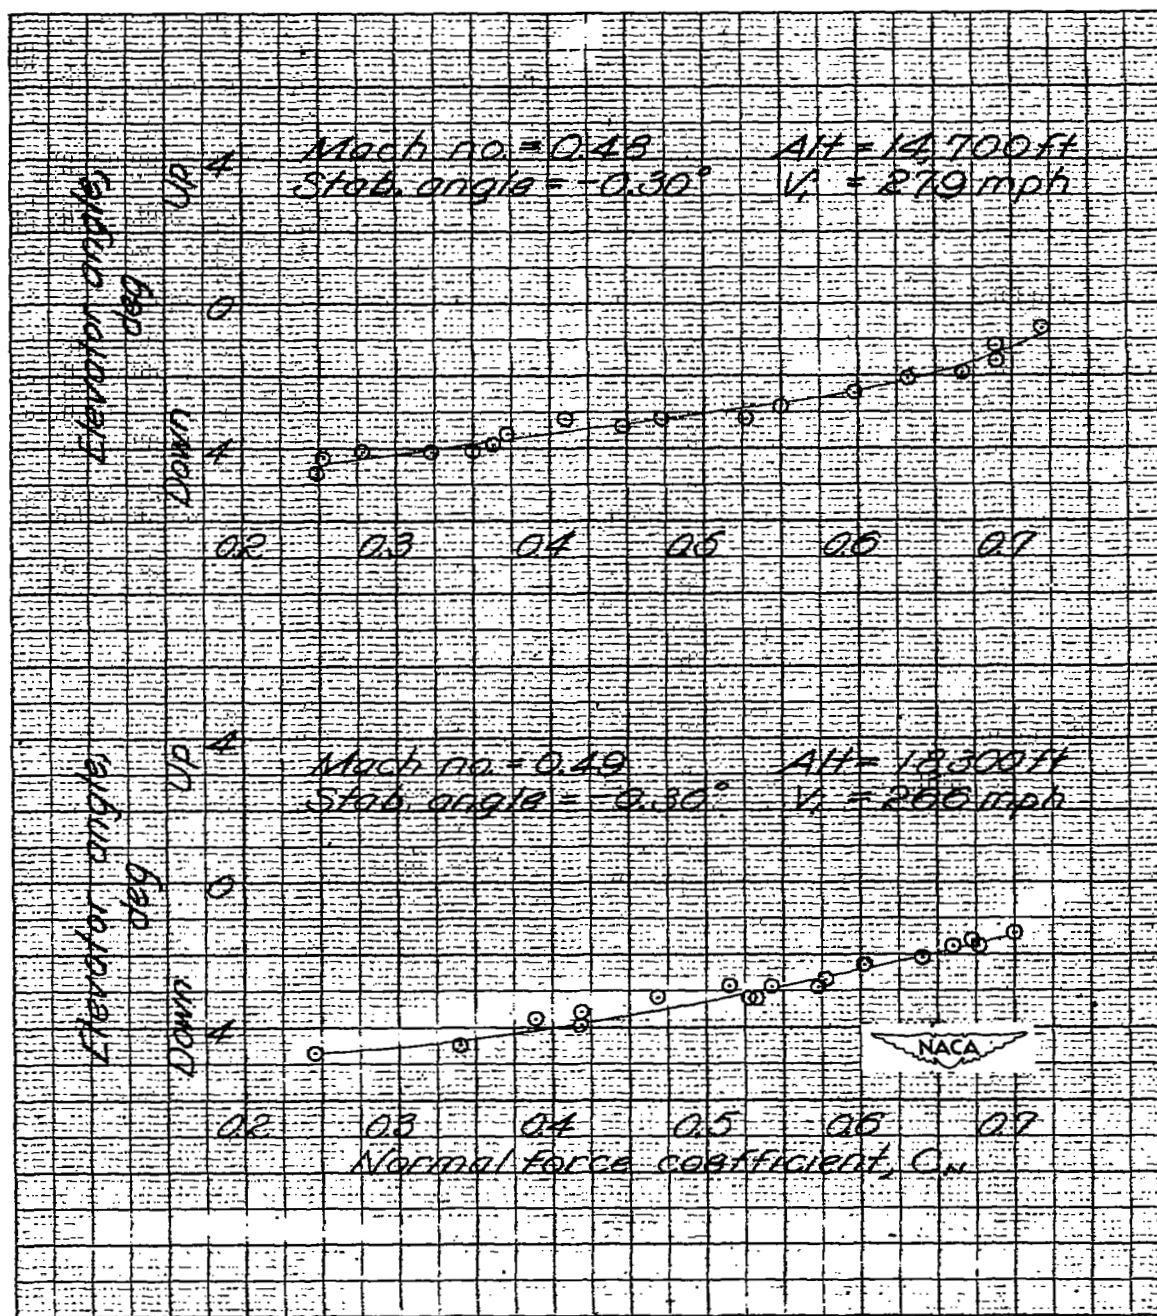
(a) Variation of elevator position with normal acceleration.

Figure 12.- Results obtained in turns at Mach numbers of 0.48 and 0.49, XS-1 airplane with 10-percent-thick wing. Gliding flight; center of gravity, 25.3 percent M.A.C.;  $\frac{W}{S} = 51.9$  lb/sq ft.

(b) Variation of elevator position with normal-force coefficient.

(c) Variation of elevator wheel force with normal acceleration.
