# RESEARCH MEMORANDUM

GENERAL HANDLING-QUALITIES RESULTS OBTAINED DURING  
ACCEPTANCE FLIGHT TESTS OF THE BELL XS-1 AIRPLANE

Walter C. Williams, Charles M. Forsyth, and Beverly P. Brown

Langley Memorial Aeronautical Laboratory  
Langley Field, Va.

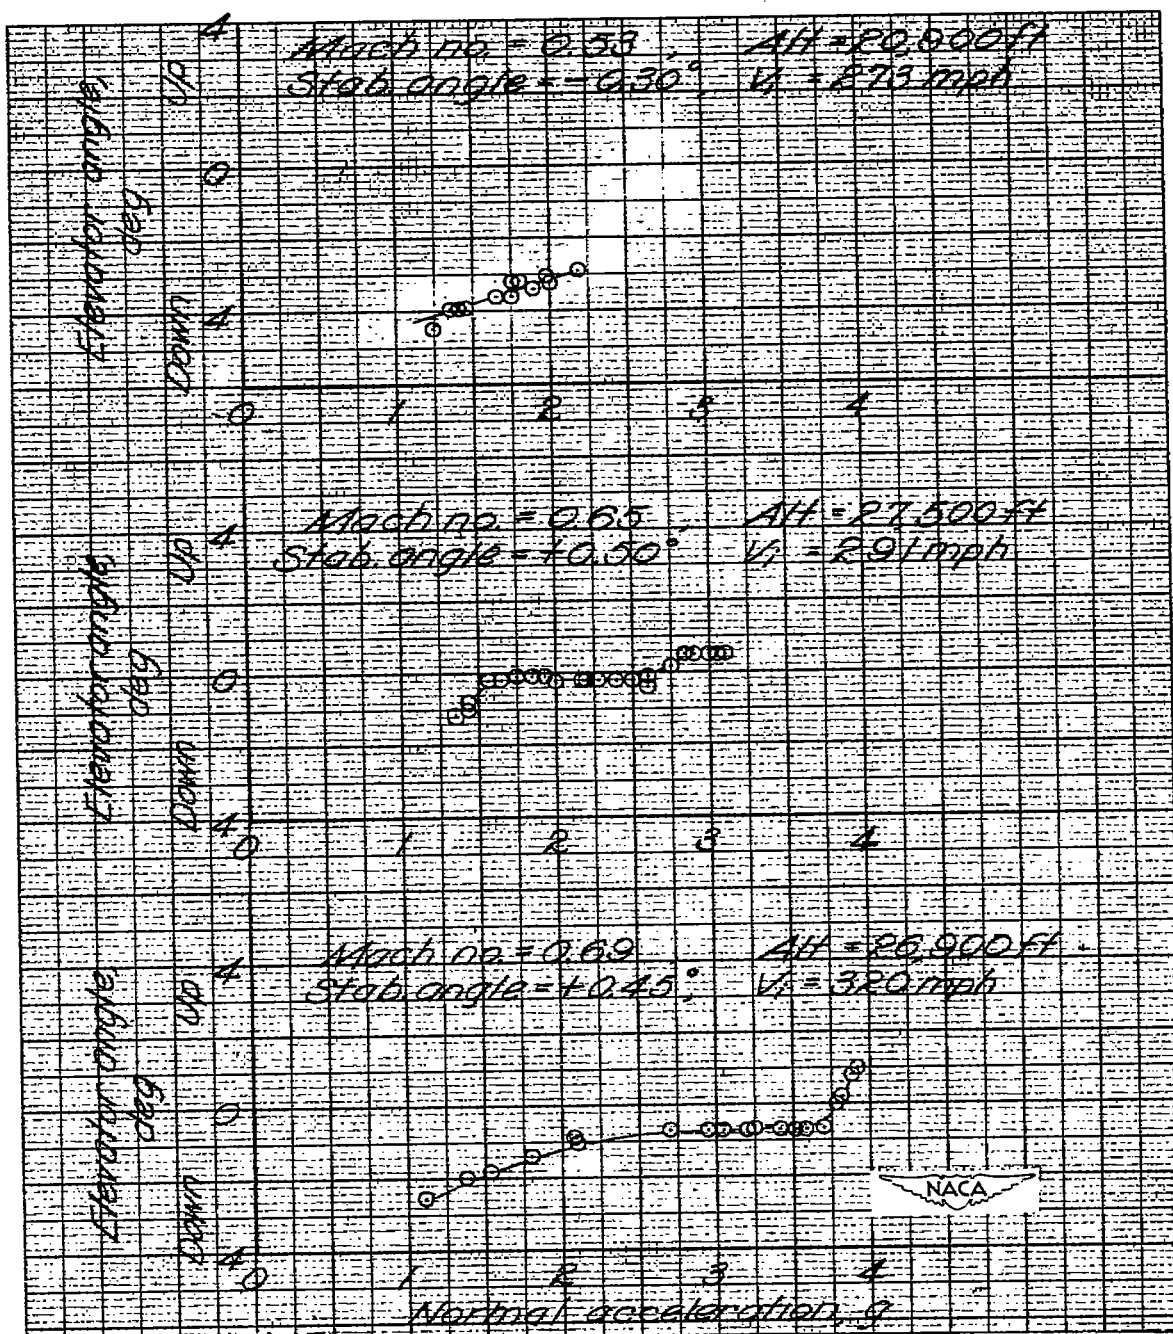
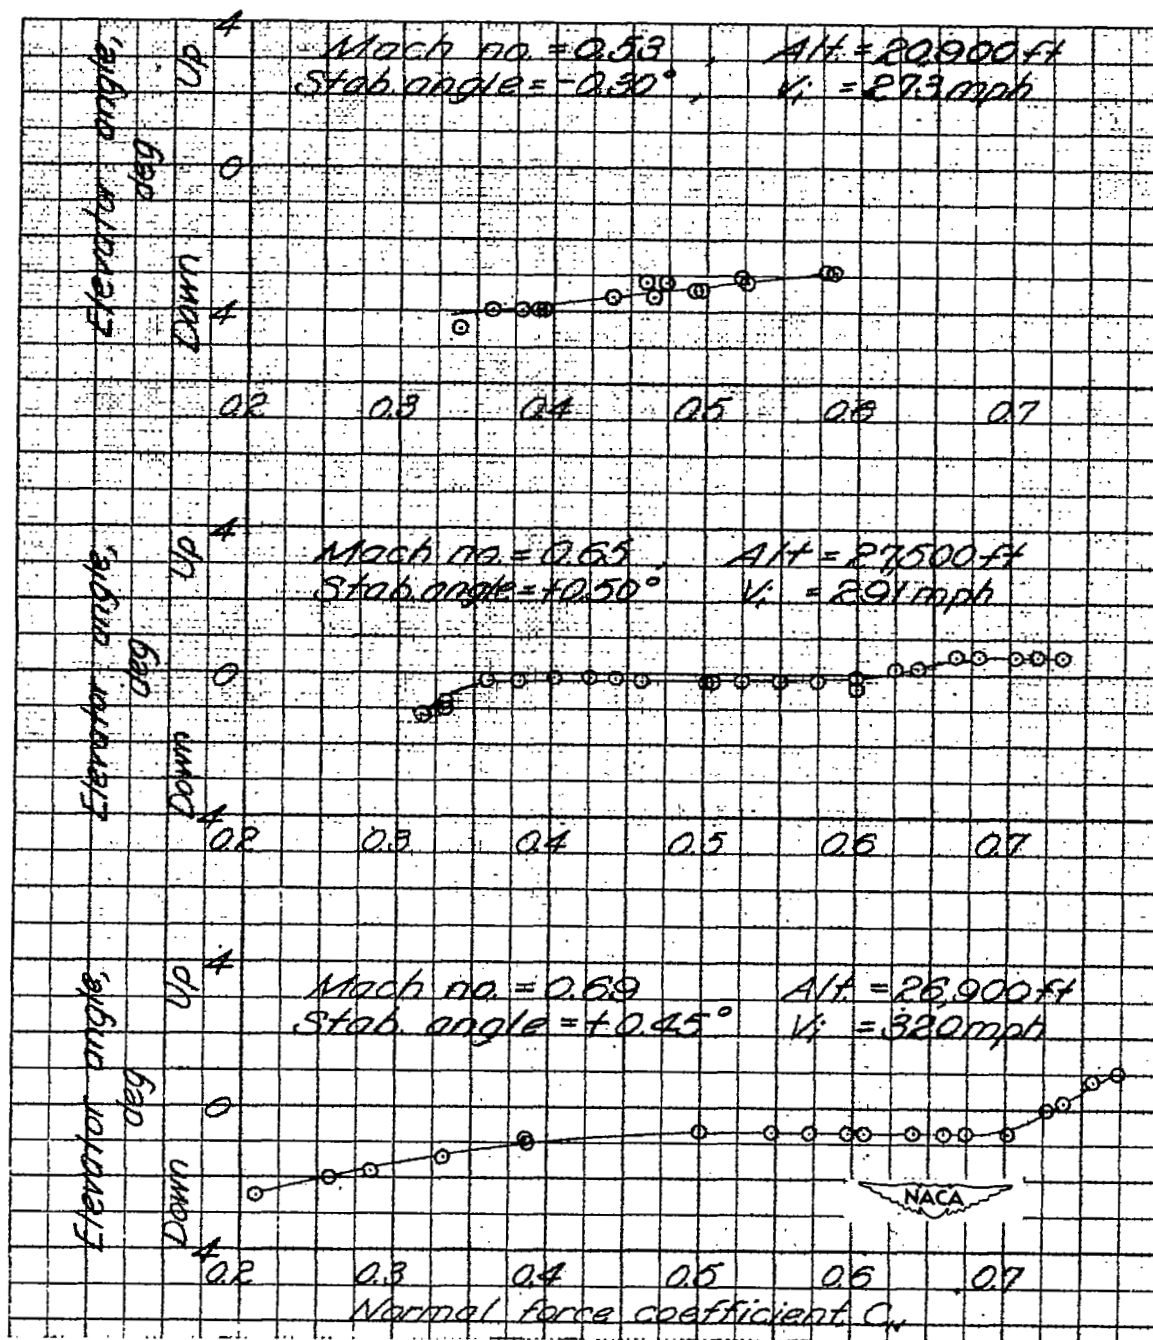
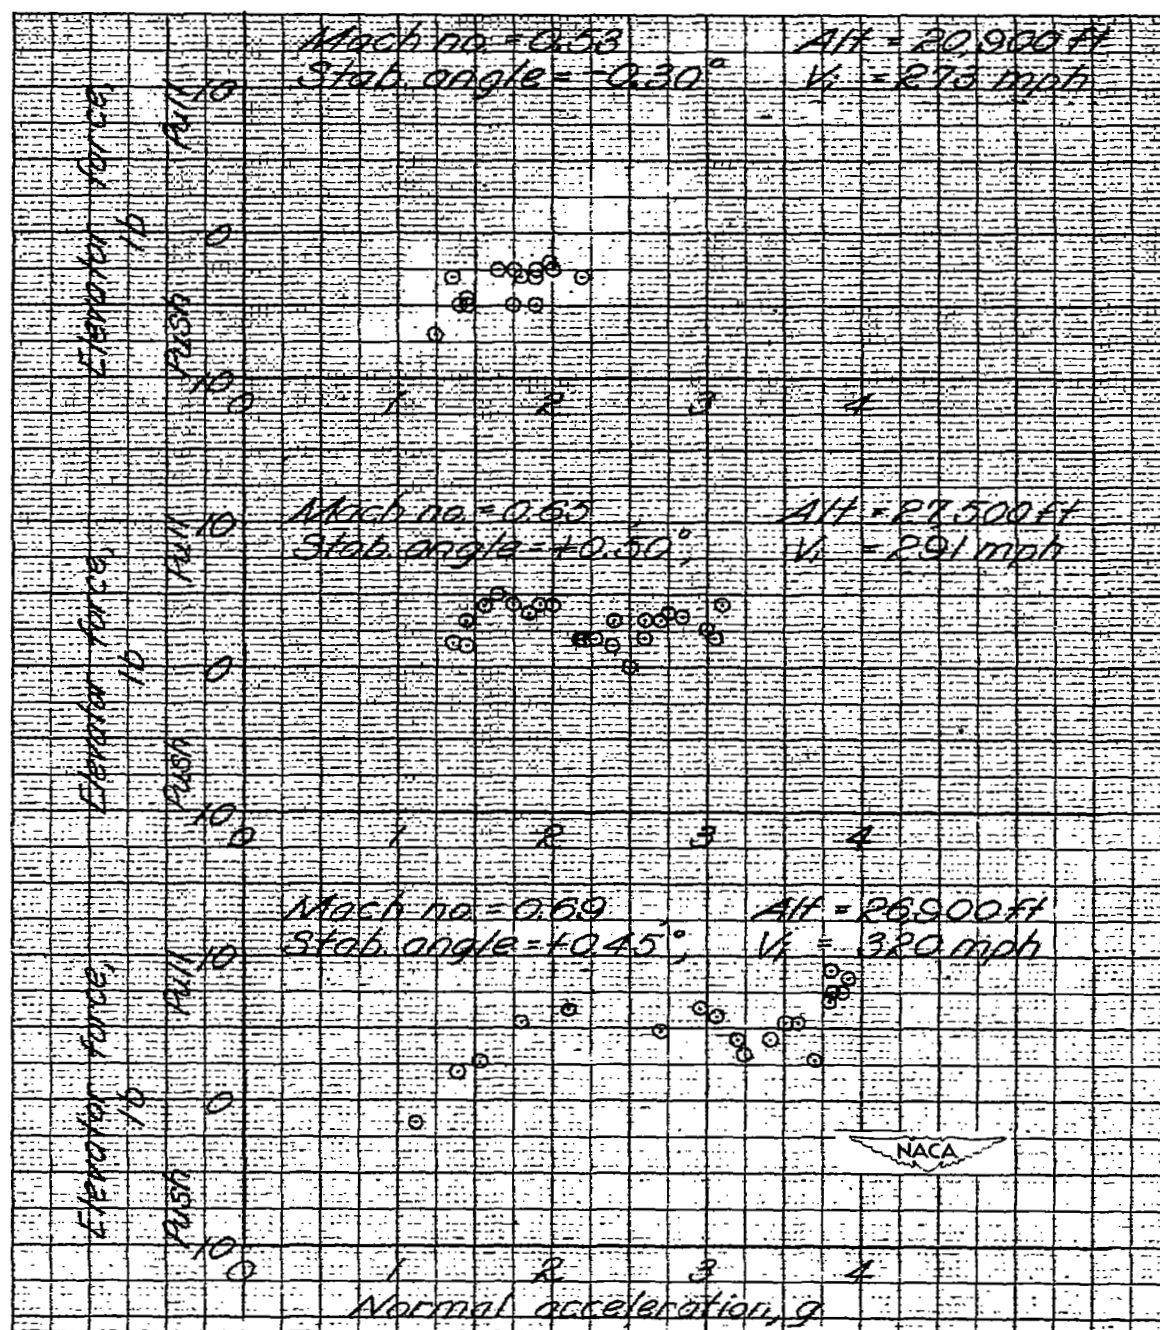
(a) Variation of elevator position with normal acceleration.

Figure 13.- Results obtained in turns at Mach numbers of 0.53, 0.65, and 0.69. XS-1 airplane with 10-percent-thick wing. Gliding flight; center of gravity, 25.3 percent M.A.C.;  $\frac{W}{S} = 51.9$  lb/sq ft.

(b) Variation of elevator position  
with normal-force coefficient.

(c) Variation of elevator wheel force  
with normal acceleration.

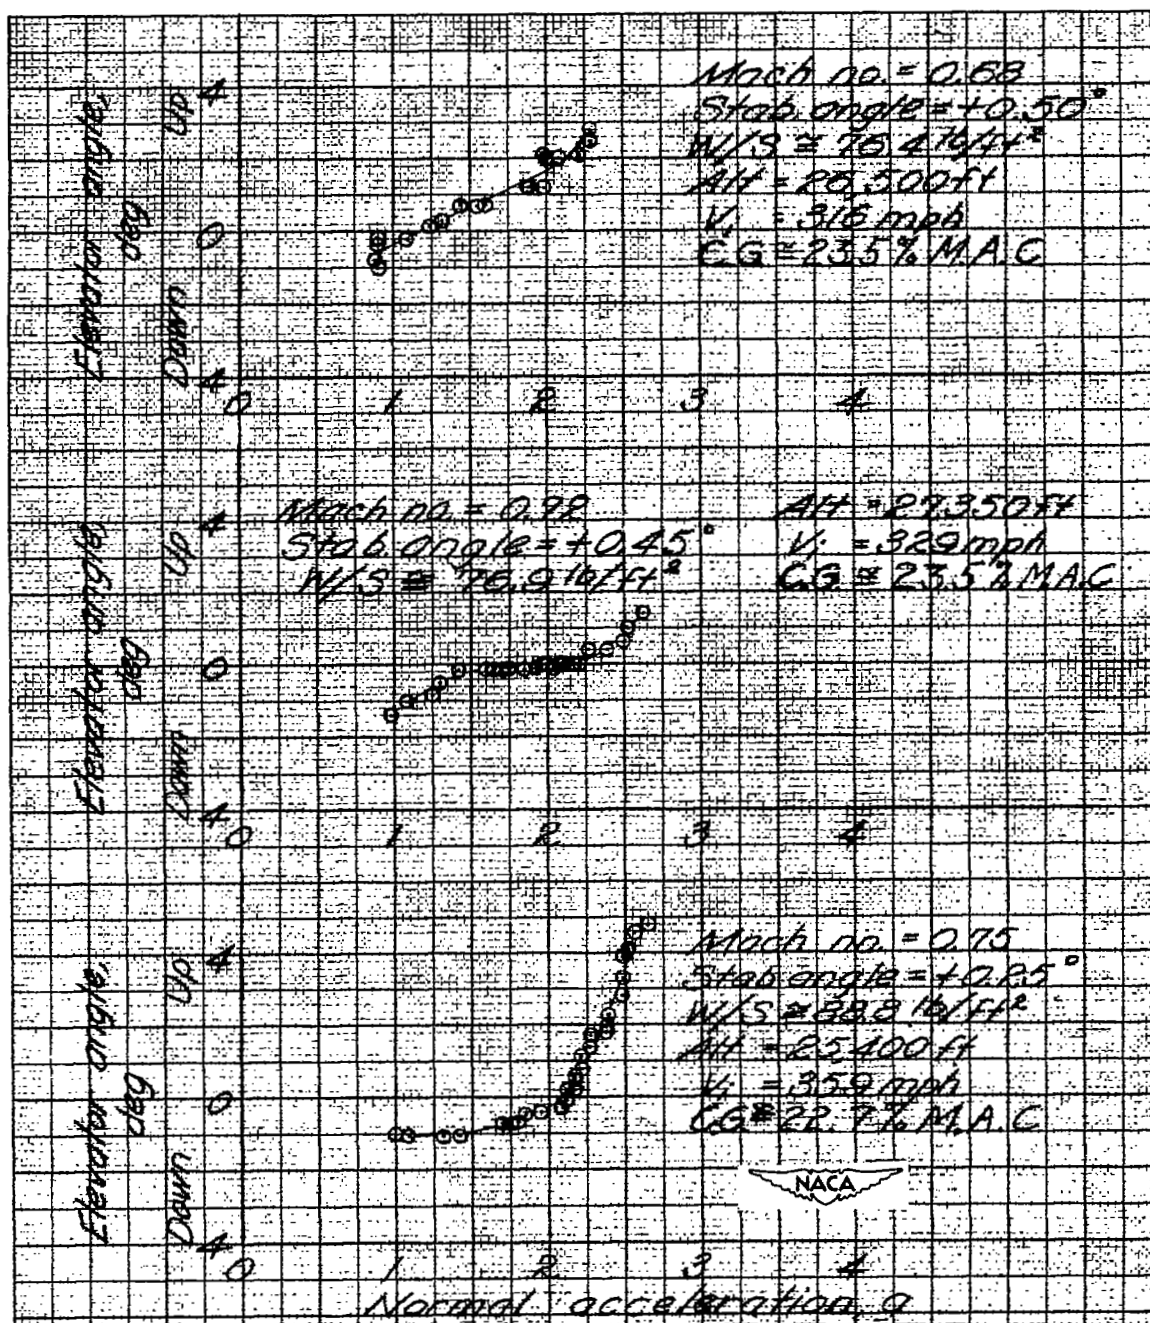
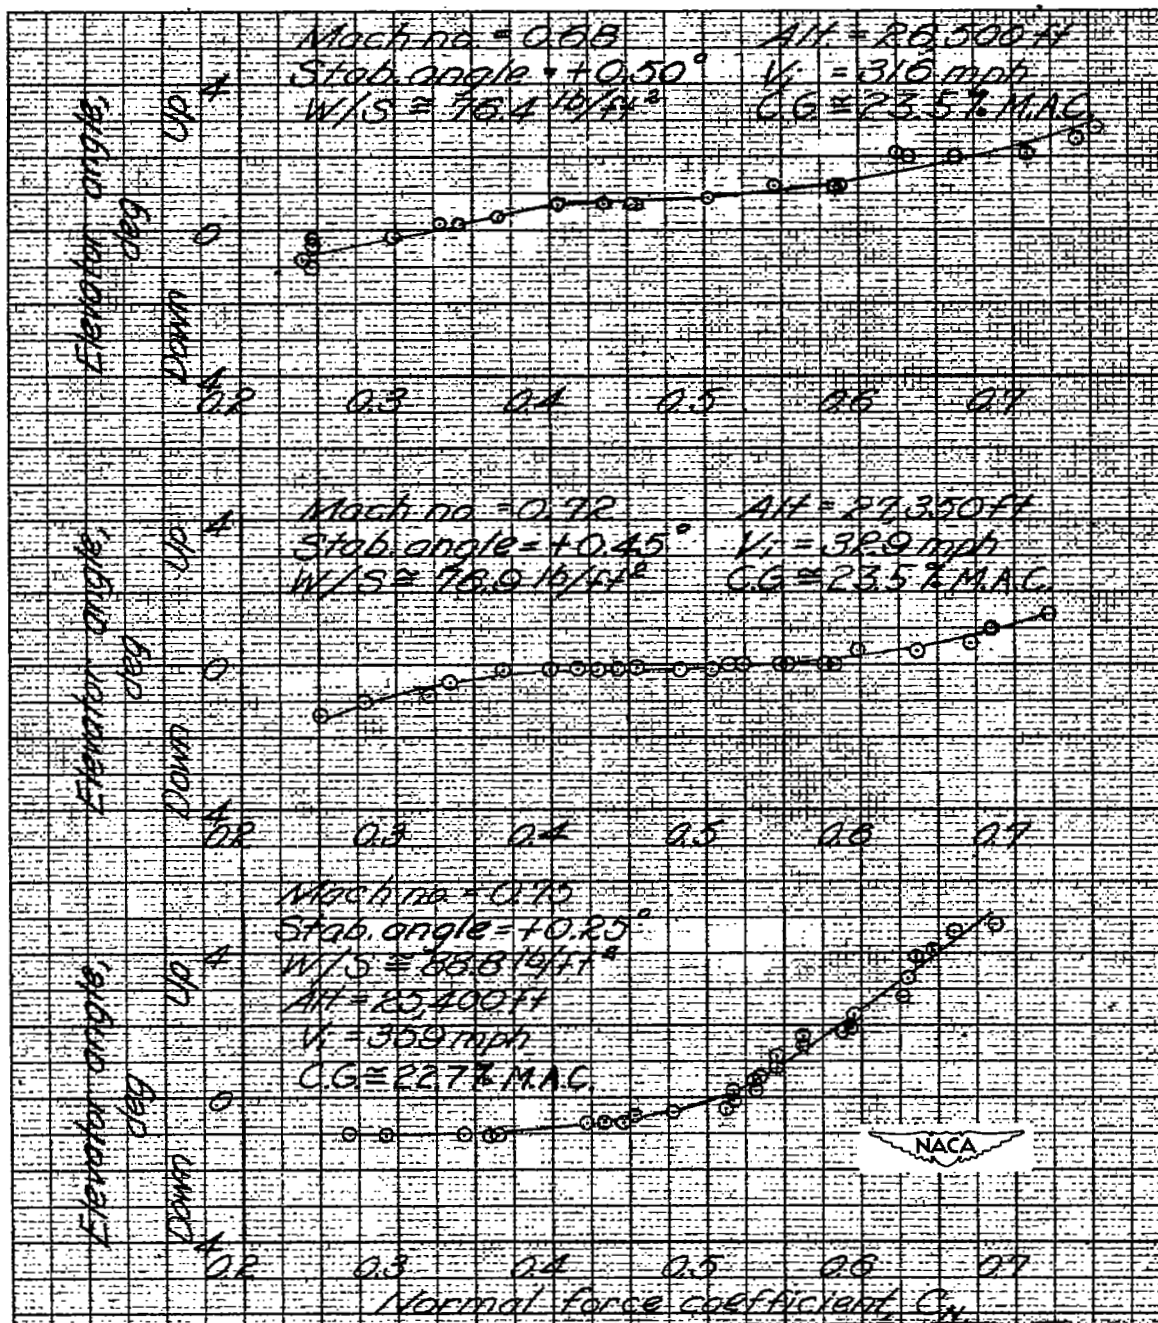
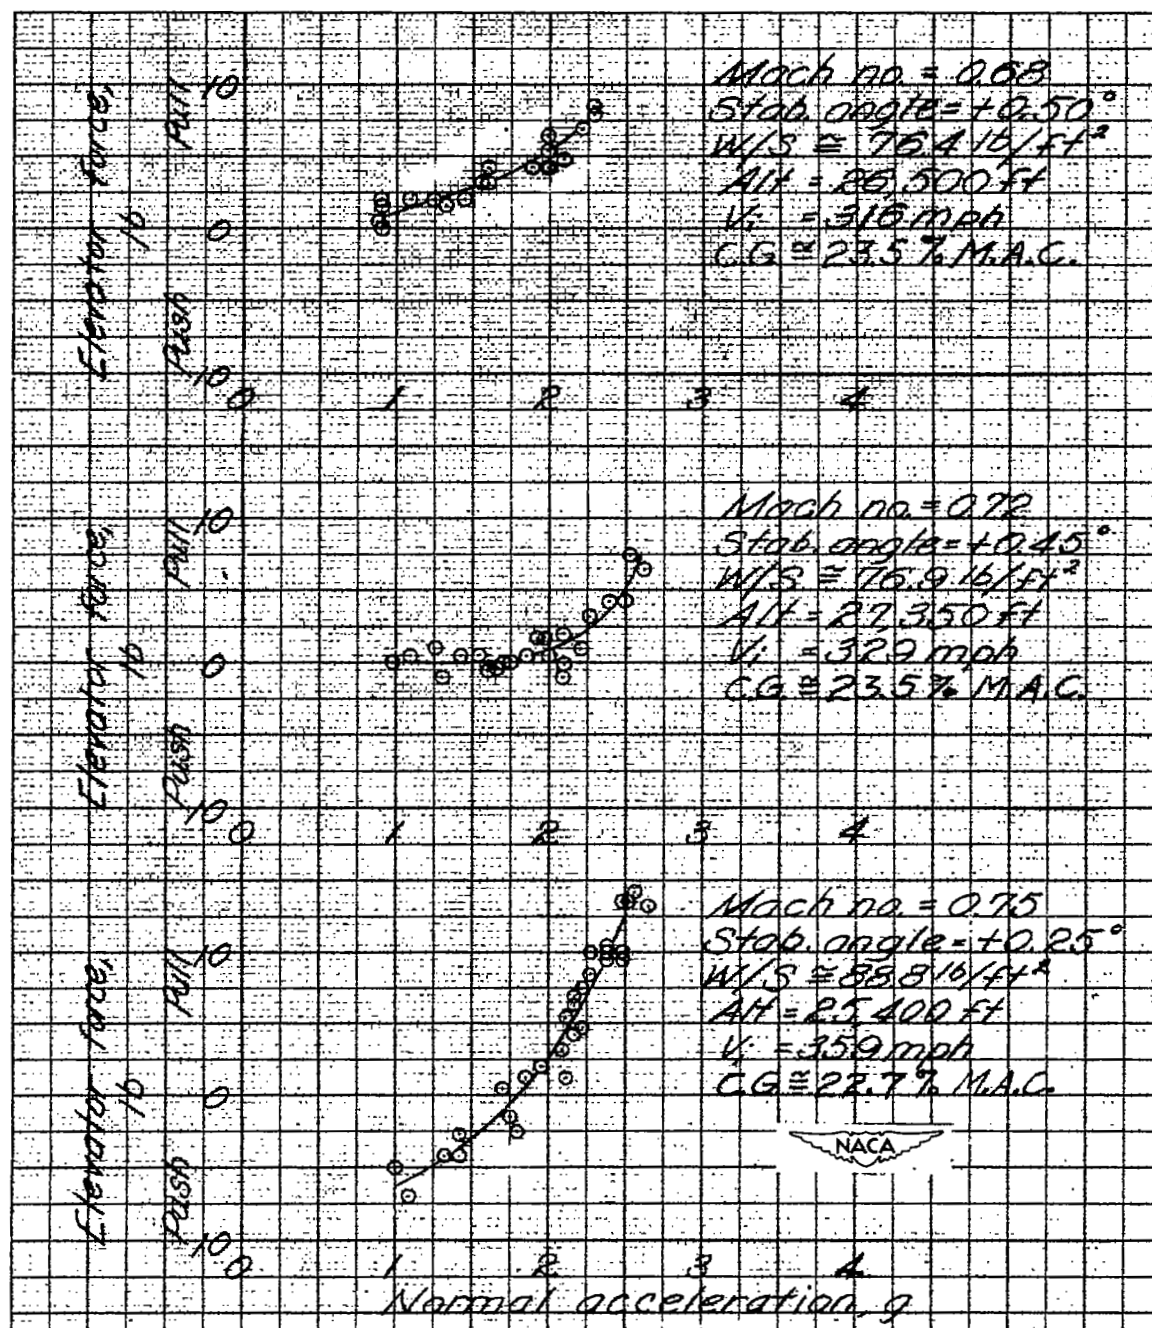
(a) Variation of elevator position with normal acceleration.

Figure 14.- Results obtained in turns at Mach numbers of 0.68, 0.72, and 0.75 with power on. XS-1 airplane with 10-percent-thick wing.

(b) Variation of elevator position with normal force coefficient.

(c) Variation of elevator wheel force  
with normal acceleration.

altitude so that complete data for a given Mach number would be obtained in one run. Time histories of two turns are presented in figures 10 and 11. In one turn (fig. 10) the record switch was turned on after the turn was started, but the turn was fairly steady considering the friction in the control system. In the other turn (fig. 11) the elevator was moved in an unsteady manner and the rate of increase of acceleration with time was too high at the beginning of the turn. Since several of the turns were made in this manner, the slopes of the curves of elevator deflection against normal-force coefficient and the elevator force per  $g$  should be compared only in a general way for large changes in acceleration or lift coefficient for turns at different Mach numbers. Figures 12 through 16 present the stick-fixed and stick-free accelerated-flight longitudinal-stability results obtained from the turns. The Mach number range covered is from 0.48 to 0.75. The elevator-position variation with normal acceleration and normal-force coefficient and the force per  $g$  gradients indicate a decrease in stability for turns (figs. 13 to 16) made at Mach numbers from 0.65 to 0.72. At the highest Mach number tested ( $M = 0.75$ ) an increase in longitudinal stability is indicated (figs. 14 and 16).

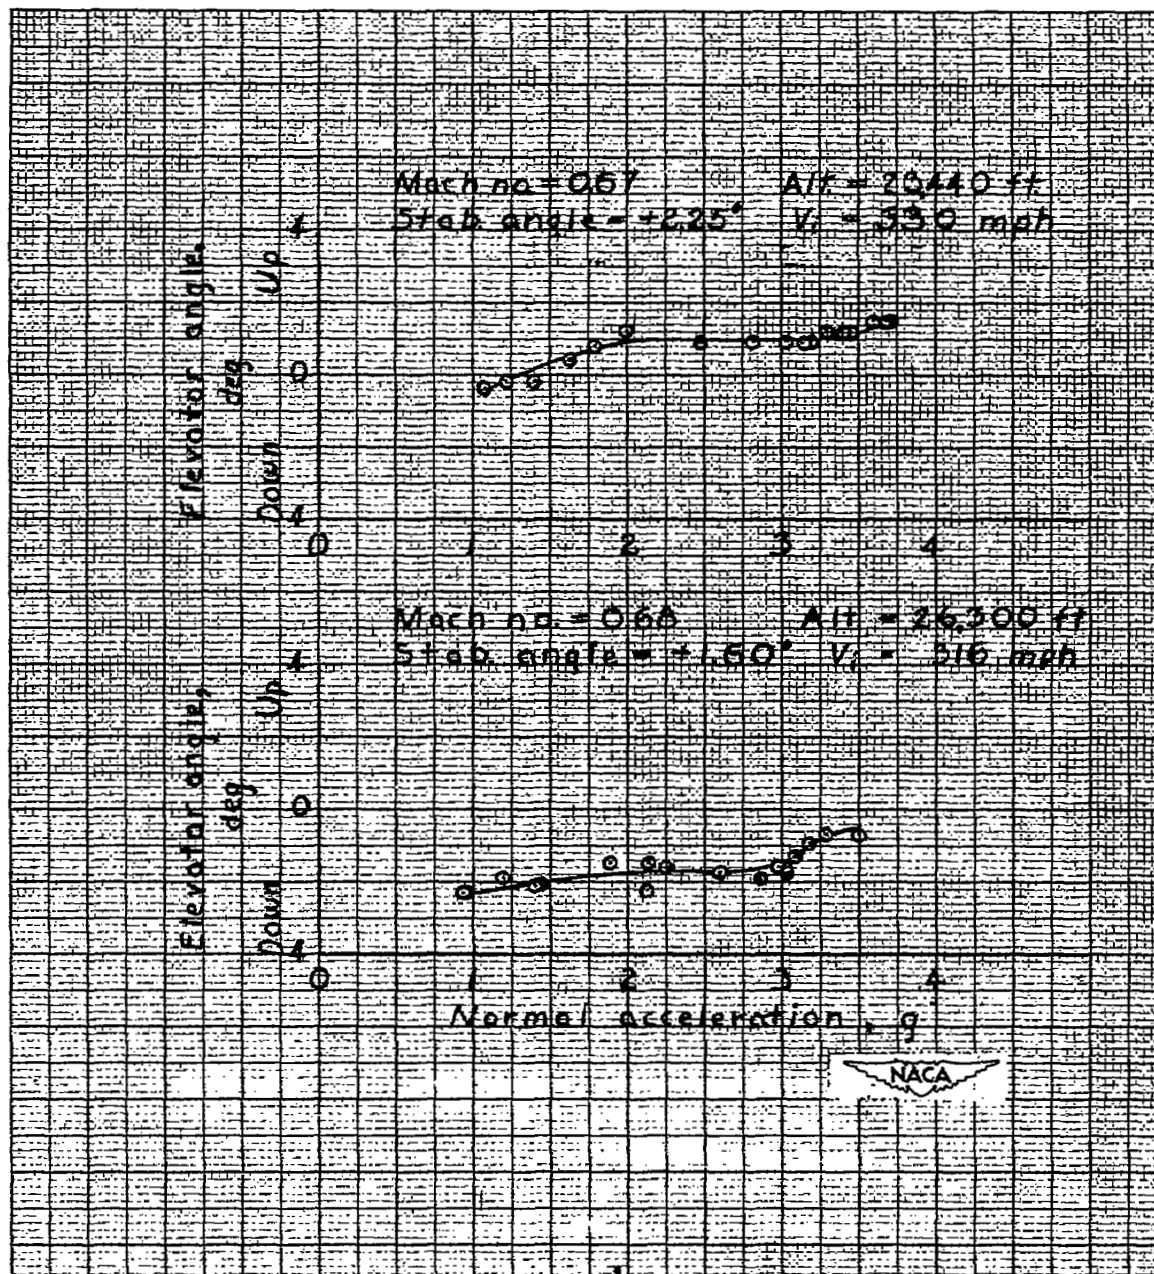
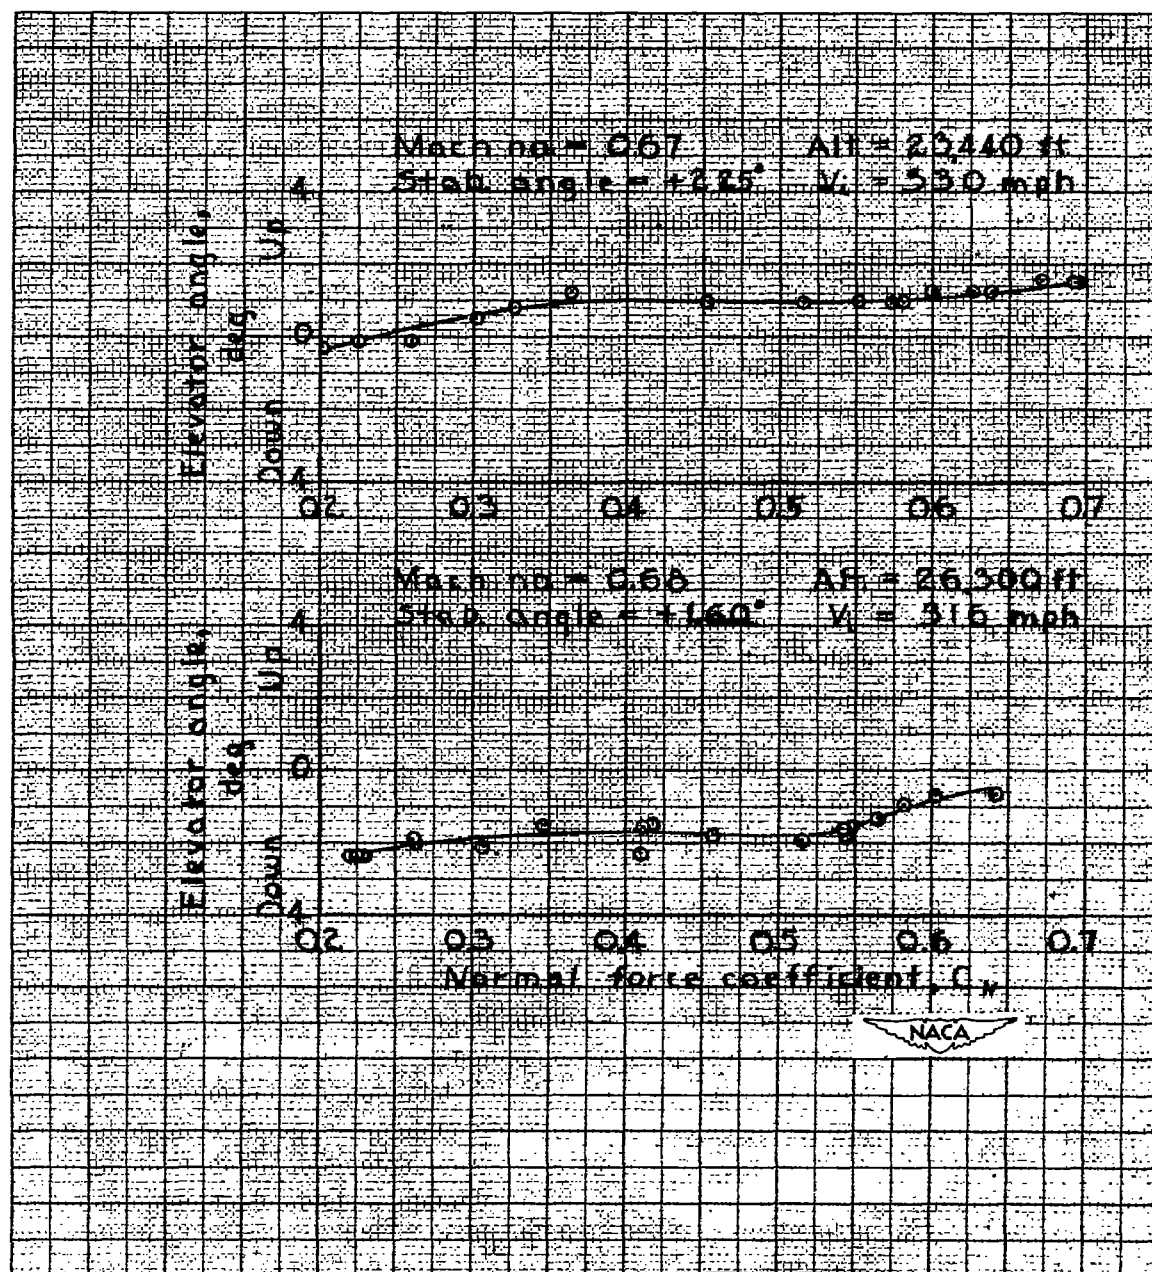
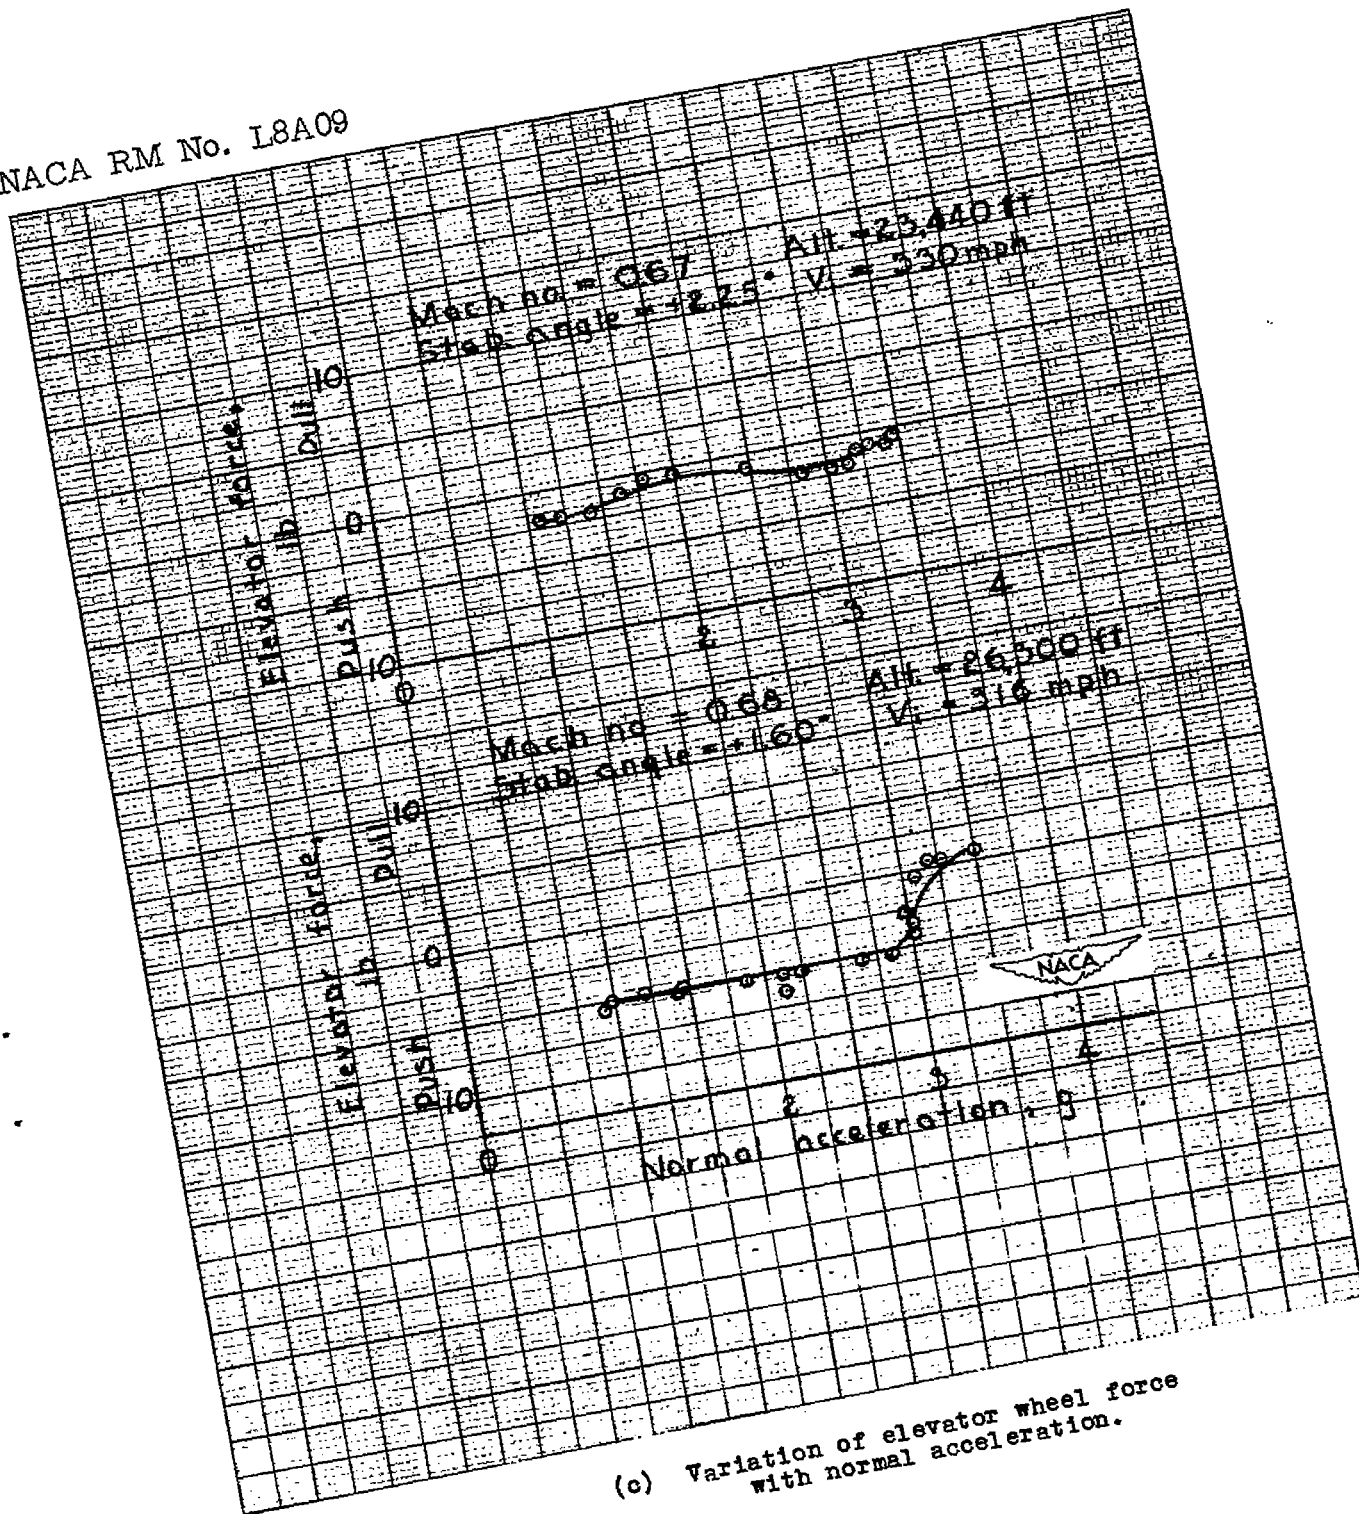
(a) Variation of elevator position with normal acceleration.

Figure 15.- Results obtained in turns at Mach numbers of 0.67, 0.68, XS-1 airplane with 8-percent-thick wing. Gliding flight; center of gravity, 25 percent M.A.C.;  $\frac{W}{S} = 53.8$  lb/sq ft.

(b) Variation of elevator deflection with normal-force coefficient.

(c) Variation of elevator wheel force with normal acceleration.

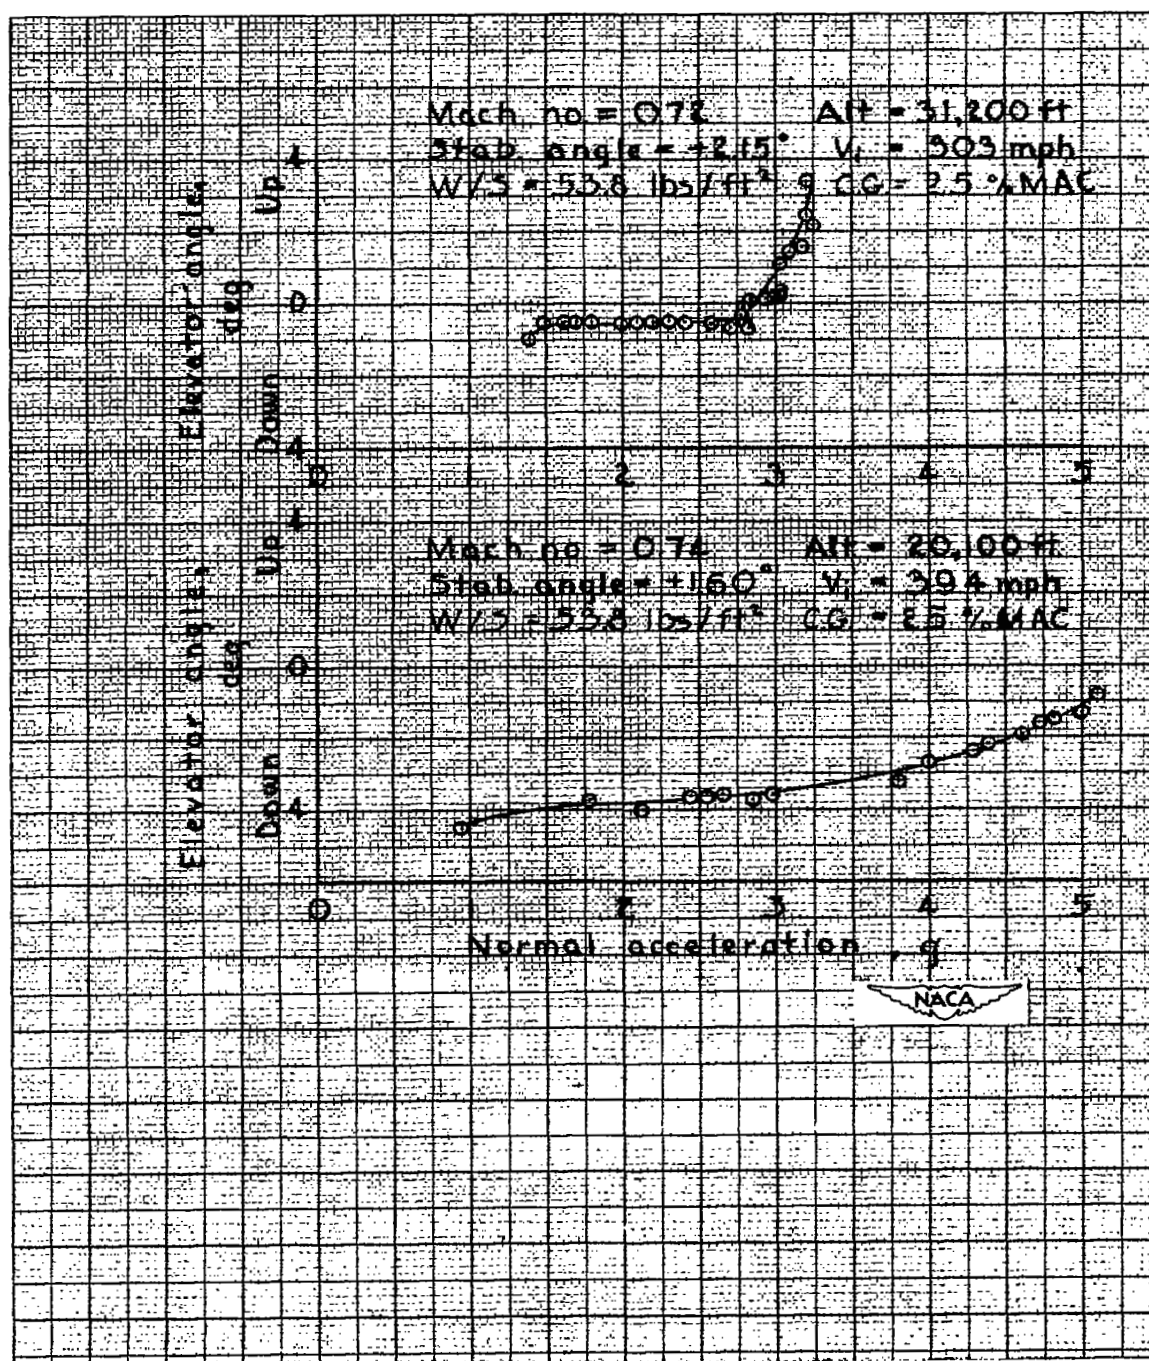
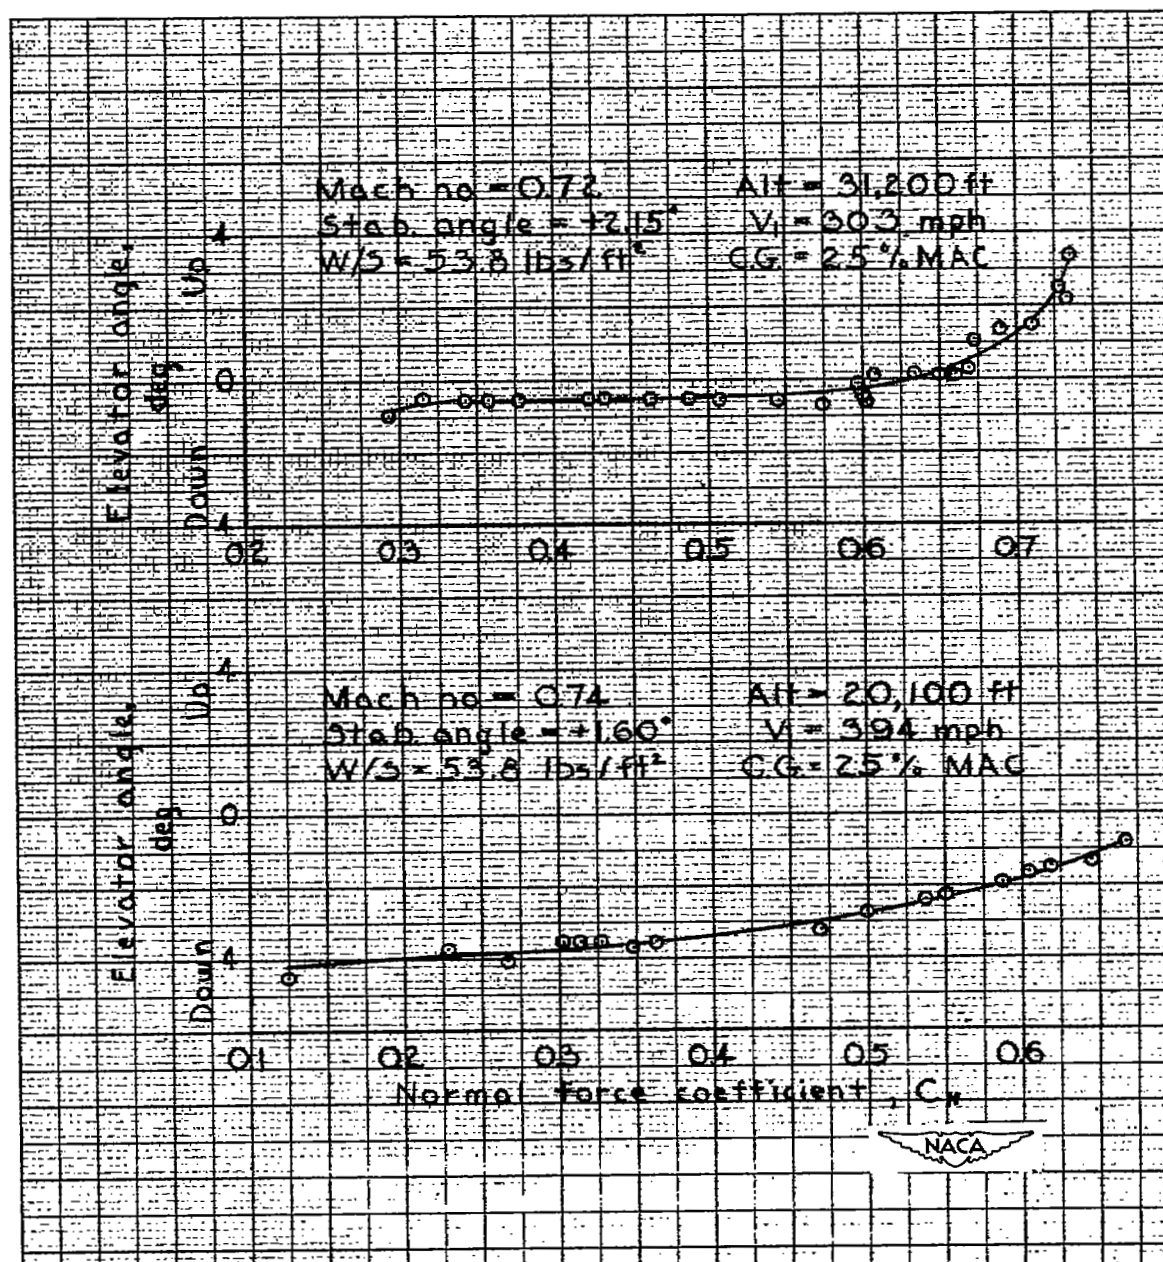
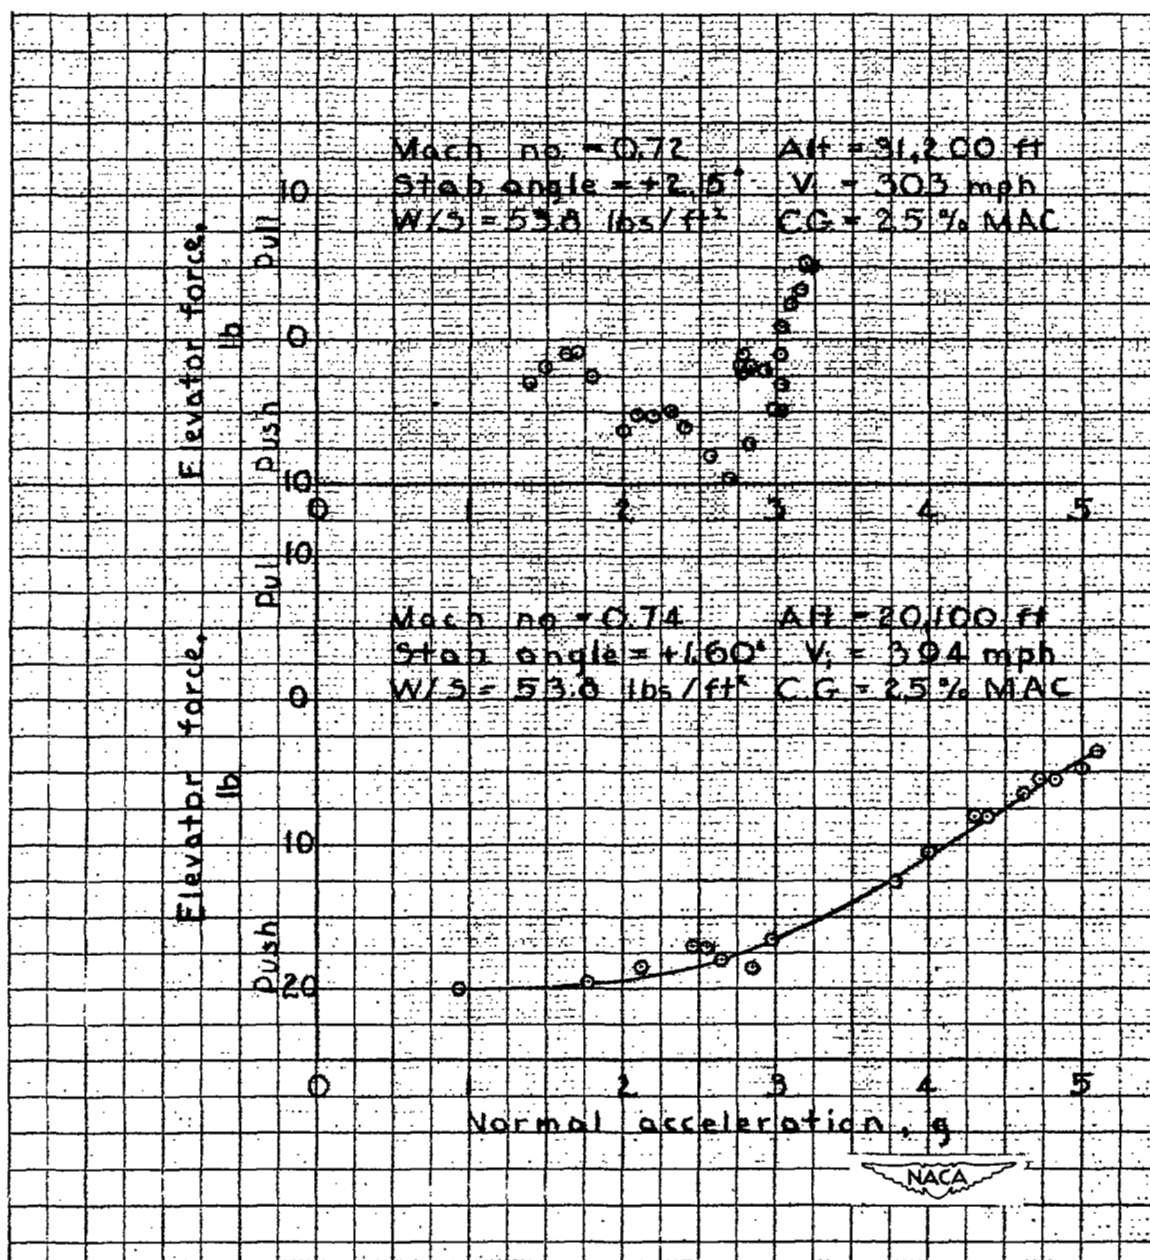
(a) Variation of elevator position with normal acceleration.

Figure 16.- Results obtained in turns made at Mach numbers of 0.72 and 0.74. XS-1 airplane with 8-percent-thick wing. Gliding flight; center of gravity, 25 percent M.A.C.;  $\frac{W}{S} = 53.8$  lb/sq ft.

(b) Variation of elevator angle with normal-force coefficient.

(c) Variation of elevator wheel force with normal acceleration.

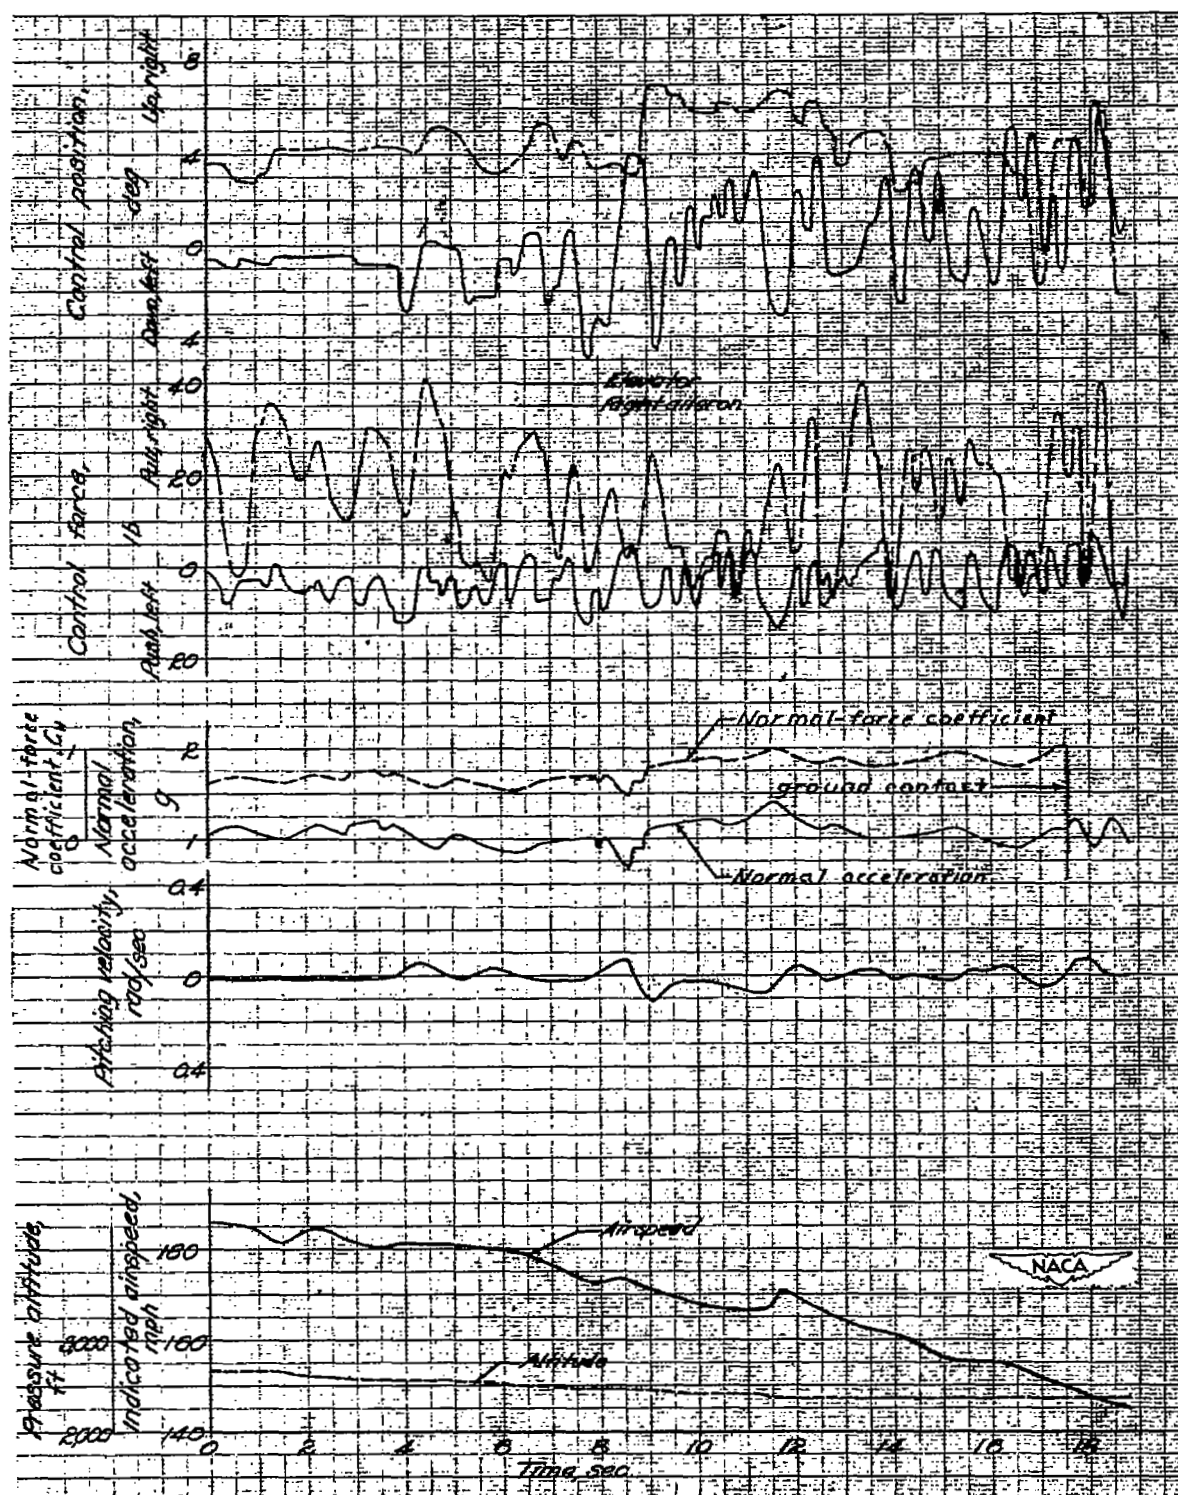
Figure 17.- Time history of a landing, XS-1 airplane with 8-percent-thick wing. Center of gravity, 25 percent M.A.C.  $\frac{W}{S} = 53.8$  lb/sq ft. Stabilizer angle,  $1.75^\circ$ .

The elevator control in landing was sufficiently powerful to effect landings near minimum speed with the stabilizer set near neutral in the center-of-gravity range tested. Time histories of landings are given in figures 17, 18, and 19. It should be noted that in figure 19 where the highest lift coefficient was reached, nearly full-up elevator was used.

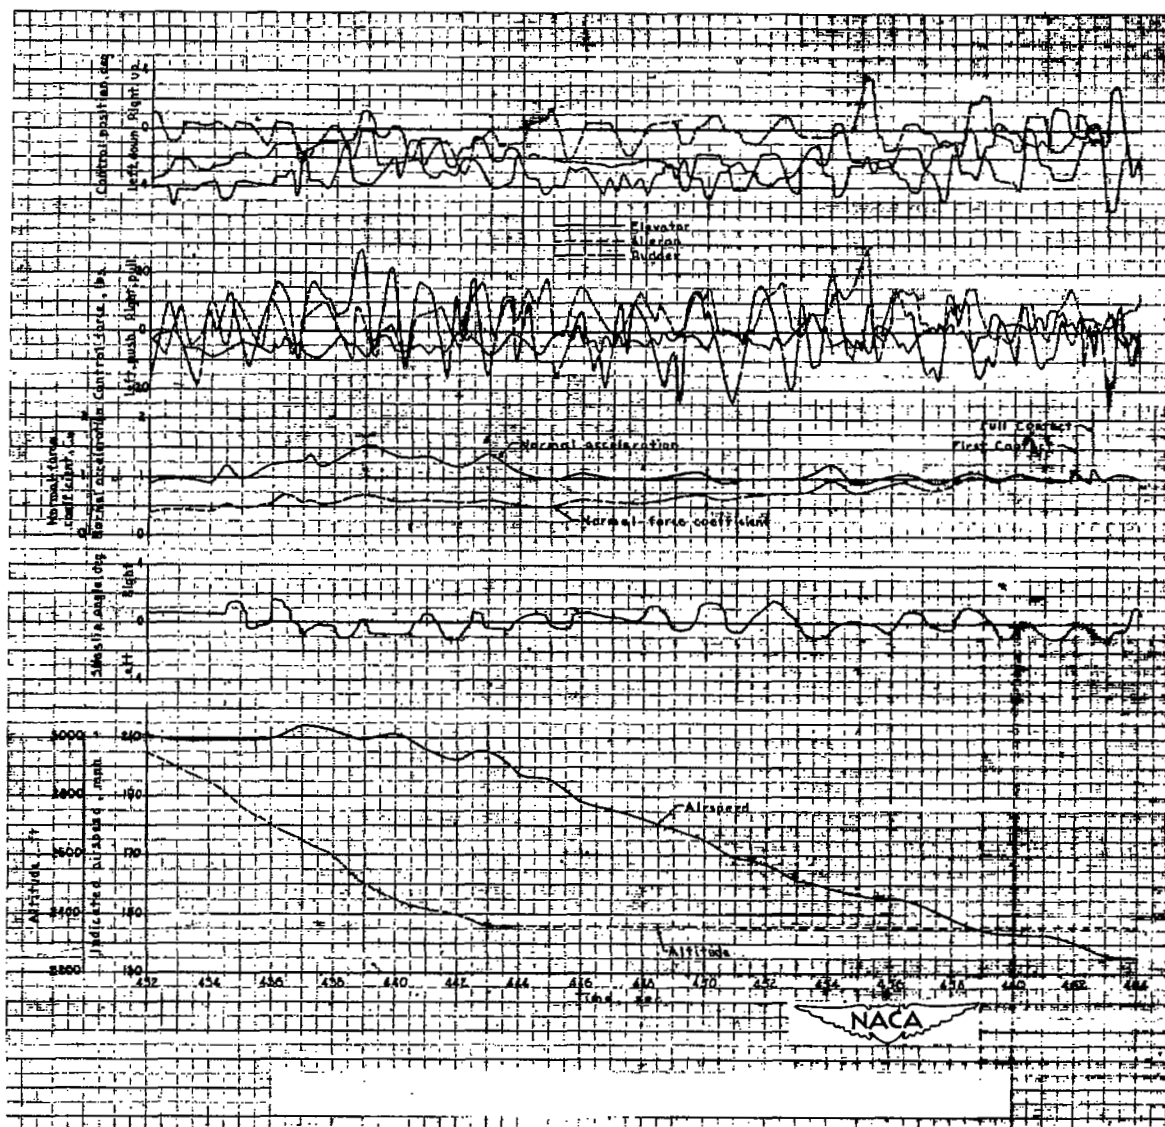
Figure 18.- Time history of a landing, XS-1 airplane with 10-percent-thick wing. Center of gravity, 25.3 percent M.A.C.

$\frac{W}{S} = 51.9 \text{ lb/sq ft.}$  Stabilizer setting,  $0.6^\circ$ .
