# RESEARCH MEMORANDUM

GENERAL HANDLING-QUALITIES RESULTS OBTAINED DURING  
ACCEPTANCE FLIGHT TESTS OF THE BELL XS-1 AIRPLANE

Walter C. Williams, Charles M. Forsyth, and Beverly P. Brown

Langley Memorial Aeronautical Laboratory  
Langley Field, Va.

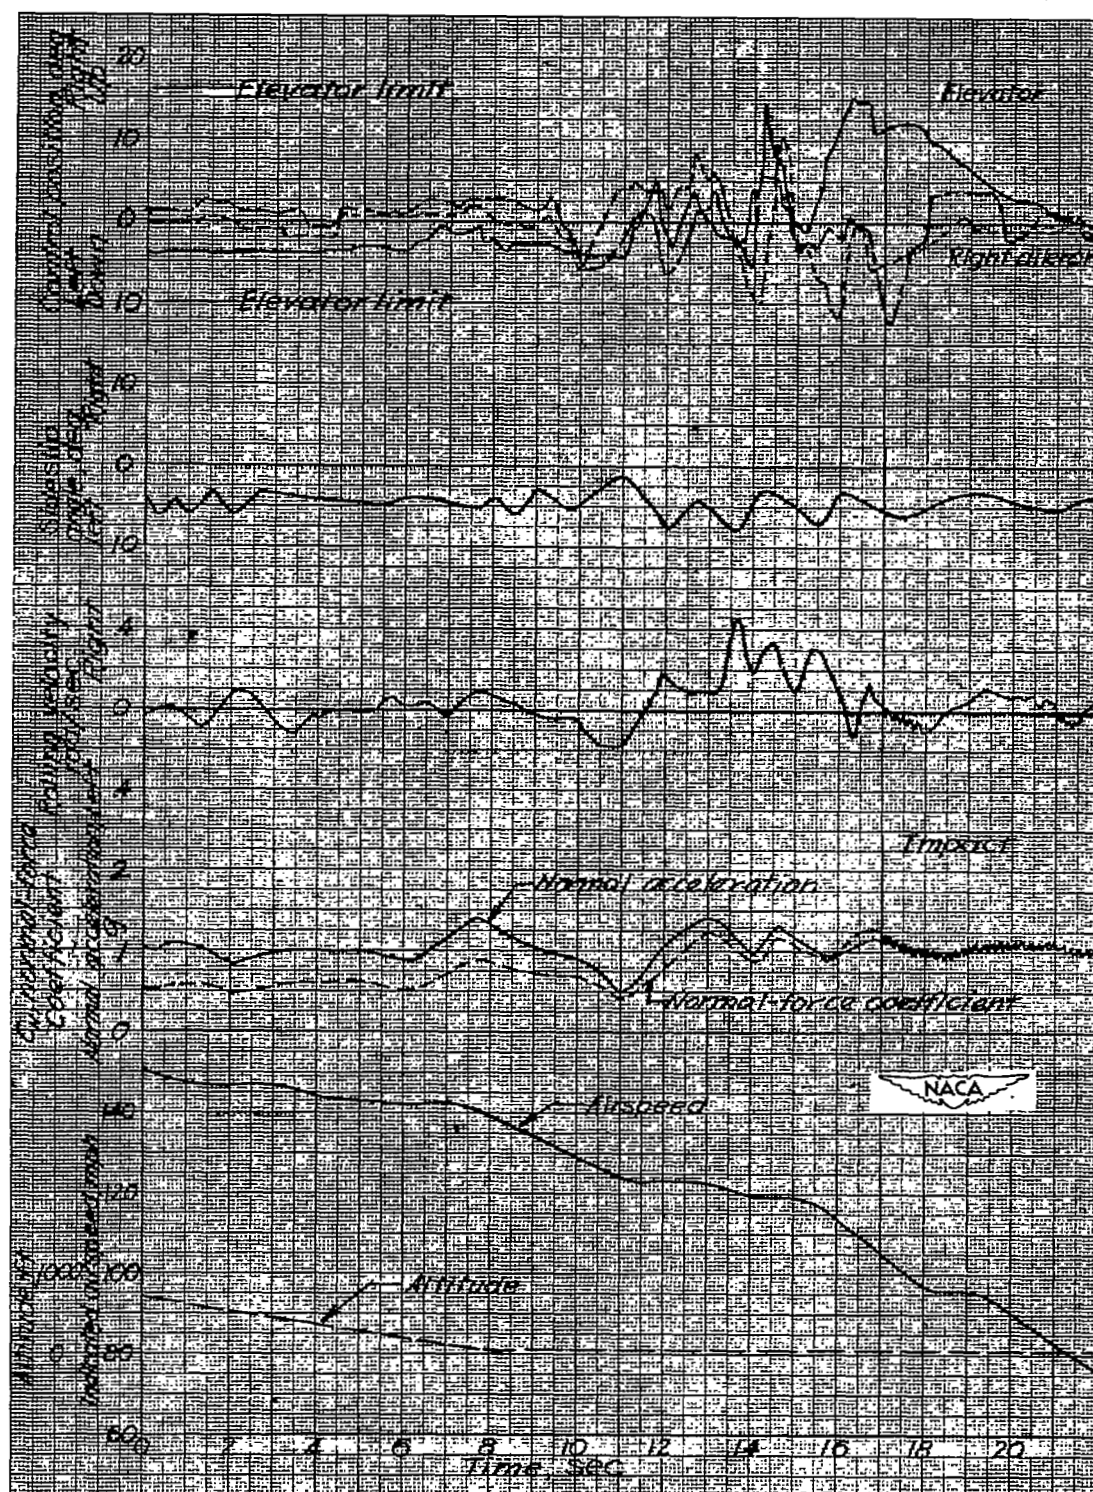
Figure 19.- Time history of a landing, XS-1 airplane with 10-percent-thick wing. Center of gravity, 25 percent M.A.C.  $\frac{W}{S} = 32.5$  lb/sq ft. Stabilizer setting,  $1.1^\circ$ .

The elevator control in landing was sufficiently powerful to effect landings near minimum speed with the stabilizer set near neutral in the center-of-gravity range tested. Time histories of landings are given in figures 17, 18, and 19. It should be noted that in figure 19 where the highest lift coefficient was reached, nearly full-up elevator was used.

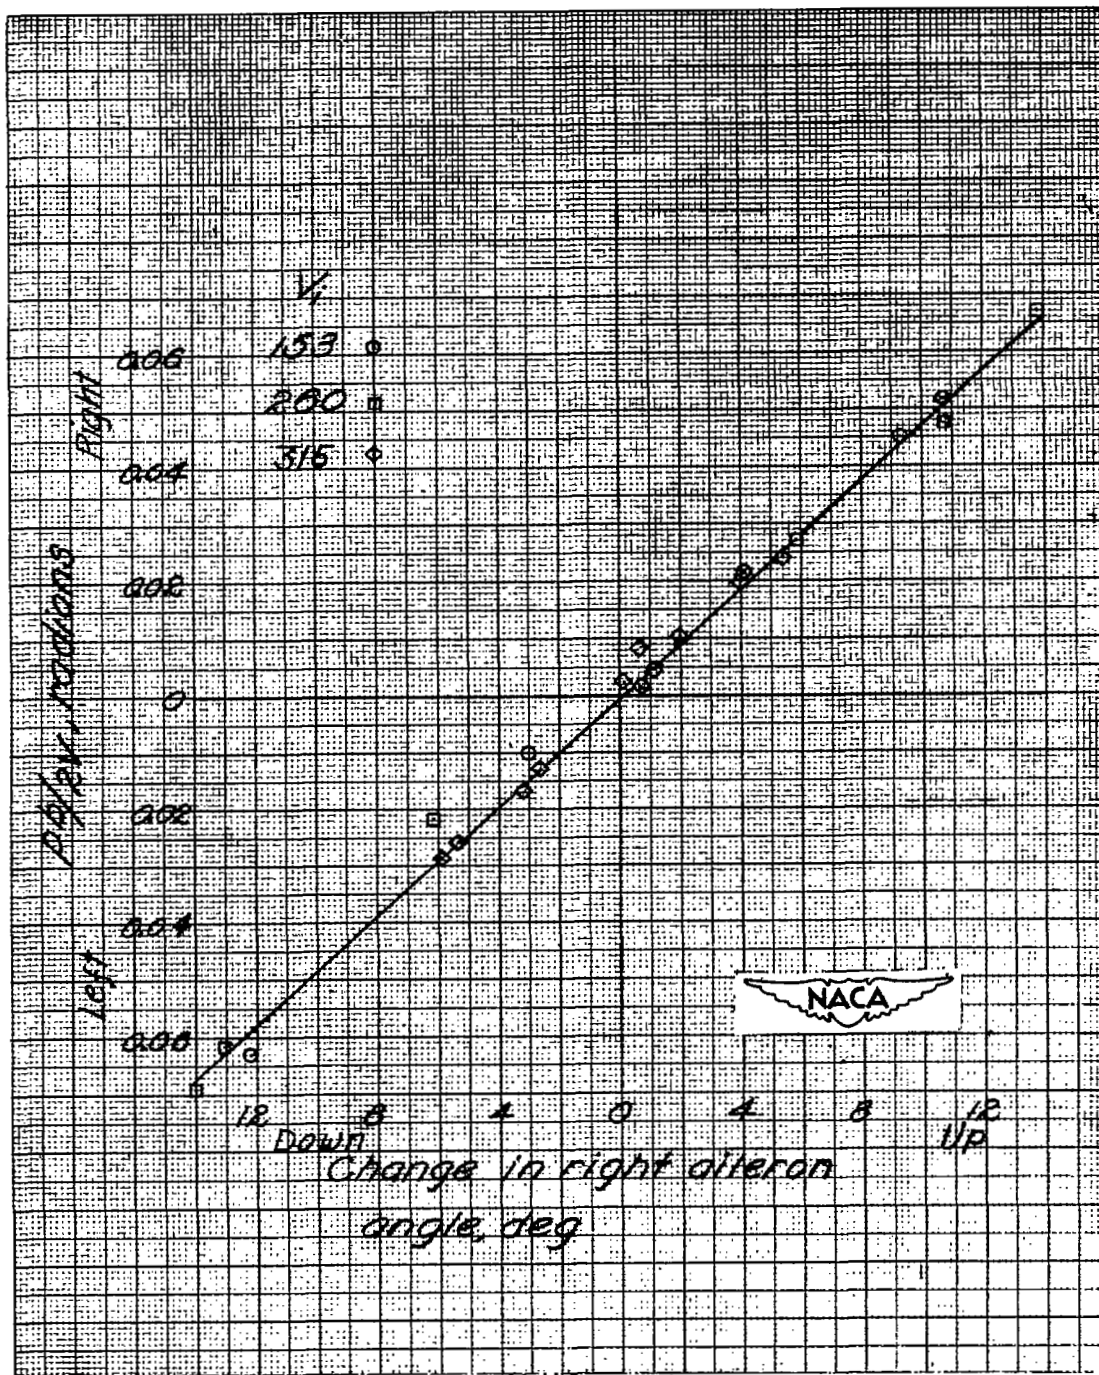
Figure 20.- Variation of helix angle  $pb/2V$  with change in right aileron deflection as measured in clean condition, rudder-fixed aileron rolls. XS-1 10-percent-thick-wing airplane.

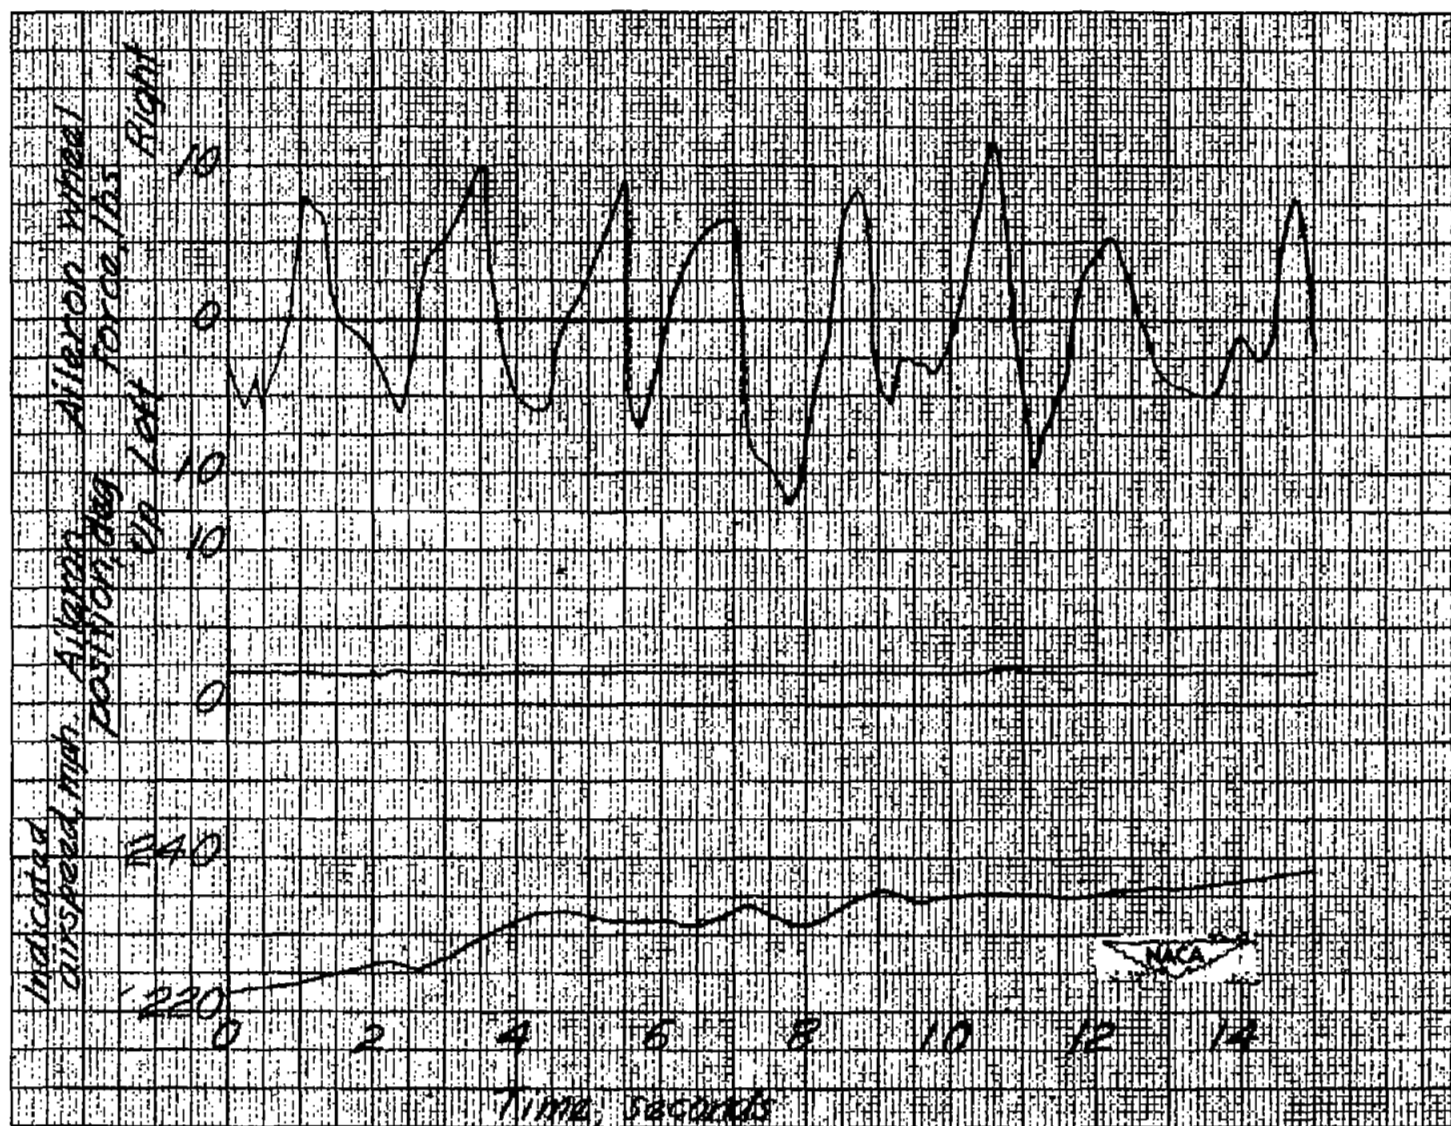
Figure 21.- Typical time history showing aileron force and position during steady flight.  
XS-1 airplane with 10-percent-thick wing.

The only measure of aileron effectiveness obtained during the Bell conducted acceptance flights was obtained from a few rudder-fixed aileron rolls at indicated airspeeds of 153 miles per hour, 260 miles per hour, and 315 miles per hour. The results are plotted in figure 20 as the variation of helix angle  $pb/2V$  with right aileron deflection. Examination of this figure shows that although the maximum value of  $pb/2V$  with full aileron deflection as obtained in the rolls at an indicated airspeed of 260 miles per hour is below the minimum acceptable of 0.07 radian, the rate of change of  $pb/2V$  with aileron deflection compares fairly well with that of present-day fighters. The aileron control is considered satisfactory, however, because even though the maximum  $pb/2V$  obtainable with the Bell XS-1 is low, the rolling velocities are fairly high because of the short wing span. No satisfactory measurements of the aileron control forces were obtained because the high aileron friction (see fig. 4) masked the aileron forces. An indication of the effect of the aileron friction in the handling characteristics of the Bell XS-1 airplane is given in figure 21, which is a sample time history from a steady-flight record. The pilot is continually applying aileron force; the ailerons, however, are not moving.

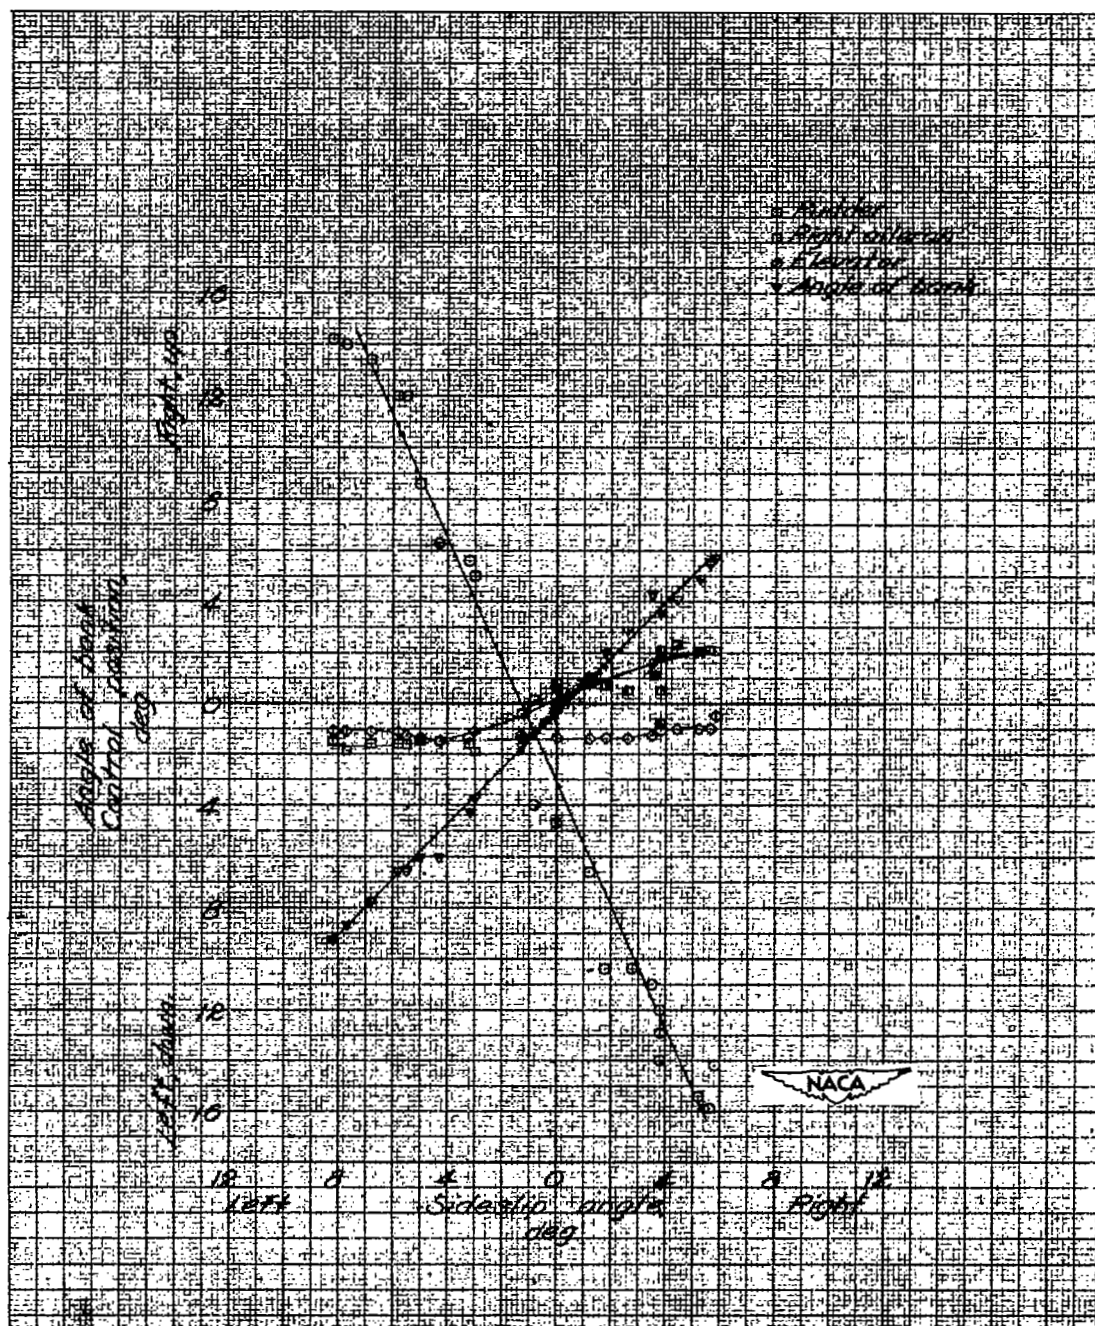
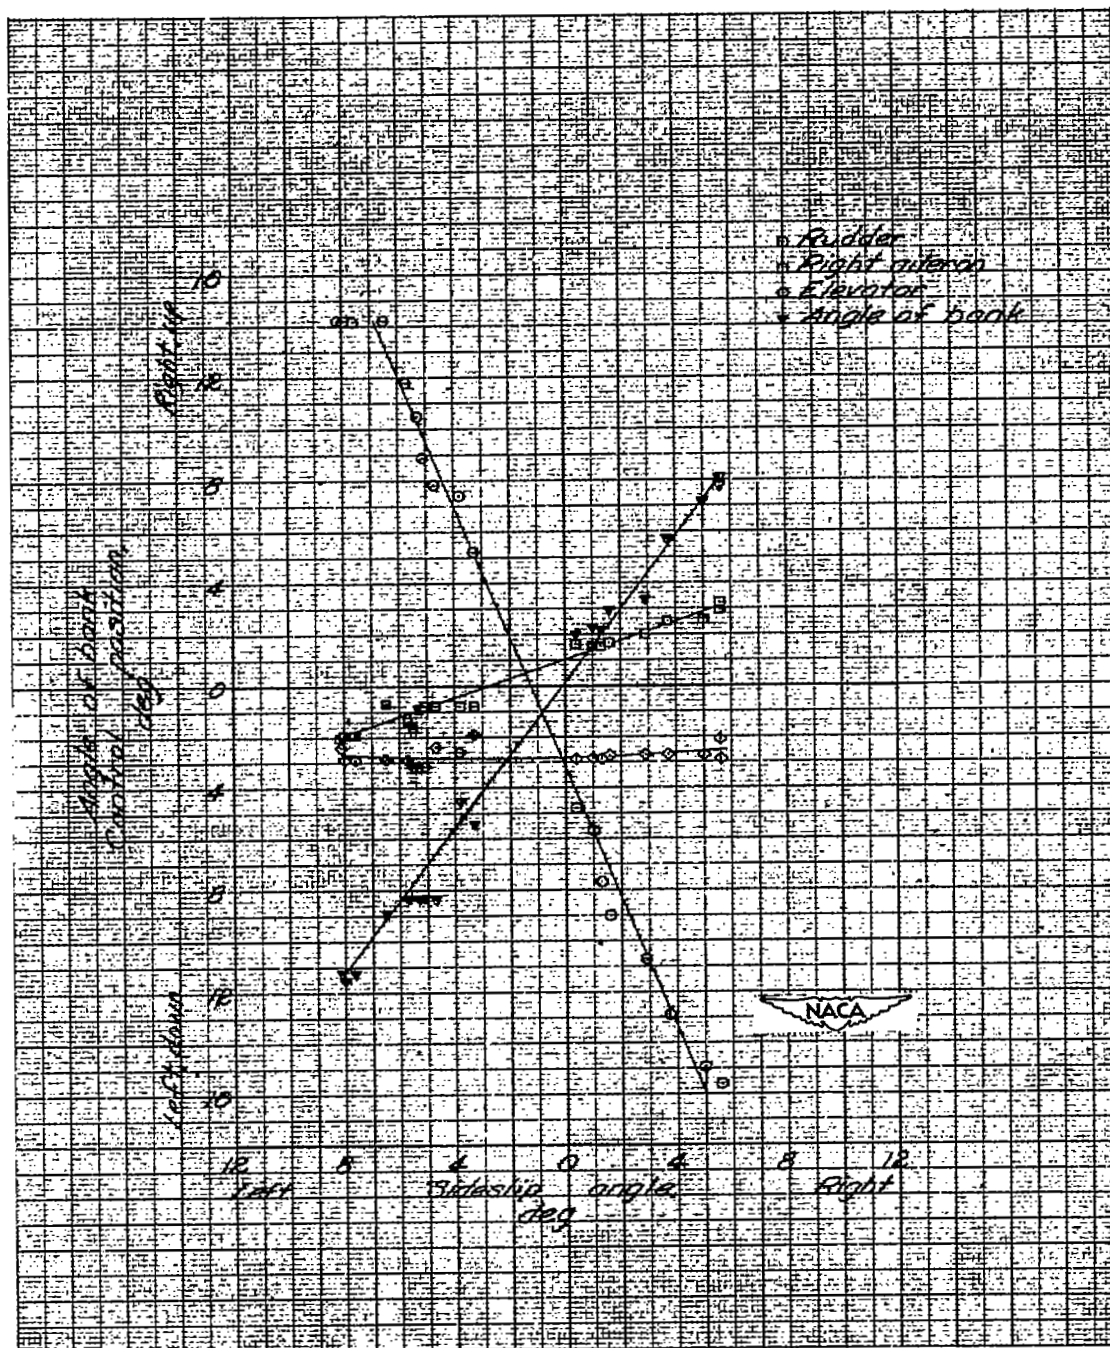
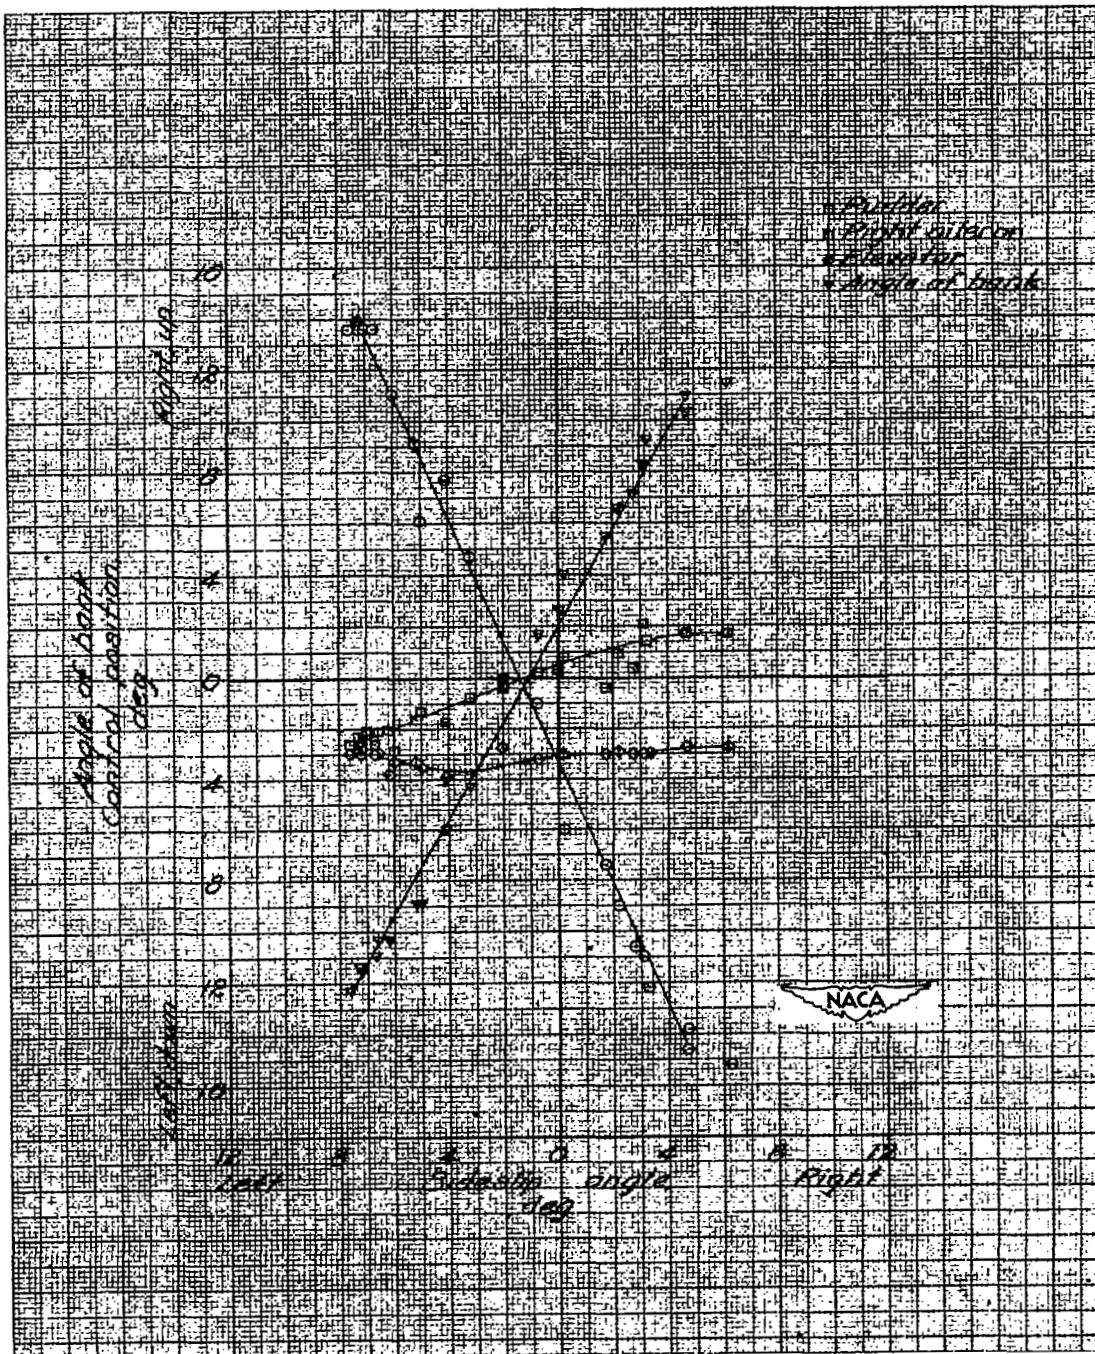
(a)  $V_1 = 130$  mph.

Figure 22.— Steady sideslip characteristics, XS-1 airplane with 10-percent-thick wing. Gliding flight; flaps and gear down.

(b)  $V_1 = 150$  mph.

(c)  $V_1 = 172$  mph.

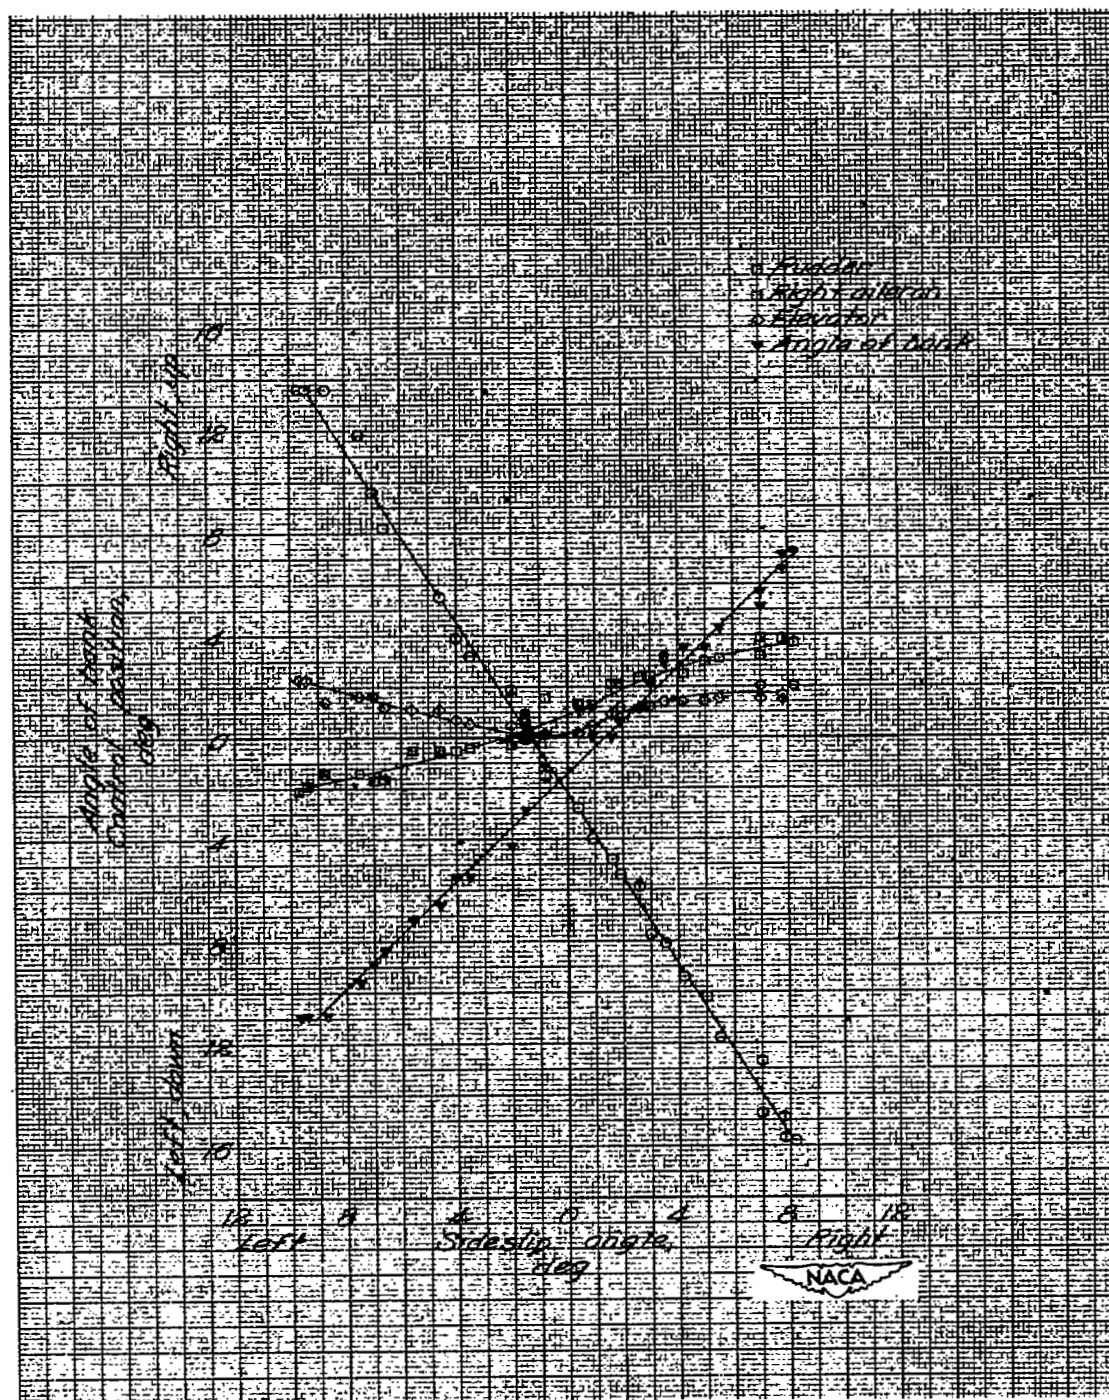
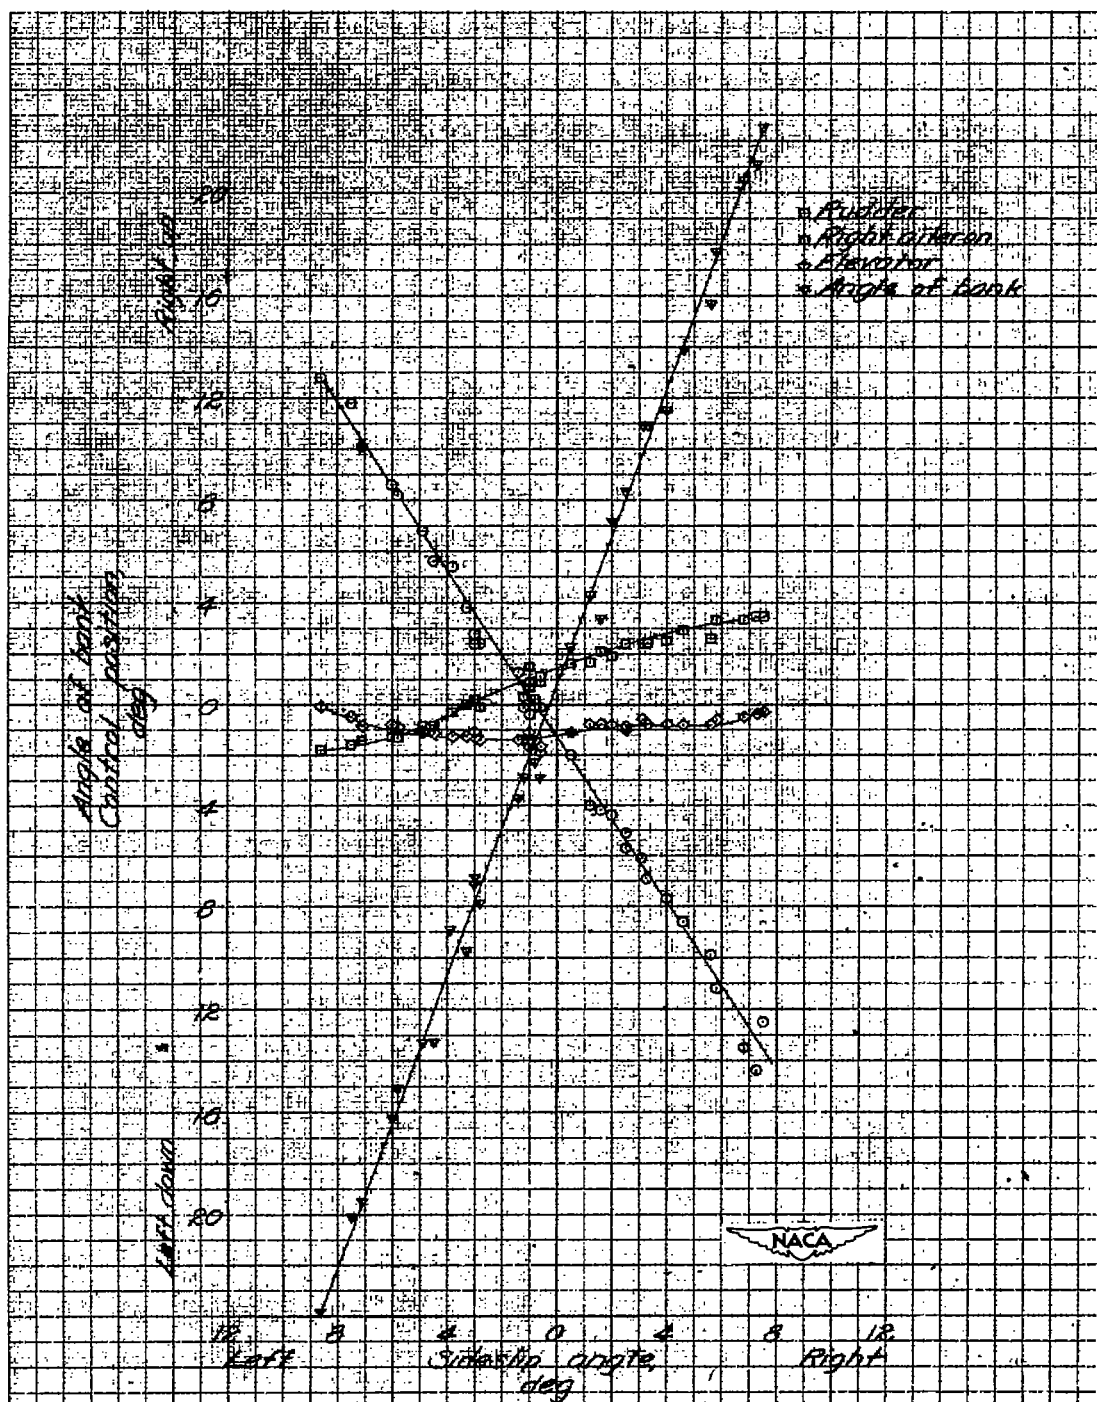
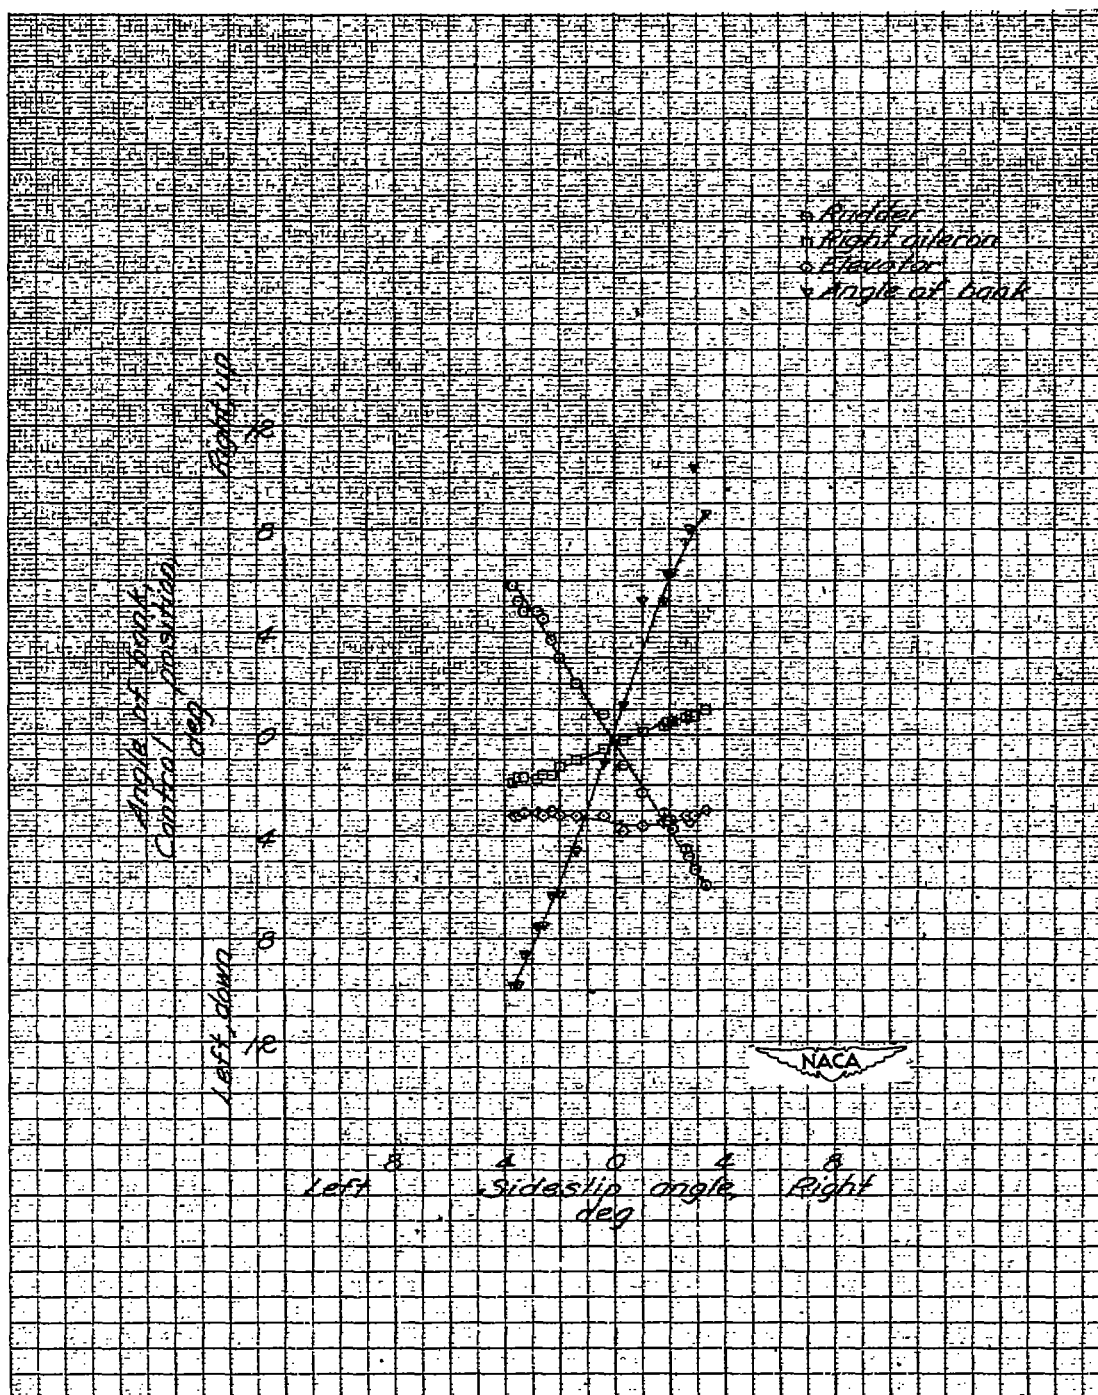
(a) Gliding flight,  $V_1 = 150$  mph.

Figure 23.—Steady sideslip characteristics, XS-1 airplane with 10-percent-thick wing. Flaps and gear up.

(b) Gliding flight,  $V_1 = 247$  mph.

(c) Power on;  $V_1 = 400$  mph;  $M = 0.72$ .

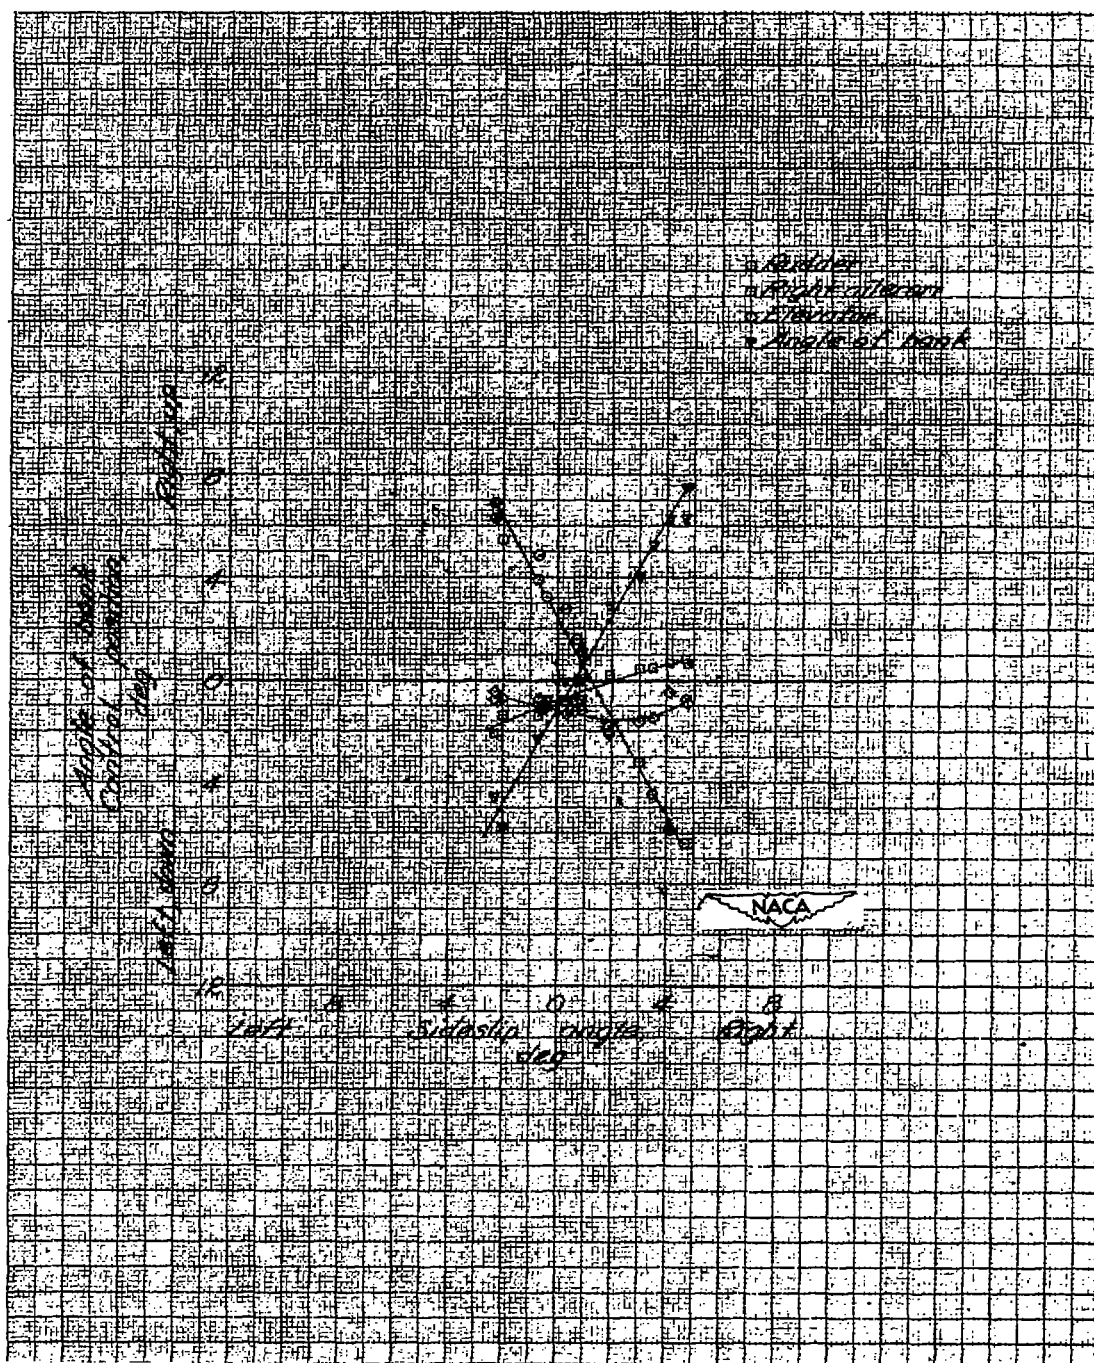
Figure 24.- Steady sideslip characteristics, XS-1 airplane with 8-percent-thick wing. Power on; flaps and gear up;  $V_1 = 295$  mph;  $M = 0.77$ .

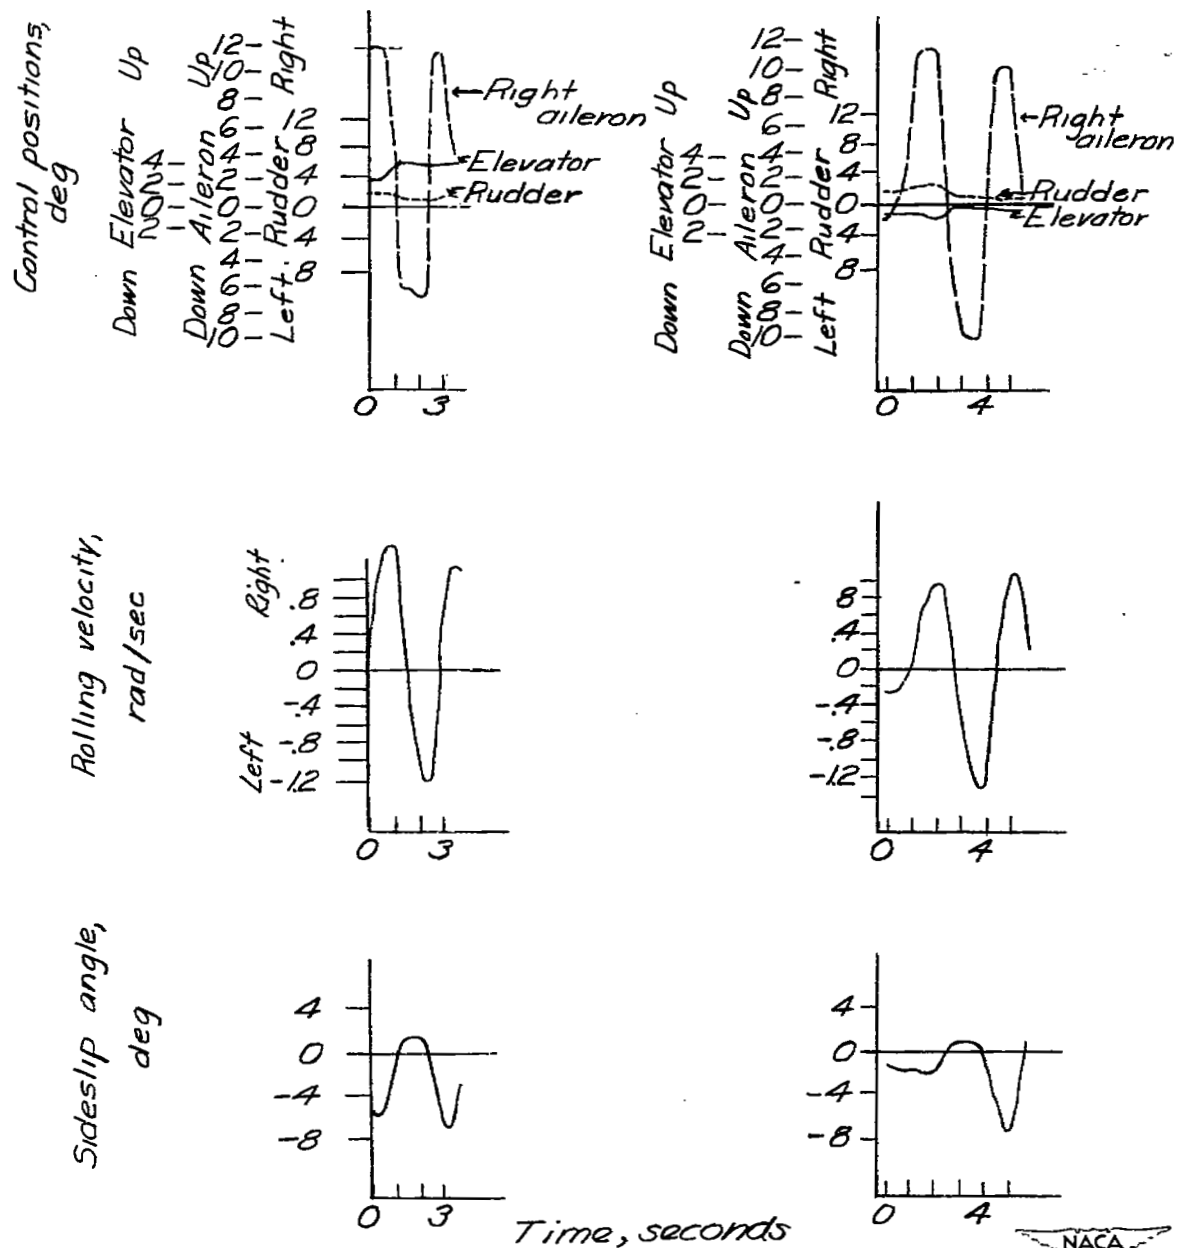
Figure 25.- Time histories of abrupt aileron rolls at 150 mph with rudder held fixed. XS-1 airplane.

The sideslip due to the use of ailerons was small even at low speeds due to the high directional stability and relatively low values of helix angle  $pb/2V$ . Time histories of aileron rolls made with rudder fixed are shown in figure 25. The rudder control was sufficiently powerful to overcome the sideslip due to the use of ailerons as indicated in figure 26, which presents time histories of abrupt aileron rolls in which the pilot overcontrolled and used more rudder than necessary to overcome the sideslip due to ailerons.

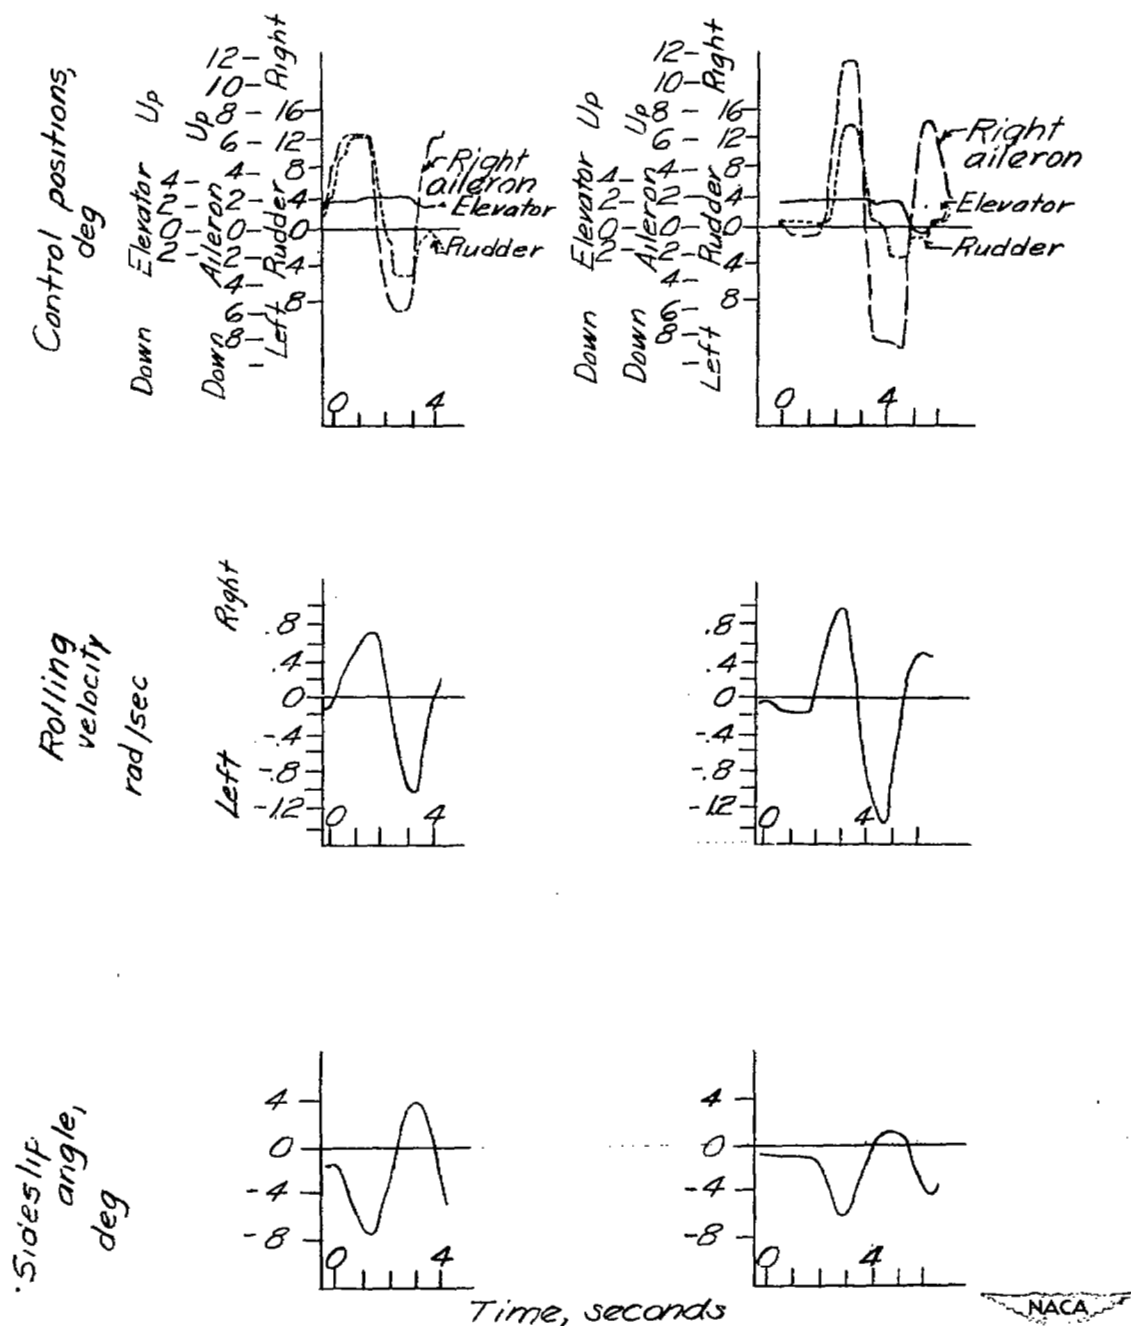
Figure 26.- Time histories of aileron rolls at 150 mph in which the pilot used more rudder than necessary to overcome the sideslip due to ailerons. XS-1 airplane.

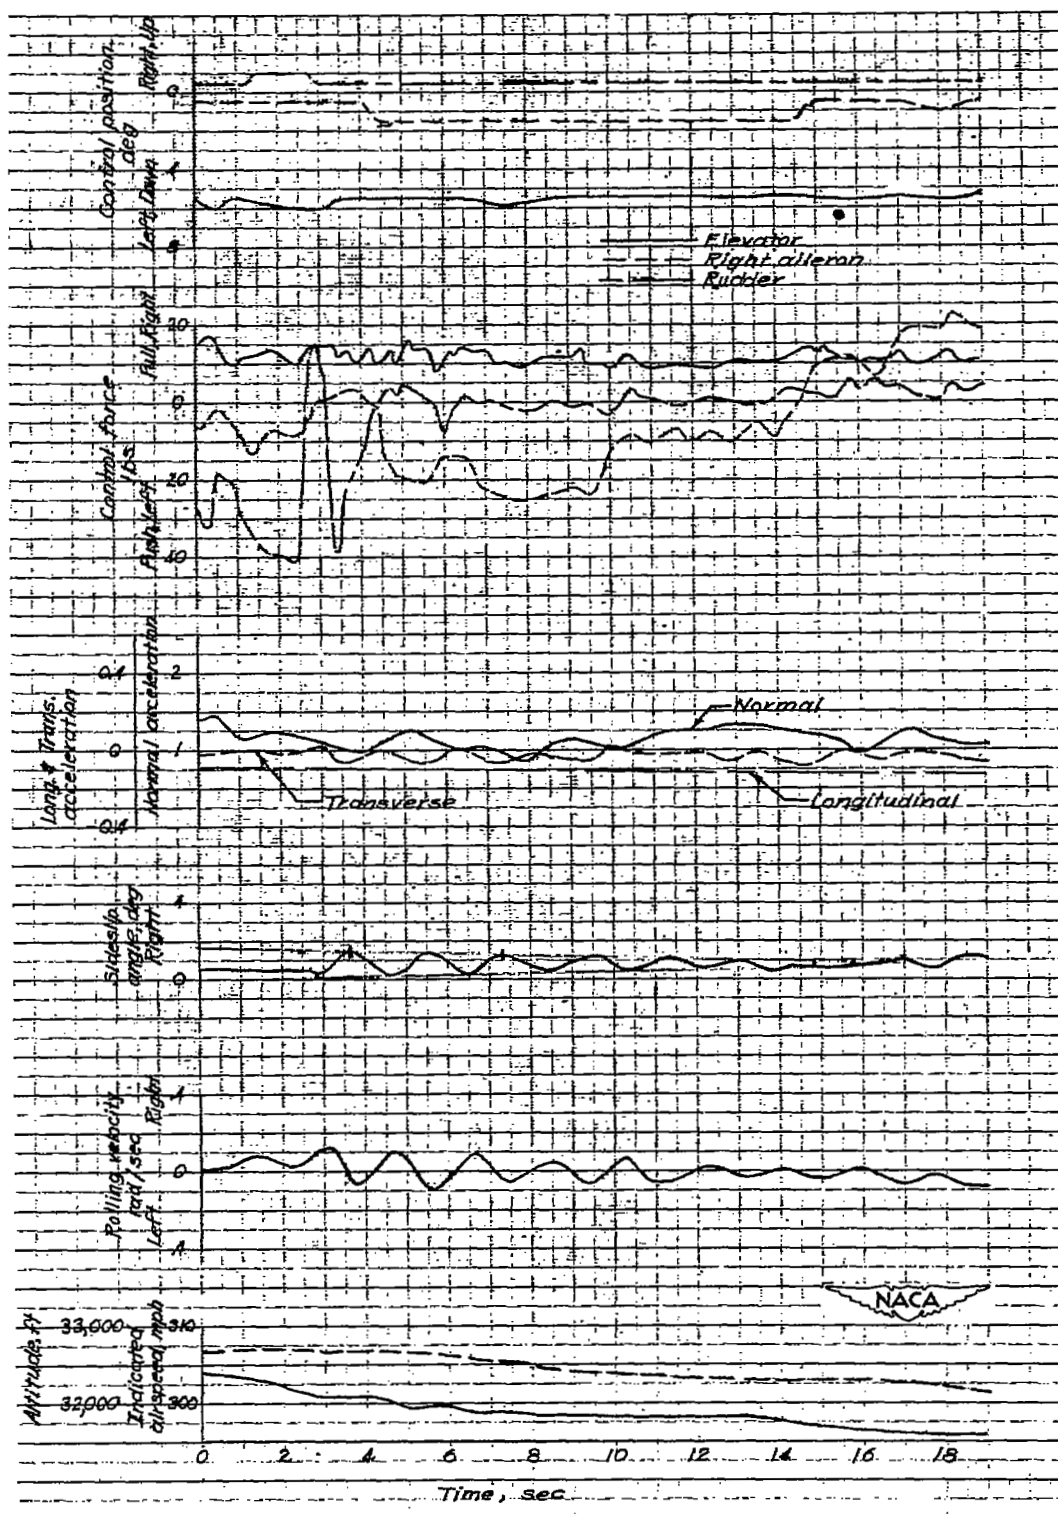
Figure 27.- Time history of a stick-fixed inadvertent lateral oscillation. Gliding flight; relative density factor,  $\mu$  of about 100. XS-1 airplane with 10-percent-thick wing.

During the course of the acceptance flight tests, inadvertent lateral oscillations were encountered at fairly high Mach numbers which were induced by small control movements. These oscillations were poorly damped. A time history of an oscillation encountered in straight flight is presented in figure 27. An oscillation which occurred during a turn entry is shown in figure 28. A lateral oscillation following abrupt release of the rudder from a yawed condition is shown in figure 29. It should be noted that the oscillation continues at small amplitude although the initial damping of the disturbance is satisfactory.

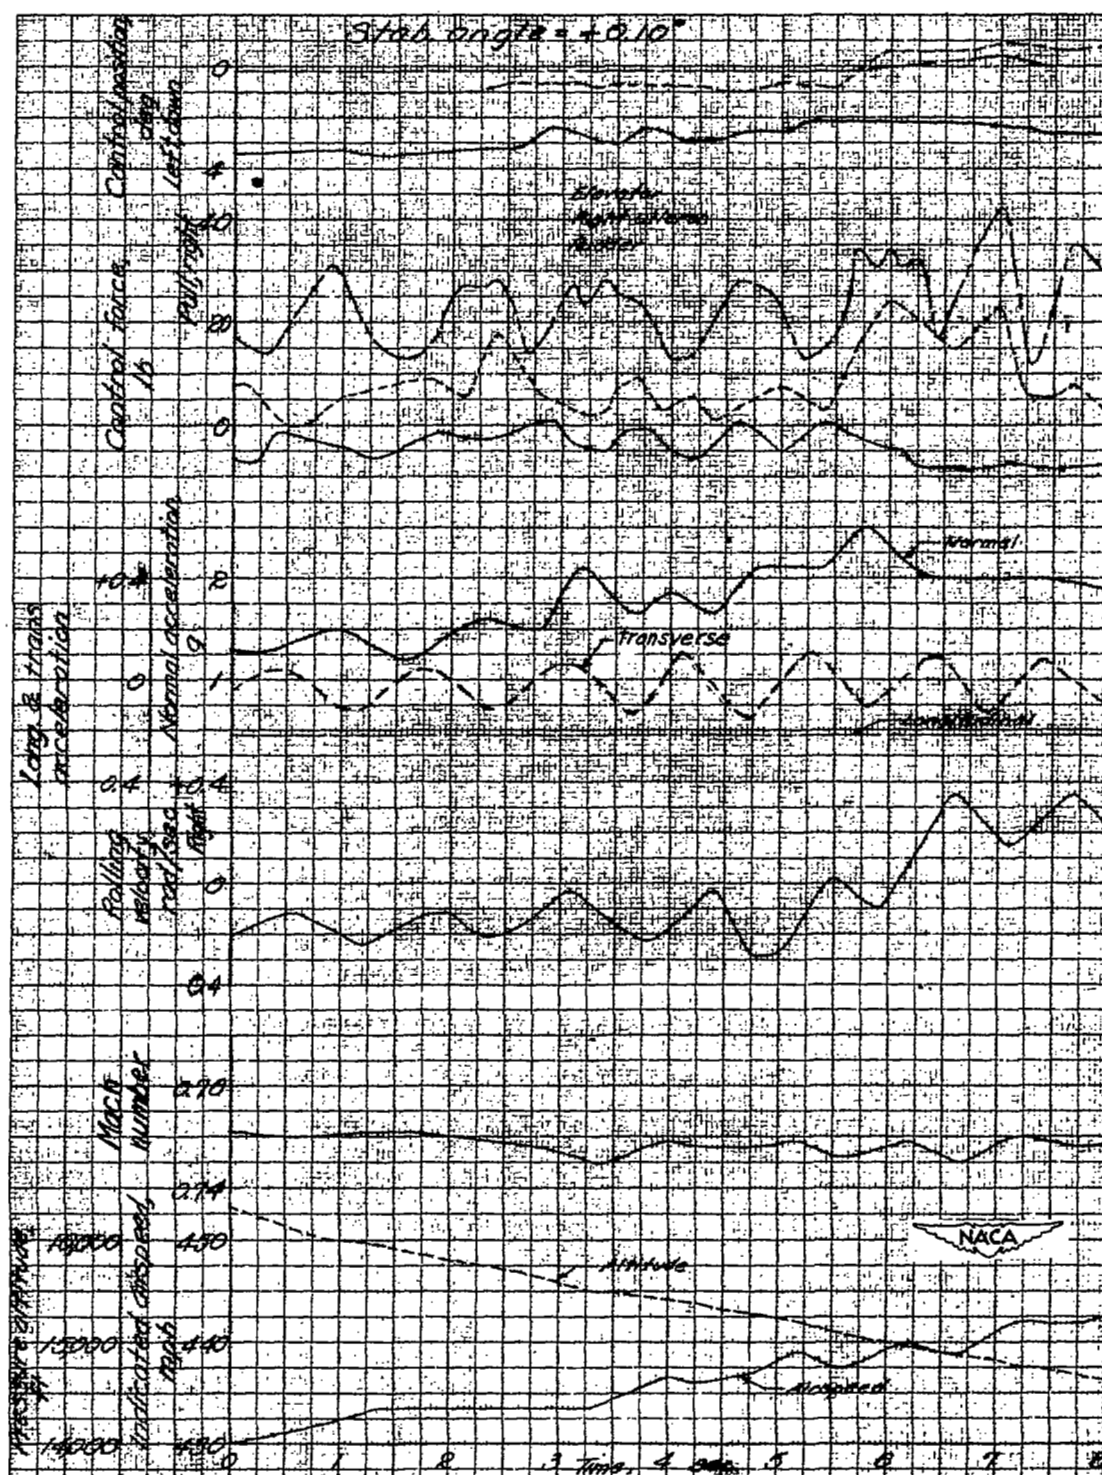
Figure 28.- Time history of an inadvertent lateral oscillation in a power-off turn, rough air. Relative density factor  $\mu$  of about 45. XS-1 airplane with 10-percent-thick wing.
