# RESEARCH MEMORANDUM

GENERAL HANDLING-QUALITIES RESULTS OBTAINED DURING  
ACCEPTANCE FLIGHT TESTS OF THE BELL XS-1 AIRPLANE

Walter C. Williams, Charles M. Forsyth, and Beverly P. Brown

Langley Memorial Aeronautical Laboratory  
Langley Field, Va.

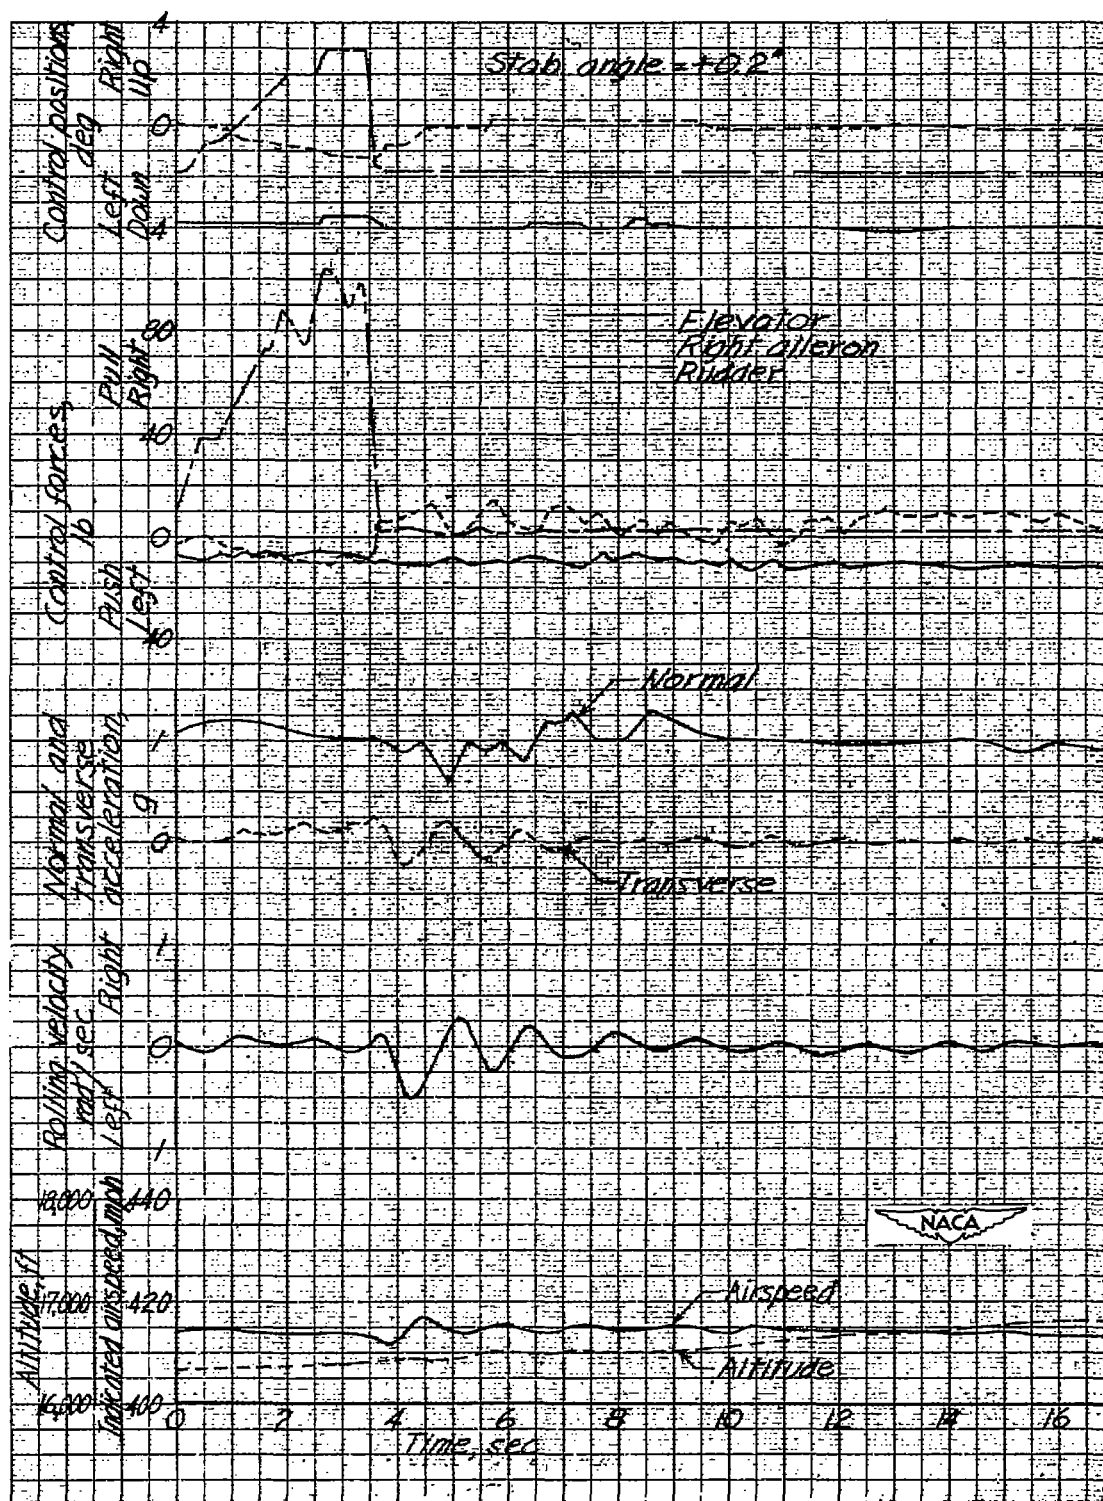
Figure 29.- Time history of abrupt rudder release with power on.  
 $M = 0.73$ ,  $\frac{W}{S} = 72.1$  lb/sq ft. XS-1 airplane with 10-percent-thick wing.

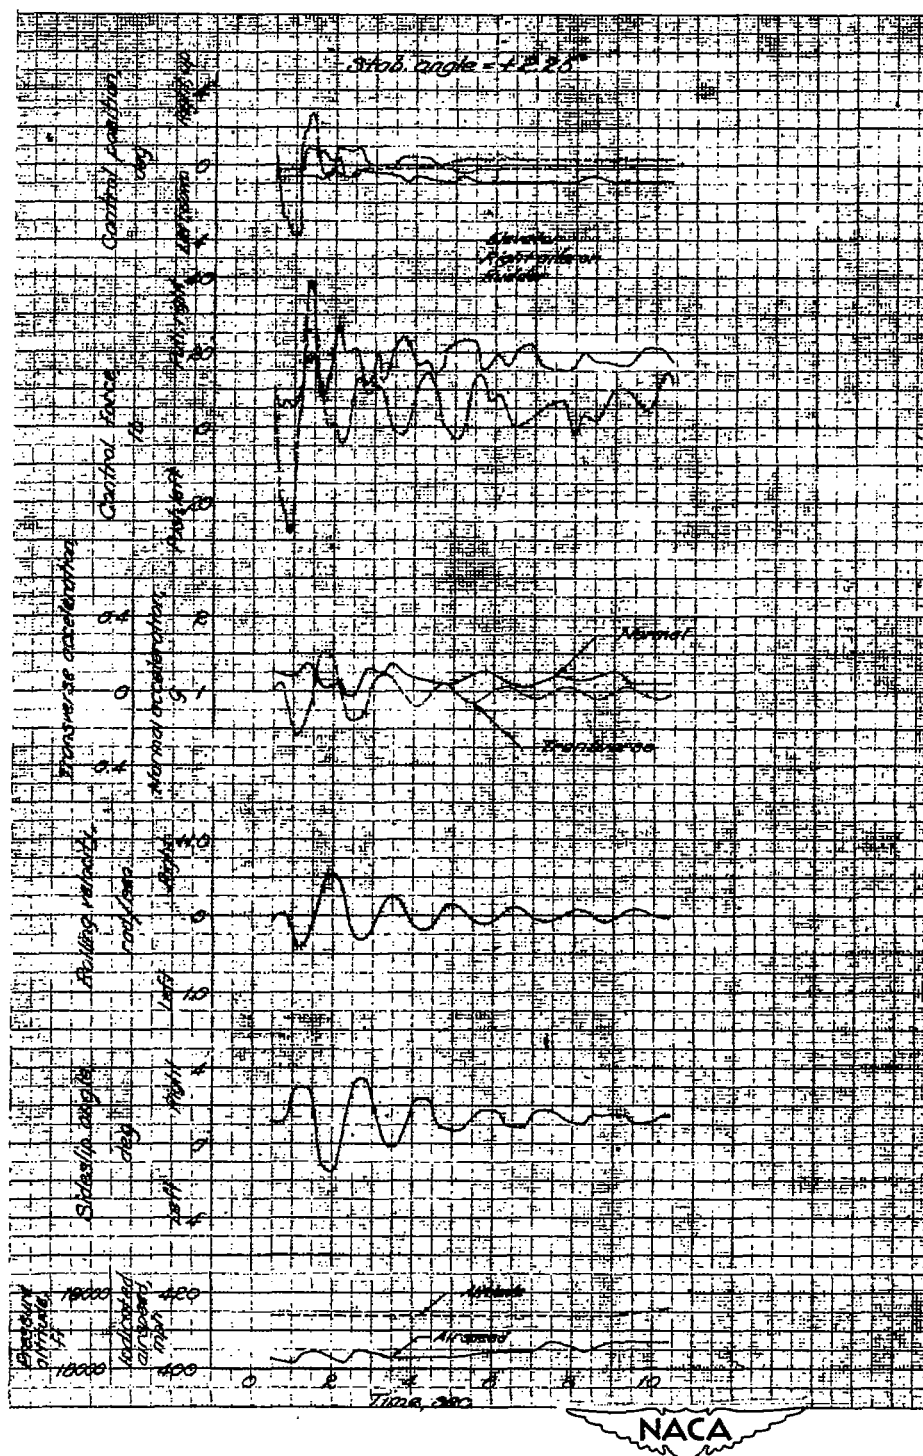
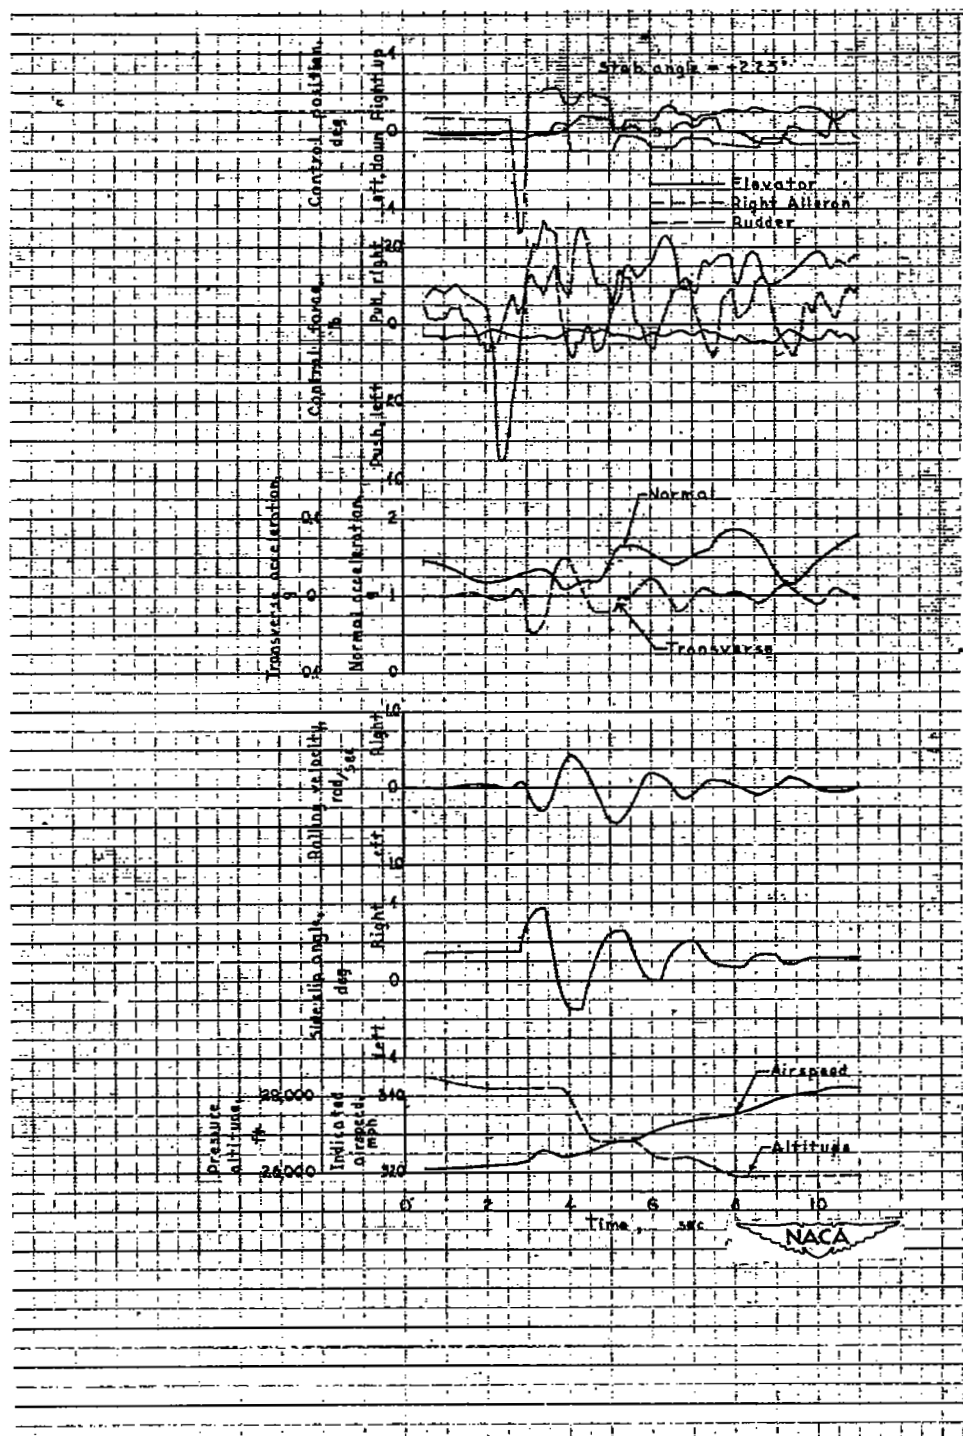
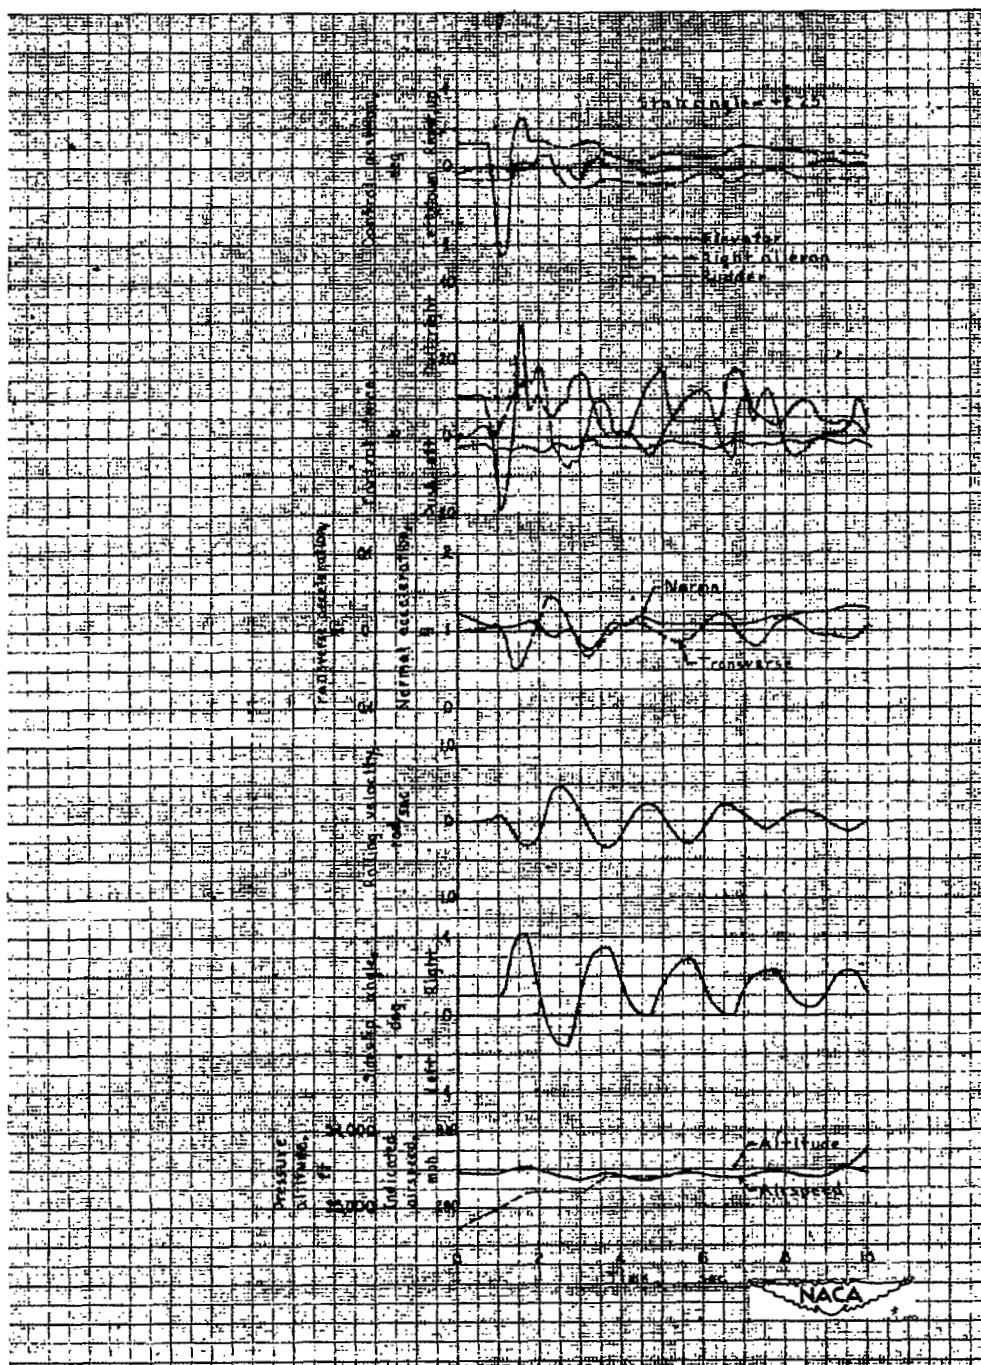
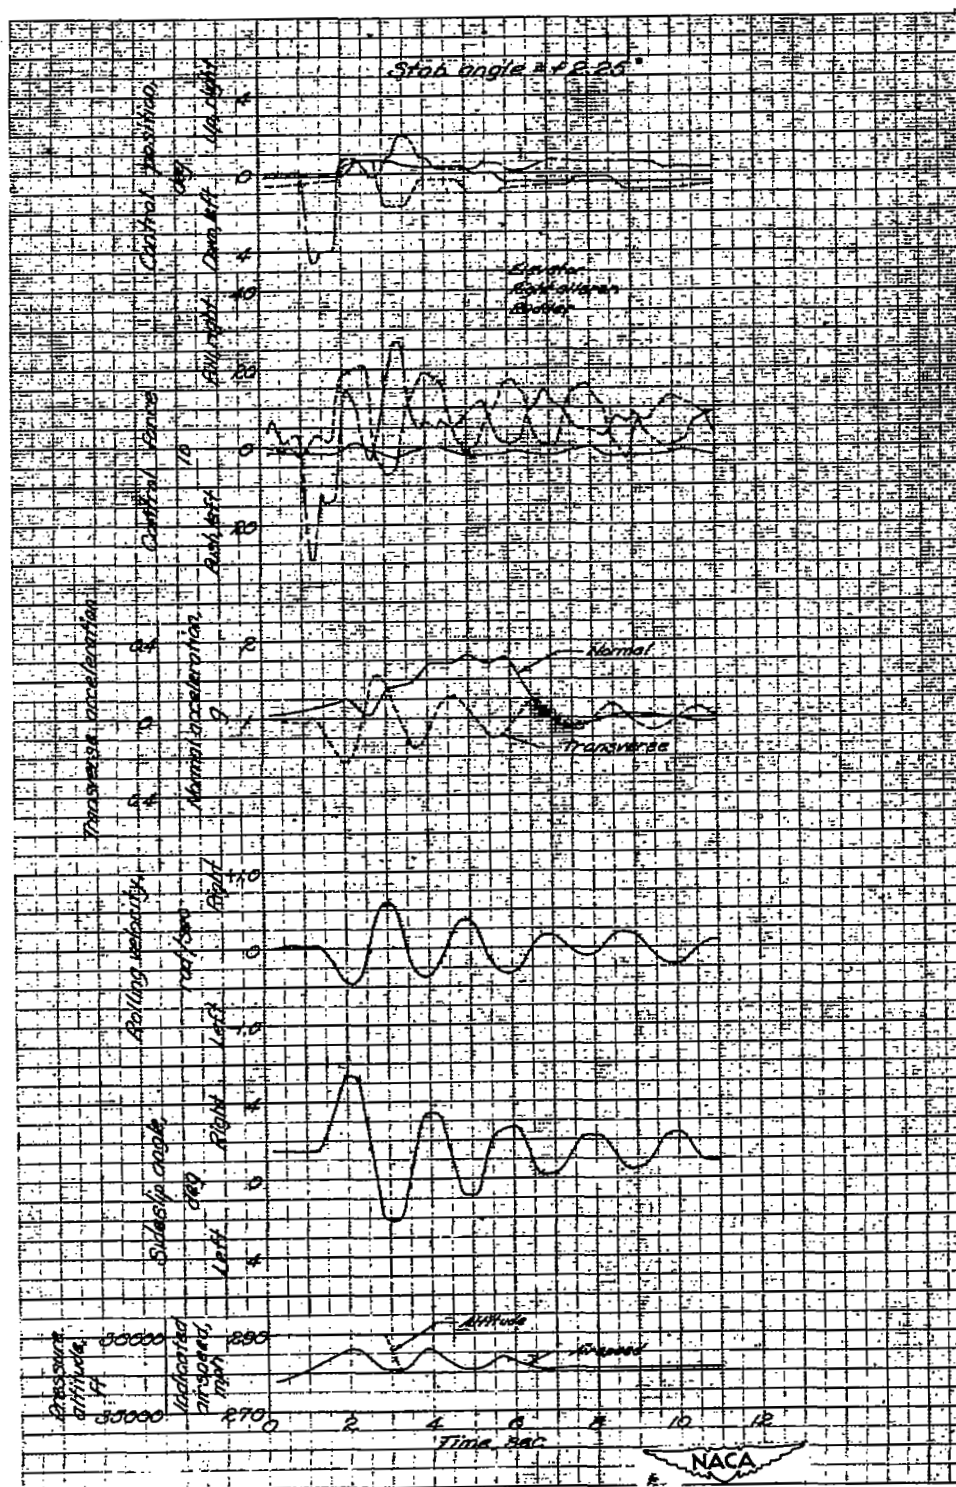
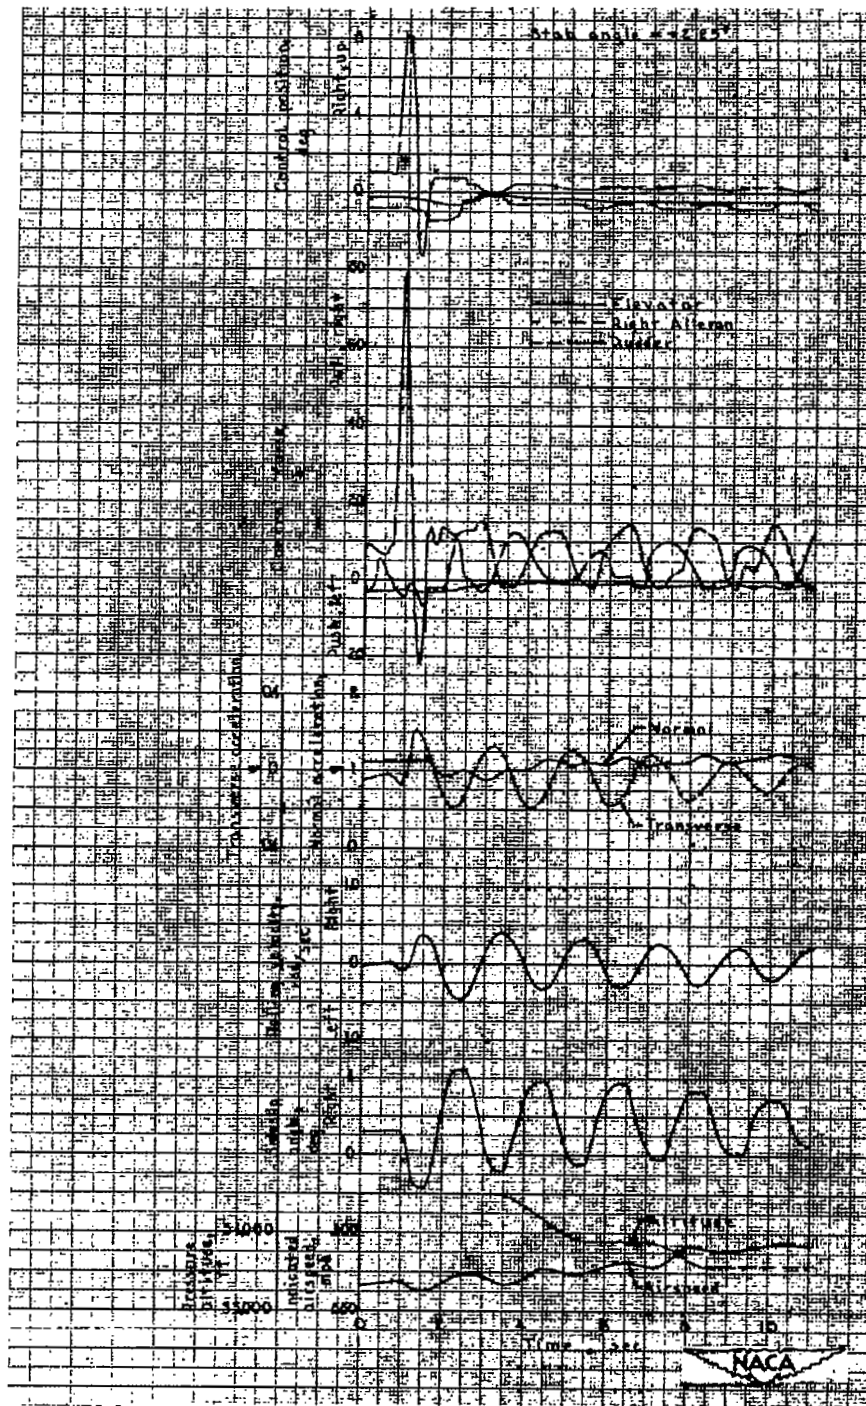
(a) Full Fuel.

Figure 30.— Time histories of abrupt rudder kicks with essentially constant relative density factors and an average Mach number of about 0.740. Various amounts of fuel aboard. XS-1 8-percent-thick-wing airplane.

(b) 40 percent fuel.

(c) 25 percent fuel.

(d) No fuel.

(e) No fuel.

pilot-induced oscillations were made with various amounts of fuel aboard. The altitude for the maneuvers was varied so that the airplane density factor and Mach number were essentially constant. The pilot attempted to deflect the rudder abruptly and then to return the rudder to neutral and hold it there. The results of these tests are presented as time histories of the rudder kicks in figure 30. As can be seen in this figure, the pilot did not hold the rudder or ailerons steady after initially deflecting the rudder. It is difficult to draw any definite conclusions concerning the effects of fuel on the damping of the lateral oscillations because of these control motions. There is no evidence, however, that the presence of fuel aboard had any effect on the damping of the lateral oscillations.

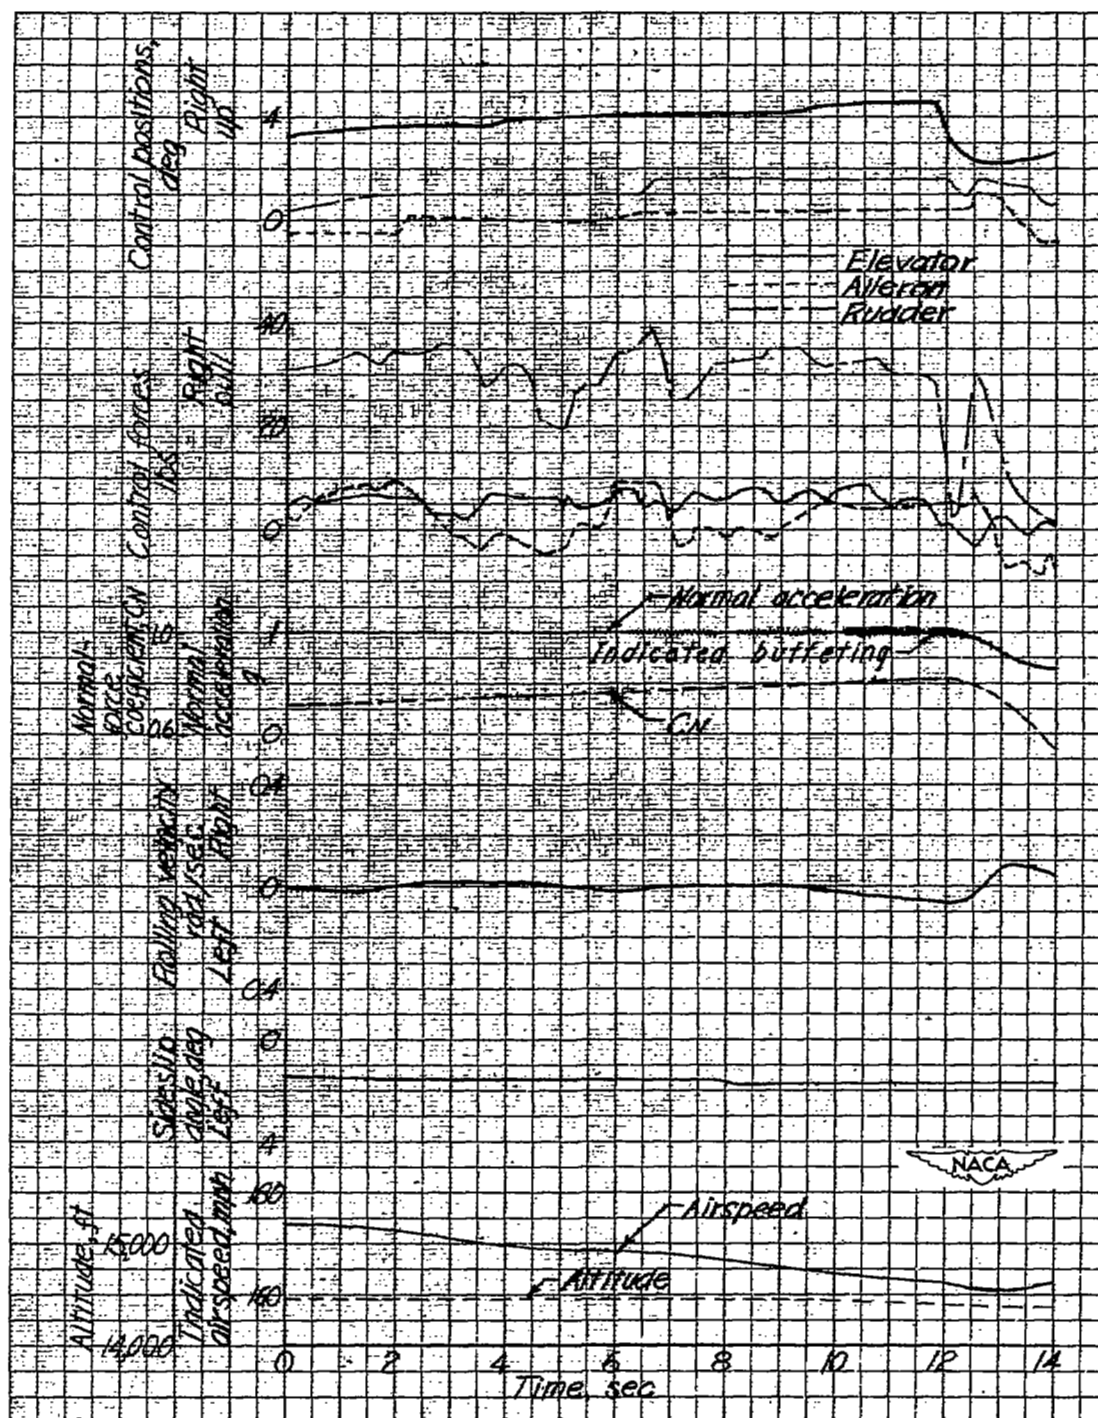
Figure 31.- Time history of a steady stall. XS-1 airplane with 10-percent-thick wing. Gliding flight; flaps and gear up. Center of gravity, 25 percent M.A.C.  $\frac{W}{S} = 56.3$  lb/sq ft. Stabilizer position,  $0.25^\circ$ .

The stalling characteristics of the Bell XS-1 were investigated in unaccelerated flight and in accelerated flight. Time histories of stalls made with flaps and gear up are presented in figures 31 and 32 for the Bell XS-1 with the 10-percent-thick wing. In the stall presented in figure 31, the pilot discontinued the stall approach at the first roll-off. The pilot reported that the roll-off was preceded by buffeting. In the stall presented in figure 32, the pilot continued the stall approach after the initial roll. An oscillation in roll developed which the pilot controlled up to the stall which was evidenced by the airplane pitching downward. It should be noted that full-up elevator was used at the stall. For this time history, it was assumed that the airplane was at 1g up to the time of minimum speed, in calculating values of normal-force coefficient. A time history of a stall made with the Bell XS-1 with the 8-percent-thick wing, flaps and gear up, is presented in figure 33. The stalling characteristics with the 8-percent-thick wing are similar to the characteristics measured with the 10-percent-thick wing. Time histories of stalls made with flaps and gear down are presented in figures 34 and 35 for the 10-percent-thick and 8-percent-thick wings, respectively. The stalling characteristics with flaps and gear down are similar to the characteristics with flaps and gear up. The pilot reported stall warning in the form of buffeting in all cases, and the rolling motions during the stall were never violent. The stalling characteristics in 1g flight, as measured during the flight tests, are in general agreement with the stalling characteristics predicted from the wind-tunnel tests.

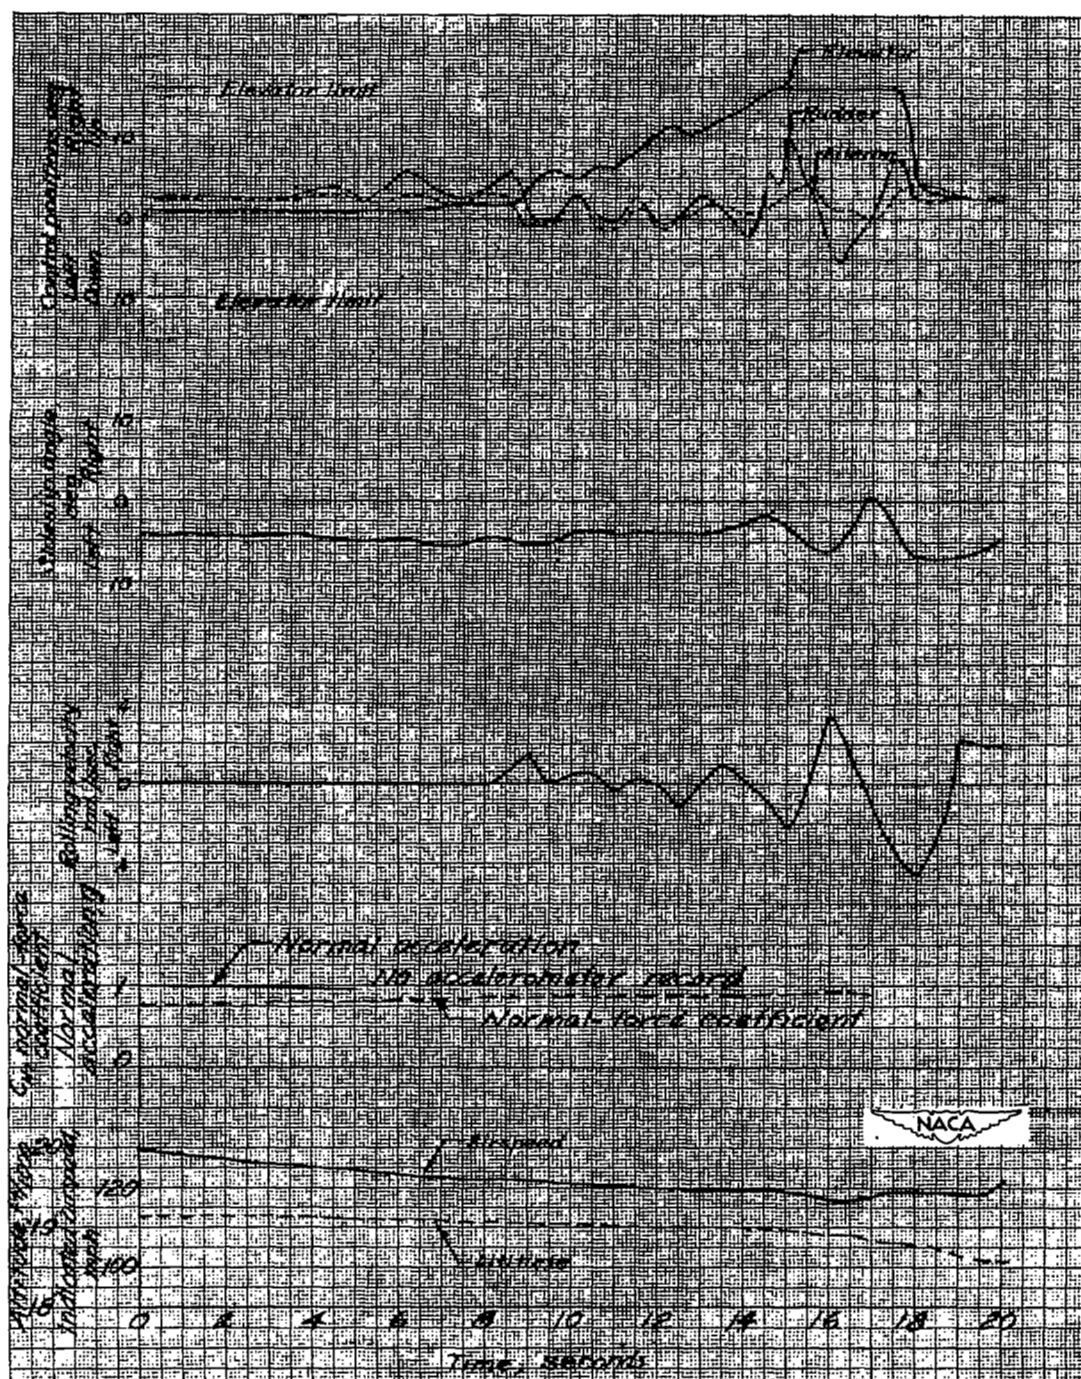
Figure 32.- Time history of a steady stall. XS-1 airplane with 10-percent-thick wing. Gliding flight; flaps and gear up;  $\frac{W}{S} = 32.5$  lb/sq ft. Stabilizer settings,  $1.0^\circ$ .

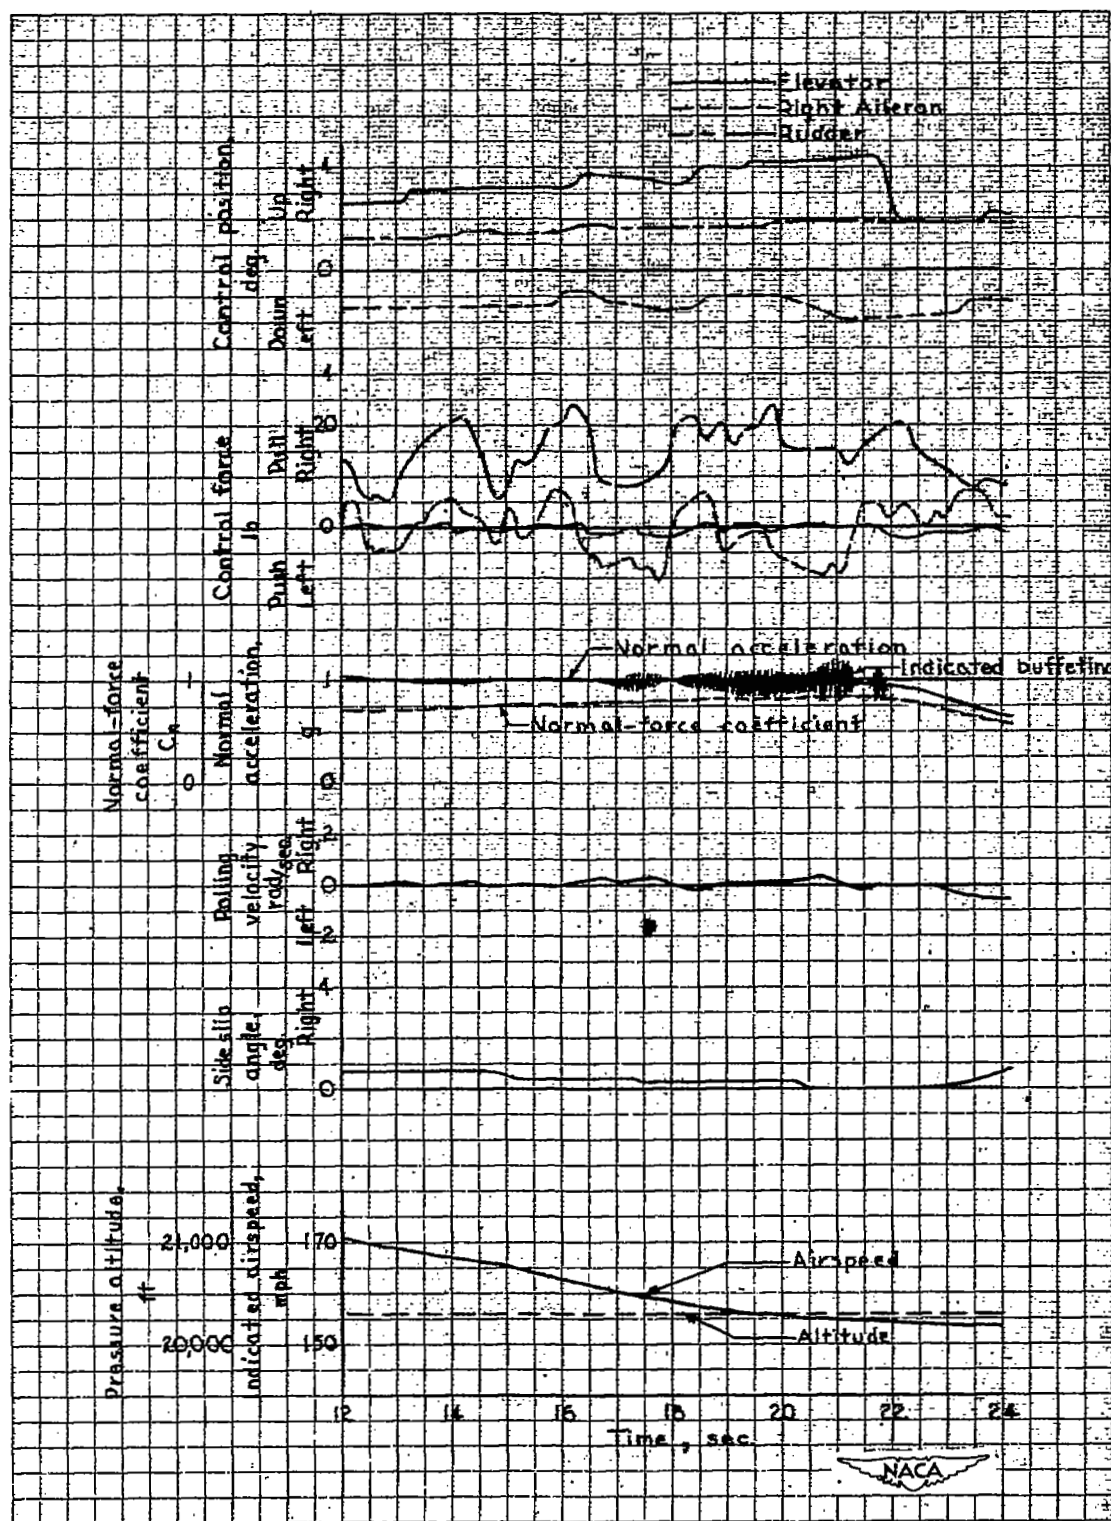
Figure 33.- Time history of a steady stall, XS-1 airplane with 8-percent-thick wing. Gliding flight; flaps and gear up.

$\frac{W}{S} = 53.8$  lb/sq ft. Stabilizer setting,  $2.35^\circ$ .

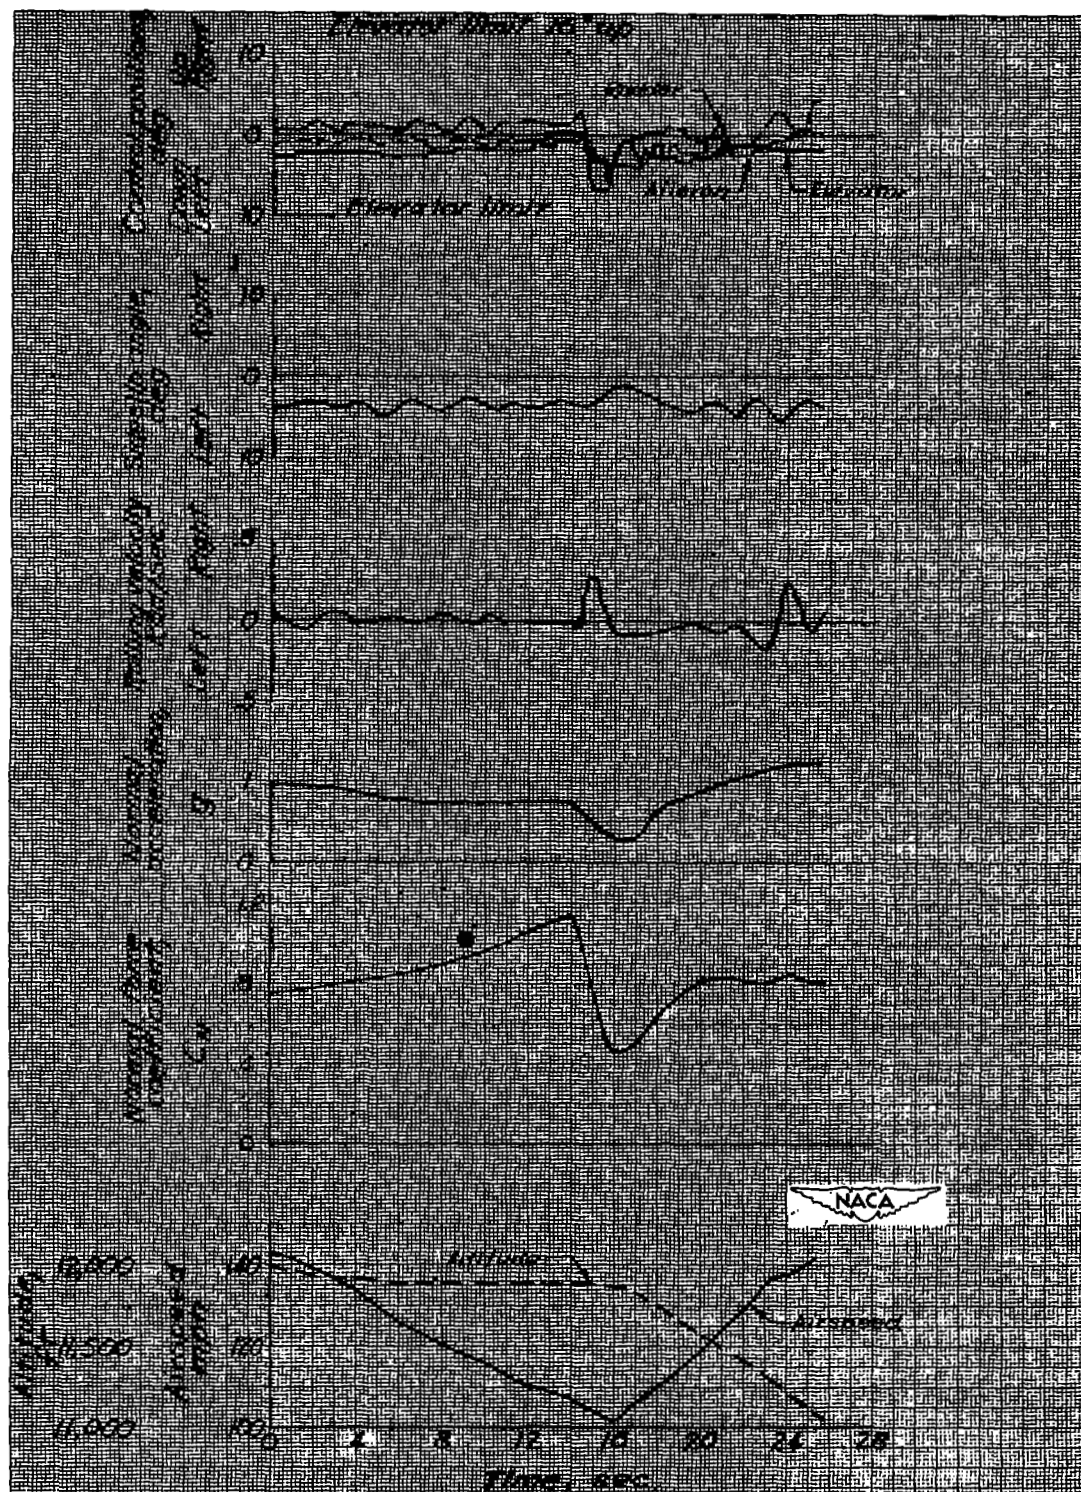
Figure 34.- Time history of a steady stall, XS-1 airplane with 10-percent-thick wing. Gliding flight, flaps and gear down. Center of gravity, 25 percent M.A.C.  $\frac{W}{S} = 32.5$  lb/sq ft. Stabilizer setting,  $1.0^\circ$ .

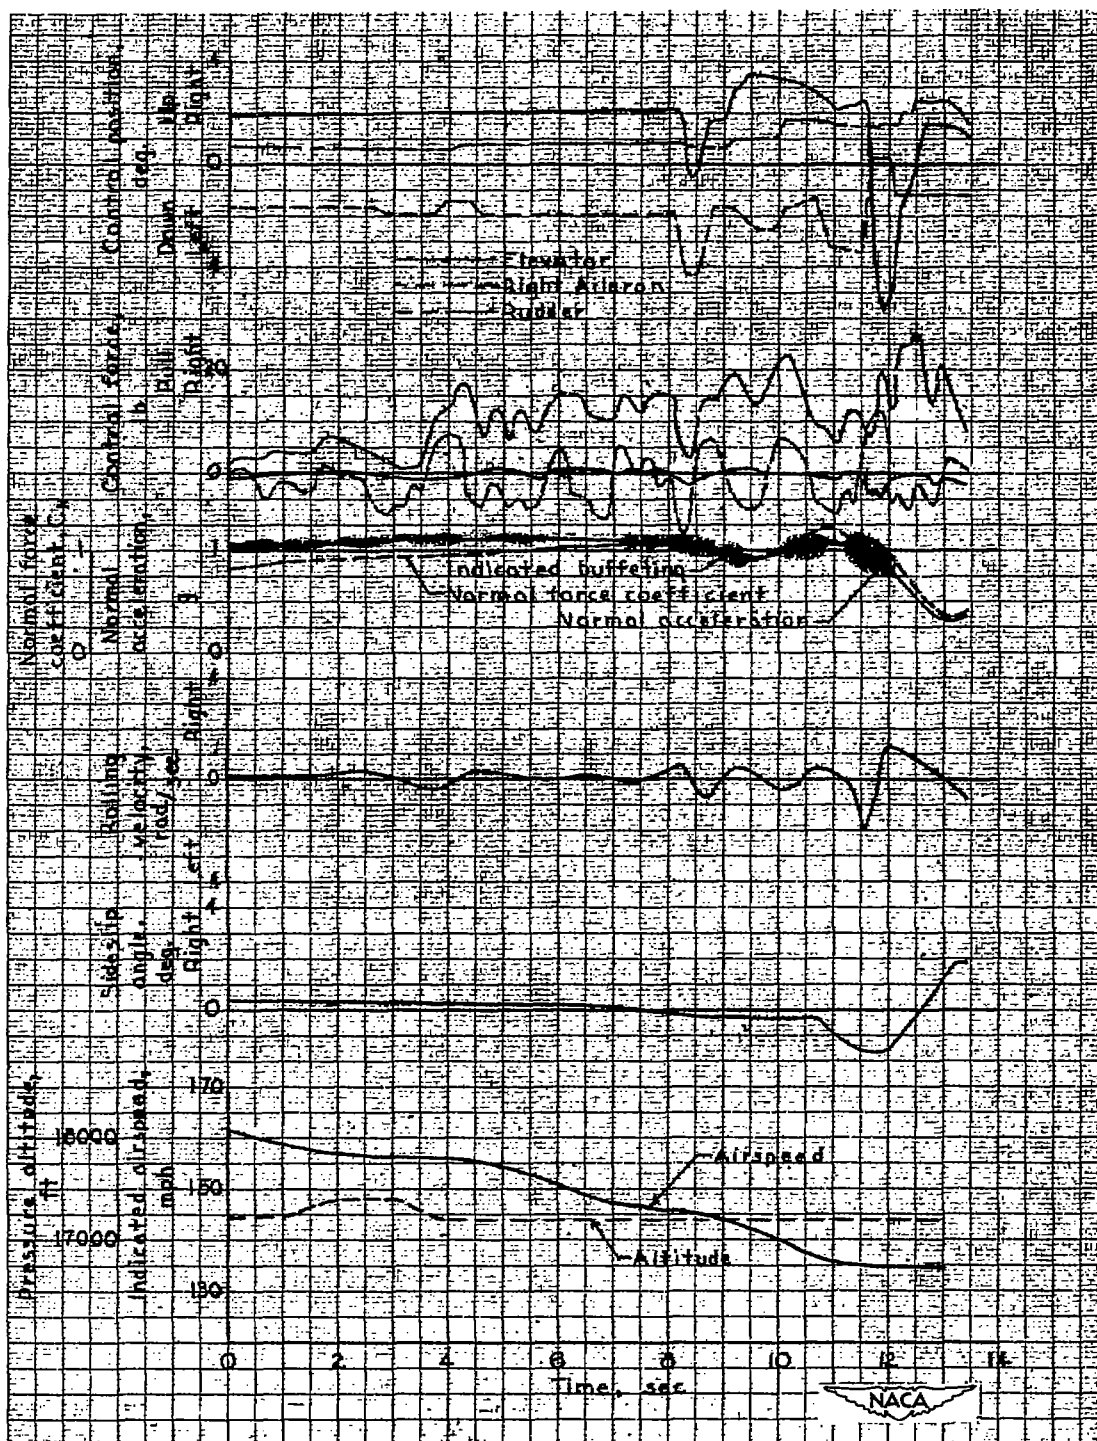
Figure 35.- Time history of a steady stall, XS-1 airplane with 8-percent-thick wing. Gliding flight, flaps and gear down. Center of gravity, 25.0 percent M.A.C.  $\frac{W}{S} = 53.8$  lb/sq ft. Stabilizer position,  $2.35^\circ$ .

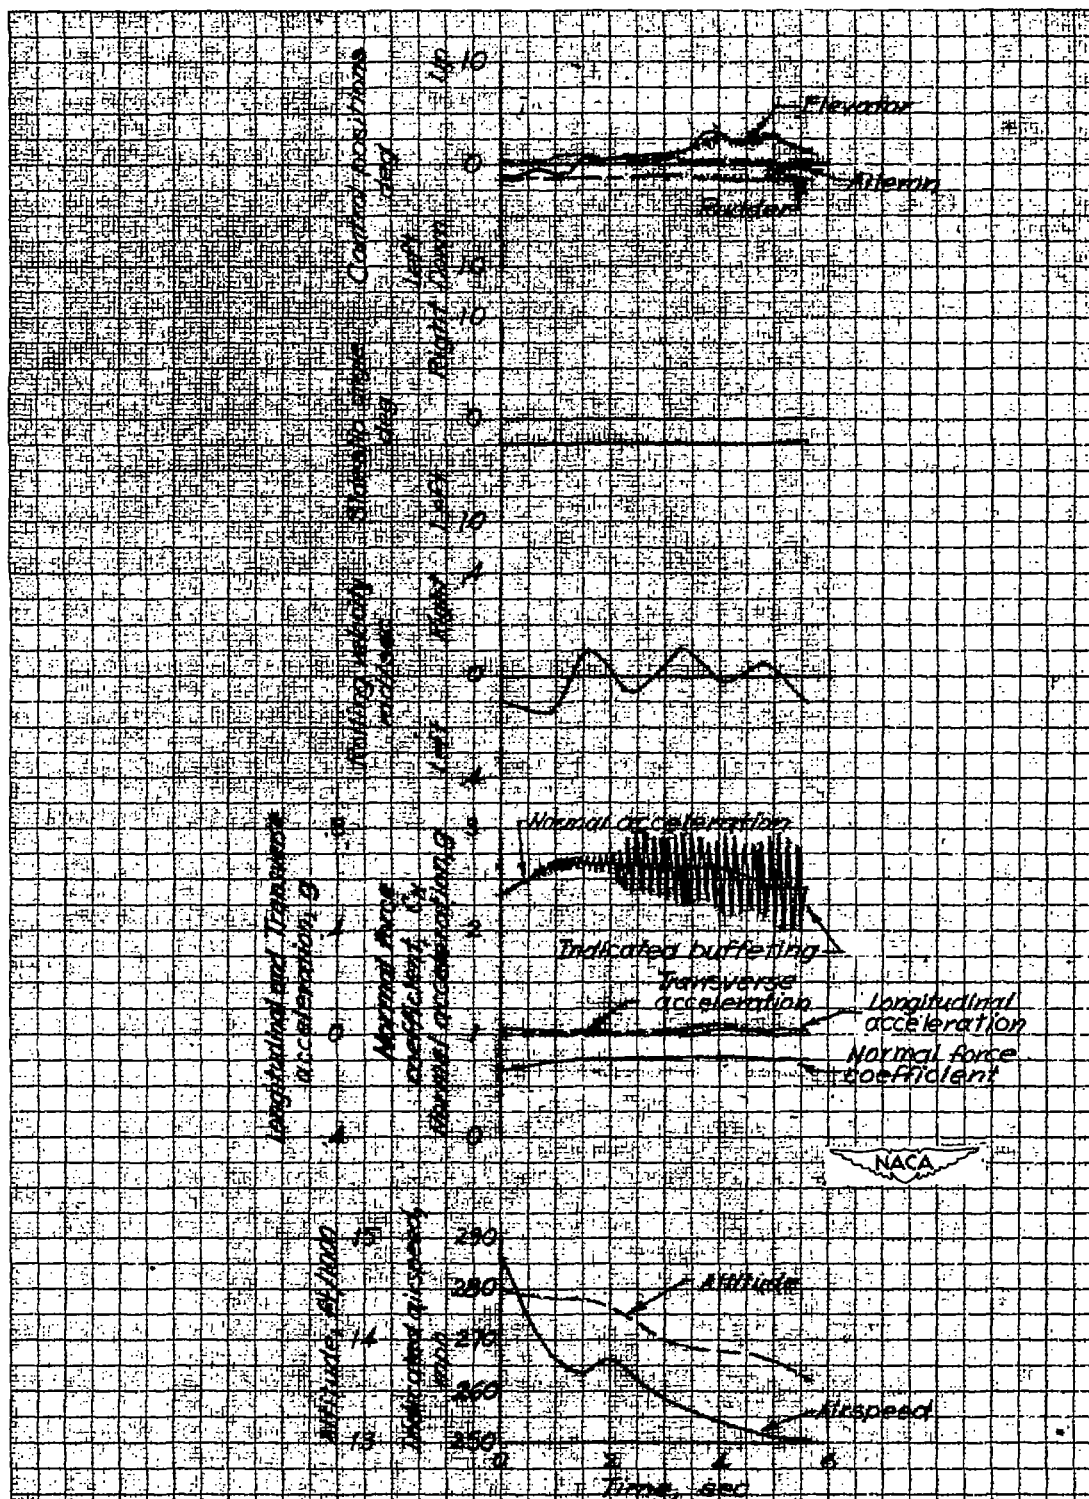
Figure 36.- Time history of a stalled turn. XS-1 airplane with 10-percent-thick wing. Center of gravity, 25 percent M.A.C.  $\frac{W}{S} = 51.9$  lb/sq ft.

The stalling characteristics in accelerated flight were considered satisfactory. There was stall warning in the form of buffeting, and there were no violent motions of the airplane as the stall was approached. A time history of a stalled turn is presented in figure 36. Time histories of abrupt pull-ups to the stall are presented in figures 37 and 38. It should be noted in figure 37 that a rolling

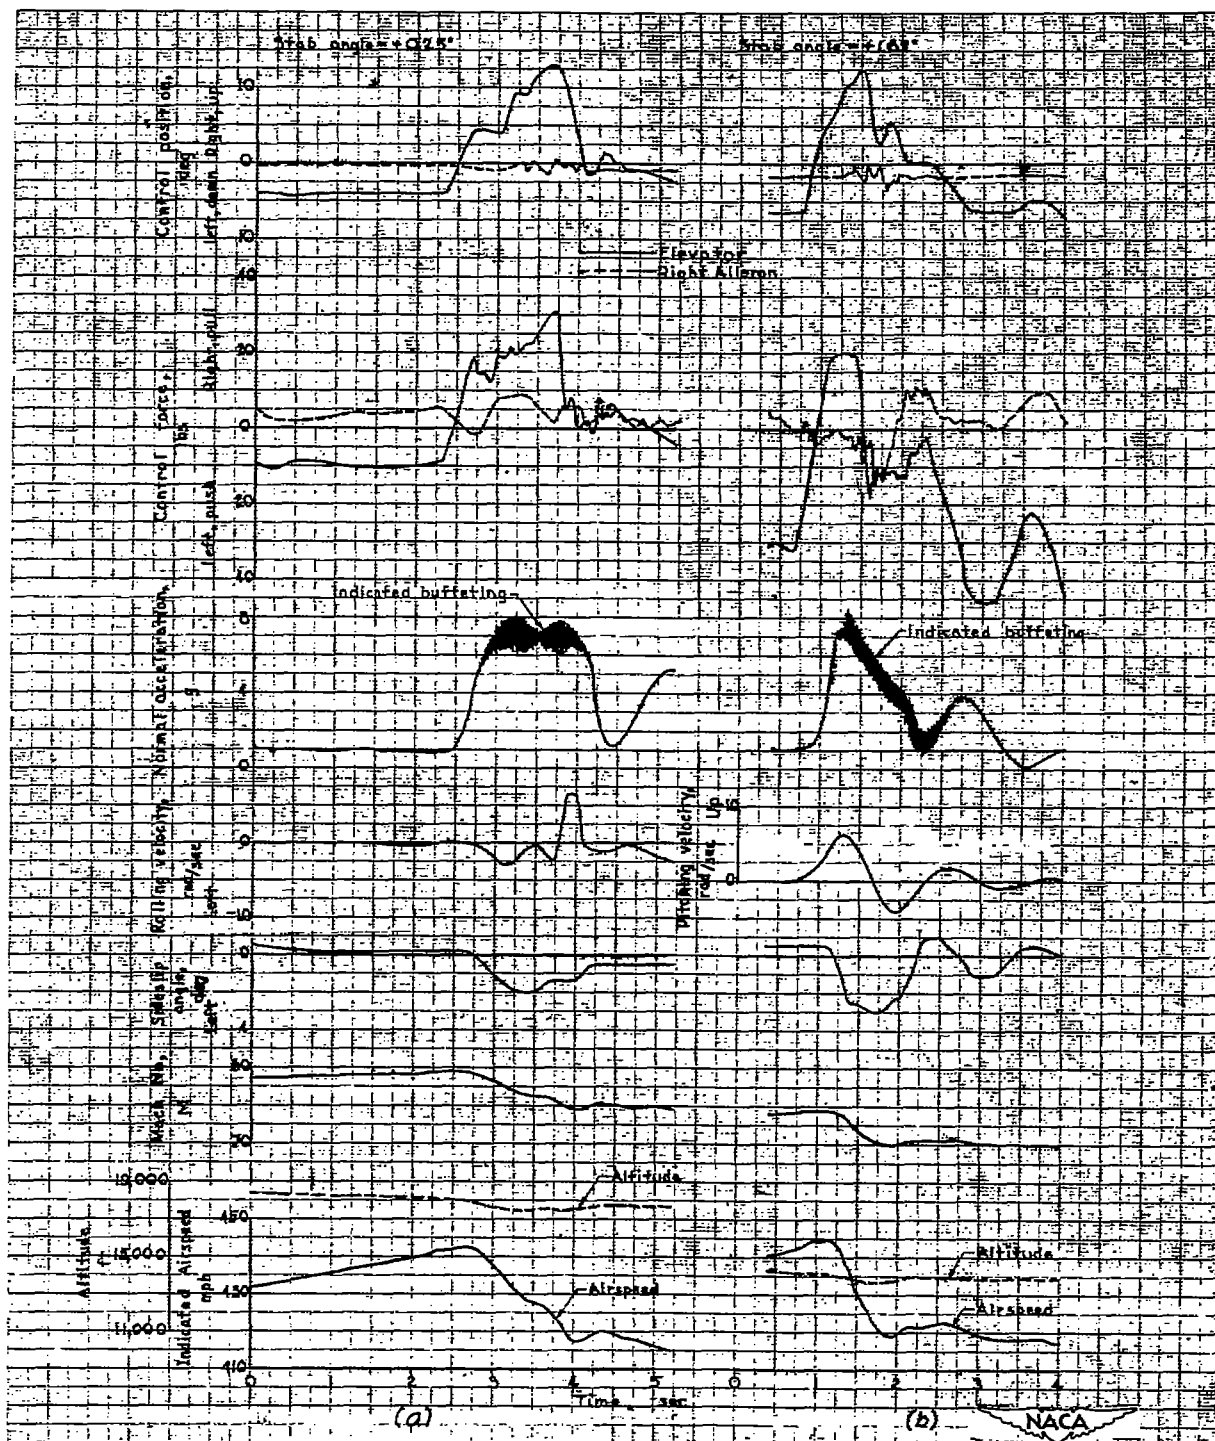
(a) XS-1 airplane with 10-percent-thick wing. Center of gravity, 25.3 percent M.A.C.

Figure 37.-- Time histories of power-off abrupt pull-ups.

oscillation accompanies the stall, but the airplane did not roll completely over when the ailerons were not used. In figure 38, aileron control was applied at the stall and a snap roll resulted.

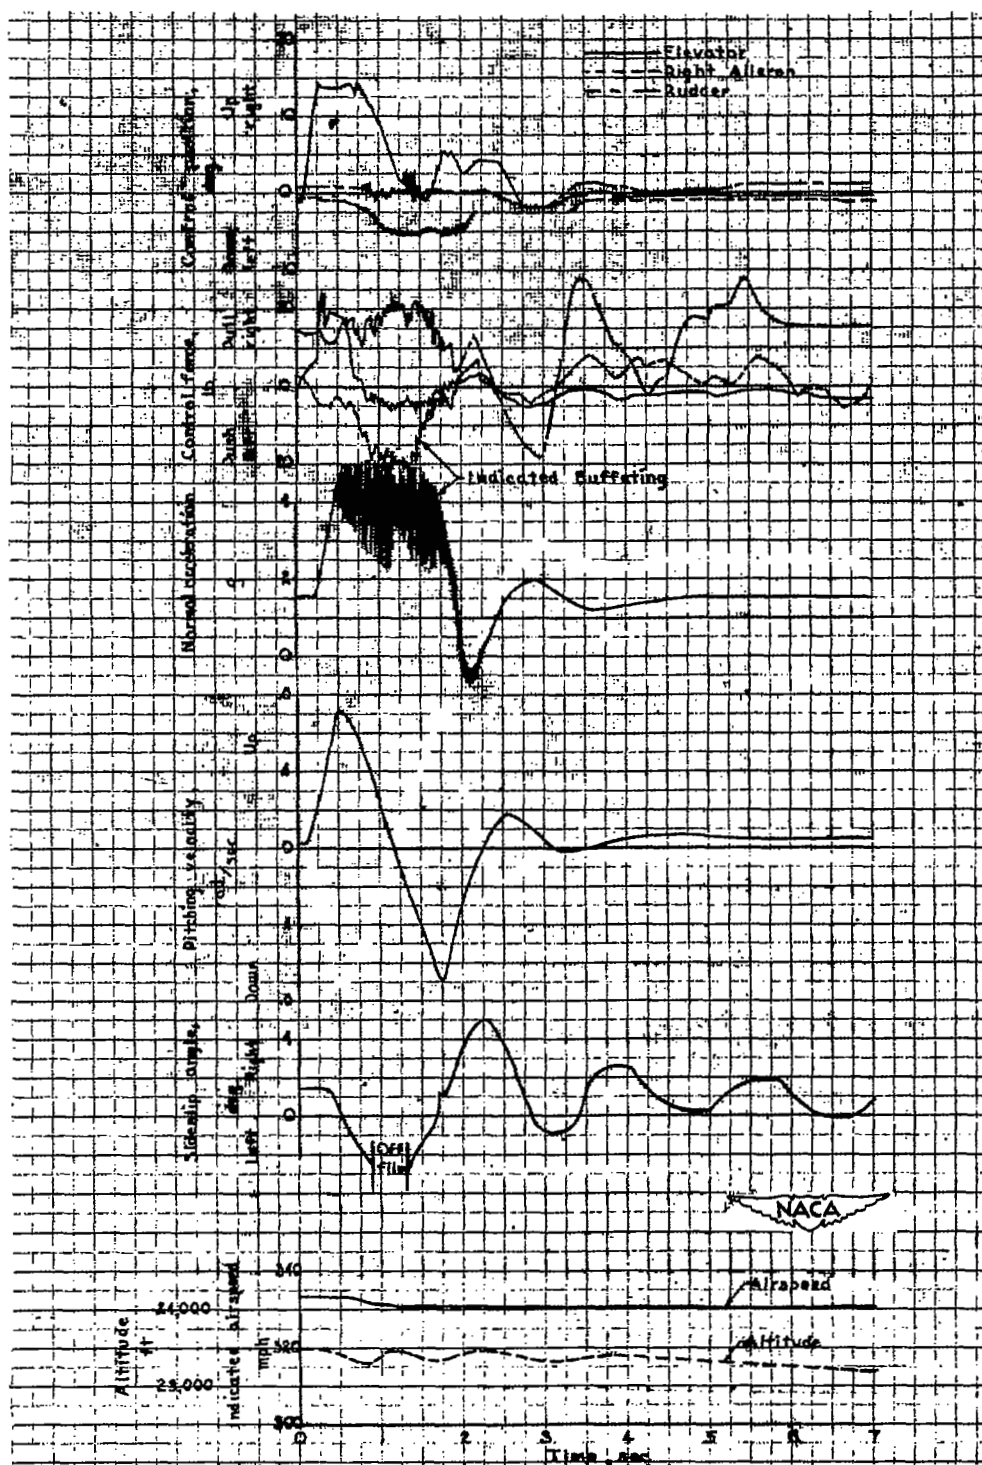
Figure 38.- Time history of an abrupt pull-up followed by a snap roll. XS-1 airplane with 8-percent-thick wing. Center of gravity, 25.0 percent M.A.C.  $\frac{W}{S} = 53.8$  lb/sq ft. Stabilizer position,  $2^\circ$ .
