WATERTOWN ARSENAL LABORATORIES

CORRELATION OF TOUGHNESS BETWEEN H-PLATE AND CHARPY IMPACT TESTS

TECHNICAL REPORT NO. WAL TR 112/98

BY
W. P. HATCH, JR.

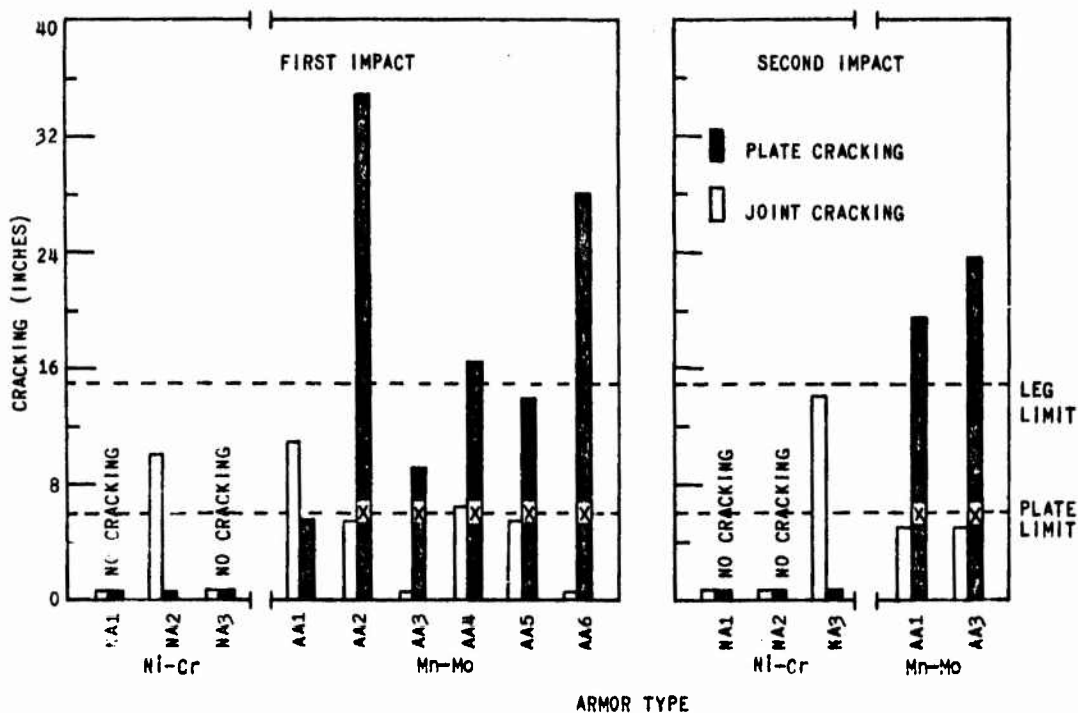
FIGURE 1: CRACKING IN AUSTENITIC EL307 WELDED ARMOR H-PLATES FROM BALLISTIC TESTS AT -40°F .

1. Welded with Austenitic E307 Electrode (see Figure 1)

Satisfactory performance, with 4 out of 6 rounds fired producing no cracking. The cracking that did occur was "fusion-zone" cracking.*

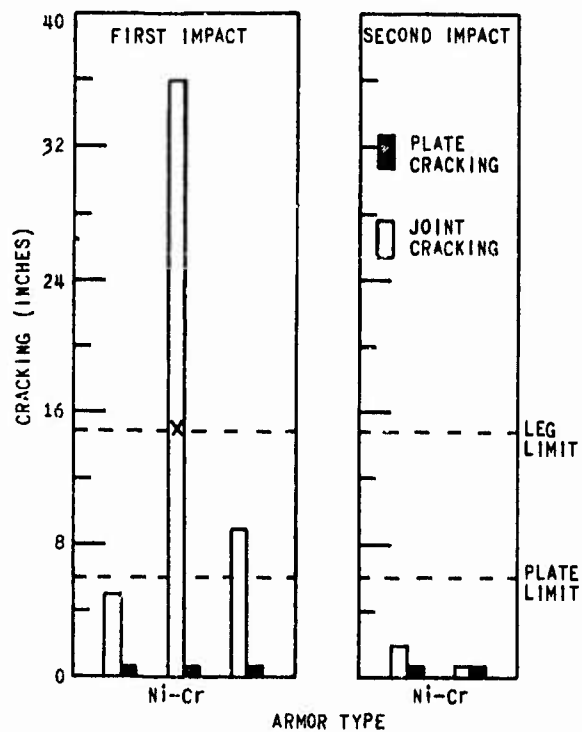
FIGURE 2: CRACKING IN FERRITIC GRADE 260 WELDED ARMOR H-PLATES FROM BALLISTIC TESTS AT -40°F.

2. Welded with Ferritic Grade 260 Electrode (see Figure 2)

Satisfactory performance, with only 1 out of 5 rounds fired producing failure. One of the rounds caused complete (36") weld metal fracture, one round caused no cracking, and 3 of the 5 rounds fired produced "fusion-zone" cracking.

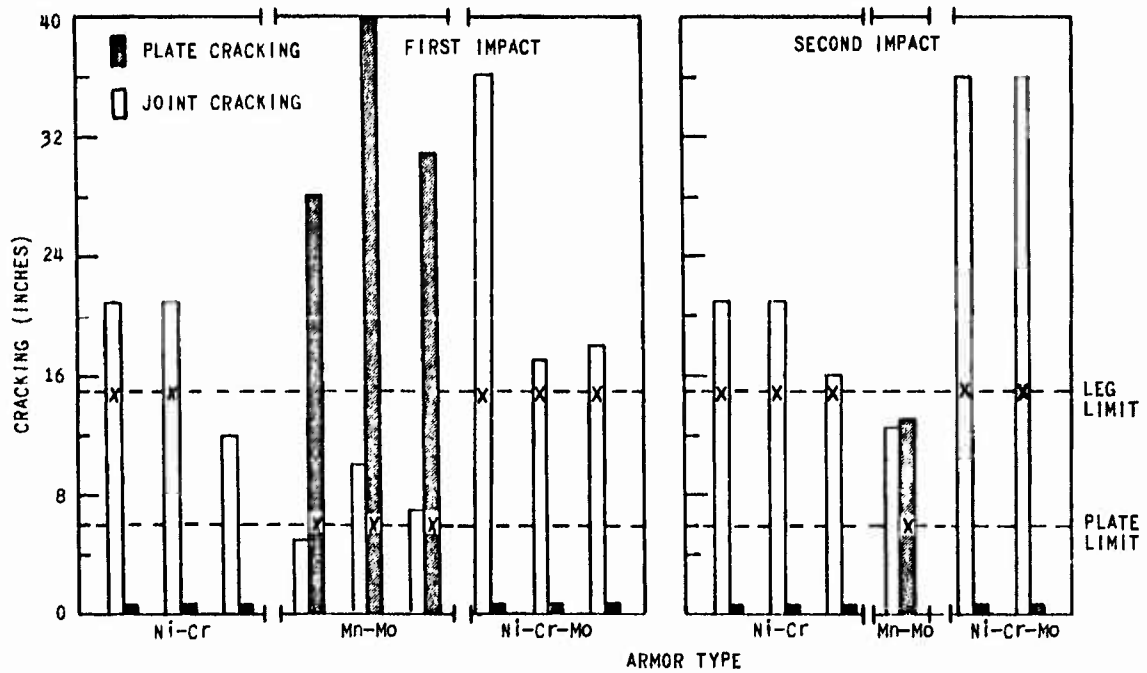
FIGURE 3: CRACKING IN FERRITIC GRADE 230 WELDED ARMOR H-PLATES FROM BALLISTIC TESTS AT -40°F.

The weld metal deposited with the Grade 230 ferritic electrodes also lacked sufficient toughness for testing at -40°F since excessive leg cracking occurred in both the Ni-Cr-Mo and the Ni-Cr armor steels. No plate cracking occurred in either the Ni-Cr-Mo or the Ni-Cr, although "fusion-zone" cracking was observed in both materials. In the case of the Ni-Cr armor "fusion-zone" cracking was predominant, whereas in the Ni-Cr-Mo armor extensive weld metal cracking occurred.

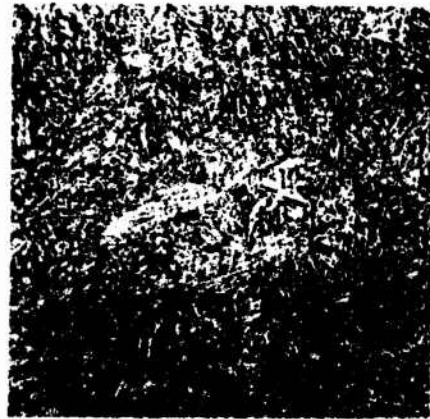
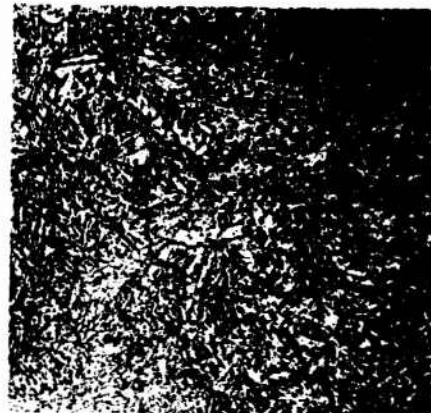
FIGURE 5: MICROSTRUCTURES OF THE H-PLATE ARMOR BASE METALS (Picraml Etch).

Specimens from all three armor steels were examined microscopically at X100 and X1000 magnification after polishing and etching with a 4% picral reagent. Reproductions of photographs of typical microstructures are included in Figure 5. At 100X magnification both the Mn-Mo and Ni-Cr-Mo appeared quite similar with a scattered distribution of fine elongated nonmetallics in what is seen as a uniformly dark-etching two-constituent field of microstructures. The uniformity of etching indicated an economical

homogeneous distribution of the alloying elements. At higher magnification both microstructures were seen to consist of tempered martensite and tempered bainite with somewhat larger amounts of bainite in the Mn-Mo composition.

Unlike the other armors, the Ni-Cr armor etched irregularly in a banded structure as seen at 100X magnification in Figure 5. Some banding was also evident at 1000X in the microstructure of tempered martensite. The presence of discrete rounded carbides evident at the higher magnification were indicative of tempering cycles involving higher temperatures and/or longer times than those for the Mn-Mo and Ni-Cr-Mo armors.

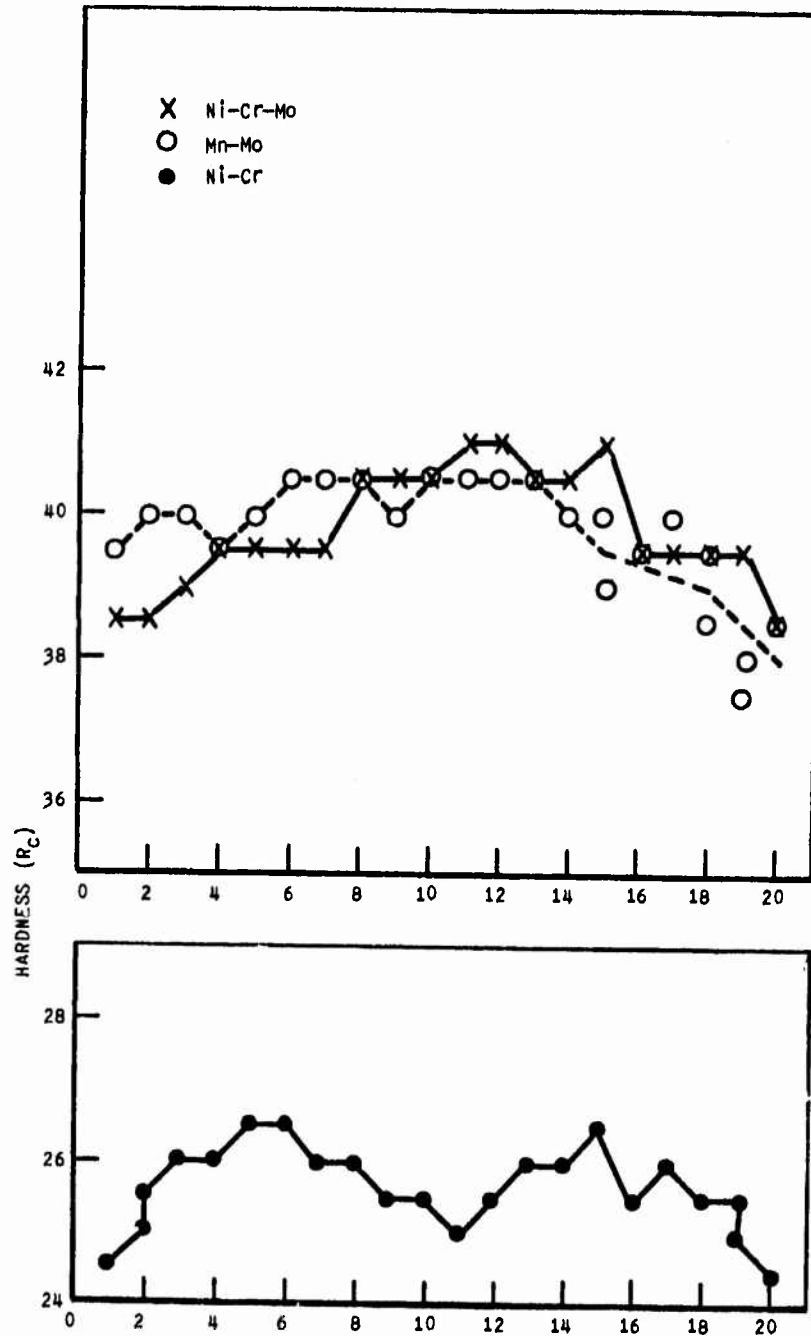
FIGURE 6: HARDNESS THROUGH CROSS-SECTION OF THE ONE-INCH THICK ARMOR BASE METALS.

Brinell and Rockwell hardness traverses were taken across a section through the thickness of each of the armor steels. The Rockwell results obtained are presented in Figure 6 and Table IIIA (appended). No evidence of excessive variations between hardnesses from surface to center which might result from improper heat treating procedures were noted. Test results indicated average hardnesses for the Mn-Mo and Ni-Cr-Mo armors at 355 to 360 BHN (39.8 to 39.9 R_c) against 255 BHN (25.7 R_c) for the Ni-Cr armor. The characteristic hardness levels which are evident were one of the major differences known to exist between the two types of armor. The reasons for the wide difference in hardness are directly associated with different service requirements for protection against ballistic penetration. Nevertheless, the wide separation in hardness level of armor types complicated direct comparison of performance in this investigation.

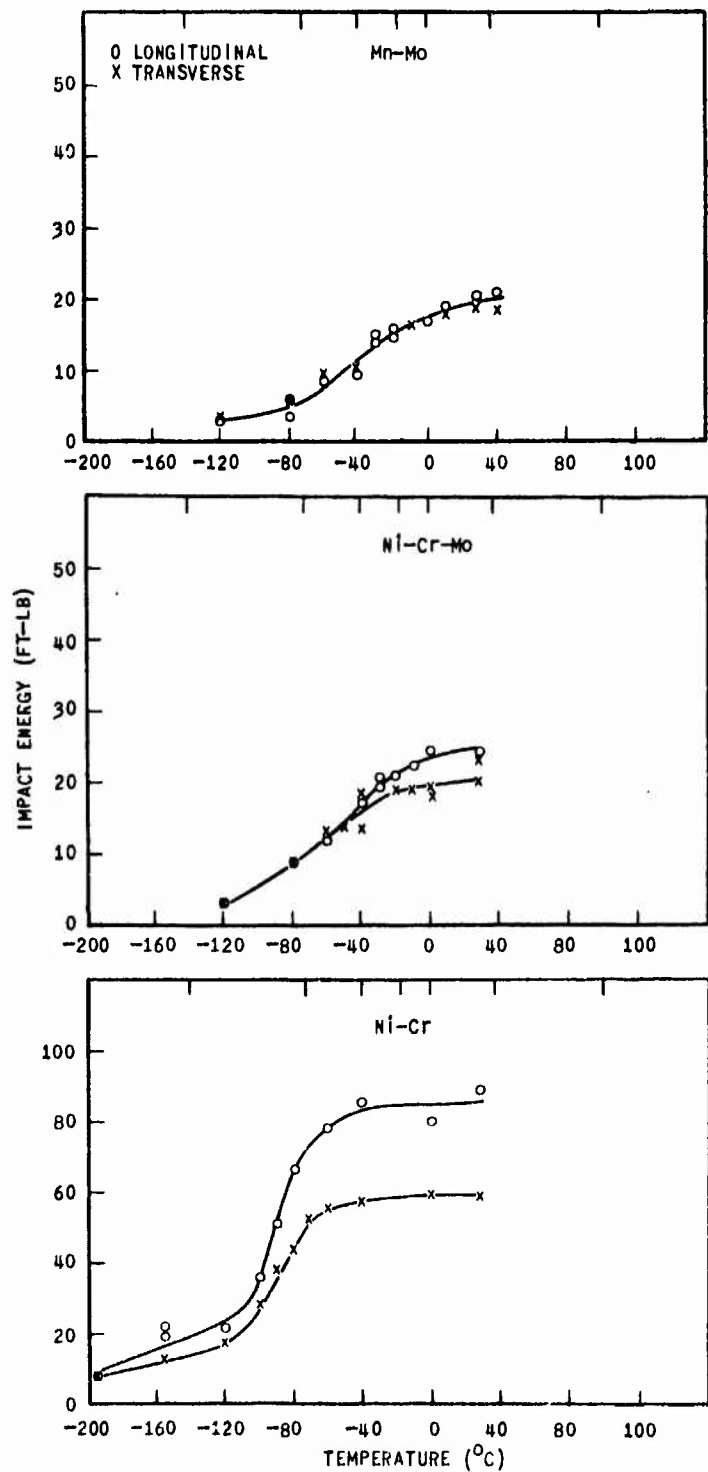
FIGURE 7: V NOTCH CHARPY IMPACT TRANSITION CURVES FOR THE H-PLATE ARMOR BASE METALS.

V notch Charpy impact specimens were machined from plate samples in both longitudinal and transverse directions. The specimens were taken from midthickness of the one-inch plates and were notched perpendicular to the plane of plate surface. Transition curves obtained from testing the specimens over a range of temperatures are presented in Figure 7. From comparison of the two curves for each material it can readily be seen that only the Ni-Cr armor exhibits marked directionality properties. No attempt was made to determine cause of the directionality which is usually associated with mill practices.

Because of the wide separation between hardnesses of the two types of armor, comparison based on a given impact-energy level favors the lower hardness material. Nevertheless, comparisons based on the relative positions of the transition curves with respect to temperature indicate the Ni-Cr armor to be superior in toughness since its entire transition occurred below -40° . The impact requirement of Specification MIL-A-12560 for transverse specimens from armor at 361 Brinell hardness is 15 ft-lb at -40° . Figure 7 shows that the Mn-Mo armor with an impact level of 11 ft-lb at -40° failed to meet minimum impact requirements while the Ni-Cr-Mo armor just met the minimum requirements with 16 ft-lb average impact energy. An energy requirement applicable to the low hardness Ni-Cr armor is indeterminate. However, it is evident that impact-wise neither the Mn-Mo nor the Ni-Cr-Mo armor approached the toughness of the Ni-Cr armor.

Certain observations with regard to H-plate performance can be made from Figures 7 and 9. First, one might predict that weld-metal cracking rather than plate or heat-affected base metal cracking would occur in the Ni-Cr H-plates tested at -40°F . H-plate results were consistent with this prediction of no plate cracking; however, numerous cases of "fusion-zone" cracking were reported by Aberdeen Proving Ground. Such results are not necessarily inconsistent since "fusion-zone" cracking may indicate either heat-affected base metal or weld metal failures (see footnote on page 6).

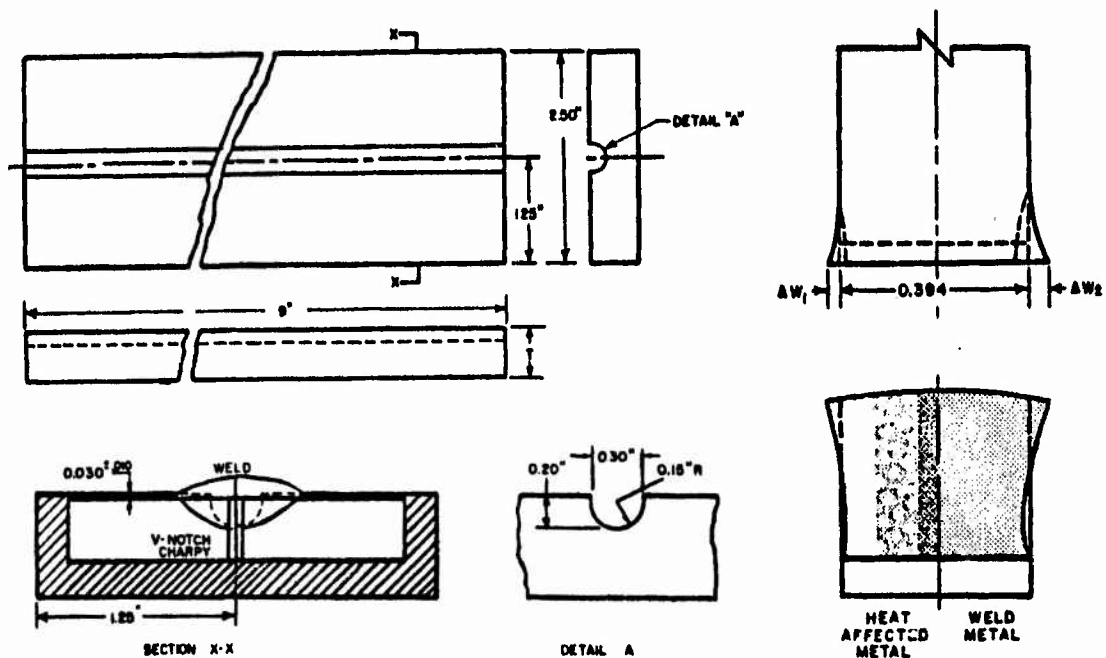
FIGURE 8: COMPOSITE CHARPY IMPACT TEST - illustration shows the test plate, orientation of test specimen, and lateral expansion in a fractured test specimen.

The composite Charpy impact test developed at Watertown Arsenal Laboratories has been found to be a useful tool for studying the effects of welding (see References 1 and 2). The test consists of a weld deposited in a groove machined in the surface of a test plate (Figure 8). Charpy impact specimens are machined from the welded test plate in such a manner that the cross-section under the notch consists of approximately equal areas of weld metal and heat-affected base metal. Measurements of the lateral deformation occurring in test specimens broken over a range of temperatures yield two transition curves indicating the relative notch toughness of weld and heat-affected base metal.

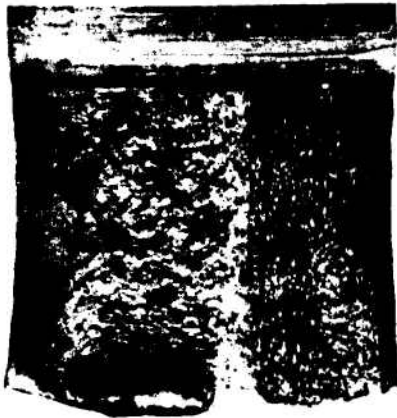
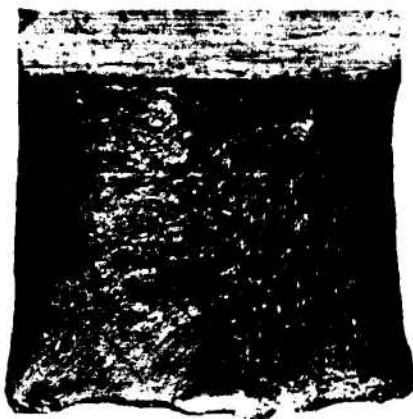
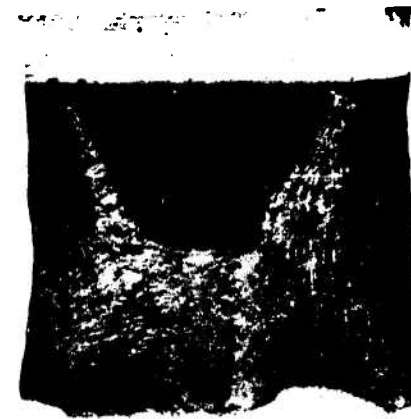
FIGURE 10: LOW-BLOW TESTS OF COMPOSITE SPECIMENS OF WELDS IN THE H-PLATE ARMORS - ink stain pattern shows cracking initiated by low-blow. Location of most sensitive structures is indicated by the leading edge of the ink stain.

Figure 10 shows results of tests conducted with 10 and 20 ft-lb initial blows at room temperature on composite specimens of each of the three armor materials. Absence of ink staining on specimens struck with a 10 ft-lb initial blow indicated that such a low blow was not sufficiently severe to initiate a crack. On the other hand, ink staining on specimens struck a 20 ft-lb initial blow showed not only initiated cracking but extensive propagation at certain locations.

In connection with the fracture mechanics of composite specimens it should be noted from Figure 10 that the ink staining was not symmetrical with respect to the centerline (midwidth) of the specimens. Thus, it must be concluded that the location of crack initiation and propagation was determined by the greater notch sensitivity of certain structures in the welded specimens rather than by geometrical considerations.

From Figure 10 it can be seen that the notch-sensitive structures were in the heat-affected base metal side of the test specimens in both the Mn-Mo and Ni-Cr-Mo armors; whereas, crack propagation occurred primarily in the weld-metal side of the composite specimens in the Ni-Cr armor. Thus, the ink staining on the fracture surfaces of specimens impacted with a 20 ft-lb blow was consistent with the relative notch toughness of weld and heat-affected base metals as indicated by the deformation-temperature transition curves of Figure 9.

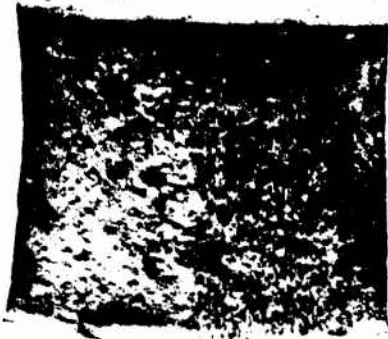
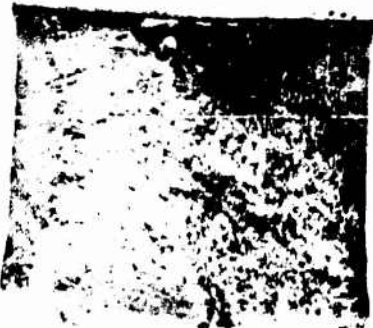
FIGURE 12: CRACK PROPAGATION IN LOW-BLOW TESTS OF COMPOSITE SPECIMENS WITH THE Mn-Mo ARMOR - Specimens impacted with 15 ft-lb initial blow at temperature shown.

A number of low-blow tests of composite specimens in each material were conducted, using a 15 ft-lb initial blow, over a range of temperatures to determine the effect of temperature on the extent and location of initial cracking. Similarity of performance in composite specimens of both the Mn-Mo and Ni-Cr-Mo armors is evident in Figures 12 and 13. Note that in each case cracking was more extensive in heat-affected base metal at temperatures down to -40°C . At approximately -50°C cracking became considerably more extensive in both weld and heat-affected base metal, and at -70°C the specimens fractured under the initial low blow.

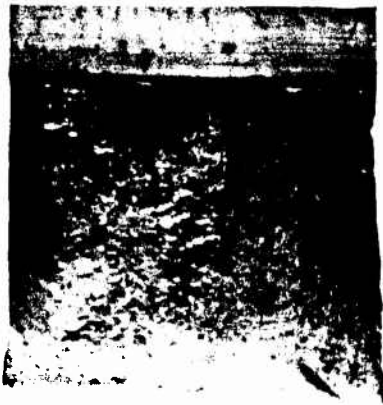
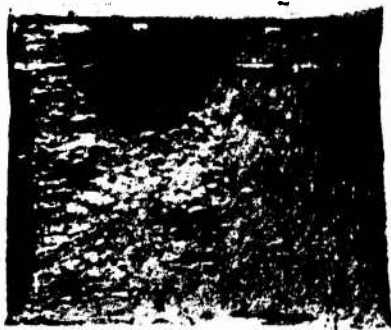
FIGURE 14: CRACK PROPAGATION IN LOW-BLOW TESTS OF COMPOSITE SPECIMENS WITH THE NI-Cr ARMOR - Specimens impacted with 15 ft-lb initial blow at temperature shown.

Performance of composite specimens in the Ni-Cr armor is shown in Figure 14. Ink staining indicated that the weld metal was more notch sensitive than the heat-affected base metal. At approximately -60°C an increase in stained area at the weld-metal side of the test specimen indicated a transition. Note that the ink staining extended even to the free surface at the side of the specimen indicating that the weld metal deposited in the second pass was also crack-sensitive at this temperature. A similar transition for the heat-affected base metal occurred at approximately -90°C . At -100°C the composite specimen fractured under the initial low blow.

The correlation between composite low-blow tests and H-plate behavior in the Ni-Cr armor was less apparent since the firing records indicated extensive "fusion-zone" cracking. The low-blow results in Figure 14 indicated notch sensitivity in weld metal at -40° to -60°C . However, in Figure 11 the most notch-sensitive structures included heat-affected base metal contiguous to the fusion line. These results appear consistent with the H-plate performance although the degree of correlation is indeterminate without extensive study of H-plate cracking to determine location of initiation and propagation.

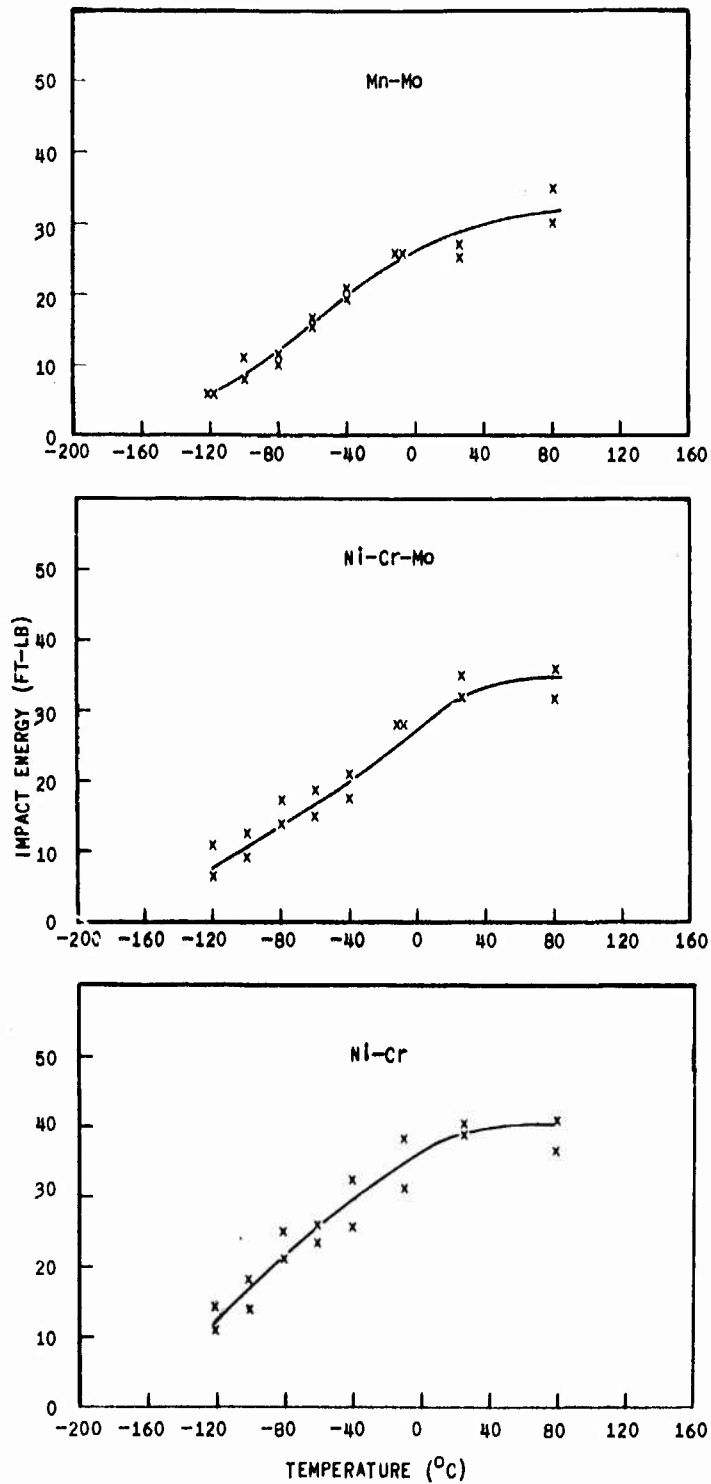
FIGURE 1A: IMPACT-ENERGY TRANSITION CURVES FOR COMPOSITE SPECIMENS OF WELDS IN THE H-PLATE ARMORS.

*Because impact energy values are not directly useful in determining relative notch toughness of weld and heat-affected base metal, the composite energy-temperature transition curves, obtained as a matter of course during fracture of the test specimens, have been appended for possible reference (see Figure 1A).
