EXPERIMENTAL REPORT

NO. WAL-311/5

CAST STEEL

Lustrous Cavities in Steel Cast in Stationary Molds

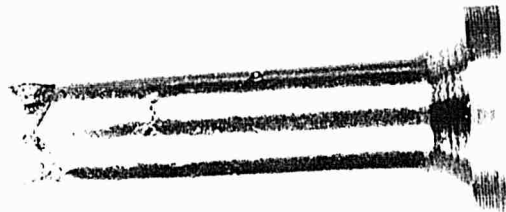
TYPE OF TENSILE BAR FRACTURES

#1 - LARGE LUSTROUS CAVITIES. #2 - LUSTROUS CAVITIES. #3 SMALL LUSTROUS CAVITIES.
#4 - NO LUSTROUS CAVITIES. MAG. X 2 19 MAY 1944 WTN.223-4741

Figure 1 shows typical tensile bar fractures found in the heat-treated test bars. They are classified visually as having (1) large lustrous cavities, (2) lustrous cavities, (3) small lustrous cavities, and (4) no lustrous cavities.

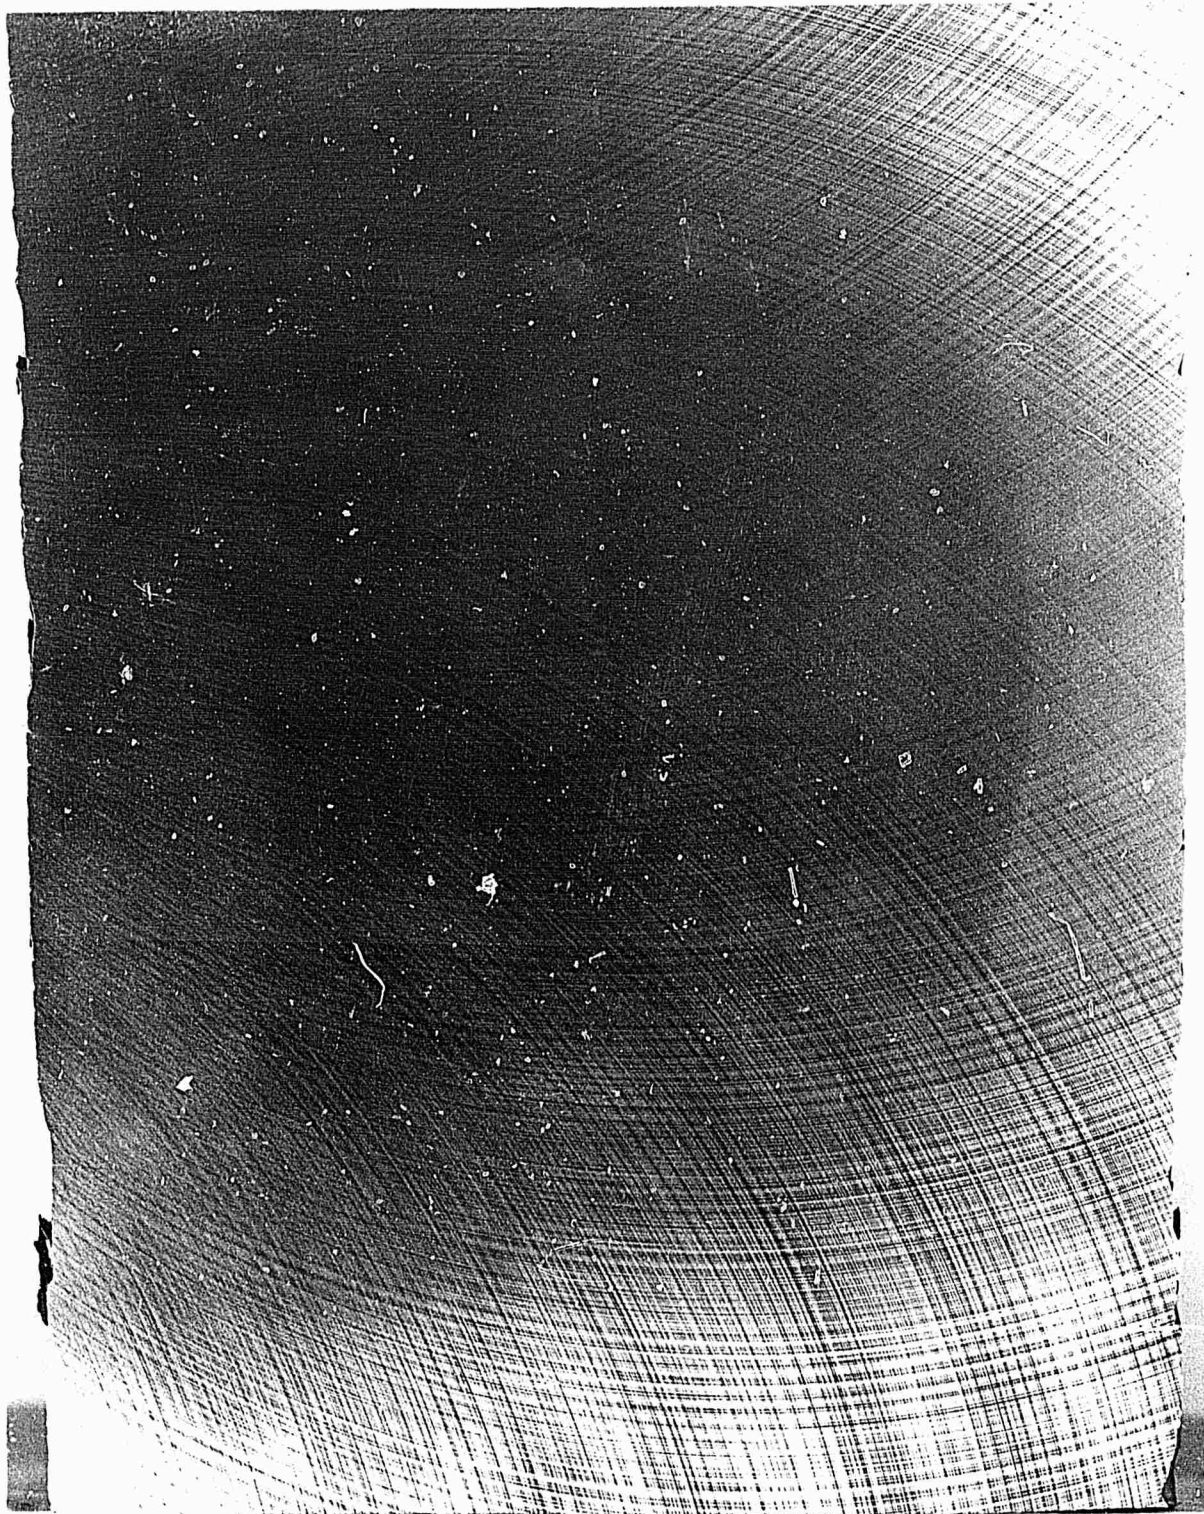
UNETCHED LONGITUDINAL VIEW OF TOP AND MIDDLE SECTIONS HEAT X-1345
8"X8"X27" INGOT SPLIT ALONG CENTER LINE. W.A. GUN COMPOSITION.
"AS CAST" 19 MAY 1944 WTN.223-4740

Figure 2 shows an unetched longitudinal view of the top and middle sections (top 18" of total 27" length) of the ingot split along the center-line. This figure shows the extent of the shrinkage cavity.

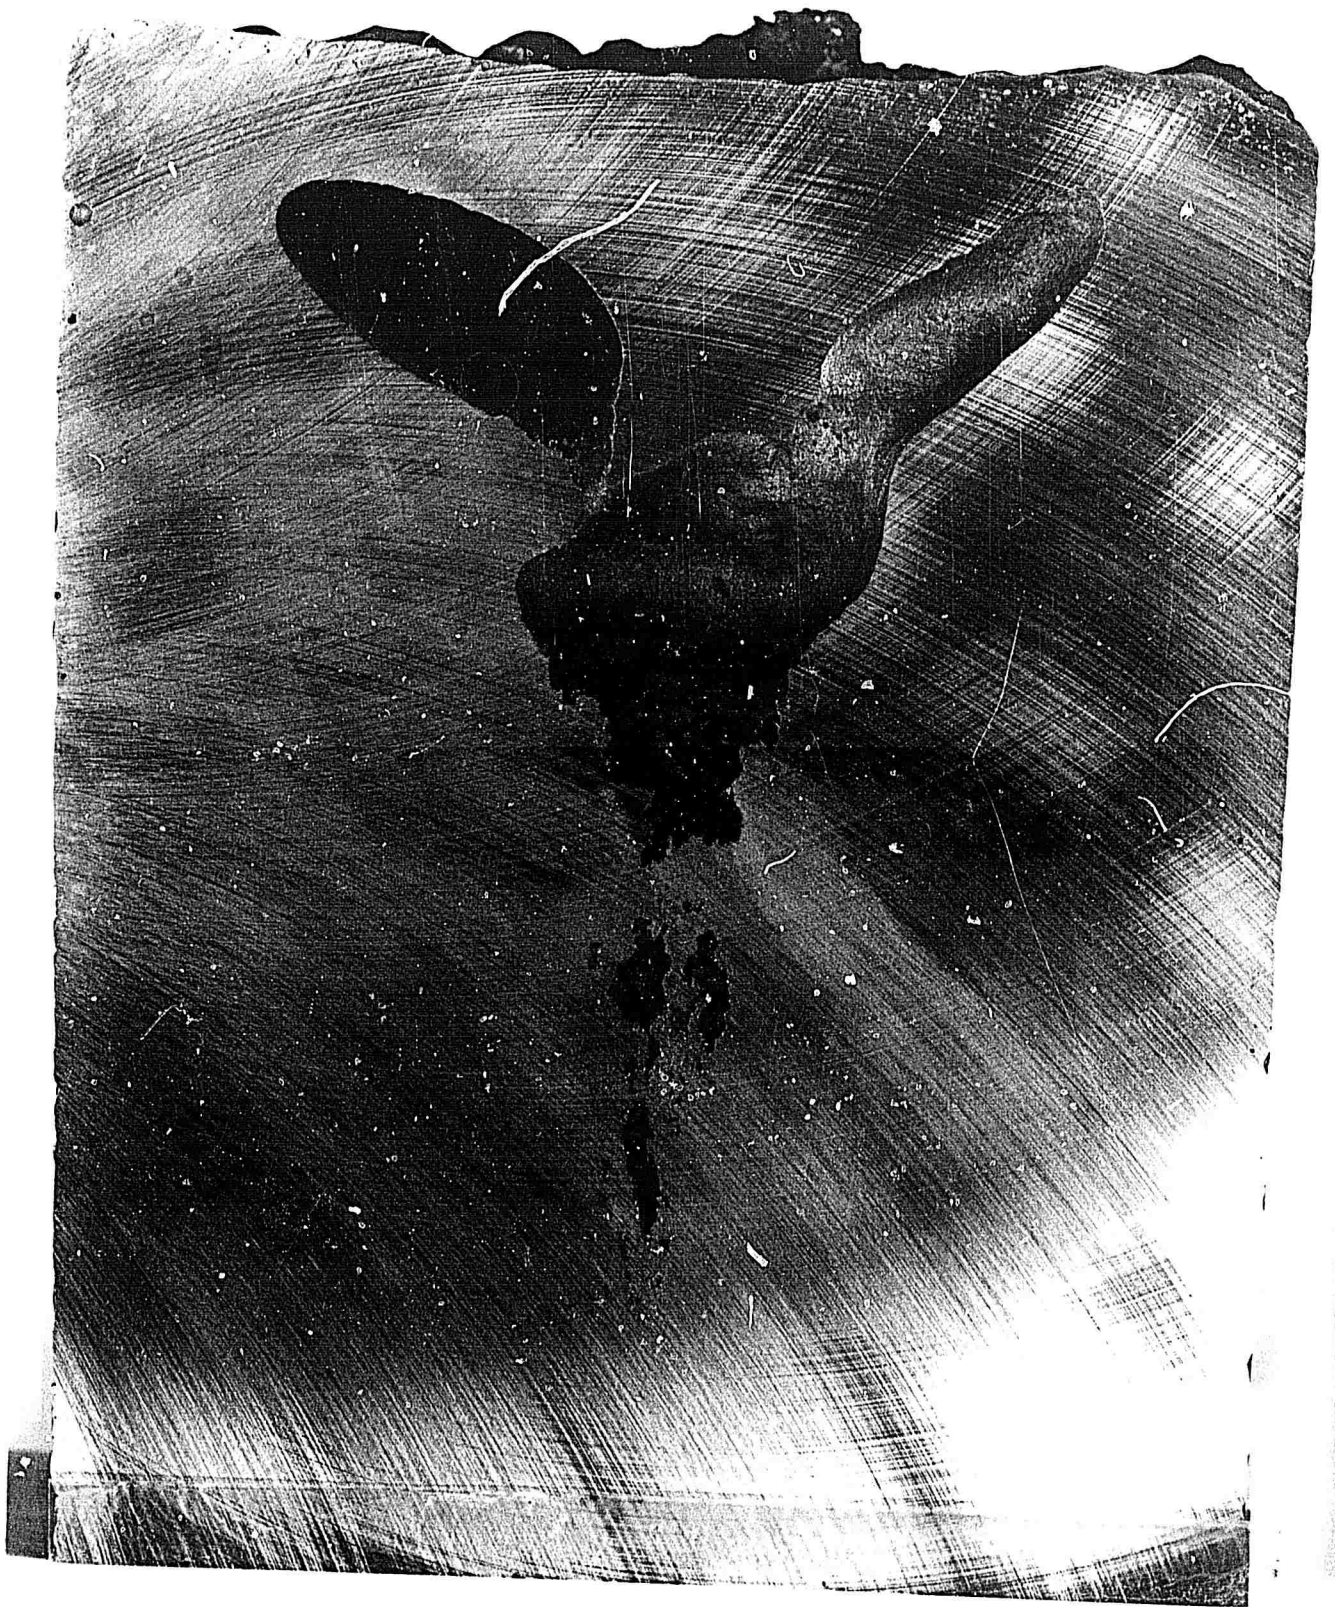
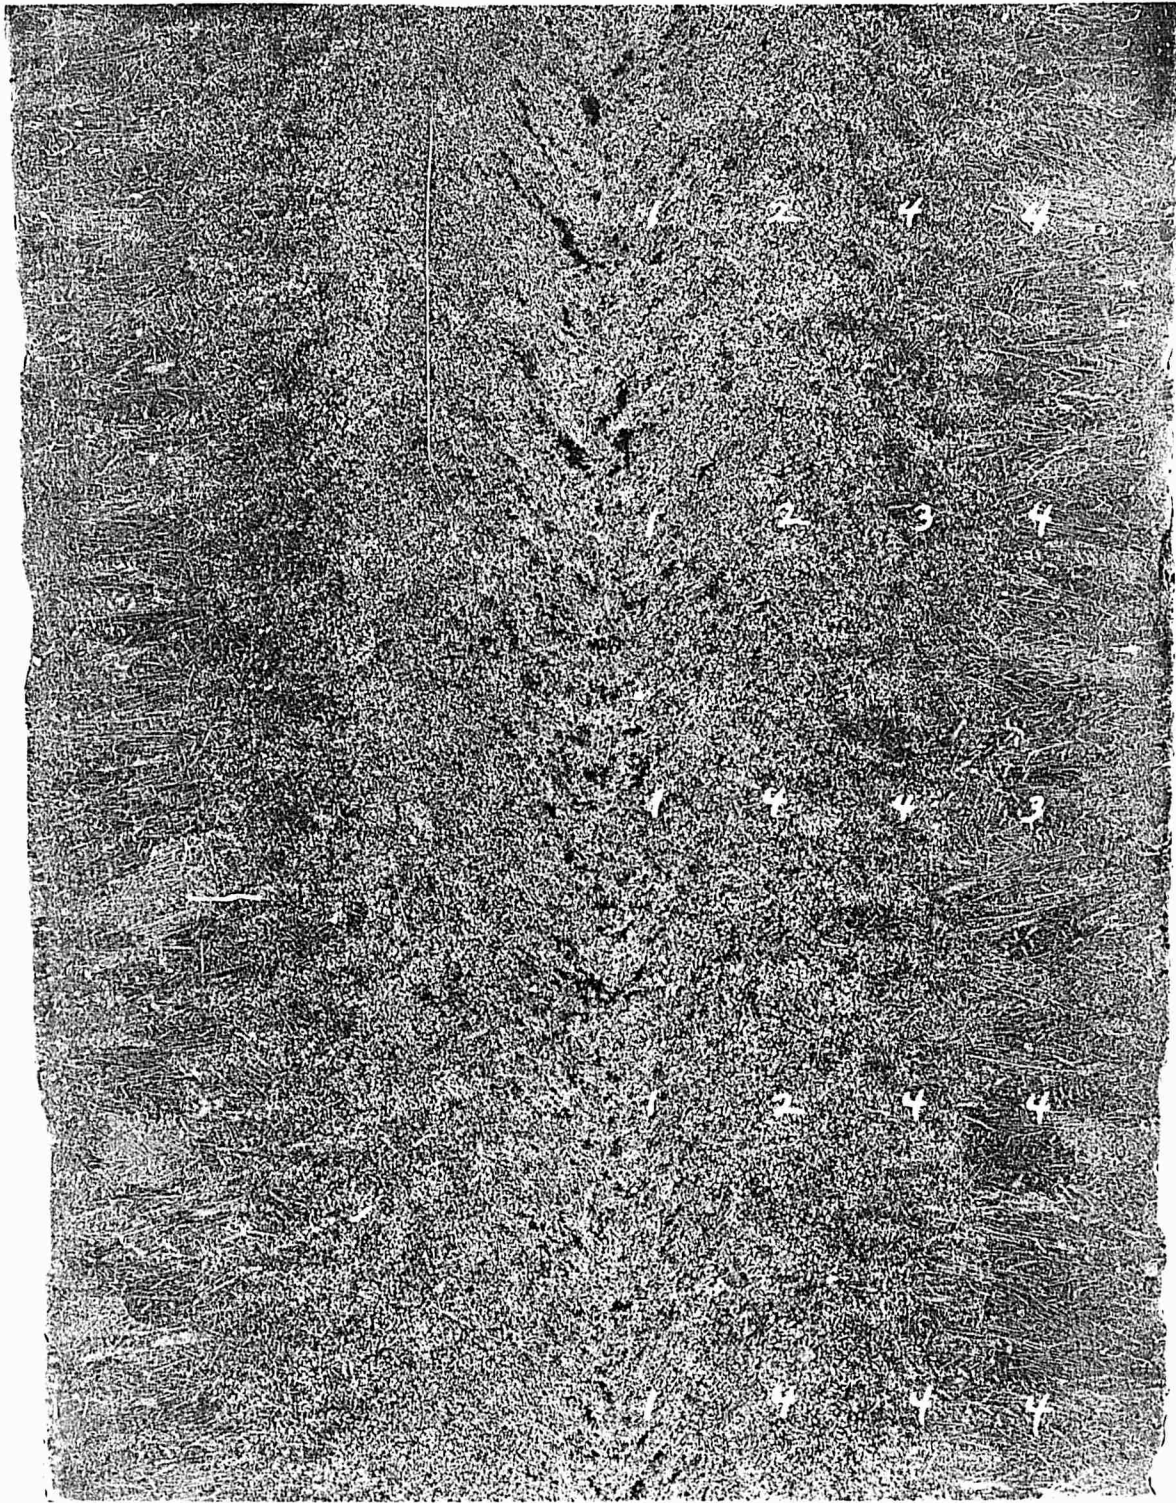
Fig 3

MACROETCHED LONGITUDINAL VIEW OF TOP AND MIDDLE SECTIONS HEAT X-1345, 8" x 8" x 27" INGOT SPLIT ALONG CENTER LINE. W.A. GUN COMPOSITION. "AS CAST". FIGURES SHOW LOCATION AND TYPE OF TENSILE BAR FRACTURES AS FOLLOWS; (1) LARGE LUSTROUS CAVITY (2) LUSTROUS CAVITIES. (3) SMALL LUSTROUS CAVITIES. (4) NO LUSTROUS CAVITIES.
5 MAY 1944 WTN.223-4676&7

Figure 3 shows a macroetched longitudinal view of the top and middle sections of the ingot. Superimposed on this photograph at the proper locations are the code numbers for the type of fractures obtained in the tensile test bars from the several locations. Figures 4 to 8 show the macroetched views of the transverse discs with the type of tensile test bar fractures again superimposed at their various locations. It is apparent from these figures that the greater the segregation as revealed by macroetch, the more pronounced the lustrous cavity condition in the tensile test bar fractures. Any exceptions to this correlation can be explained by the fact that the centers of the physical test bars were of necessity a small distance, probably $3/8"$, away from the macroetched faces photographed. It would appear that the lustrous cavity condition is associated with segregation, either metallic or nonmetallic, or minute voids which impart a spongy appearance to the macroetched surfaces.

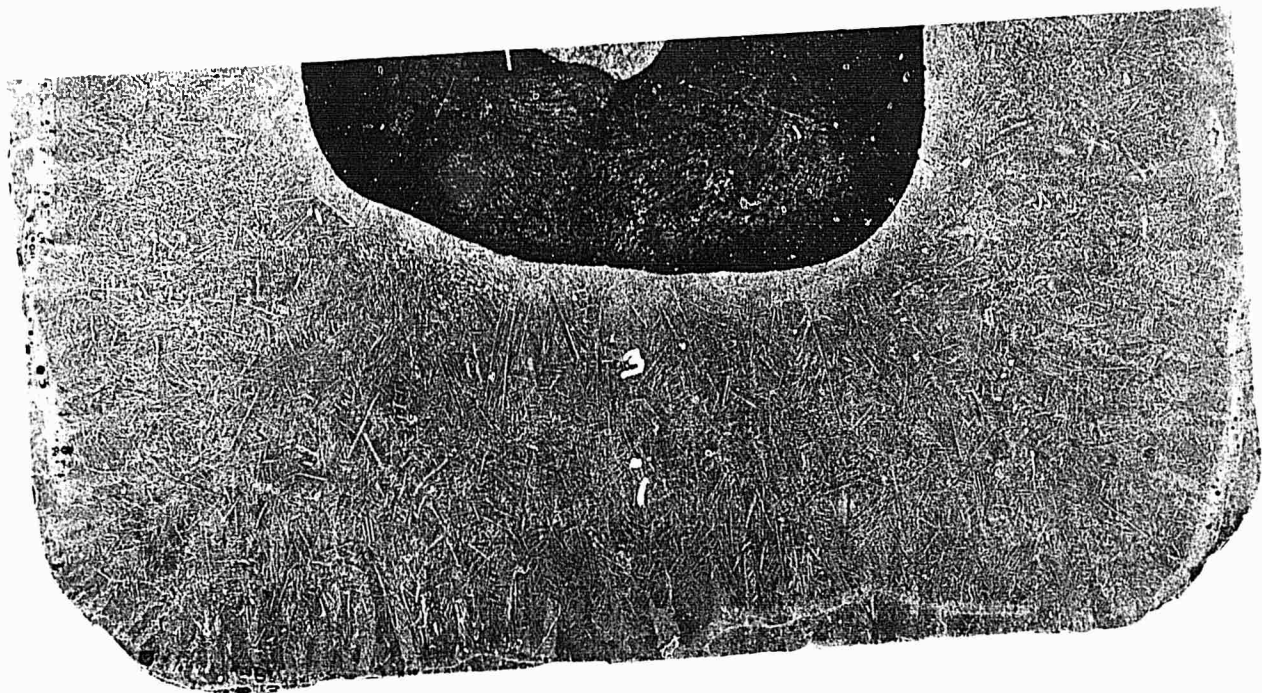
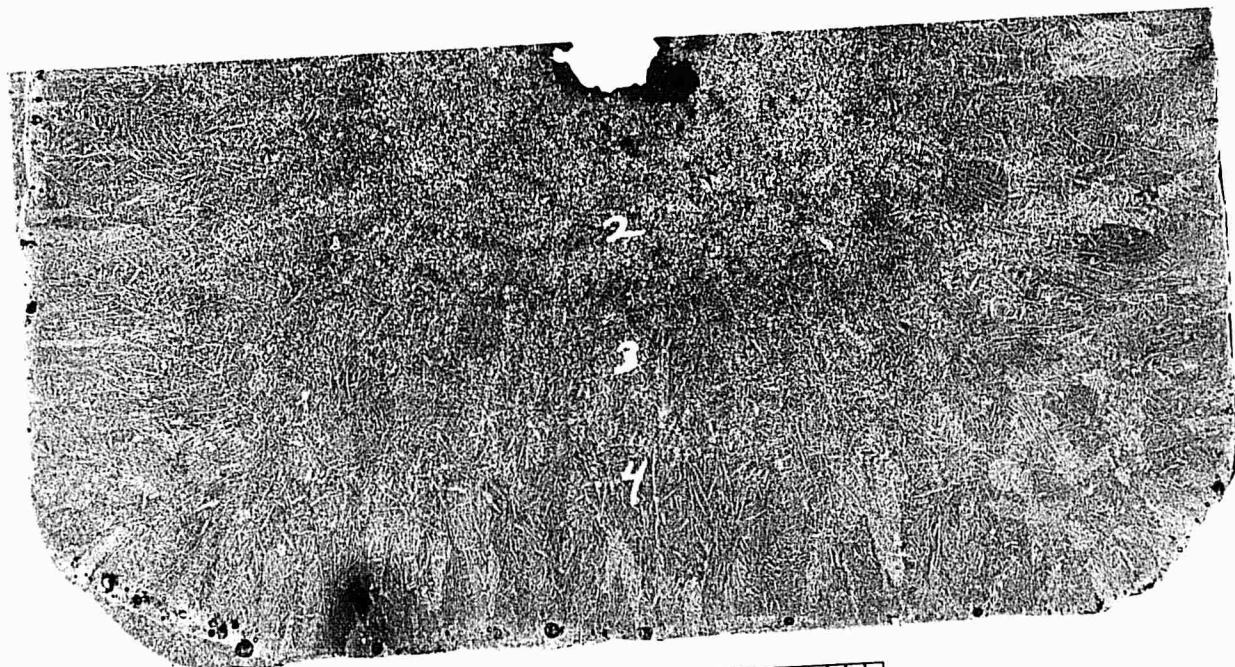
MACROETCHED VIEW OF HALF CROSS SECTIONS 2" (UPPER) AND 5" (LOWER) BELOW TOP OF 6"x8"x27" INGOT. HEAT X-1345. W.A. GUN COMPOSITION. "AS CAST". FIGURES SHOW LOCATION AND TYPE OF TENSILE BAR FRACTURES AS FOLLOWS: (1) LARGE LUSTROUS CAVITIES. (2) LUSTROUS CAVITIES (3) SMALL LUSTROUS CAVITIES. (4) NO LUSTROUS CAVITIES. 5 MAY 1944 WTN.223-4678&9

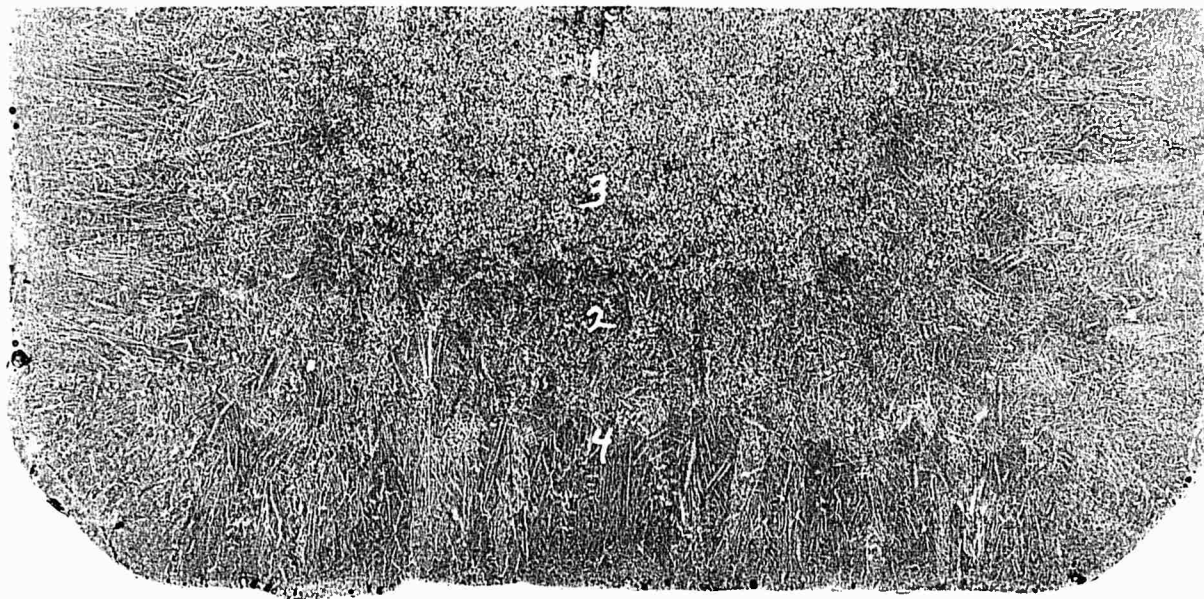
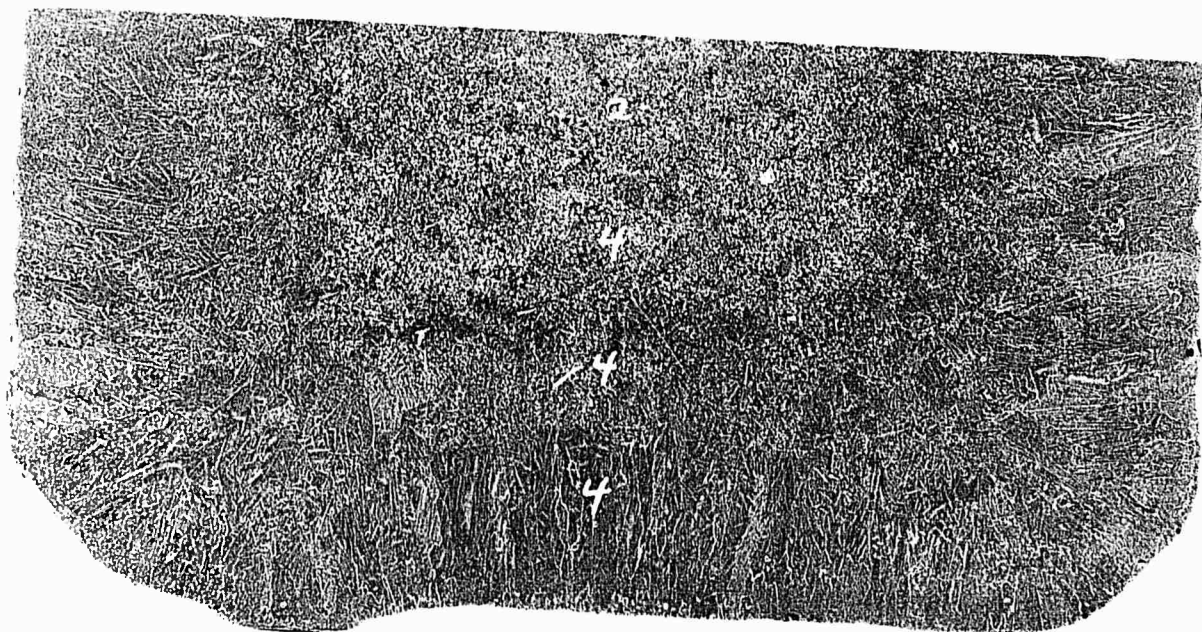
MACROETCHED VIEW OF HALF CROSS SECTIONS 6½" (UPPER) AND 8" (LOWER) BELOW TOP OF 8"X8"X27" INGOT. HEAT X-1345. W.A. GUN COMPOSITION. "AS CAST". FIGURES SHOW LOCATION AND TYPE OF TENSILE BAR FRACTURES AS FOLLOWS: (1) LARGE LUSTROUS CAVITIES. (2) LUSTROUS CAVITIES (3) SMALL LUSTROUS CAVITIES. (4) NO LUSTROUS CAVITIES. 5 MAY 1944 WTN.223-4680&1

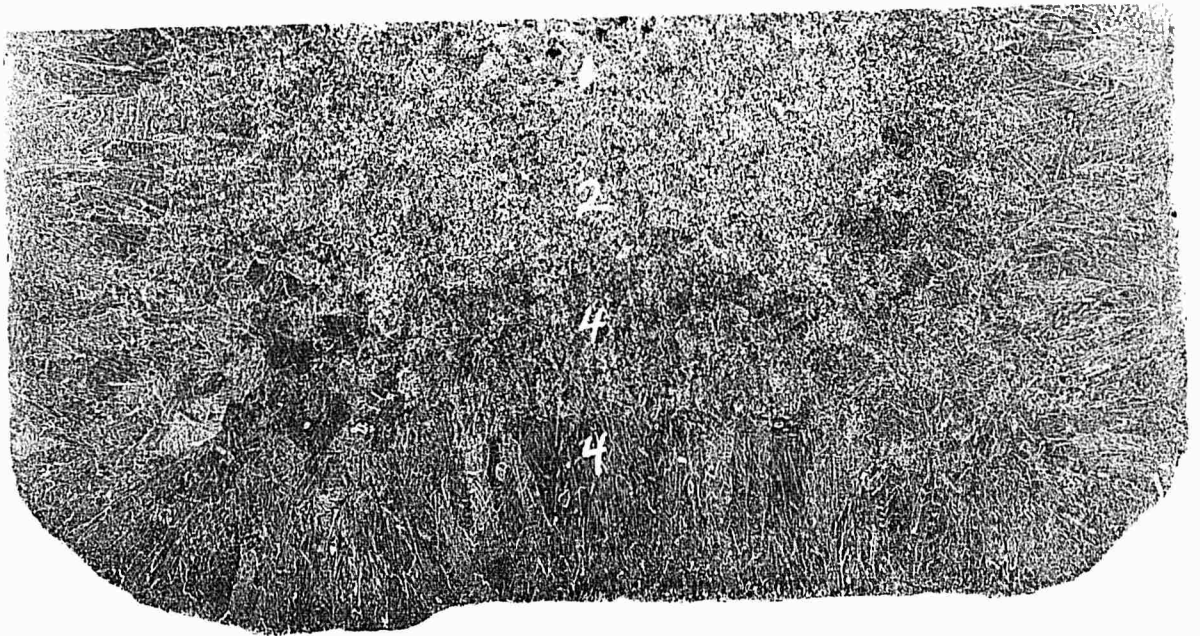
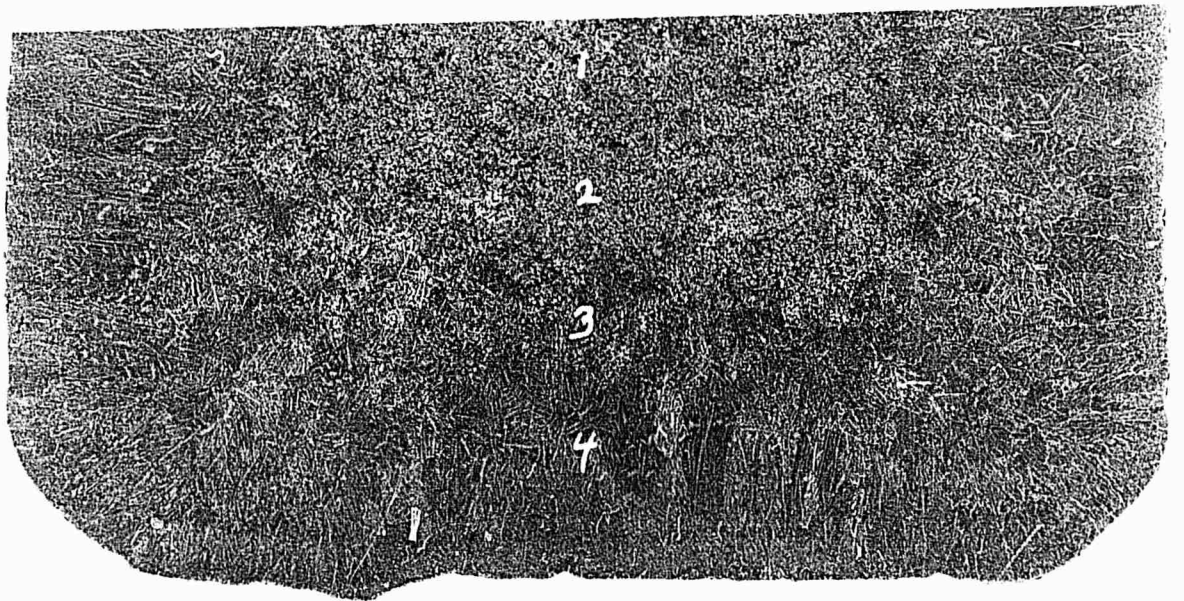
Fig 6

MACROETCHED VIEW OF HALF CROSS SECTIONS 10" (UPPER) AND 12" (LOWER) BELOW TOP 8"x8"x27" INGOT. HEAT X-1345, W.A. GUN COMPOSITION, "AS CAST". FIGURES SHOW LOCATION AND TYPE OF TENSILE BAR FRACTURES AS FOLLOWS: (1) LARGE LUSTROUS CAVITIES. (2) LUSTROUS CAVITIES (3) SMALL LUSTROUS CAVITIES. (4) NO LUSTROUS CAVITIES. 5 MAY 1944 WTN.223-4682&3

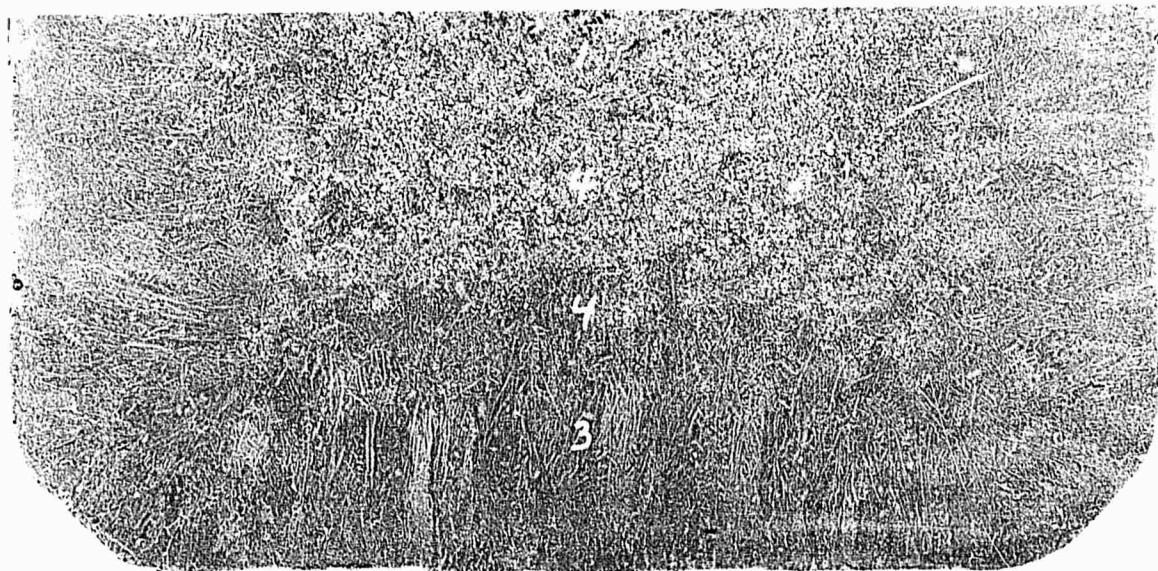
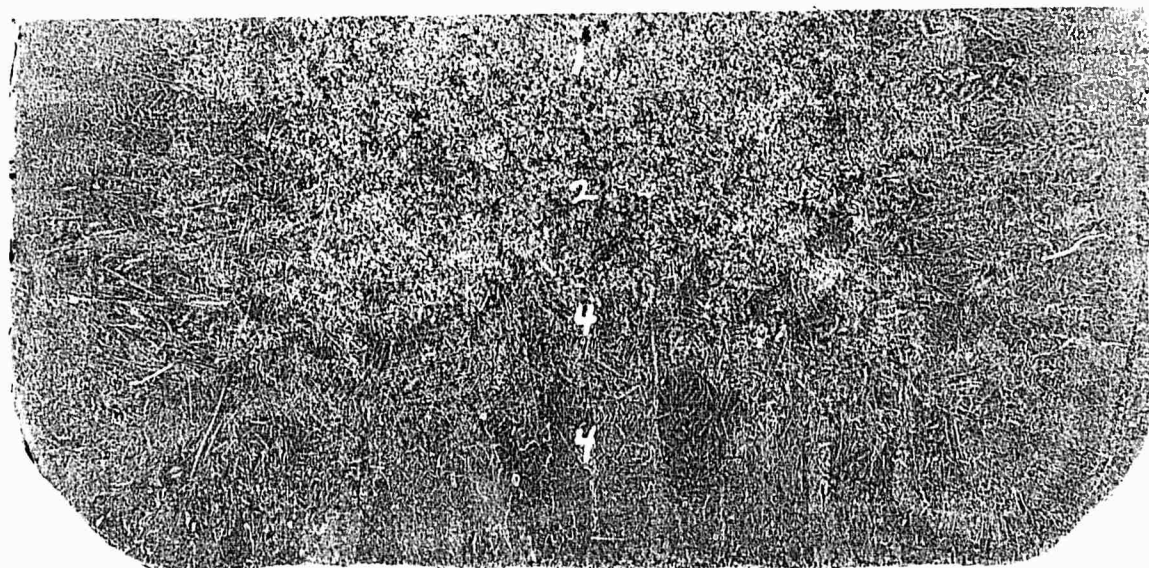
MACROETCHED VIEW OF HALF CROSS SECTIONS 13 $\frac{1}{4}$ " (UPPER) AND 15" (LOWER) BELOW TOP 8"x8"x27" INGOT. HEAT X-1345. W.A. GUN COMPOSITION. "AS CAST". FIGURES SHOW LOCATION AND TYPE OF TENSILE BAR FRACTURES AS FOLLOWS: (1) LARGE LUSTROUS CAVITIES. (2) LUSTROUS CAVITIES (3) SMALL LUSTROUS CAVITIES. (4) NO LUSTROUS CAVITIES. 5 MAY 1944 WTN.223-4684&5

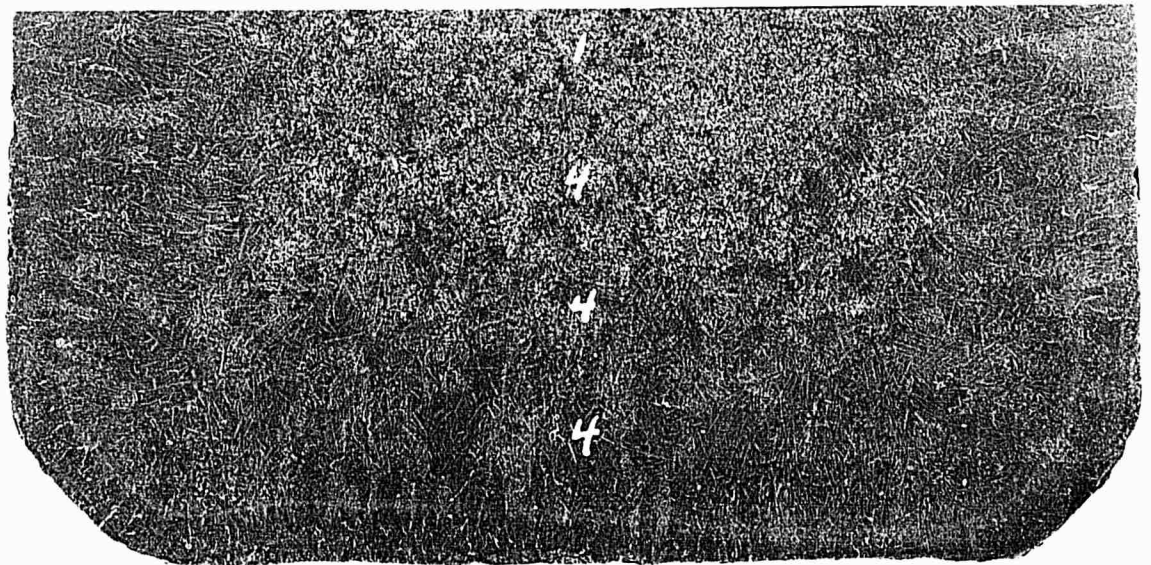
MACROETCHED VIEW OF HALF CROSS SECTION 17" BELOW TOP 8"x8"x27" INGOT, HEAT X-1345, W.A. GUN COMPOSITION, "AS CAST". FIGURES SHOW LOCATION AND TYPE OF TENSILE BAR FRACTURES AS FOLLOWS: (1) LARGE LUSTROUS CAVITIES. (2) LUSTROUS CAVITIES. (3) SMALL LUSTROUS CAVITIES (4) NO LUSTROUS CAVITIES.

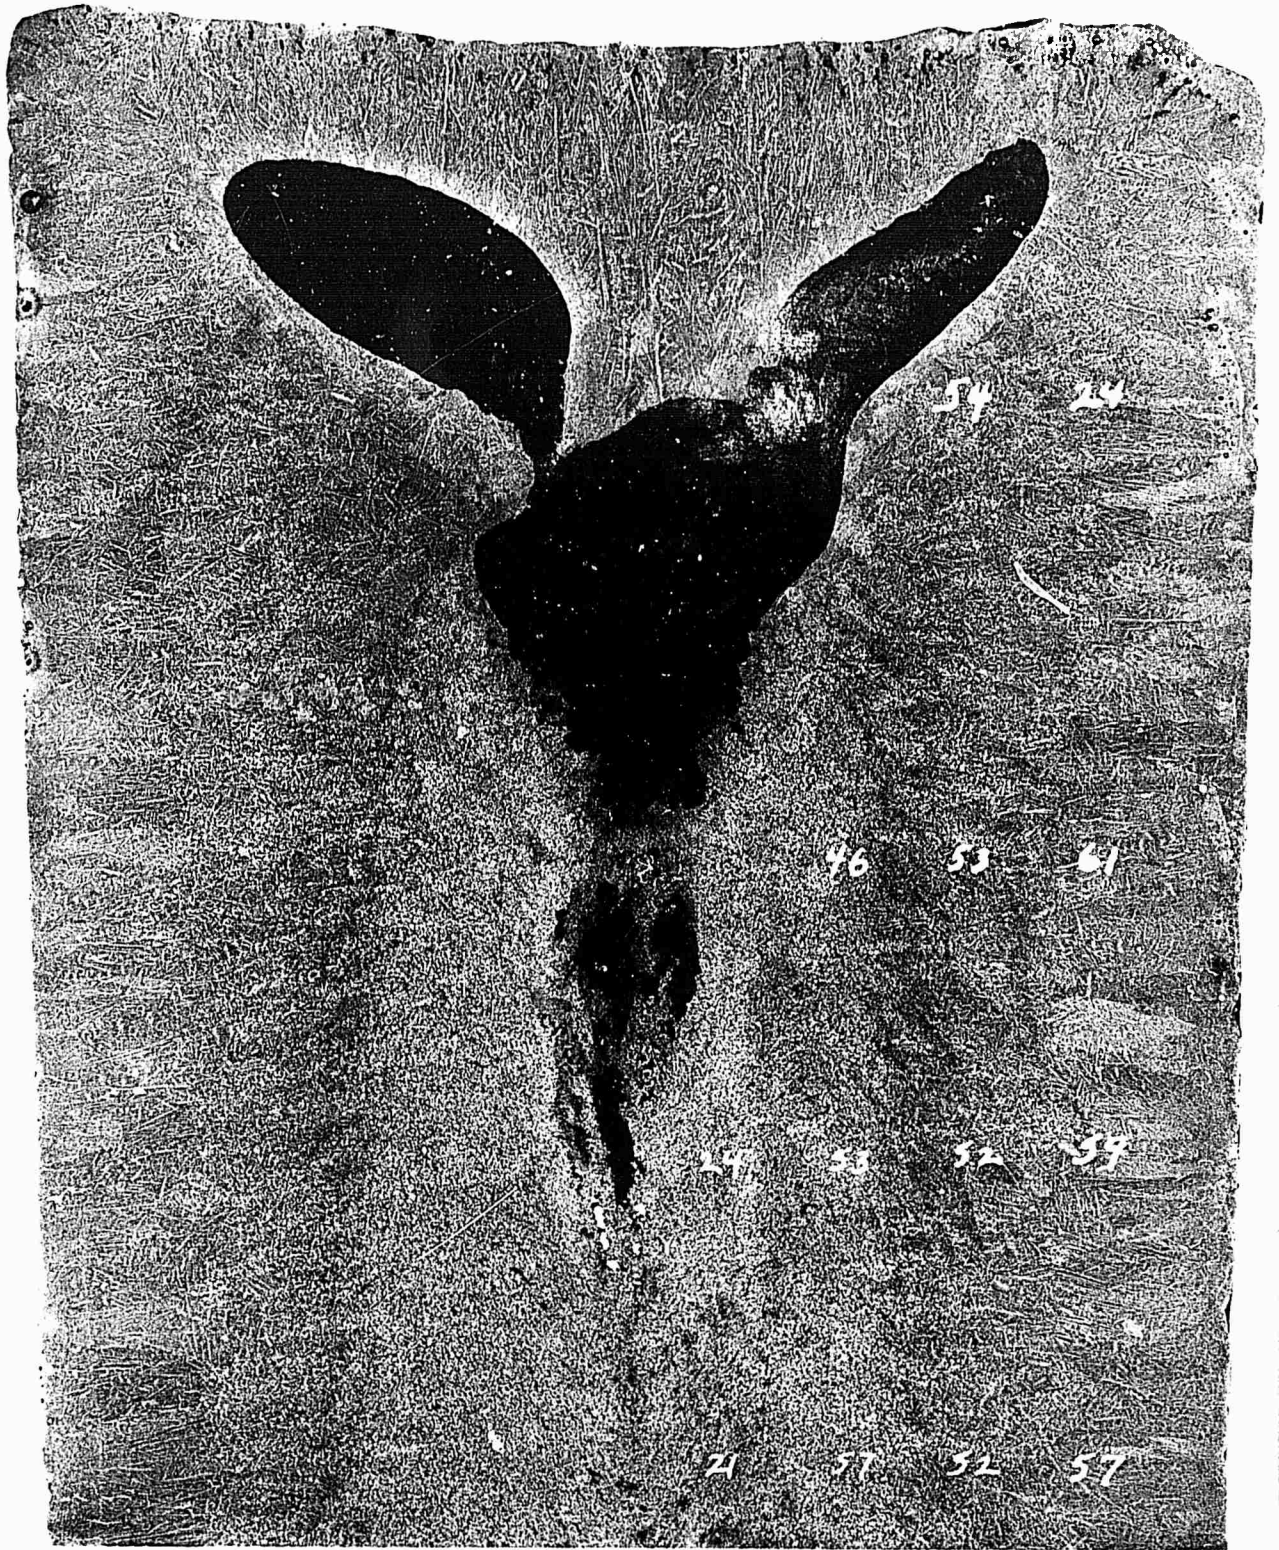
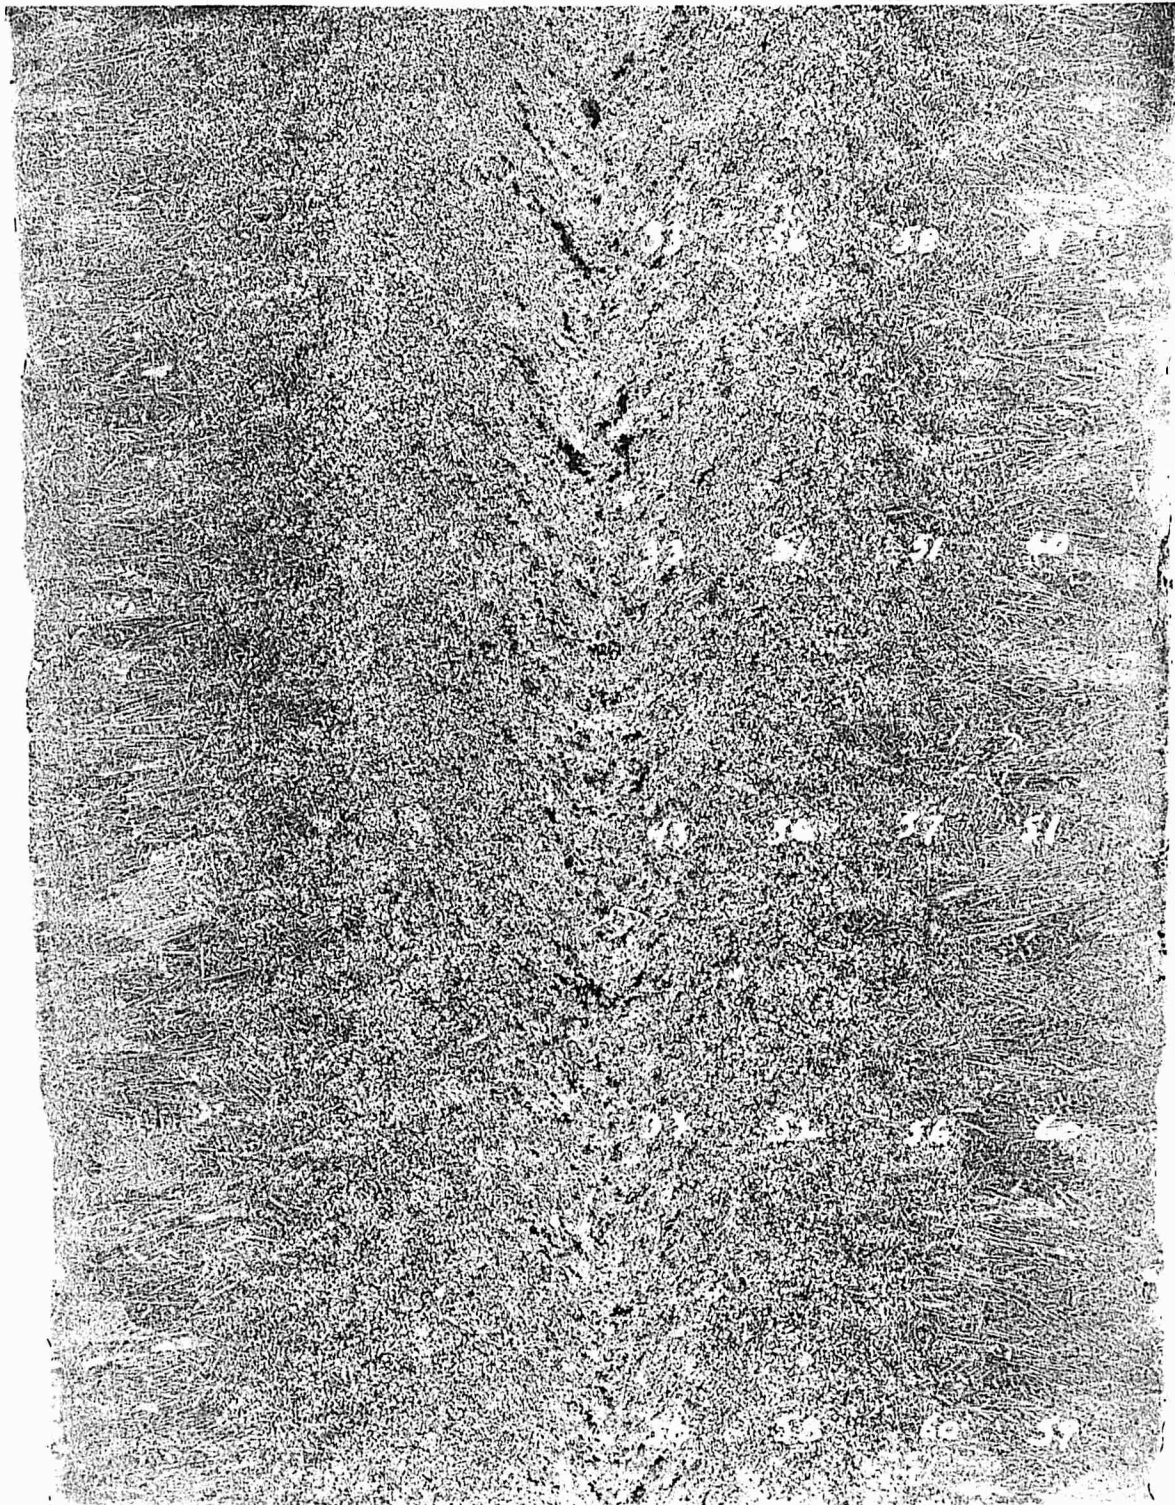
MACROETCHED LONGITUDINAL VIEW OF TOP AND MIDDLE SECTIONS HEAT X-1345, 8" X 8" X 27"
INGOT SPLIT ALONG CENTER LINE. W.A. GUN COMPOSITION. "AS CAST". FIGURES SHOW
LOCATION OF TENSILE BAR TESTS AND THEIR PERCENT REDUCTION IN AREA. WTN.223-4676&7

The reduction of area figure has been sometimes used as an index of lustrous cavities. Figures 9 to 14 are the same as Figures 3 to 8, respectively, except that the reduction in area values are substituted for the type of fracture code numbers. In this case the average reduction of area for each type fracture is as follows:

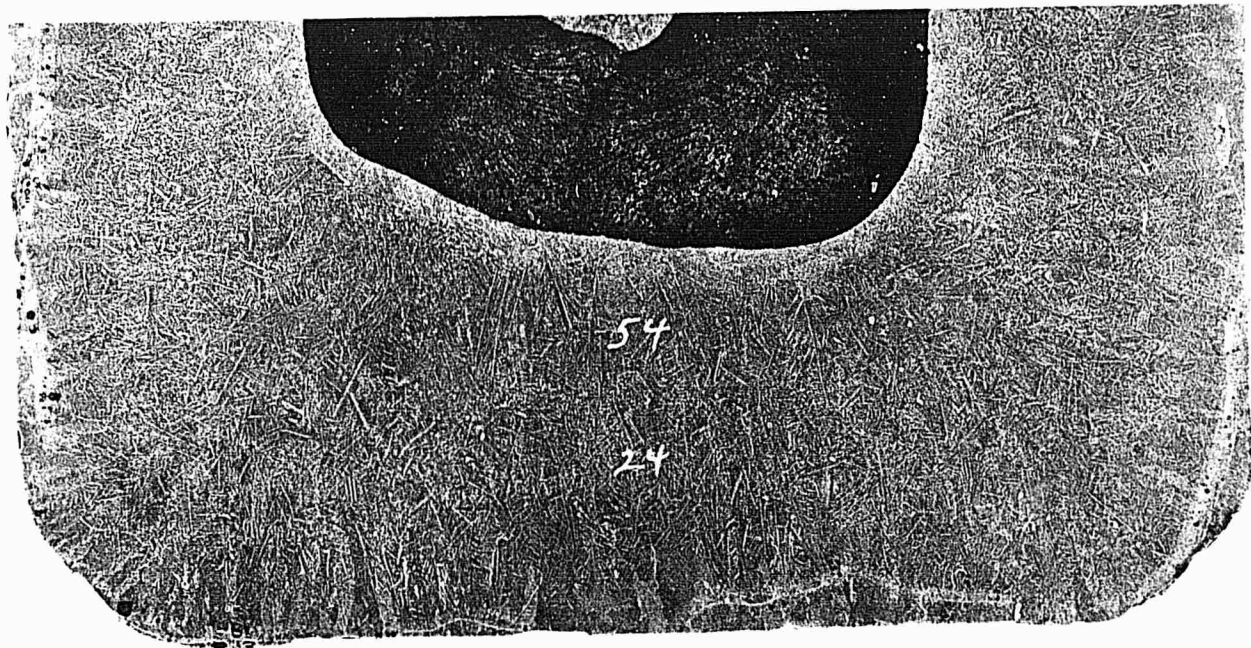
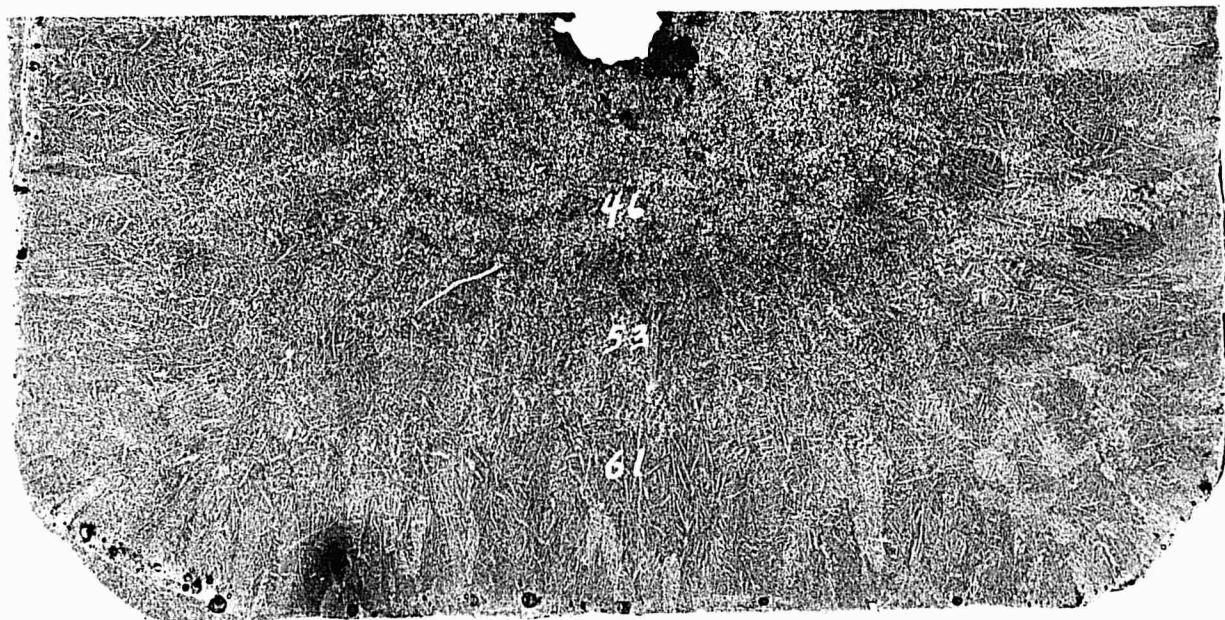
MACROETCHED VIEW OF HALF CROSS SECTIONS 2" (UPPER) AND 5" (LOWER) BELOW TOP OF 8"x8"x27"
INGOT. HEAT X-1345. W.A. GUN COMPOSITION. "AS CAST". FIGURES SHOW LOCATION OF TENSILE
BAR TESTS AND THEIR PERCENT REDUCTION IN AREA VALUES. 5 MAY 1944 WTN.223-4678&9

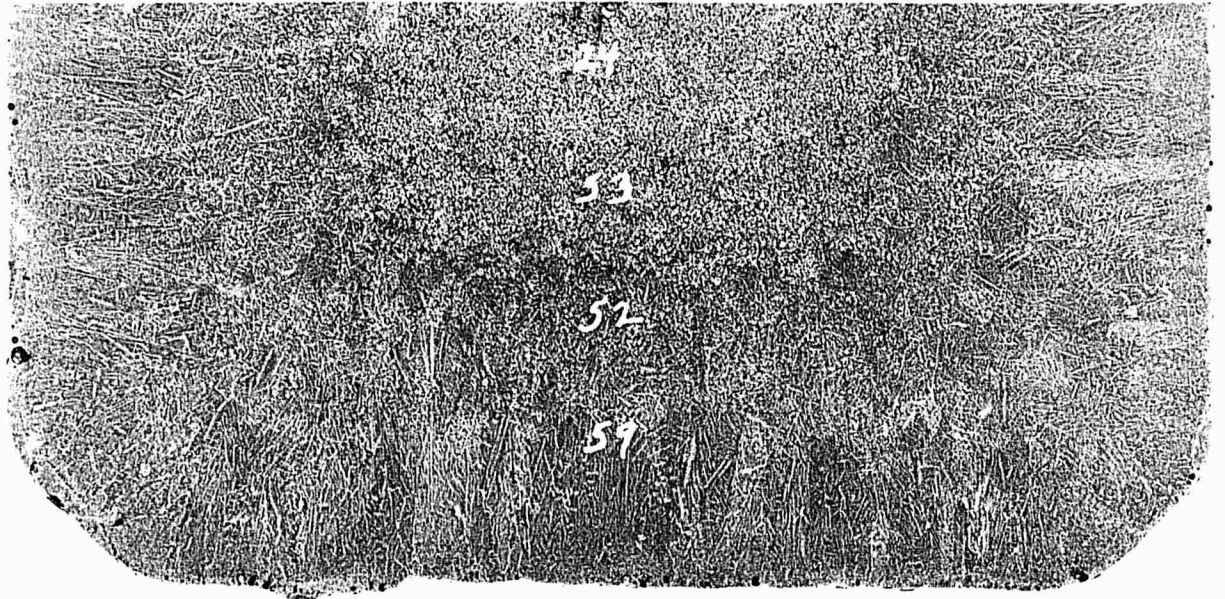
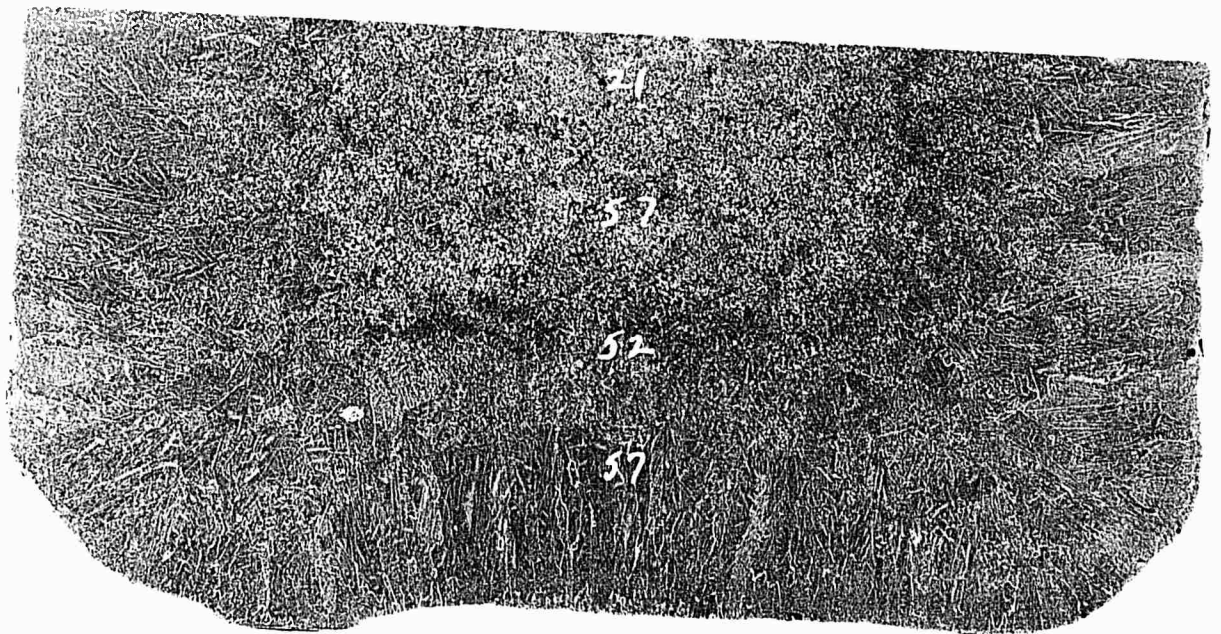
MACROETCHED VIEW OF HALF CROSS SECTIONS $6\frac{1}{2}$ " (TOP) AND 8" (LOWER) BELOW TOP OF 8"X8"X27" INGOT. HEAT X-1345. W.A. GUN COMPOSITION. "AS CAST". FIGURES SHOW LOCATION OF TENSILE BAR TESTS AND THEIR PERCENT REDUCTION IN AREA VALUES. 5 MAY 1944 WTN.223-4680&1

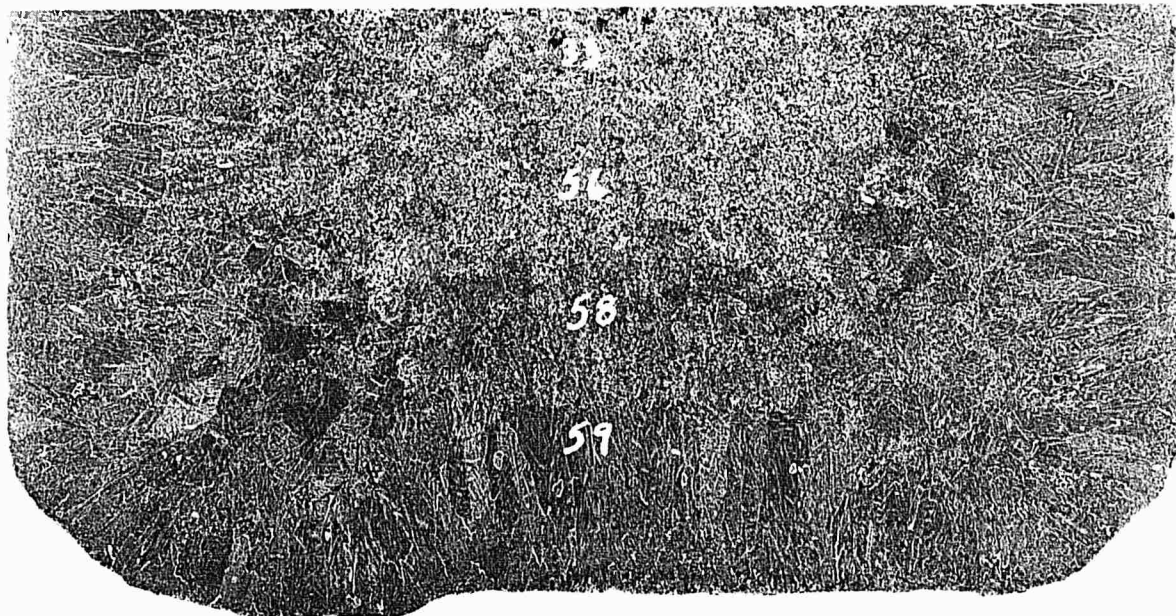
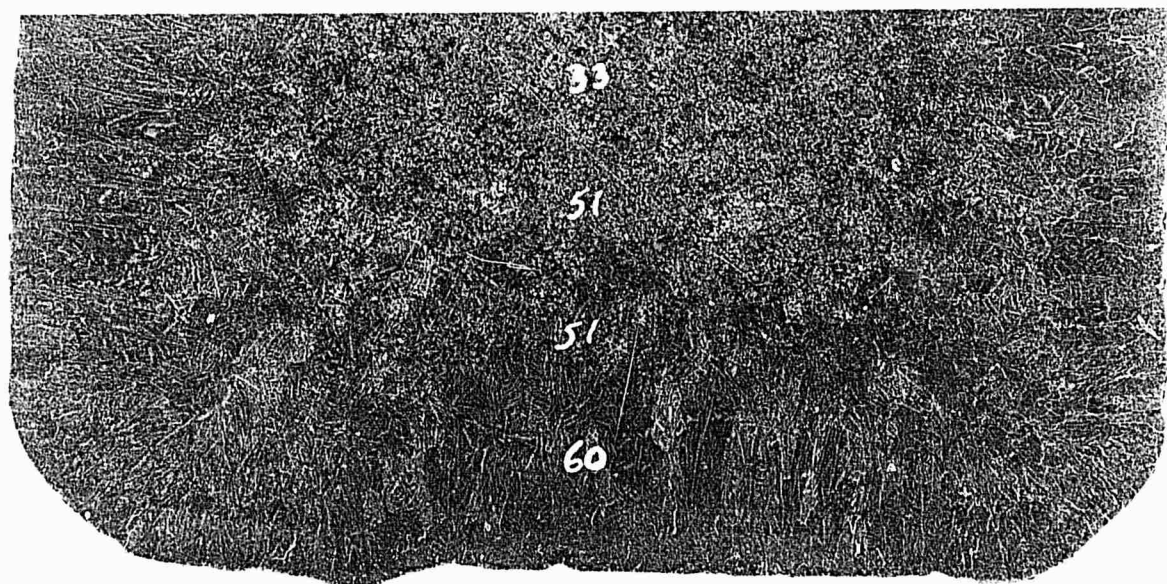
Fig 12

MACROETCHED VIEW OF HALF CROSS SECTIONS 10" (UPPER) AND 12" (LOWER) BELOW TOP 8"x8"x27" INGOT. HEAT X-1345. W.A. GUN COMPOSITION, "AS CAST". FIGURES SHOW LOCATION OF TENSILE BAR TESTS AND THEIR PERCENT REDUCTION IN AREA VALUES. 5 MAY 1944 WTN.223-4682&2
