EXPERIMENTAL REPORT

NO. WAL-311/5

CAST STEEL

Lustrous Cavities in Steel Cast in Stationary Molds

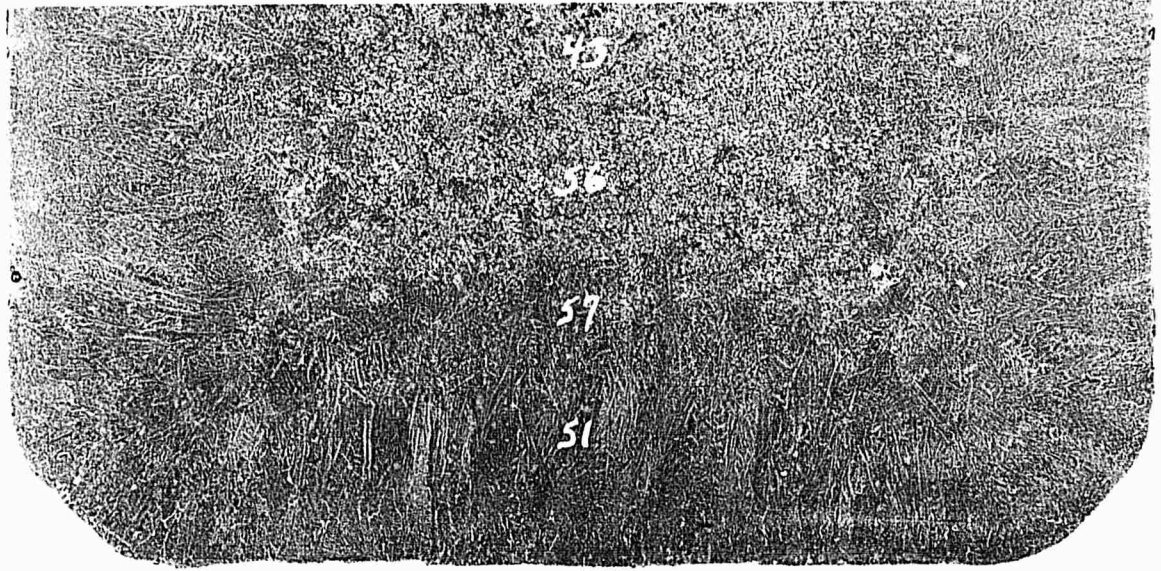
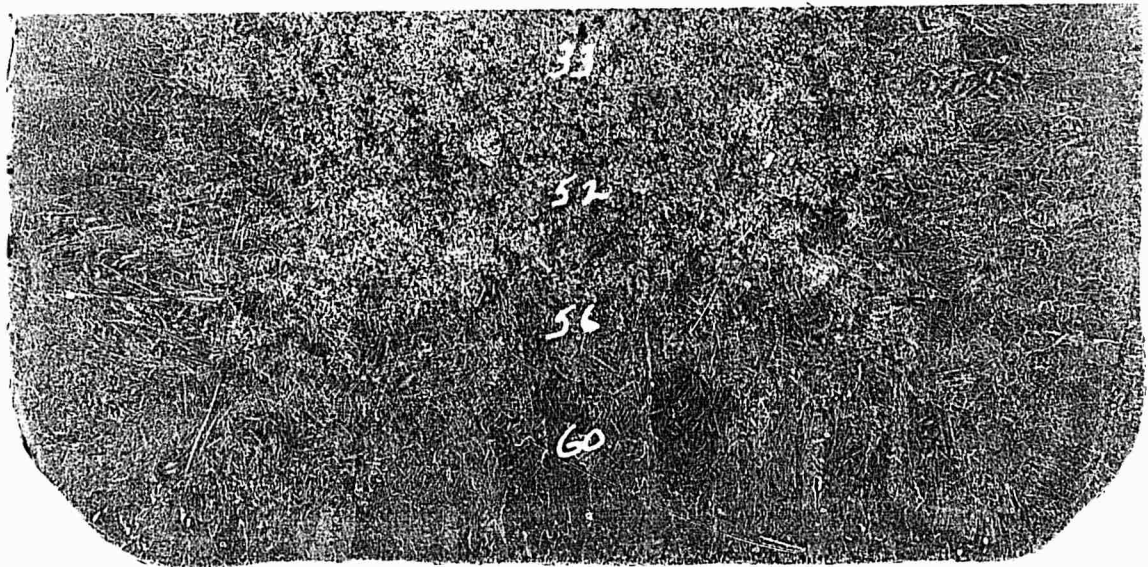
MACROETCHED VIEW OF HALF CROSS SECTIONS 13½" (UPPER) AND 15" (LOWER) BELOW TOP 8"x8"x27" INGOT. HEAT X-1345. W.A. GUN COMPOSITION, "AS CAST". FIGURES SHOW LOCATION OF TENSILE BAR TESTS AND THEIR PERCENT REDUCTION IN AREA VALUES. 5 MAY 1944 WTN.223-4684&5

The reduction of area figure has been sometimes used as an index of lustrous cavities. Figures 9 to 14 are the same as Figures 3 to 8, respectively, except that the reduction in area values are substituted for the type of fracture code numbers. In this case the average reduction of area for each type fracture is as follows:

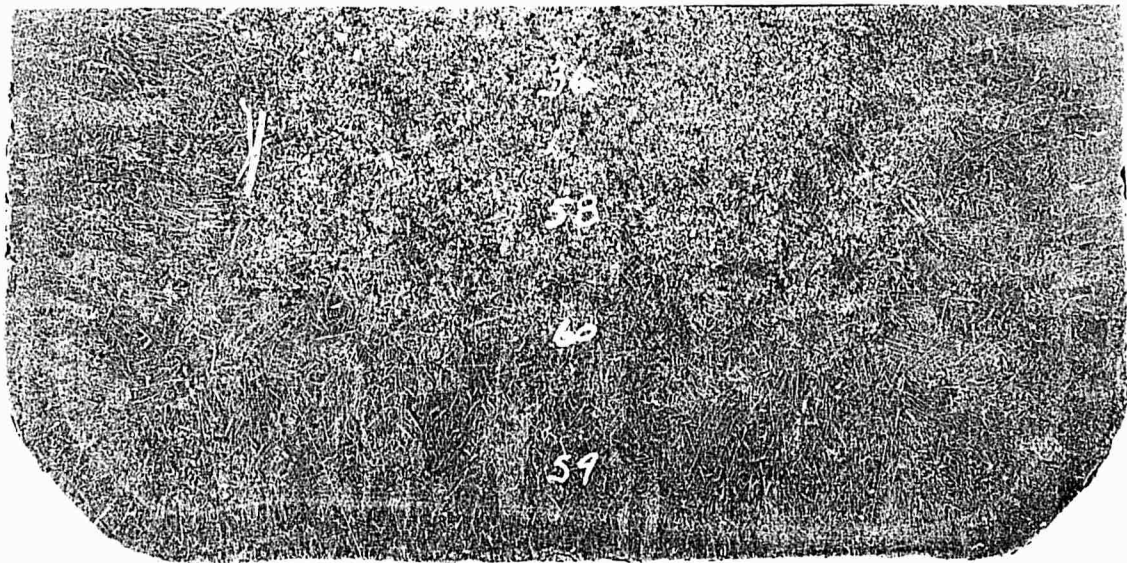
Fig 14

MACROETCHED VIEW OF HALF CROSS SECTION 17" BELOW TOP 8"x8"x27" INGOT. HEAT X-1345. W.A. GUN COMPOSITION. "AS CAST". FIGURES SHOW LOCATION OF TENSILE BAR TESTS AND THEIR PERCENT REDUCTION IN AREA VALUES. 5 MAY 1944 WTN.223-4686
