FLOOD PLAIN INFORMATION LITTLE TIMBER CREEK

CAMDEN COUNTY
NEW JERSEY

PREPARED FOR
CAMDEN COUNTY PLANNING BOARD
AND
NEW JERSEY DEPARTMENT OF CONSERVATION
AND ECONOMIC DEVELOPMENT
BY
CORPS OF ENGINEERS, U. S. ARMY
PHILADELPHIA DISTRICT
MARCH, 1969

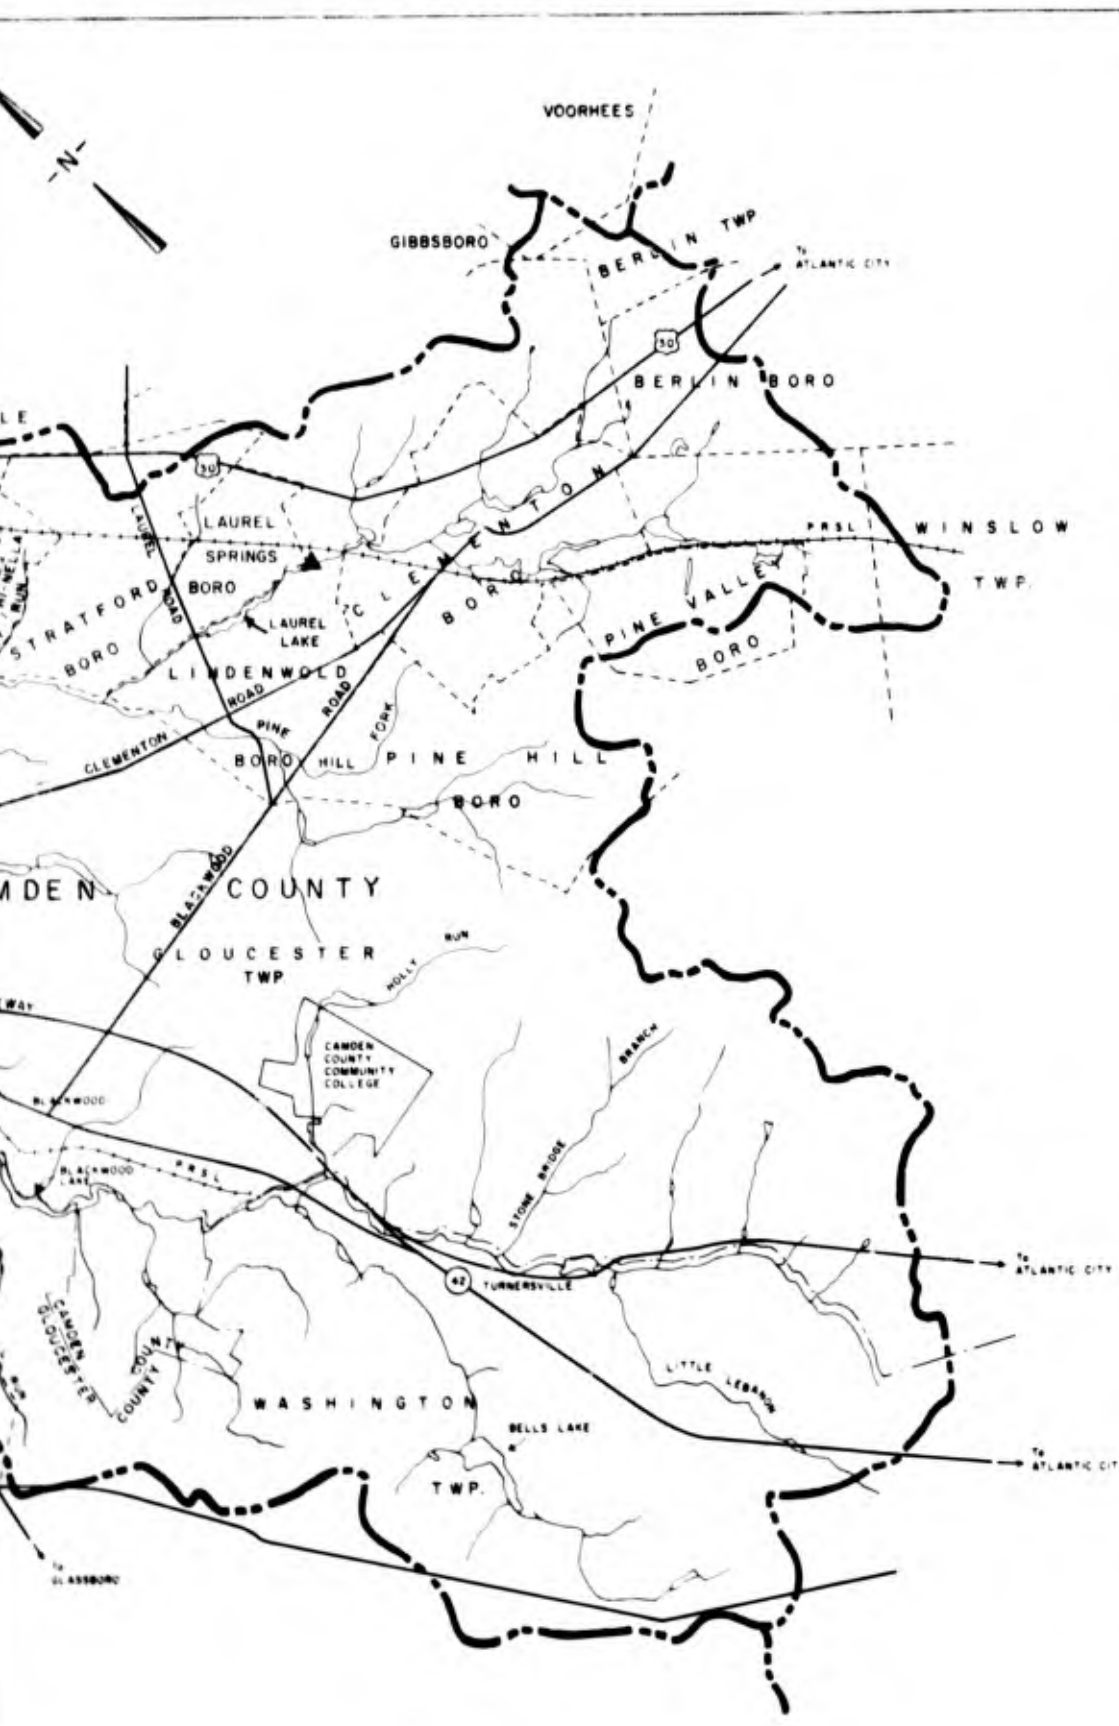
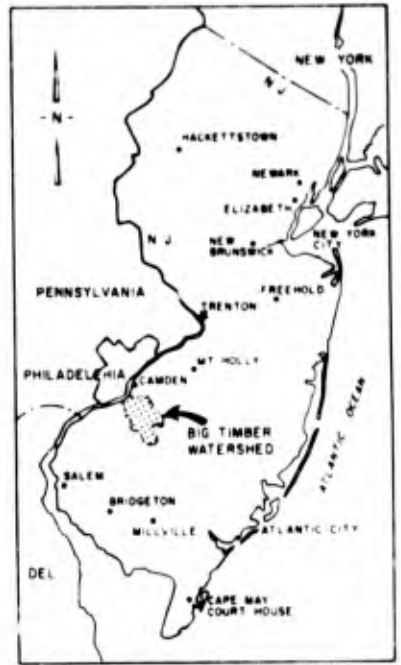
LOCATION MAP

REACH COVERED BY THIS REPORT

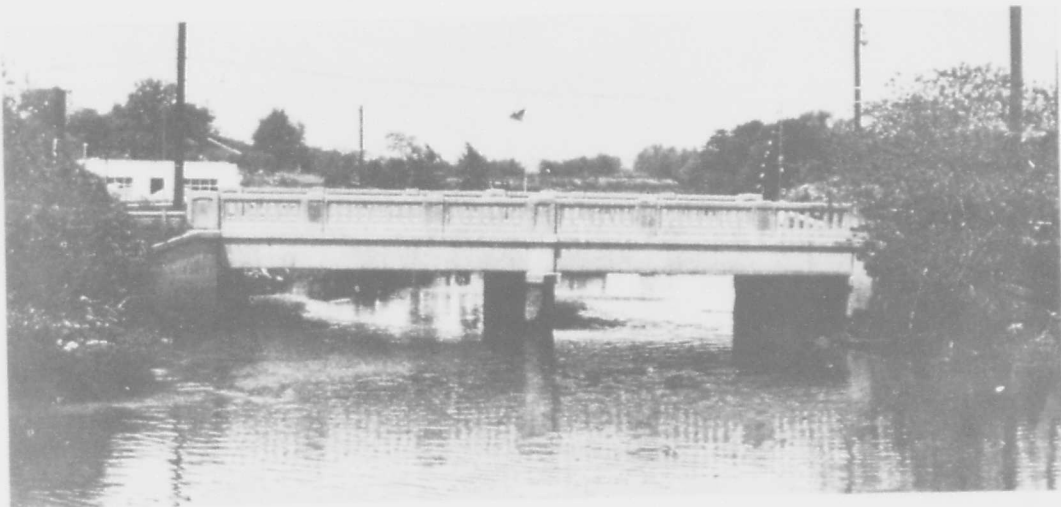
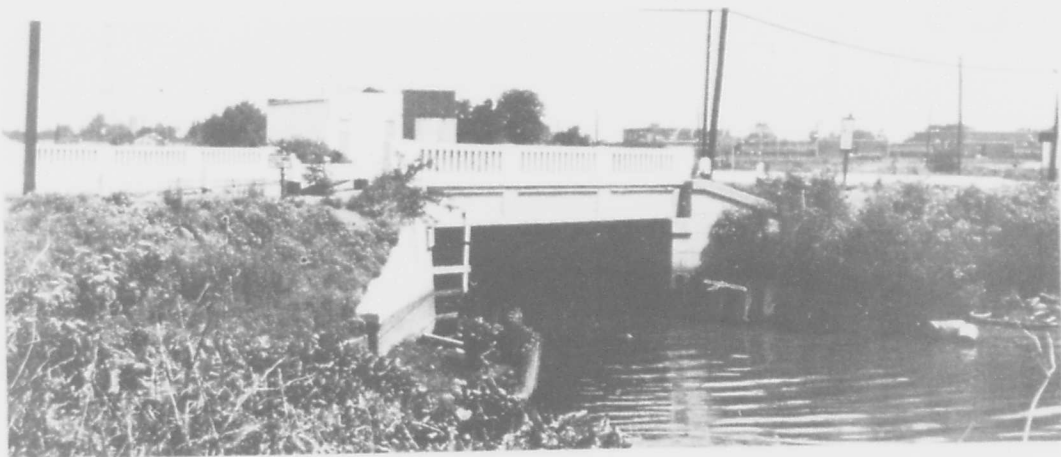
Figure 1.--LITTLE TIMBER CREEK BRIDGES

Upper view is upstream side of Broadway bridge. Middle view is upstream side of Crescent Boulevard bridge. Lower view is upstream side of Kings Highway bridge.

The Broadway bridge, located 5,100 feet above the mouth of Little Timber Creek, is a concrete structure with two 30 foot spans. Both the New Jersey Floodway and the New Jersey Flood Hazard Area Design Floods would be above the floor of the bridge, while the Standard Project Flood would completely cover the bridge. The head loss under all circumstances would be negligible.

Crescent Boulevard crosses the Creek about 8,000 feet above its mouth on a 42 foot single span concrete bridge. Only a flood on the order of the Standard Project Flood would rise above the roadway and head losses would be negligible under all conditions.

Kings Highway, crossing 1,500 feet further upstream, would, like Broadway, be flooded by both the New Jersey Floodway Design and New Jersey Flood Hazard Area Design Flood, and would be completely covered by the Standard Project Flood. The head losses under any of these conditions would be negligible.

The Broadway, Crescent Boulevard and Kings Highway bridges are shown in Figure 1. These three are the most significant bridges within the study limits since they are the only highway bridges that would be under water in the event of major flooding.

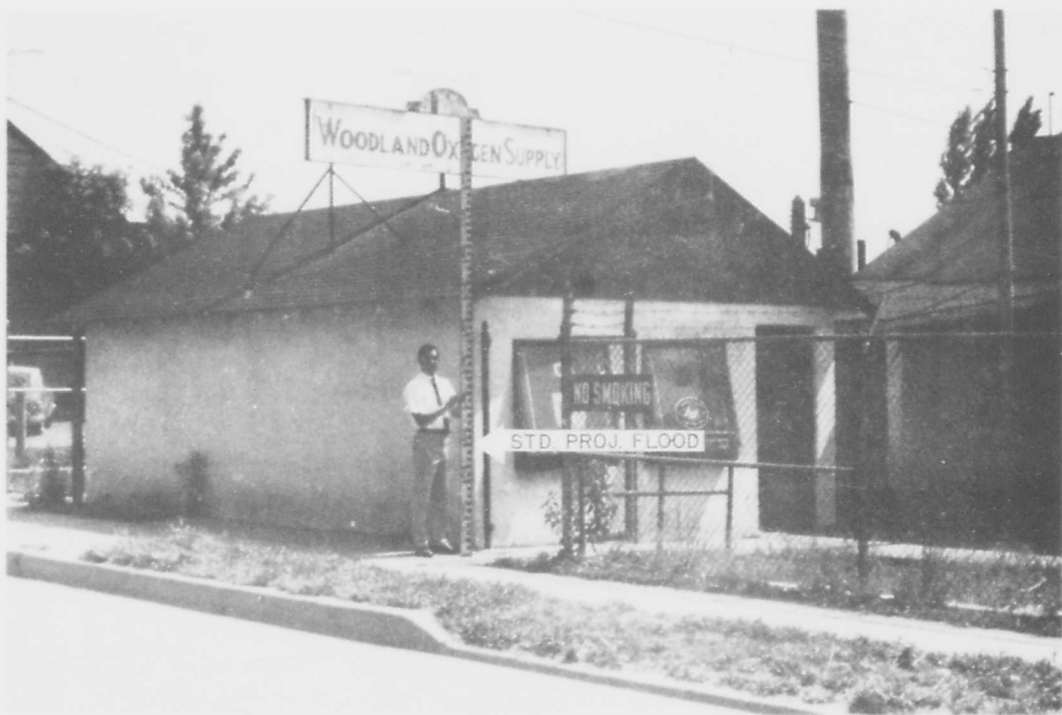
Figure 2.--FLOOD HEIGHTS ON LITTLE TIMBER CREEK

The upper view is Woodland Oxygen Supply on Broadway in Gloucester City. The lower view is the 7-Up Bottling Plant, also on Broadway in Gloucester City.

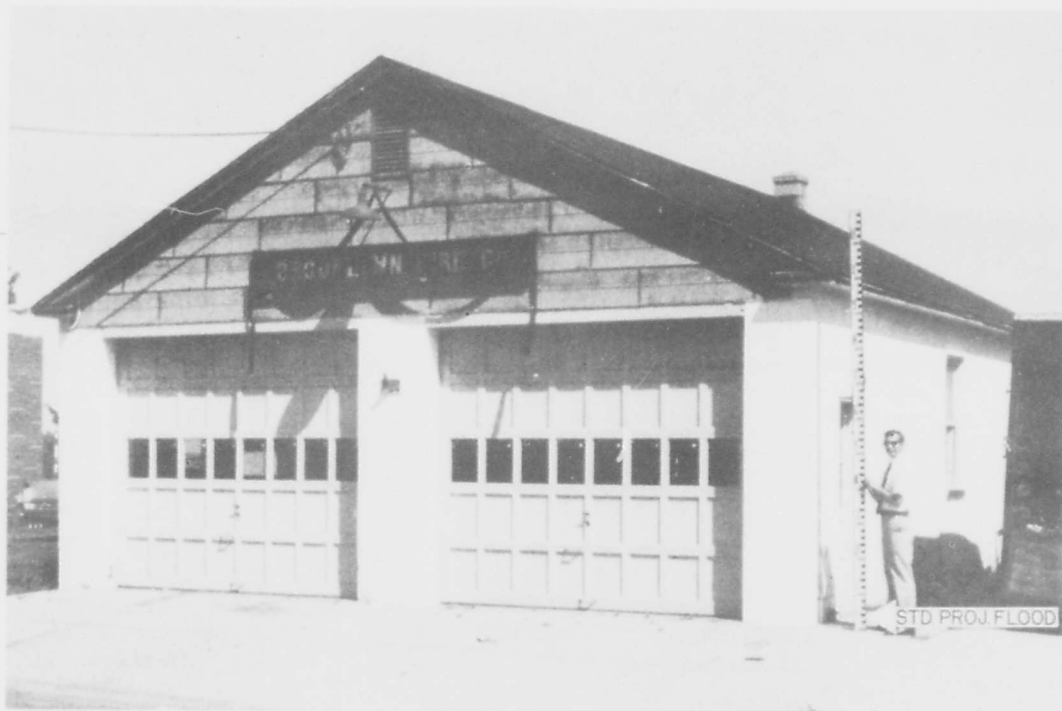
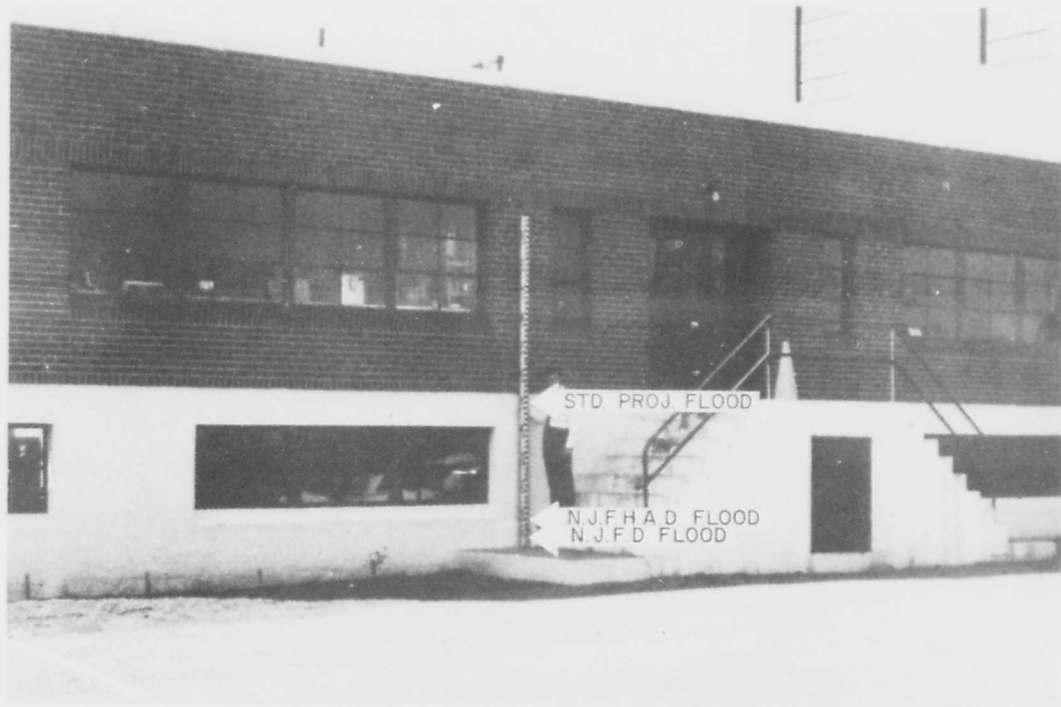
Figure 3.--FLOOD HEIGHTS ON LITTLE TIMBER CREEK

The upper view is the Brooklawn Fire House on Chestnut Street. The lower view is the Gloucester City Sewage Treatment Plant, located west of Broadway.

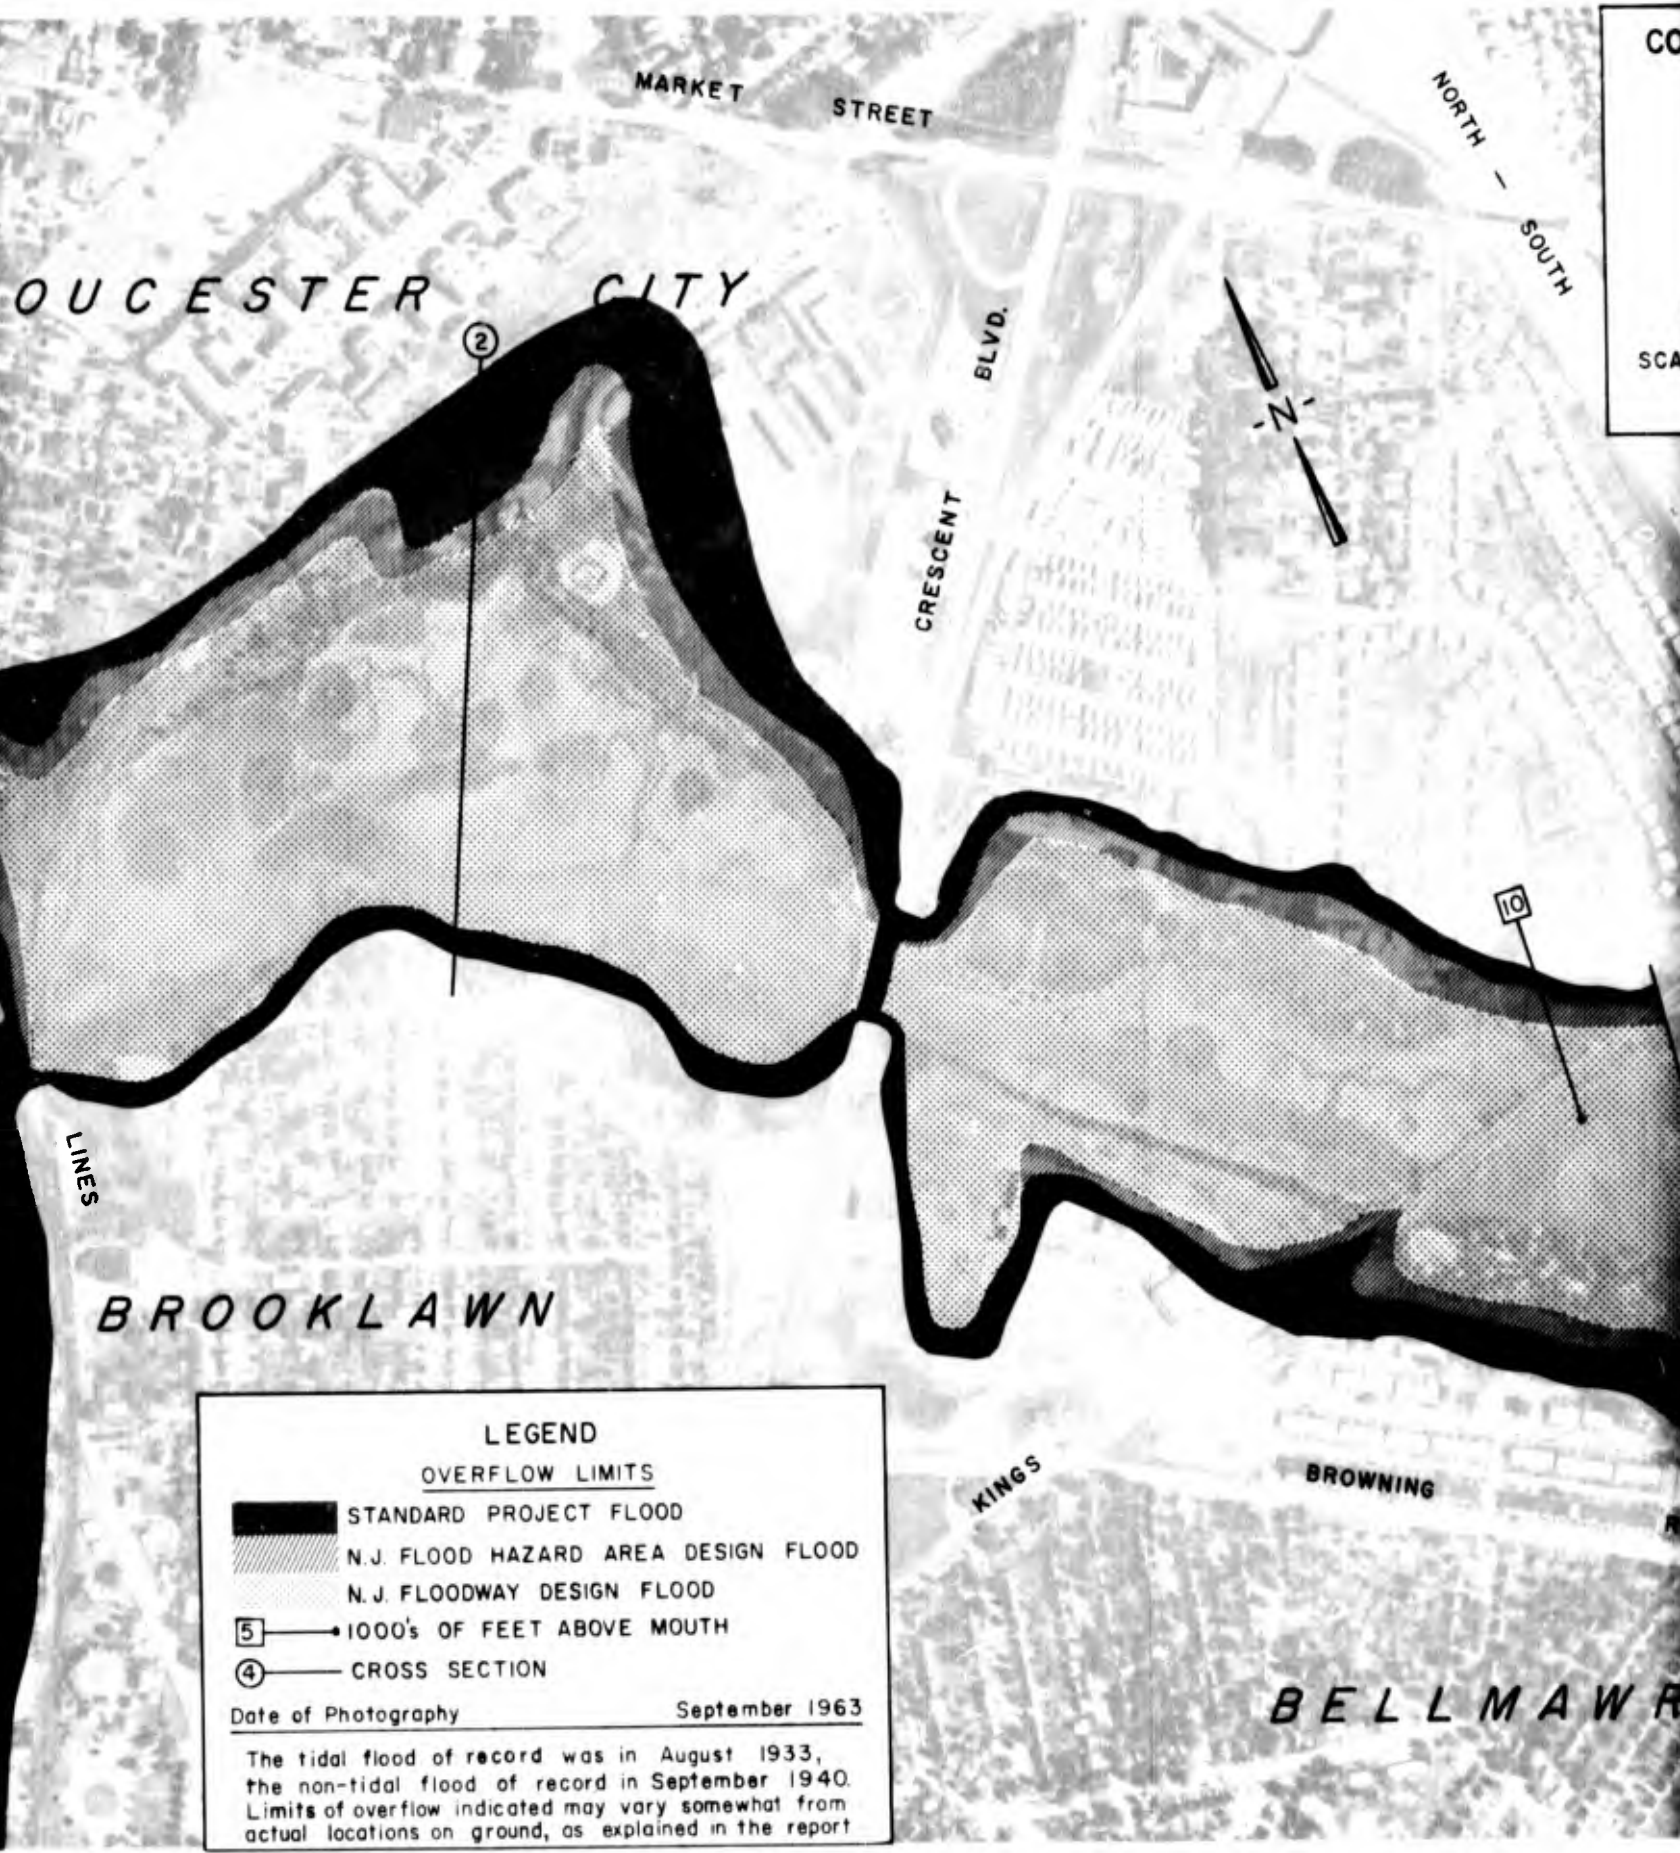
LEGEND

OVERFLOW LIMITS

The tidal flood of record was in August 1933, the non-tidal flood of record in September 1940. Limits of overflow indicated may vary somewhat from actual locations on ground, as explained in the report.
