NO. WAL 640/98

WELDING OF ARMOR

Metallurgical Examination of Samples from
Ballistically Tested Unionmelt Welded "H" Plate,
New York Air Brake Company, No. 47

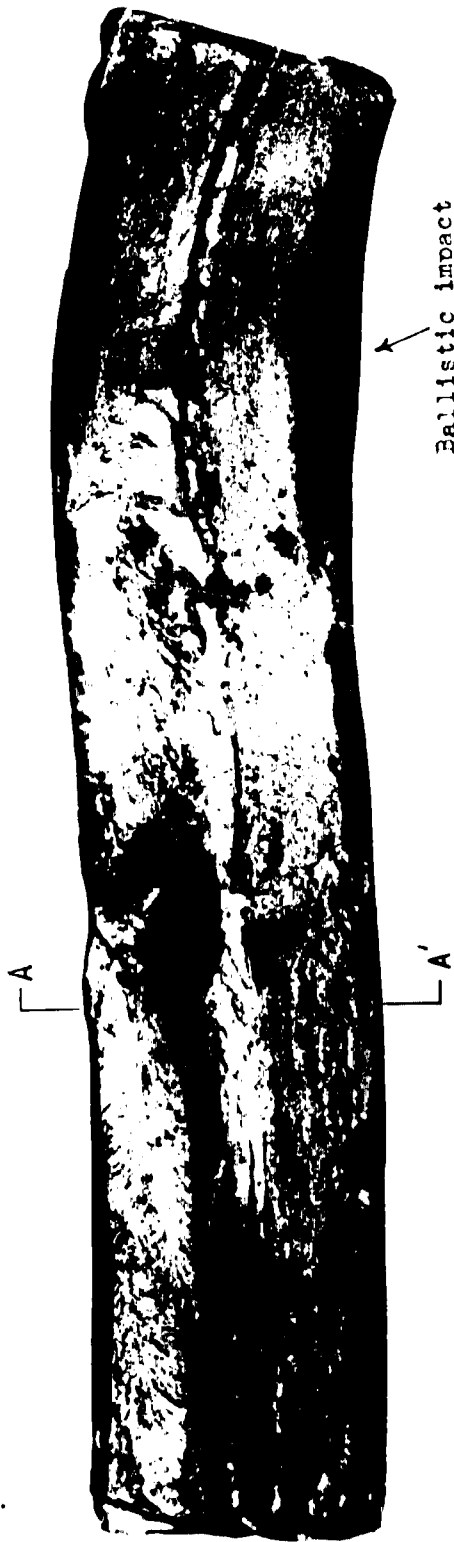
FIGURE 1A SURFACE OF BALLISTIC FRACTURE - RIGHT LEG WELD SAMPLE

Figure 1A is a photograph of the surface of the ballistic fracture of the sample from the right leg weld. Most of the fracture is in the weld heat-affected zone of the armor plate parallel and within a few hundredths of an inch of the weld fusion line. A part of the fracture extends into the armor plate along a shelf parallel to the plate surface for a distance equal to the width of the weld heat-affected zone (approximately $\frac{1}{8}$ inch) and then breaks to the back surface of the plate at an angle. The shelf appears to be along a lamination in the armor plate as shown in Figure 1B which is a photograph of a macroetched section taken through this part of the ballistic fracture. The appearance of the macroetched surface indicates acceptable steel quality. The fracture near the point of impact shows no sign of plate metal defects and it is impossible to determine whether the lamination affected the propagation of the ballistic fracture.

Ballistic impact

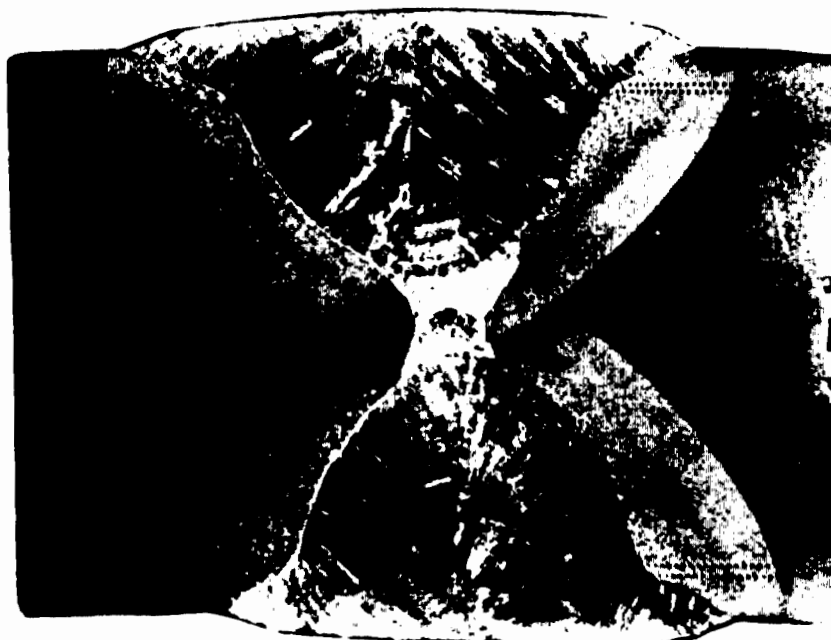
FIGURE 2B MACROETCHED CROSS SECTION THROUGH LEFT LEG WELD SAMPLE

Figure 2A is a photograph of macroetched cross section through sample from right leg weld. Figure 2B is a photograph of macroetched section through left leg weld. No significant differences are apparent between the macrostructures of the two leg welds.

Etch: 4% picral followed by
10% chromic acid (electrolytically)

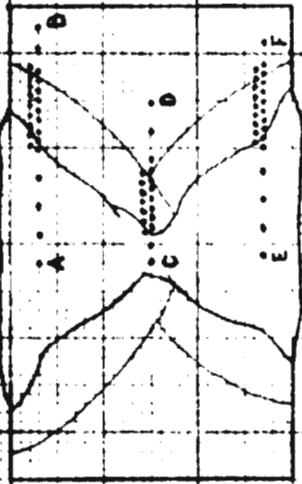
FIGURE 3 HAZ/HAZ SURVEYS

Figure 3 shows results of Vickers hardness surveys on polished surfaces of cross sections taken through samples from each leg weld. No significant differences are apparent between hardnesses of the weld metal, heat-affected zone, or base plate of the two leg welds.

.05" spacing in weld metal and unaffected plate
 Impressions in heat-affected zone staggered to give .01" spacing
