Report No. 640/60

ARMOR PLATE - WELDING

Adaptability of Four Procedures for  
Welding Pistol Port Splash Beads

**WATERTOWN ARSENAL**  
WATERTOWN, MASS.

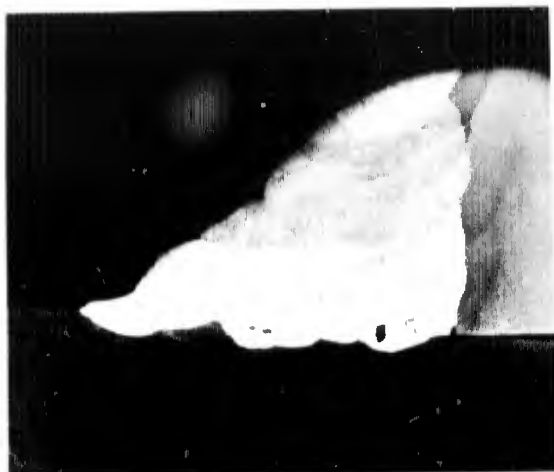
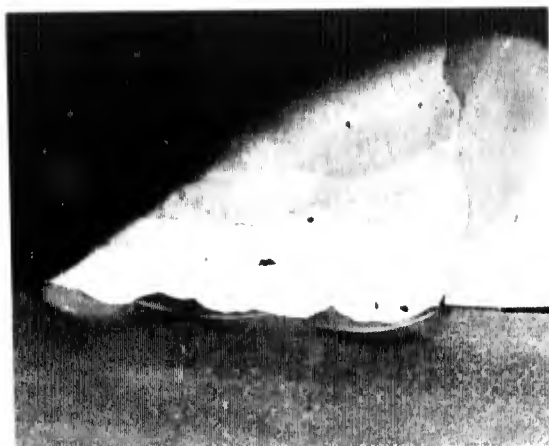
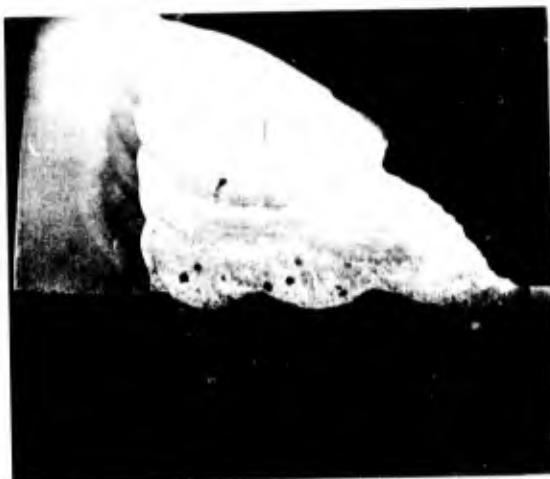
Figure 4

Passes 1,2,3, - 5/32"D Mn modified 18-3 stainless steel electrode, passes 4-10 - 3/16"D reversed polarity mild steel electrode. Cracks observed in passes 4 and 5 of both specimens resulted from alloy pick-up.

Passes 1,2,3, - 5/32"D bare mild steel electrode, passes 4-10 - 3/16"D reversed polarity mild steel electrode. Excessive porosity was observed in passes 1,2, and 3 of both sections.

CROSS SECTION OF PISTOL SPLASH PORT BEADS  
ETCHES IN VILELLA'S REAGENT  
Mag. x2

Sample A. The first three passes made with a stainless steel electrode formed a good bond with the base metal and the structure was austenitic. The remaining passes (4 to 10) were made with a reverse polarity mild steel electrode. Passes 4 and 5 dissolved some alloy from the high alloy weld beads and formed a martensitic structure in which an interdendritic type of cracking was observed. The crack system is clearly shown in Section A-4 of Figure 4. A detail of the interdendritic type of cracking formed is shown in Sample A-1 of Figure 6.

Sample B. The first three passes made with a bare mild steel electrode formed an excessive amount of porosity, but the weld metal formed a good bond with the base metal. The remaining passes made with reverse polarity mild steel electrode formed a heterogeneous structure of ferrite and pearlite. No cracking was observed in either the heat affected zone of the base metal or in the weld metal. The porosity in passes 1 to 3 is clearly shown in Sections B-1 and B-4 of Figure 4.

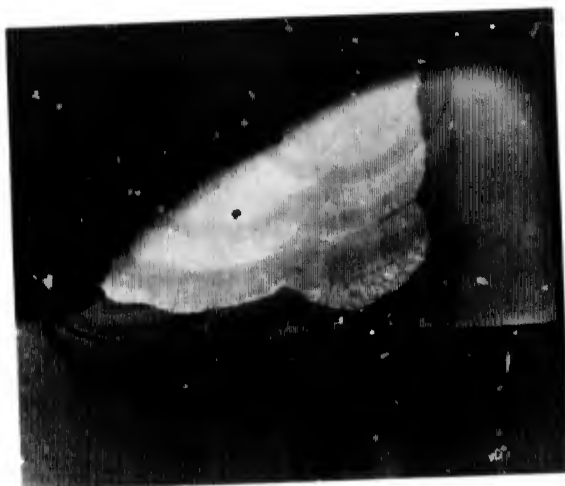
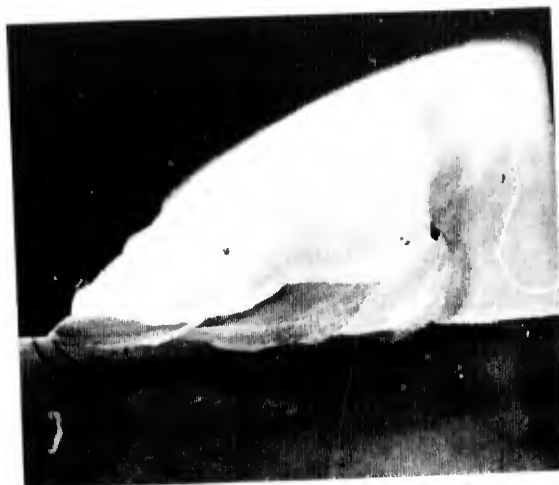
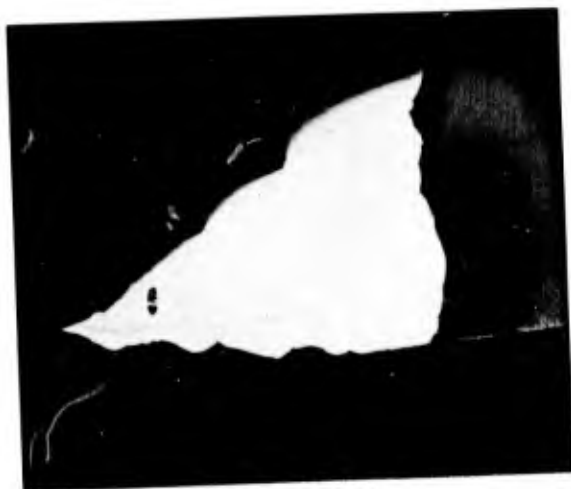
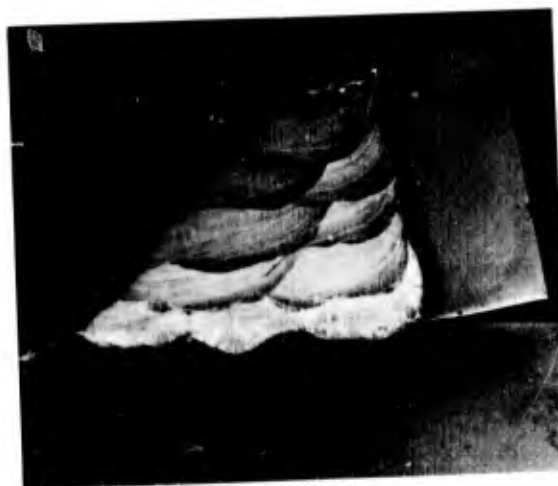
Figure 5

Passes 1,2,3, - 5/32"D reversed polarity mild steel electrode, passes 4-10 3/16"D reversed polarity mild steel electrode. Note cracking in heat affected zones under pass 3 and 1 in section C1 and under passes 2 and 3 in section C4.

Passes 1,2,3, - 5/32"D Mn modified 18-8 stainless steel electrode, passes 4-10 - 3/16"D Mn modified 18-8 stainless steel electrode. Oblique illumination used in section D4 to reveal grain structure in the weld metal.

CROSS SECTION OF PISTOL SPLASH PORT  
BEADS ETCHED IN VILELLA'S REAGENT  
Mag. x2

Sample C. All passes were made with a reverse polarity mild steel electrode which formed a heterogeneous microstructure of ferrite and pearlite. In the heat affected zone of the armor plate, cracking was observed parallel to the line of fusion and perpendicular to it. See Sections C-1 and C-4 of Figures 5 and 6. A cracking condition of this type is extremely undesirable since any cracking perpendicular to the plate surface may weaken the armor and initiate a ballistic failure. The cause of this cracking was probably associated with the shrinkage which occurs during the solidification of the weld metal, but it should be noted that this sample would be more susceptible toward cracking since the welding was conducted parallel to the rolling direction whereas welding of the other three samples was conducted perpendicular to the rolling direction of the armor. This factor is significant in straight-away rolled Great Lakes armor which is susceptible toward cracking during welding fabrication.

Sample D. In this weldment a manganese modified 18-8 stainless steel electrode was employed, and the weld metal, which was completely austenitic, formed a good bond with the base metal. No defects were observed and the weldment is considered to be completely satisfactory. See Sections D-1 and D-4 of Figure 5.

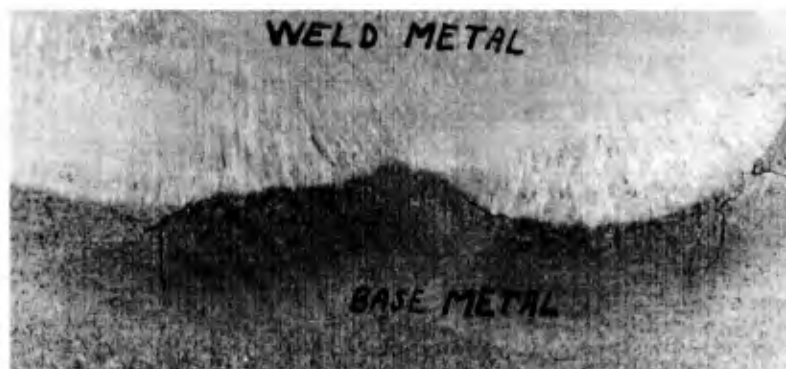
X7 Sample C-4 Ammonium persulfate  
 Crack systems observed in this sample at the line  
 of fusion.
