Memorandum Report No. 624/16

June 3, 1942
WATERLOO ARSENAL
WATERLOO, MASS.

ARC WELDING OF ARMOR

Straight Gap Butt Welds Made With
A Ferritic Type Alloy Electrode

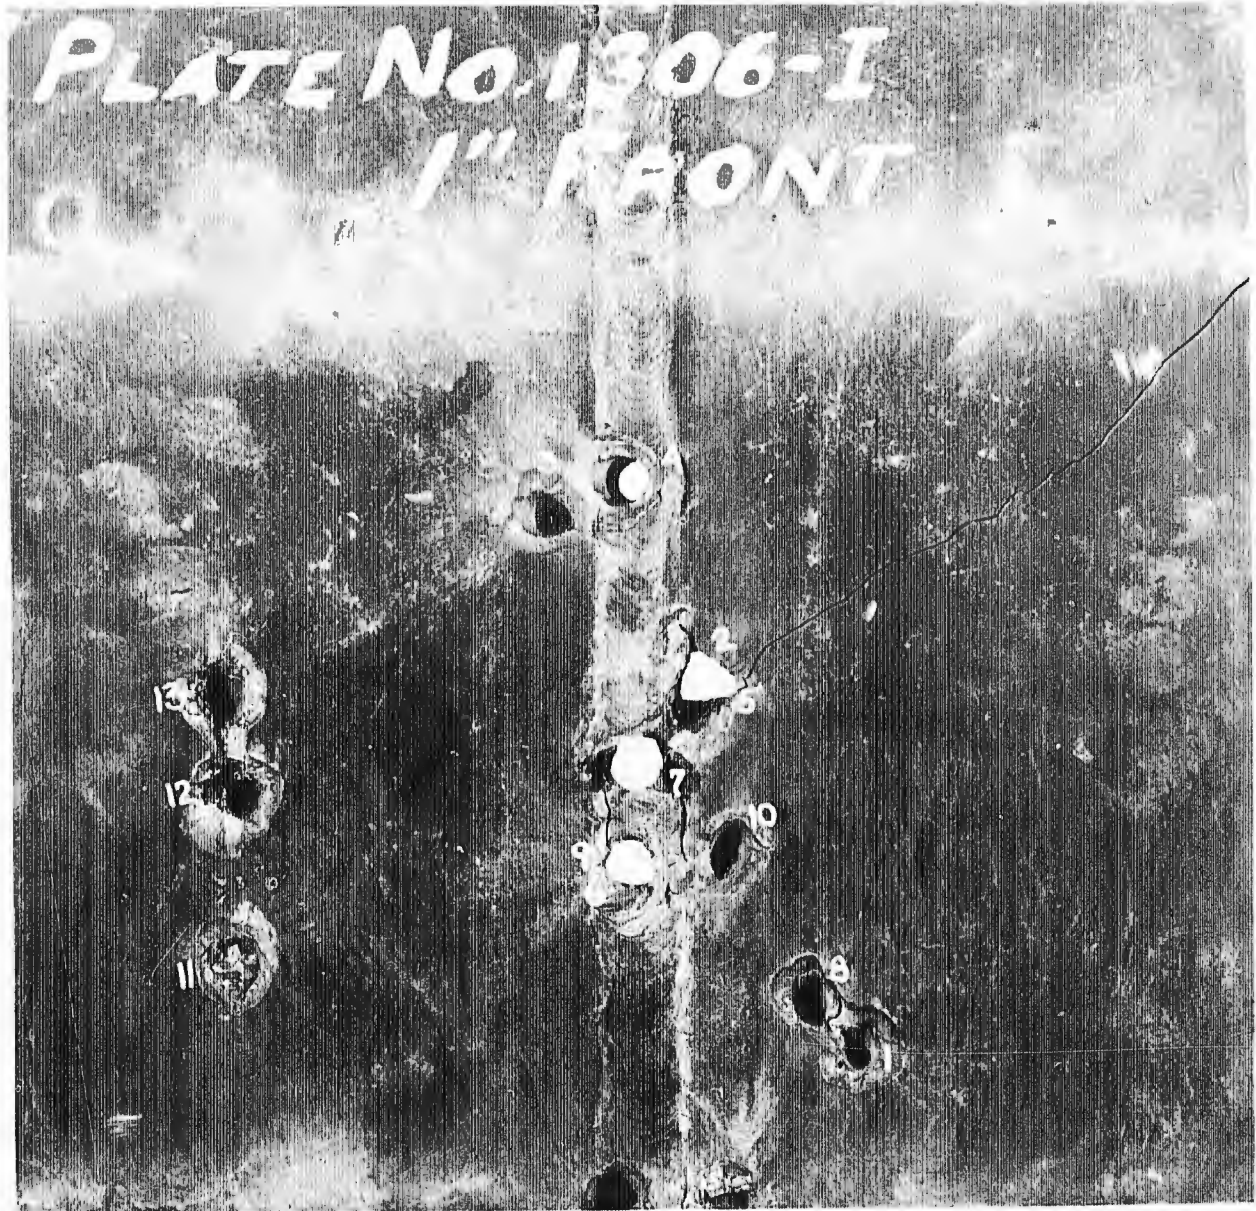
Figure 3

Front View of Plate No. 1 after Ballistic
Test. Note cracked plate and weld spall.

Figures 3 and 4 are photographs of the front and back of Plate No. 1 after ballistic test. Face and back spalling of the weld metal and a large crack in the plate, initiated in fusion zone, are shown. Figures 5 and 6 are photographs of the front and back of Plate No. 2 after ballistic test. The upper half of the weld was hard faced with a layer of Rollex #600. As shown in Table III the weld with hard facing had a higher ballistic efficiency. Cracks developed between the weld and plate metal during welding and the hard facing weld metal cracked after it had cooled. These cracks were ground out and repaired. A few very small cracks were detected after repair and the firing tests opened them up, as shown in Figure 5.

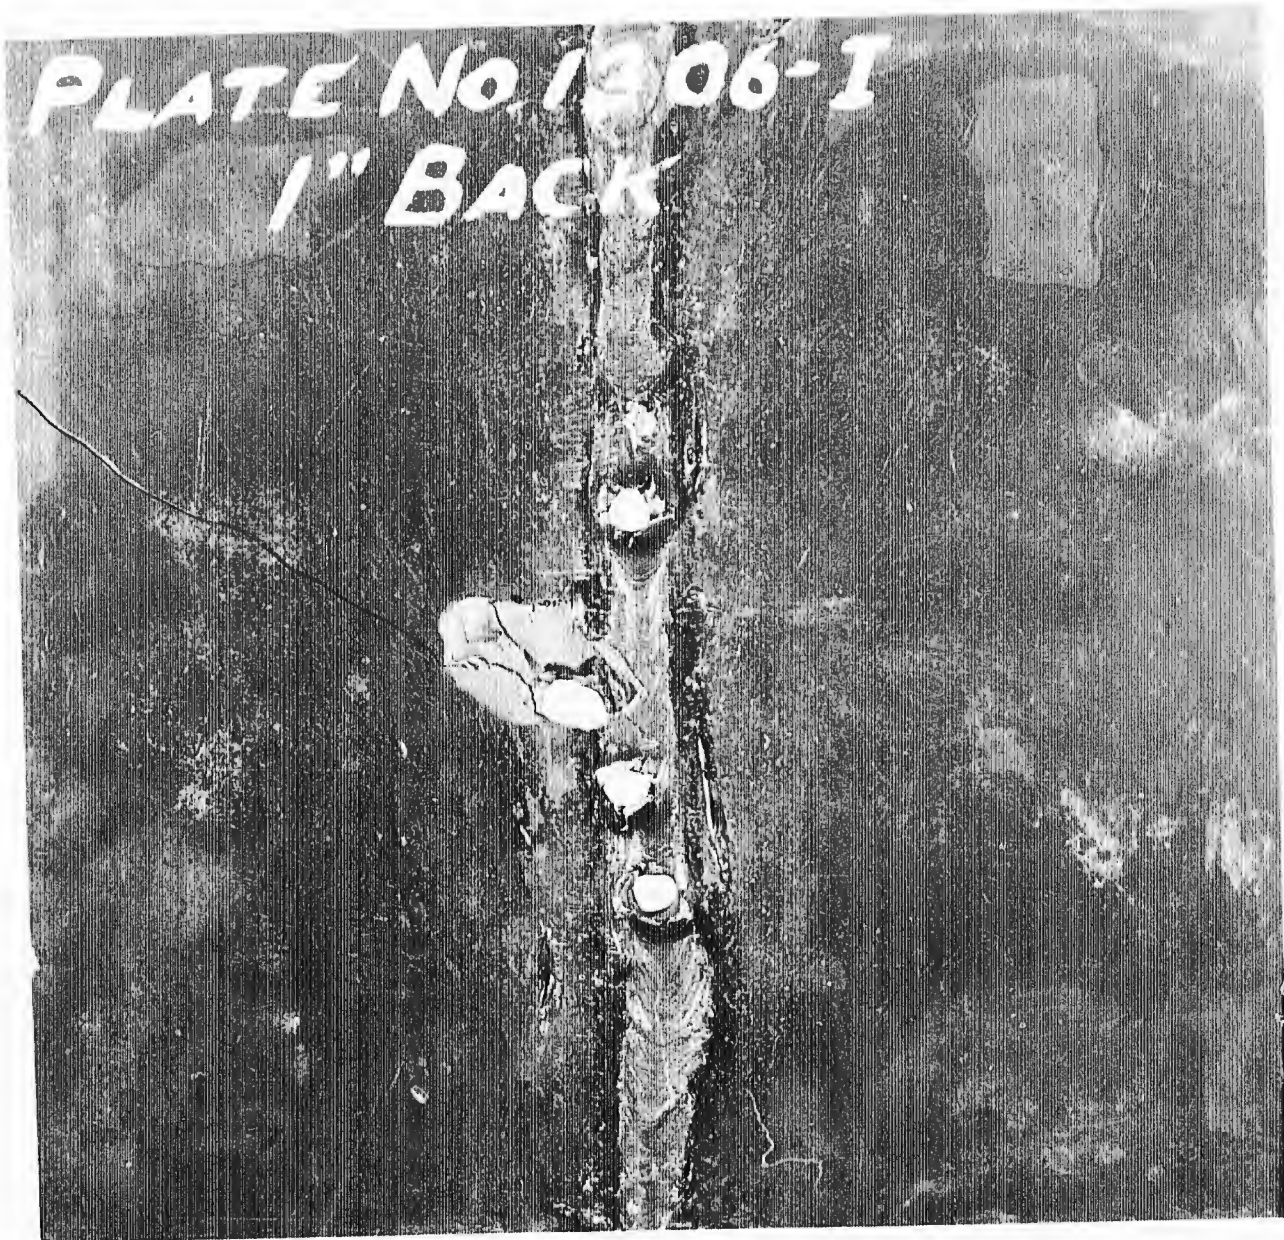
Figure 4

Rear View of Plate No. 1 after Ballistic Test.

Note spalling.

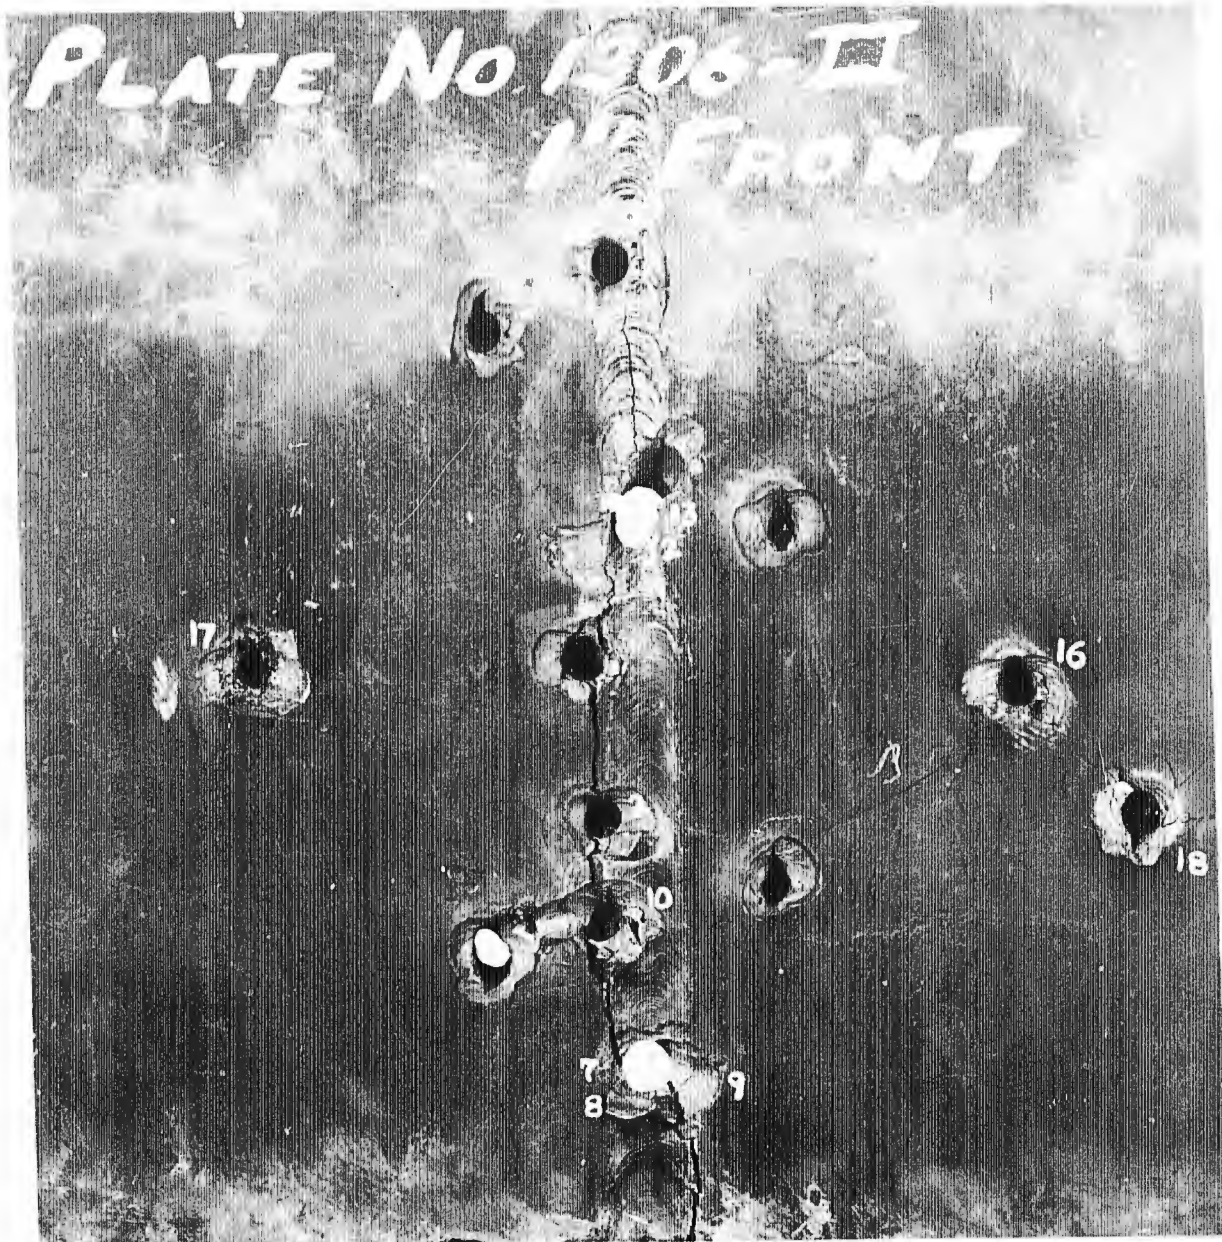
Figure 5

Front View of Plate No. 2 after Ballistic Test.

Upper half of weld completed with hard surface
layer of Rollex #600. Note weld and plate cracks.

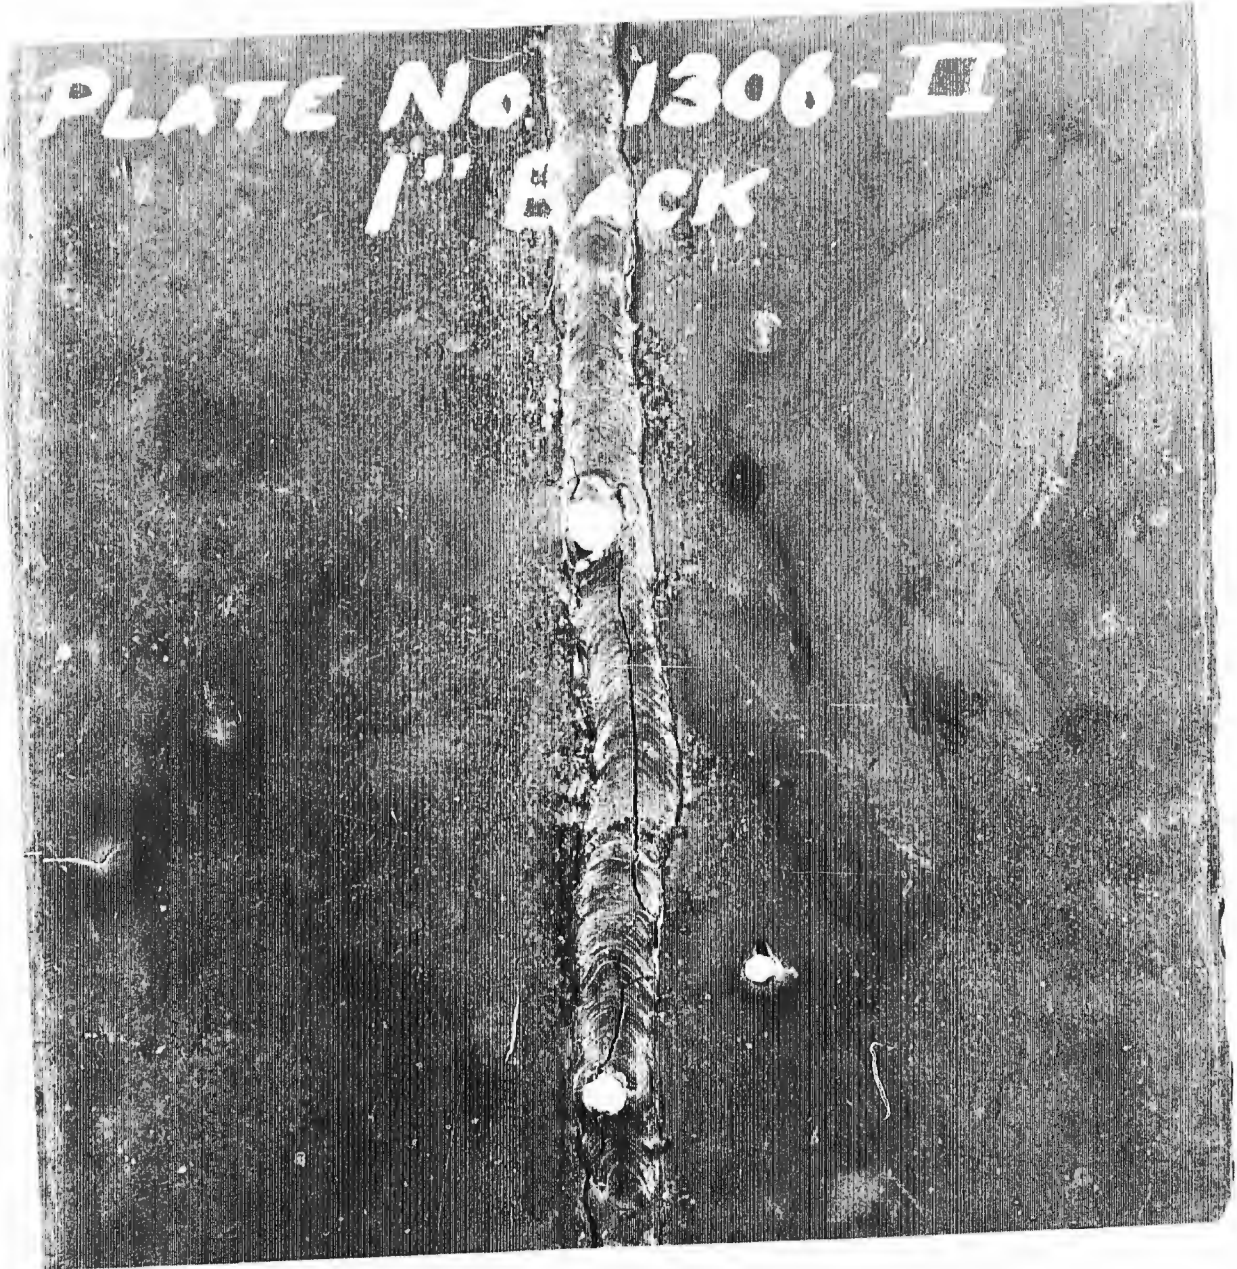
Figure 6

Back View of Plate No. 2 after
Ballistic Test. Note weld crack.
