Memorandum Report No. 642/17
Watertown Arsenal

ARC WELDING OF ARMOR

Preclad Butt Joints and Hard Facings

OBJECT

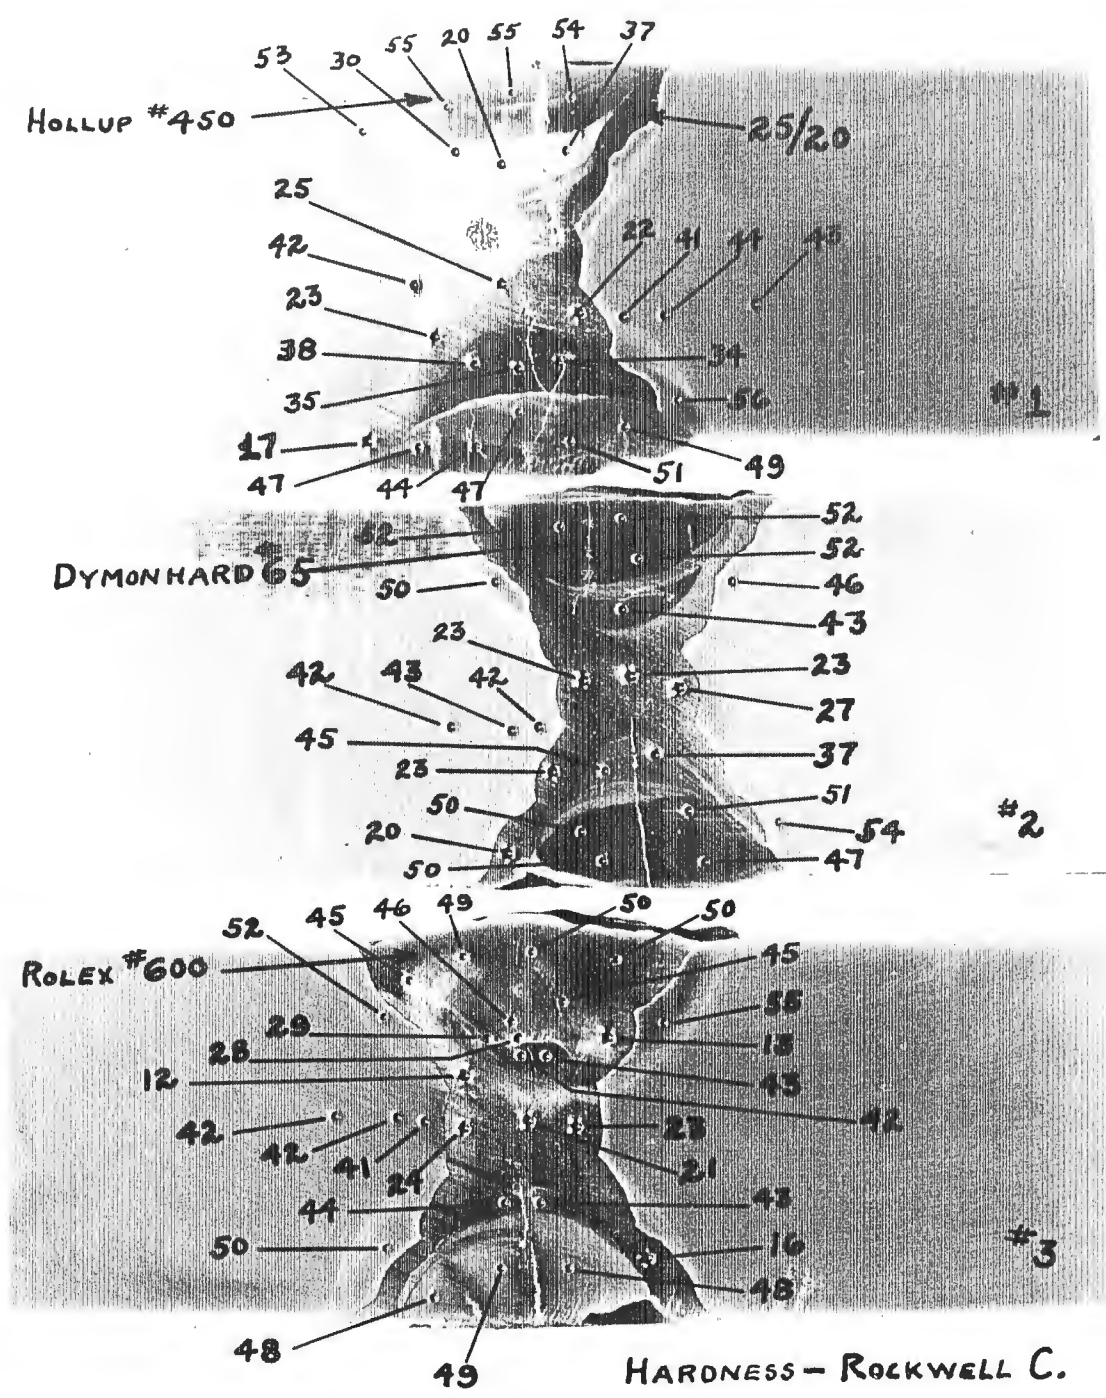
Hardness Surveys and
Macroexamination of Plates.

Figure 1 shows cross sections of the weld joints as prepared for macroexamination. Cracks occurred in the hard facing and extended into the weld metal. These cracks were opened up during firing tests.

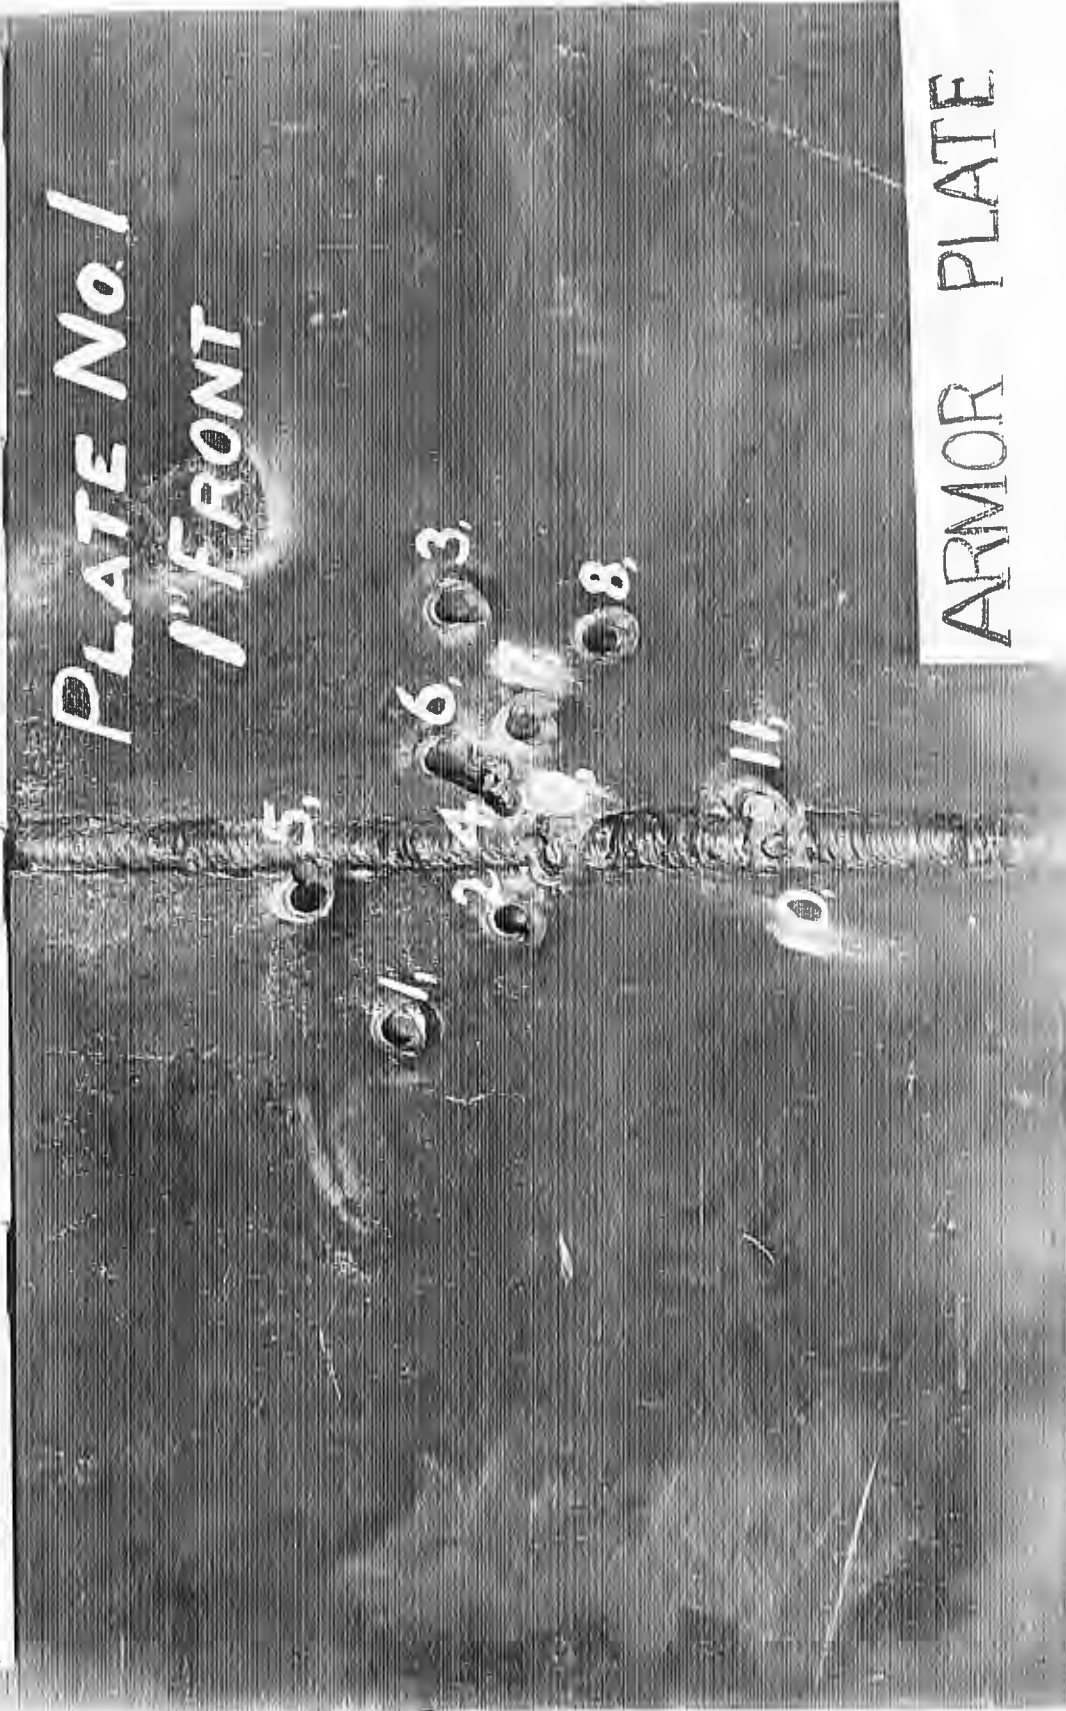
Figure 2

Front of Plate No. 1. Spalling of Weld
Metal.

Figures 2 through 7 are photographs of the front and rear of each weld after ballistic test. The extent of cracking and spalling of the weld metal are such that the method of welding described in this report cannot be regarded as satisfactory for homogeneous armor plate of the type tested.

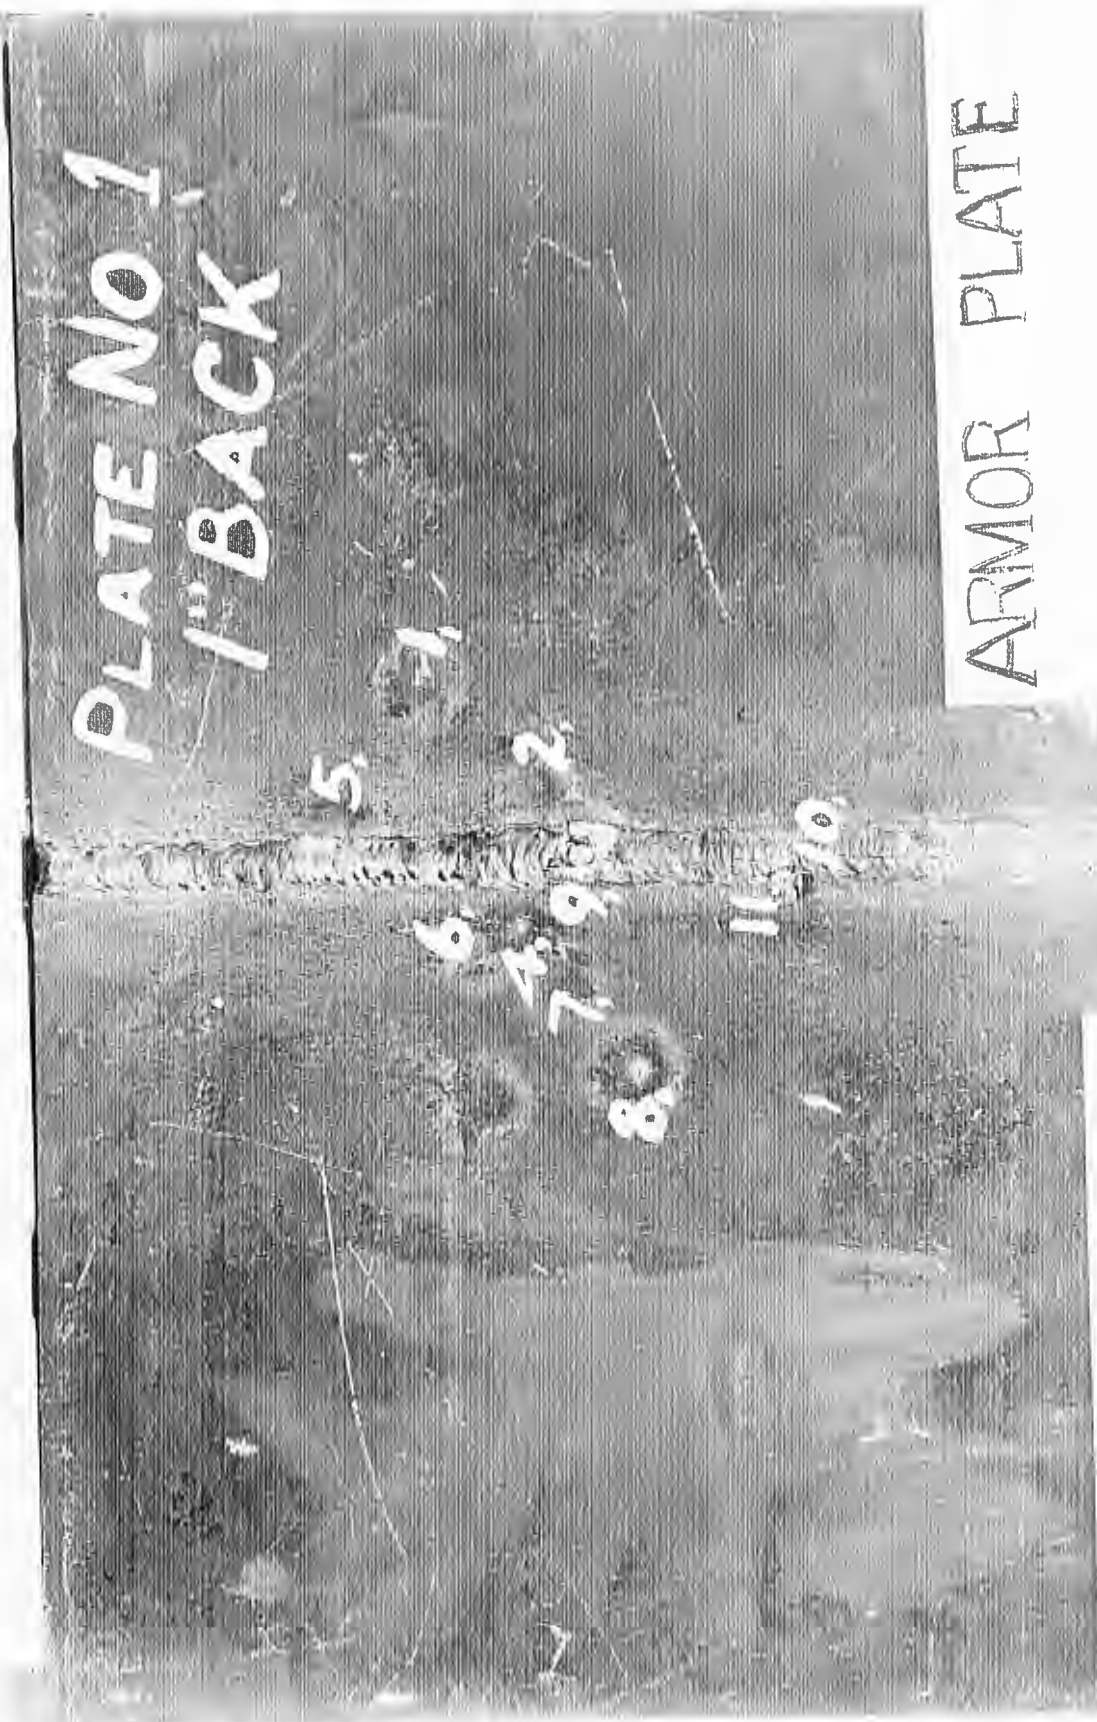
Figure 3

Back of Plate No. 1.

Weld crack starting at weld metal spall.

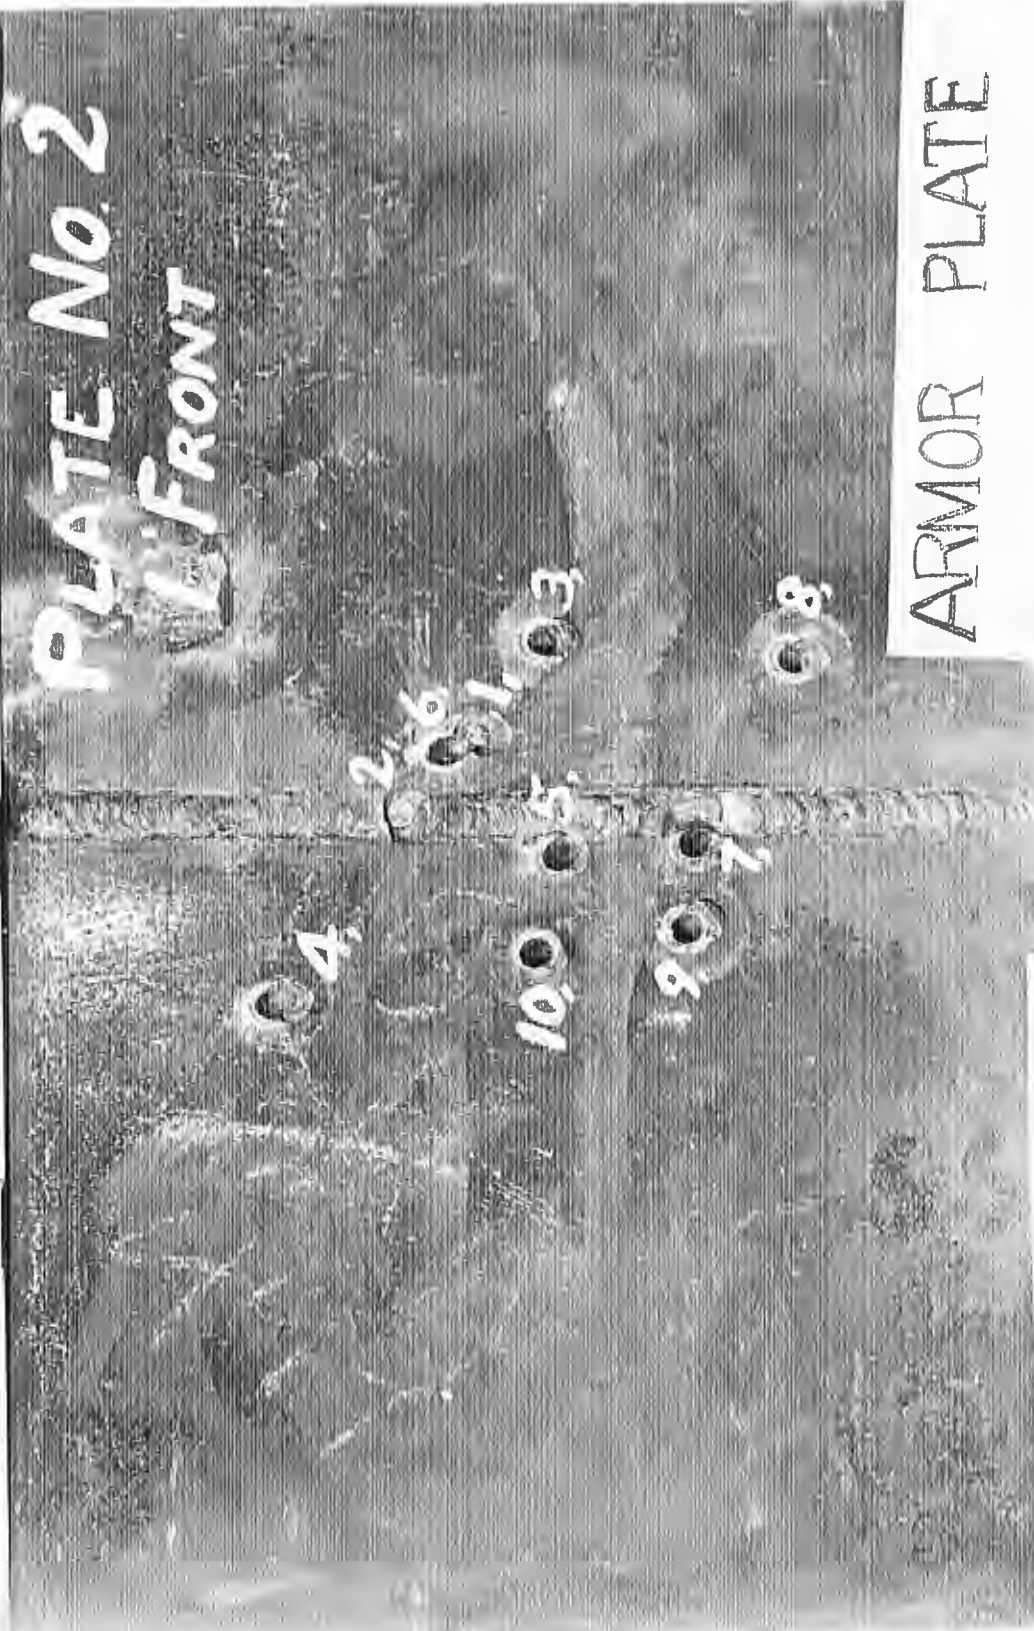
Figure 4

Front of Plate No. 2.

Spalling of weld metal.

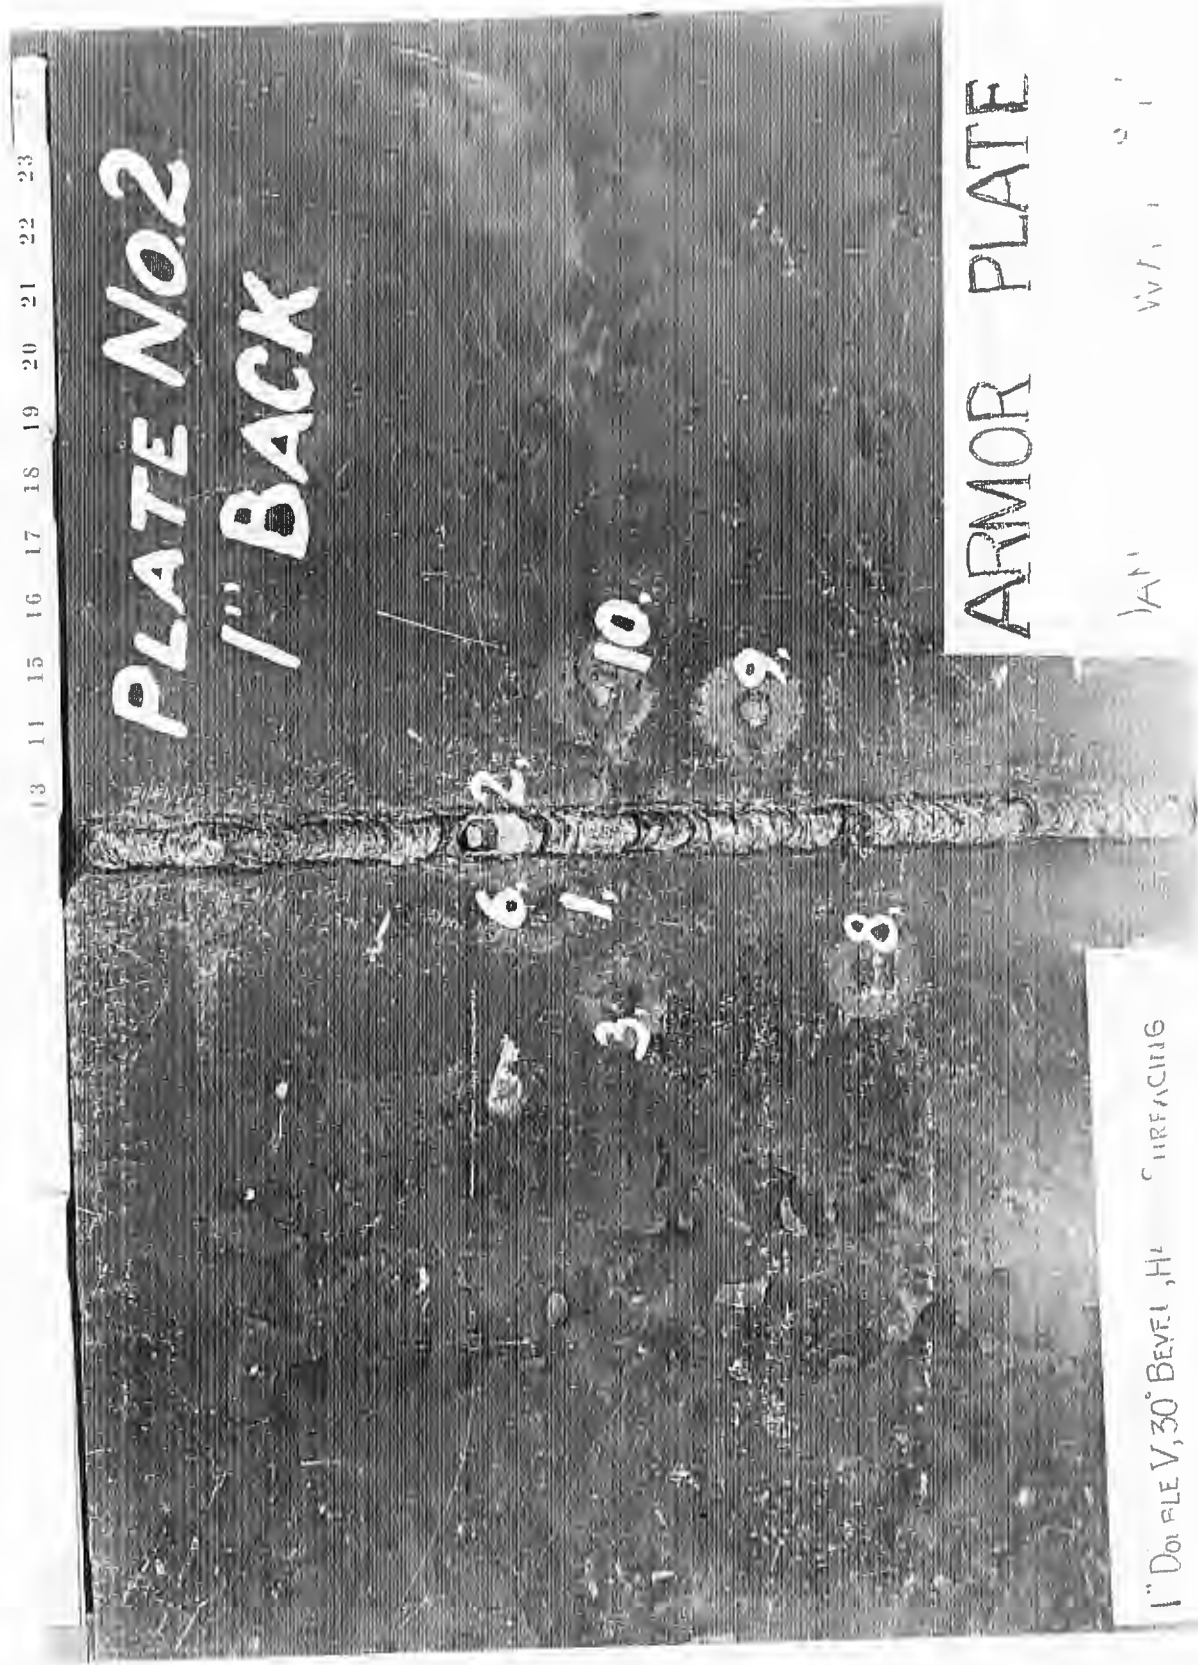
Figure 5

Back of Plate No. 2.

Spalling of weld metal.

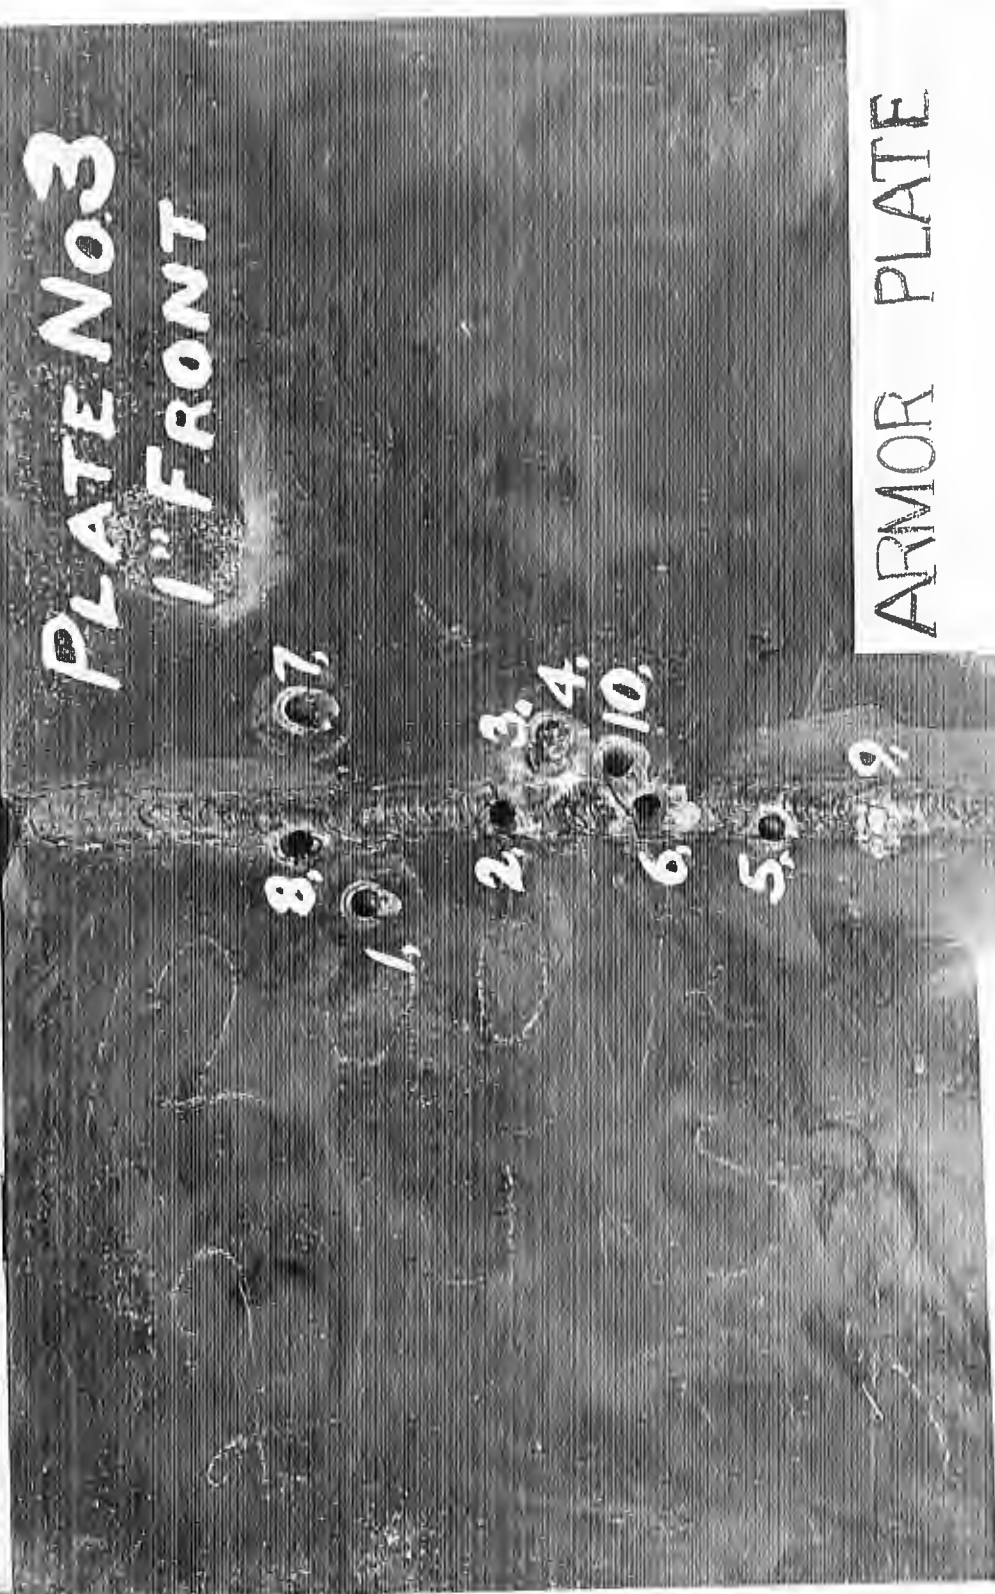
Figure 6

Front of Plate No. 3.

Weld crack and spalling.

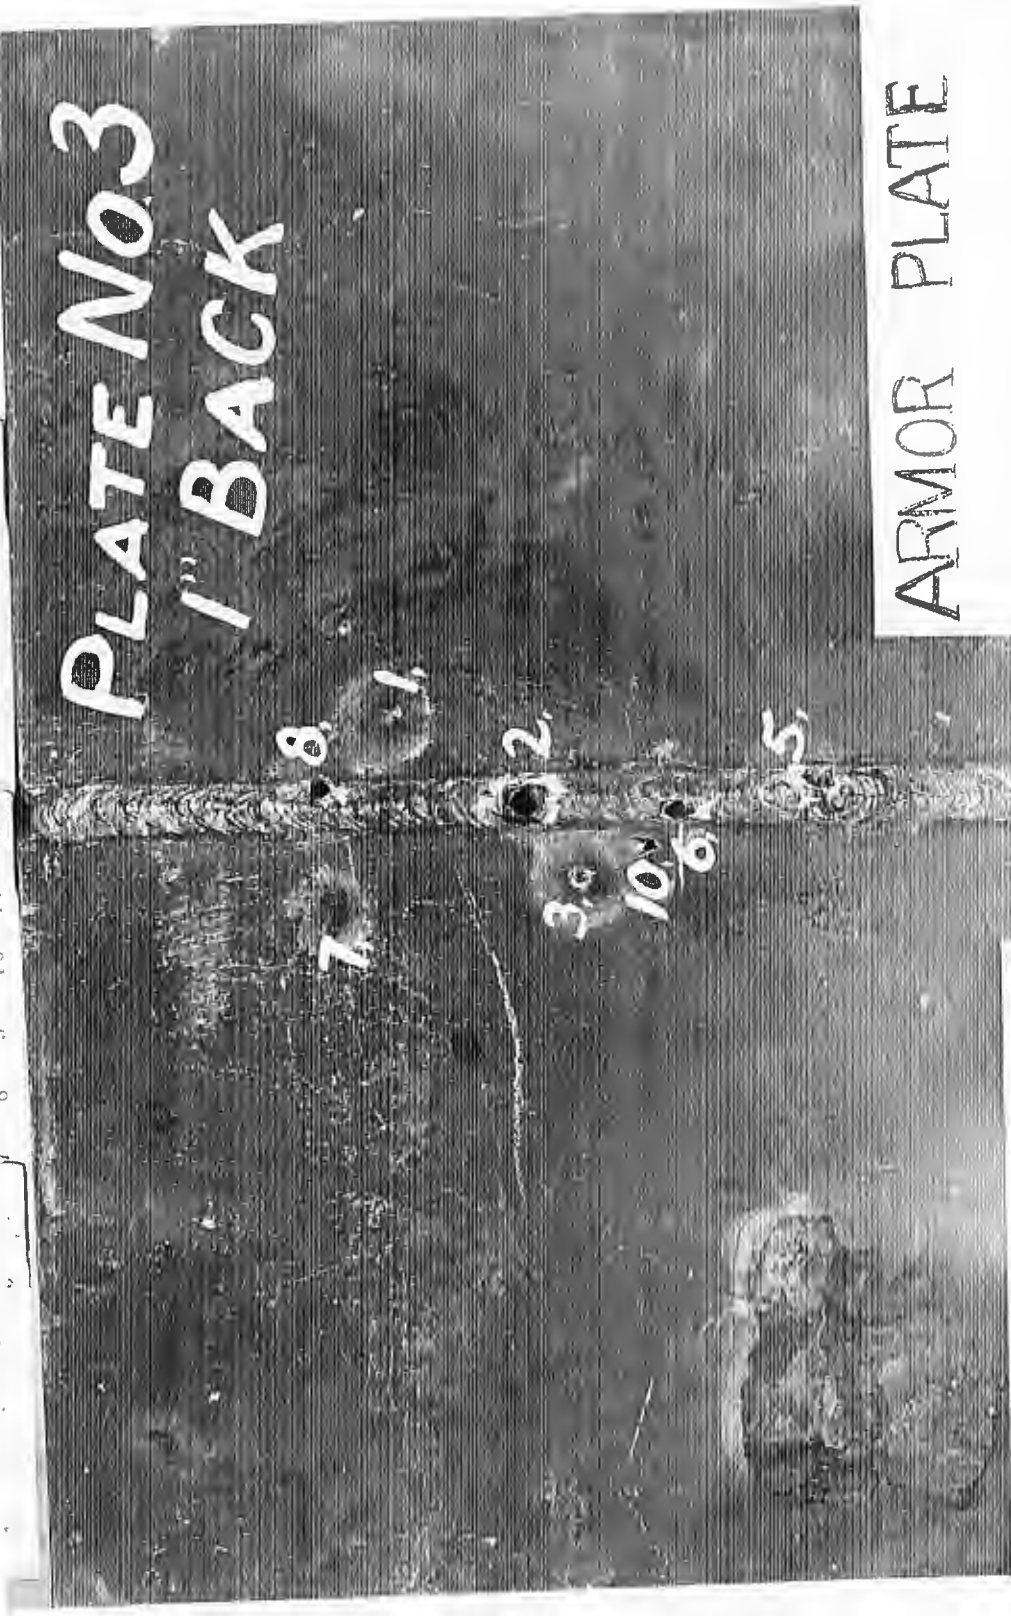
Figure 7

Back of Plate No. 3.

Weld crack and spalling.
