Report No. 642/18
Watertown Arsenal

ARC WELDING OF ARMOR

Welded Y Plate of Two-Inch Thick

Rolled Homogeneous Armor

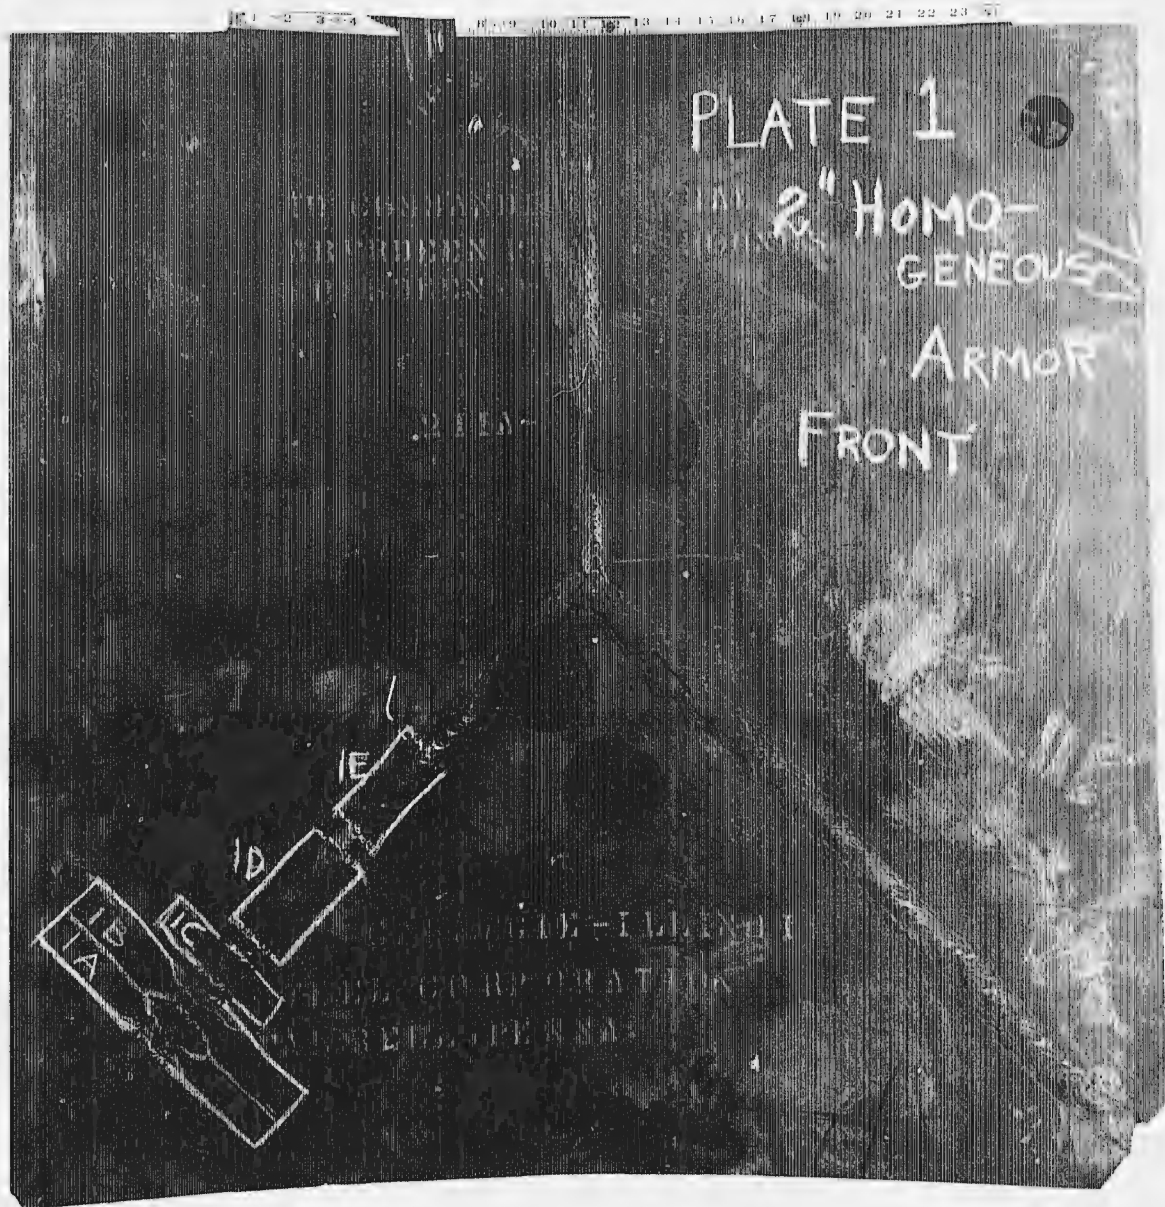
FIGURE 1

Front view of Y joint in 2" rolled
homogeneous armor plate after ballistic test.
Specimens were marked out for the following
purposes:

- 1A for tension test of welded joint
- 1B " " " " " "
- 1C " macro, micro, and hardness survey
- 1D " tension test of weld metal
- 1E " chemical analysis of weld metal

2" ROLLED HOMOGENEOUS ARMOR 36" x 36". "Y" JOINT
OF LINCOLN ARMORWELD. FLAME CUT EDGES
FEBRUARY 18 1942 FRONT W.A.710-1749

Specimens for physical and metallurgical examination were taken as indicated in Figure 1 and the accompanying table. The area from which specimens were taken was not affected by the ballistic test as far as could be determined by visual examination.

Figures 1 and 2 are photographs of front and rear of plate. Cracks opened up by ballistic shock are shown.

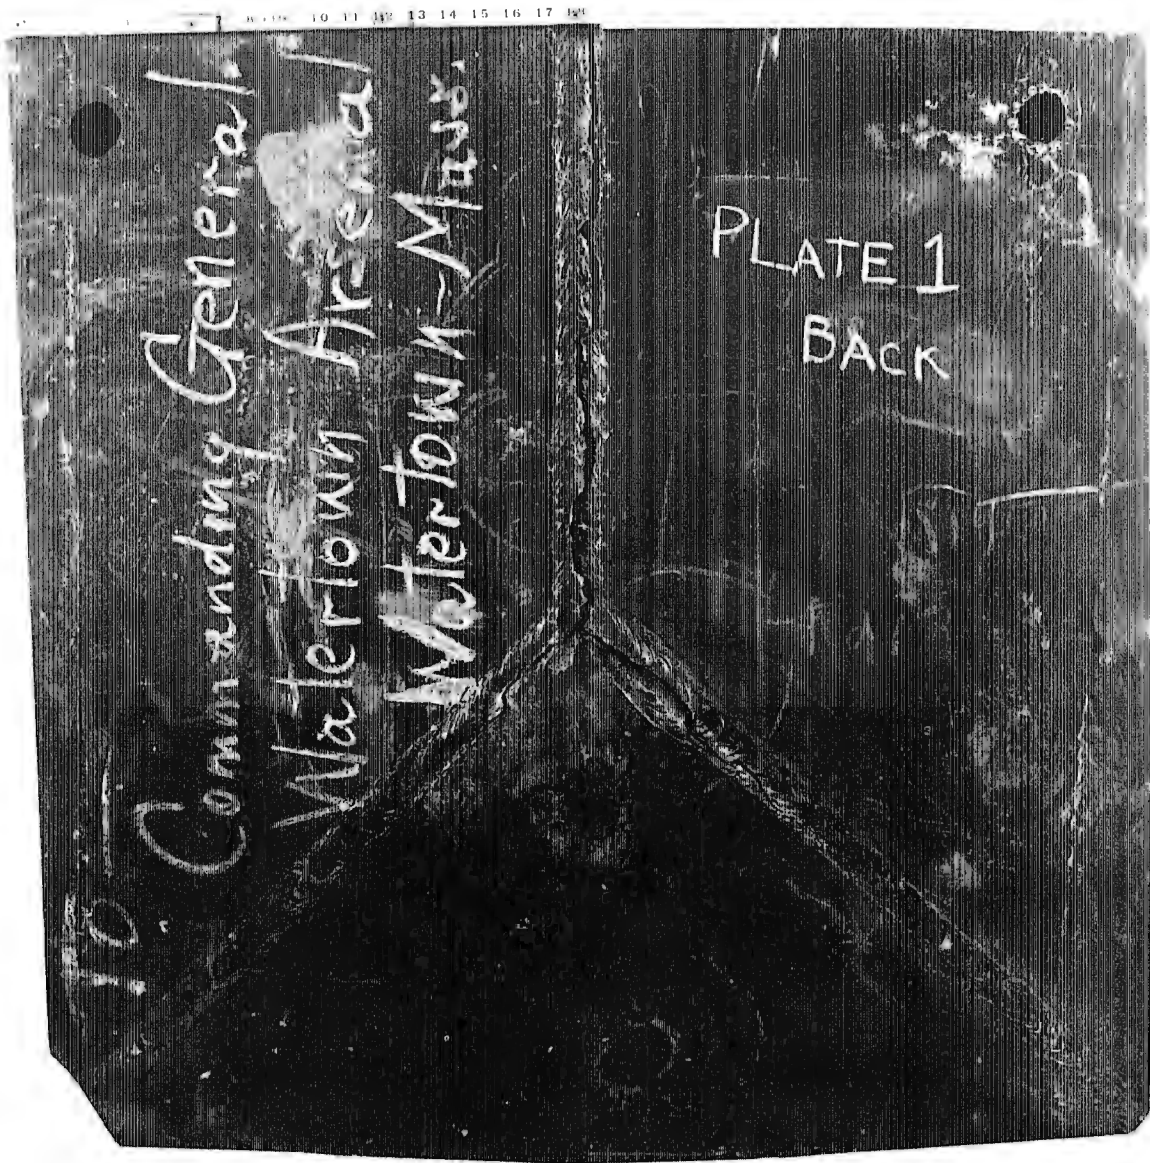
FIGURE 2

Rear view of Y joint in 2" rolled
homogeneous armor plate after ballistic
test.

2" ROLLED HOMOGENEOUS ARMOR 36" X 36". "Y" JOINT
OF LINCOLN WELD ARMOR. FLAME CUT EDGES
FEBRUARY 18 1942 BACK W.A. 710-1750

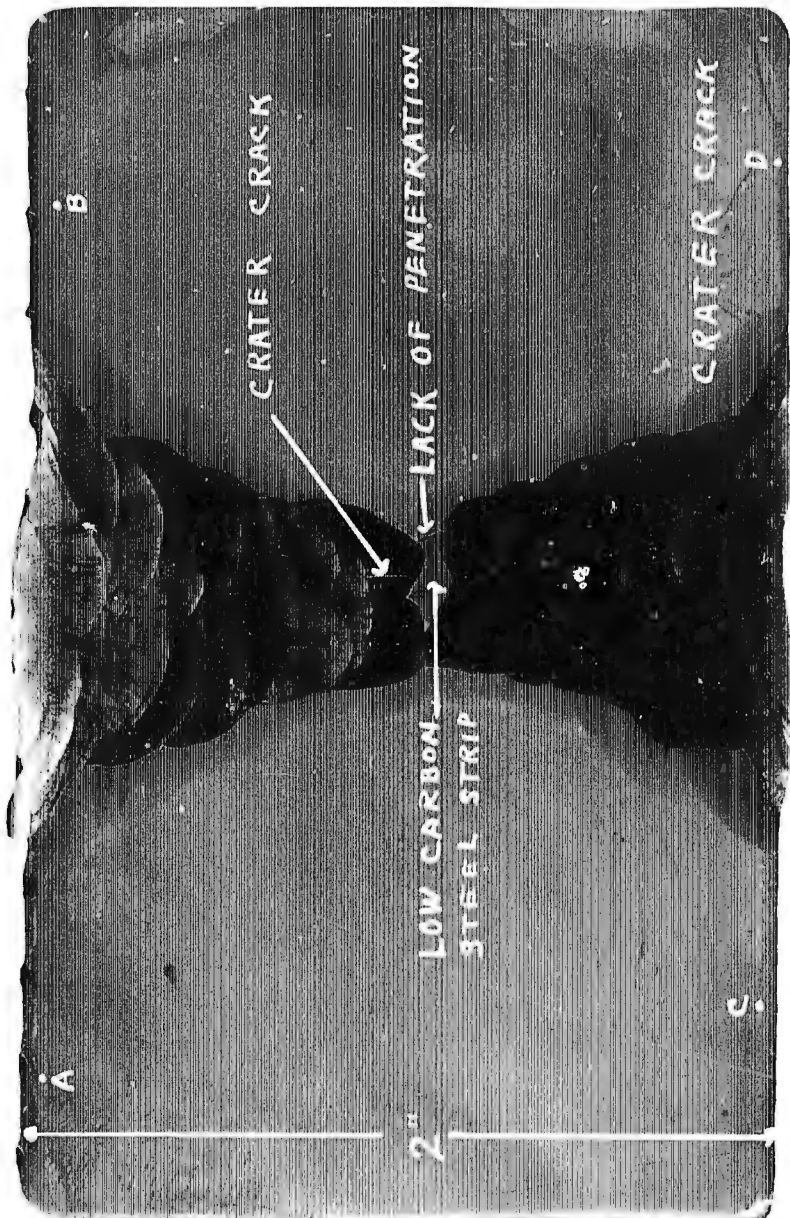
FIGURE 3

Cross section of weld as prepared
for macroexamination. Area of incomplete
weld metal penetration and cracks are
indicated by arrows.

CROSS SECTION OF 2" 1/4" ROLLED HOMOGENEOUS ARMOR PLATE
 WELDED WITH A MODIFIED 18/8 ELECTRODE. NOTE MILD STEEL
 STRIP AT THE ROOT OF JOINT. 3-25-42 W.A.710-1794

A cross section of the weld, as prepared for macroexamination, is shown in Figure 3. Incomplete penetration of the weld metal and small weld metal cracks are evident.

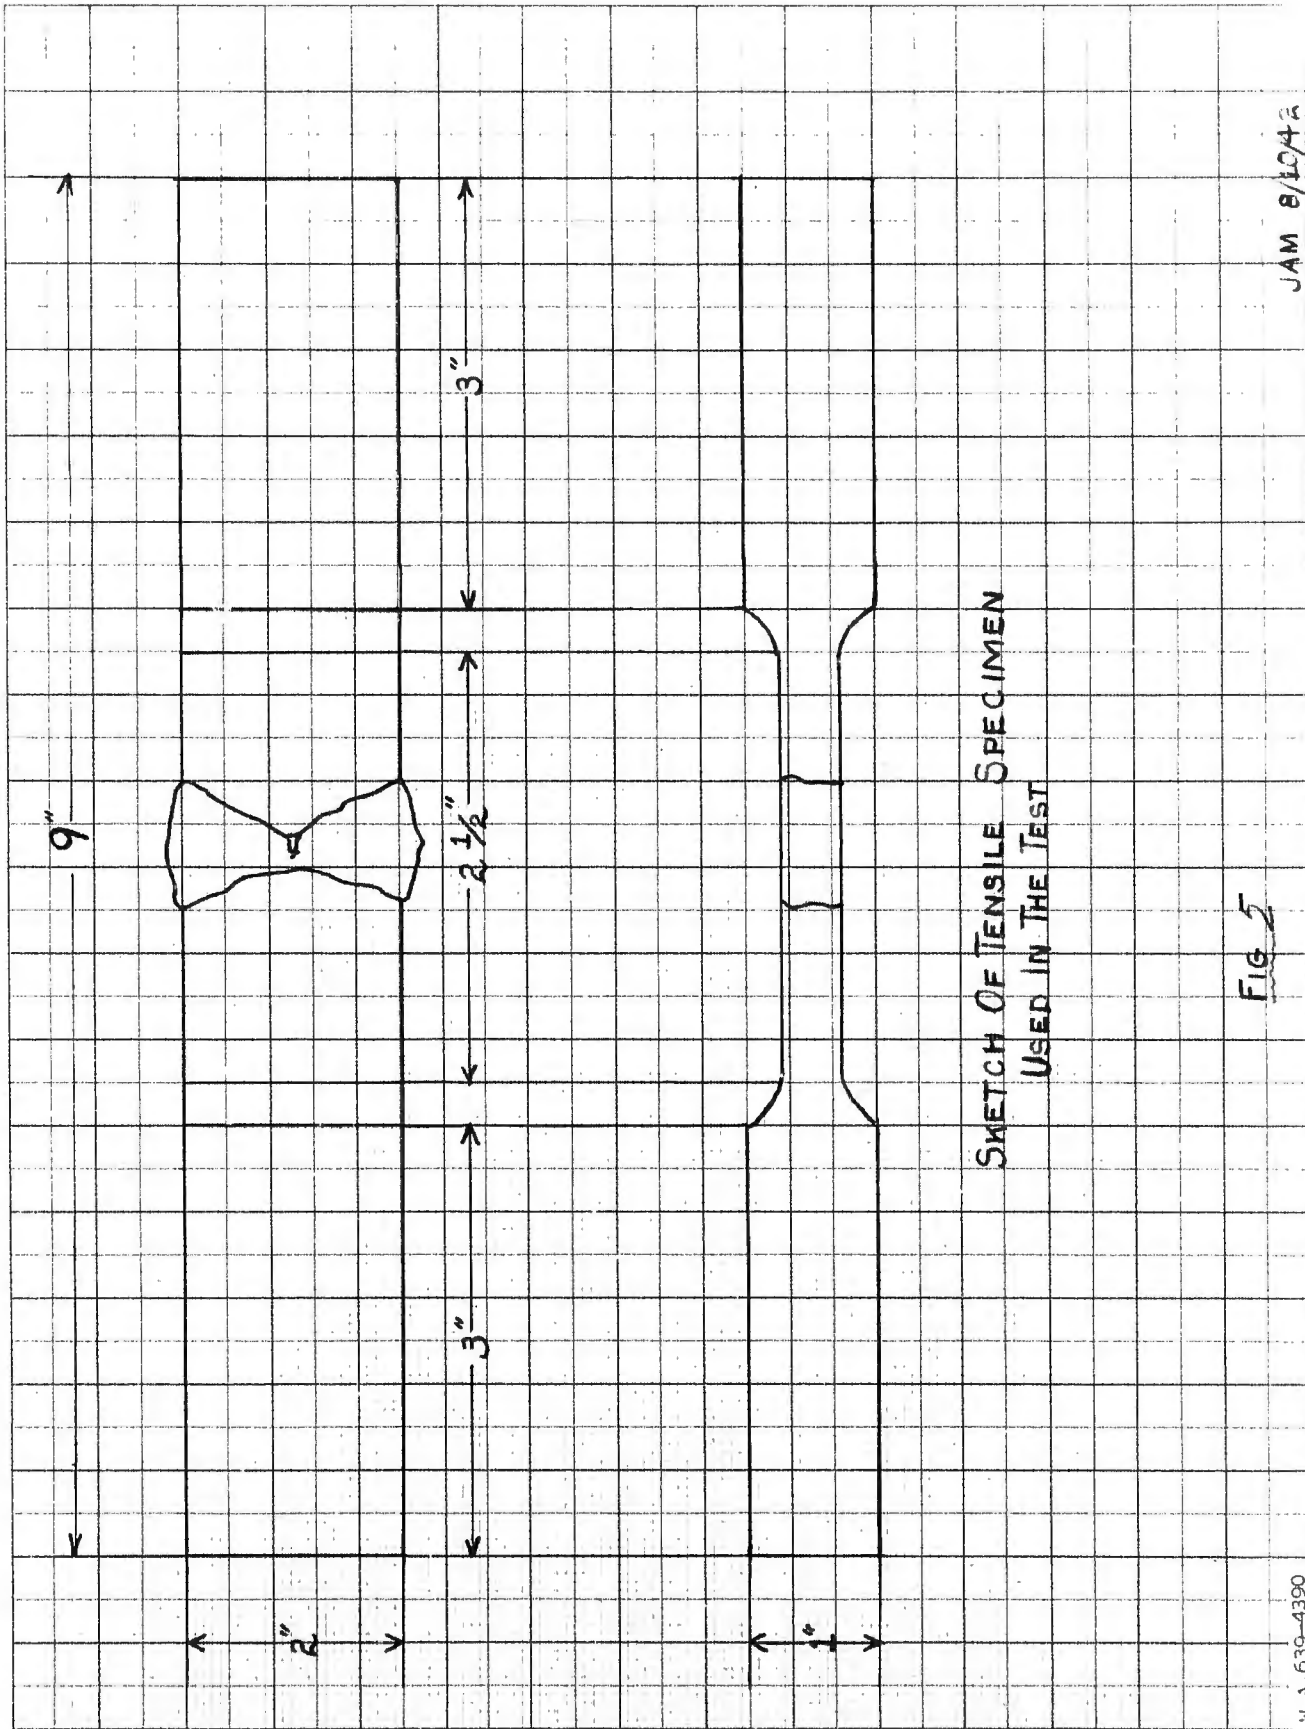
FIGURE 5

Type of tensile test specimen
taken across weld joint.

SKETCH OF TENSILE SPECIMEN
USED IN THE TEST

A standard .505" diameter tensile bar was taken longitudinally in the weld metal and two (2) flat tensile bars were taken across the joint. Figure 5 is a sketch of flat tensile bars. Results of tests were as follows:

<u>Location</u>	<u>Yield Strength psi(0.1% ext.)</u>	<u>Tensile Strength psi</u>	<u>Elongation % (1" gage)</u>	<u>Remarks</u>
Across joint 1 A	76,900	84,500	20	Break occurred in weld metal at center of joint.
Across joint 1 B	69,200	70,200	17	Break occurred in weld metal & showed slag inclusions at edge of steel strip.
Longitudinally in weld metal	70,000	94,700	33	Break occurred in middle third of specimen & showed a large slag inclusion.

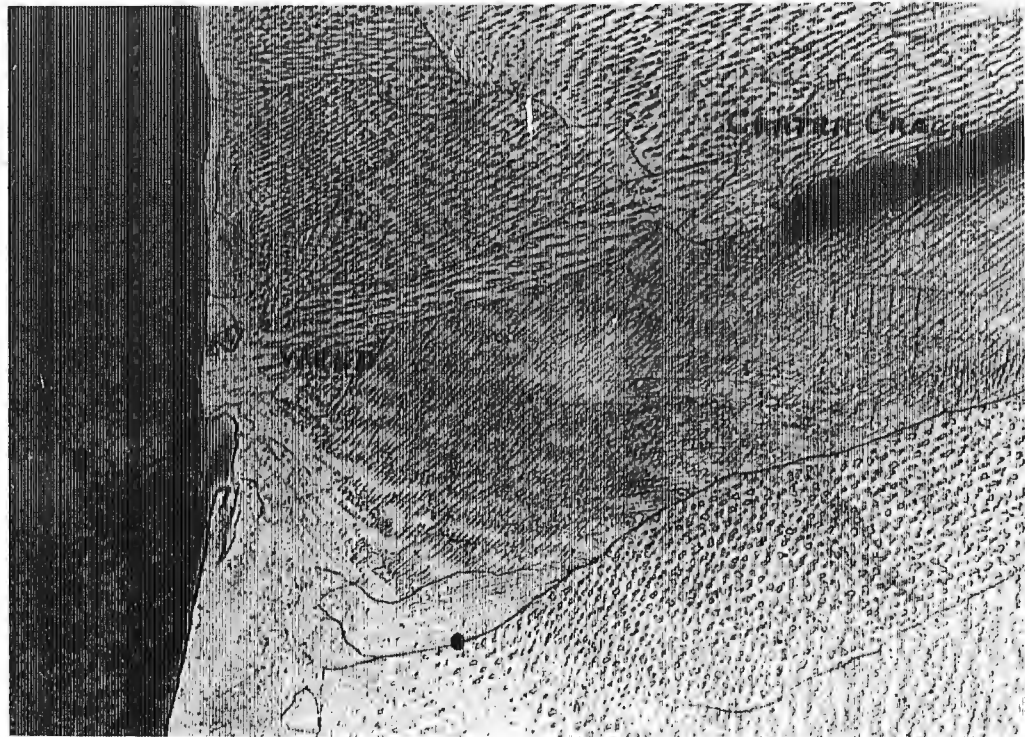
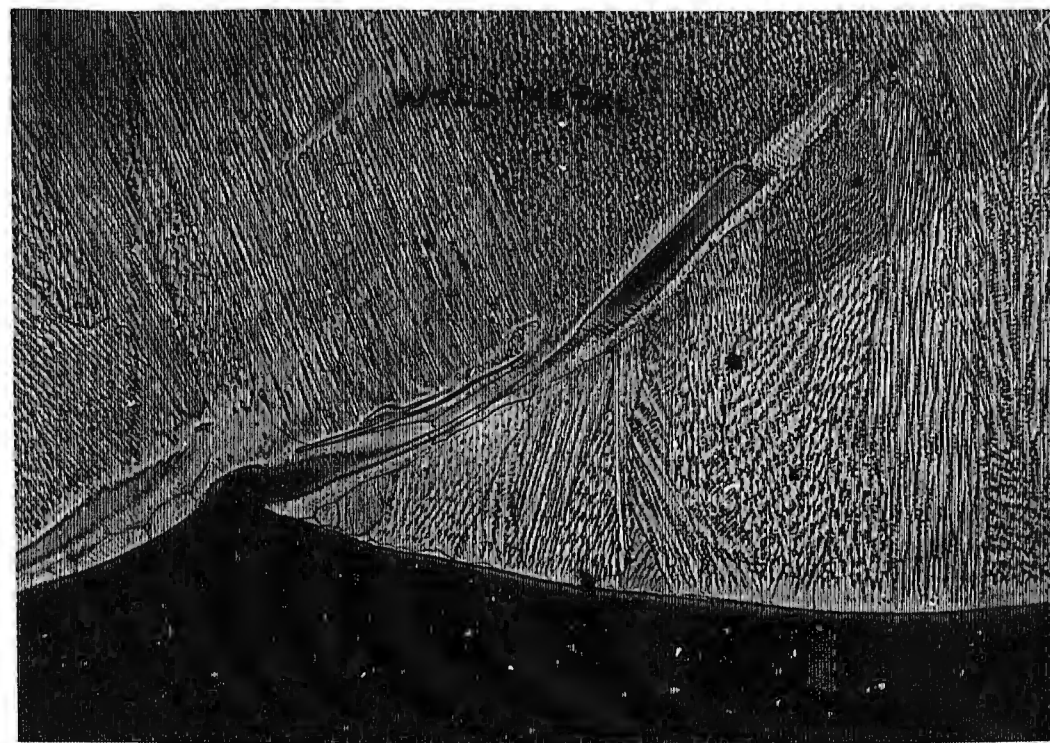
FIGURE 6

A. Boundary of 18/8 weld metal
and mild steel strip.

B. Boundary of 18/8 weld metal
and armor plate.

Figures 6, 7, and 8 are photomicrographs of the weld section. Figure 6 shows boundaries of weld metal and low carbon steel strip and of weld metal and armor plate. Figure 7 shows area where weld metal did not penetrate between armor plate and low carbon steel strip. Figure 8 shows a crater crack and an area of weld metal near the steel strip in which carbides have precipitated. The weld defects of Figures 7 and 8 are regarded as deleterious to the resistance to ballistic shock of this type joint.

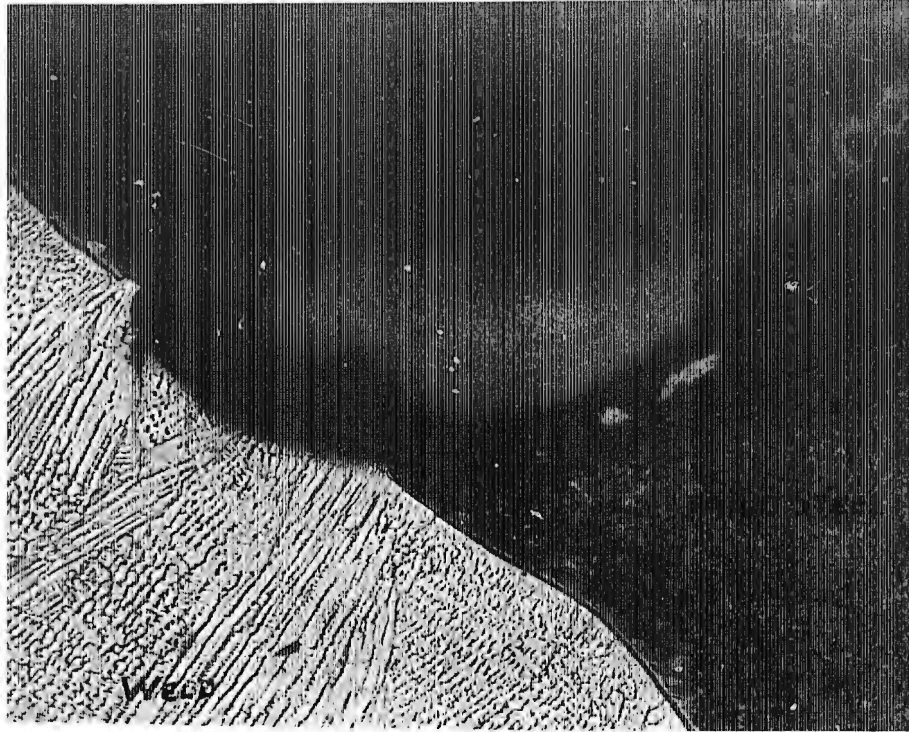
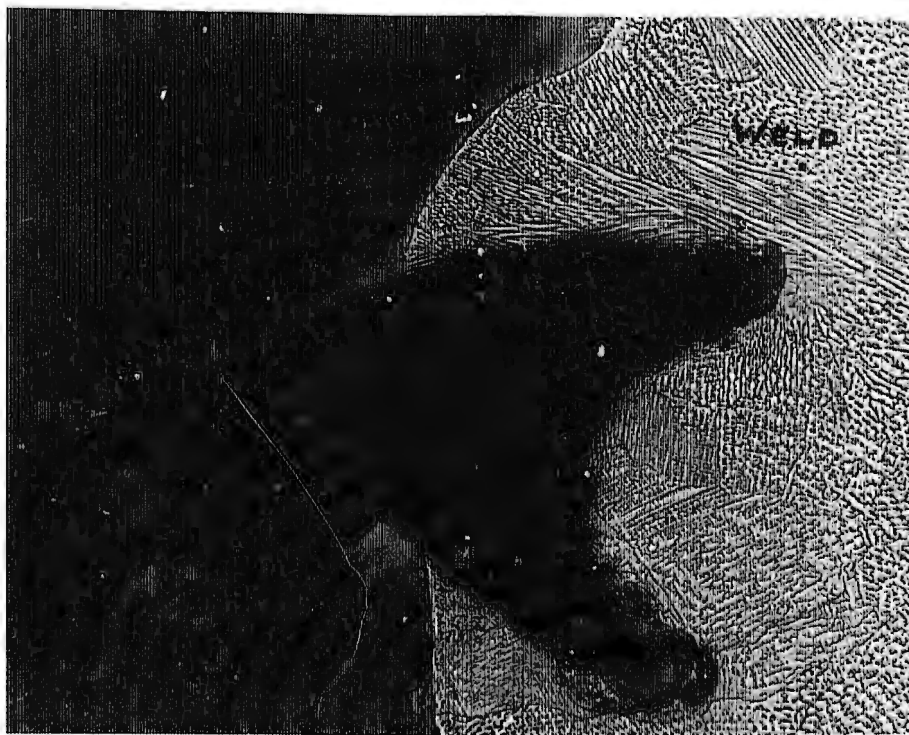
FIGURE 7

Areas where weld metal failed to
penetrate between mild steel strip and
armor plate.

Radiographic examination of the weld before ballistic test disclosed a lack of penetration of weld metal, between the armor plate and low carbon steel strip used at root of joint, and crater cracks in the weld metal.

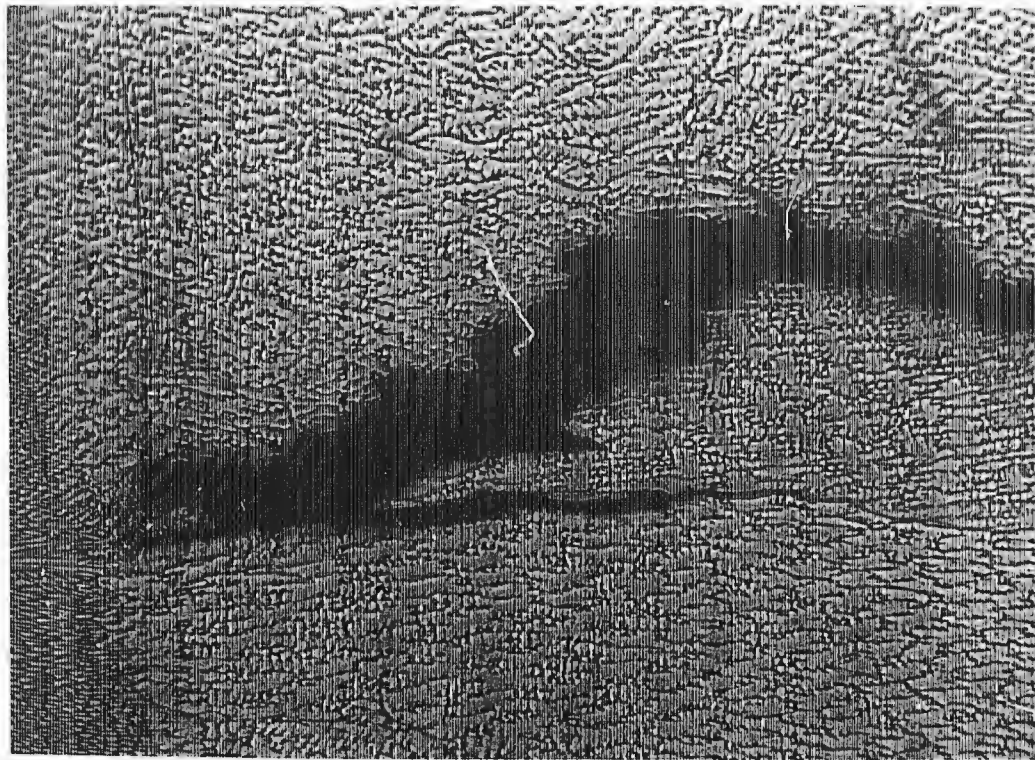
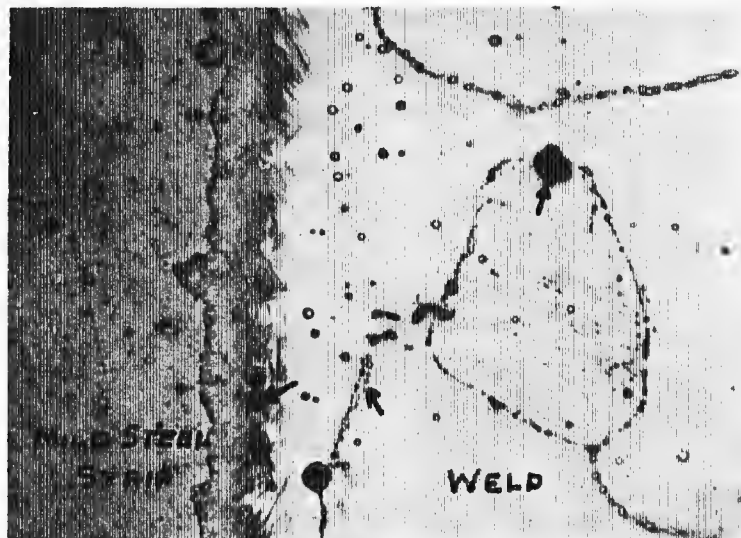
FIGURE 8

A. Crater crack in weld metal.

B. Area of carbide precipitation in
weld metal at boundary of mild steel strip
and weld metal.
