# WATERTOWN ARSENAL LABORATORY

NO. WAL 640/153

WELDING OF ARMOR

Examination of Samples from "H" Welded Ballistic Test Plates  
Three Submitted by Chrysler Plymouth Corporation and One by  
General American Transportation Company

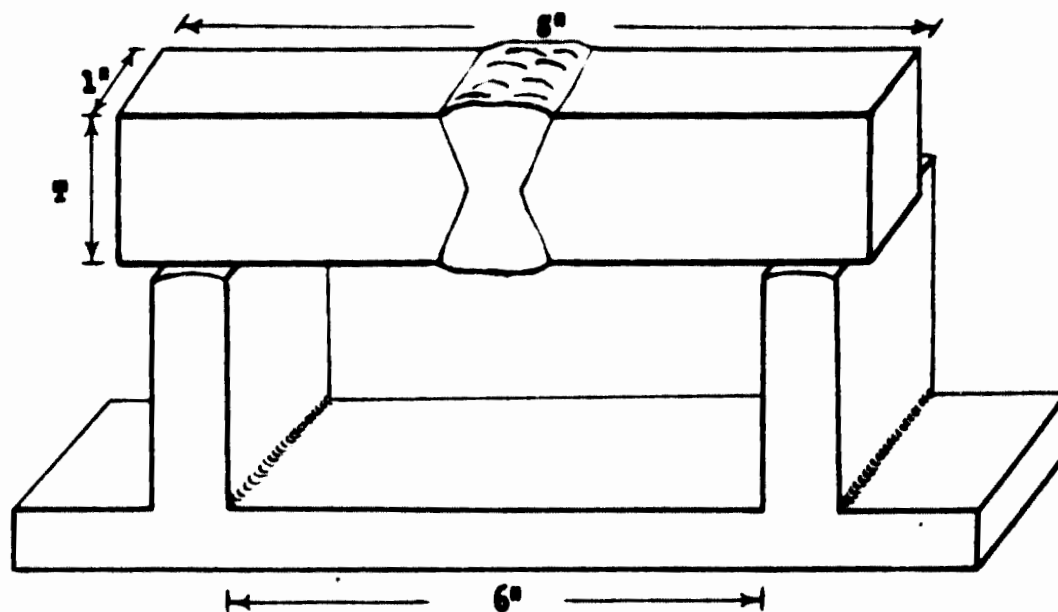
Figure 2. Bend Fracture Test of Weld Joint

Load applied to center of weld

Supported on six-inch span; bars of 1 inch and 1 1/2 inch thickness broken in a steam press; bars of lesser thickness broken with one blow of drop weight

Samples were notched and broken as indicated in Figure 1 to develop fibre characteristics of the plate metal, heat affected zone and weld metal on fractured surface through weld joint. From one half of the fractured specimens, bend bars one inch wide were taken transversely through the weld joint. Bend bars were broken as shown in Figure 2 with slow rate of loading at approximately +70°F. One half of the broken bar was ground and macroetched to show path of fracture.
