EXAMINATION OF SAMPLES  
OF  
LIGHT ARMOR PLATE

Report No. 710/55  
Watertown Arsenal

June 17, 1936

Examination of Samples  
of  
Light Armor Plate

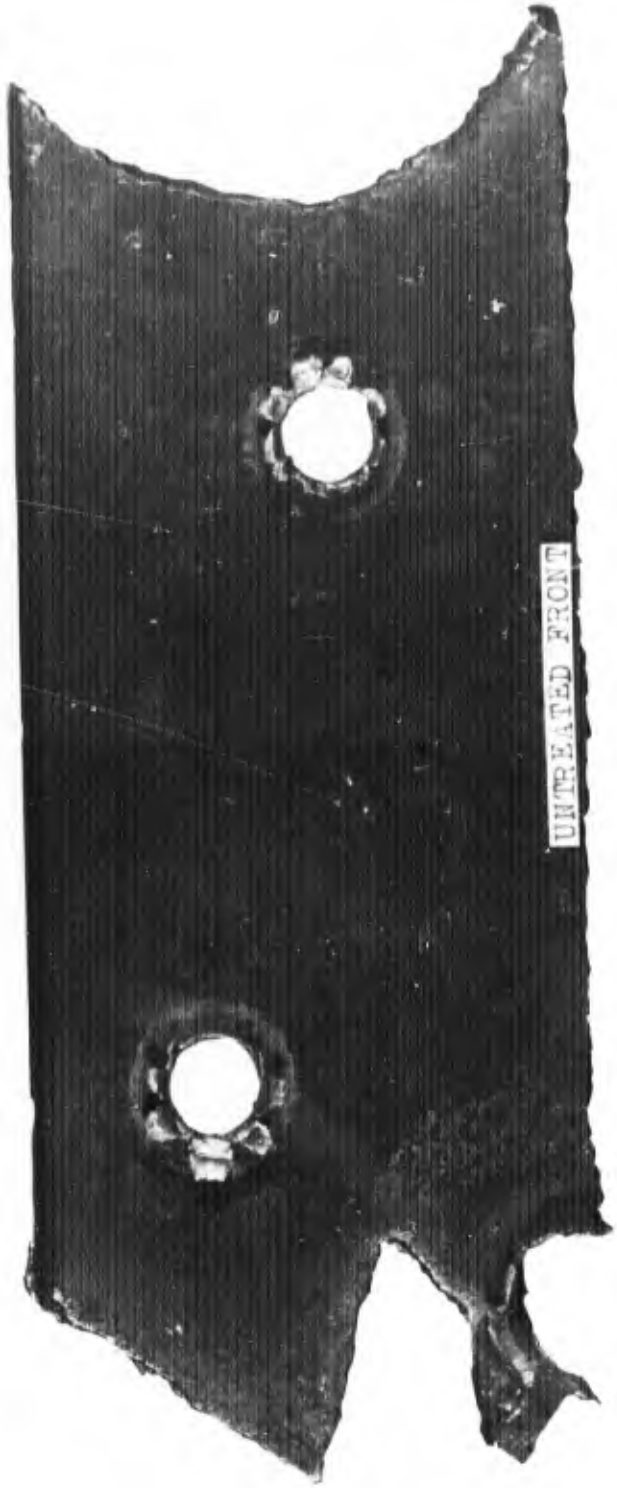
FIGURE 1.

Untreated Sample

Front Face

Brinell Hardness 121

Fired at with a service rifle and  
service ammunition, at a distance of 20  
yards.

No complete penetrations were found on the treated samples, while the untreated sample was easily penetrated by the ammunition used, see Figures 1, 2, 3, 4, 5 and 6.

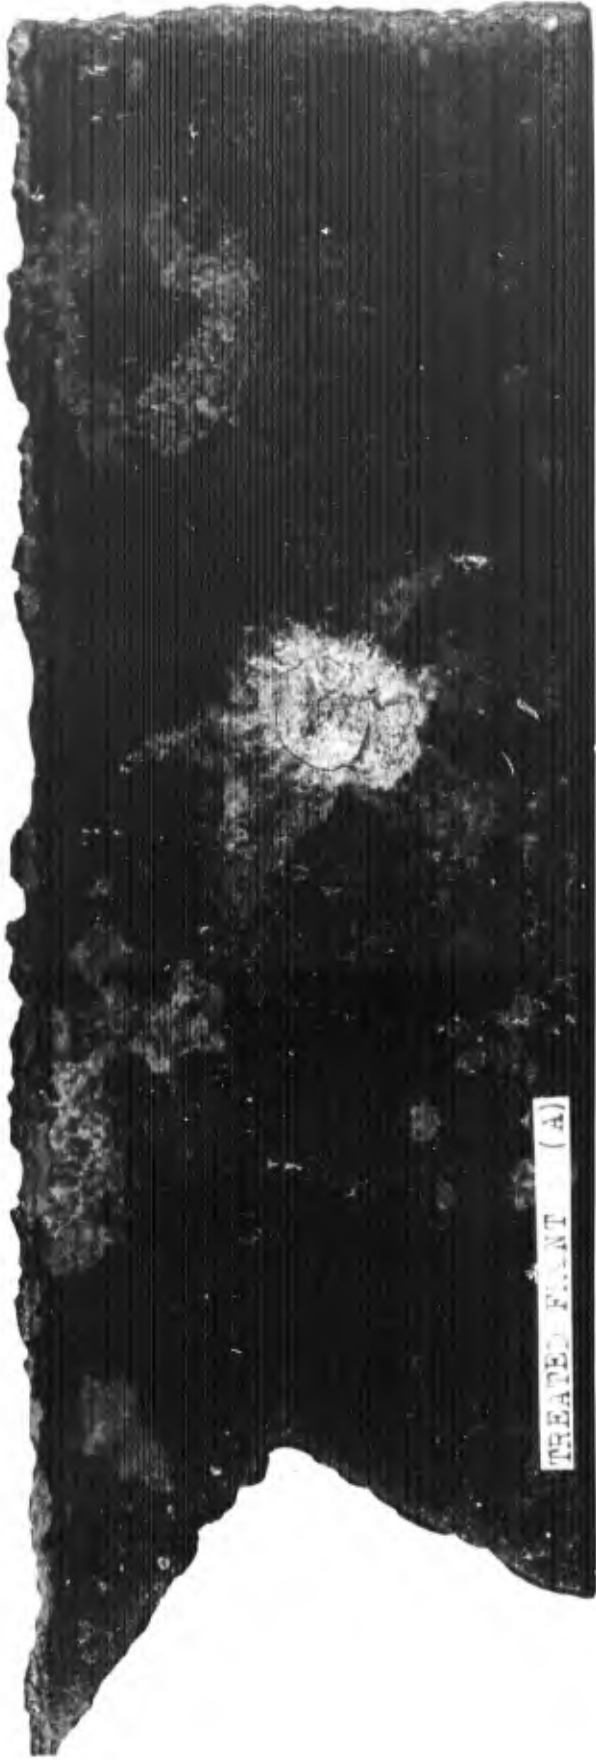
FIGURE 3.

Treated Sample "A"

Front Face

Brinell Hardness case-front-533

Brinell Hardness core -286

Fired at with a service rifle and service  
ammunition at a distance of 20 yards.

Photographs illustrating the brittleness of the plates resulting from the ballistic tests as described by Capt. Neal in his letter of March 16, 1936 to the

Ordnance Officer, Ft. Sam Houston, Texas, are shown in Figs. 3, 4, 5 and 6.

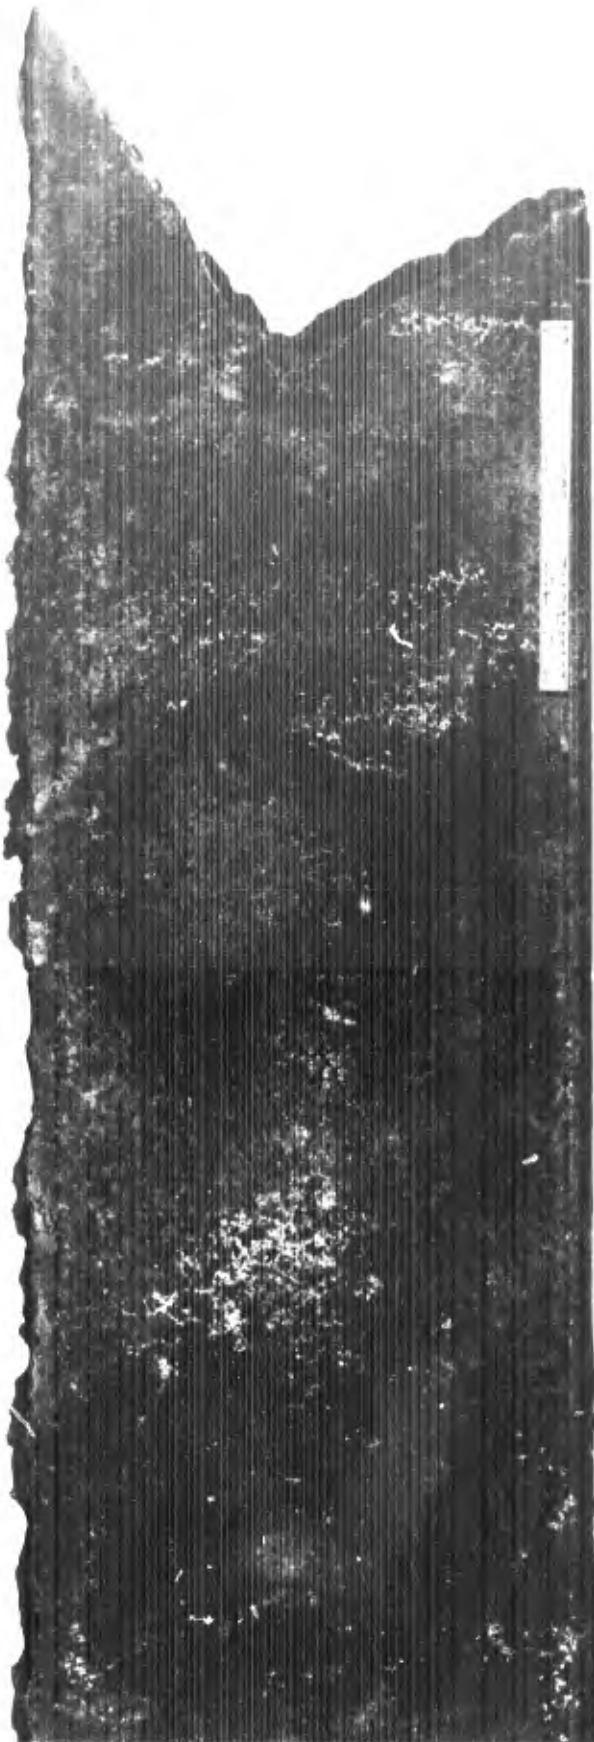
FIGURE 4.  
Treated Sample "A"  
Back Face

Brinell Hardness case-front-533  
Brinell Hardness core -286

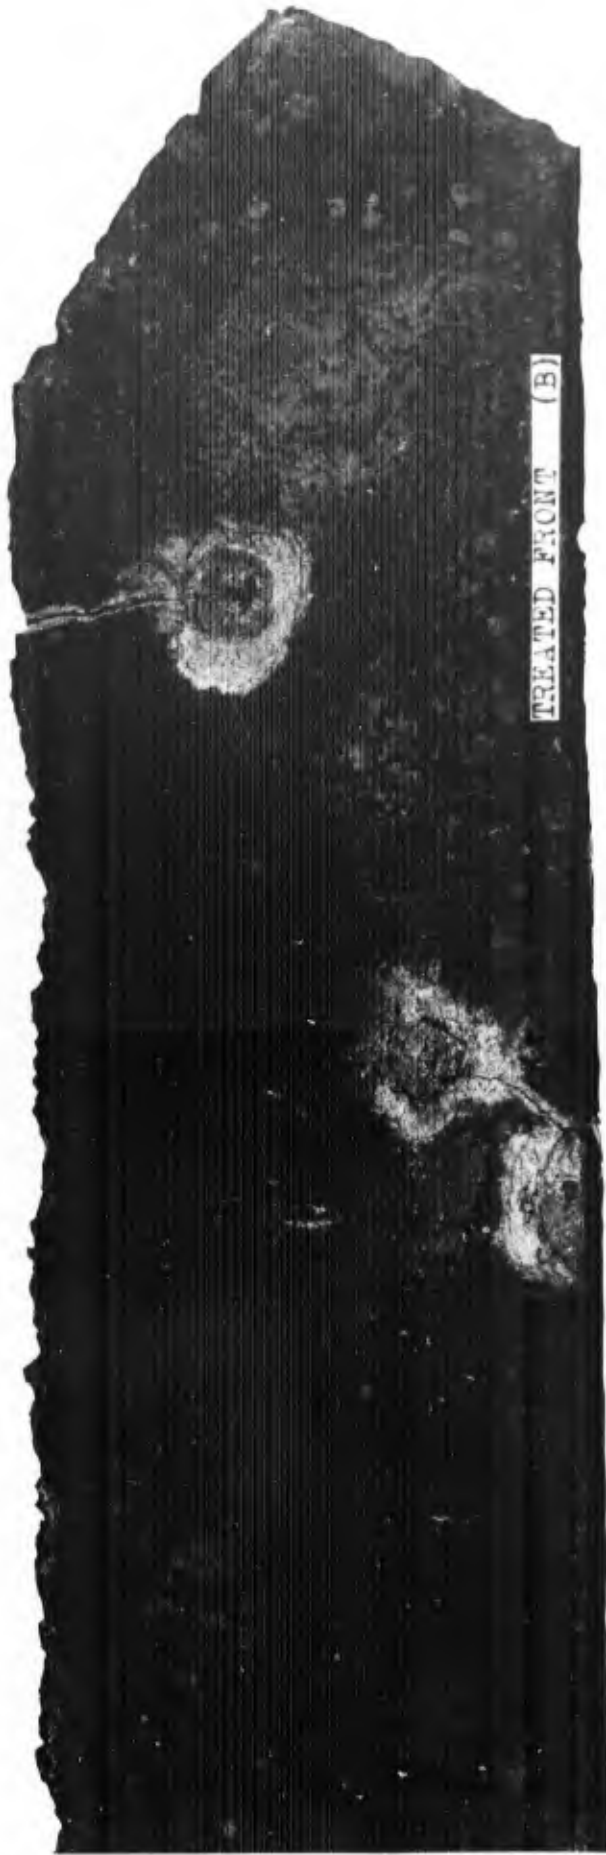
FIGURE 5.

Treated Sample "B"

Front Face

Brinell Hardness case-front-533

Brinell Hardness core -286

Fired at with a service rifle and  
service ammunition at a distance of 20  
yards.

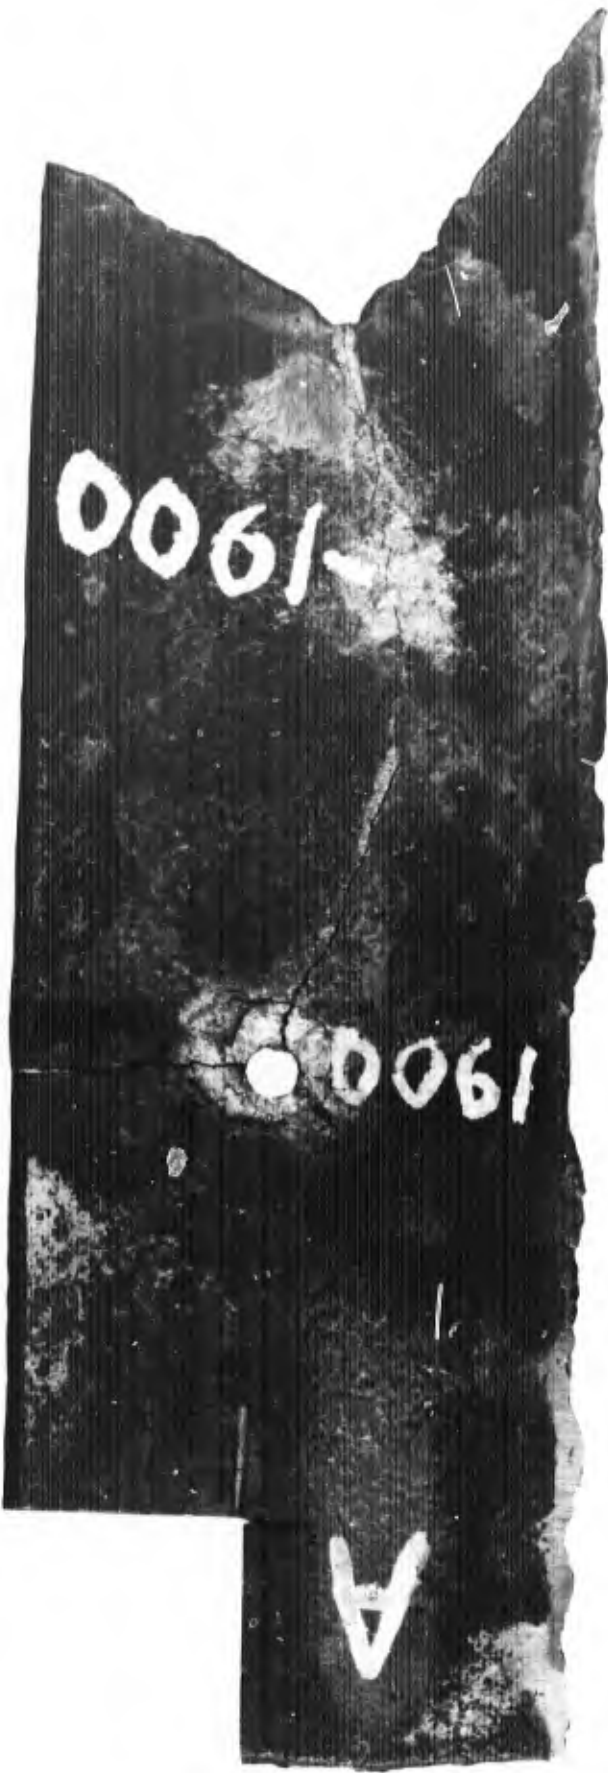
FIGURE 7.

Treated Sample "A"

Front Face

After Ballistic Test (Watertown Arsenal)

Distance from muzzle to plate 100  
yards ammunition cal .30 A.P. M 1922,  
1900 F/S striking velocity, preloaded.

<u>Plate No.</u>	<u>Round No.</u>	<u>Striking Velocity</u>	<u>Penetration</u>	<u>Appearance of Back Plate</u>
Treated "A"	1	1900 f/s	Partial	Crack from edge of plate to round 2
	2	1900 f/s	Complete	Large radial cracks on same spot as former impact
Treated "B"	1	1600 f/s	Partial	No bulge, no cracks
	2	1900 f/s	Partial	No bulge, plate cracked into two pieces through area of impact

Photographs illustrating the lack of toughness in the plates after the Ballistic tests at Watertown Arsenal, are shown in Figs. 7, 8, 9 and 10.

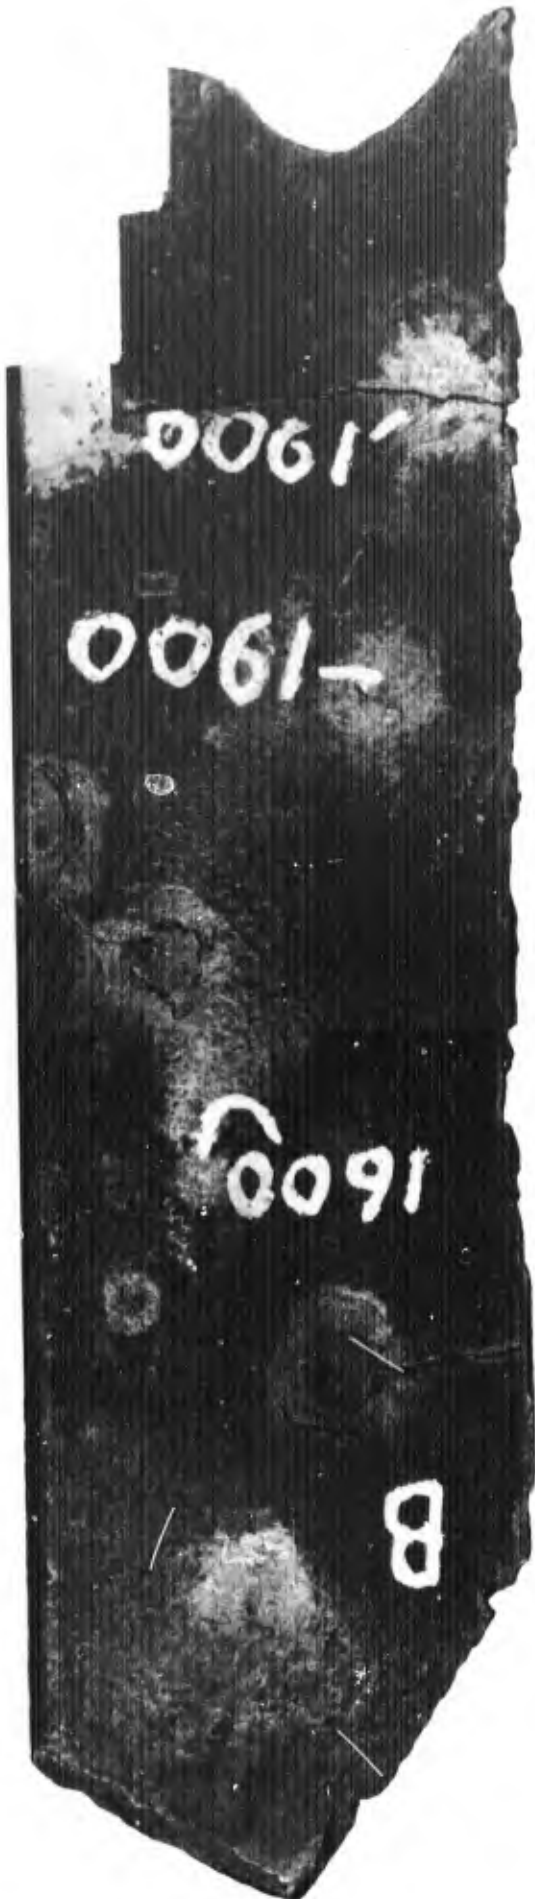
FIGURE 9.

Treated Sample "B"

Front Face

After Ballistic Test (Watertown Arsenal)

Distance from muzzle to plate 100 yards,  
ammunition cal. .30 A.P. M 1922, 1600 F/S  
and 1900 F/S striking velocity, preloaded.

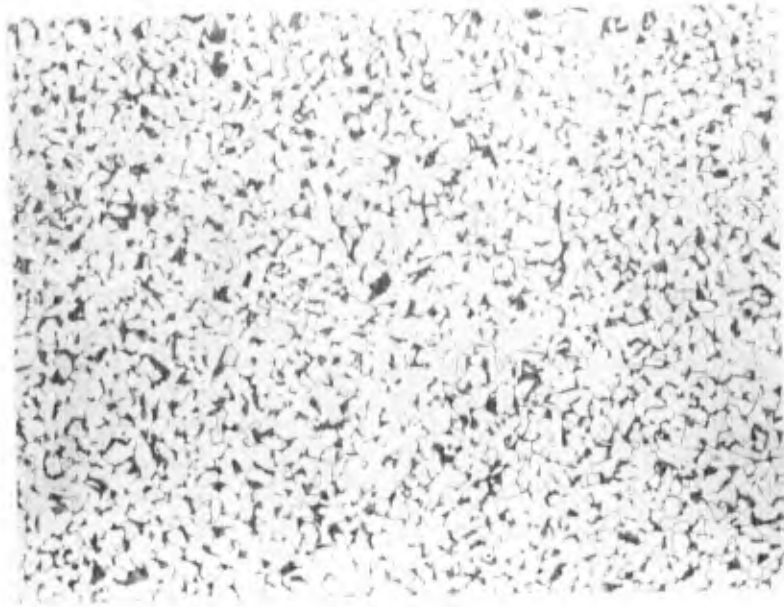
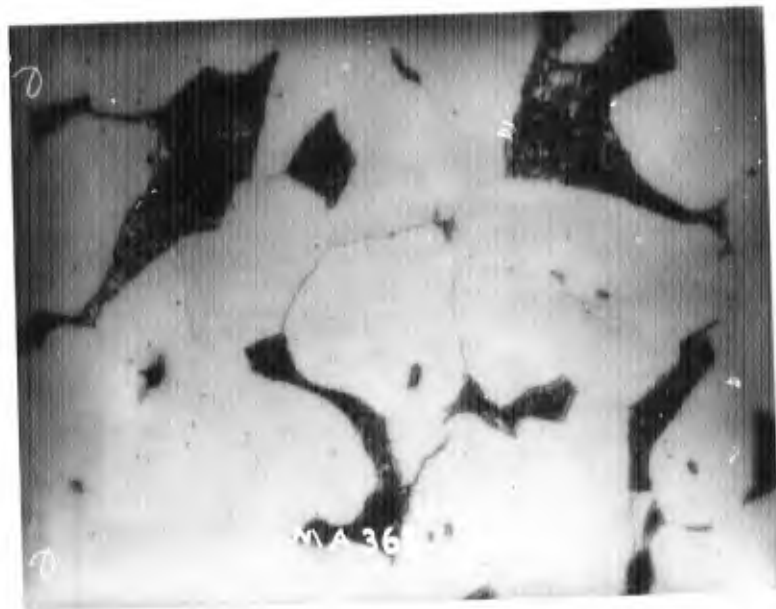
FIGURE U

Untreated Specimen, U.

1.) X100 Typical area of specimen, showing ferrite and pearlite indicating an annealed low carbon (approximately 20 carbon).

2.) X1000 Shows structure of the pearlite.

Chemical analysis of the material submitted in the untreated state indicates that it is a plain low carbon steel.

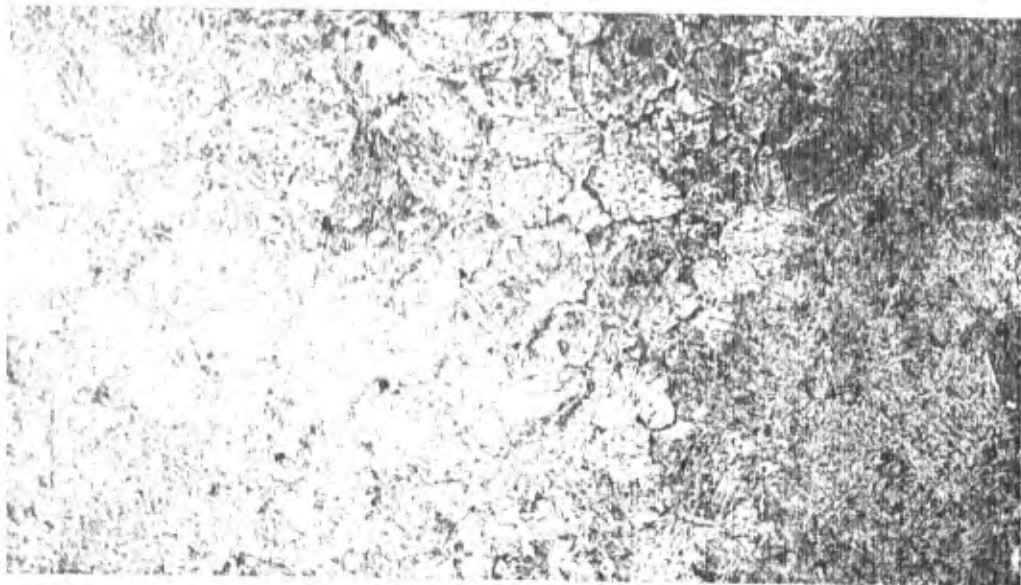
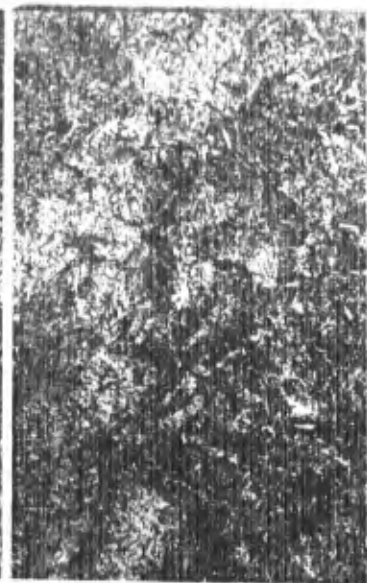
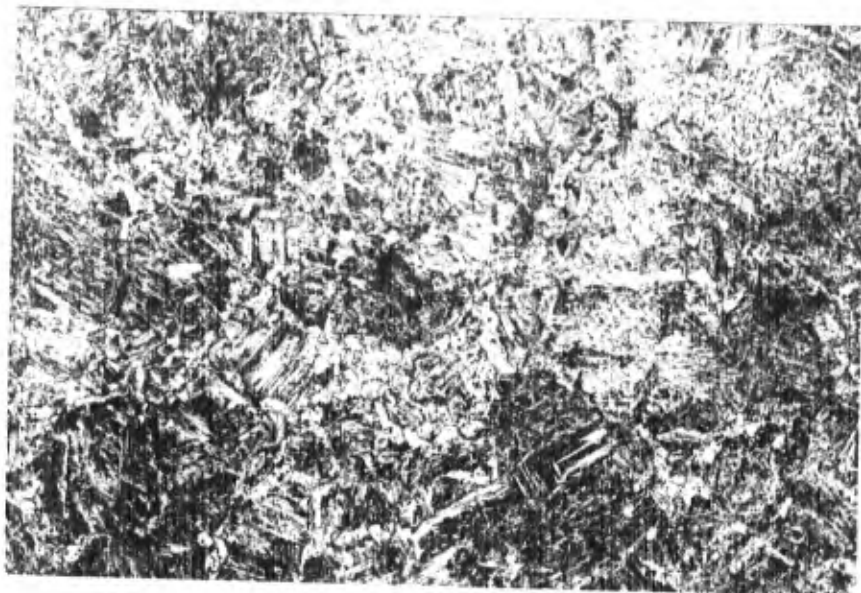
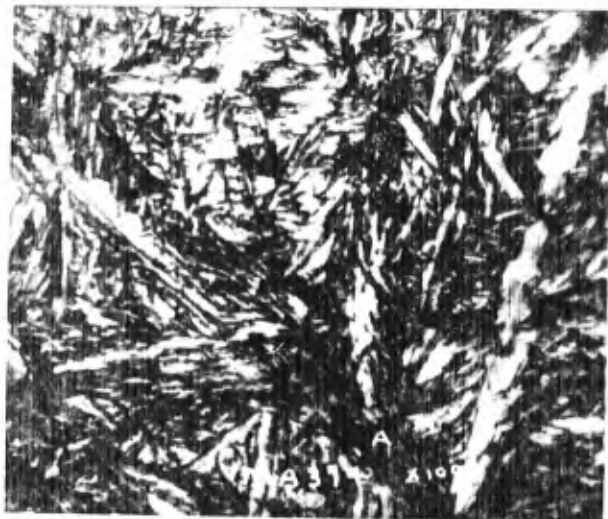
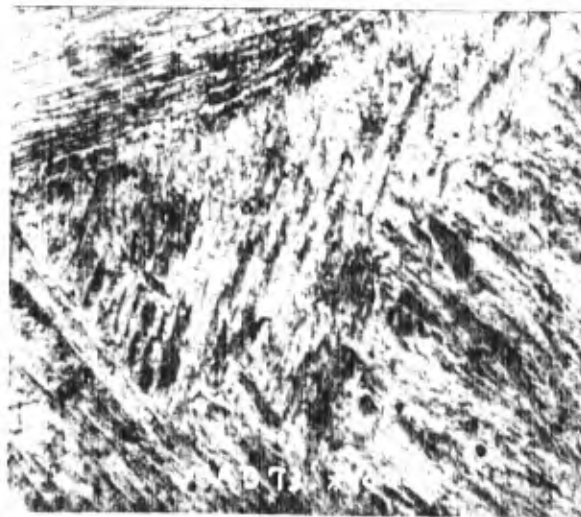
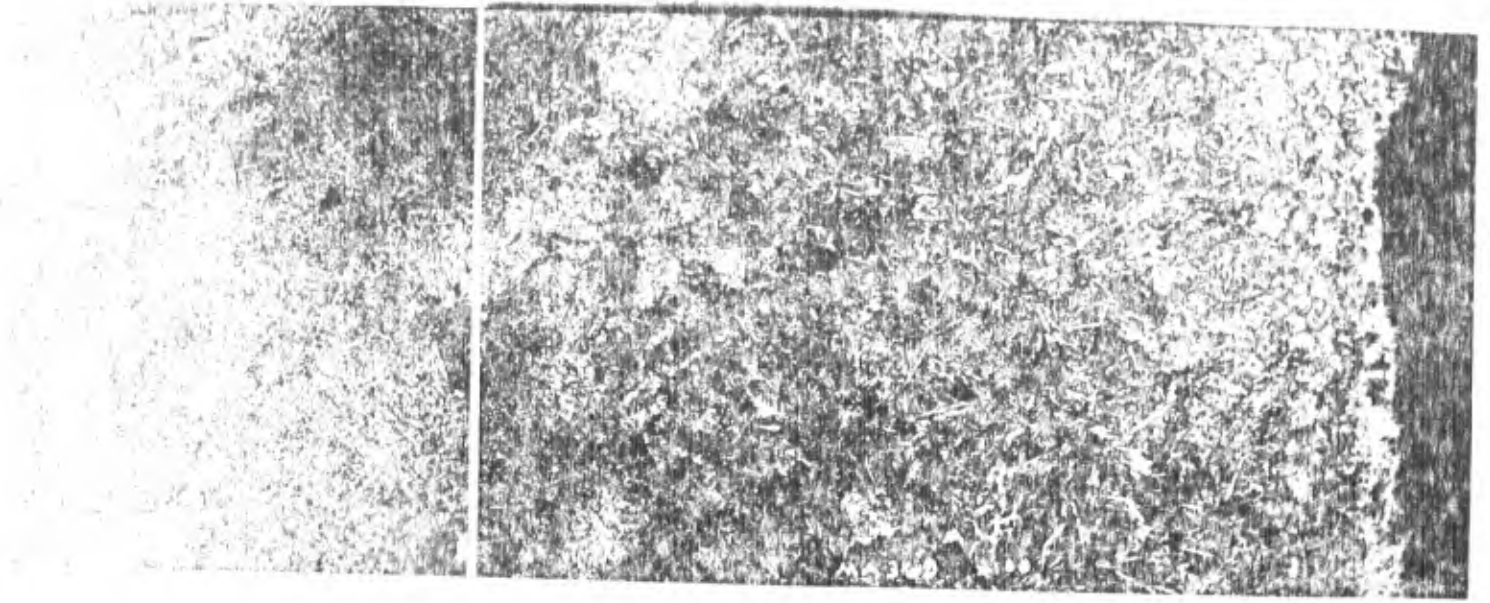
FIGURE A.

Treated Specimen - A & B

1.) X100 (A) - Case, typical of both sides and specimens showing very coarse martensite. This should be very brittle, chip and crack easily.

2.) X100 (A) - Core, typical of both specimens. Coarse grained martensitic troostite.

3.) X1000 (A) - Case, showing at high power typical needles of martensite with the  $60^\circ$  angle. Evidence of sementite at the far right.

4.) X1000 (A) - Core, pseudo-martensitic structure with both  $60^\circ$  and  $90^\circ$  angles formed by needles of ferrite.

Microscopic examination clearly shows that the samples have been case hardened and subsequently quenched from a temperature considerably above the critical range.

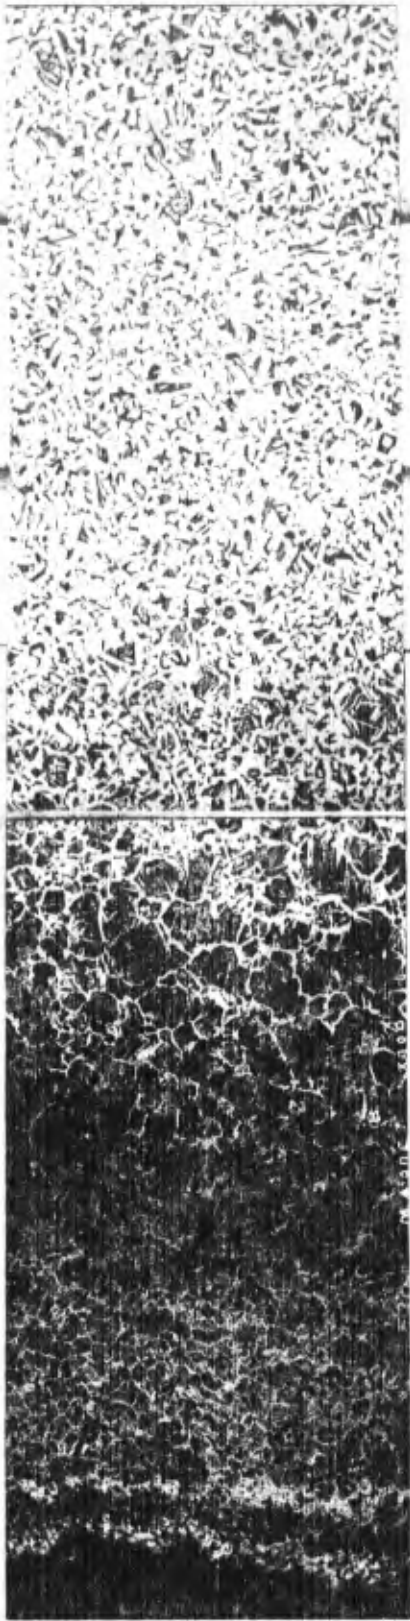
FIGURE B.

Specimen B after annealing. Previous to Watertown Arsenal treatment this specimen showed the same properties as specimen A in Fig. A.

1.) X100. - Panorama showing that the case had been carburized.

Hyper-Eutectoid----	.02 in.
Eutectoid-----	.0075 in.
Hypo-Eutectoid----	<u>.0325</u>
Total case	.06 in.

A soft skin of about .005 in. is probably due to residual scale.

Both surfaces of the plate have been case hardened. A treated sample was heated above the critical temperature of the case and core and cooled slowly in order to determine the depth of case, the results of which are as follows:

Depth of Hyper-eutectoid case	.02"
" " Eutectoid case	.01"
" " Hypo eutectoid case	.025"
