REPORT NO. 642.1/28

BUTT & FILLET WELDS  
1/4" TENSILE STRENGTH STEEL, GRADE #1  
(REPUBLIC STEEL CORP.)  
(SPECIMENS FURNISHED BY MR. HOWARD MILLER)

Hardness and Microstructures  
on R.D.S. Grade #1 - 1/4"  
Welded Plates.

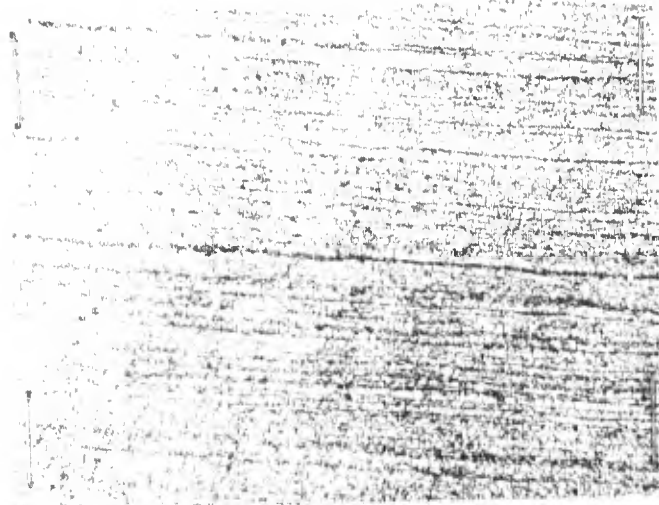
Fig. 2 10% Nital x100  
Normalized plate structure - position #1

Figs. 2 to 15 are micrographs illustrating the structures at various positions adjacent to the hardness impressions.

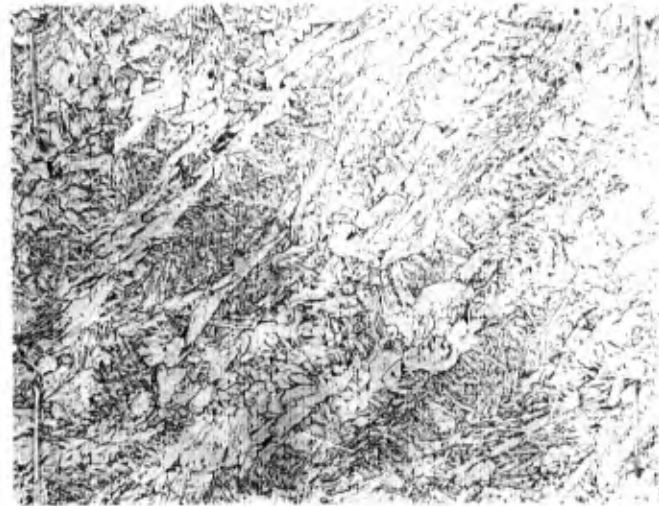
Fig. 11 10% Nital x100 Weld structure - position #2

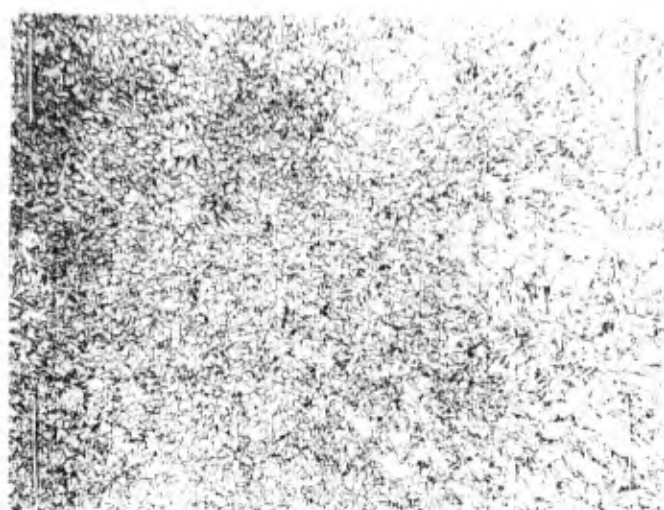
Fig. 15 10% Nital x100 Fusion zone of weld and plate. Position #3
