# AIR CORPS INFORMATION CIRCULAR

## SPOT WELDING AND ITS APPLICATION TO AIRCRAFT STRUCTURE CORROSION-RESISTANT STEEL 18:8

(MATÉRIEL BRANCH REPORT)

(Prepared by Charles L. Hibert, Materiel Division, Air Corps, Wright Field, Dayton, Ohio, Nov. 15, 1933)

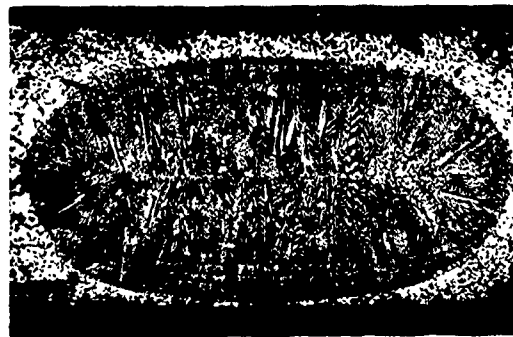
FIGURE 1.

PLATE 4492-M.—Surface view of a perfect spot weld.

PLATE 4497-M.—Interior view of the same spot weld.

0.026 Allegheny sheet magnified 18X.

*Welding conditions.*— Die size, one-fourth inch; die pressure, 175 pounds, breaking strength, 360 pounds, time, 0.0833 second, current, C.

PLATE 4491-M.—Photomicrograph magnified 36X. Etch, glycerol.

In figures 1 to 5, inclusive, are shown photomicrographs of typical spot welds. It will be noticed that all welds with normal strength show evidence of pipes or gas holes, and indicate splashes between the sheets. Figure 1 represents a structurally perfect spot weld with no evidence of gas holes or splashing between

sheets. The breaking strength of this spot is too low for practical purposes. Neither was it ductile enough to be rotated through an angle of 60°.

The views of the interior of the joint (figs. 1 and 2) present a different appearance but still do not give conclusive evidence as to the value of the respective spot welding. The spot weld free from defects shows a clean-cut appearance and outline with absence of splashes or gas holes, but lacks high tensile strength.

The photomicrographs of a vertical section through a spot weld give some indication of its relative strength. In figure 1, plate no. 4491-M, the spot weld free from blow holes shows a definite line of demarcation between the plane of the sheets. This indicates improper fusion between the sheets. Consequently the shear value is lower and the breaking strength of the joint is insufficient for practical purposes. Although in figure 2, plate no. 4439-M, there is evidence of a gas hole, no line of demarcation is noticeable, and fusion of the joint is good.
