MEMO RPT. WAL NO. 710/545

METALLURGICAL EXAMINATION OF FORD MOTOR COMPANY 1" CAST ARMOR TEST PLATES

H. A. Matthews  
Maj., Ordnance Dept.  
Watertown Arsenal

Oct. 18, 1943

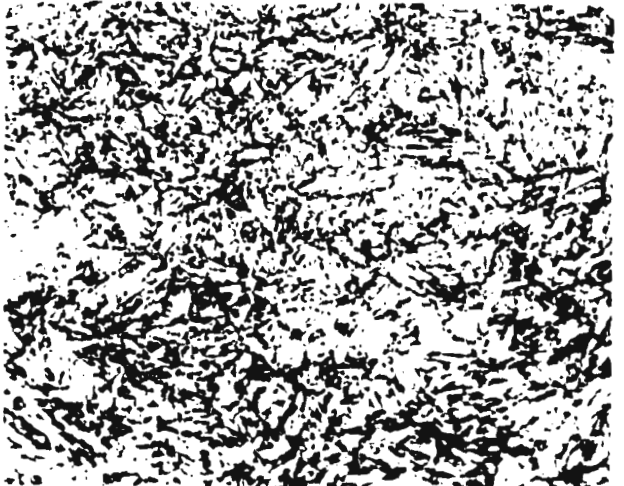
2642B

(5). Plate 2642B. Non-metallic inclusions well distributed. Some large silicate inclusions visible, average cleanliness. Shrinkage voids at center of section. Decarburization .035" and .03". Microstructure consists essentially of tempered martensite with slight traces of ferrite.

Essentially tempered martensite.  
Slight amounts of ferrite and  
carbide segregates visible.

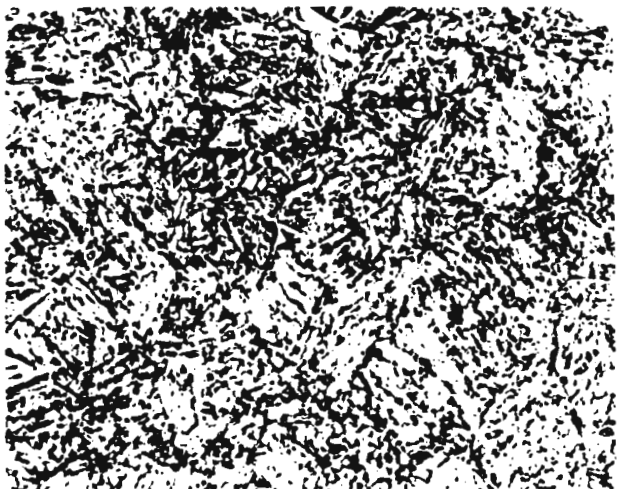
2663

(6). Plate 2663. Average non-metallic condition. Shrinkage porosity at center of section. Decarburization .020" and .03", average .025". Grain size 6-7. Microstructure essentially tempered martensite with small amounts of high temperature transformation products including ferrite.

Essentially tempered martensite.  
Slight amounts of ferrite and  
other high temperature transforma-  
tion products visible.

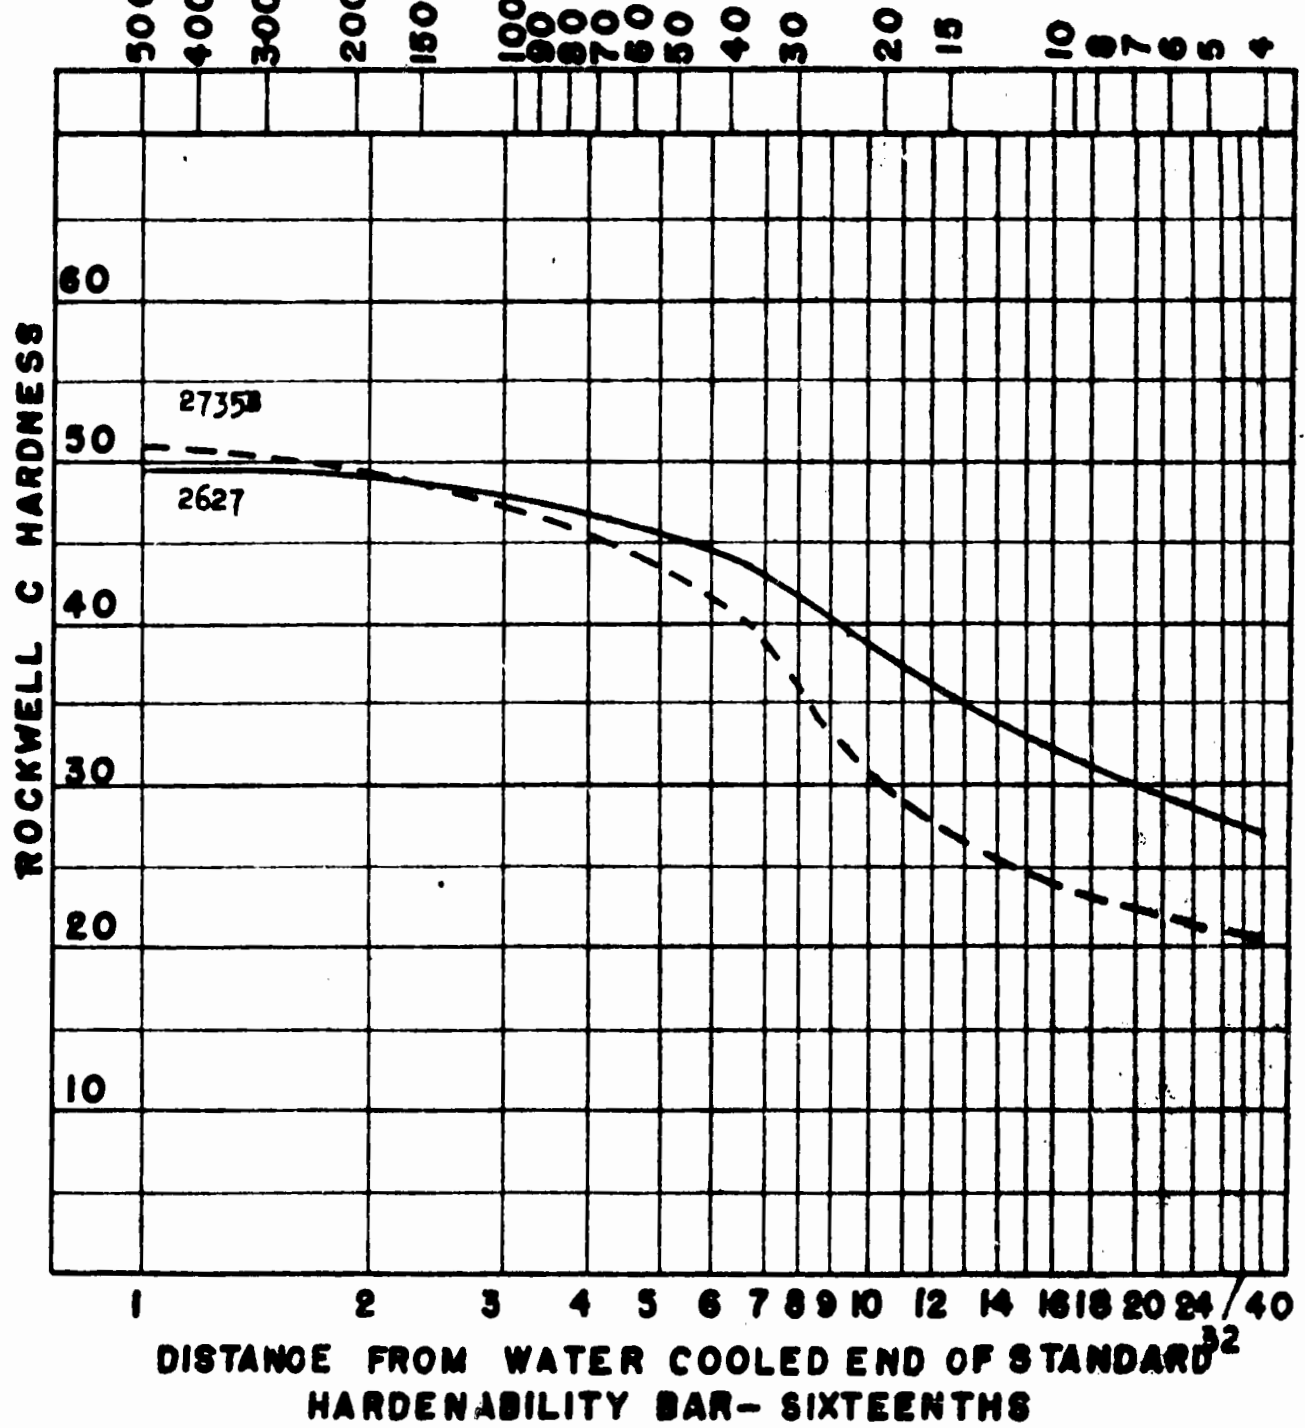
FIGURE 3.

d. Chemistry and Jominy Hardenability. Chemical analyses and Jominy hardenabilities were obtained on plates 2627 and 2735B. The results follow:

COOLING RATE, DEG. F PER SECOND AT 1300°F.
