July 28, 1923.

Report No. 5.

Light Armor Plate Development.

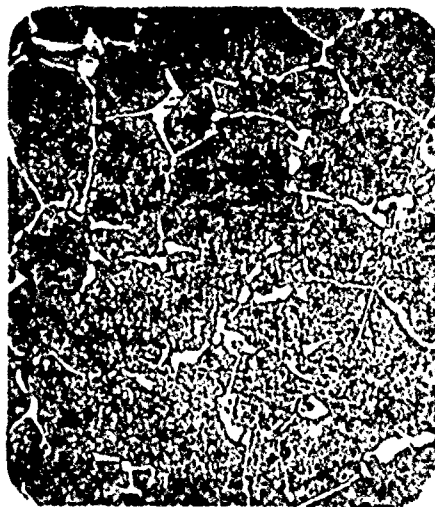
Fig. 15. x 500.  
Specimen No. 51 Q. Quenched  
from 775° C in water.

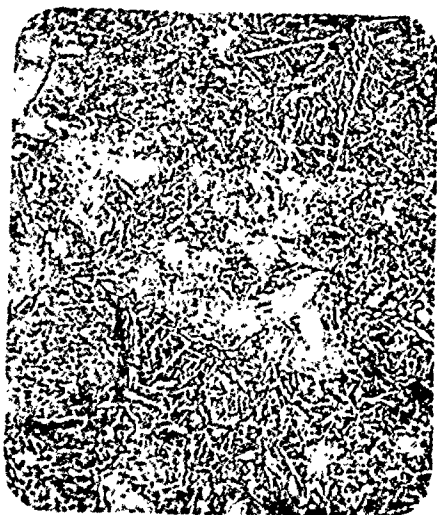
Fig. 19. x 500.  
Specimen No. 36 Q. Quenched  
from 850° C in water.

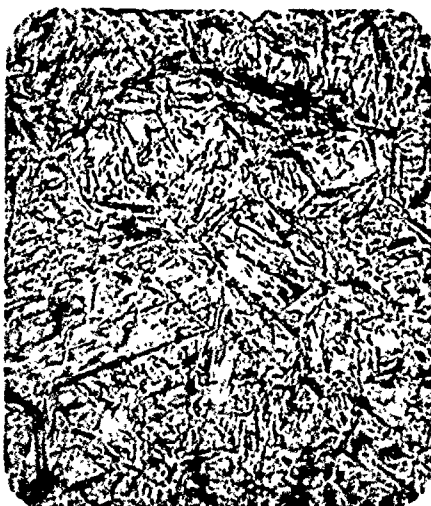
Fig. 23. x 500.  
Specimen No. 27 Q. Quenched  
from 925° C in water.

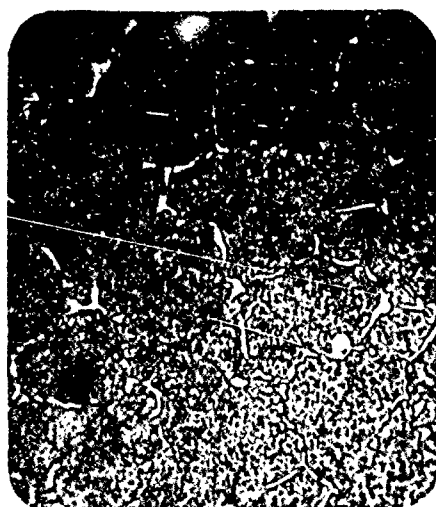
Fig. 29. x 500  
Specimen No. 49 Q. Quenched  
from 775° C in oil. Requenched  
from 775° C in oil.

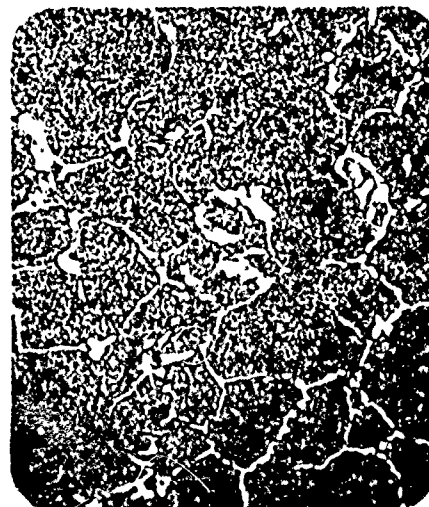
Fig. 30. x 500,  
Specimen No. 50. Quenched from  
775° C in oil. Requenched from  
775° C in oil. Tempered at  
285° C.

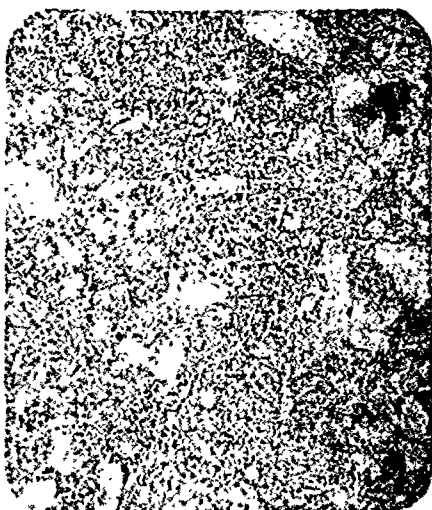
Fig. 39, x 500.  
Specimen No. 24 (core). Representative of emulsified martensite in the non-carburized areas.

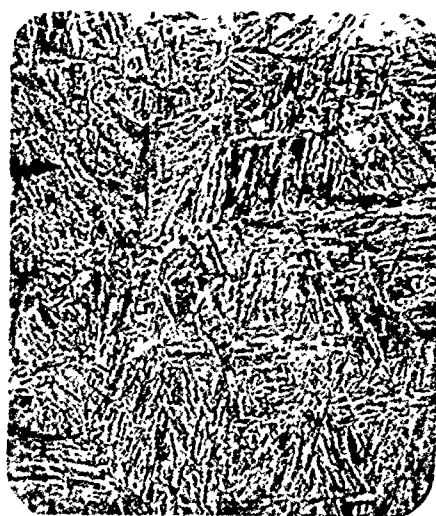
Fig. 40, x 500.  
Specimen No. 30. (core). Representative of martensite (needle structure) in the non-carburized areas.

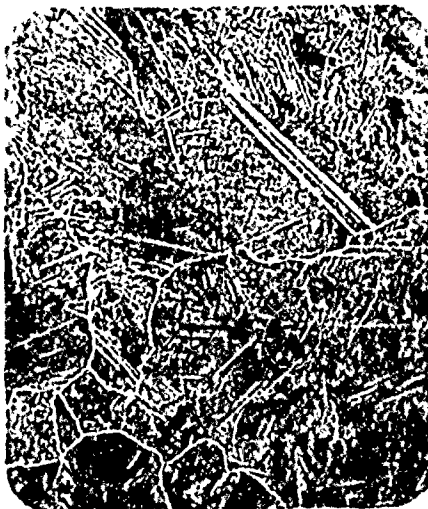
Fig. 43. x 100.  
Exceptional structure in armor plates of lot  
C D E after carburization but before heat treatment.
