### ARC WELDING OF ARMOR

Test of Five H Plates - 1 Inch Thick Rolled Homogeneous Armor  
Welded with Plain Carbon, Low Alloy, and Medium Alloy  
Ferritic Electrodes at Watertown Arsenal

March 20, 1943

WATERTOWN ARSENAL  
WATERTOWN, MASS.

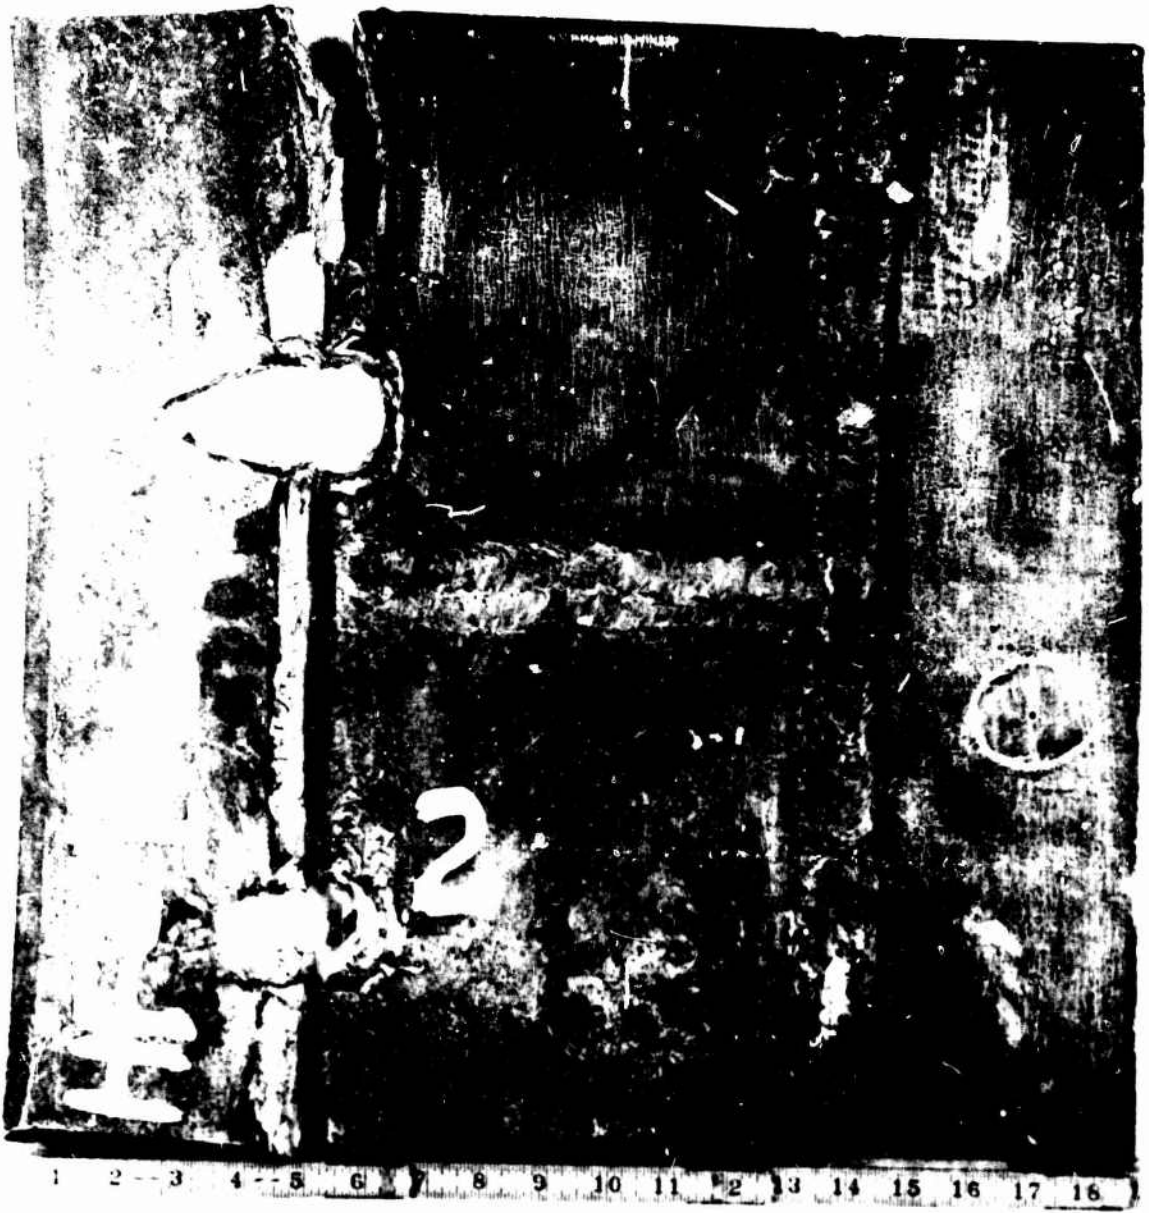
FIGURE 1 - FRONT VIEW OF 18 X 18 X 1 INCH M PLATE ARC WELDED WITH <sup>"B"</sup> ELECTRODE, AFTER BALLISTIC TESTING. DECEMBER 4 1942 WTN.710-1967

Figures 1 through 10 are photographs of front and rear of each plate after ballistic testing.

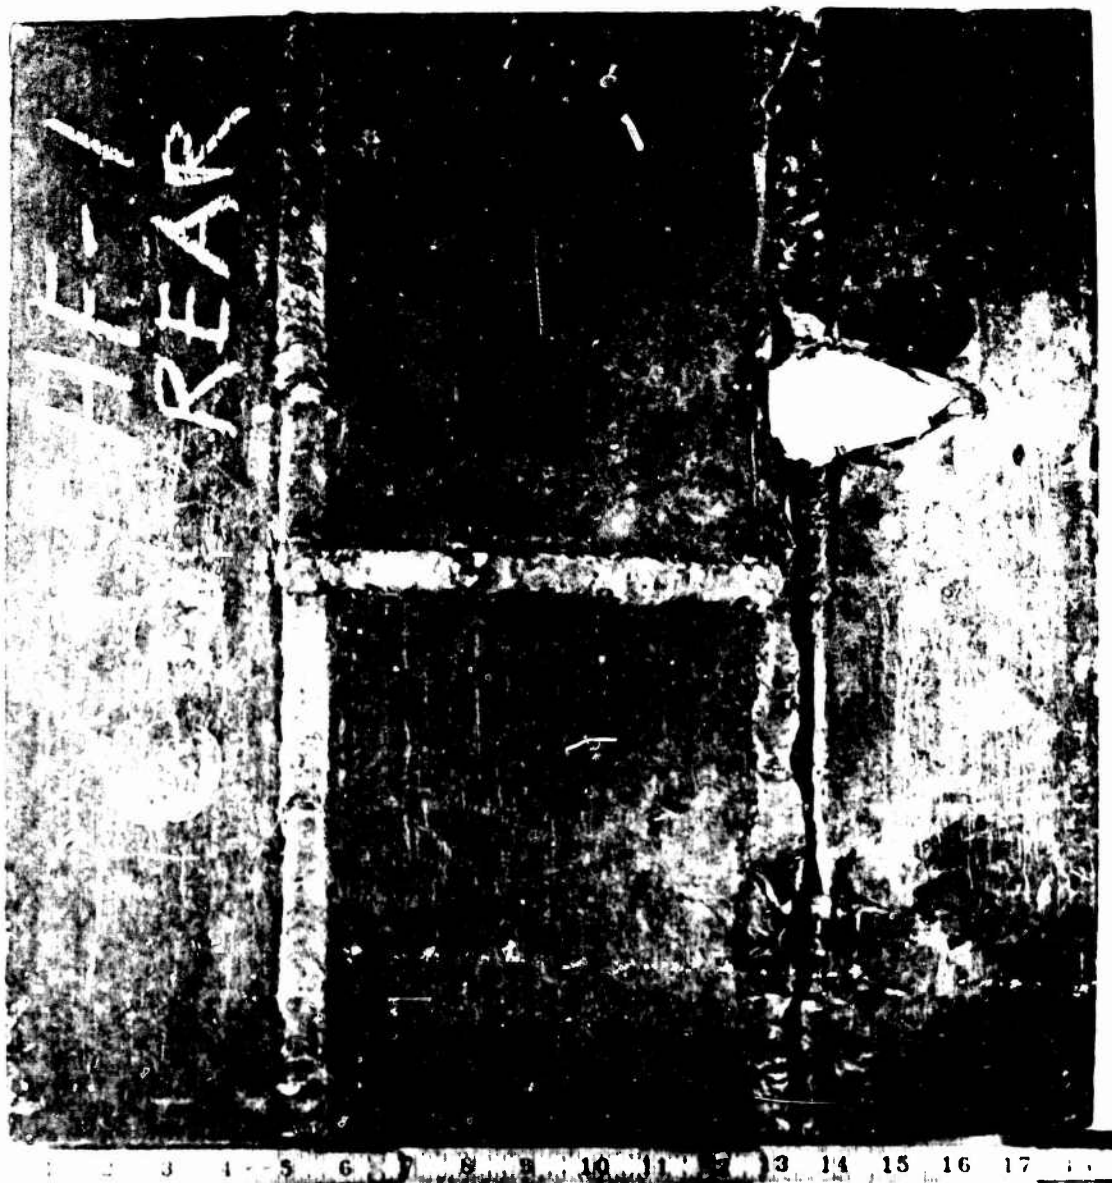
FIGURE 2 - REAR VIEW OF 18 X 18 X 1 INCH M PLATE ARC WELDED WITH ~~ROPER~~ ELECTRODE, AFTER BALLISTIC TESTING. DECEMBER 4 1942 WTN.710-1968

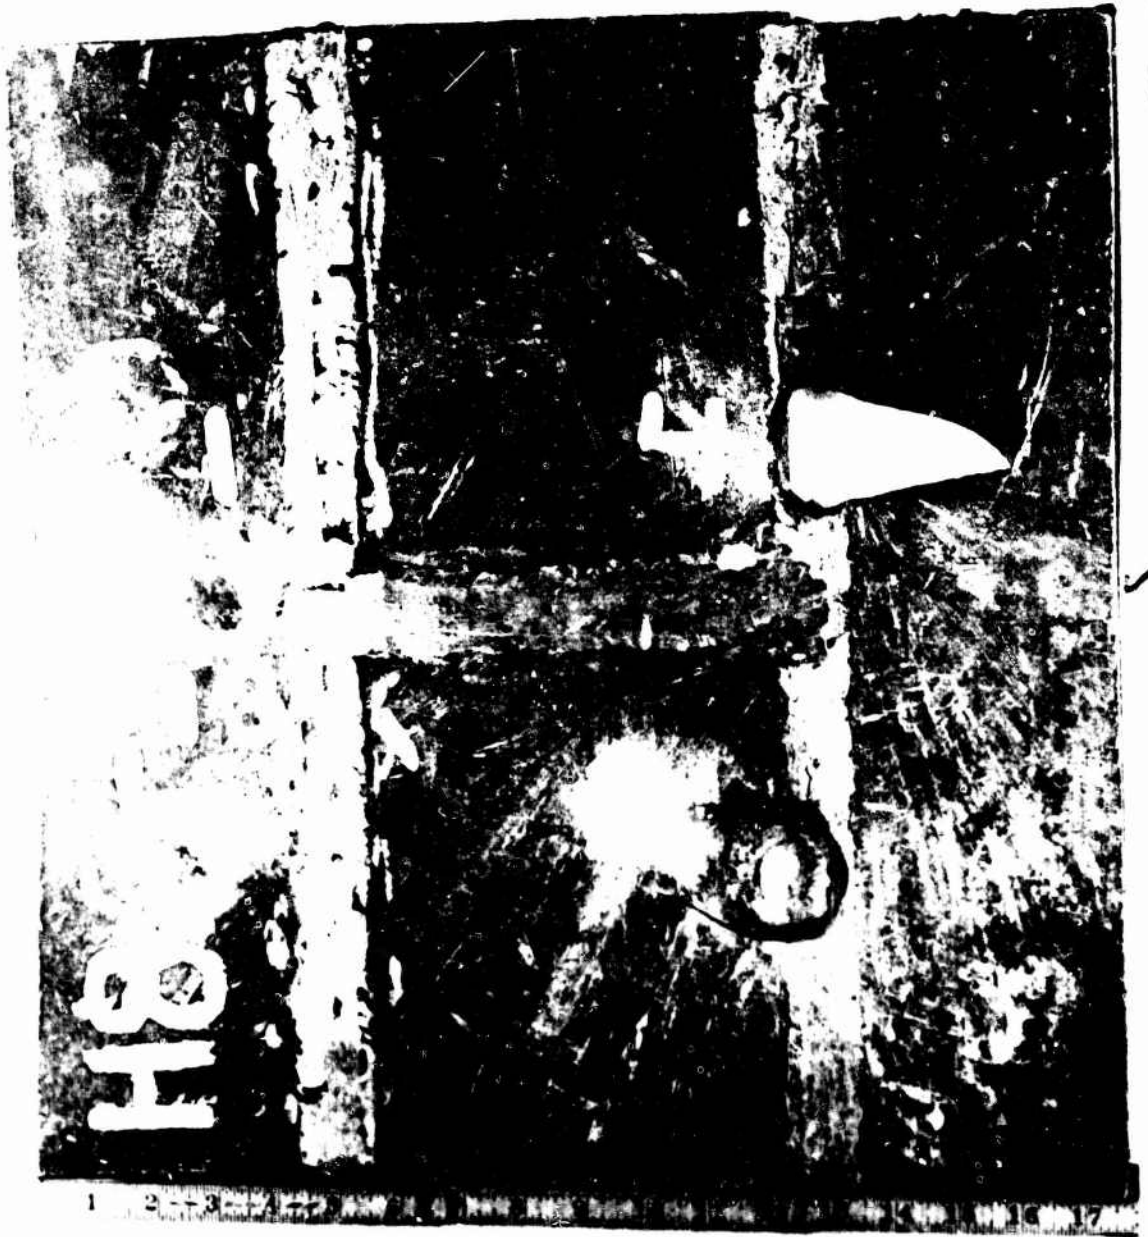
FIGURE 5 - FRONT VIEW OF 16 X 16 X 1 INCH M PLATE ARC WELDED WITH ~~STANDARD~~  
~~STANDARD~~ ELECTRODE, AFTER BALLISTIC TESTING, DEC 4 1942 WTN.710 -1971

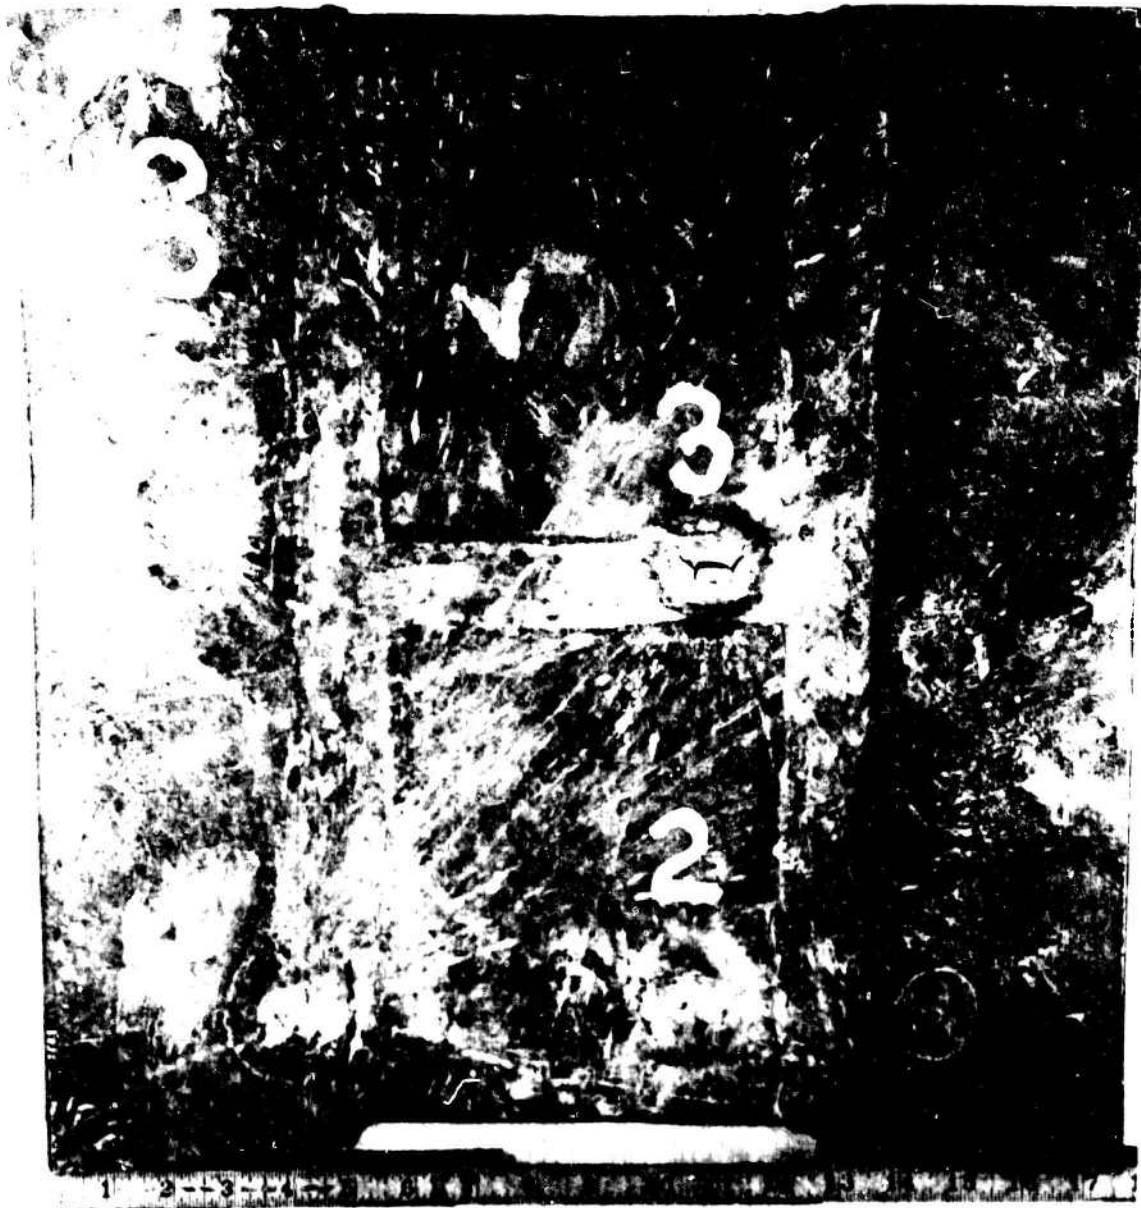
FIGURE 7 - FRONT VIEW OF 18 X 18 X 1 INCH PLATE ARC WELDED WITH ELECTRODE, STRESS RELIEVED AT 1000°F FOR 3 HOURS (AIR COOL) AFTER BALLISTIC TESTING. DECEMBER 4 1942 WTN.710-1973

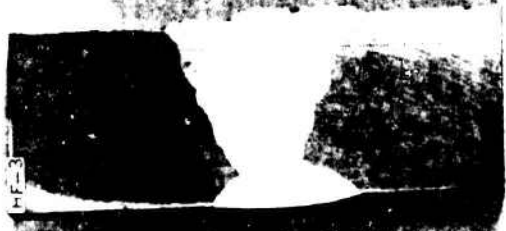
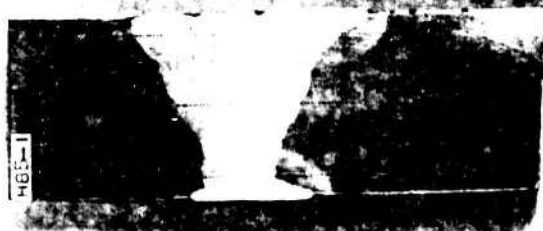
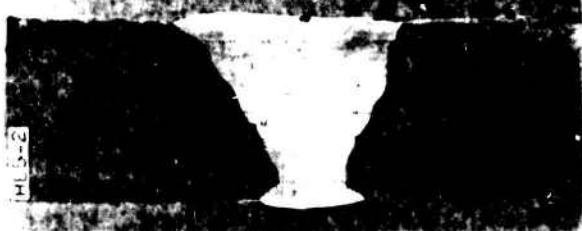
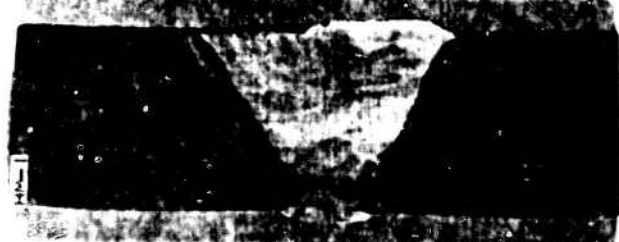
SINGLE V JOINT WELDED WITH PLAIN CARBON ~~MUREX~~ ELECTRODE. AS WELDED ✓

SINGLE V JOINT WELDED WITH PLAIN CARBON ~~MUREX~~ ELECTRODE. STRESS RELIEVED AT 1000°F FOR 3 HRS. AND AIR COOLED

SINGLE V JOINT WELDED WITH LOW ALLOY ~~LOW ALLOY~~ ELECTRODE. AS WELDED

SINGLE V JOINT WELDED WITH LOW ALLOY ~~LOW ALLOY~~ ELECTRODE. STRESS RELIEVED AT 1000°F FOR 3 HRS. AND AIR COOLED

SINGLE V JOINT WELDED WITH ~~MUREX~~ ELECTRODE. AS WELDED

CROSS SECTIONS FROM CROSS BAR OF 16" X 16" X 1" WELDED "M" PLATES  
AS PREPARED FOR MACROEXAMINATION - MGF IX, NITAL - PICRAL ETCH  
JANUARY 4 1943 WTN.121-513

Figure 11 is a photograph of cross section of welded joint from each of the five H plates as prepared for macroexamination and hardness survey. These specimens were taken through center of horizontal crossbar of each H plate.

Macrophotographs illustrate degree of elimination of heat-affected structures in the two specimens which were subjected to the post heat treatment of 1000° F. and air cool. Specimen welded with Arcos Manganend electrode is seen to have a relatively narrow root opening and rather sharp definition of heat-affected zones in plate metal bordering the weld.

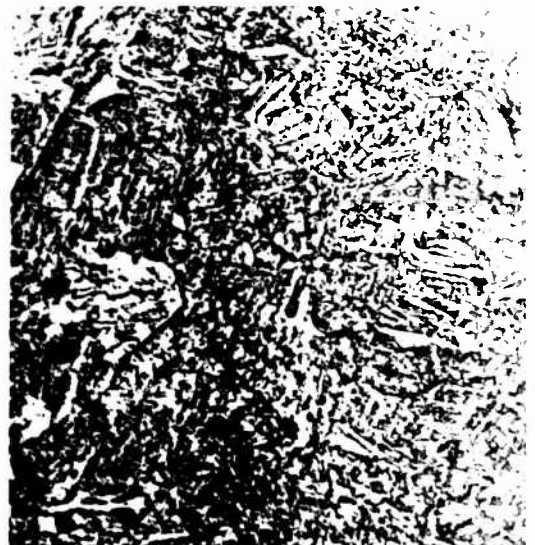
PLATE NOT STRESS RELIEVED  
(LOCATION 1)

PLATE STRESS RELIEVED AT 1000°F FOR 3 HOURS AND AIR COOLED (LOCATION 5)

FIGURE 1B. MICROSTRUCTURE OF UNAFFECTED PLATE METAL

Figure 18 shows structure of both the "as welded" armor plate and the armor plate after a post heat treatment of 1000° F. for 3 hours with air cool, at 100 and 1000 magnifications in regions unaffected by welding heat.

Structures are acicular tempered martensite, typical of quenched and drawn armor plate of the type composition used. There is very slight, if any, evidence of additional tempering in the post heat treated structures. The brilliant white rectangular areas visible in the lower right hand figure are zirconium nitride, nonmetallic inclusions, occasionally seen in Great Lakes' armor compositions.

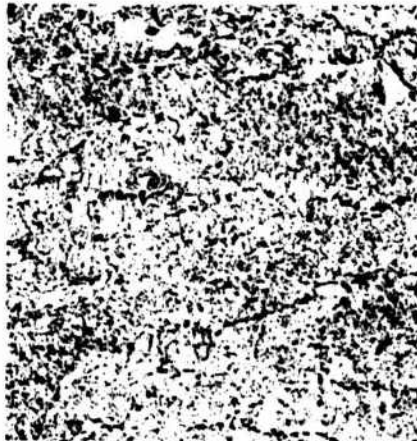
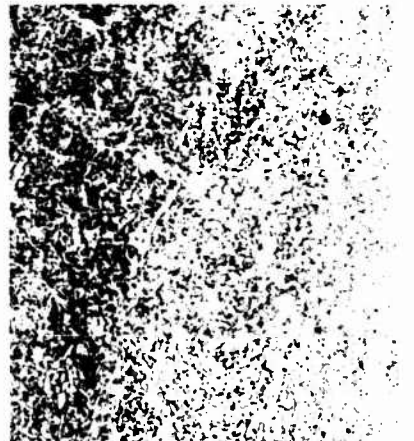
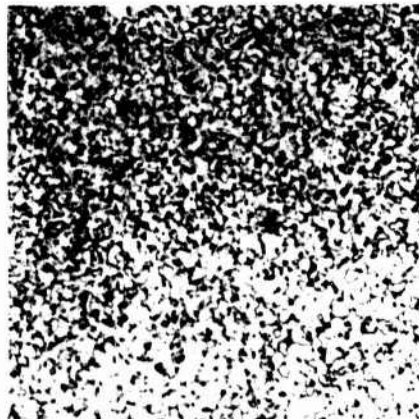
MICROSTRUCTURE OF WELD METAL NEAR CROWN (LOCATION 9)

MICROSTRUCTURE OF WELD METAL NEAR ROOT (LOCATION 10)

MICROSTRUCTURE OF WELD METAL NEAR CENTER OF WELD (LOCATION 11)

MICROSTRUCTURE AT BOUNDARY BETWEEN PLATE AND WELD METAL (LOCATION 12)

MICROSTRUCTURE OF HEAT AFFECTED PLATE IMMEDIATELY ADJACENT TO WELD NEAR EDGE (LOCATION 13)

Figure 21, representing microstructures of the low alloy Lincoln Shield Arc No. 85 electrode joint, includes an additional view of weld metal at center of weld deposit, and a view of the hardened zone of plate metal immediately adjacent to the crown of the weld. This latter area is seen to be martensitic, a structure of high hardness and strength, but low ductility and high stress, which is often responsible for the initial failure under ballistic shock.

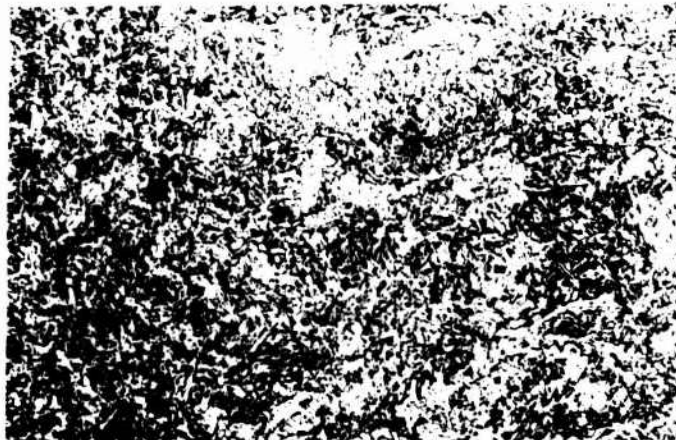
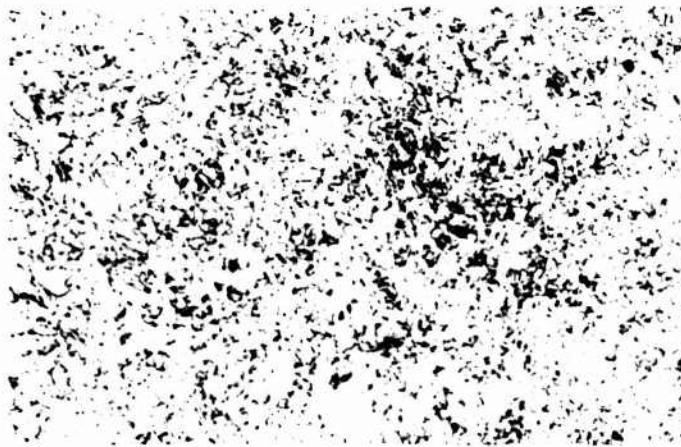
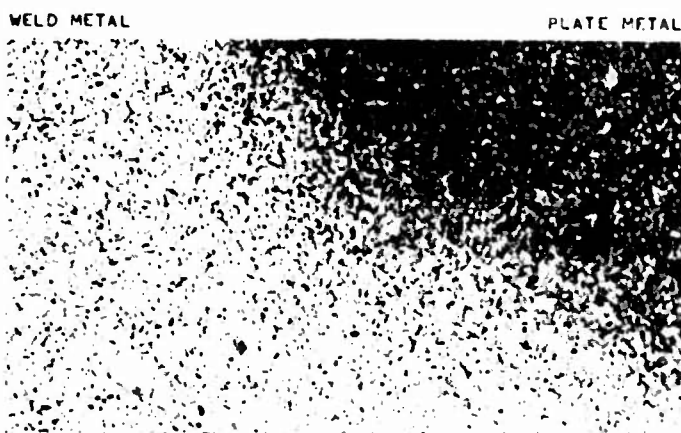
X100 1% NITAL  
 MICROSTRUCTURE OF WELD METAL NEAR ROOT (LOCATION 14)

X100 1% NITAL  
 MICROSTRUCTURE OF WELD METAL NEAR CROWN (LOCATION 15)

X100 1% NITAL  
 MICROSTRUCTURE AT BOUNDARY BETWEEN PLATE AND WELD METAL (LOCATION 16)

FIGURE 22. SINGLE V JOINT WELDED WITH LOW ALLOY ELECTRODE. STRESS RELIEVED AT 1000°F FOR 3 HOURS AND AIR COOLED.

Figure 22 represents a joint, similar to the above, which has been subjected to a post heat treatment at 1000° F. for 3 hours with an air cool. In this weld the martensitic structure adjacent to the plate has been tempered by the heat treatment, eliminating the objectionable hard structure. Structure of weld metal itself has not been significantly altered by the heat treatment.

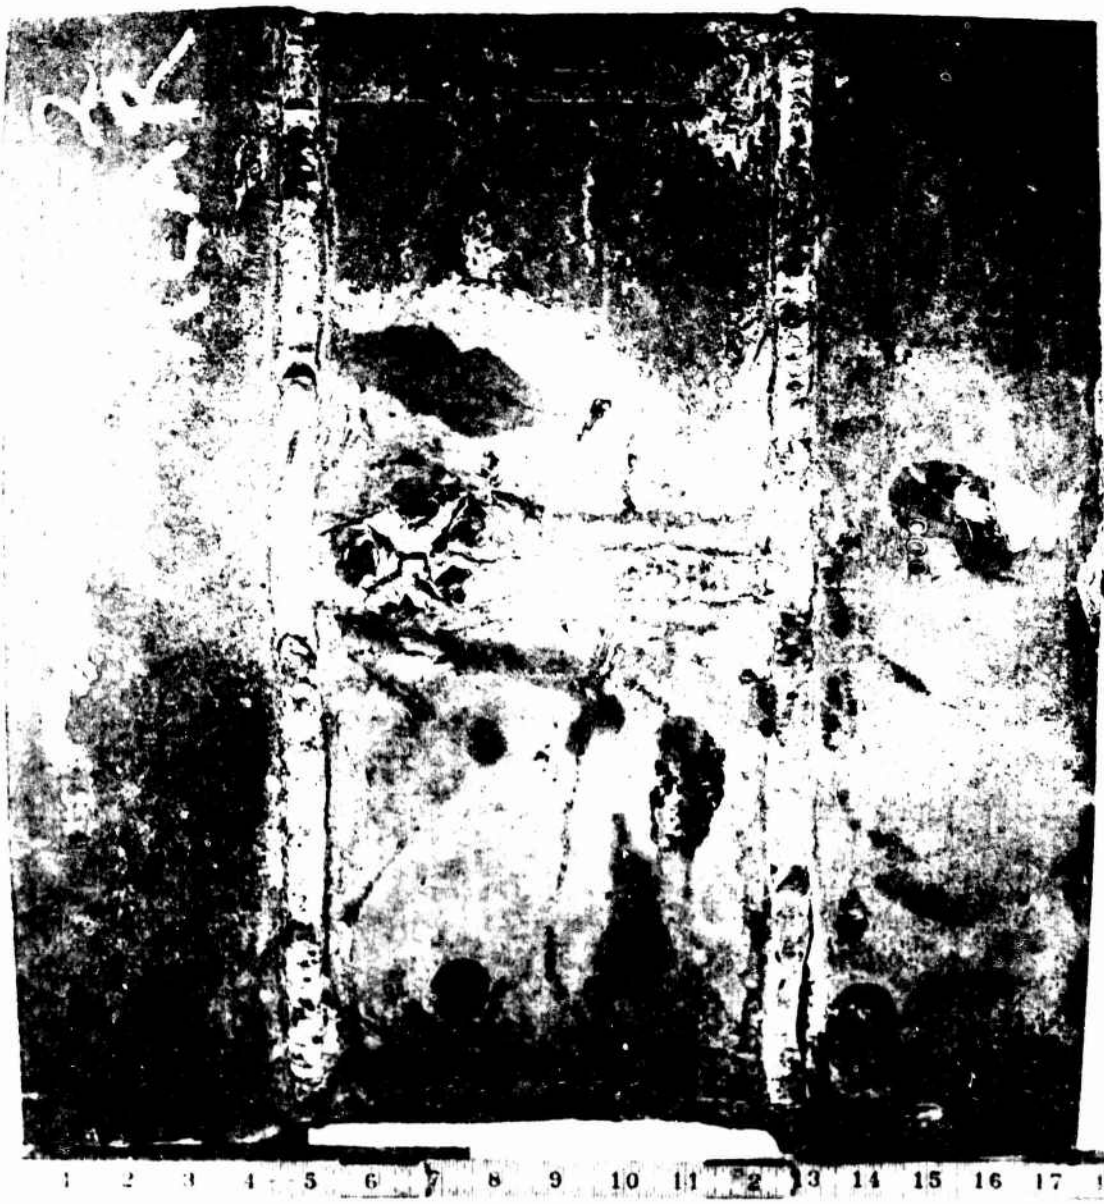
FIGURE 5 - REAR VIEW OF 18 X 18 X 1 INCH PLATE ARC WELDED WITH ~~XXXXXXXXXX~~ ELECTRODE, STRESS RECEIVED AT 1000°F FOR 3 HOURS (AIR COOL) AFTER BALLISTIC TESTING. DECEMBER 4 1942 WTN.710-1974

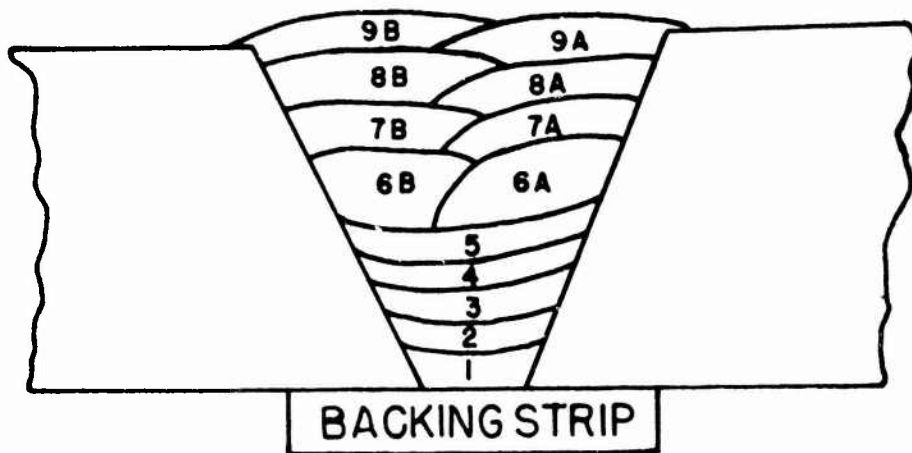
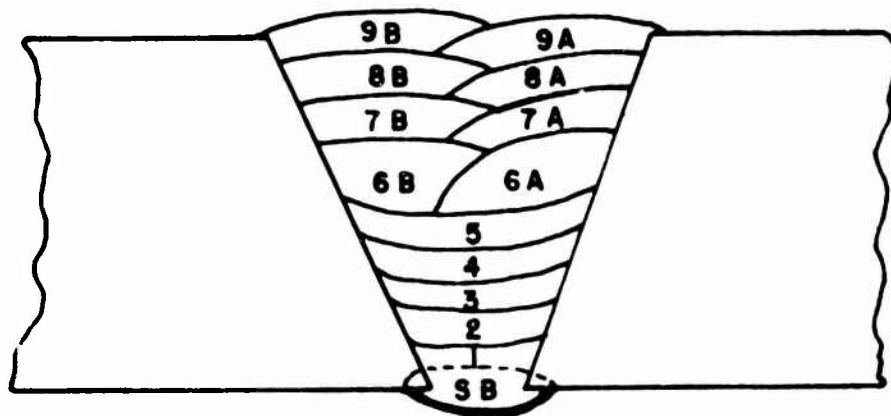
FIGURE B

TYPICAL  
WELD METAL DEPOSITION

Details of welding are given in Appendix A which includes a table of all welding data and two sketches showing sequence and deposition technique of welding.

Back strip (Figure B) chipped off and light cut taken out of root to sound metal. Two beads deposited with 3/16" Fillex at 225 Amps. 26 Volts to form the Seal Bead.
