March 12, 1936

Progress Report I  
Heat Treatment of Chromium Plate  
on Steel

To determine maximum effects of very high temperature heat treatment of chromium plated steel

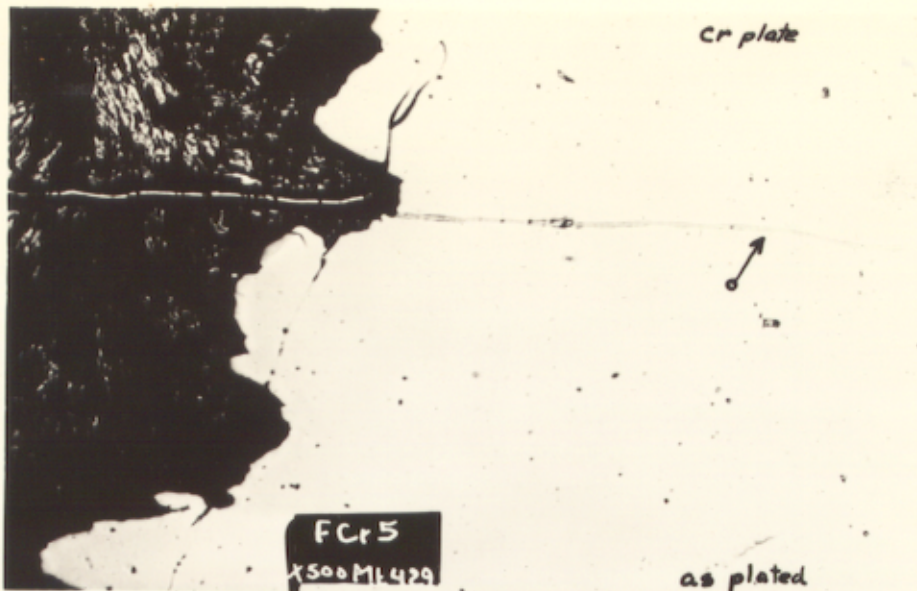
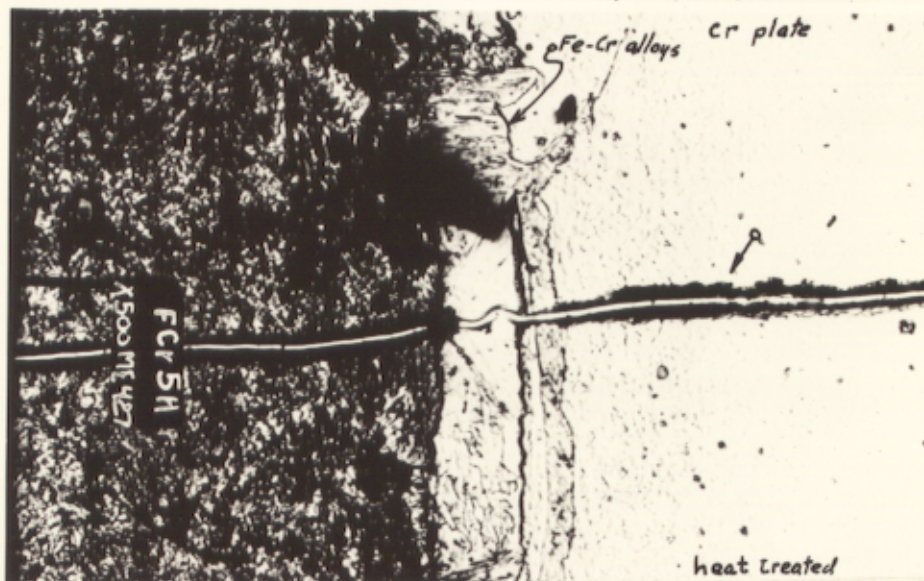
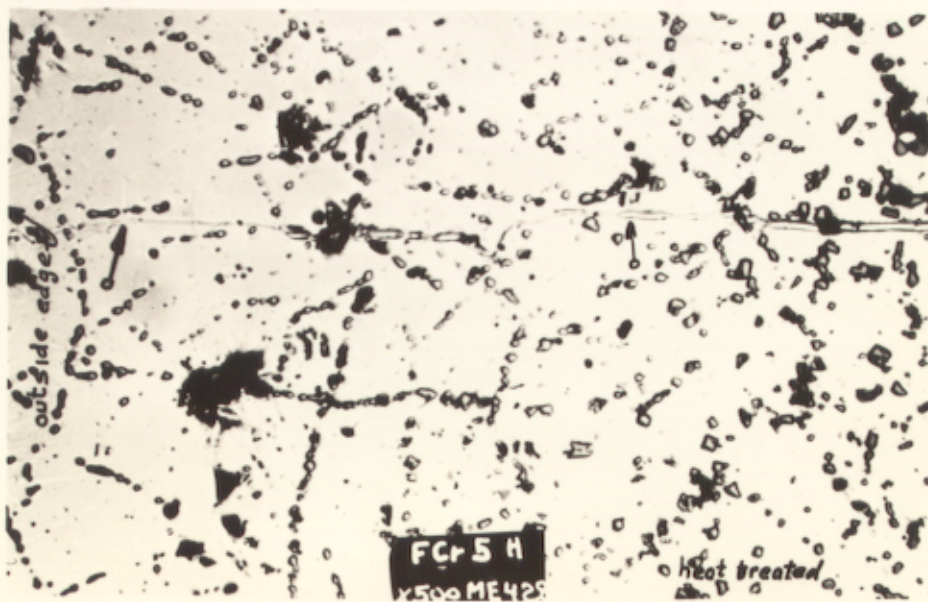
Fig. 3

Scratch hardness of Cr Plate on Steel. Bierbaum Microcharacter 3 g. load.  $\text{FeCl}_3$  etch X500.

Top FCr5 (left) steel base: Vickers Hardness, 10 Kg, 135, (right) Cr plate: Vickers Hardness, 10 Kg, 724

Middle FCr5H, heat treated Cr plate 1150°C, 8 hrs, Furnace cooled. (left) steel base: Vickers Hardness, 10 Kg, 131, (right) Cr plate: Vickers Hardness 139, (middle), hard layer of Fe-Cr alloys.

Bottom Outside edge of FCr5H (left) Oxidized Cr plate at surface is hard. (right) Cr plate further from surface is softer.

of these cracks around the Vicker's impression in the heat-treated and softened Chromium plate. This may be taken as an indication of the improvement in ductility of the plate due to heat treatment.

An interesting observation is shown on the bottom print of Figure 3, (ME 428). The surface of the Chromium plate was oxidized: Grain boundaries and old crack lines are filled with a dove gray constituent taken to be an oxide. This must have formed a solid solution with the Chromium for the extreme outside edge is very hard.
