1. There is attached one (1) copy of Watertown Arsenal Laboratory Report No. 710/552 entitled "Armor - Development of a Fracture Test to Indicate the Degree of Hardening of Armor Steels Upon Quenching" for his information and file.

Development of a Fracture Test to Indicate the  
Degree of Hardening of Armor Steels Upon Quenching

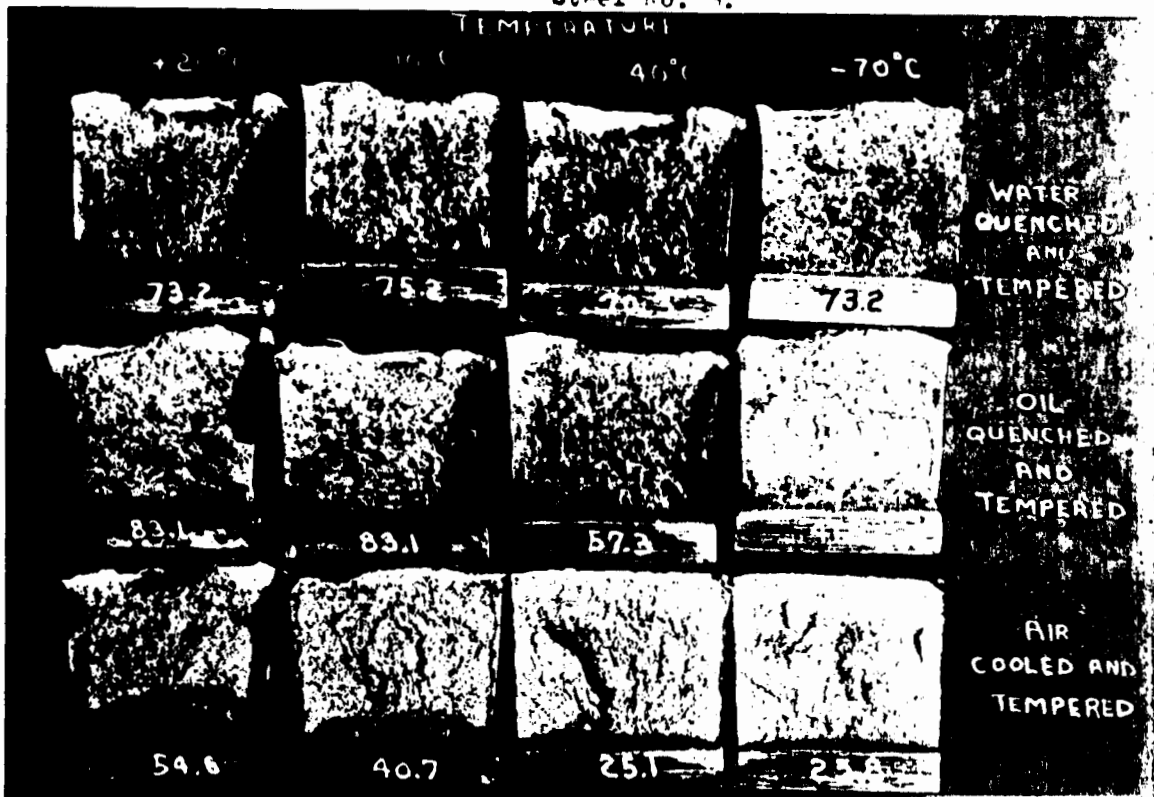
Ordnance Steel Foundry - 2" Cast Armor #819-7  
Steel No. 3.

Republic Steel Corp. - 2" Rolled Armor #RH74K-11  
Steel No. 6.

The fractured surfaces of the Charpy bars of steels Nos. 3 and 6 are shown in Figure 18 to illustrate the effect of temperature and quenching rate upon impact strength and upon the appearance of the fracture.
