REPORT NO. 710/261-1

CORRELATION OF MICROSTRUCTURE AND BALLISTIC  
PROPERTIES OF ARMOR PLATE

FACE HARDENED PLATE

ORDNANCE DEPARTMENT  
FRANKFORD ARSENAL, MD.

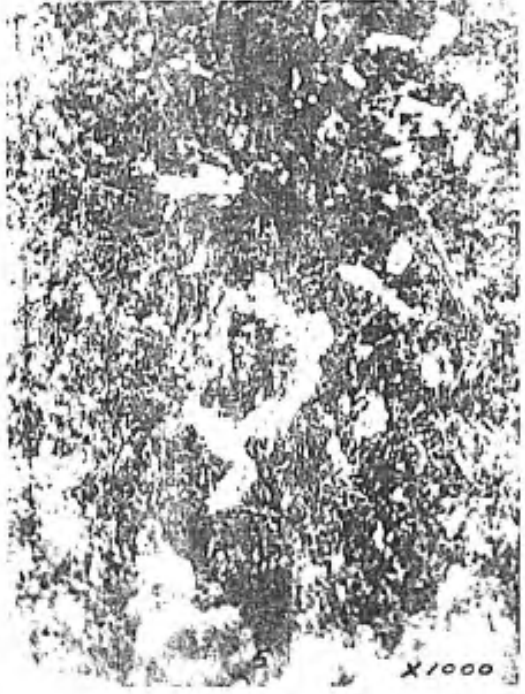
5/8" Plate #4911B (Cont.)

(4) Slight decarburization of case with remnants of massive carbides at edge.  
X100 MA724

(5) Shows structure of massive carbides at outer edge of case, resembling ledeburite.  
X1000 MA727

(6) Uniform distribution of medium sized carbides in sorbito-troostite, constitutes main portion of case.  
X1000 MA729

(7) Uniform sorbitic core structure.  
X1000 MA728

As an example of high quality face hardened armor plate, plate No. 4911B is illustrated in Figures 1 - 7, inclusive, pages I and II. For comparison, see Figures 8 - 16, inclusive, pages III and IV, which show the corresponding microstructures of poor ballistic plate No. 020238.

An example of good sorbitic core structure (Brinell 387) in a high ballistic plate is shown in Figure 7, page II, while a sorbito-troostitic structure (Brinell 430/444) of a similar appearance occurs in brittle plate, see Figure 47, page XIII.

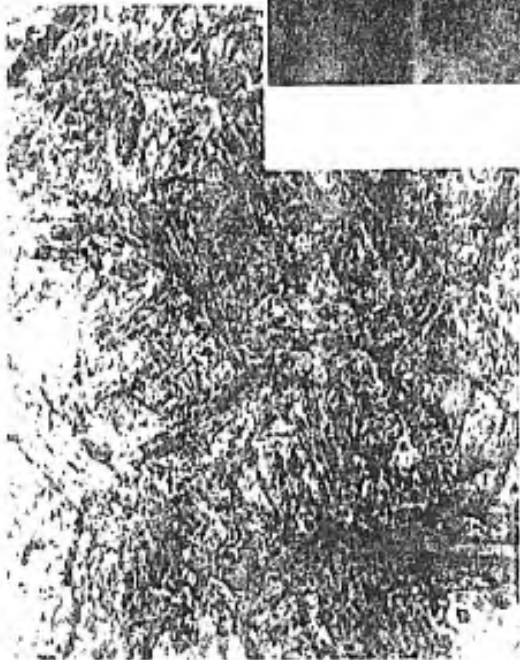
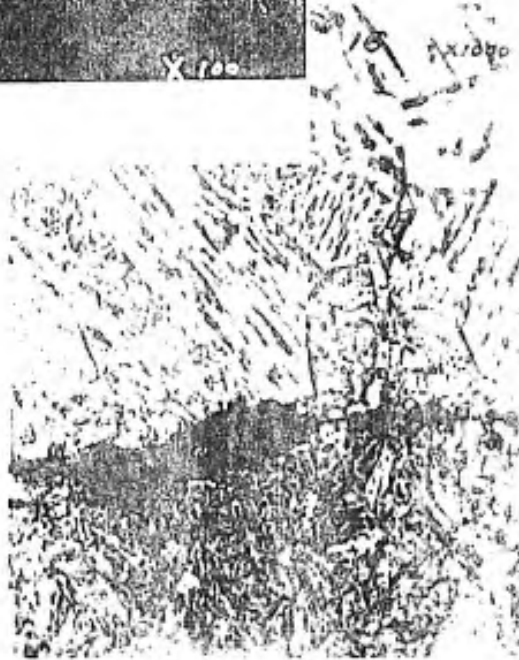
5/8" Plate #C2D239 (Cont.)

(12) Ferritic streak which runs through core.  
X100 MA723

(13) Structure of massive carbides in Figure  
(11) resembles ledeburite.  
X1000 MA730

(14) Troostite-sorbite in central portion of  
case shows many carbides, the larger sized  
ones being segregated at the grain boundaries.  
X1000 MA731

(15) Tempered martensite found in major portion  
of core.  
X1000 MA733

(16) Higher magnification of ferritic streak  
where it joins the normal core structure.  
Slag appears at the sharp demarcation be-  
tween ferrite and tempered martensite.  
X1000 MA732

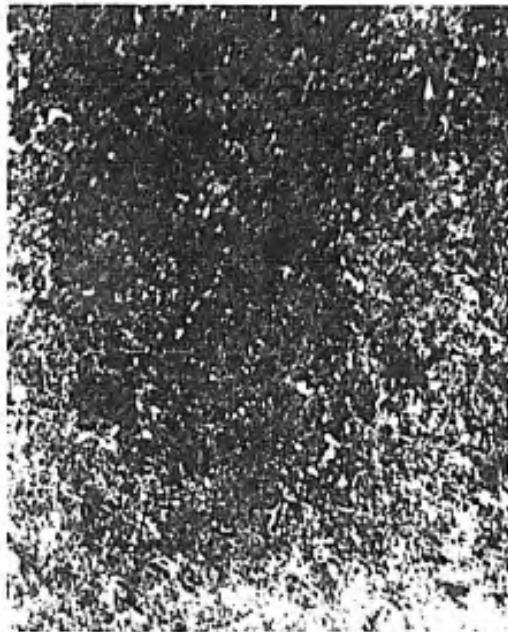
1/2" Plate #1-1

(30) Bad laminations of nonmetallics.  
Unetched, X100 MA1343

(31) Uniform carbide distribution in case.  
Murakami etch, X1000 MA1347

(32) Troostite-sorbite case structure.  
1% Nital etch, X1000 MA1356

(33) Large patches of ferrite uniformly dis-  
tributed throughout the sorbitic core.  
1% Nital etch, X1000 MA1368

Examples of laminations in good quality carburized plate are given in Figure 17, page V, Figure 30, page IX, and Fig. 34, page X. This condition would not be acceptable in homogeneous plate, see Watertown Arsenal Report No. 710/261, Figure 2A. However, Figures 24 and 25, page VII, shows a lamination so serious that it caused spalling in carburized plate.

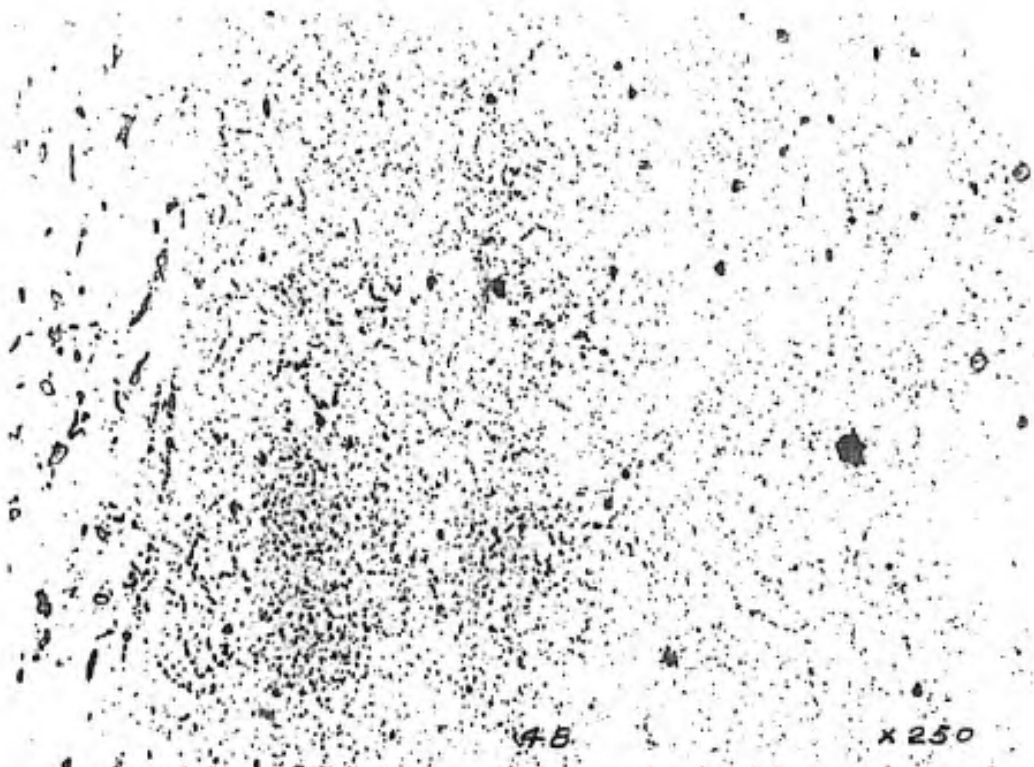
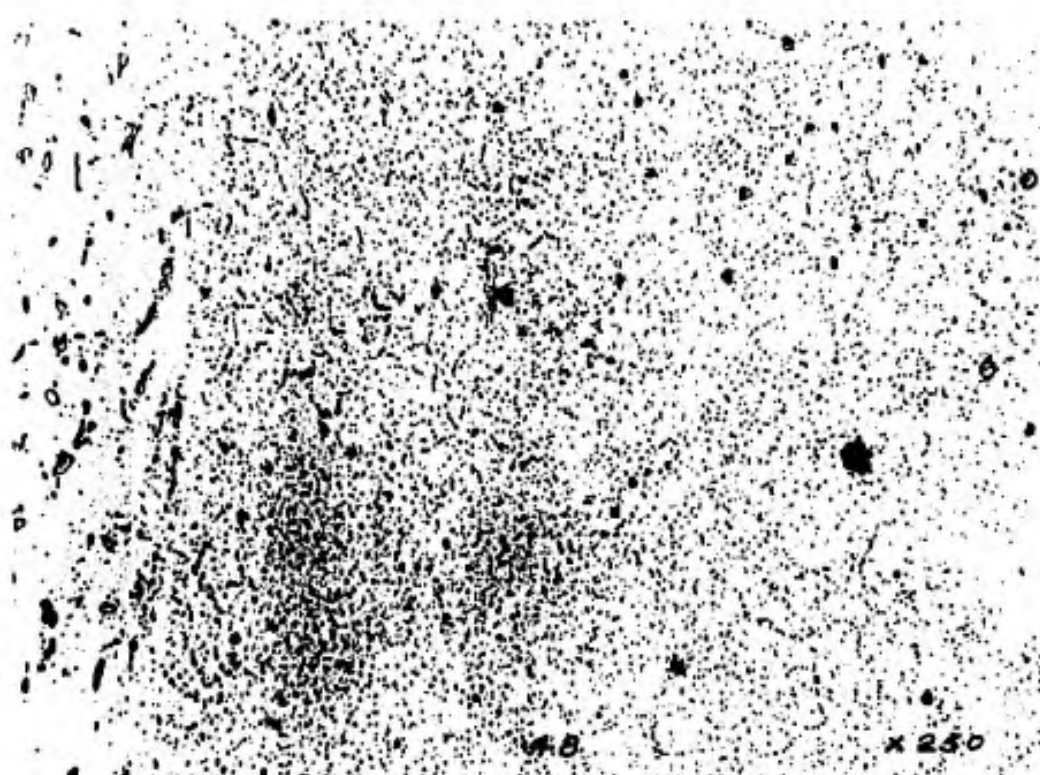
45

(48) Grain boundary carbides in case.  
      X260

for homogeneous plate (X250 rather than X1000) reveals this carbide condition more clearly, see Figures 48 and 49, page XIV. Both plates illustrated in these figures shattered under 37 mm. impact. If Figure 49 is compared with Figure 50, page XV, it is evident that Figure 50 (X1000) gives no indication of the serious carbide condition revealed by Figure 49 (X250).

Plates which show some indications of carbides in the grain boundaries but not to the extent shown in Figures 9 and 10, page III, Figure 39, page IX, or even Figures 48 and 49, page XIV, are 1/2" armor plates #444-2 and #4-445. Plate No. 444-2 is classified as good ballistic plate while plate No. 4-445 is considered brittle, although both plates exhibit nearly similar structures. However, plate No. 4-445 was tested with caliber .50 A.P. and spalled, although under caliber .50 A.P. it was ballistically ductile. Since plate No. 444-2 was tested only with caliber .30 A.P., it is reasonable to assume that this also would spall under caliber .50 A.P. impact. Therefore, even a slight tendency to carbide segregation in grain boundaries must be considered undesirable.

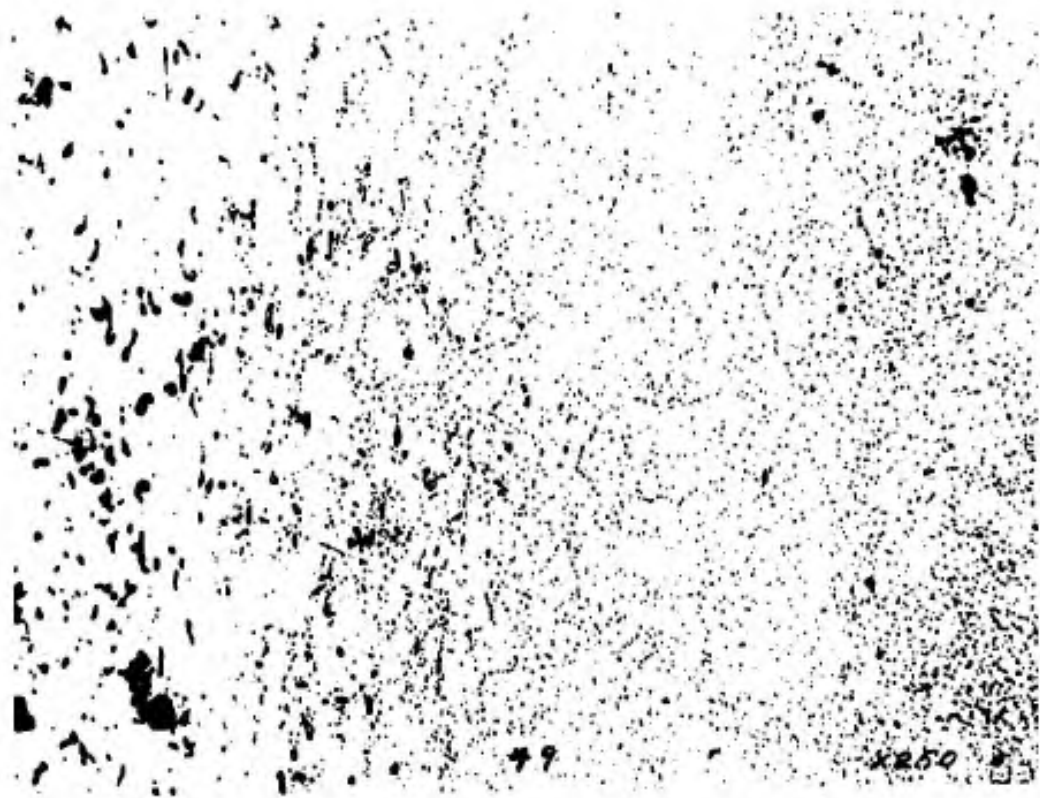
49

(49) Grain boundary carbides in case.  
      X260

Both figures had Murakami etch.

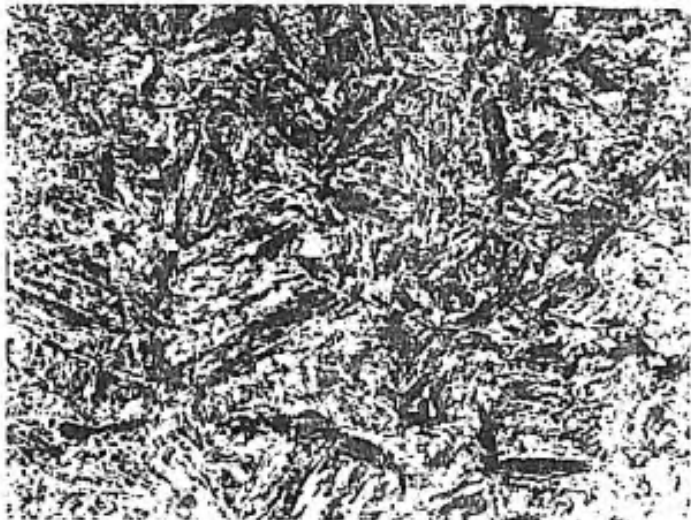
W.A. 633-1541

Macro Structures of -

Typical macrostructures of good and poor face hardened plate are given on page XXII.

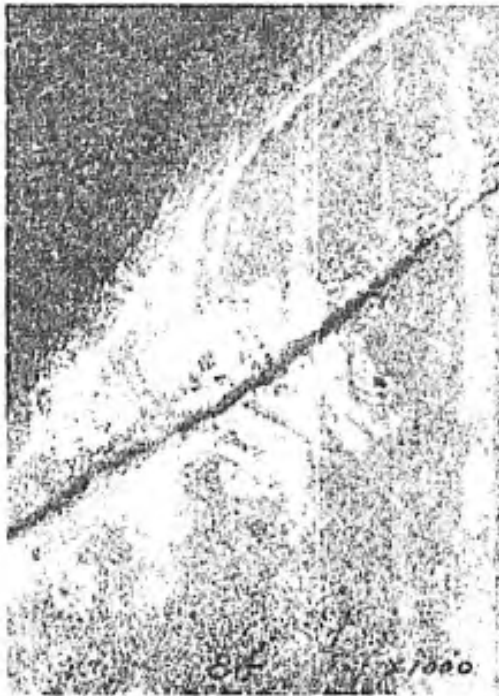
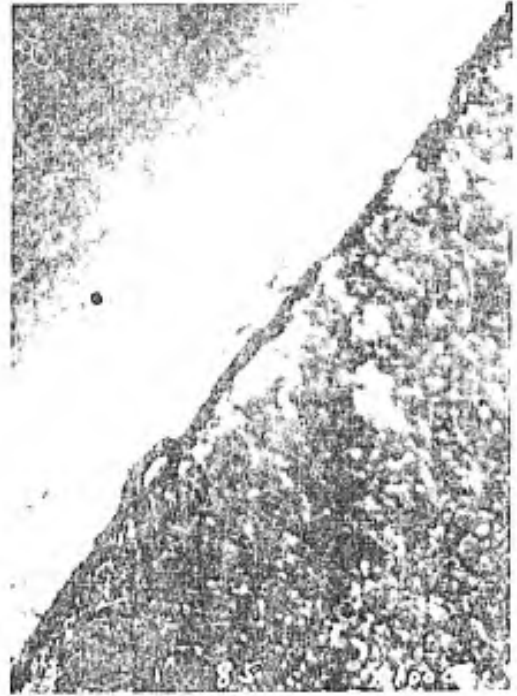
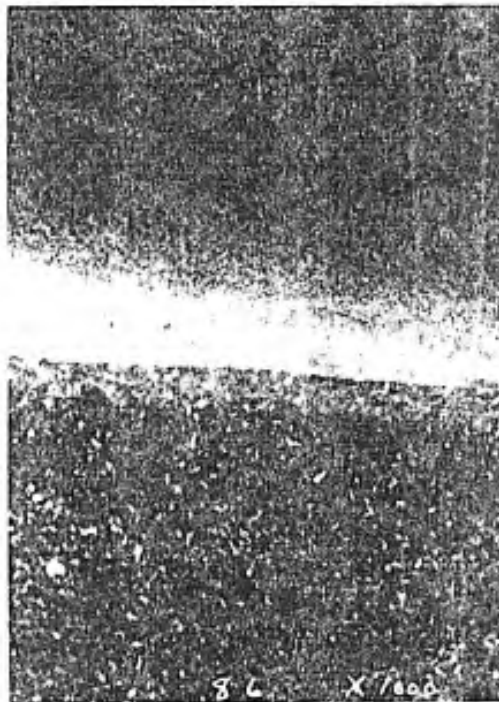
1/4" Plate #2A1 (Cont.)

(84) Zone of fusion (fine dendritic structure)  
in white layer found in carburized case.  
X1000 MA762

(87) Typical white layer found entirely with  
the core of the bullet.  
X1000 MA763

"White layer, which was previously revealed in the vicinity of penetrations of homogeneous armor plate (see W.A. Report No. 710/197), was readily detected at the junction of the bullet core and carburized case and also in the fused bullet core, see Figure 83, page XXIII, and Figures 84, 85, 86, and 87, page XXIV.

Proof that the nose of the bullet and that some areas along the junction of bullet core and outer case melted under impact is indicated by the presence of tiny dendritic structures shown in Figures 84 and 85, page XXIV. It is well known that dendritic structures result from solidification of metals from liquid state.
