METALLURGICAL EXAMINATION

OF EXPERIMENTAL CAST ARMOR TURRET NO. 2

MANUFACTURED BY THE GENERAL STEEL CASTINGS CORPORATION

Sept. 6, 1941

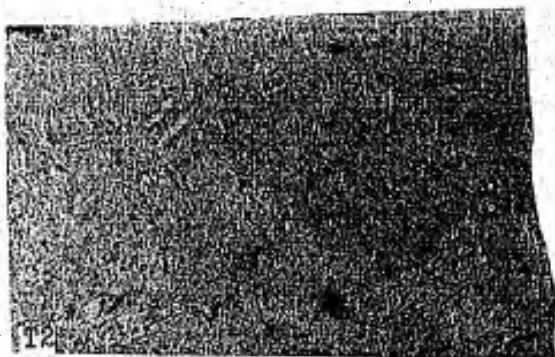
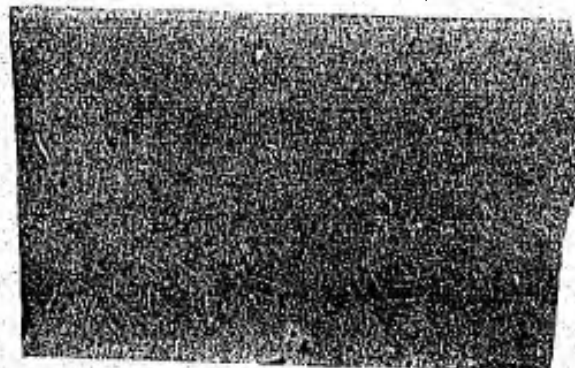
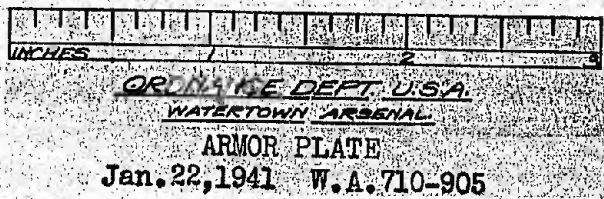
FIG. 4

(a) The structure throughout the plate is dendritic and shows a columnar pattern near the surface of the plate. The central portion has a coarse nearly equiaxed structure, and contains a great many prominent, partially etched-out nonmetallics.

(a) DEEP ETCH

The macrostructure as revealed by the deep etch shows that the structure throughout the section is dendritic and exhibits a columnar pattern near the surface of the plate. The central portion has a coarse, nearly equiaxed structure, and contains a great many prominent, partially etched-out nonmetallics, see Figure 4.

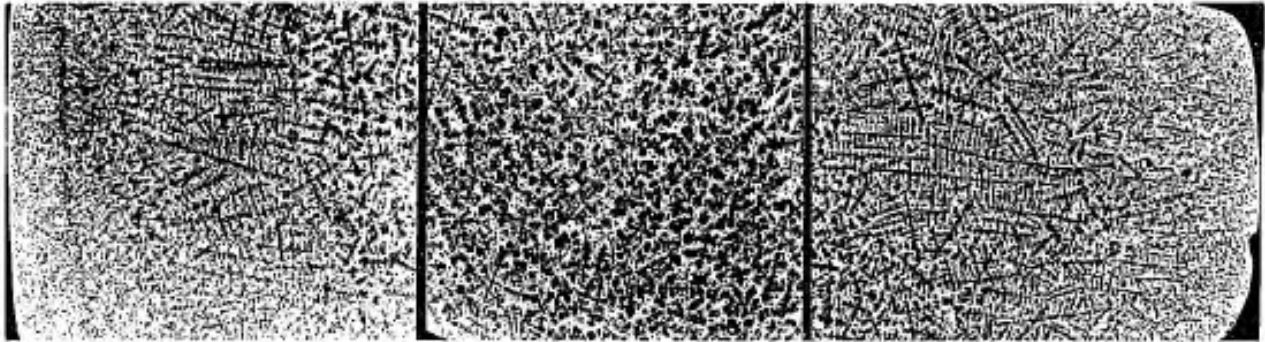
b. Oberhoffer Etch - Magnified 3 Diameters

(b) Photomicrograph of cross section of casting showing dendritic structure. The two outer thirds of the cross section are relatively sound, while the middle third contains porosity. Cross section cut into thirds for polishing and photographing.

The central portion contains some porosity but shows a refined dendritic structure. Sections near the front and rear surface of the section had a pronounced dendritic structure.

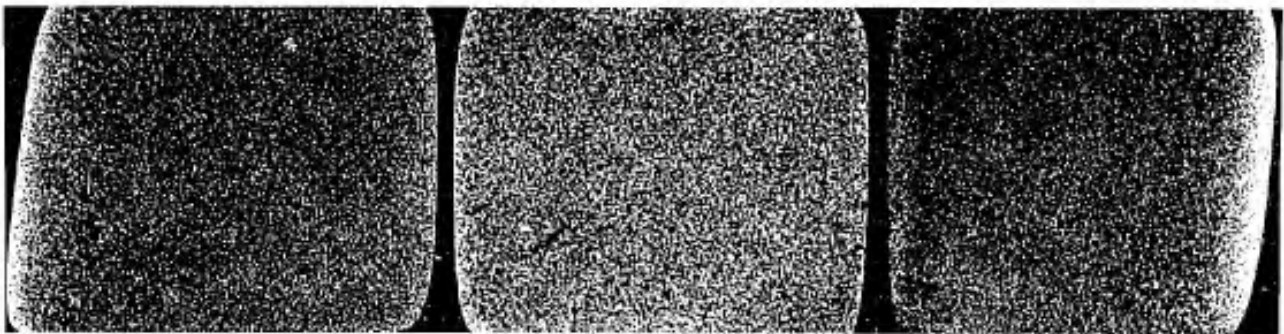
c. Deep Nital Etch - Magnified 3 Diameters

(c) Same as above but deep etched with 1% Nital, showing surface decarburization. Maximum depth of decarburization is 0.035", with 0.010" severely decarburized. The two outer thirds have a uniform structure, while the middle third contains segregation and porosity.

Porosity was present only in the center of the cross section of the casting, see Figure 4c.

Some dendritic segregation was revealed by the Murakami etch and evidence of decarburization was observed on the outer surface, see Figures 7 and 4c.

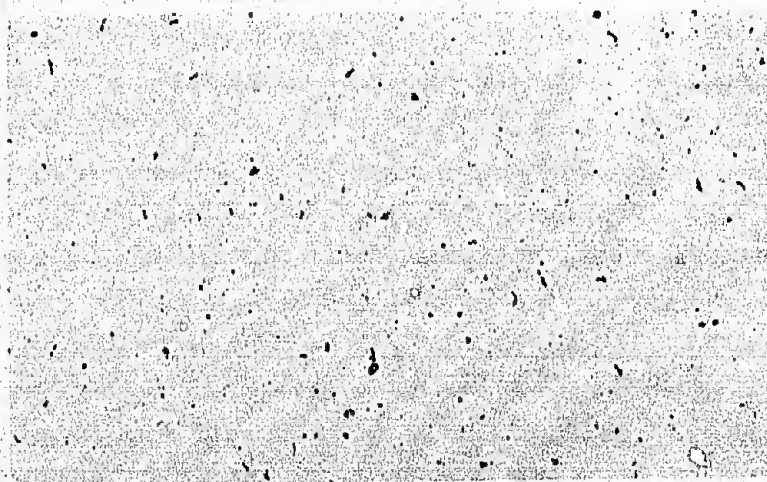
A. Magnified 25 Diameters

- A. Average distribution of nonmetallics in outer layers of cross section of casting. Coarse particles distributed among many fine nonmetallics. There is no tendency towards network formation.

The central portions of the cross section of the casting contained the greatest percentage of nonmetallic inclusions and porosity, (Figure 5) while the areas near the outer surfaces of the cross section showed the presence of some large nonmetallics present in conjunction with a uniform distribution of fine nonmetallics. (Figure 5c).

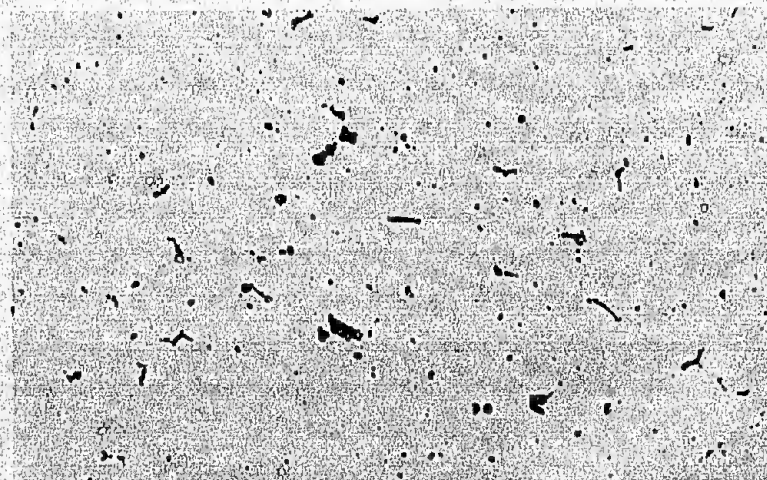
B. Magnified 25 Diameters

- B. Most prominent segregation of nonmetallics found in the central portion of the cross section of the casting. Some fine porosity exists in this section.

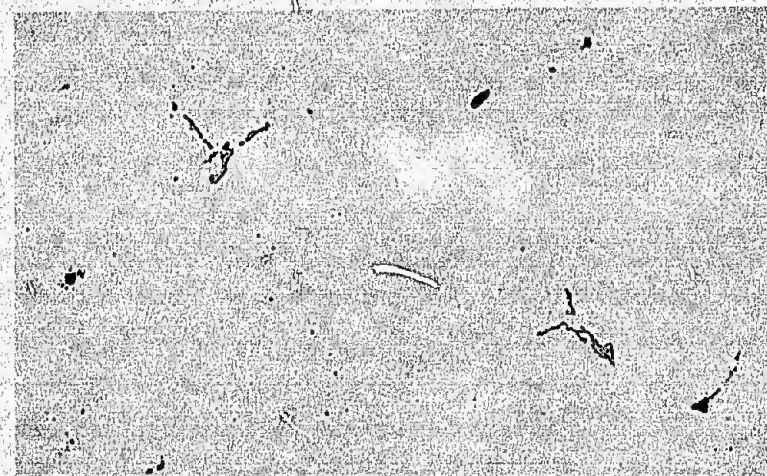
C. Magnified 100 Diameters

- C. Typical nonmetallic inclusions at a higher magnification. All inclusions have random distribution.

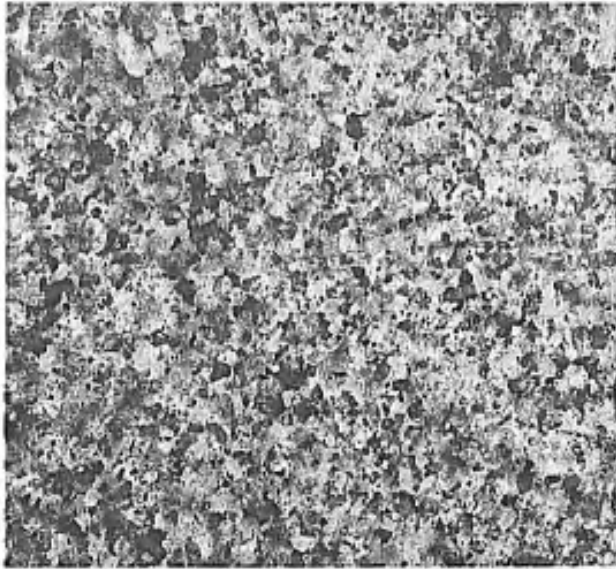
A. Magnified 25 Diameters

- A. Typical structure found at the two outside surfaces and extending down to a depth of $1/3$ of the wall thickness. This region is quite uniform with very little segregation and porosity. The grain size is well revealed by the nital etch.

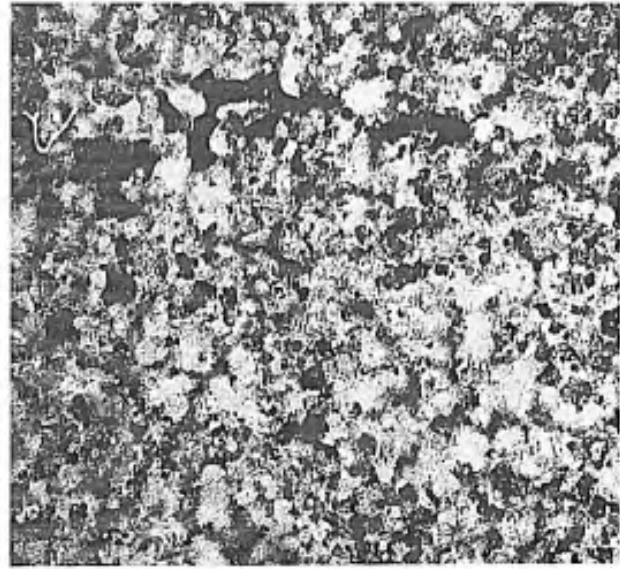
B. Magnified 25 Diameters

- B. Typical structure found in middle third of the cross section of the casting. Segregation and shrinkage porosity occur throughout this region.

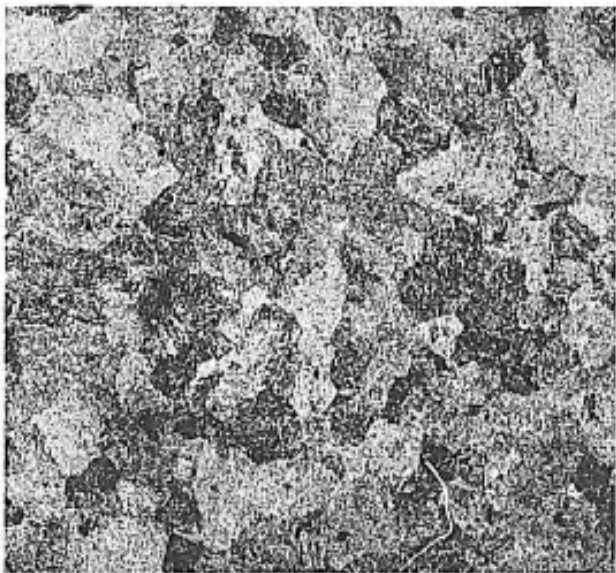
C. Magnified 100 Diameters

- C. Same region as "A" photographed at higher power. A.S.T.M. grain size rating No. 5.

The casting was heat treated to a uniform sorbitic structure. The grain size of the casting was determined as A.S.T.M. No. 5, see Figure 6c.

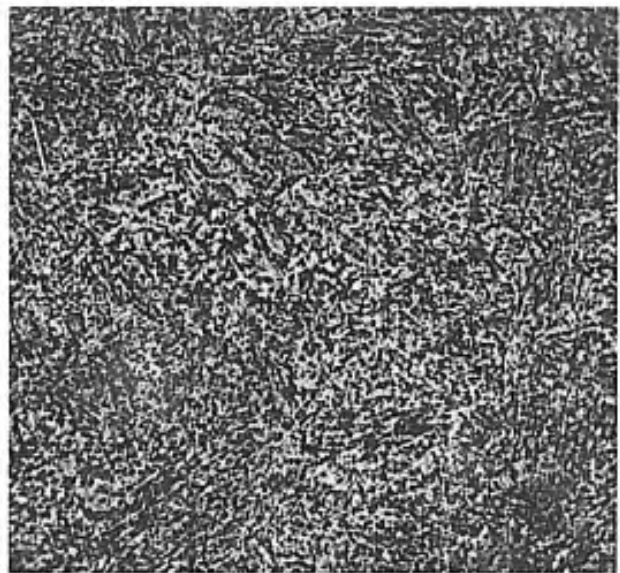
D. Magnified 1000 Diameters

- D. Microstructure of casting is highly spheroidized sorbite. This structure is quite uniform throughout the section.

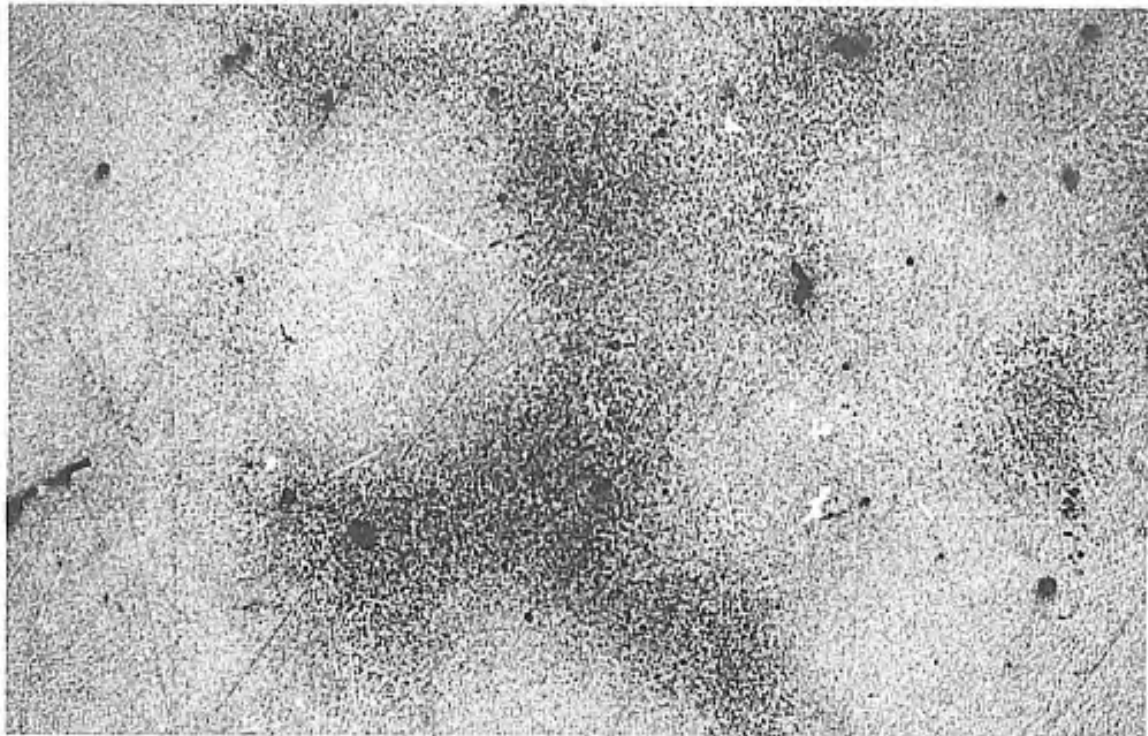
A. Magnified 250 Diameters

- A. Coarse carbides segregated in the interdendritic fillings of the casting. Uniformly fine carbides are distributed throughout the matrix.

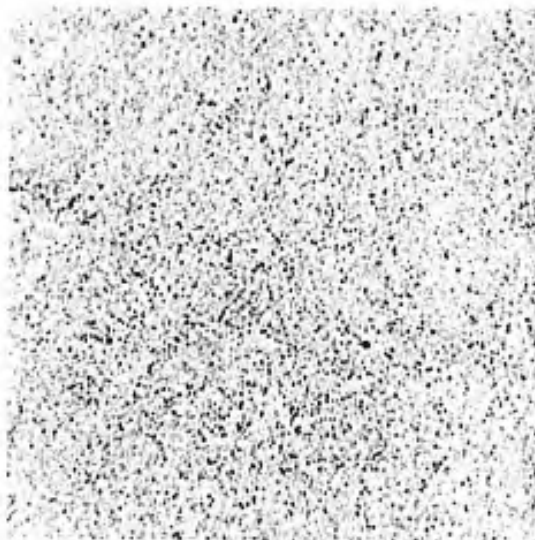
B. Magnified 1000 Diameters

- B. Magnification at X1000 showing fine carbides in the matrix. There is a very faint tendency for the carbides to outline grain boundaries.

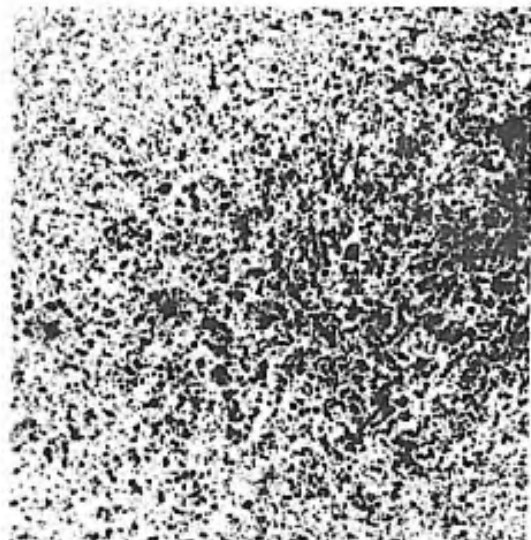
C. Magnified 1000 Diameters

- C. Magnification at X1000 showing coarse carbides in the interdendritic fillings.
