WATERTOWN ARSENAL LABORATORY

MEMORANDUM REPORT

Metallurgical Examination of Eighteen Pieces of
25/64" Thick Rolled Homogeneous Armor

Final report on Problem B-4.67

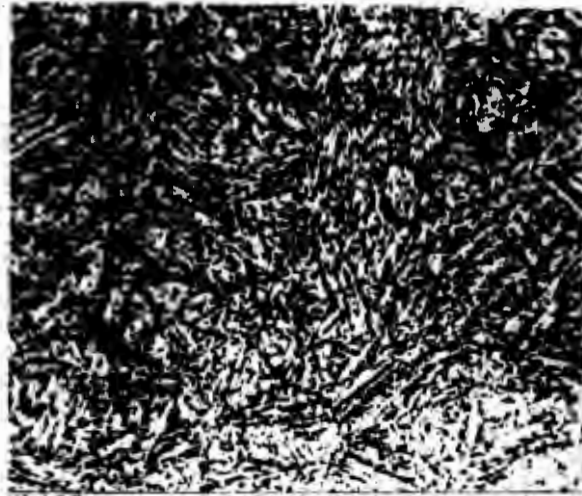
X1000 N219-1M1 Picral
Tempered martensite. Typical of 1M1 and 1B1.

A sample from each section was examined microscopically. The nonmetallic content of 1T1 and 1M1 was fairly high with stringers of silicate nonmetallic inclusions evenly distributed throughout the areas examined. The nonmetallic inclusion content of 1B1 was considerably lower, with occasional stringers of silicate inclusions. A streak of alumina oxide was observed in 1B1. The nonmetallic inclusion content distribution observed in the unetched areas of the microspecimens correlated fairly well with both the torsion test and the "woodiness" revealed by the fracture test for steel soundness. The microstructure of the top, middle and bottom samples was a tempered martensite. For typical photomicrographs, see Figure 2.
