U. S. NAVAL PROVING GROUND  
DAHLGREN, VIRGINIA

A STUDY OF NON-UNIFORMITY

IN 3"0 and 4"0 HOMOGENEOUS ARMOR.

July 1946

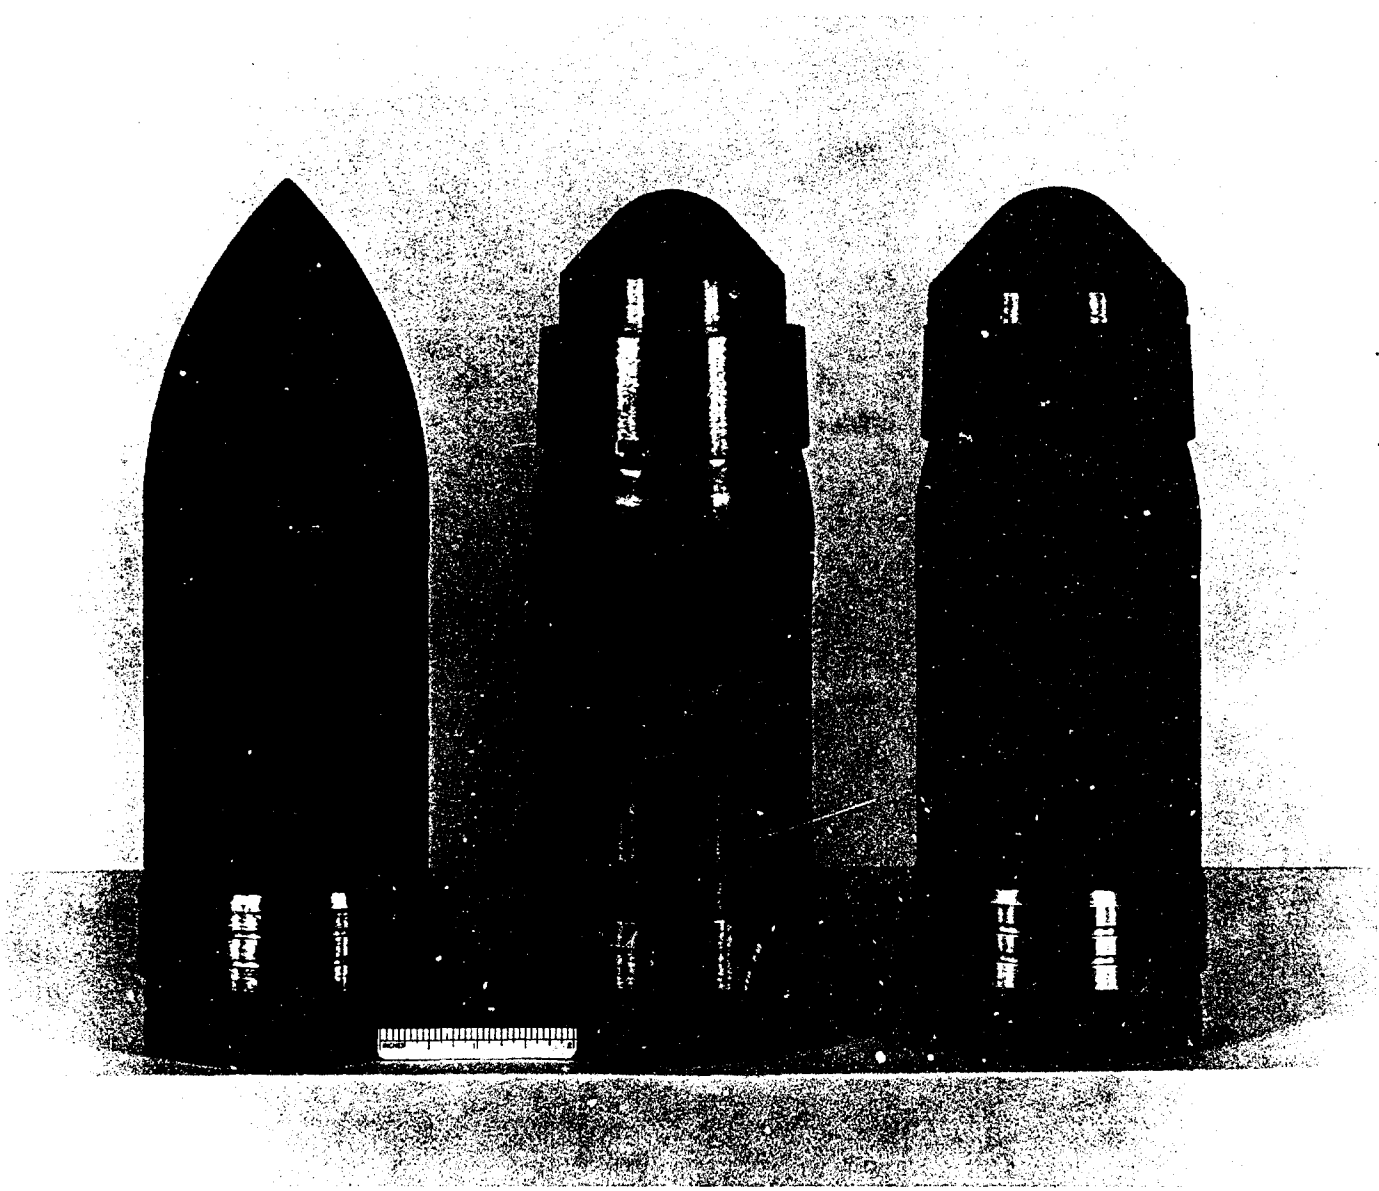
NPG PHOTO NO. 3271 (APL).  
Projectiles used in study of armor non-uniformity. Left to Right:  
3" M79, 3" M61, 3" M62.  
15 April 1946

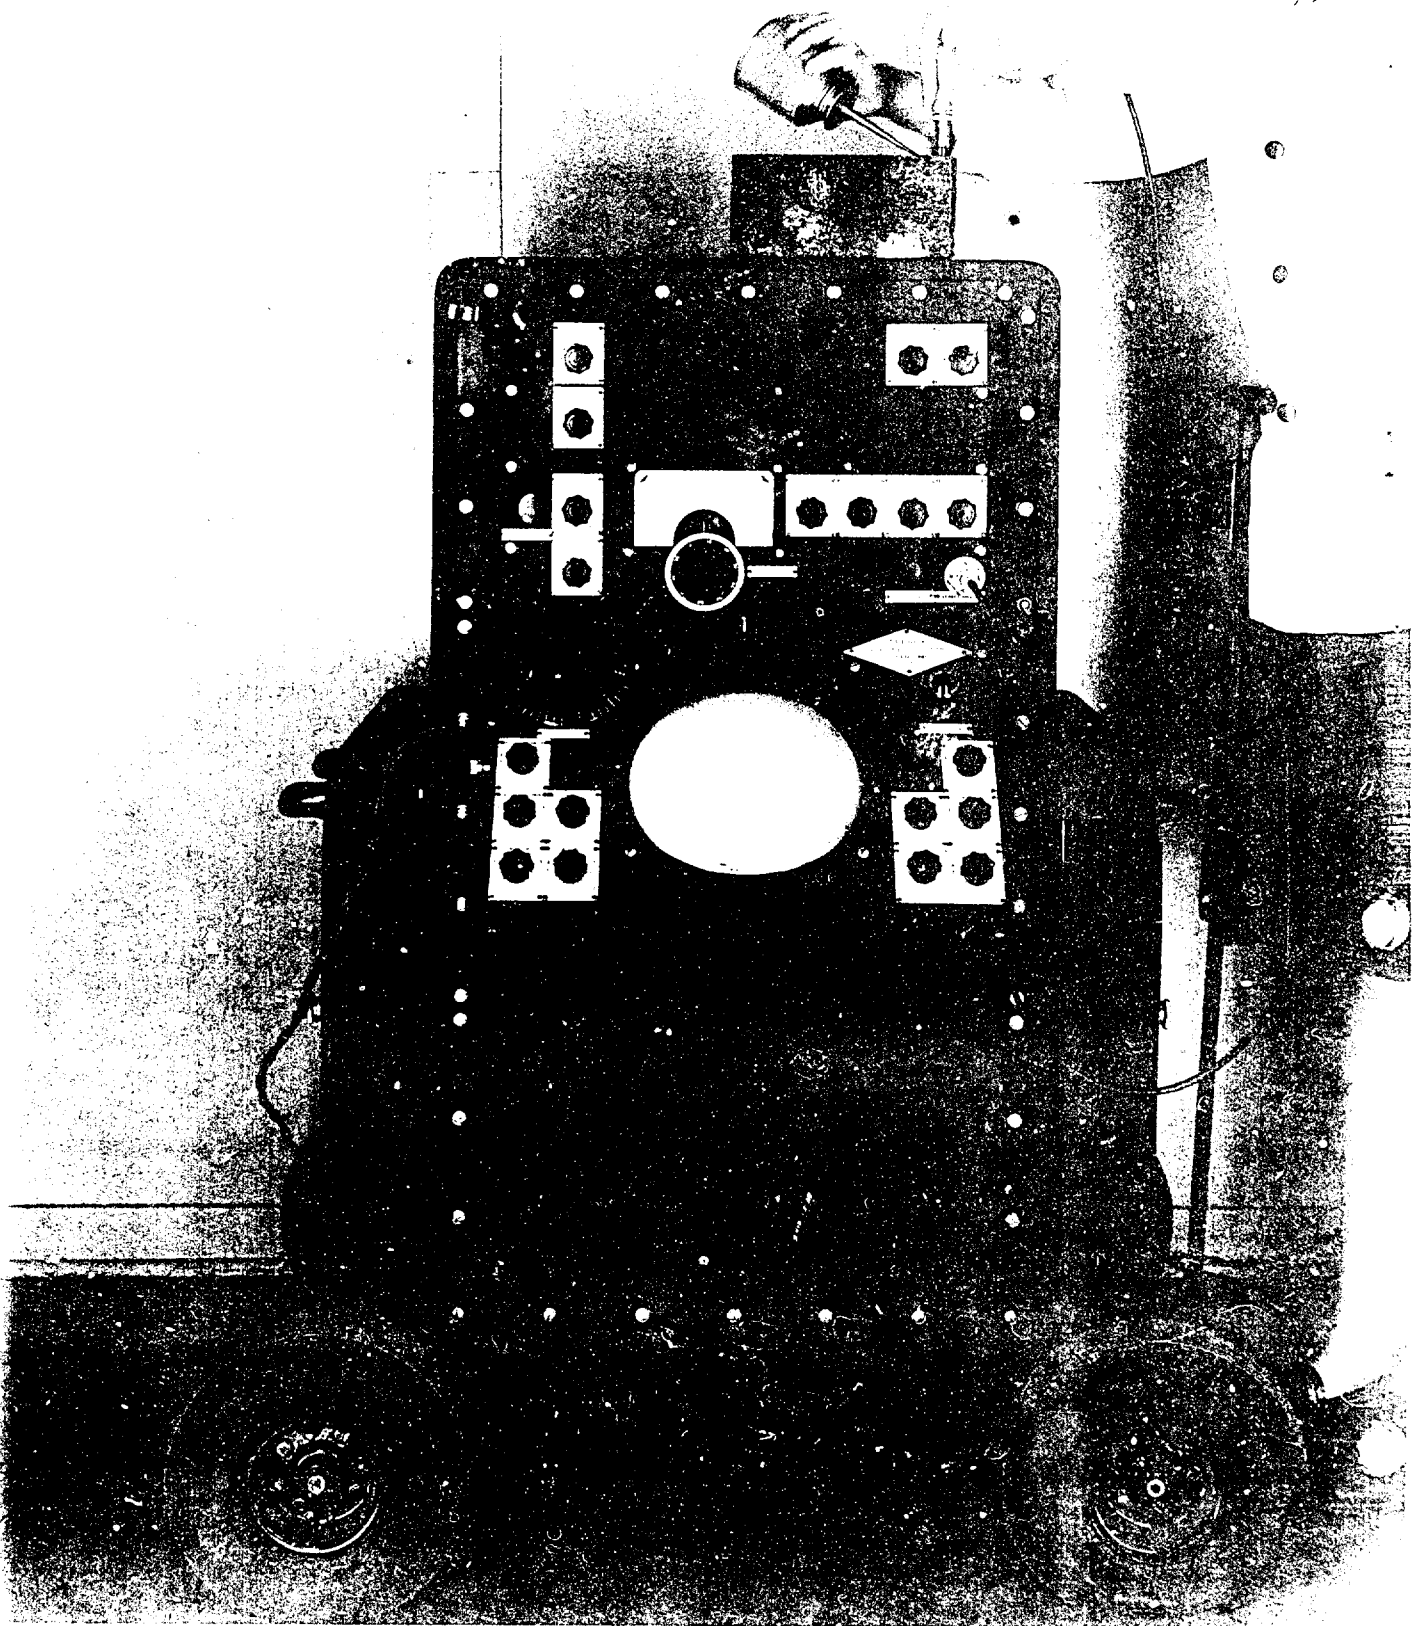
Fig. 2

NPG PHOTO NO. 3776 (APL).  
Operator making test with Sperry Supersonic Reflectoscope.  
15 April 1946

The Sperry supersonic reflectoscope is an instrument which employs a vibrating crystal to send and receive supersonic signals through a plate (or other solid medium) and visually indicates on a cathode ray oscilloscope the time elapsed between the transmission of the signals and return of their reflections. If the plate being tested is free from defects having reflecting surfaces, the reflections will come from the opposite side only. If the plate contains defects

possessing reflecting surfaces, reflections will be received in a shorter time and will appear on the oscilloscope between the indication representing the signal entering the plate and that representing the signal being reflected from the back of the plate. The location on the oscilloscope trace of the reflection from the defect indicates the depth of the defect below the surface of the plate. There is also some evidence that the visual appearance of the reflection depends somewhat on the character of the flaw.

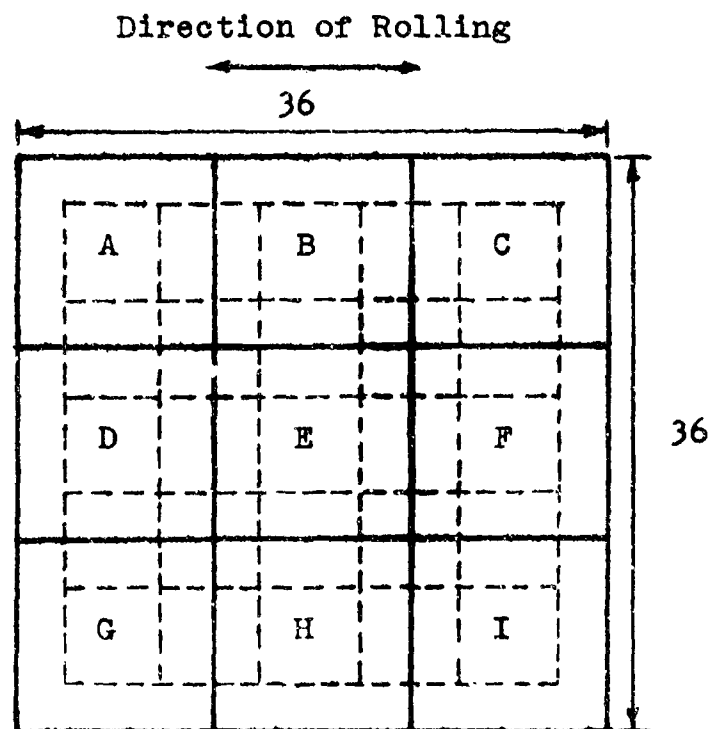
NPG PHOTO NO. 3075 APL 15 April 1946

DIAGRAM SHOWING LOCATION ON APL PLATES OF  
TESTS MADE WITH SUPERSONIC REFLECTOSCOPE

Letters identify 12" x 12" regions of plate. The position of each impact listed in ballistic data, Appendix C, is described by one of these letters.

Tests were made with supersonic reflectoscope at least every six inches, starting 3" from edge of plate. Points of tests are indicated by intersection of dotted lines.

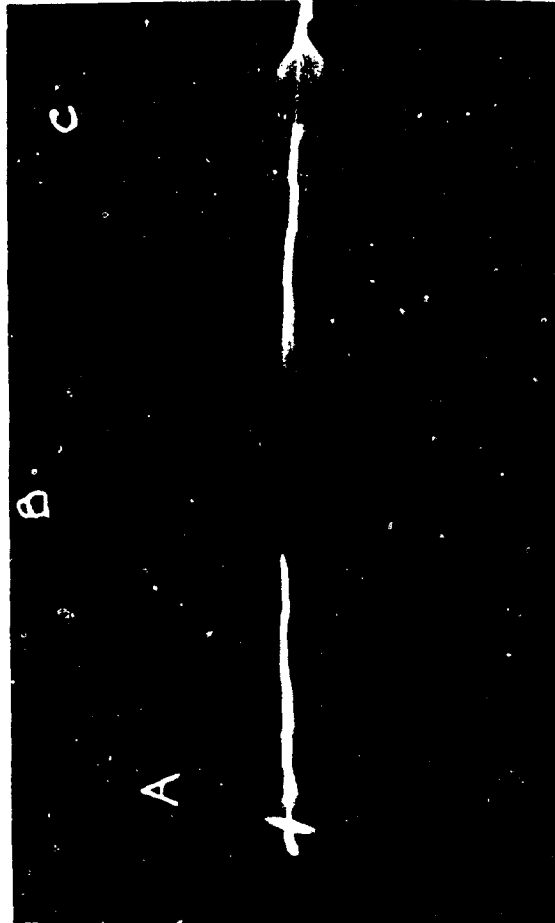
Fig. 5

NPG PHOTO NO. 3259 (APL).  
Supersonic reading obtained at indicated point on macroetched section of  
APL 166, Region A. A - initial pulse. B - back reflection. C - second  
back reflection (not usually considered in evaluating readings). No  
flaws indicated.  
15 April 1946

With only a few exceptions each of the impact areas listed in the detailed ballistic data, Appendix C, was surveyed for flaws with the 5 megacycle supersonic searching unit. Fig. 4 shows the location of tests on an APL plate. Fig. 3, previously referred to, lists the results of supersonic testing and the type of failures obtained on plate 89001. Figs. 5-8 are composite photographs of supersonic readings and the corresponding macroetch sections taken from some of the APL plates used in the subject investigation. The supersonic readings were taken about 0.25 below the macroetched surfaces at the cross section indicated in the photographs.

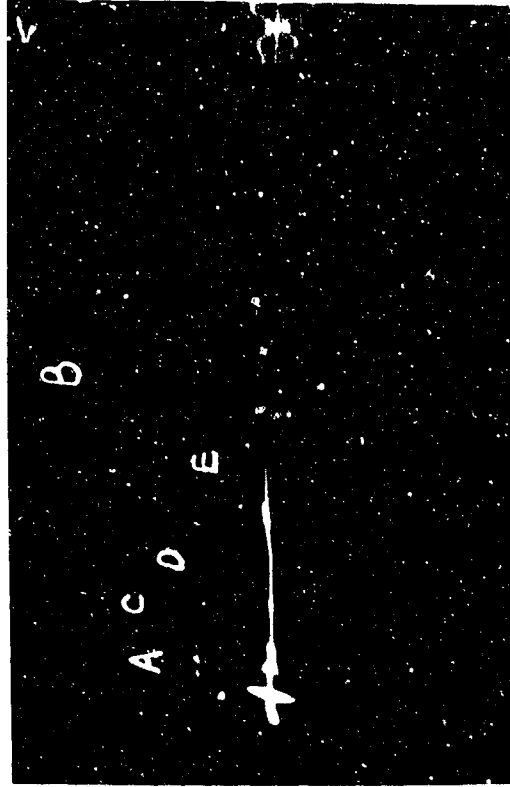
FIG. 7

NPG PHOTO NO. 3255 (APL).  
Supersonic reading obtained at indicated point on macroetched section of APL  
180, Region E. A - initial pulse. B - back reflection. C - large flaw  
indication. D - medium flaw indication. E - small flaw indication.
