| 4. Title and Subtitle<br><br>OH-58 HELICOPTER TRANSMISSION FAILURE ANALYSIS | | 5. Report Date |

## OH-58 HELICOPTER TRANSMISSION FAILURE ANALYSIS

by D. P. Townsend, J. J. Coy, and B. R. Hatvani

Lewis Research Center and  
U.S. Army Air Mobility R&D Laboratory

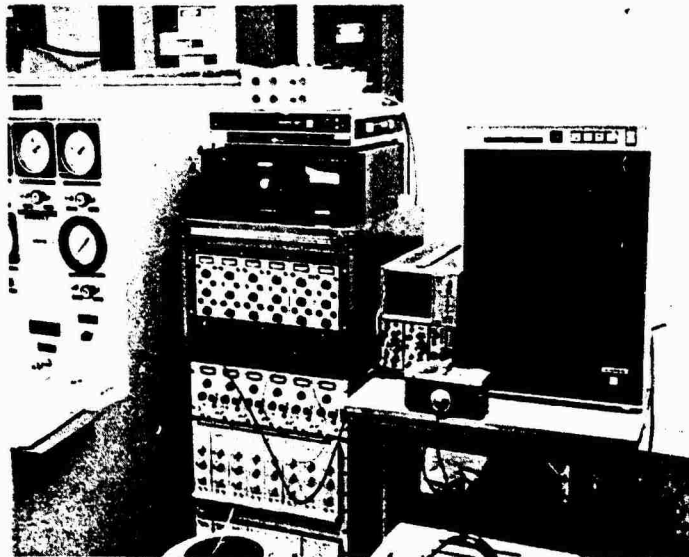
Figure 5. - View of NASA instrumentation in transmission test control room.

The OH-58 gearbox was placed in the Corpus Christi Army Depot OH-58 test stand after being fully instrumented (fig. 3). Figures 4 and 5 show the control room adjacent to the test cell. The test stand was calibrated and the gearbox filled with MIL L-23699 oil. The gearbox was operated for several hours to check out the instrumentation and to check for oil leaks, slipping operation and input shaft balance condition. This running time also gave additional break-in time for the new gearbox.

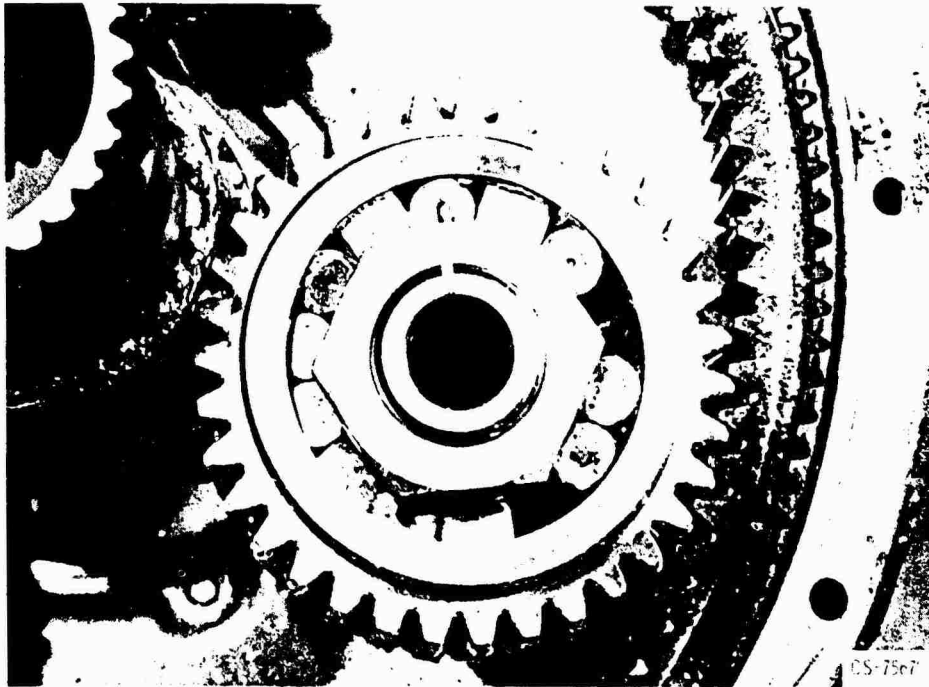
The rate of increase of the pinion temperatures slowed until at approximately 14 minutes the rate began to increase again (figs. 8(a) and (b)). These increases in temperature were caused by additional planet bearing cages melting which allowed the spherical rollers in the planet gear bearings to tumble and slide within the bearings (fig. 11).

Figure 11. - Planet gear support bearing. Badly misaligned and skewed rollers caused high vibration and temperature levels.

3. Change the spherical roller bearings to cylindrical roller bearings with rigid straddle mounting to replace the overhung mounting. This change would reduce the heat generation in the planet bearing up to 30 percent. Further testing would be required.
